Durability of Repaired and Aged Lead-free Electronic Assemblies

Anupam Choubey, Michael Osterman, Michael Pecht
Center for Advanced Life Cycle Engineering (CALCE)
Department of Mechanical Engineering
University of Maryland

Abstract

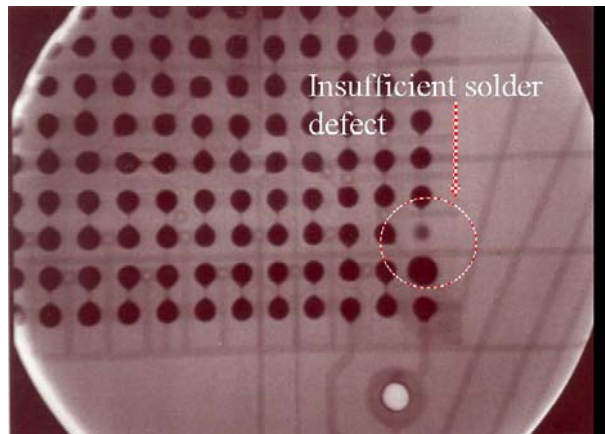
After repair all the components were inspected with X-ray. No defects were found in BGA components except for one open chain due to insufficient solder in the repaired BGA (Figure 4). Figure 5 shows a solder mask rip-off defect found on a repaired QFP package. Solder mask rip-off causes exposure of copper trace, which could result in failure due to copper migration and corrosion. No such defects were found in the non-repaired assemblies.

Figure 4 - X-ray image of BGA solder balls showing insufficient solder site

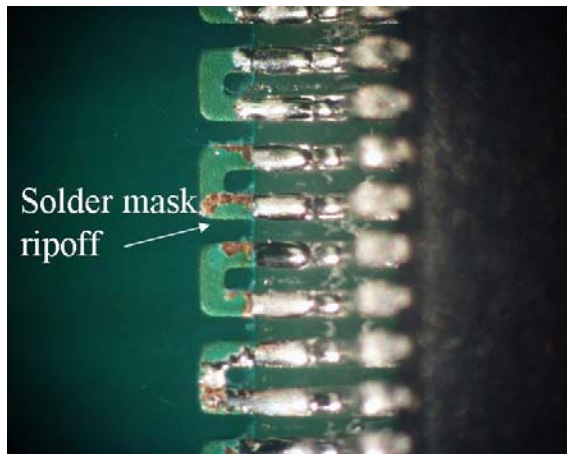
Figure 5: Solder mask rip off defect (QFP (Sn finish) repaired with Sn37Pb solder)

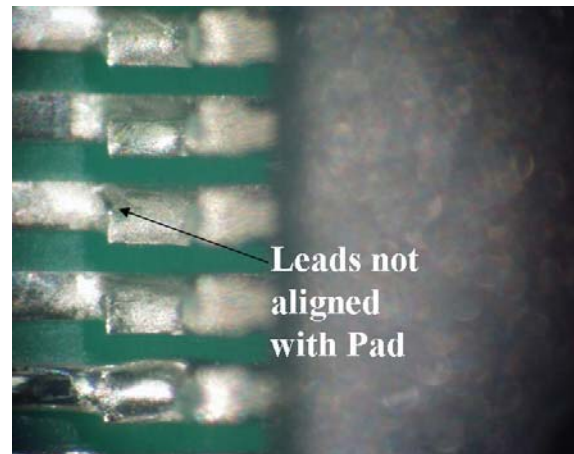
Figure 6 shows misaligned leads of a repaired QFP package, which causes reduction in the solder-joint area. According to the IPC-A-610D standard [13], a side overhang of < 50 percent is allowable for qualifying assemblies for class 1 and 2 applications, and < 25 percent is allowable for class 3 applications (classes as per the standard). Figures 7 and 8 show the optical image of solder balls at the edge and at the center, respectively, of a repaired BGA. A difference in solder joint height was clearly observed between the corner balls and balls in the middle of the outer rows. The observed effect indicates that the BGA components experience warpage during the assembly process. The difference in solder ball height was confirmed with X-ray images of the same BGA package (shown in Figure 9).

Figure 6: Lead not aligned with pad (QFP (tin-lead) repaired with Sn3.0Ag0.5Cu solder on HASL)

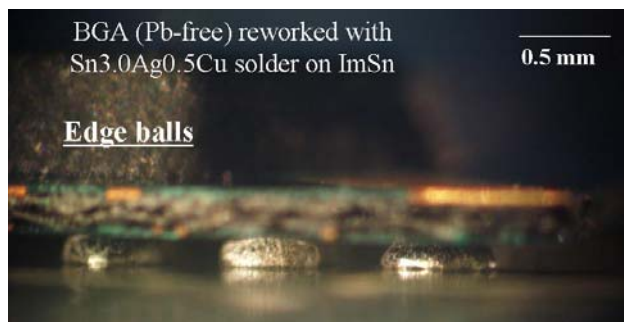
Figure 7 - BGA solder ball on the edges (corners) show less solder-joint height than midsection balls

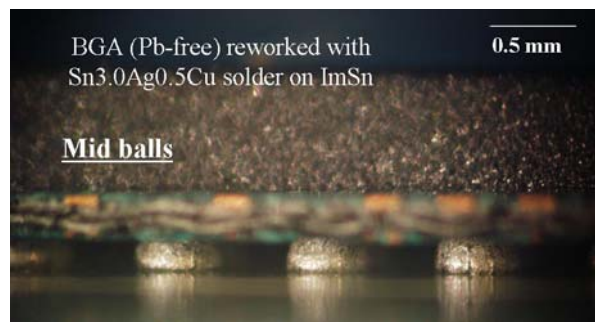
Figure 8 - BGA solder balls on the midsection show higher solder-joint height than edge (corner) balls

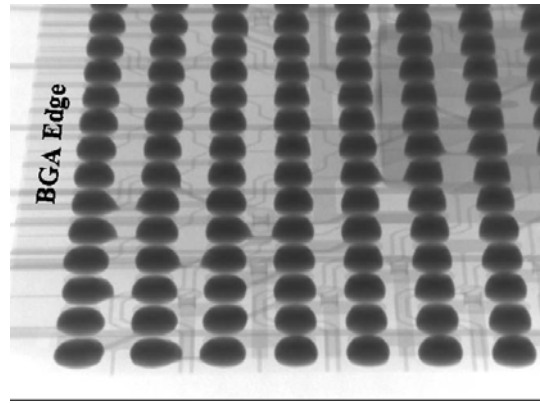
Figure 9 - X-ray image of BGA solder balls showing difference in ball diameter between corner and center

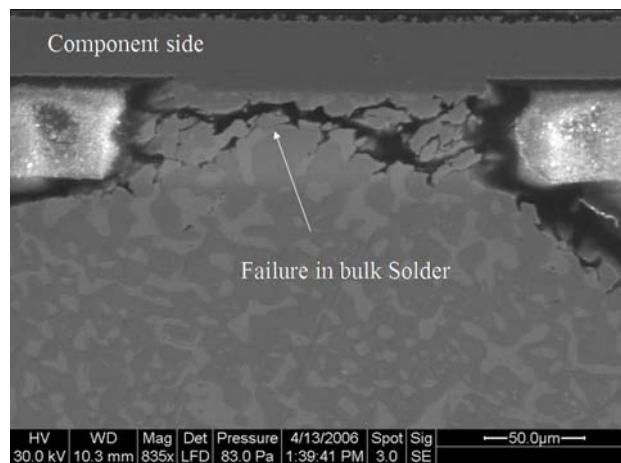
Destructive physical analysis was conducted to determine the failure location in the resistance networks of the failed PBGAs. In all cases, the failure location was found to occur in the solder joint near the component side around the die shadow region for both lead-based and lead-free PBGAs. Material analysis of the copper pad on the component substrate for the BGA package confirmed that it was nickel-plated for both tin-lead and lead-free BGA components. Gold was not found in the solder region near the pad. The solder joint was solder-mask-defined at the component side and copper-pad-defined at the board pad side. Figure 14 shows the failure in a tin-lead solder joint at the component side in the bulk solder.

Figure 14 - Failure was found on the component side for BGA (SnPb) assembled with SnPb solder on HASL(SnPb) pad finish, not repaired, not aged

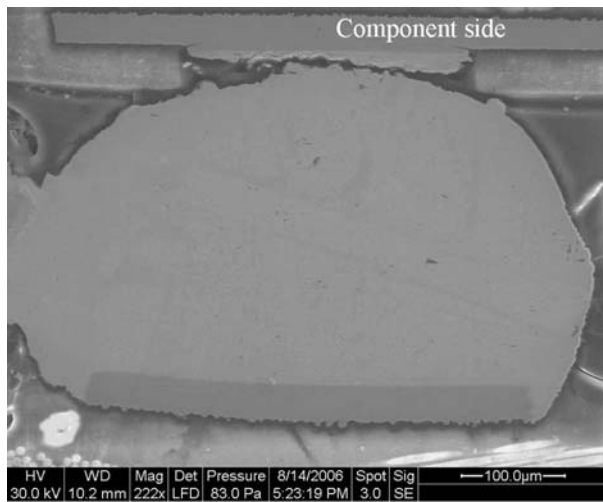
Figure 15 shows an electron image of the failure location for a non-aged lead-free solder joint. Like the lead-based PBGA, the crack was found to be in the bulk solder on the component side. Figure 16 shows an optical image of a failed solder ball for aged lead-free solder joint. For the thermal-aged solder joint, the intermetallic thickness at the board side is observed to be thicker than the intermetallic observed on the board side for the non-aged PBGA.

Figure 15 - BGA (SnAgCu)-SnAgCu solder-ImSn finish (non-aged)--failed ball shows failure on the component side.

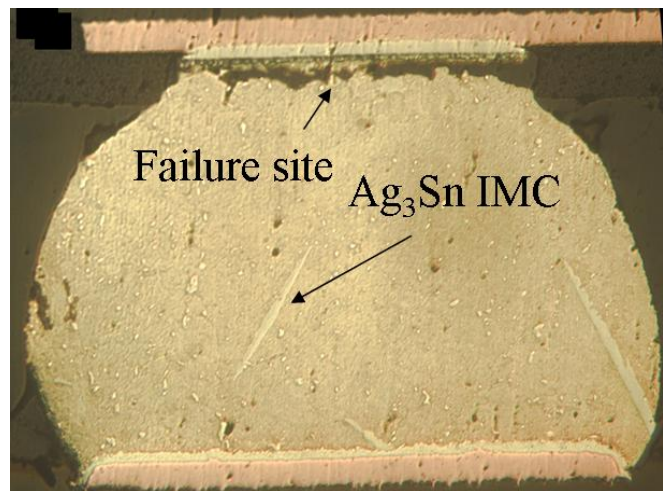
Figure 16 - BGA (SnAgCu)-SnAgCu solder-ImSn finish-aged--failed ball shows failure on the component side.

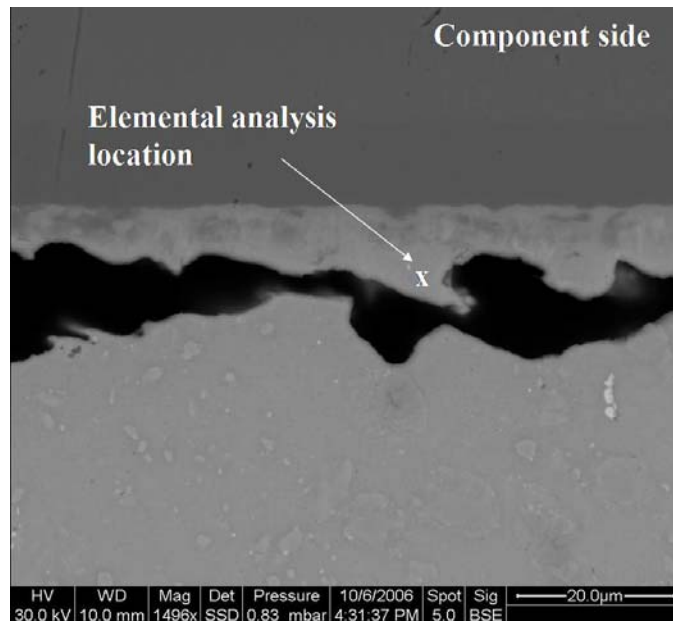
Elemental analysis was conducted using energy-dispersive X-ray spectroscopy (EDS) to investigate the presence of various elements above the fracture site. It was found that the area above the crack was rich in tin, which indicates the crack was present in the bulk solder below the intermetallic layer (see Figure 17).

Figure 17 - BGA (SnAgCu) on HASL finish. Repaired by replacing BGA (tin-lead) with BGA (SnAgCu) on HASL (tin-lead) board. Failure location was seen in the bulk solder on component side

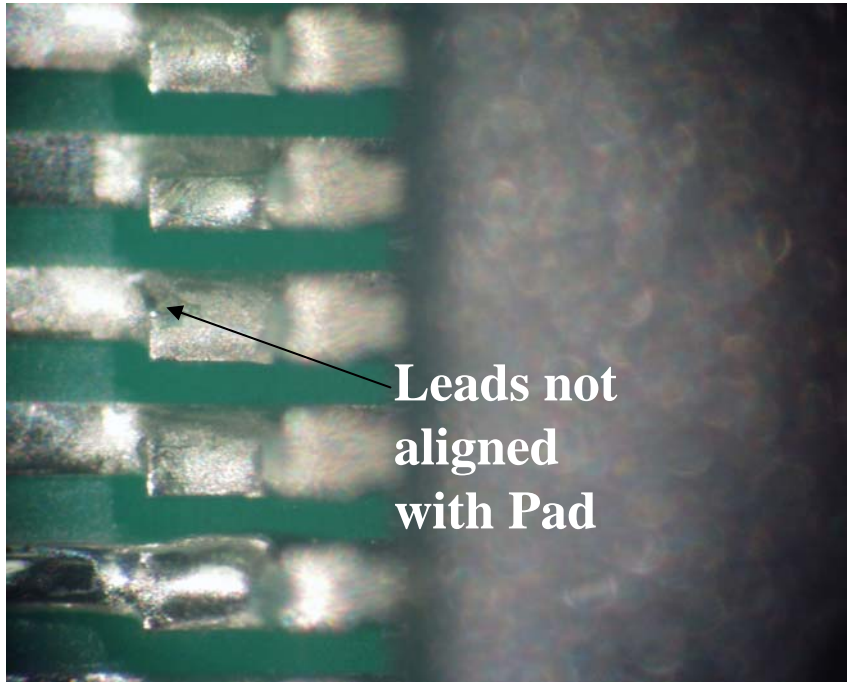
QFP (SnPb) reworked with Sn3.0Ag0.5Cu solder on HASL

- IPC-610D: Side overhang < 50% acceptable for class 1 and 2 and < 25 % acceptable for class 3, Reworked assembly passes class 1 and 2 may not be acceptable for class 3
- Exposed copper may lead to other failure mechanisms

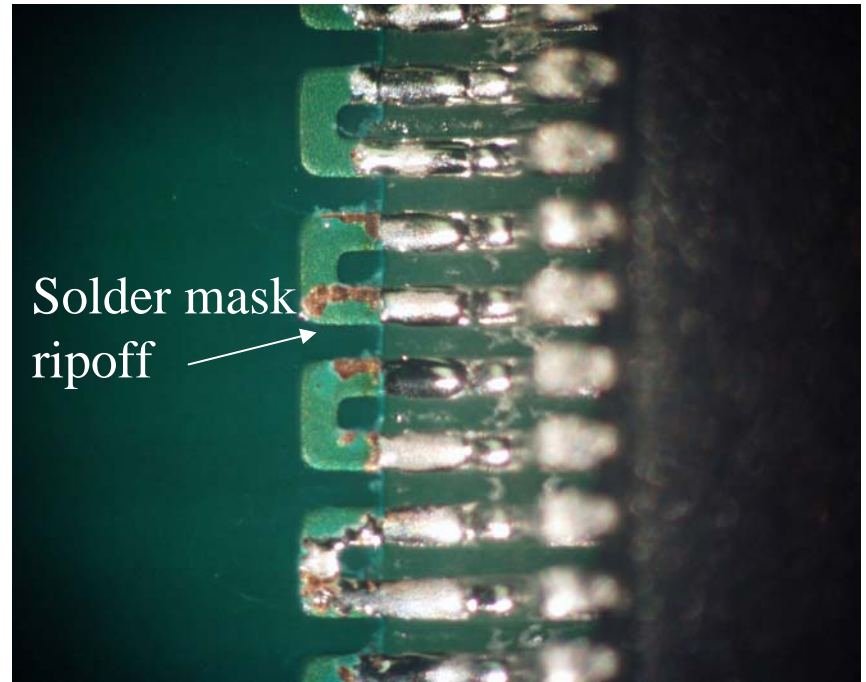
QFP (Sn finish) reworked with Sn37Pb solder

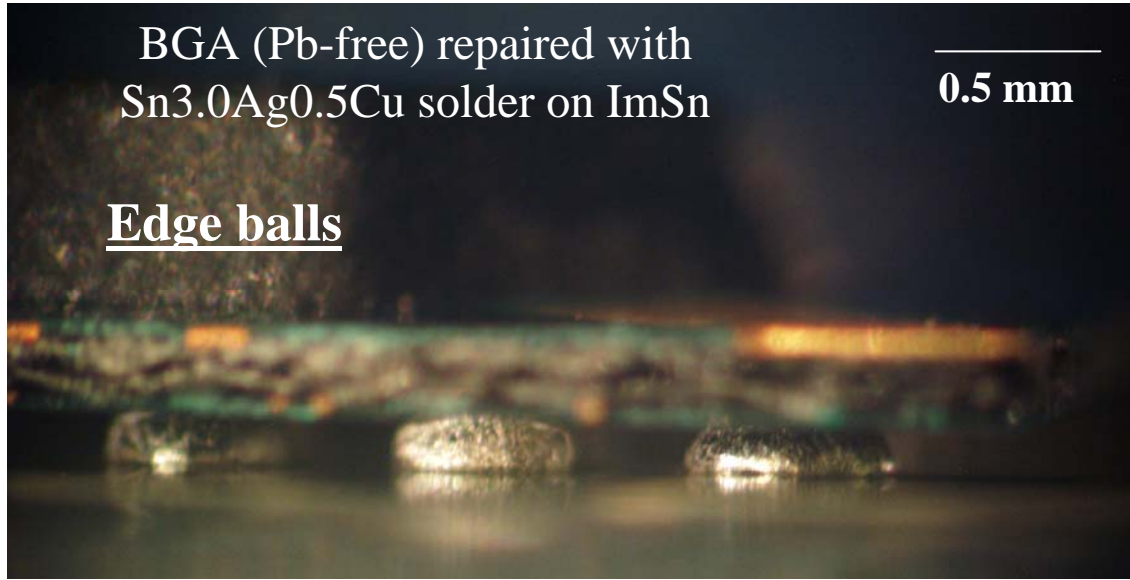
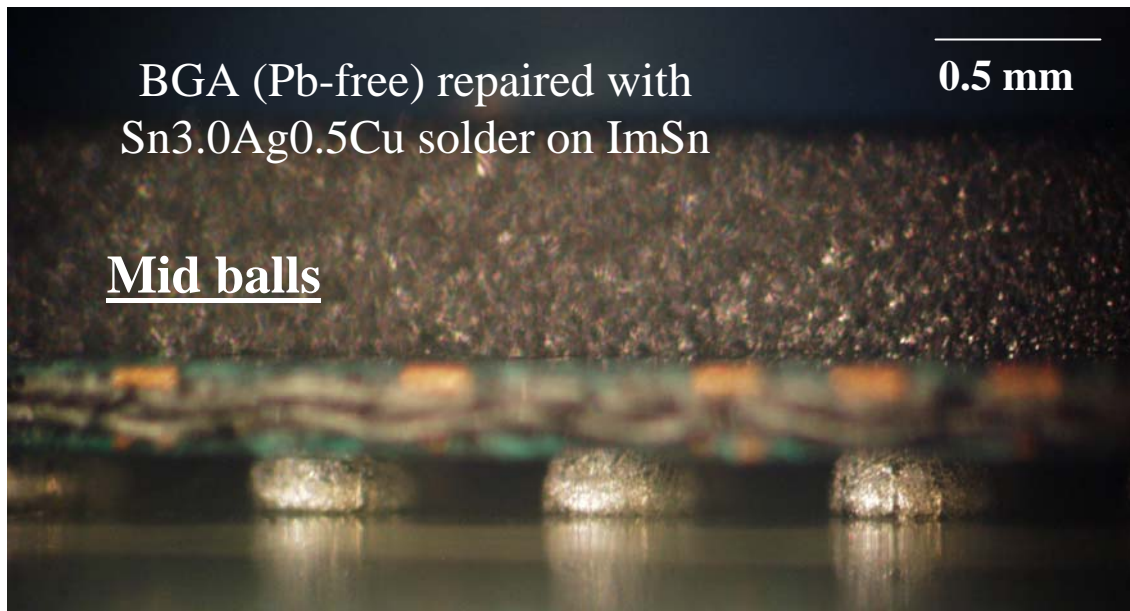
Detailed Inspection of Replaced BGAs

- Difference in solder joint height in the package was observed in repaired BGAs.
- Balls at the edge were squeezed more than those at the mid section of the package.
- Difference in solder height may be due to the warpage in the assembly of board.

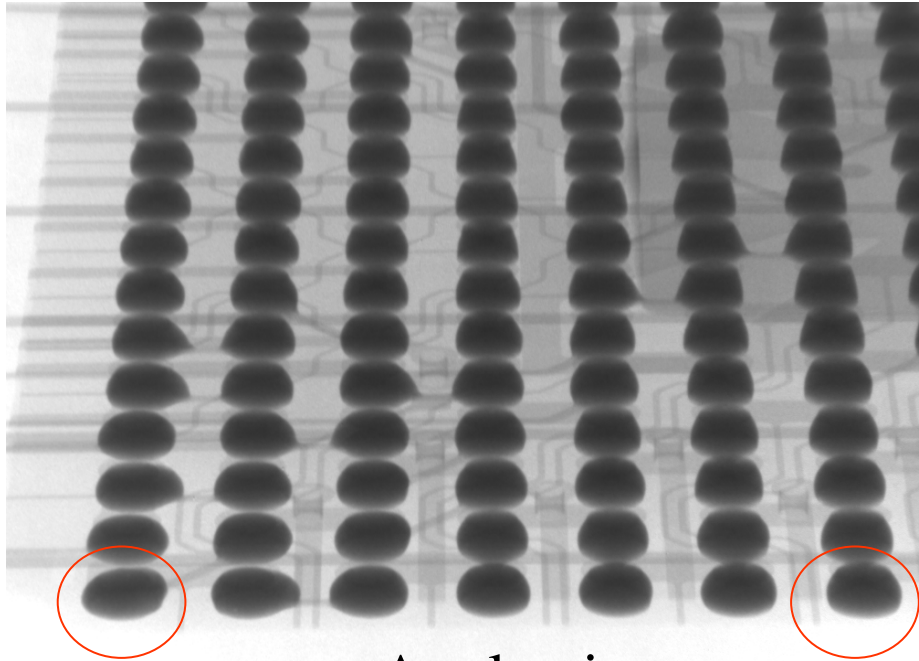
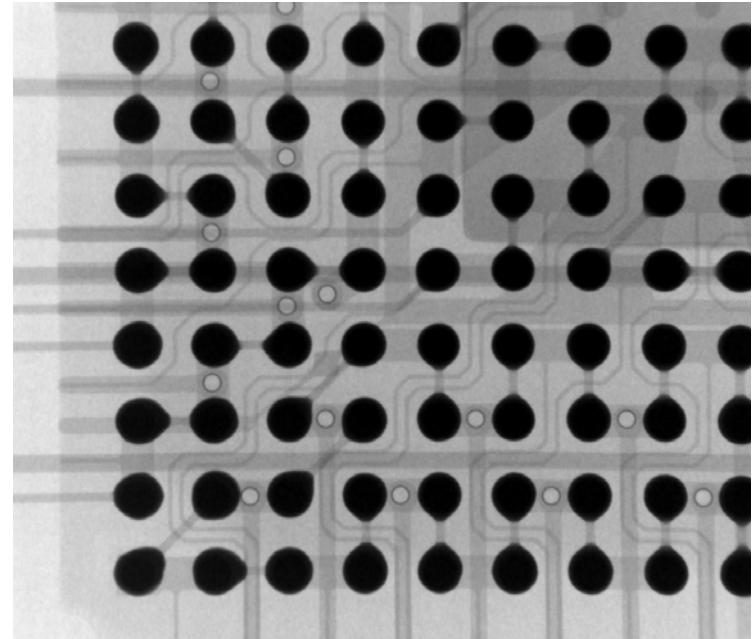
Detailed X-Ray Imaging of Replaced BGAs

BGA (Pb-free) repaired with Sn3.0Ag0.5Cu solder on ImSn

Solder joint height in BGA was confirmed with X-Ray, balls at the edge were observed to have large diameter than those in the mid sections

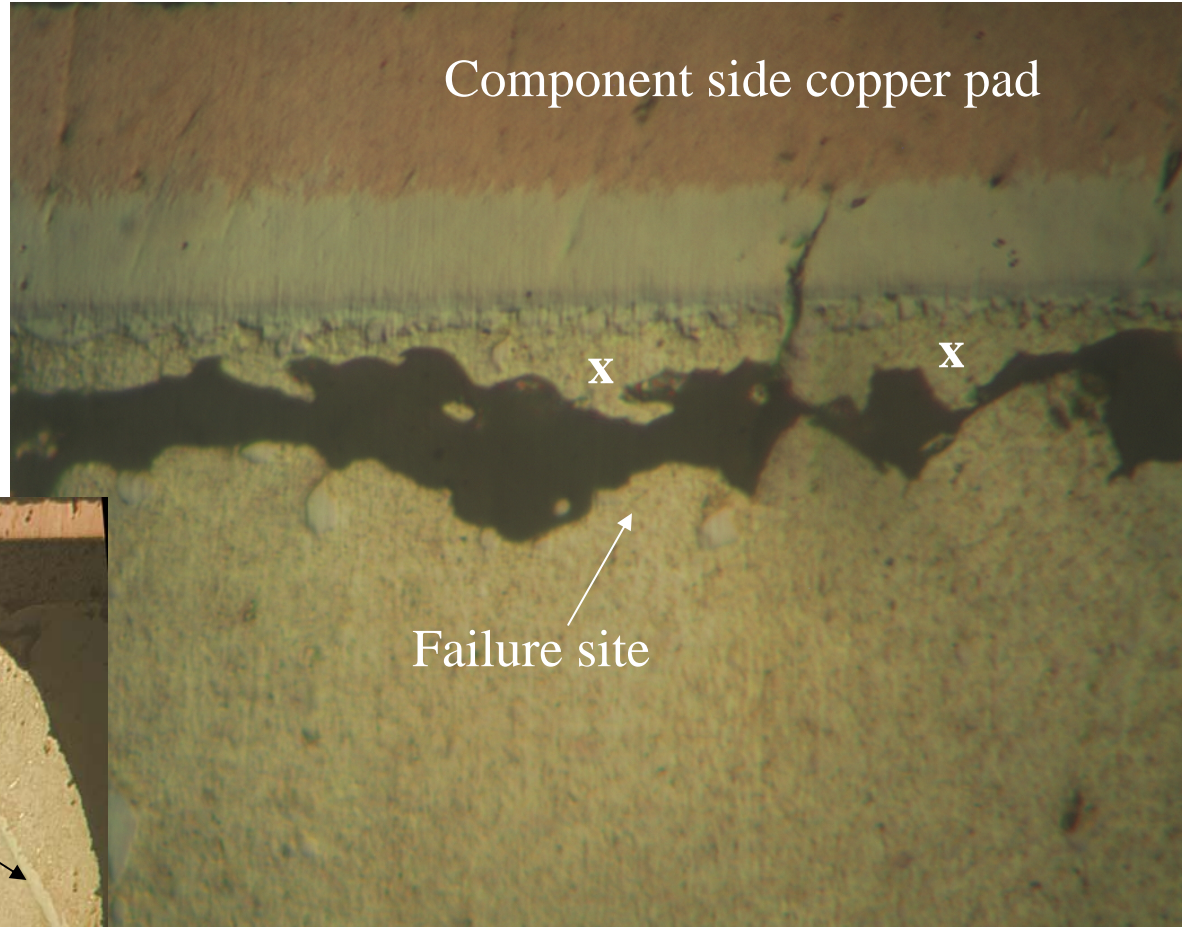
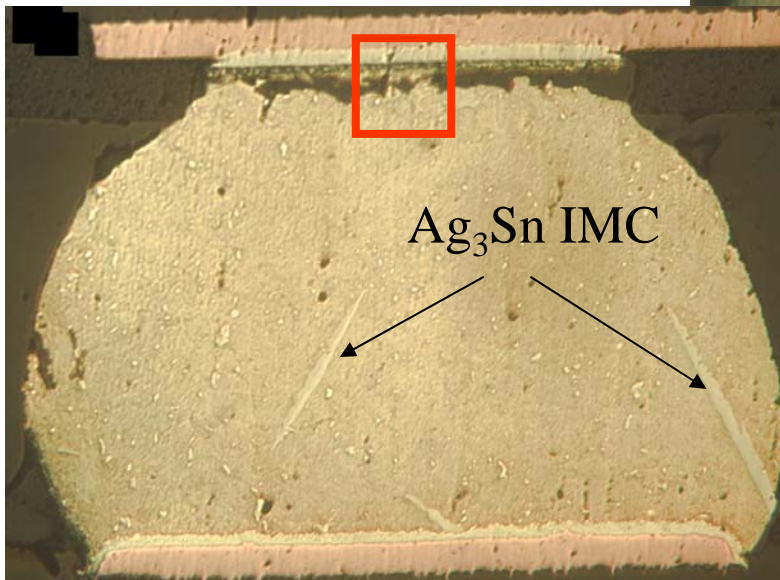
BGA (SnAgCu) – SnAgCu Solder – ImSn Pad Finish – Aged –

Observation: 100% Sn was found in the marked locations above the crack which indicated the location of crack to be in bulk solder
