IPC Electronics Midwest 2010

Drop Testing of a Pb-Free Board after Assembly and SnPb-Rework

P. Snugovsky, J. Bragg, E. Kosiba, M. Thomson, B. Lee, R. Brush,
S. Subramaniam, M. Romansky
Celestica International Inc.

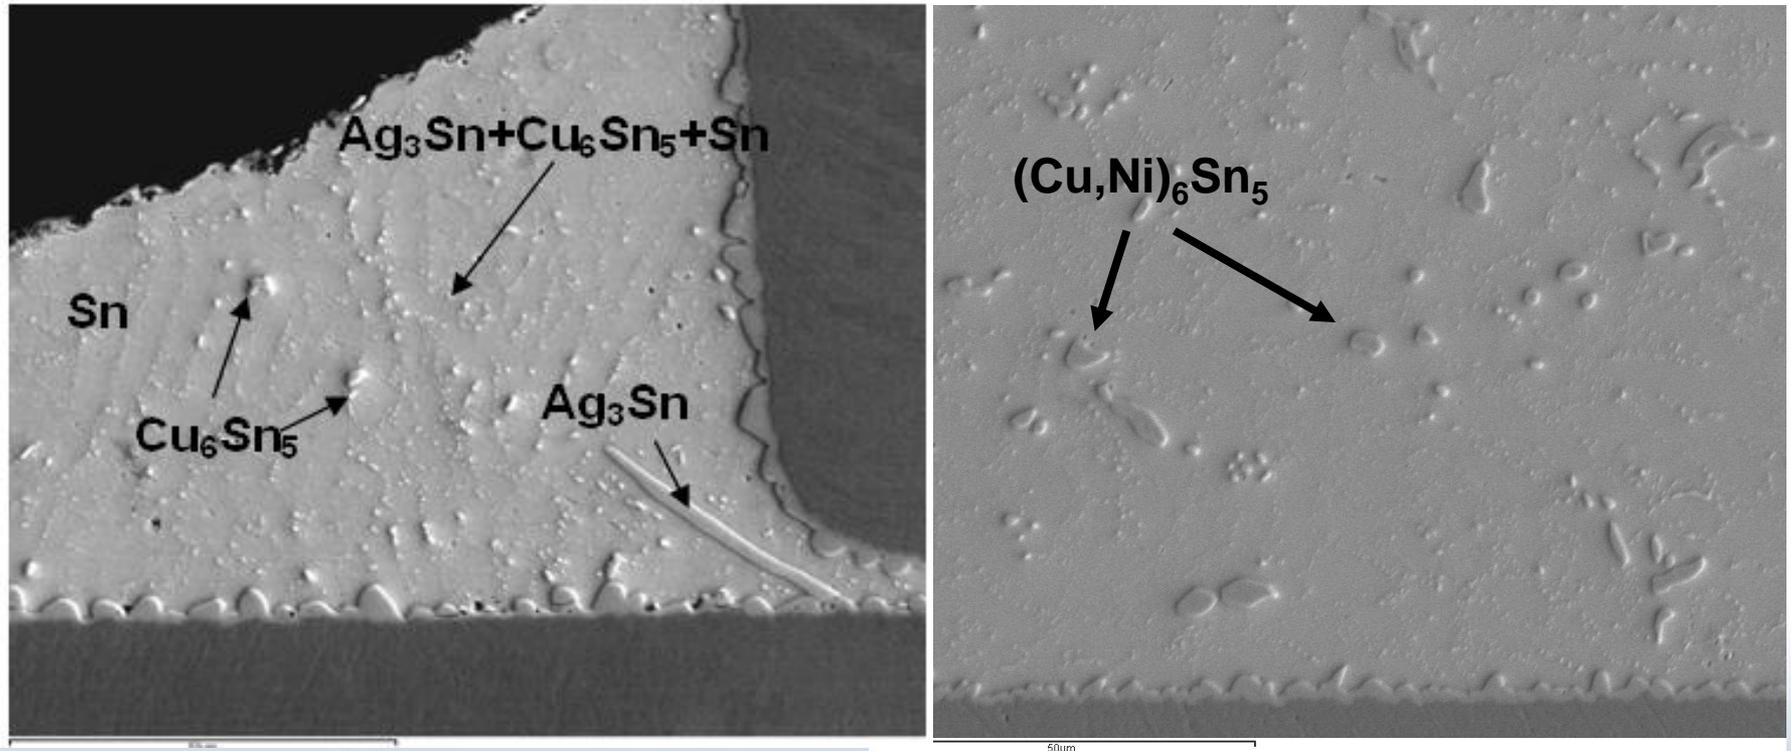
Microstructure of SAC305 solder joints before rework (SEM 1000x)
LHS = TQFP (Cu), RHS = TSOP (alloy 42)

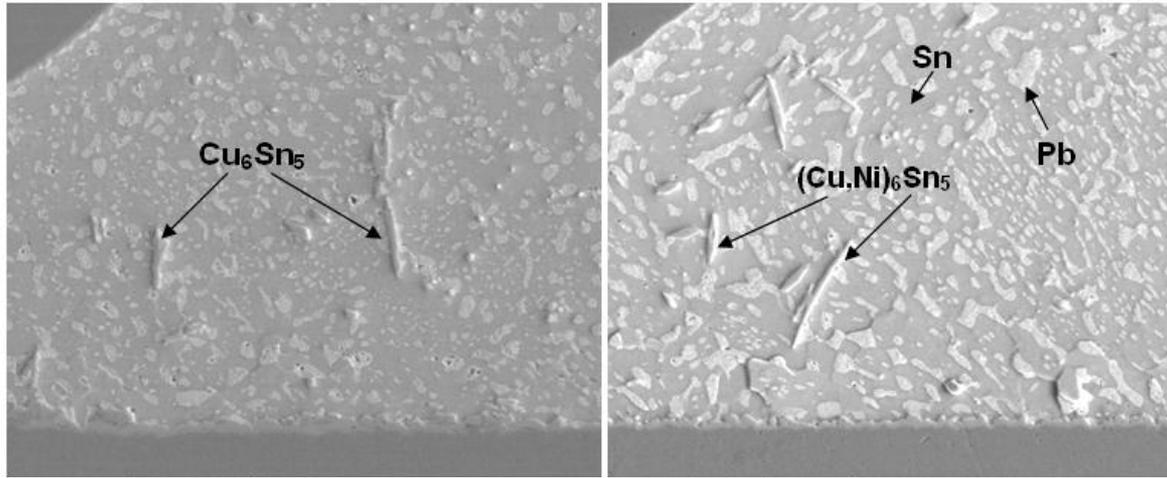
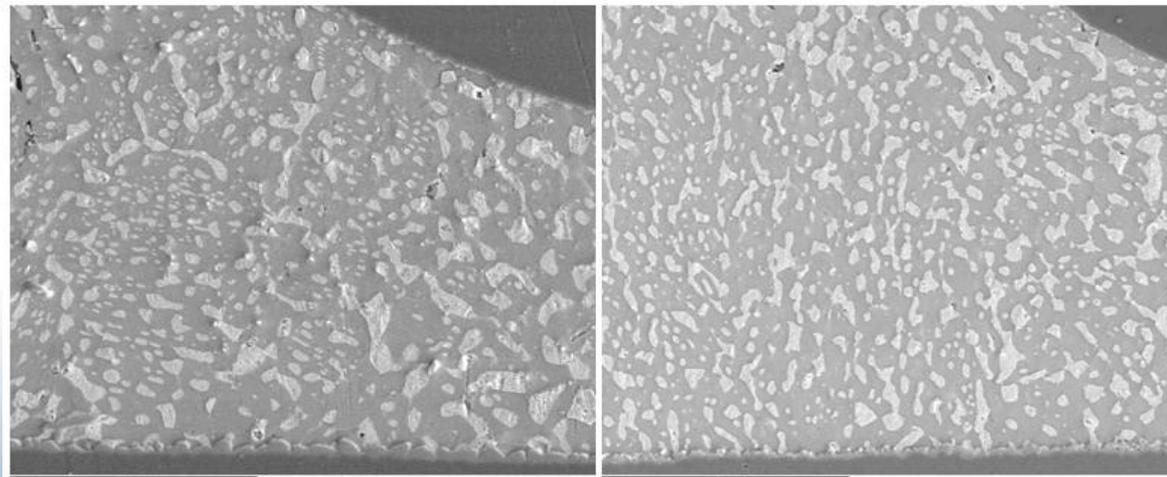
Microstructure of SAC 305 reworked using SnPb solder (SEM, 1000x)
LHS = TQFP (Cu), RHS = TSOP (alloy 42)

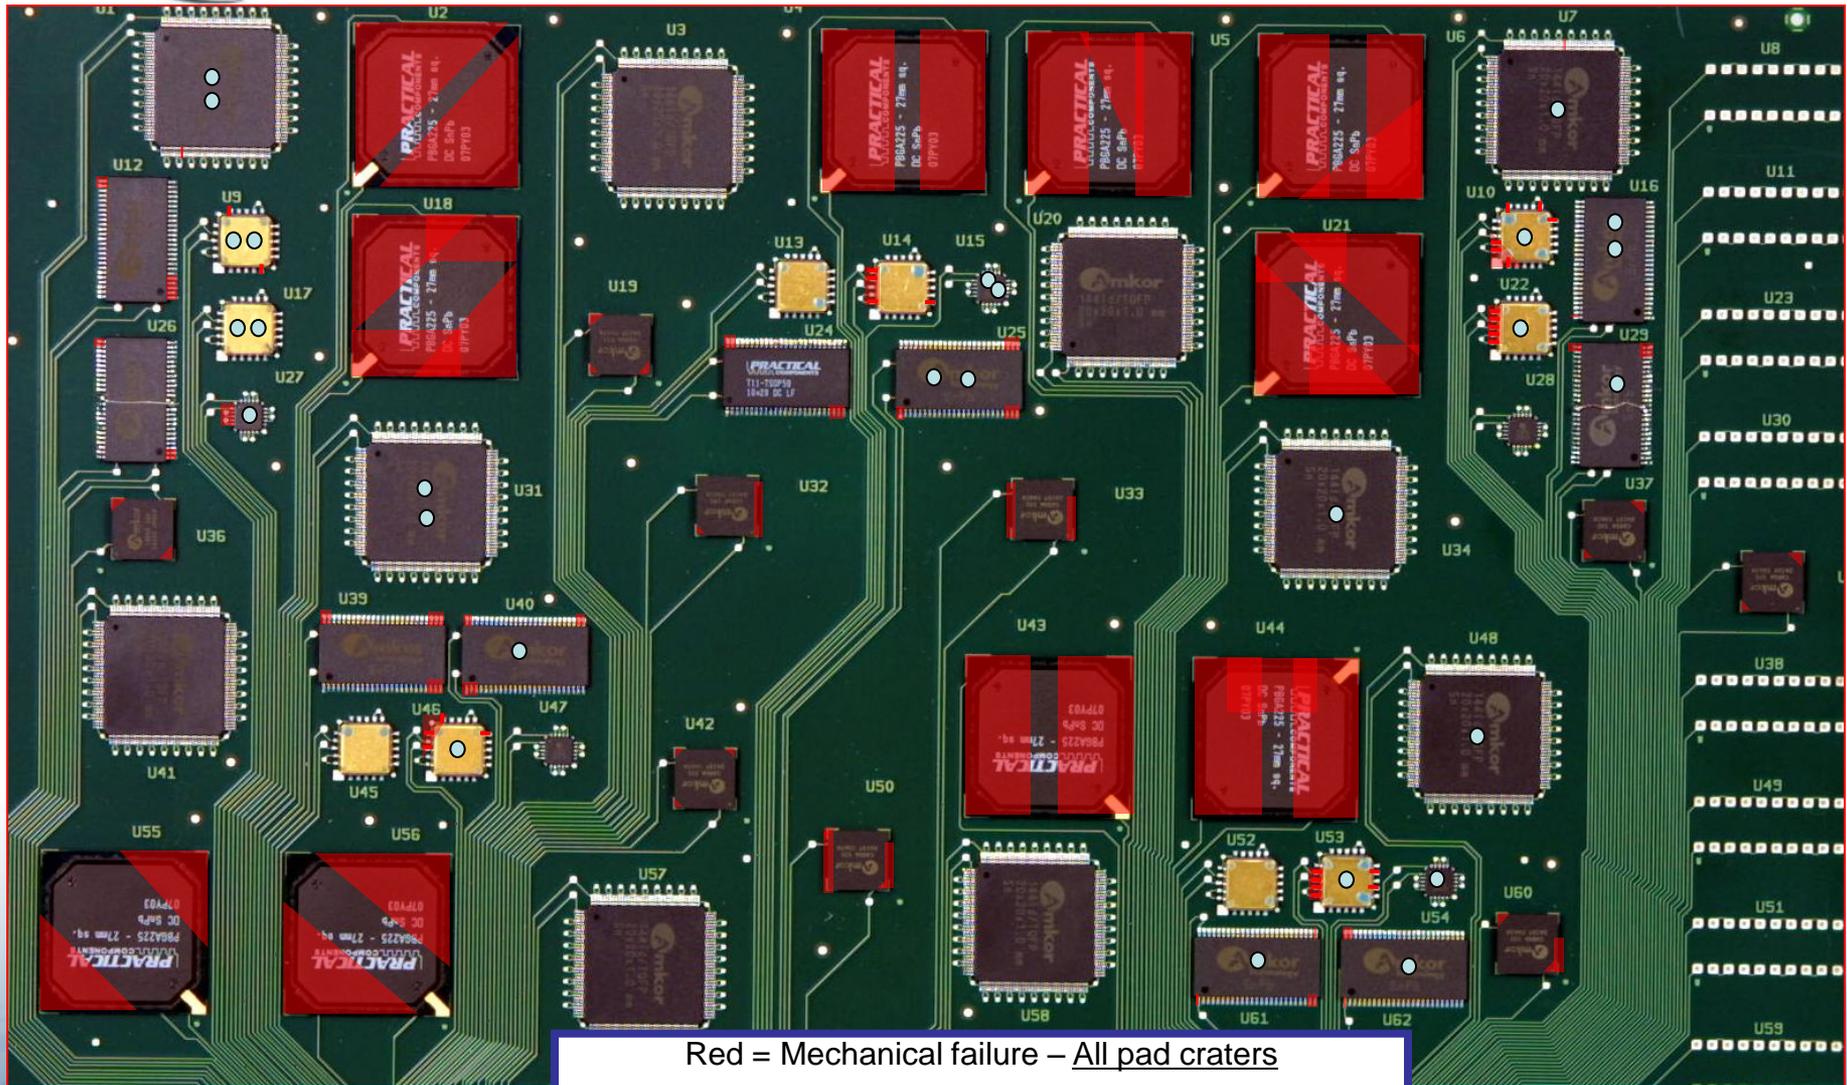
Red = Mechanical failure – All pad craters
All BGAs are Electrically Failed
No leaded parts on this exact board electrically failed
Blue Dots on Some Parts = # of SnPb Hand Reworks

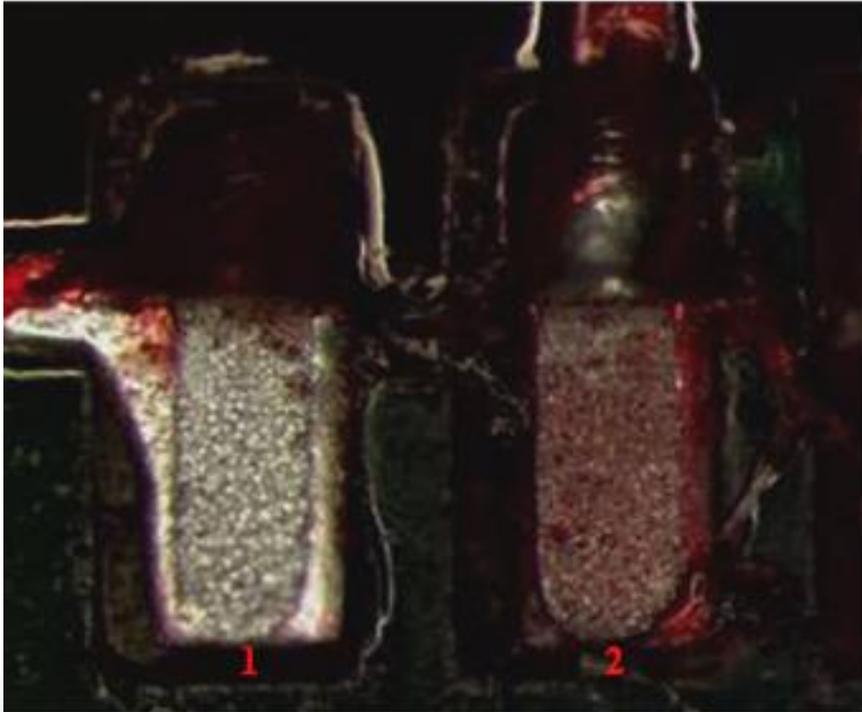
Solder Fracture,
Full Dye Penetration
(QFN, lead 2)

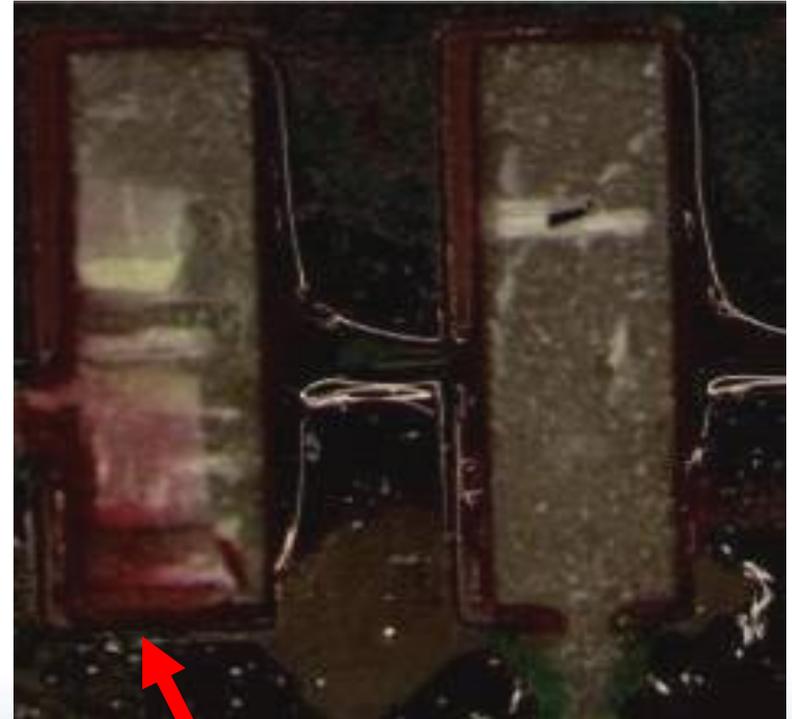
Pad Crater,
Partial Dye Penetration
(CLCC)

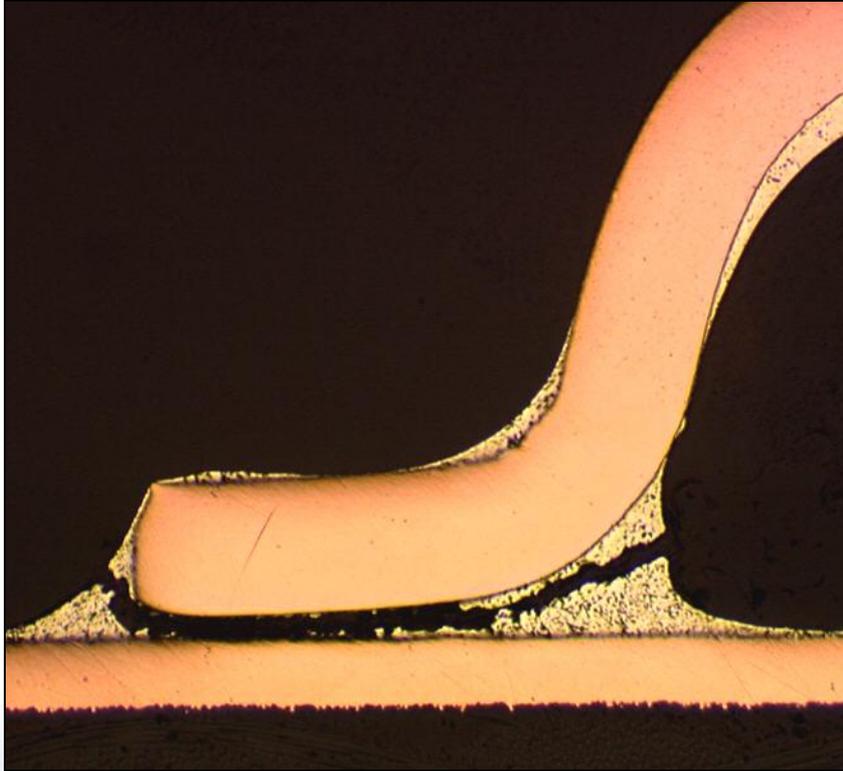
Solder Fracture
(TQFP-144, 1x rework)

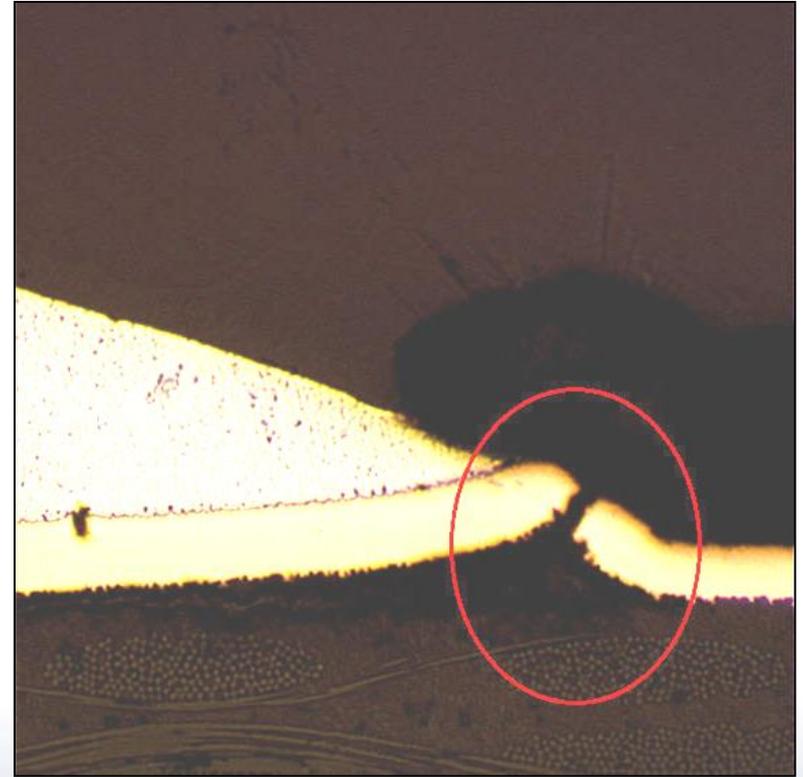
Pad Crater with Trace Break
(CLCC)

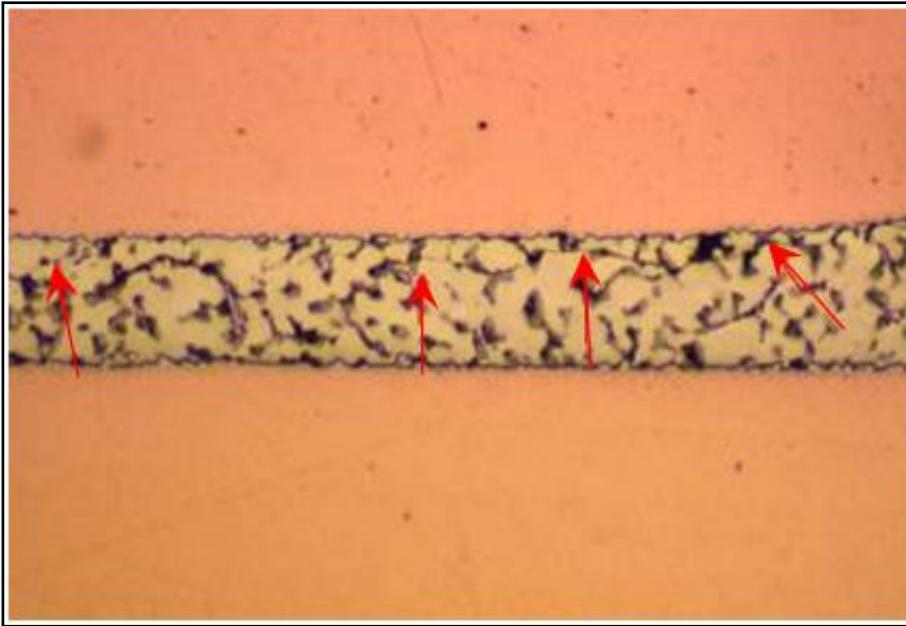
Partial Solder Fracture
(QFN-20, 2x rework)

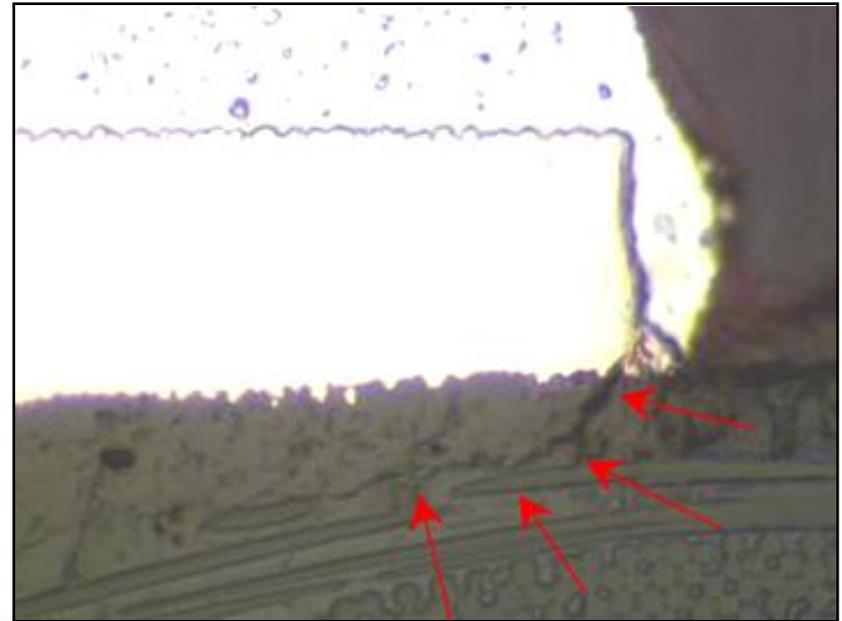
Partial Pad Crater
(QFN-20, 1x rework)
