Bare Board Material Performance after Pb-free Reflow

Ted Lach, Alcatel-Lucent

IPC Midwest Conference Sept, 2009

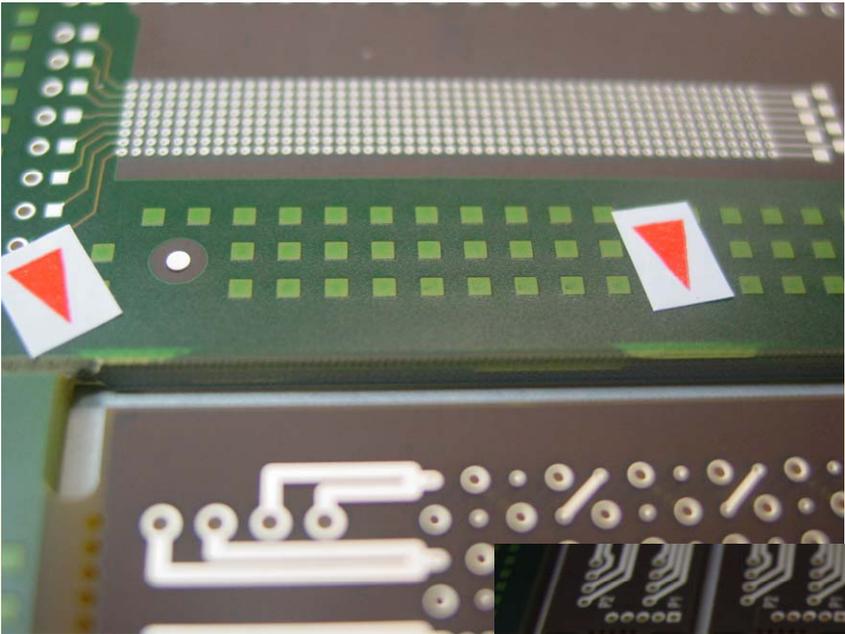
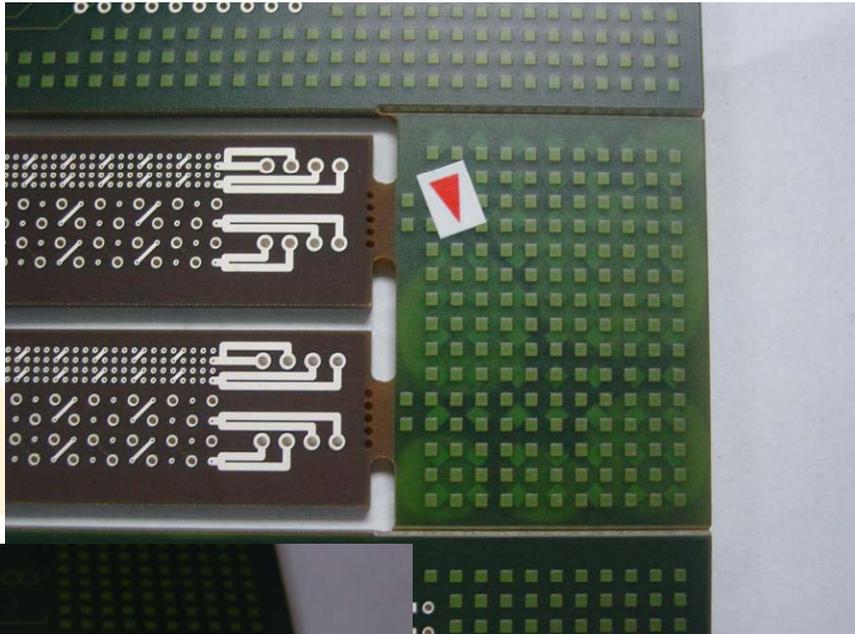
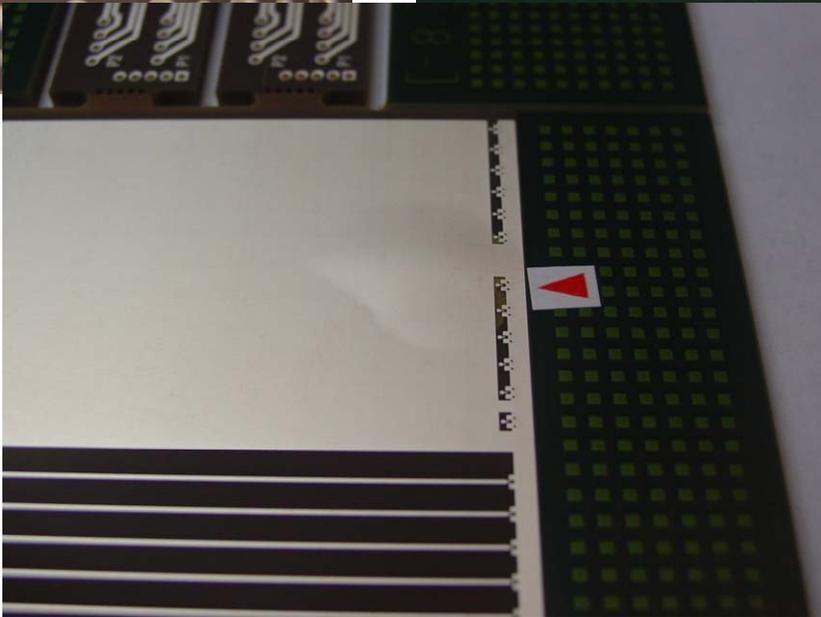
Some Materials showed Visible Defects after Reflow

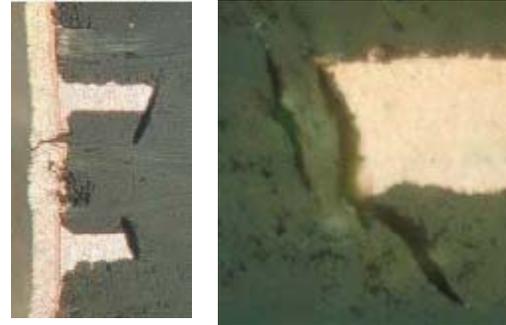
Eyebrow Cracking

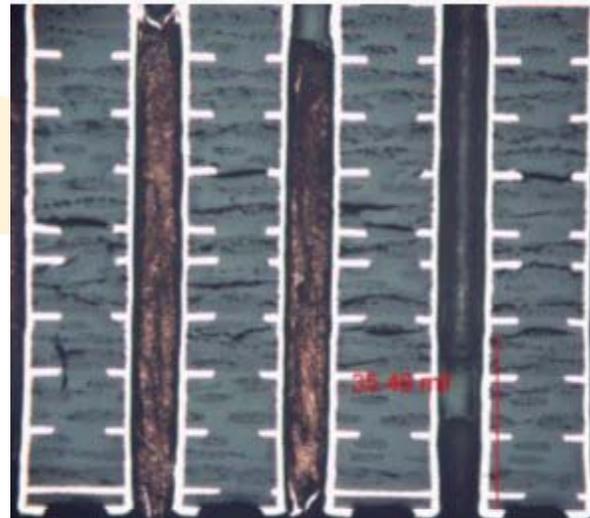
Longitudinal Cracks

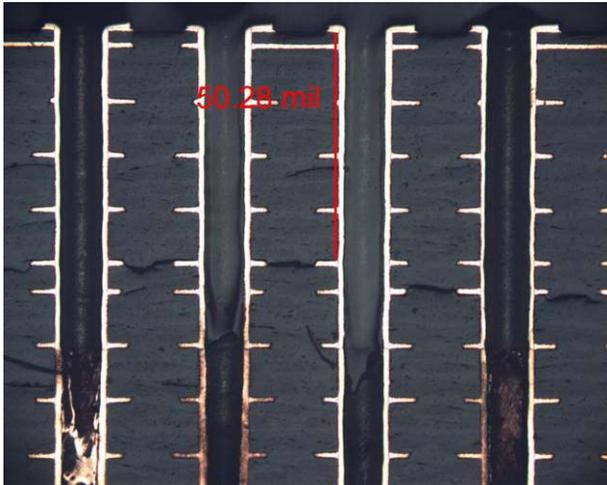
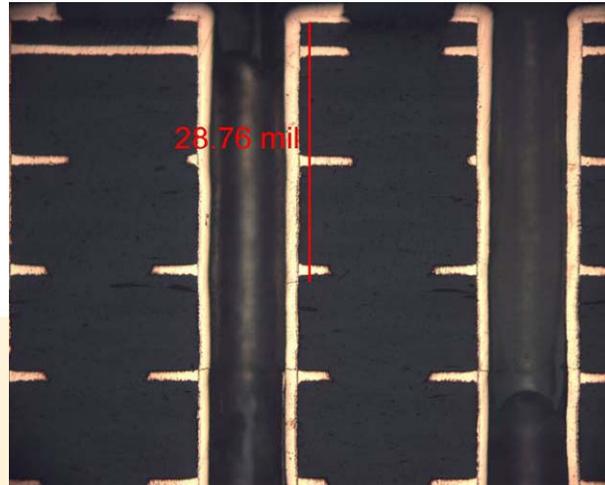
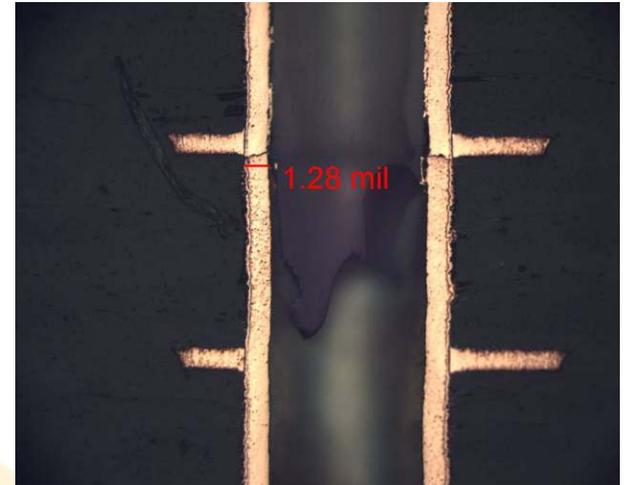
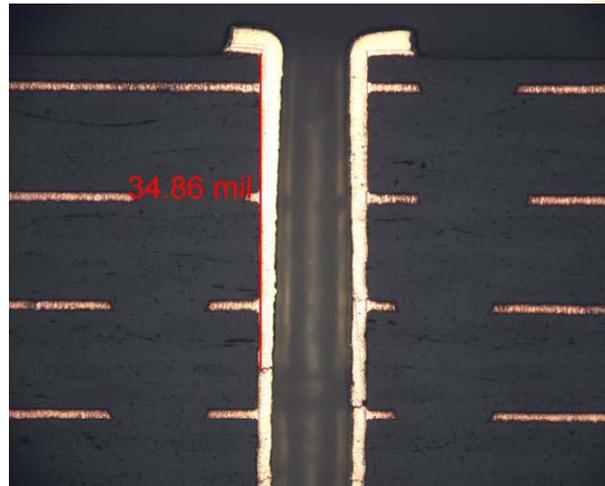
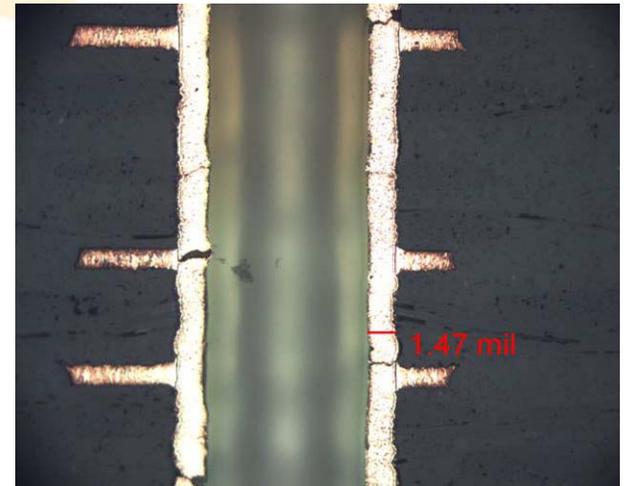
FA – ATC Example (G)

0.8mm pitch (above)
.100" pitch (right)

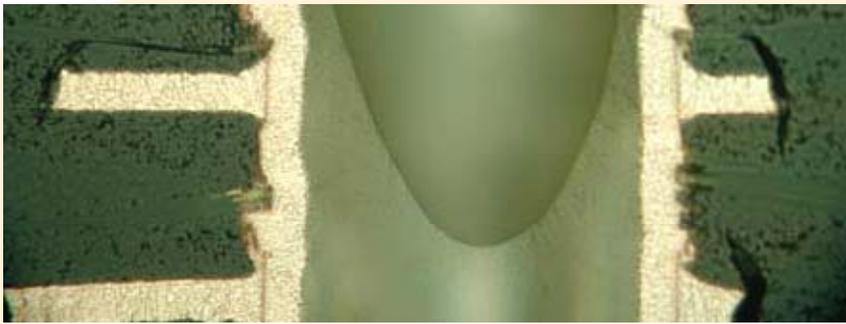
Example of Eyebrow
Cracking
(D)

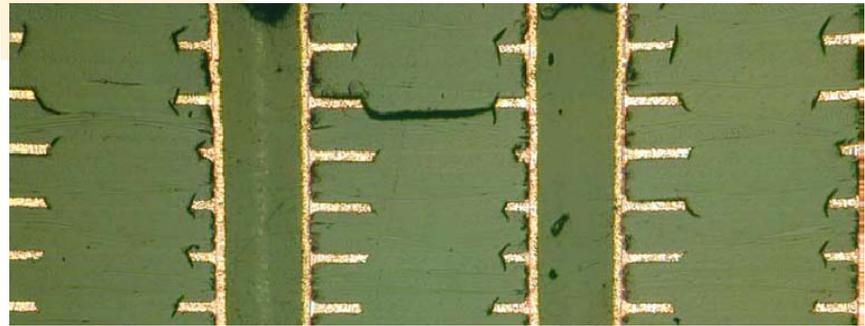
Example of Delamination
(I)
