A Novel Approach to Evaluate the Impact on Solder Joint Reliability due to Multiple BGA Rework

Bala Nandagopal, Zequn Mei, Sue Teng and Mason Hu
Cisco Systems, Inc.,
San Jose, CA

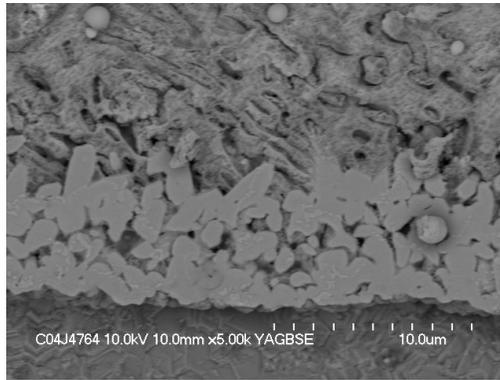
Figures 1 and 2 (a and b) & Table 1 shows the PCB side intermetallics of 3 and 5 BGA reworks in both traditional and novel method. The Cu₆Sn₅ (\square -phase) exhibited the typical scallop shape in the 3 and 5 rework samples. The IMC thickness increased with the number of reworks performed. The IMC structure was similar in thickness range and porous in nature for both, 3 and 5 reworks, independent of the rework method employed.

Figure 1a - IMC at the PCB side of a 3 times Reworked BGA Sample Using the Traditional Methodology

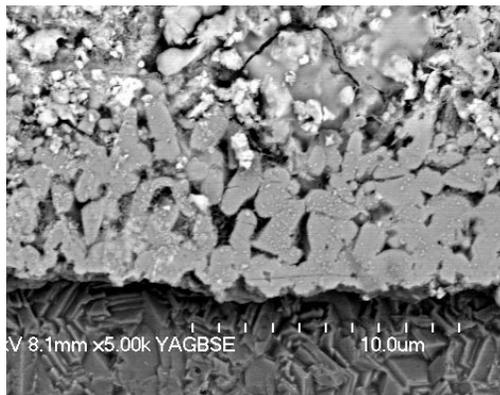
Figure 1b - IMC at the PCB Side of a 3 Times Reworked BGA Sample Using the Novel Methodology

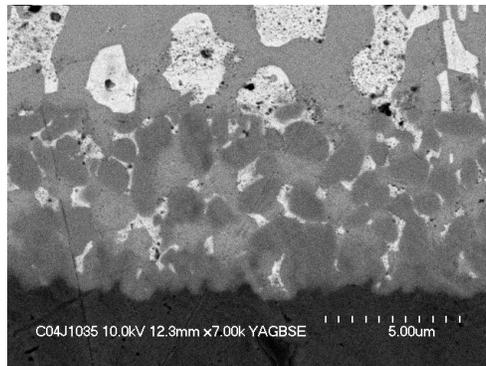
Figure 2a - IMC at the PCB side of a 5 Times Reworked BGA Sample using the Traditional Methodology

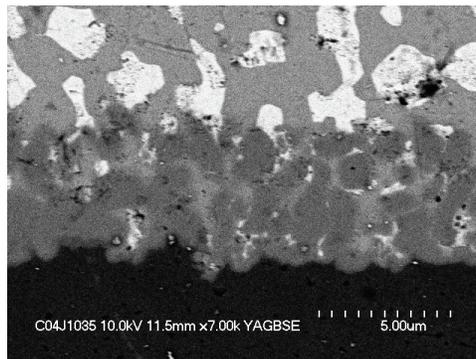
Figure 2b - IMC at the PCB side of a 5 Times Reworked BGA Sample Using the Novel Methodology

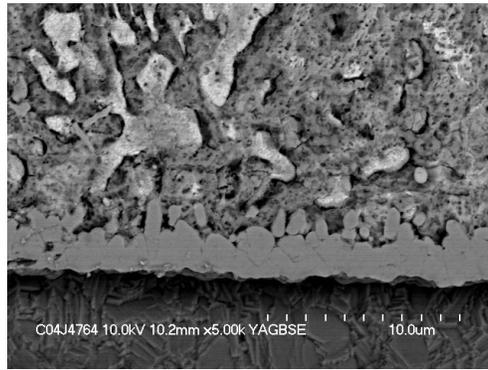
The boards 5 and 6, which did not have the new BGA part after multiple rework simulation, was also studied at N-1 rework cycle, as shown in figures 3 (a and b). Multiple reflows during the novel method, without removing the package, resulted in dense/planar \square -phase due to increase in the scallop size. Subsequent rework in the traditional manner, removing existing BGA and replacing with new BGA part, resulted in porous and scalloped \square -phase microstructure. This phenomenon of dissolution of \square -phase into an un-saturated solder (fresh BGA ball) due to subsequent reflow has been well demonstrated by Schaefer [1]. The microstructure study presented sufficient evidence that the degree of \square -phase dissolution that occurred, for the rework profile conditions studied, during the Nth rework (traditional method) of a novel sample resulted in similar intermetallic structure as that of the traditionally reworked sample. Therefore, it was determined that the novel rework can be employed in place of the traditional rework method for this study.

Figure 3a - IMC at the PCB Side of Board-5 (no fresh part)

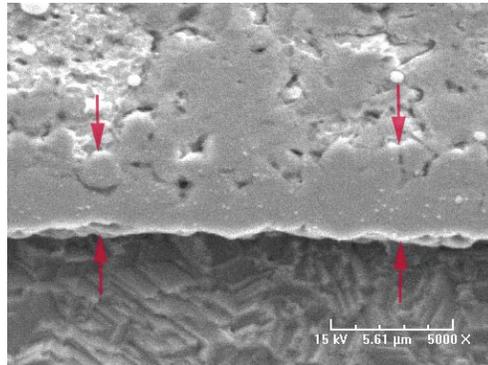
Figure 3b - IMC at the PCB Side of Board-6 (no fresh part)

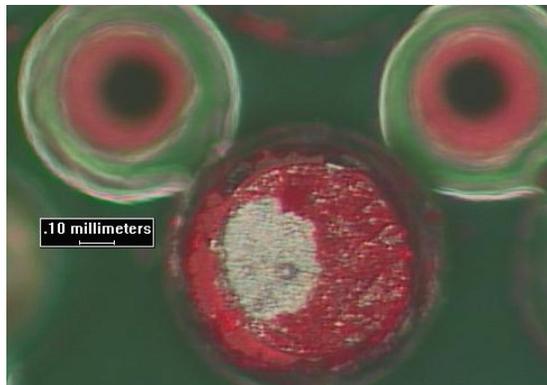
As part of ATC testing, the FCBGA packages underwent 3500 cycles without any failures. Failure analysis included dye and pries and cross sectioning of 0, 3 and 5 rework assemblies, which showed typical solder fatigue cracks. The dye and pry results showed solder cracks as high as 50 to 75% of the package pad area (Figure 5a). The worst case joint was always under the die periphery for all the scenarios, reworked and non-reworked. A typical cross section of a FCBGA is shown in figure 7a, which has 50% crack on the package side.

Figure 5a - 75% dye Penetration at the Package Interface for FCBGA

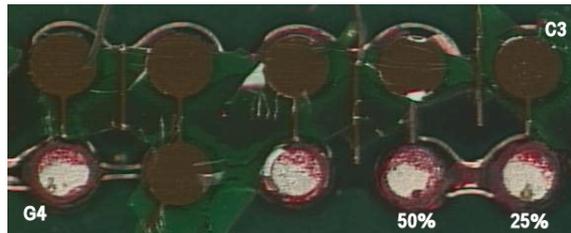
Figure 5b - 75% dye Penetration at the Package Interface for WBG92

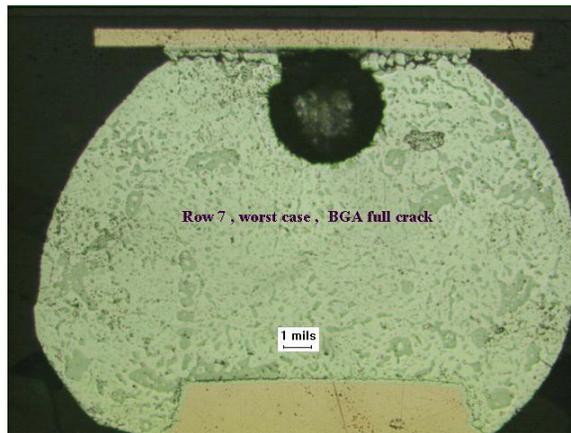
The CSPs underwent 5000 cycles without any failures, except for one from the 3 rework samples, which failed at 3322cycles. This failure was confirmed to be a typical solder fatigue as shown in figure 6. The CSPs did not show any difference between the reworked and non-reworked samples with the exception of the one failed sample mentioned earlier. Dye and pry showed that the worst case crack propagation among 0, 3 and 5 rework CSP parts had a maximum of 50% dye penetration along the package pad interface (Figure 5b). A typical cross section of the CSP samples tested up to 5000 cycles is shown in figure 7b. Thus, we can conclude that there is no impact to solder joint fatigue life when reworked up to 5 times.

Figure 6 - Failure Mode of 3 Times Reworked WBGA Which Failed at 3322 Cycles

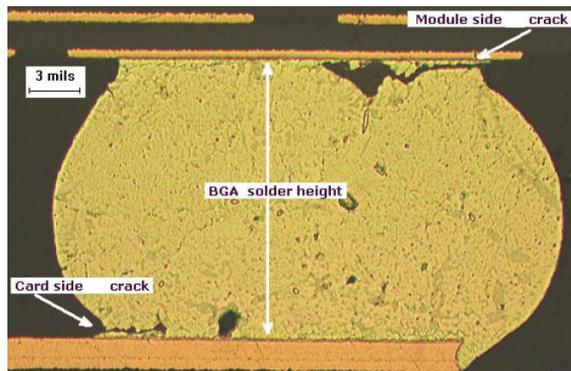
Figure 7b - Typical Cross section Image of an FCBGA after 3500 Cycles

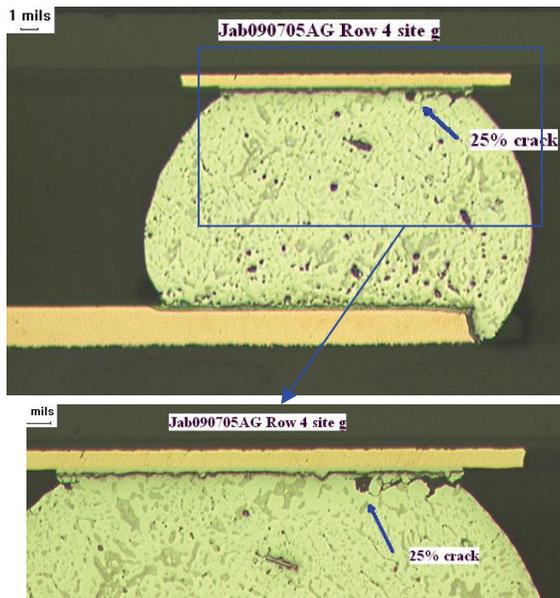
Figure 7b - Typical Cross Section image of an WBGA after 5000 Cycles
