A Proposed Mechanism and Remedy for Ball-in-Socket and Foot-in-Mud Soldering Defects on Ball Grid Array and Quad Flat Pack Components

Brian Smith
Kester
Des Plaines, IL

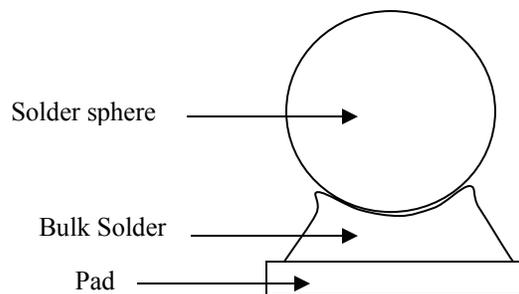
Ball-in-socket defects often occur randomly on ball grid array (BGA) components without an obvious root cause. Figure 1 demonstrates the appearance of a typical ball-in-socket defect. Note that the ball appears to be connected to the solder but is actually resting in a depression in the solder without actually making a connection to the bulk solder.

Figure 1 – Side view of Ball-in-Socket defect

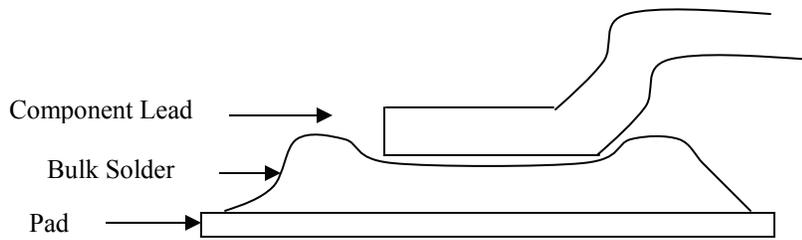
Foot-in-mud defects are similar to the ball-in-socket defects described above, except that these non-contact failures occur on large quad flat packs (QFP) instead of BGA components. Figure 2 demonstrates the appearance of a typical foot-in-mud defect. Again, the component lead is sitting in a depression within the solder but not actually metallurgically connected to the bulk solder.

Figure 2 – Side View of Foot-in-Mud Defect

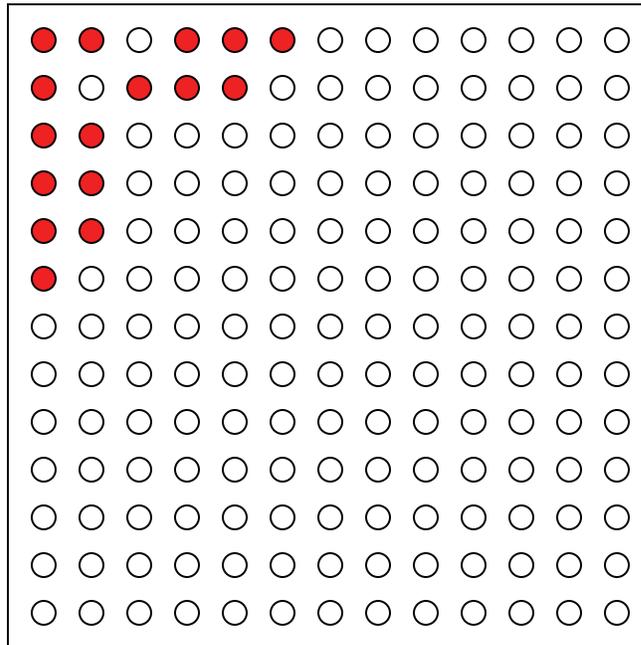
Figure 3 – Typical BGA Ball-in-Socket Defect Map

Charting the location of the ball-in-socket or foot-in-mud defects across a particular BGA or QFP often leads one to discover that the defect does happen much more frequently on one side or corner of the component than the opposing side or corner. In many of these cases, customers have noted that over 95% of the defect occurrences occur on the same corner or side of the component. As example of a typical defect map on a BGA is shown in Figure 3.

Note that all of the defect locations represented in Figure 3 have occurred in the top-left corner of the component. This type of repeatability in one geographical area of the component could not be caused by poor solderability, inadequate paste height/volume, or component co-planarity. Another root cause must be the culprit in this type of defect. The purpose of this work is to propose another potential root cause and identify a remedy for these defects.

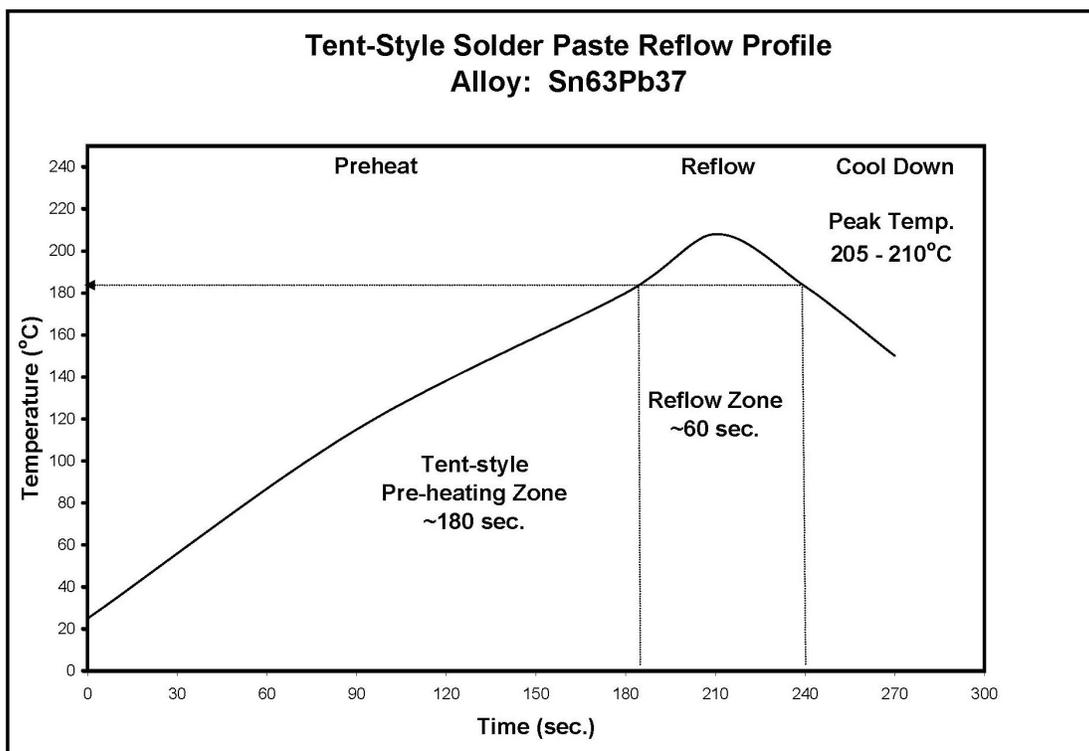
Figure 4 – Reflow Profile Used at Customer A

Customer A was using a reflow profile a similar to the one shown in Figure 4.

This profile is of the “ramp-to-spike” (or “tent”) variety with no discernable soak zone. The ramp rate was a steady 0.9 – 1.0 °C/sec for the pre-reflow portion of the profile and the peak temperature was 205-210 °C. After measuring the temperature on all four corners of the component, it became evident that the ball-in-socket defects were occurring on the coolest corner of the component. Furthermore, the Delta T across the component was ~7 °C as the hotter corner reached the reflow temperature (183 °C), leading to a significant difference in melting times. This difference in temperature was driven primarily by the other components surrounding the large BGA, but was also exacerbated by the fact that the hotter corner was at the leading edge of the component and would therefore sooner experience the higher temperature of the subsequent reflow zones in the oven. A basic schematic of the board is shown in Figure 5.

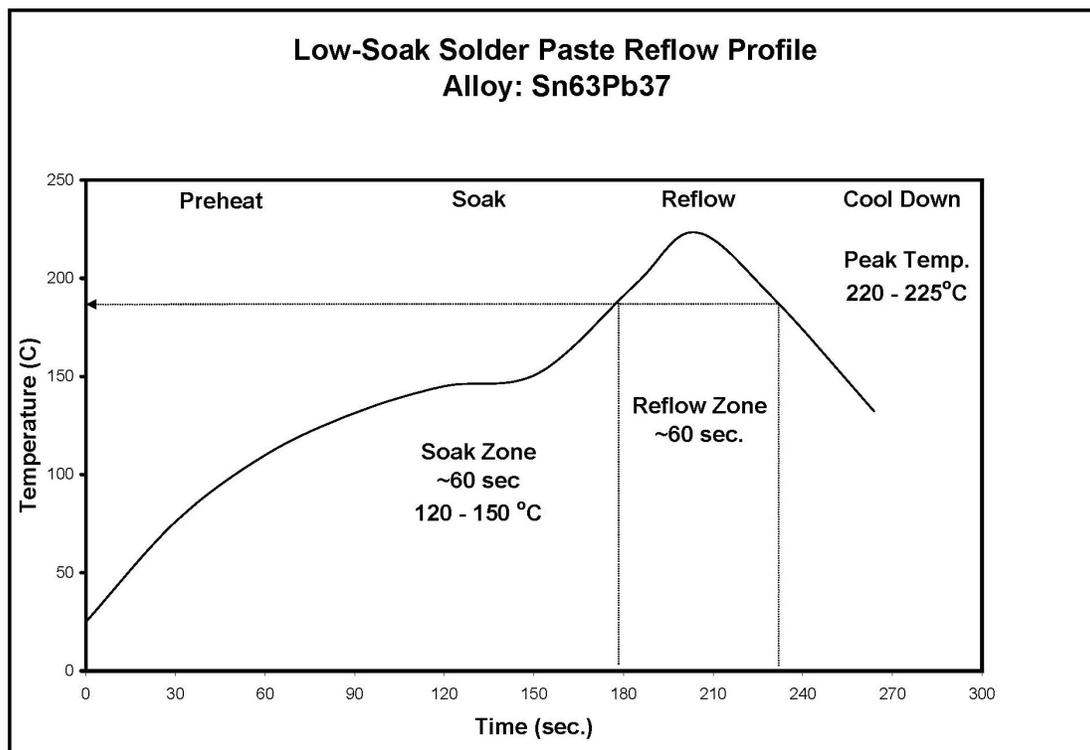
Figure 6 – Reflow Profile Used at Customer B

Customer B was using a reflow profile with the general appearance shown in Figure 6.

Note that the reflow profile used at Customer B is a “ramp-soak-spike” with a soak temperature of 120-150 °C and a peak temperature in the range of 220-225 °C. Upon performing a reflow profile specifically on the component demonstrating the foot-in-mud defects, it was found that the cooler corner of the component was the location of all of the foot-in-mud defects. It was noted that the Delta T from the cooler corner to the hotter corner was ~6 °C as the hotter corner reached the reflow temperature. This led to the hotter corner melting several seconds before the cooler corner.
