Measles in Advanced Technology

Michael Vernoy, Wennei Chen, Bruce Dall, and Mahendra Gandhi
Northrop Grumman
Redondo Beach, CA

Abstract

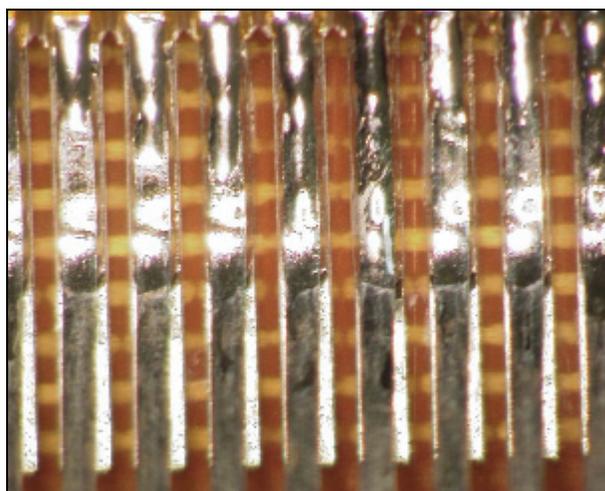
PN A, SN 1, LDC I, hand-soldering with wide-tip iron

This investigation began with the appearance of anomalies in a multi-layer polyimide PWB during hand soldering of fine pitch edge connectors. The anomalies, shown in Figure 1, were first believed to be severe measling; however, unlike typical measles, the anomalies appeared as bright stripes in the PWB dielectric that ran fully across the connector solder pads. Further investigation determined that the stripes were continuous and were similar in appearance to a crazed PWB.

The striped anomalies followed the glass reinforcement bundles of the dielectric, but presented themselves in one direction only. Upon examination of coupon cross sections, it was found that all PWBs of the same manufacturing lot exhibited significant missing glass fiber reinforcement. Subsequent searches of coupons revealed additional lots of material, from different part numbers that also had significant fiber pullout. One of these additional coupons corresponded to an assembled PWB that exhibited discrete areas of measling following hand soldering using a point-tip iron.

Figure 1 – Crazing/Measling below fine pitch leads of PWBs after hand soldering.

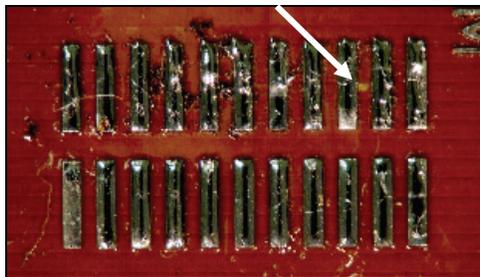
Prior to the convection-reflow heat and humidity exposures, no coupons showed any anomalies. However, after the introduction of moisture into the coupons, two of the five test coupons showed measling or crazing when heat was applied during hand soldering. A discrete measle that appeared in an M coupon following a second solder iron application is shown in Figure 2.

Figure 2 – Measled M coupon after soldering following moisture exposure. Measle is shown with arrow.

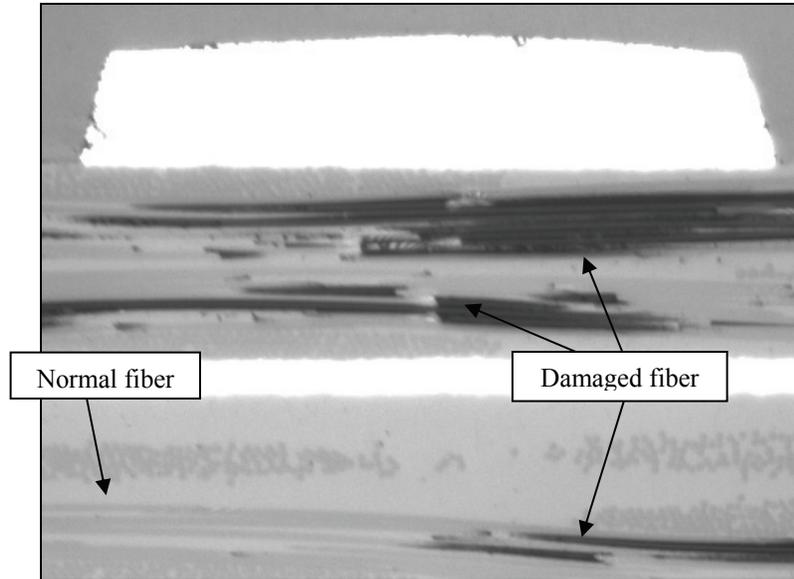
Cross-sections of the test PWB (SN 2) are shown in Figures 3 through 6. These sections showed significant damage to the glass fiber reinforcement. The fiber damage was continuous and ran the length of the mounts. The damage was also observed to extend beyond the connector solder pad areas into sections of the board with plated vias. The discovery of damage that extended beyond the connector area was cause for concern as it indicated that 100% bridging of the cracks was likely

between conductors or plated vias/holes. This condition created a direct pathway between isolated conductors. In addition to the lateral reduction in dielectric, the dielectric spacing between layer 1 and layer 2 was effectively reduced to between 0.5 and 2 mils. This vertical reduction in dielectric was well in excess of 50%. Also of note was the condition of the glass fiber reinforcement in the sample that did not show visual signs of measling or crazing. The visually acceptable case showed significant cracking within fiber bundles as shown in Figure 6. These cracks were no less severe than those in the areas that visibly showed crazing. Cracks in the glass fiber bundles may provide an ideal pathway for fast conductive filament growth between closely spaced signal or power vias^{5,6}.

Figure 3 – Longitudinal cross-section showing damaged glass fiber reinforcement of test PWB following humidity exposure and wide tip soldering simulation. Damage appears as black lines.

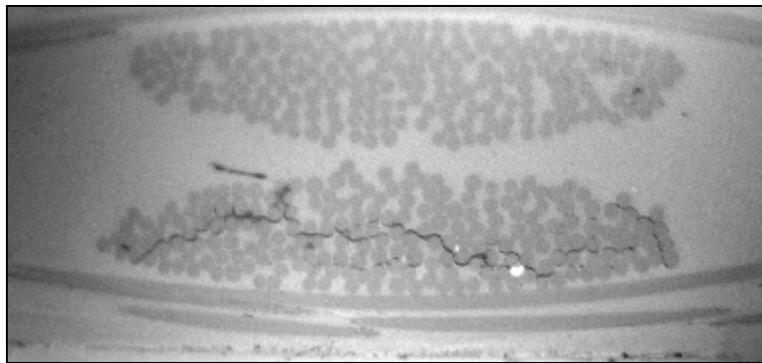
Figure 4 – Lateral cross-section showing end view of damaged glass fiber reinforcement shown in Figure 3.

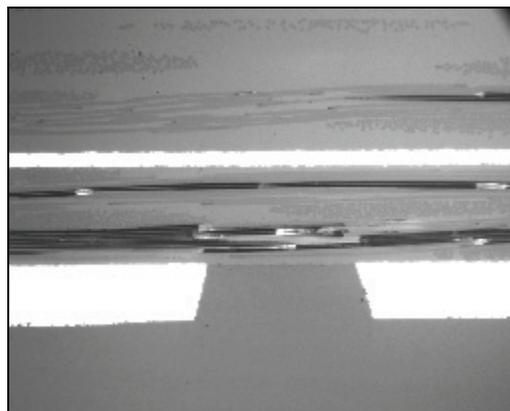
Figure 5 – Glass fiber bundles are damaged even following an 18-hour continuous bake.

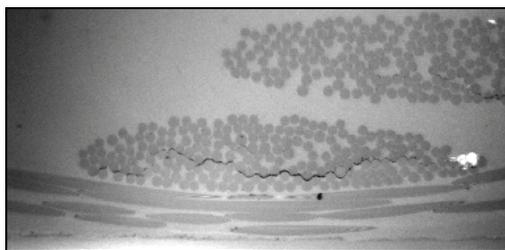
Figure 6 – Lateral cross-section showing end view of damaged glass fiber reinforcement shown in Figure 5.

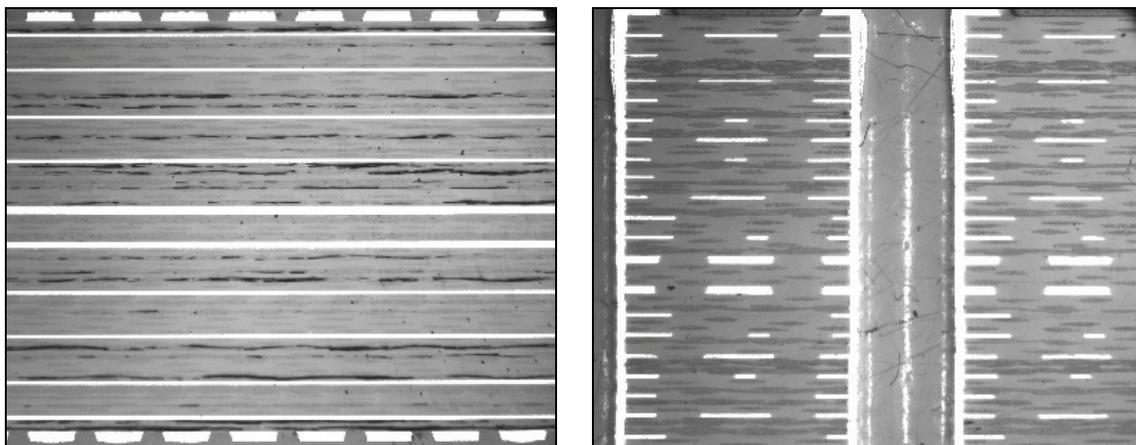
Figure 7 – Two cross-sections of PN A. The photo on the left was taken of the crazed LDC I. The photo on the right was taken of a normal LDC II.

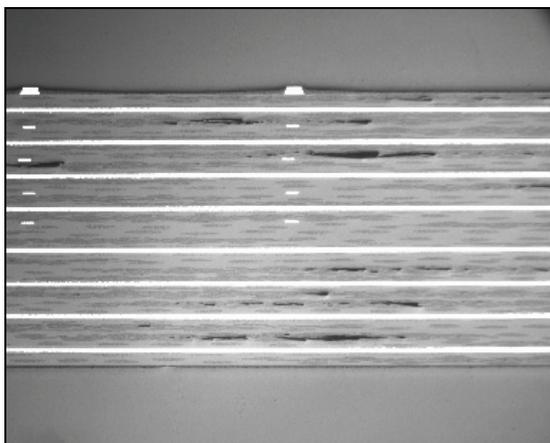
Figure 8 – Cross-section of acceptance coupon for PN B, LDC IV, from a PWB that measled during assembly.

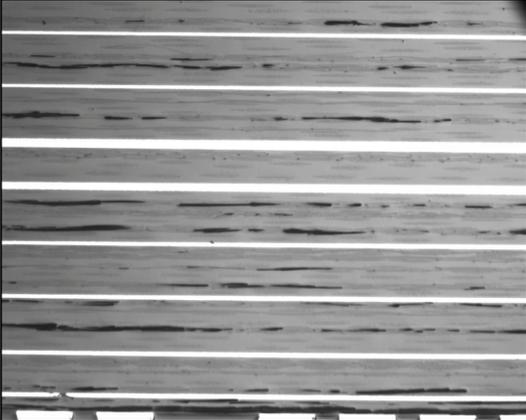
<p data-bbox="418 663 743 688">Fiber pullout in wrap direction</p>

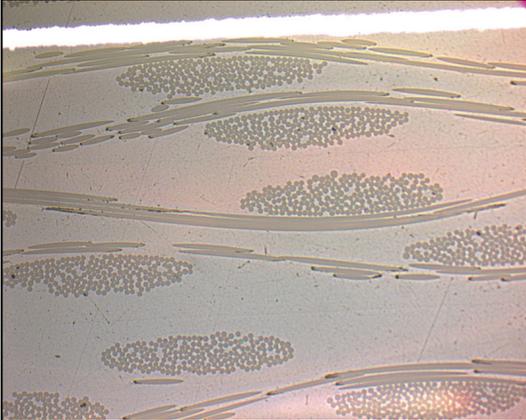
<p data-bbox="1019 663 1360 688">No fiber pullout in fill direction</p>
PN B, LDC IV V-0 rating Sections reviewed for 2 SNs

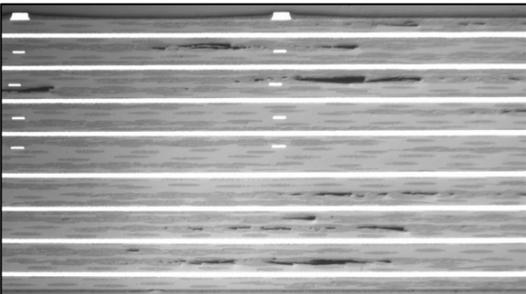
<p data-bbox="418 1050 743 1075">Fiber pullout in wrap direction</p>

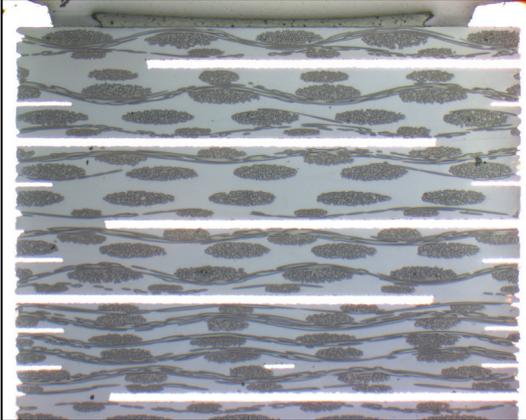
<p data-bbox="1019 1119 1360 1144">No fiber pullout in fill direction</p>
PWBs made from V-1 rating laminate No fiber pullout in either direction

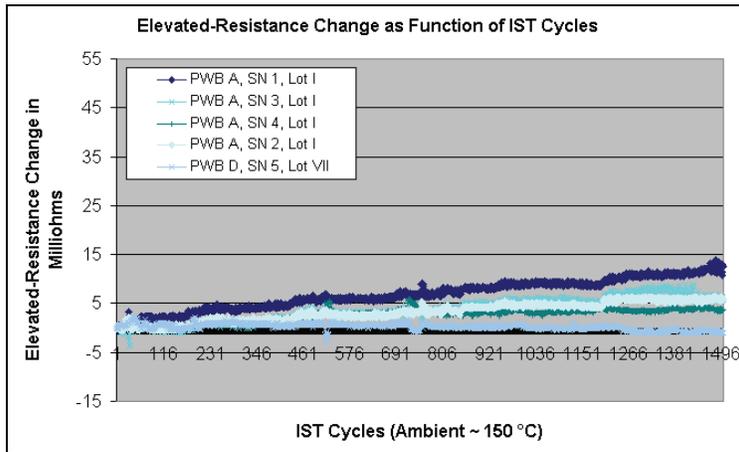
All coupons were IST tested at the same time and resistance was monitored over 1500 cycles⁷. No meaningful resistance changes were detected in power nets over 1500 cycles. No post interconnect defects were expected to be detected as the power nets are typically very robust. Figure 9 shows the power net resistance changes, no more than 3%. The blind via sense nets also showed little resistance change as shown in Figure 10. No coupon's blind via sense net reached more than a 7% resistance increase before the test was ended after the 1500th cycle. Small fatigue cracks in the barrels were expected. Figure 11 shows the PTH sense net resistance changes. The PTH sense net did show increased resistance with thermal cycling. However, all coupons passed the 700 cycles with less than 10% resistance increase. All coupons are therefore considered to have passed reliability screening⁸. The elevated resistances of the PTH barrels began to rise after 100 to 300 cycles. PWB,

Figure 9 – Plot of resistance changes in the Power nets. All coupons passed reliability screening.

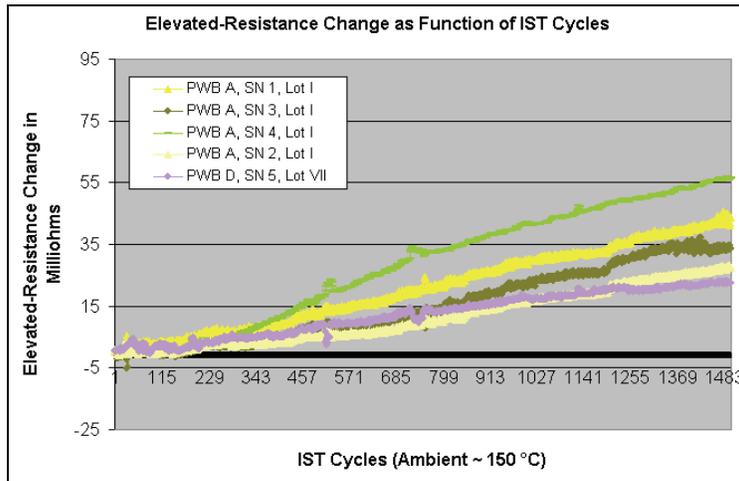
Figure 10 – Moderate rising resistance trends were observed in test nets associated with blind via barrels. All coupons passed reliability screening.

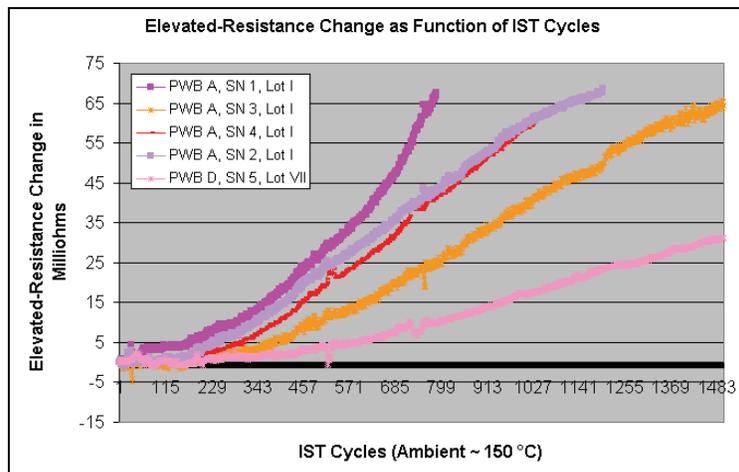
Figure 11 – Plot of resistance changes in the PTH Sense net. All coupons passed reliability screening.

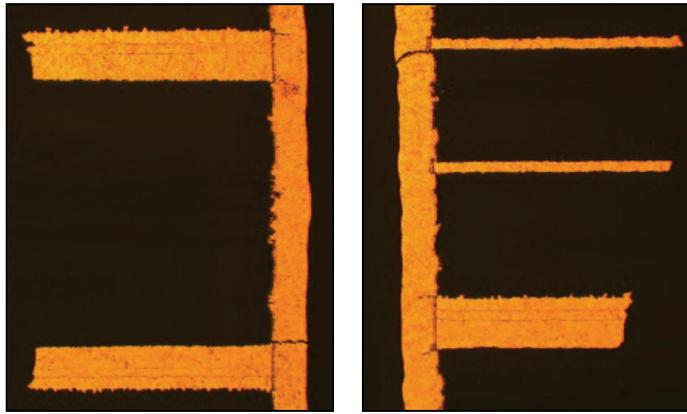
Figure 12 – These cross-section images sections show the central or near central portions of the IST coupon PTH sense net barrels from SN 1.

These cross-section images show the central or near-central portions of the IST coupon PTH sense net barrels from SN 1. SN 1 had the fastest resistance growth (Figure 11). All cracking appears to be fatigue-related, as signified by the rising IST curve. Copper plating in the barrels was measured to exceed 1.5 mils in PTHs. Some barrel cracks appear to be through the barrel wall. It is believed that these cracks correlate to the “bright spots” from the infrared images used to identify failure locations. Infrared images are shown in Figure 13.

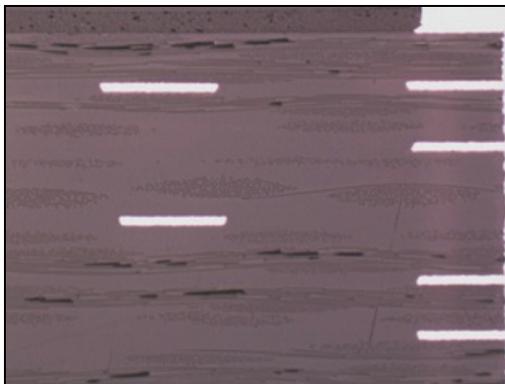
Section along the longitudinal direction of the IST coupon

The cross sections taken to evaluate barrel cracking were also examined for signs of glass fiber pullout and cracking within or between fiber bundles. Both pullout and cracking was observed. Figure 14 shows fiber pullout from cross sectioning in the longitudinal direction of the IST coupon. When cross-sections were performed in the lateral direction, warp yarn cracks were not seen unless examined under much higher magnification.

Figure 14 – Cross-sections confirming the fiber pullout condition typical to PWB A, Lot I. The photos were taken from SN 1 after 1500 IST cycles.

Fiber fall-out condition appears in one direction of the laminate only (the warp direction). This is again confirmed by one out of every two bi-axial cross-sections for all coupons from Lot I. When cross-sections are perpendicular to warp yarns, all fill yarns look normal and the warp yarn condition is not apparent. However, unlike SN 1, warp yarn damage is still evident for SN 4 (same lot) coupons that are exposed sub-ambient shock of -65 °C prior to contacts of hot soldering iron. The warp bundle cracks are confined within the bundles, and do not extend into the polymer as shown in Figure 15. The fill yarn remained intact under this severe test condition. This implies that fill yarn is much more robust than the warp yarn.

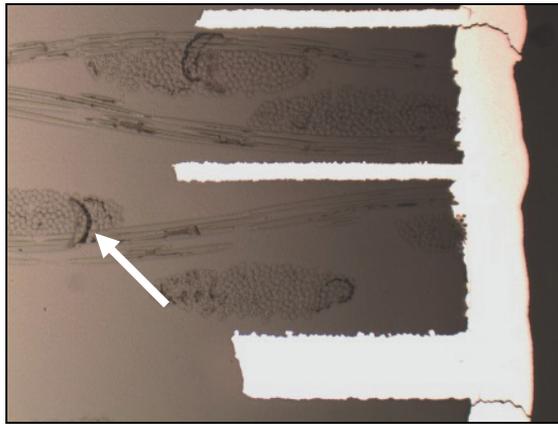
Figure 15 – Cross-section showing the central portions of PTH sense net barrels from SN 4 with warp bundle cracks.
