# Double Reflow-Induced Brittle Interfacial Failures in Pb-free Ball Grid Array Solder Joints

## ABSTRACT

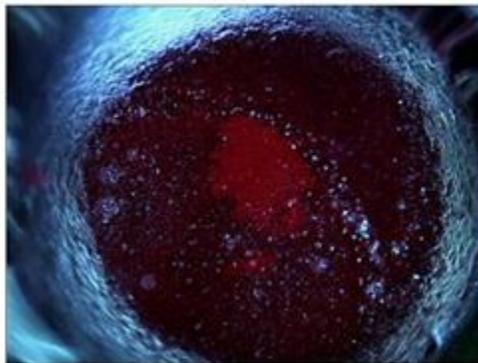
Because the suspect failure locations were not in the outer rows, defect detection by visual and low magnification optical inspections was unsuccessful. Transmission X-ray inspection also was unable to detect or image failed solder joints. This is expected since conventional, transmission X-ray cannot resolve fine cracking or thin planar defects that are nothing more than air gaps in the soldered structure. Consequently, destructive analyses were initiated starting with the “dye and pry” (DnP) method. The primary objective of the DnP was to determine if the solder joint had failed at the package or PCB side of the joint. Dye intrusion occurred at multiple solder joint sites and dye penetration was observed at the component side of all failed solder balls. A typical image of a DnP surface is shown in Figure 2. It was also noted that incomplete dye penetration was observed at some locations. This is indicative of either incomplete initial solder joint formation or subsequent cracking through only a fraction of the intended attachment area.

**Figure 2: Optical photomicrograph of a failed solder ball surface after dye and pry (DnP) testing. This surface has fractured between the solder ball and BGA package pad (at the component side). The red color on the surface is from the dye intrusion that occurs prior to the mechanical prying.**

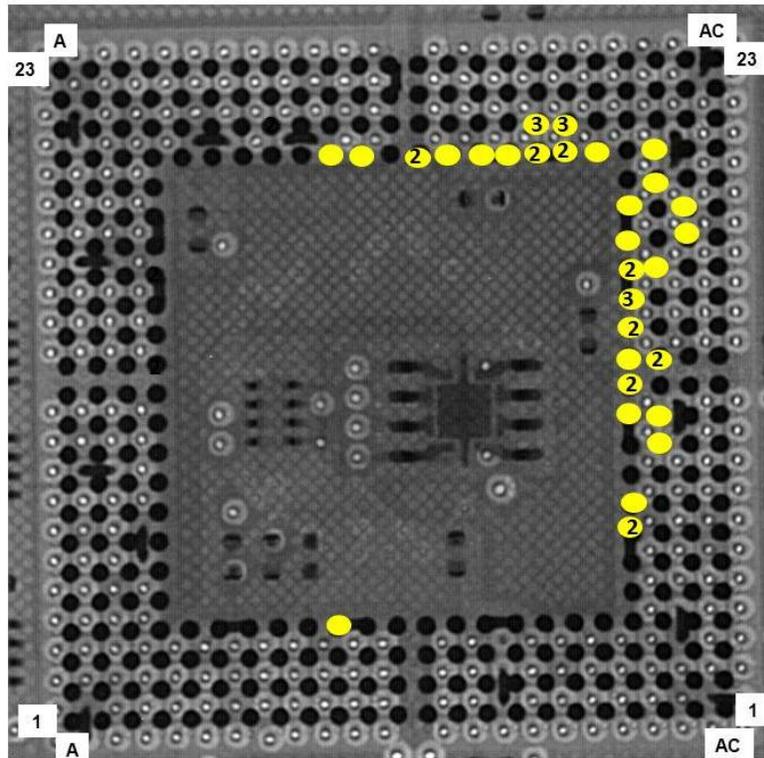
Figure 3 shows the a composite map of failure locations taken from three different Component A samples overlaid on a low magnification transmission X-ray micrograph of the package ball pattern. The pattern of indicted sites is asymmetric within the package array and is concentrated in proximity to the inner row of perimeter ball array. This inner row failure signature is atypical for many of the intermittent failure modes discussed in the previous section. Those types of failures tend to manifest in the outer rows at the corner and near-corner locations that are known to be the highest stress-strain locations in BGA packages. However, exceptions to this trend can be found in PBGA packages that exhibit certain specific warpage signatures. It is common for warpage stresses to be high at the corner sites, but they also can be high in the die shadow region due to the high CTE mismatch between the package laminate and the silicon die.

Asymmetric failure patterns (Figure 3) are not common but when they occur, they are believed to result from mechanically or thermally unbalanced structures in either the PCB or the package that affect CTE and thermal transfer.

**Figure 3: Failure location map from dye and pry test data overlaid on a transmission X-ray image of BGA Component A. This map is a composite of failures for Component A taken from three different PCBAs.**

Subtle differences in local solidification and stress could account for the observed inner row failures and the variations in the extent of the cracking from site to site along the inner row. The asymmetric failure pattern could be caused by thermo-mechanical imbalances in the package and PCB. The fact that fractures occur only at the package side of the joints is most likely related to the fact that a solder joint formed on a non-solder mask defined Cu pad (as on the PCB) is more resistant to tensile and shear loading than a solder joint formed on a solder mask defined Ni plated pad (as on the package).

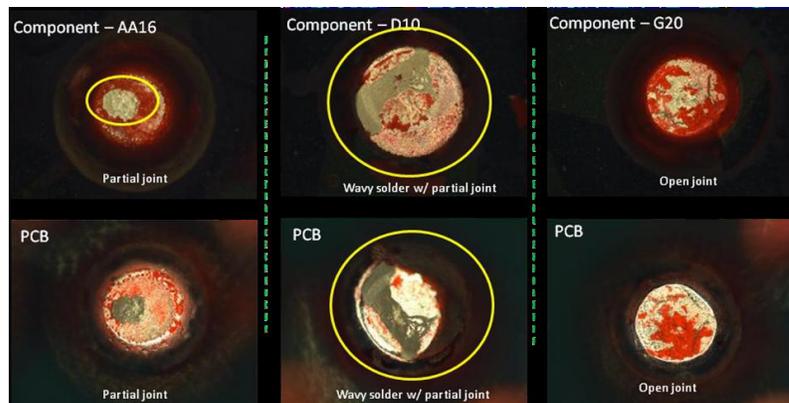
Additional optical and SEM micrographs of failed solder joints at the component side are shown in Figures 4 and 5. These failures initially were diagnosed as ball de-wet or ball drop, pointing to the assembly process as the root cause.

**Figure 4: Optical photomicrographs of various fracture surfaces after DnP testing.**

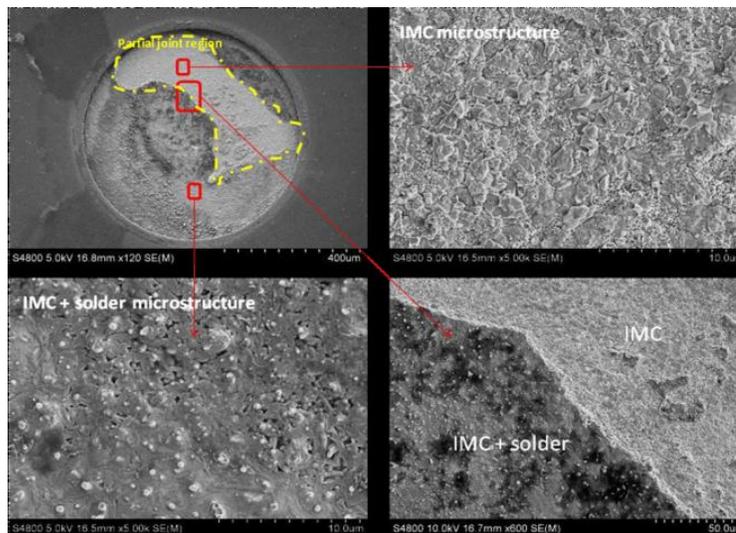
**Figure 5: SEM micrographs of various fracture surfaces after DnP testing.**

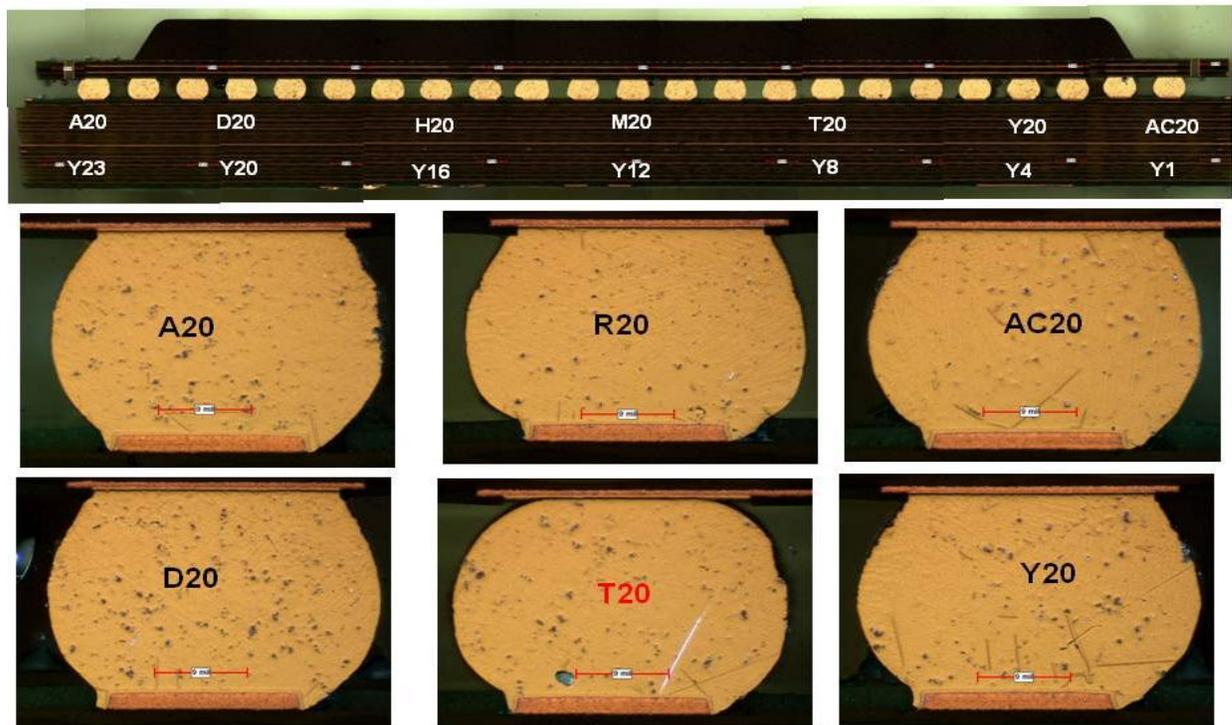
Destructive cross sectional metallographic analysis was performed to provide more detailed and conclusive failure mode data. The analysis was conducted on Component A from a PCBA sample that contained suspected solder joint opens. The component was cross-sectioned with row by row analysis and optical photomicrographs were obtained for multiple solder balls in each row. The photomicrographs in Figure 6 show cross sections of multiple solder balls across Row 20 in Component A. Row 20 is one of the inner rows of the “picture frame” of the BGA package pin diagram. The solder joint at pin location T20 does not appear to be formed properly and this is confirmed in the higher magnification image in Figure 7.

**Figure 6: Multiple metallographic cross sections of solder balls in Row 20 of Component A.**

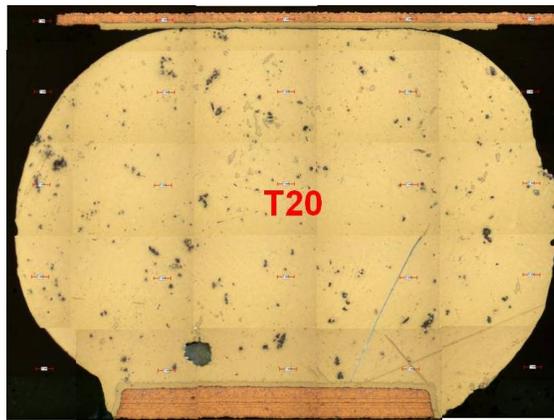
**Figure 7: A higher magnification photomicrograph (initial magnification 500X) showing a defect that appears to be de-wetting at package location T20 in Component A. The ball seems to be detached from the package pad.**

The initial indication from the high magnification photomicrograph in Figure 7 is that the T20 ball was never soldered to the BGA pad. At this low magnification, the solder ball appears to be de-wetted from the pad. However, an even higher magnification photomicrograph presented in Figure 8 shows that the T20 solder joint actually separated from the BGA pad at the interface between the Ni-Sn (nickel-tin) intermetallic compound (IMC) and the bulk solder. The presence of an IMC layer and a relatively small amount of solder on the PBGA pad confirm the solder ball had been previously attached to the pad. The spherical curved surface of the bulk solder at the perimeter of the solder ball also indicates melting. By all indications, the soldering reaction was successful initially and the solder joint was formed properly. In contrast, the top of the solder ball is flat and parallel to the component pad indicating that a brittle solder joint fracture occurred. This failure signature is consistent with that reported in the Double Reflow references [1, 2] and it is suggested that a similar failure mechanism can account for the T20 solder joint failure. As the solder joint temperature increased and approached the melting temperature during the second reflow, mechanical stress in the PCBA structure was sufficient to induce a brittle fracture at the IMC interface just prior to reaching the melting temperature. The source of the stress could be a combination of CTE mismatch in the package as well as PCB and component warpage. The subsequent melting of the solder ball moments later in the reflow process accounts for curved surface of the solder ball and de-wetted appearance at lower magnification.

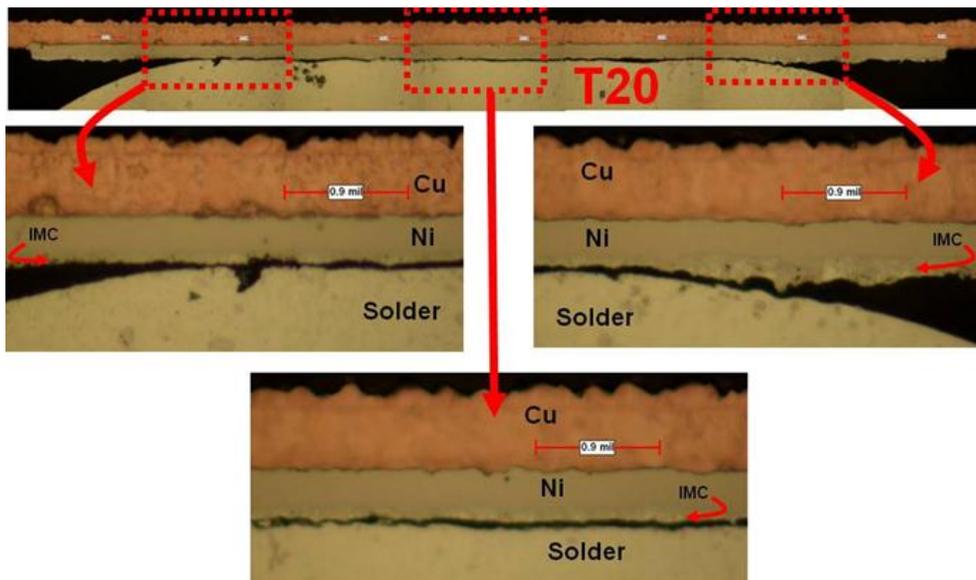
**Figure 8: Higher magnification photomicrographs (initial magnification 1000X) adjacent to the T20 BGA pad area showing evidence of a prior successful soldering reaction on the BGA pad with subsequent fracture at the interface between the IMC layer and the bulk solder.**

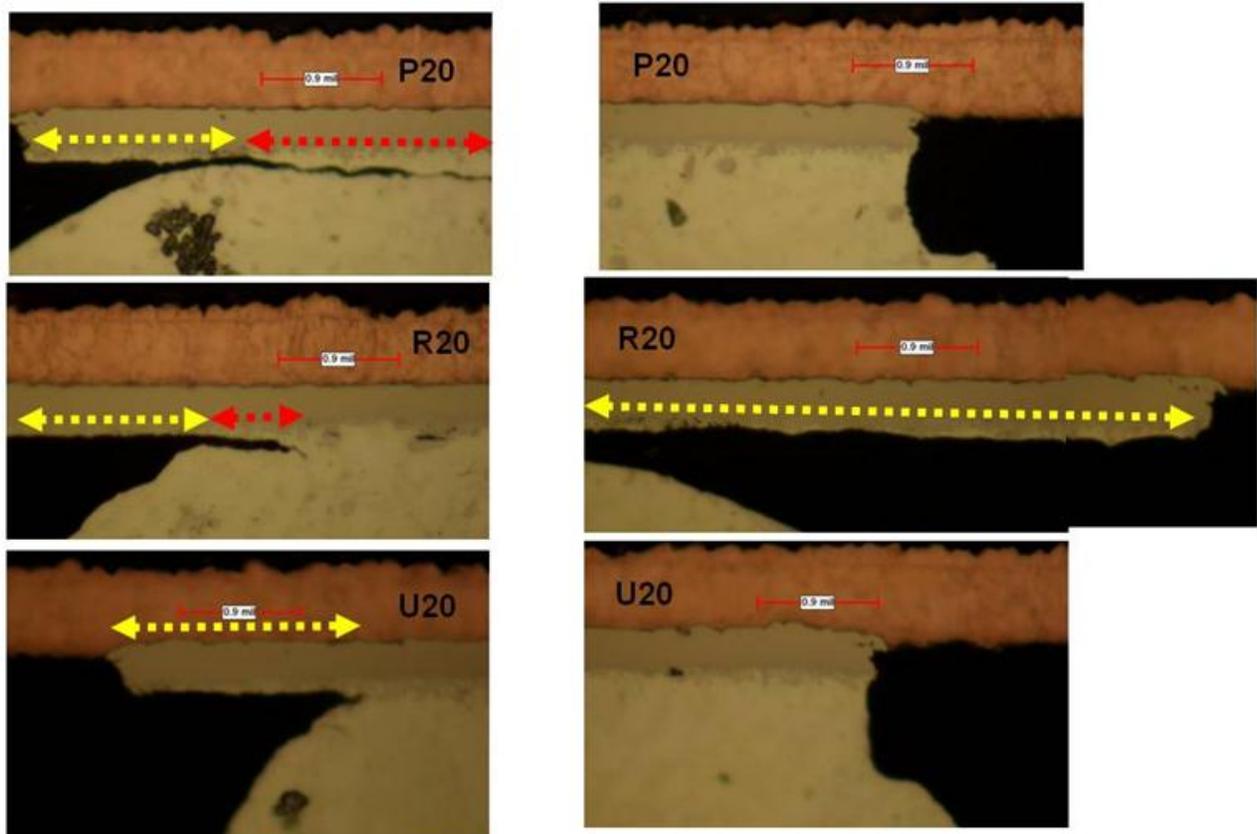
To draw a distinction between the de-wet and brittle fracture modes, the solder joint separation surfaces (interfaces) must be analyzed carefully. In addition to the total separation shown in the T20 solder joint, the three adjacent balls P20, R20 and U20 shown in Figure 9 exhibit similar but partial separation of the solder ball from the Ni-Sn IMC. At first glance, the separations marked by the dashed yellow lines in Figure 9 look like the solder joint de-wetting failures. However the separated areas marked by the dashed red lines in Figure 9, show clear indications of cracking or fracturing rather than de-wetting.

**Figure 9 - Magnified cross section, 1000X, of PCBA, Component A, solder balls P-20, R-20, and U-20.**

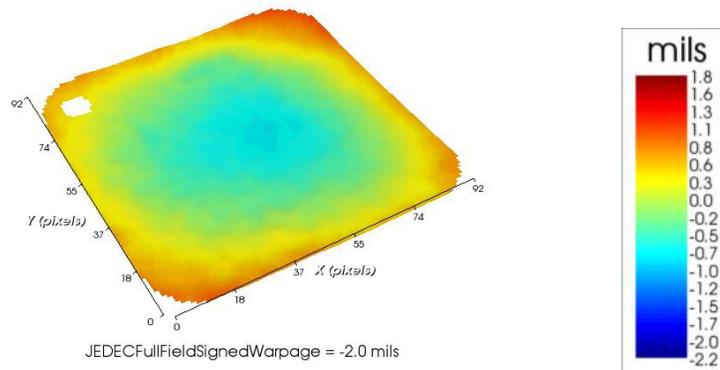
**Figure 10: A warpage displacement map across the overmolded area of Component A measured during temperature ramp up at 220°C.**

The thermal shadow Moiré data in Table 2 indicate a net displacement or warpage of Component A relative to the PCB of approximately 4 mils during heating in advance of melting or during cooling before solidification takes place (shaded Max.  $\Delta$  cells in Table 2). It must be acknowledged that there are uncertainties in interpreting these displacement measurements. First, these measurements may not reflect the component and PCBA behavior accurately as it would occur during an actual factory reflow cycle. More importantly, the amount of warpage needed to induce solder joint fracture is unknown. A similar amount of warpage can create other serious BGA defects such as head on pillow (HoP) but HoP is a completely different failure mode [6, 7].

In most applications 4 mils of warpage would be considered acceptable because defects like HoP and dropped ball would not occur. On the other hand, solder assembly defects due to warpage can appear with deviations in warpage as small as a few mils [8]. In the case of BGA double reflow, the magnitude of the warpage and induced thermal stress may not be the primary consideration. The more important factor may be the strength of the solder interconnection at higher temperatures close to the melting and solidification points of the solder. Consequently, it is conceivable that a small stress applied to the solder joint at high temperature when the joint has its lowest strength could cause a brittle interfacial fracture.

The obvious path for elimination of the failures in this design was to subject the BGA-side of the PCBA to only a single reflow pass. This corrective action was implemented successfully. The soldering of the heavy daughter card modules on the non-BGA side of the board was achieved by modifying other aspects of the assembly process.

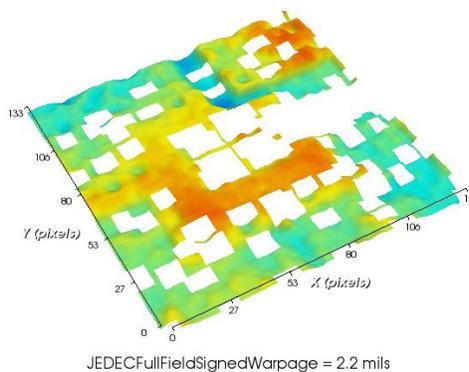
**Figure 11: A warpage displacement map for the PCB footprint matching Component A. The measurements were made during temperature ramp up at 220°C.**

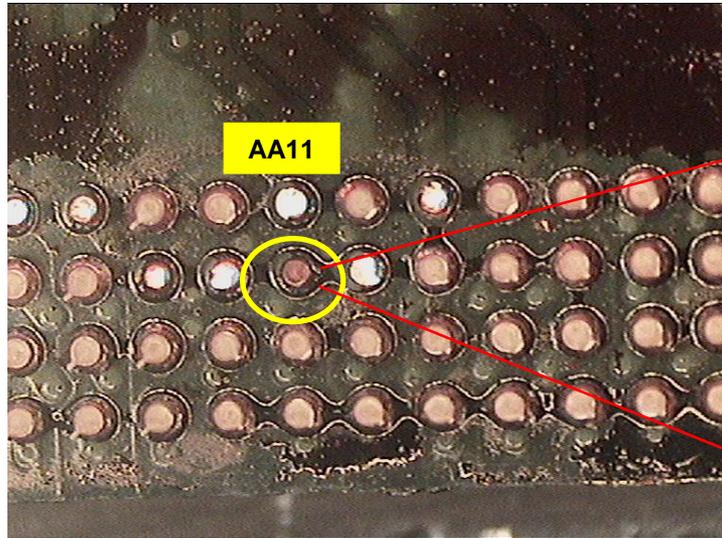
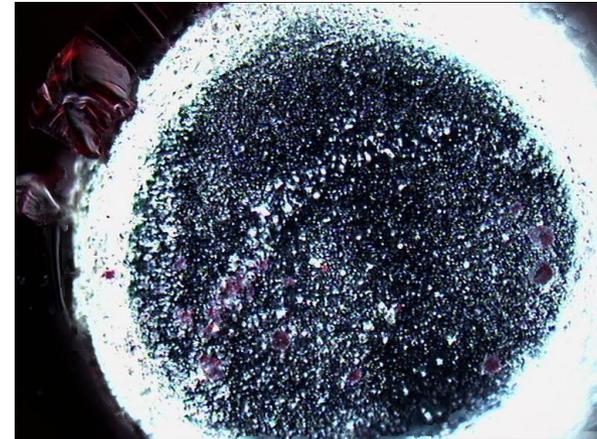
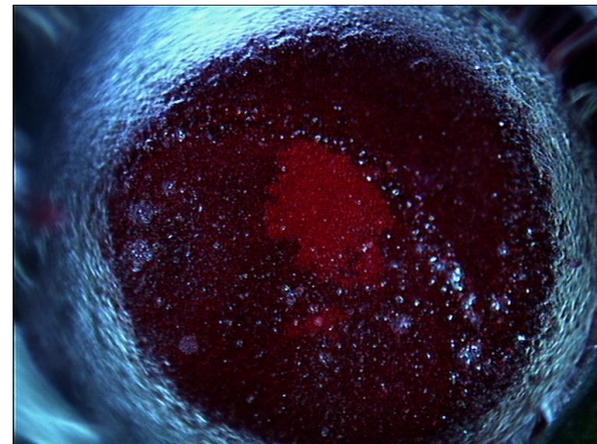
Component A, PCB side.

200x substrate side.

200x ball side.

\*Optical images show dye intrusion on location# AA11

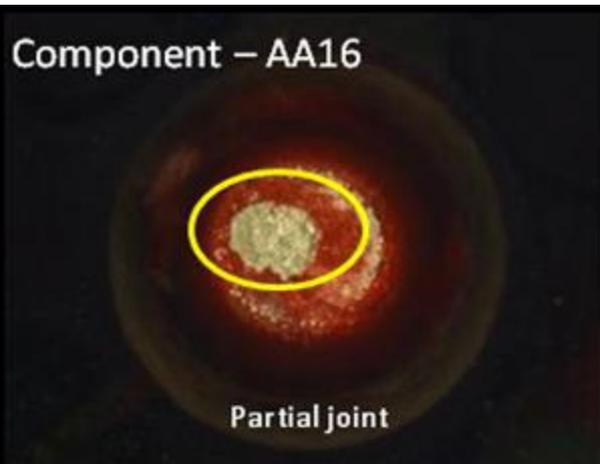
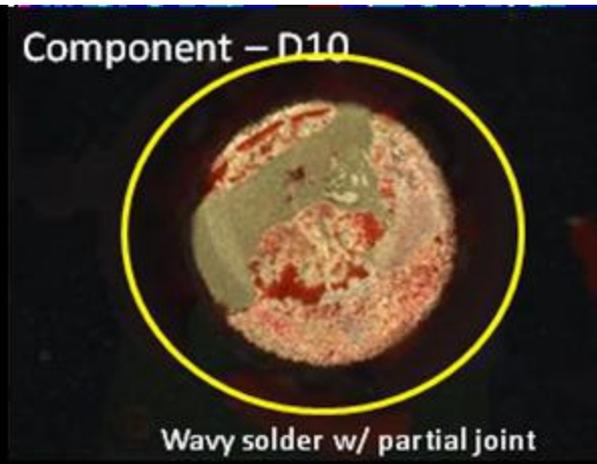
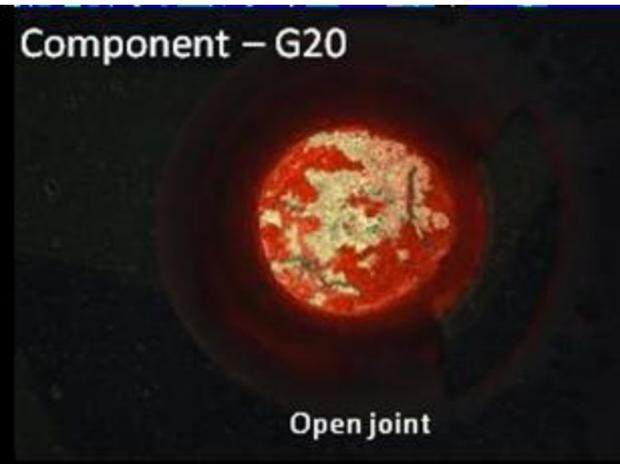
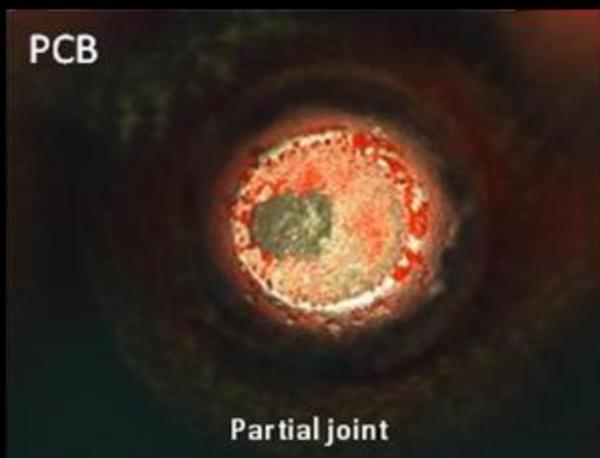
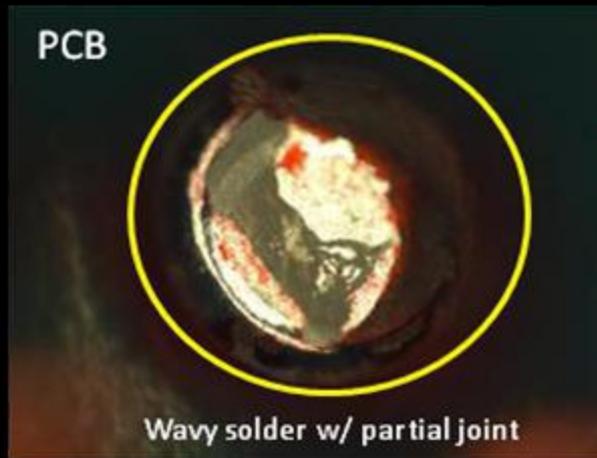
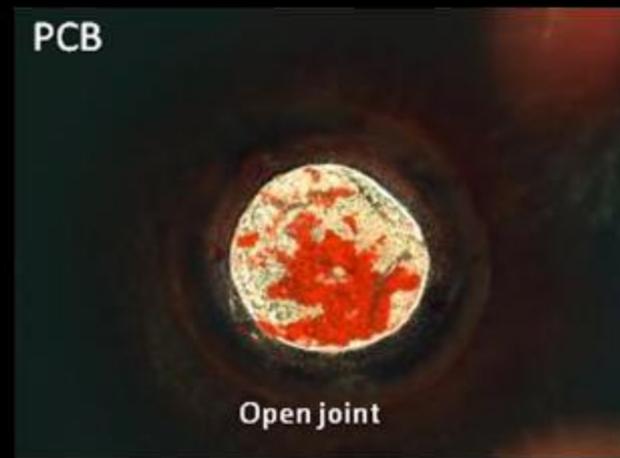
Partial and completely open solder joints were found

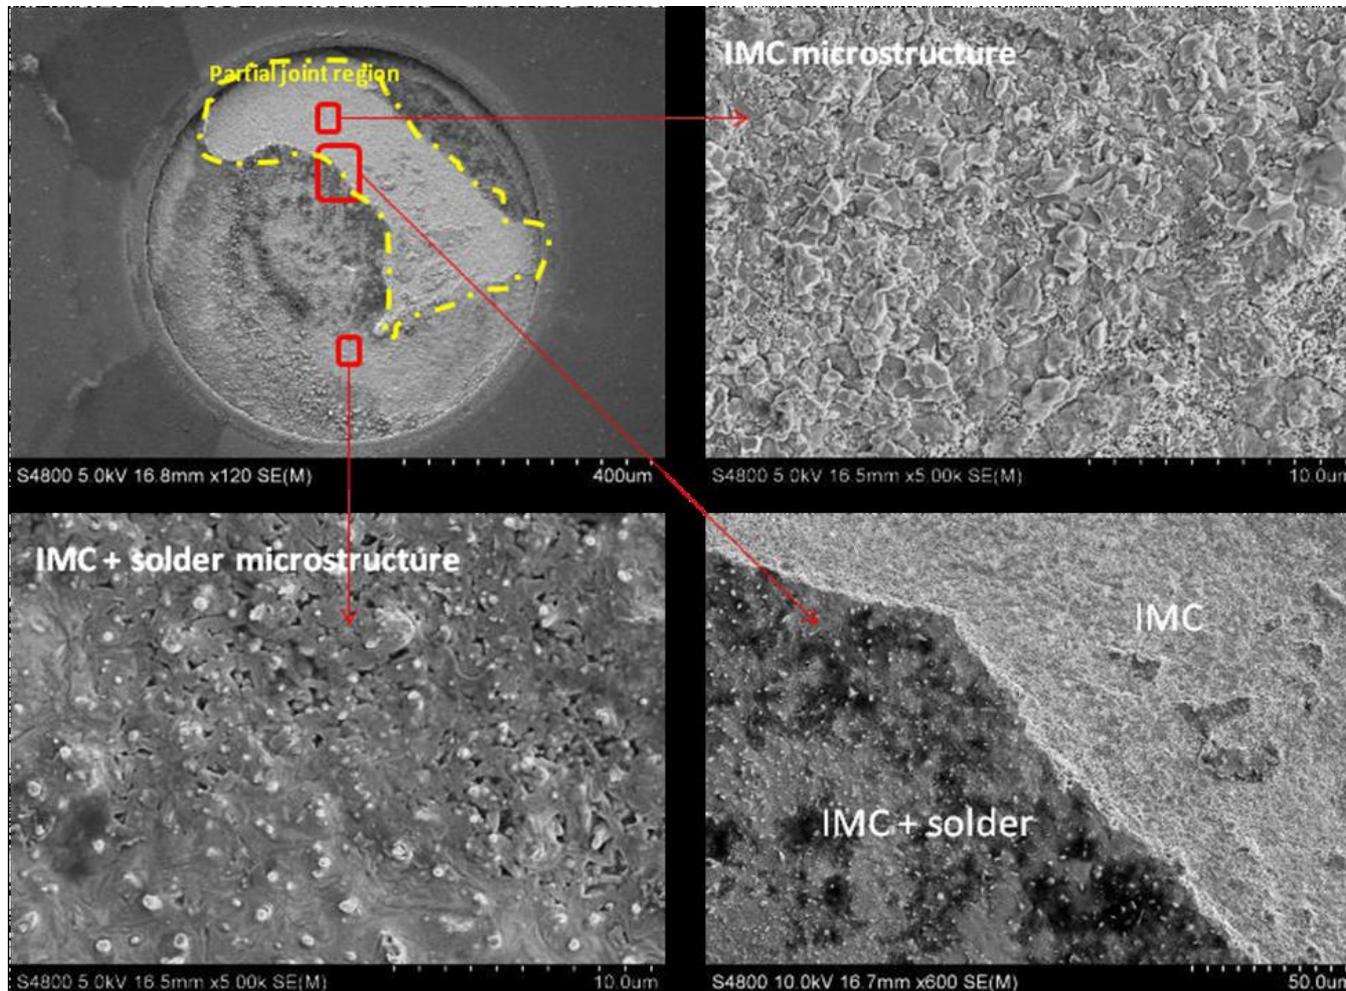
Post Dye and Pry SEM/EDX  
IMC presence at substrate pad implies ball had been attached

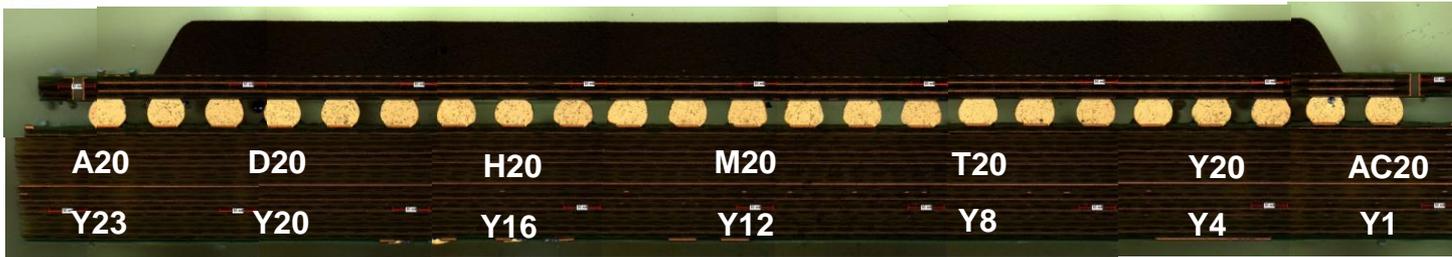
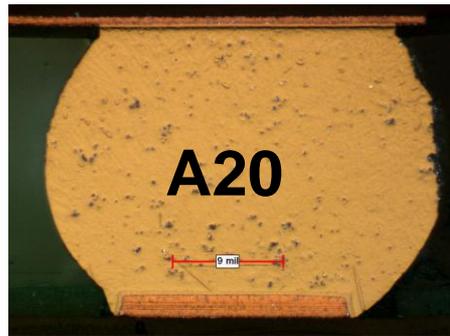
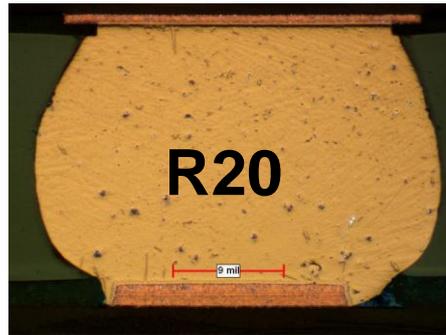
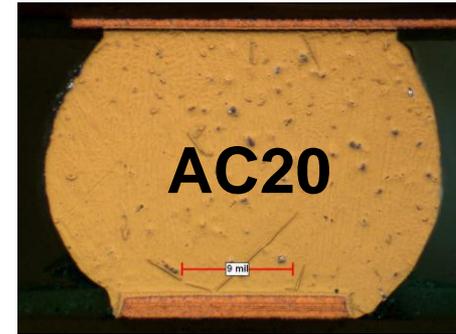
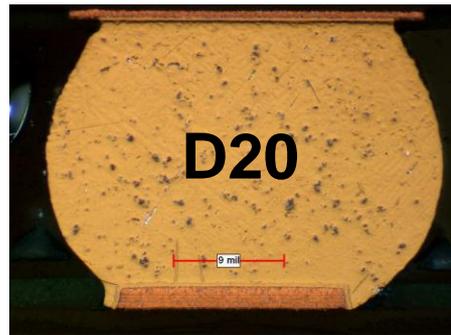
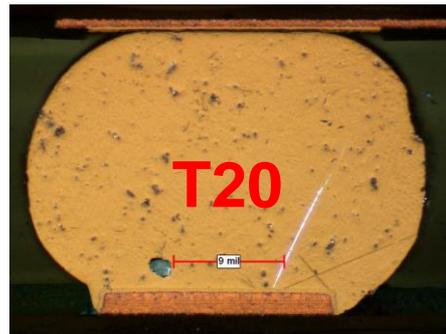
Multiple metallographic cross sections of solder balls in Row 20 of Component A.  
Note solder ball **T20** appears to be dewetted.

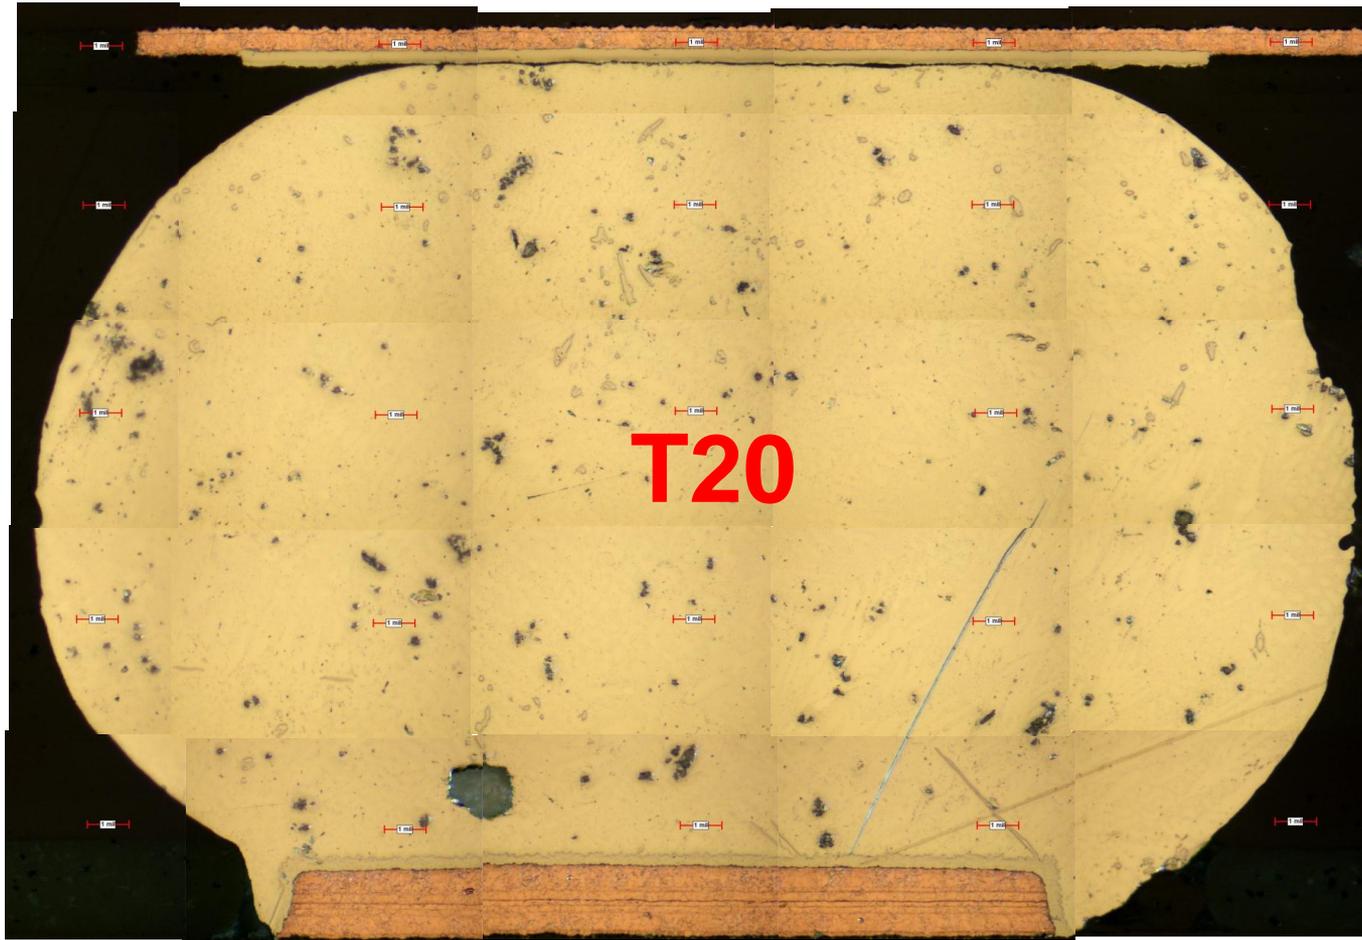
A higher magnification photomicrograph (initial magnification 500X) showing a defect that appears to be de-wetting at package location T20 in Component A. The ball seems to be detached from the package pad.

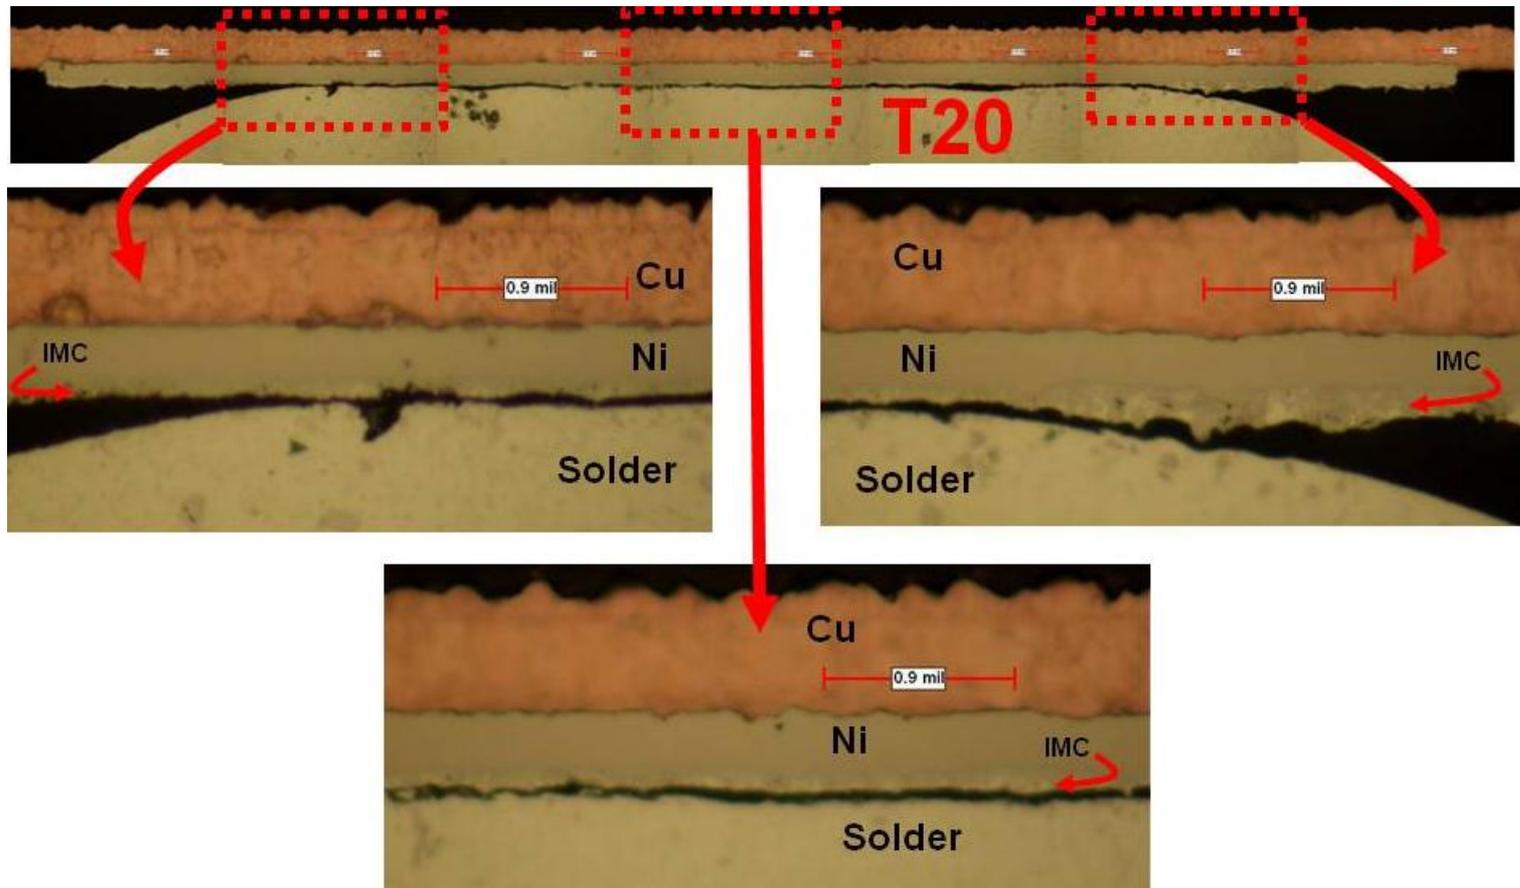
Higher magnification photomicrographs (initial magnification 1000X) adjacent to the T20 BGA pad area showing evidence of prior successful soldering on the BGA pad with subsequent fracture at the interface between the IMC layer and the bulk solder.

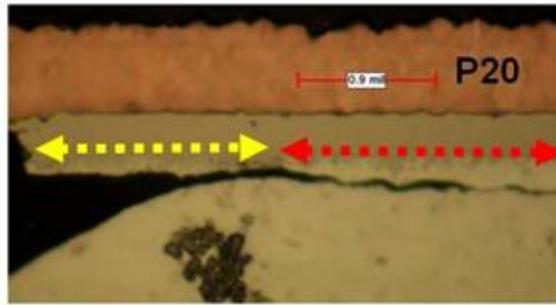
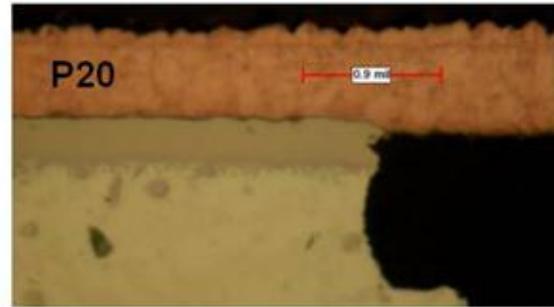
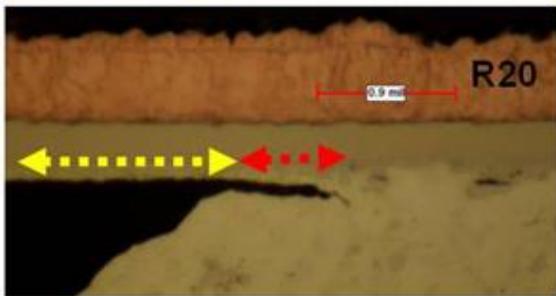
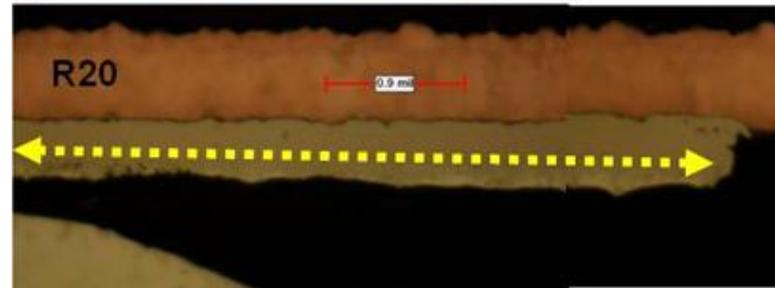
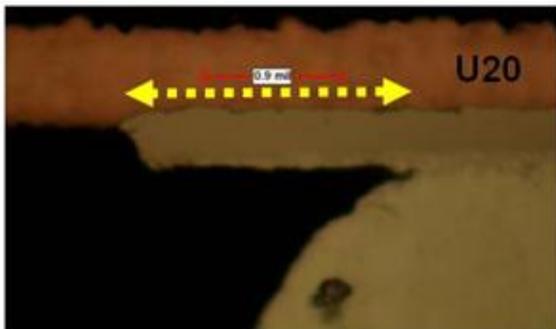
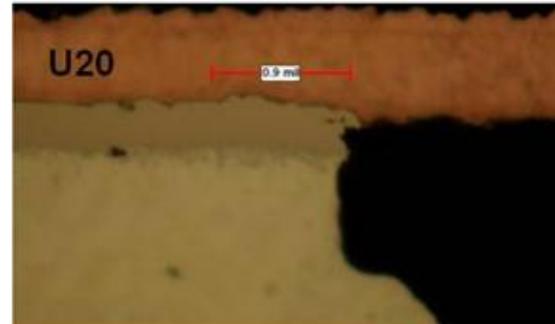
Magnified (1000X) cross section of PCBA, Component A, solder balls P20, R20 and U20.

At the dashed yellow lines, these look like de-wetting failures  
At the dashed red lines, clear indications of fracturing are seen

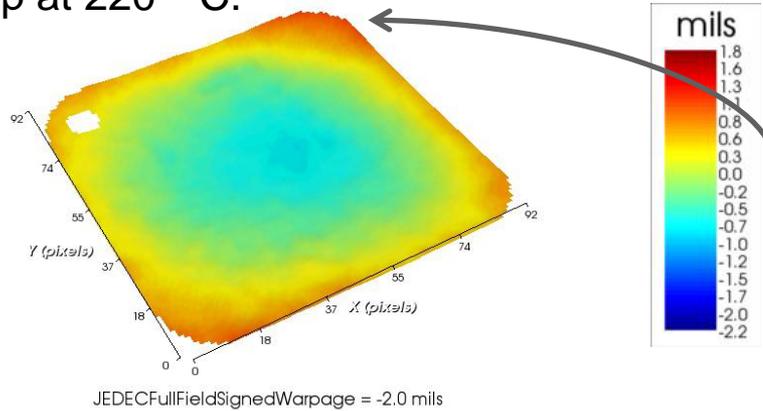
A warpage displacement map across the overmolded area of Component A measured during temperature ramp up at 220° C.

Corner with majority of failures

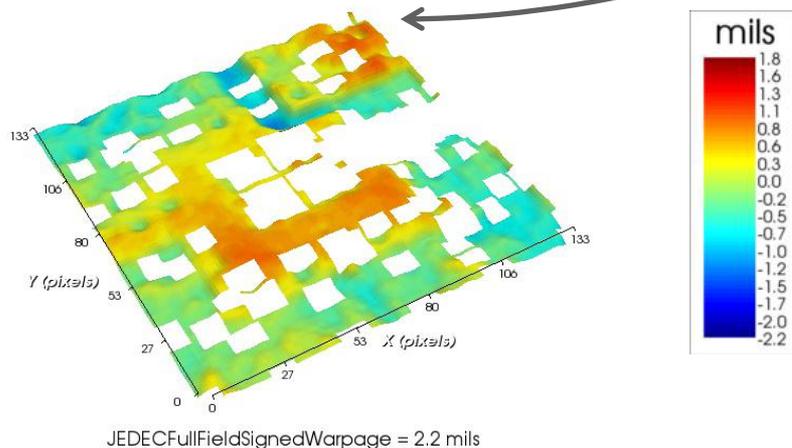
A warpage displacement map for the PCB footprint matching Component A. The measurements were made during temperature ramp up at 220° C.

- The thermal shadow Moiré data indicate a net displacement or warpage of Component A relative to the PCB of approximately 4 mils during heating in advance of melting or during cooling before solidification takes place (shaded Max.  $\Delta$  cells in Table 2).
- In most applications 4 mils of warpage would be considered acceptable because defects like HoP and dropped ball would not occur. On the other hand, solder assembly defects due to warpage can appear with deviations in warpage as small as a few mils.

The solder assembly process was changed to allow the BGA components to be assembled during the second reflow. This process change was successful in that it eliminated the Double Reflow Defects.
