# Assessment of Reterminated RoHS Components for SnPb Applications

Chris Hunt, Martin Wickham, Ling Zou, Owen Thomas and Bufa Zhang  
National Physical Laboratory  
Teddington, UK

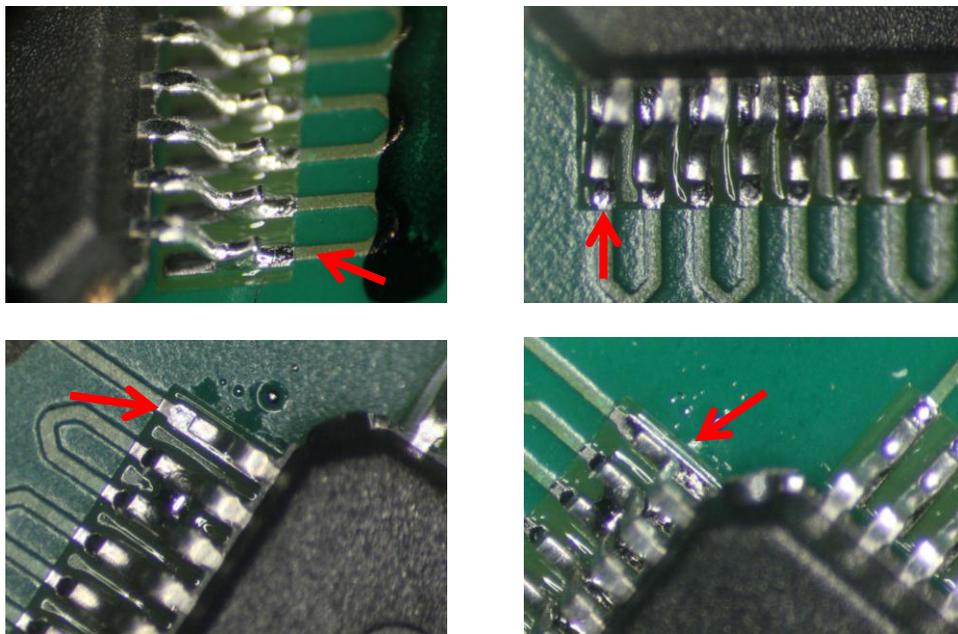
All reterminated components were inspected under microscope (magnification x10–60) to check solder coverage and other surface conditions. Relatively few problems were experienced with the surface mount components. The only issue of note was some bent terminations on LQFP100 components. These were restricted to the supplier which used manual handling during the retermination of these devices. Examples of these components after assembly and the resulting open and misaligned joints are given in Figure 1.

**Figure 1: Examples of open joints and bent terminations on QFP components after manual handling during retermination**

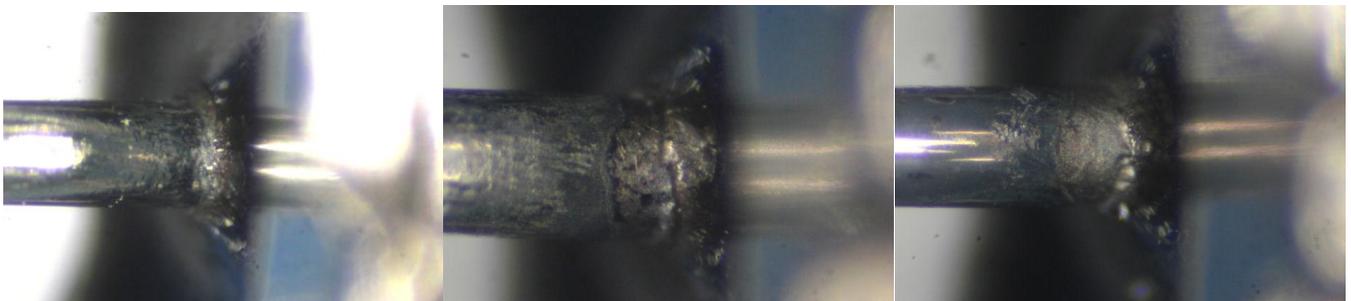
Some through-hole components exhibited issues with poor coverage and package body damage. Poor coverage occurred for two reasons. Firstly, some terminations exposed outside the package body were not solderable, due to the method of component manufacture. These were not solder coated during original manufacture and therefore it was not possible to reterminate these areas with SnPb solder. Examples of this can be seen in Figure 2. Other problems were experienced with components where the terminations extended into cavities within the component body. To prevent damage to the package body or solder wetting the body if metallic, the package bodies of such components were held above the solder pot during retermination. This resulted in incomplete conversion of the solder coating on the termination as the SnPb solder did not wet high enough along the termination (Figure 3).

**Figure 2: Showing upper termination areas on original (left) and reterminated examples (centre and right) exhibiting non-wetting due to original manufacturing issues**

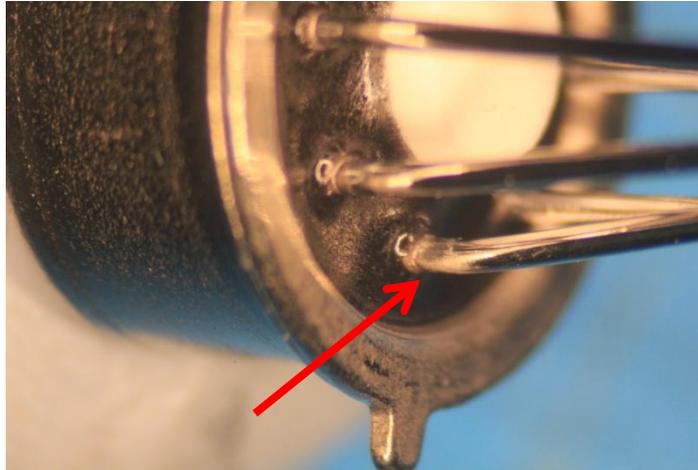
**Figure 3: Showing unconverted region at top of termination inside metal can component recess**

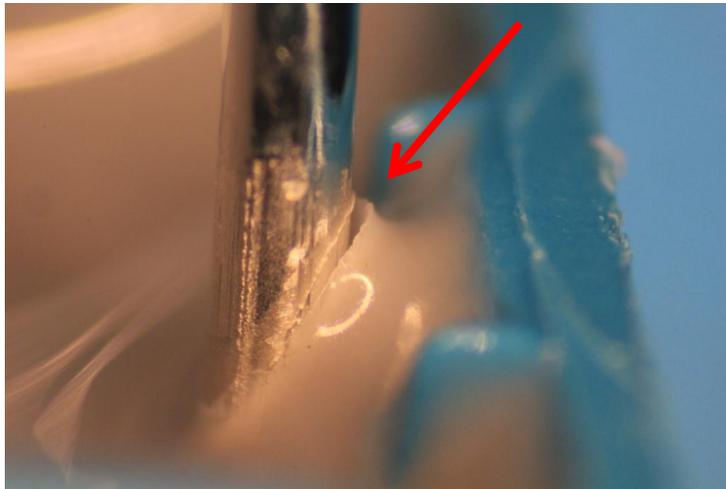
Several examples of damage to TH component bodies were also seen, with the possibility of exposing unconverted areas of the component termination (Figure 4 and Figure 5). It should be noted that in normal assembly, these areas of the components would not see molten solder temperatures being on the opposite side of the PCB to the soldering operation. However, during retermination, in an effort to achieve full conversion of the termination, package bodies may be subjected to temperatures well in excess of those to be expected in normal soldering.

**Figure 4: Separation of the component body encapsulant from the termination after conversion to SnPb**

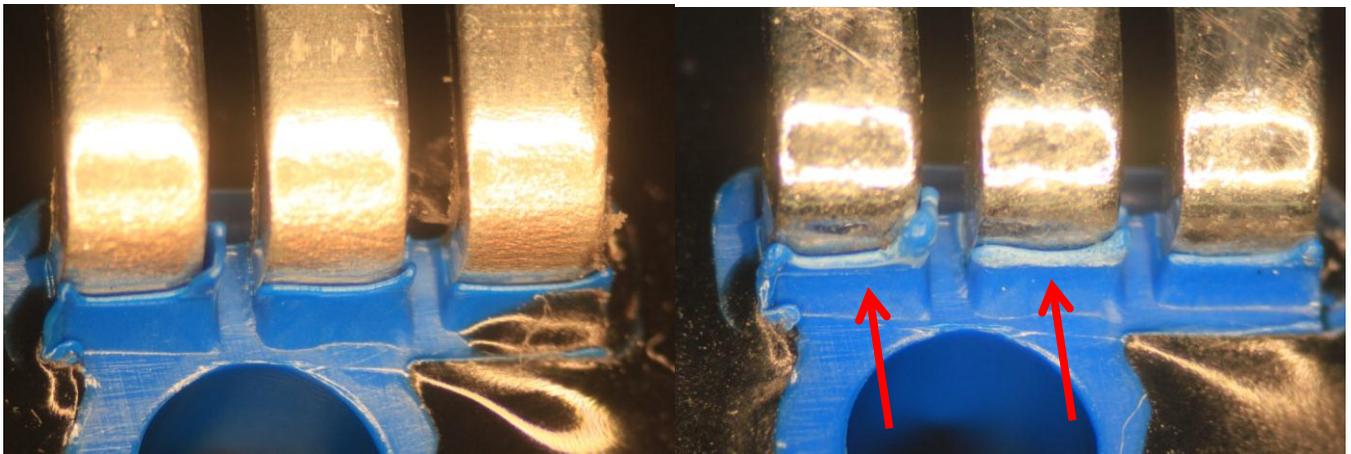
**Figure 5: Body encapsulation before (left) and after (right) conversion to SnPb**

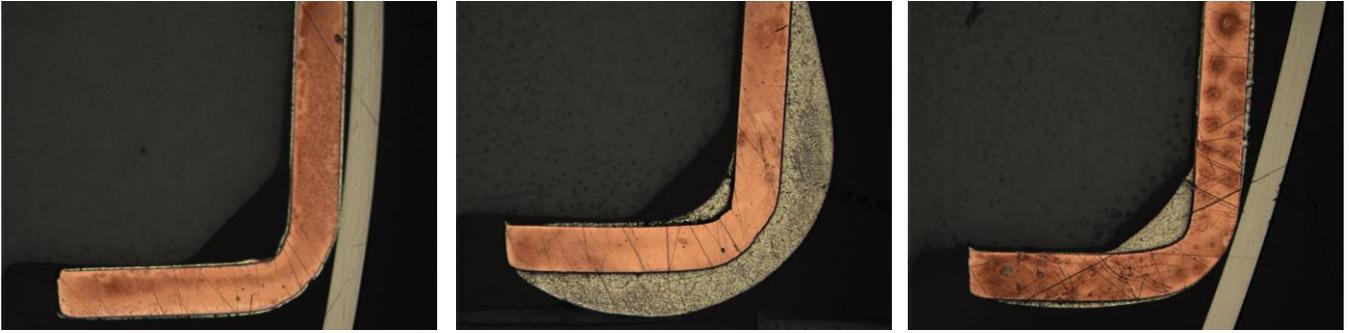
Examination of micro-sections of both the original and reterminated samples showed greater variation in solder thickness of the reterminated samples. The molten SnPb formed menisci in lead bends of components causing significantly increased solder thickness as can be seen in Figure 6 and Figure 7. This could lead to placement problems in production particularly for fine pitch components. Additionally, thinner solder was noted around the edges of terminations compared to the original terminations. After long term storage, these areas may present poor solderability during assembly. No significant intermetallic thickening was noted as a result of the conversion process.

**Figure 6: Optical micrographs of a SM LED terminations before (left) and after (centre and right) showing increased solder volume at termination bends**

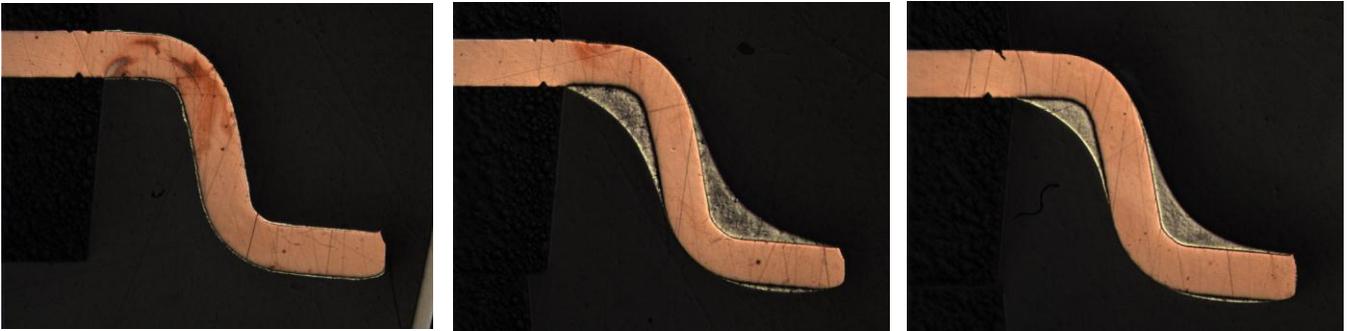
**Figure 7: Optical micrographs of a SPAK gull-wing terminations before (left) and after (centre and right) showing increased solder volume at termination bends**

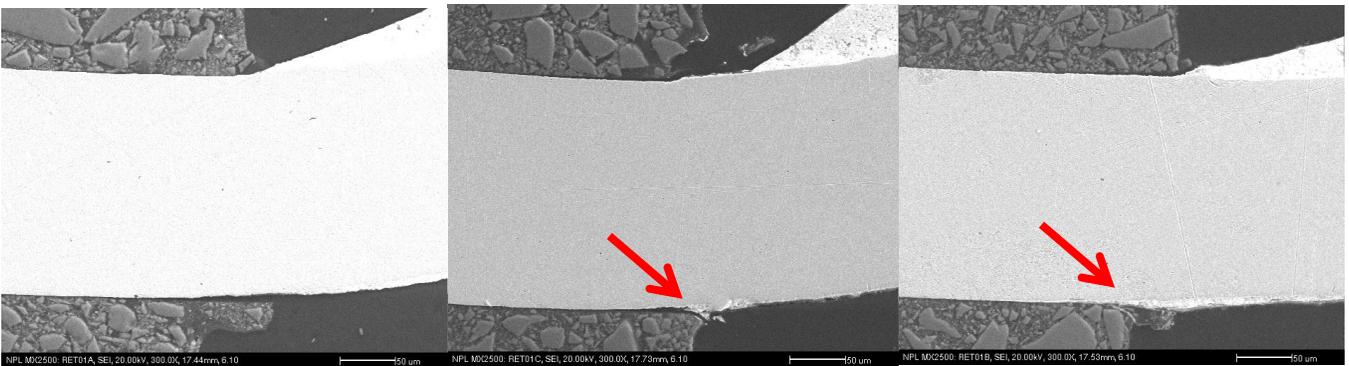
Solder ingress along internal gull-wings of reterminated plastic bodied components was also noted in optical and SEM micrographs, an example is shown in Figure 8. This was confirmed to be SnPb using EDX analysis. No solder was present in the original components although the separation between the component body and lead-frame was present. It is perhaps, testament to the efficacy of the conversion process that SnPb has penetrated into the component body along the lead frame.

**Figure 8: SEM micrographs of a LQFP100 gull-wing terminations before (left) and after (centre and right) showing solder ingress along lead frame**

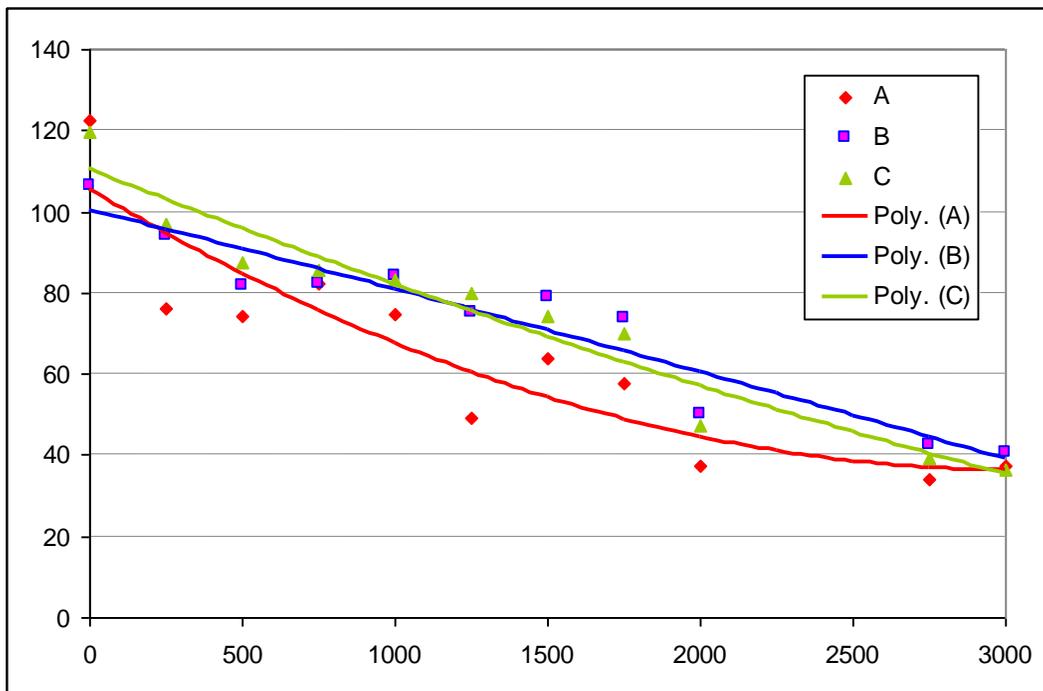
Figure 16 shows the degradation of the shear strength of 1206 resistors as a function of thermal cycle conditioning. The degradation is similar for the three sample sets (A- as-received, B- first reterminator, C- second reterminator). The as-received exhibit slightly more rapid degradation in shear strength and this is related to the increased solder joint volumes associated with the reterminated components, resulting in a greater stand-off.

Figure 16: Degradation of the shear strength of 1206 resistors as a function of thermal cycle conditioning (A- as-received, B- first reterminator, C- second reterminator)

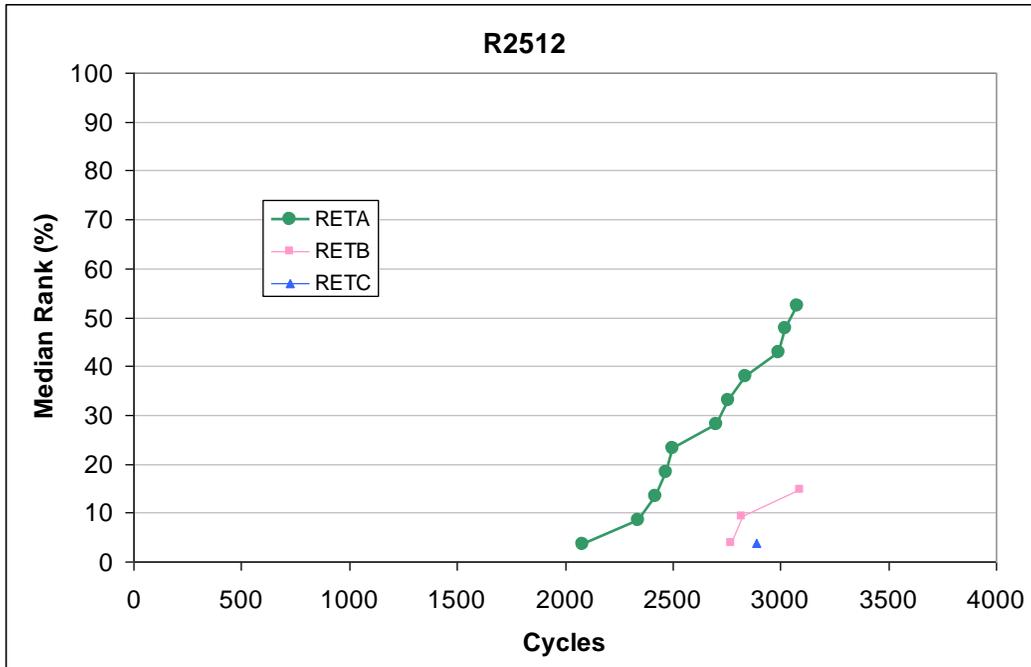
Figure 17 shows similar data for the constant monitoring of electrical performance of the 2512 resistors during the 3000+ cycles of thermal cycle conditioning. Electrical failures occurred earlier for the As-received Sn components (RETA). Few failures were experienced for either of the reterminated component sets (RETB & RETC). Again the higher failure rate of

the Sn finished components is related to the increased solder joint volumes associated with the reterminated components, resulting in a greater stand-off.

Figure 17: Electrical performance of the 2512 resistors during thermal cycle conditioning

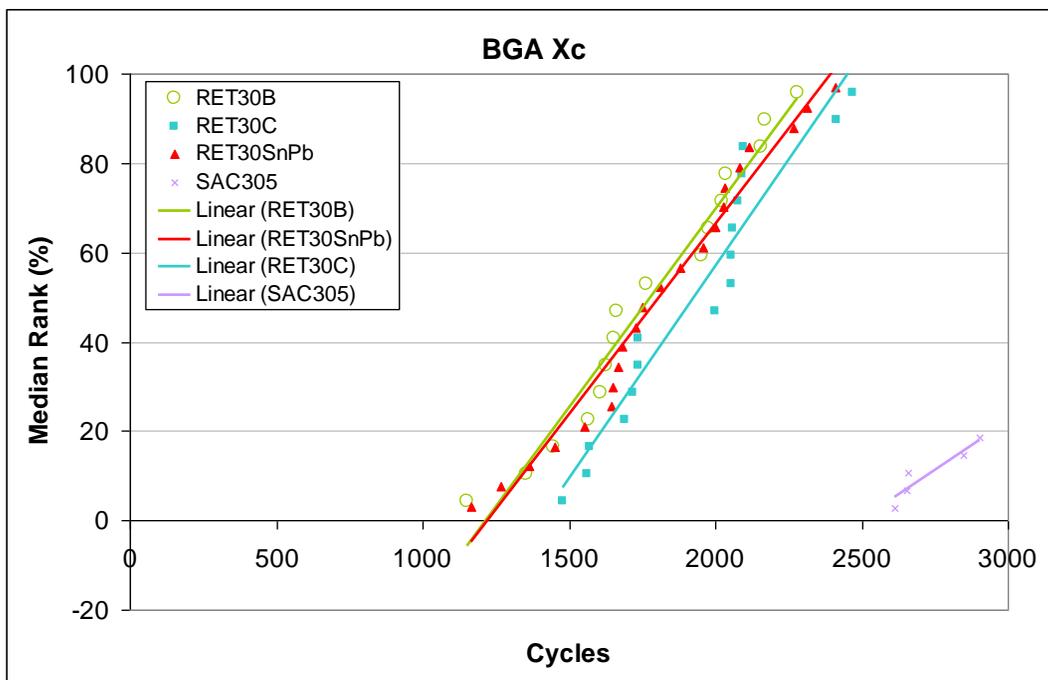
Figure 18 shows the failure rate of the C-rings of the PBGA components as a function of thermal cycles. All three SnPb data sets (RET30B – first reterminator, RET30C – second reterminator, RET30SnPb – SnPb control) show very similar failure rates. The RET30C results indicate a slightly improved failure rate. This can be explained the standoff heights given in Table 3, where the height for RET30C can be seen to be greater than for the other components. This is due to a larger ball being used in this retermination operation. The performance of the SAC control BGAs is superior to the SnPb terminated examples because of the better fatigue performance of the SAC alloy at the strain rates generated during this type of thermal cycling.

Figure 18: failure rate of the C-rings of the PBGA components as a function of thermal cycle conditioning (A- as-received, B- first reterminator, C- second reterminator)

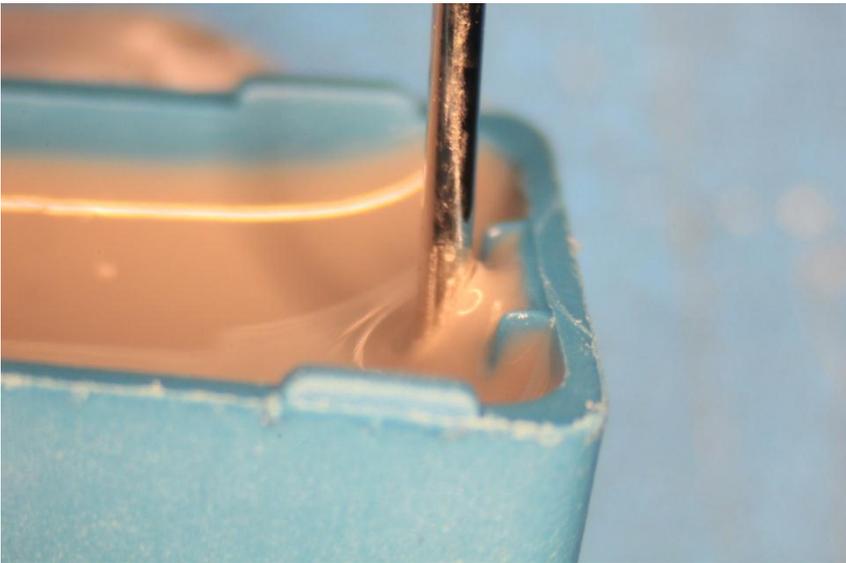
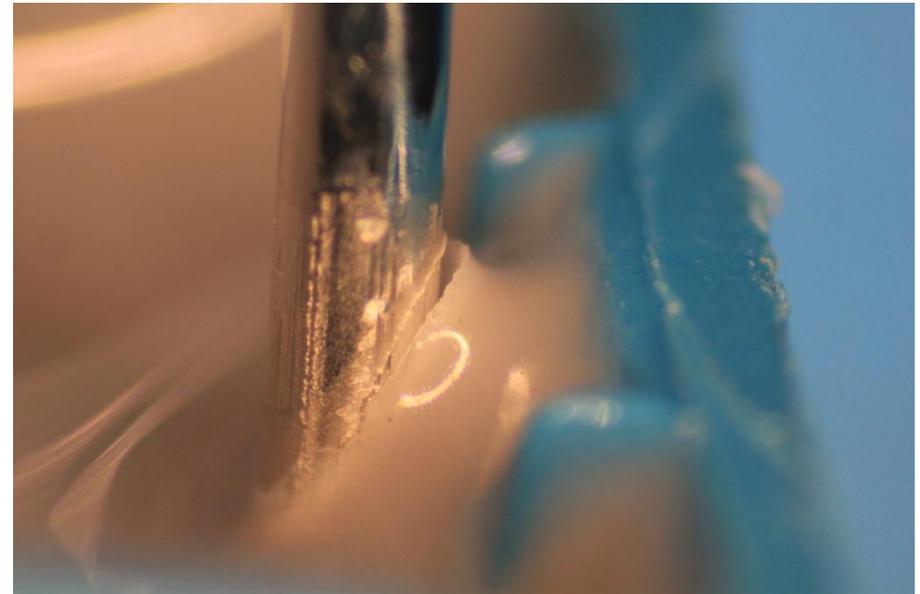
# Visual Inspection – Radial Electrolytic

Present in both reterminated samples

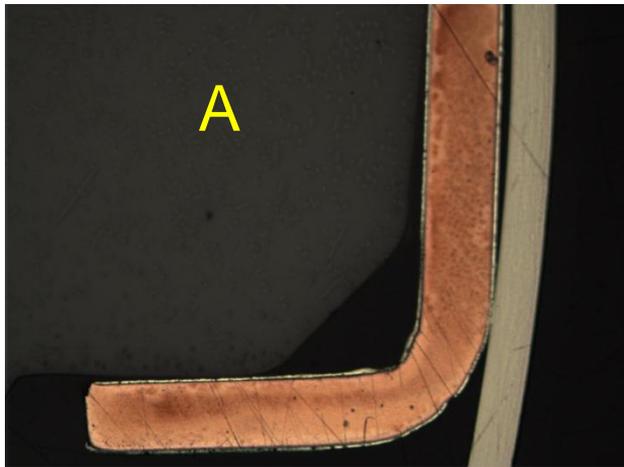
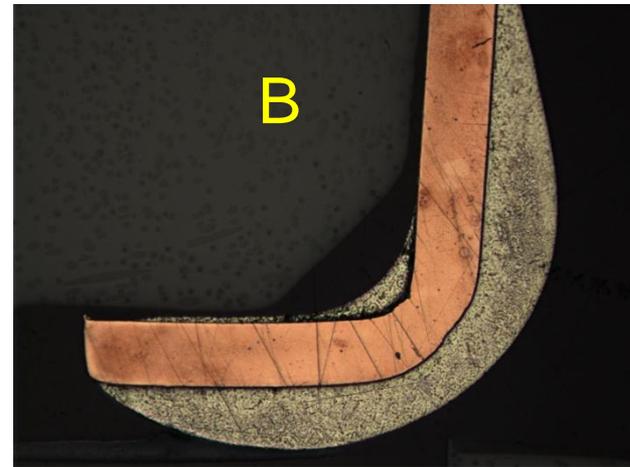
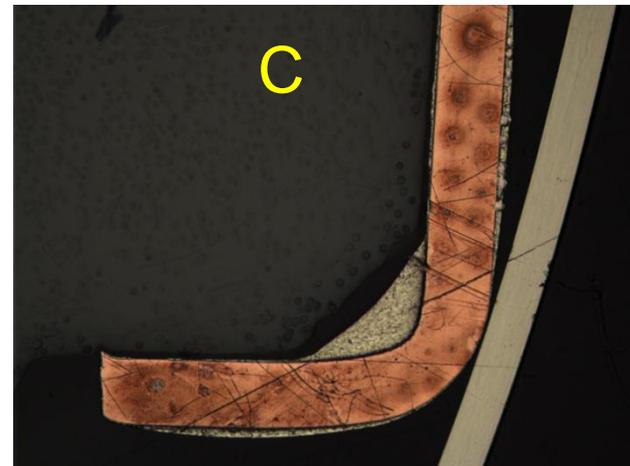
# Optical Inspection - SMLED

- Solder in lead bends for B & C
- Minimal intermetallic thickness change

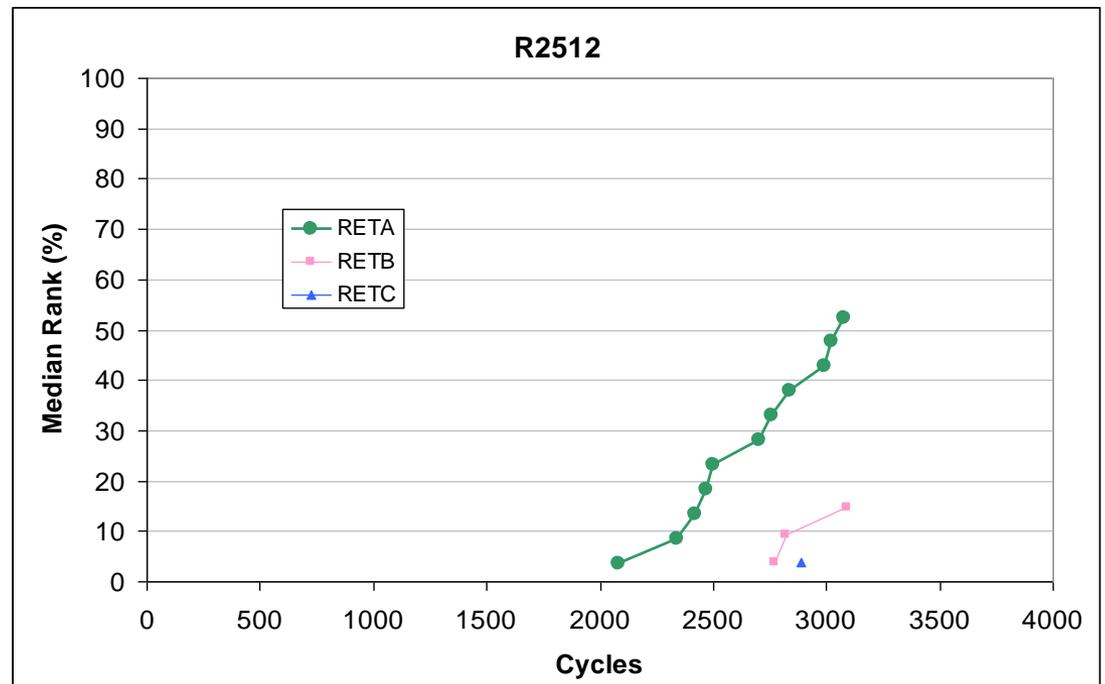
# R2512 Electrical Failures – 3000 cycles

- Single electrical failure in chain of 10 joints
- Sn
  - 55% failures
- RET B
  - 17% failures
- RET C
  - 6% failures

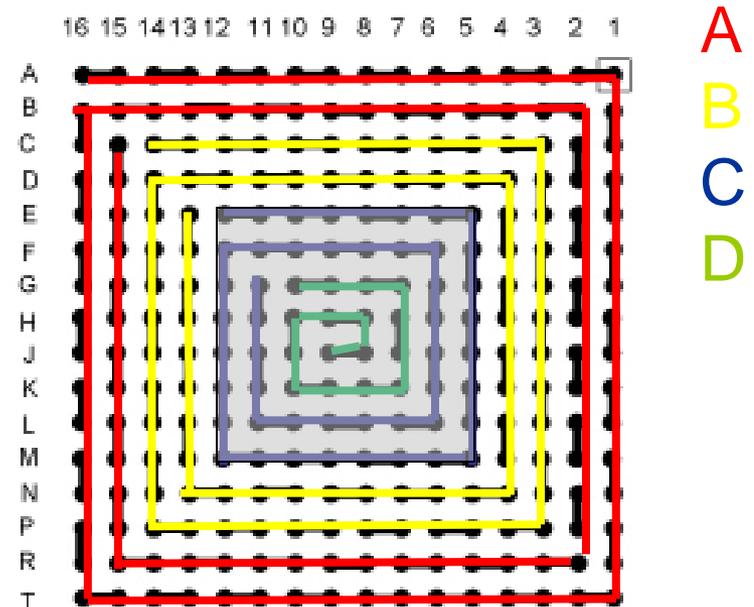
# BGA Electrical Testing – 3000 cycles

- BGA A-rings
  - 11% failures
  - All as-received SnPb
- BGA B-rings
  - 25% failures
  - All SnPb, mainly as-received
- BGA D-rings
  - 10% failures
  - All as-received SnPb
