# Microstructural Evolution and Damage Mechanisms in Pb-Free Solder Joints During Extended $-40^{\circ}\text{C}$ to $125^{\circ}\text{C}$ Thermal Cycles

Steven O. Dunford  
Nokia Mobile Phones,  
Irving, TX

Anthony Primavera, Ph.D. and  
Michael Meilunas  
Universal Instruments Corporation  
Binghamton, NY

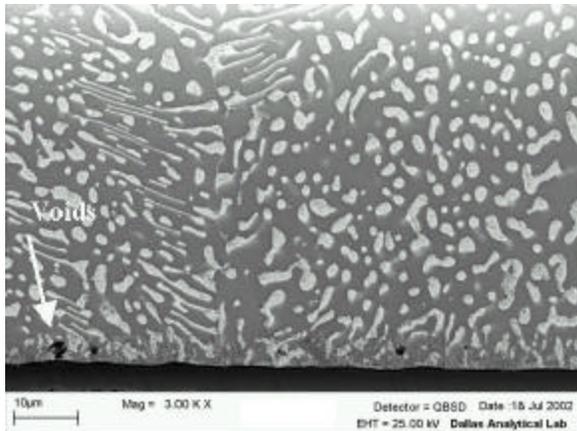
Ni/Au surface finish produced numerous small voids found in and around the intermetallic formations at the solder interface. These small voids were more numerous in the SAC, and Sn/Ag solders as compared to the Sn62 solder. They were so small that they were not identified in the xray inspection. Examples of the small voids are shown in Figures 1 and 2. Small voids were rare at the interface of Cu/OSP solder pads.

**Figure 1 - Eutectic Sn/Pb Solder Joint on ENIG after Assembly Small Voids at Interface were Typical of all Ni/Au Solder Joints**

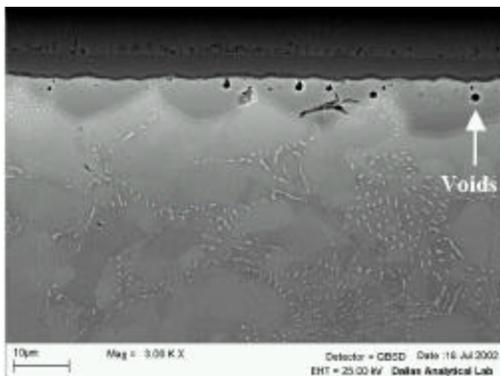
**Figure 2 - Sn/Ag Solder Interface to ENIG on Component Side**

Figure 2 shows an example of the intermetallic compounds formed in SnAg solder at the ENIG interfaces on an ENIG finished PWB. IMCs in solder joints with ENIG on both the component and the PWB were primarily Ni<sub>3</sub>Sn with small amounts of Ni<sub>3</sub>P. The maximum height of the IMC peaks was approximately 6µm. A continuous layer of Ni<sub>3</sub>Sn<sub>4</sub> formed between the phosphorous rich Ni layer after thermal cycling. The IMC formations from SnAg on OSP finished PWBs were different at the PWB and component interfaces. After assembly the IMCs at the PWB interface consisted mainly of Cu<sub>6</sub>Sn<sub>5</sub> as shown in Figure 3. The SnAg/OSP combination produced the thickest IMC formation at the solder interface when compared with the other samples. It measured up to

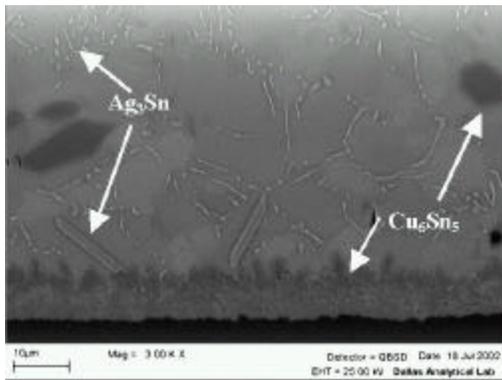
**Figure 3 - Sn/Ag Solder at Cu/OSP Interface after Assembly  $Ag_3Sn$  Forms in the Grain Boundaries Hexagonal  $Cu_6Sn_5$  is seen in the Bulk Solder**

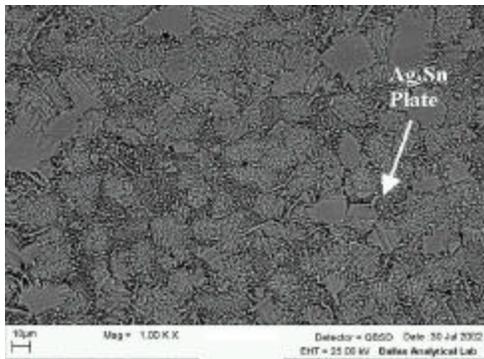
Small plates, spheroids, and elongated particles of  $Ag_3Sn$  formed mostly in the small angle grain boundaries of the solder. The small plates are more clearly seen in an etched sample shown in Figure 4. Large plates of  $Ag_3Sn$  were occasionally found at random locations and orientations in the bulk solder. These larger plates were more common in the SnAg/OSP components. EDS analysis identified a small percentage of Cu in the plates but this was not fully investigated at the time of this report. The population of large  $Cu_6Sn_5$  needles was similar to that of the Sn62/OSP solder joints but with a slight increase.

**Figure 4 - Typical Morphology of Sn/Ag Solder Joints with Small Grain Size and Numerous  $Ag_3Sn$  Plates in the Grain Boundaries - Etched Sample**

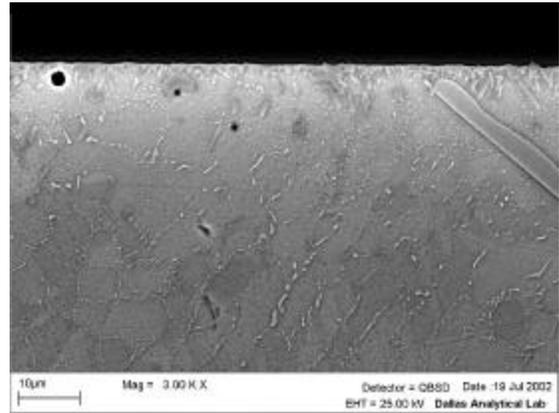
The IMC compounds formed with the ENIG/SAC combination were similar to those observed with the SnAg solder. However, the  $(Ni,Cu)/Sn$  IMC compounds at the interface with ENIG changed from a block-like structure seen in Figure 2 to a needle-like structure seen in Figures 5 and 6. The layer was also thinner with an average near 4µm. The layer consisted of  $(Ni,Cu)_6Sn_5$ ,

**Figure 5 - Intermetallic Formations Seen at ENIG/SAC Interfaces**

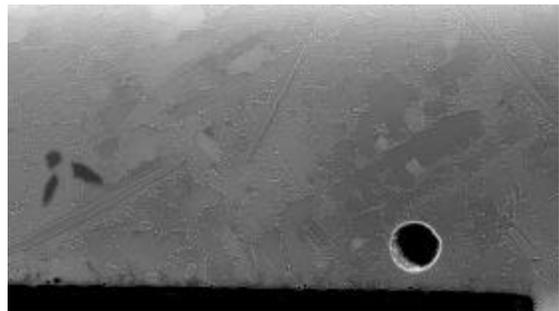
**Figure 6 - Typical SAC on Ni/Au Bulk Solder at 1000x.  $Cu_6Sn_5$  is Seen at Left above an  $Ag_3Sn$  Plate**

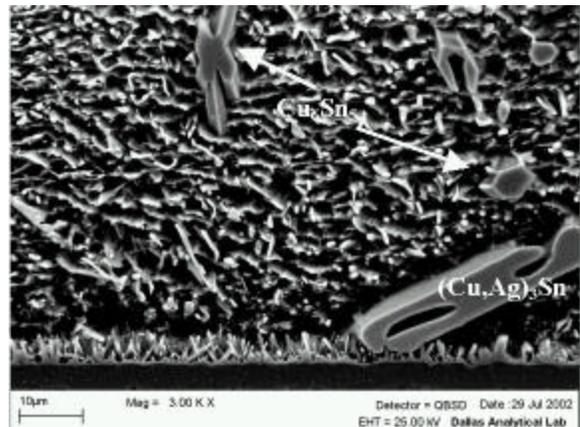
$(Ni, Cu)_3Sn$  and a layer of  $Ni_3Sn$  that increased in thickness as thermal cycling progressed. Large  $Ag_3Sn$  plates and voids similar to those shown in Figure 7 were more numerous when compared to the SnAg solder.

**Figure 7 - Etched Sample of SAC Solder on OSP after Assembly**

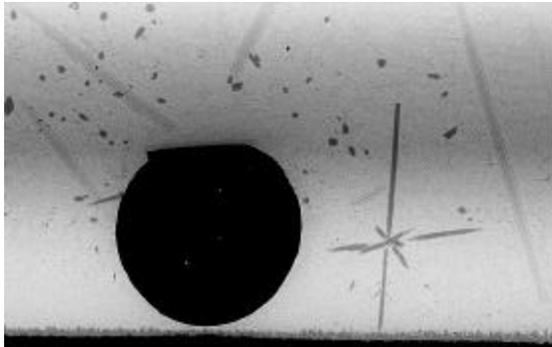
structure at the top of the image is also  $\text{Cu}_6\text{Sn}_5$  and is a result of the increased Cu content of the solder joints. It is similar to the Cu-Sn structure found in Babbitt, which has a Cu content of 7%.<sup>22</sup> Figure 8 shows the star structure with greater clarity. EDS measured the Cu content in the bulk solder joint at approximately 6 wt%.

The void in Figure 8 is representative of many truncated voids seen during this investigation. They were often attached to an  $\text{Ag}_3\text{Sn}$  plate. It is hypothesized that the plates interfere with the evolution of voids during the soldering process.

**Figure 8 - SAC on OSP at 1000x. Cu Intermetallic Formations are Found in the Bulk Solder Including the  $\text{Cu}_6\text{Sn}_5$  Star -  $\text{Ag}_3\text{Sn}$  Plates are most Common in this Metallurg**

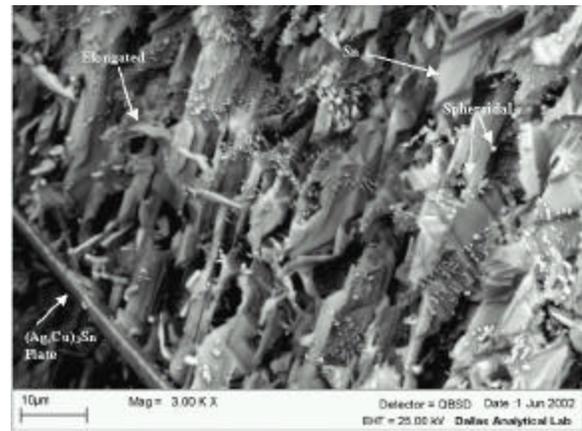
The spheroidal, elongated and plate-like structures of  $\text{Ag}_3\text{Sn}$  were found in small angle grain boundaries throughout the bulk solder.<sup>23-24</sup> Figure 9 shows a heavily etched SAC solder ball. The spheroidal  $\text{Ag}_3\text{Sn}$  particles can be seen where they form in the grain boundaries between Sn rich areas. It was observed that the particles increase in size with closer proximity to the Ag/Sn plates. These larger elongated particles contain 3-5 weight percent Cu and the Ag/Sn plates contain up to 7% Cu as measured by EDS. This identified Cu as a key component for the formation of the larger particles and plates that are more correctly labeled as a  $(\text{Cu},\text{Ag})_3\text{Sn}$  compound.

**Figure 9 - Etched Sample of SAC/OSP showing  $\text{Ag}_3\text{Sn}$  - Spheroidal, Elongated, and Plate in Sn Matrix**

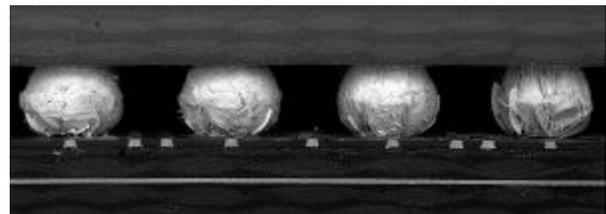
Figure 10 provides a perspective on the size, location, and distribution of the  $\text{Ag}_3\text{Sn}$  plates within SAC solder balls on OSP. The solder balls have been through 6500 thermal cycles without failure. An extended etch was used to highlight the plate formation. Evaluation of adjacent solder balls shows the variations in plate formation from one solder ball to another on the same component. The solder ball on the left is at the corner of the component.

**Figure 10 - Extended etch of SAC/OSP Solder Joints show the Range of Variations in IMC Content in Adjacent Solder Joints**

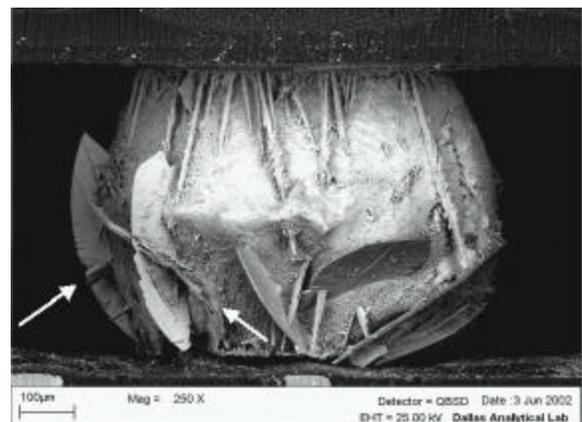
A magnified view of the right hand solder ball is shown in Figure 11 and is presented as an extreme example as the number and size of intermetallic formation in this joint was not common for solder balls in this study. The two  $(\text{Ag},\text{Cu})_3\text{Sn}$  plates on the left extended from the top to the bottom of the solder joint before being broken after etching.  $(\text{Ag},\text{Cu})_3\text{Sn}$  plates could be found throughout the solder joints, but were generally observed more often toward the PWB side of the joint.

**Figure 11 - Magnification of Solder Ball in Figure 10 shows Maximum IMC Content that was Found - Plates are  $(\text{Ag},\text{Cu})_3\text{Sn}$  and Needles are  $\text{Cu}_6\text{Sn}_5$**

$\text{Cu}_6\text{Sn}_5$  needles extend from both interfaces toward the middle of the solder joint. The long needle on the right shows the extent of needle length. Adjacent solder balls in

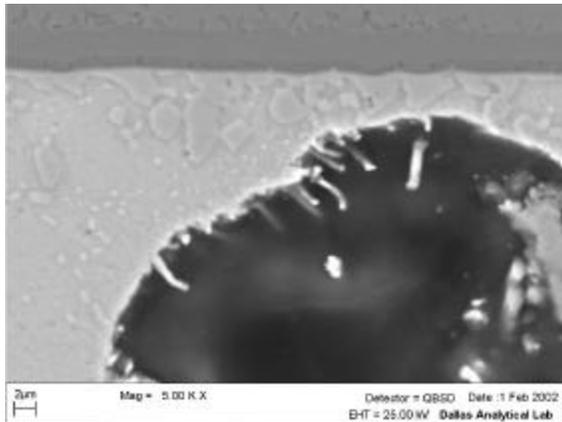
Cross sectional analysis of the Pb-free solder joints revealed Sn whiskers growing within some voids. Figure 12 shows Sn whiskers extending from the surface of an internal void in a Sn/Ag solder joint on an ENIG PWB after 2700 temperature cycles. Similar whiskers were also found in SAC solder joint voids at various stages of thermal cycling.

**Figure 12 - Sn Whiskers found on the Surface of Internal Voids in Sn/Ag and SAC Solder Joints**

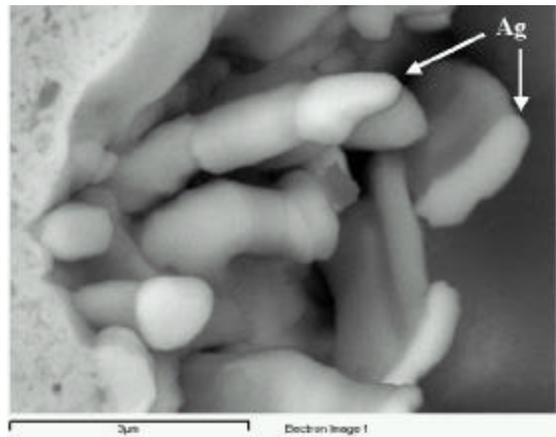
Figure 13 shows a magnified view of the whiskers. The size and shape of the whiskers are non-uniform with the body conforming somewhat to the shape of the Ag compound found at the end of each whisker. The Ag compound on the end is similar in size and shape to the small  $\text{Ag}_3\text{Sn}$  particles found throughout the bulk solder. Proposed theories about the formation of Sn whiskers suggest a compressive force is acting on the voids.<sup>25</sup> It demonstrates the potential for whisker growth in these high Sn solders.

**Figure 13 - A Magnified View of Sn Whiskers Inside a Solder Void - Lighter Colored End of the Whisker is an Ag Compound**

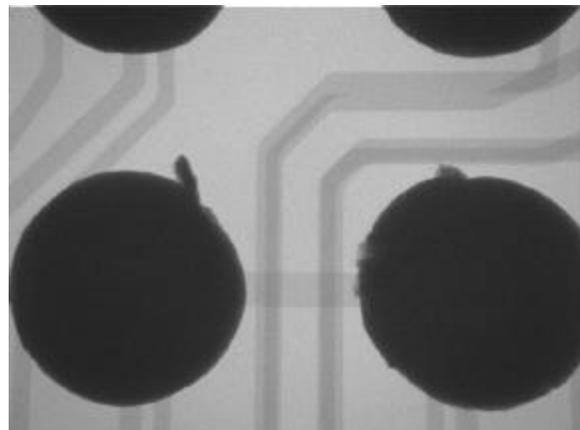
Figure 14 shows an xray image of the largest of the protrusions as seen from the top of the component and Figure 15 provides a side view of these same solder balls. All the other protrusions found on Sn/Ag and SAC were needle like in shape. However, in this case, the protrusions are large Sn rich formations growing out from regions between two vertical cracks in the solder balls. These vertical cracks will be discussed further in the Failure Mechanisms section. Please note the neighboring solder balls are free from horizontal or vertical cracking. The sample was SAC/ENIG and had completed 6500 thermal cycles without a recorded failure. The dark horizontal line on the solder balls is flux residue.

**Figure 14 - This x-ray Image shows Sn Growths at the Edge of Two Solder Balls**

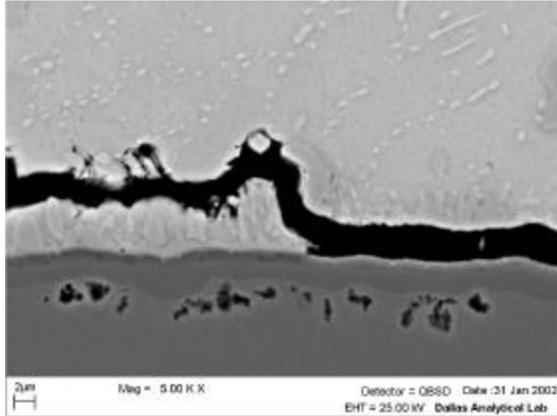
Similar failures occurred with 5 SnAg/ENIG solder components between 180 and 1051 temperature cycles. The difference in the failures is shown in Figure 16 where only a partial separation occurred at the Ni to solder interface. Up to one half of the fracture was in the bulk solder above the intermetallic compound formations. The continuous Ni<sub>3</sub>Sn layer can be seen at the surface of the phosphorous rich Ni layer in Figure 16. These were not deemed to be solder fatigue failures.

**Figure 16 - PWB Side Failure at 650 Cycles on SA/ENIG Construction**

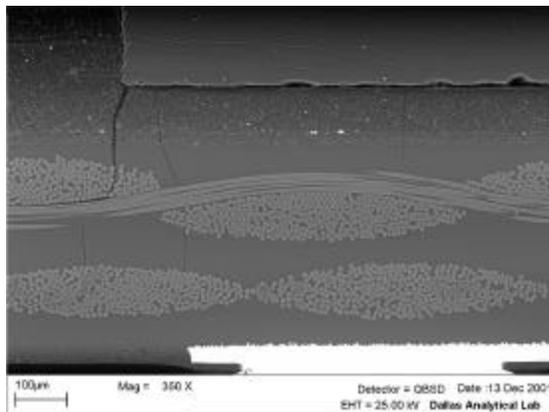
Component delamination was initially seen in samples taken at 2000 cycles. Separation typically started at the edges of the glass slide and could be seen with a simple visual inspection. The delamination of the glass was not extensive at this point however, Figure 17 shows cracks progressing from under the glass slide, through the underfill material, and into the component substrate laminate at 2000 cycles. It is suspected that the delaminations did influence the CTE mismatch between the component and the PWB and resulted in some out of plane stresses. Figure 17 also shows the relative position of the edge of the glass plate to the corner solder balls.<sup>8</sup> The deformation and grain coarsening of PbSn solder shown in Figure 18 indicate the areas of greatest stress on the solder joints.

**Figure 17 - Delamination in the Component as Seen after 2000 Temperature Cycles**

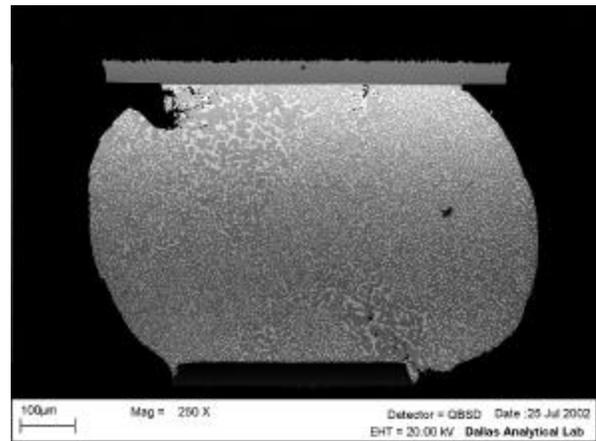
**Figure 18 - Representative Grain Coarsening and Deformation of Eutectic Sn/Pb Solder Joint after 6500 Cycles**

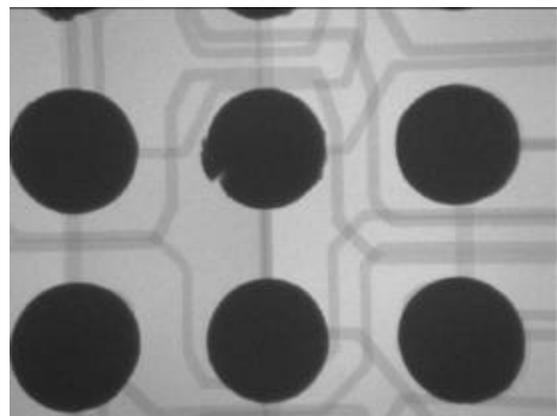
X-ray inspection gave indications of the formation of vertical cracks in components as early as 2700 cycles. The solder balls with the vertical cracks were located randomly across the arrays of the Pb-free components with surrounding solder balls being unaffected as shown in Figure 19. There were no vertical cracks found in the Sn/Pb solder joints.

**Figure 19 - X-ray Image showing a Vertical Crack in a Sn/Ag Solder Joint after 6500 Temperature Cycles**

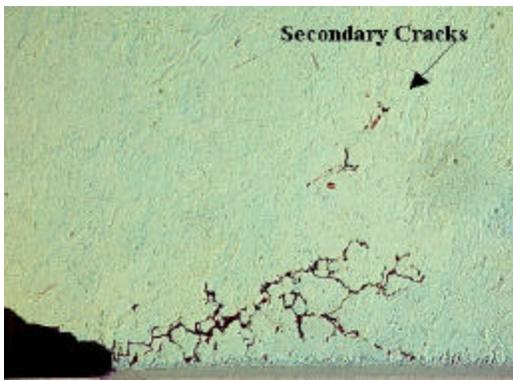
Multiple fractures occurred in the small angle grain boundaries in the Sn rich solder matrix giving a shattered look to the failures as seen in Figure 20. Cracks often progressed away from the solder interface or secondary cracking occurred (Figure 20). The frequency of fractures occurring on the component side and the PWB side of the solder joint was approximately equal.

**Figure 20 - Multiple Cracks Propagate through Small Angle Grain Boundaries in Pb-Free Solder**

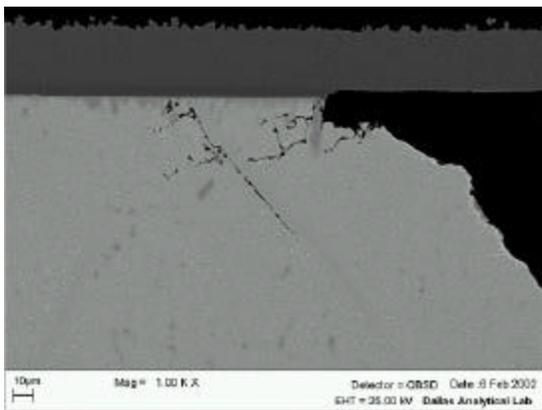
Figure 21 shows a SAC solder joint after 2700 cycles where crack propagation has been modified by the presence of the  $(\text{Ag,Cu})_3\text{Sn}$  plate. In an electrically “good” solder ball after 6500 cycles, the crack propagation at the pad interface in Figure 22, appears to have been arrested or retarded by the presence of the  $(\text{Ag,Cu})_3\text{Sn}$  plate. At the same time, the intermetallic plate at the right edge of the solder ball likely contributed to the initiation of vertical cracks at each end of the plate.

**Figure 21 - Fracture Path is Modified by the Presence of an  $\text{Ag}_3\text{Sn}$  Intermetallic Plate (2700 Cycles, SAC)**

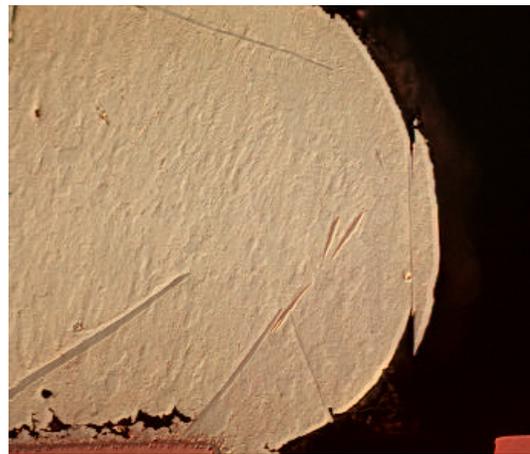
**Figure 22 - Intermetallic Plates can Retard Crack Growth or Influence the Crack Initiation (SAC/ENIG, 6500 Cycles)**

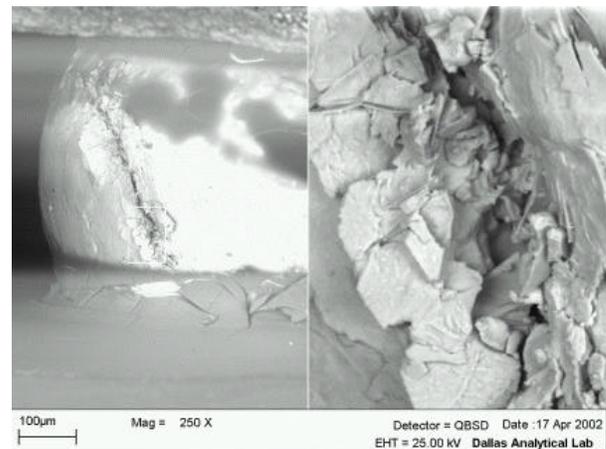
The inspection of the exterior of the solder balls provides an improved view of the vertical cracks seen in the x-ray. Figure 23 shows a vertical crack on the outside of a Pb-free solder joint. The magnification shows Sn plates fanning out perpendicular to the crack on the left side and parallel the crack on the right side indicating continuing modification of the solder structure. The cracked material at the base of the solder joint and the dark areas on the side of the solder ball are flux.

**Figure 23 - A Vertical Crack in a Sn/Ag on Ni/Au Solder Joint after 6500 Cycles**

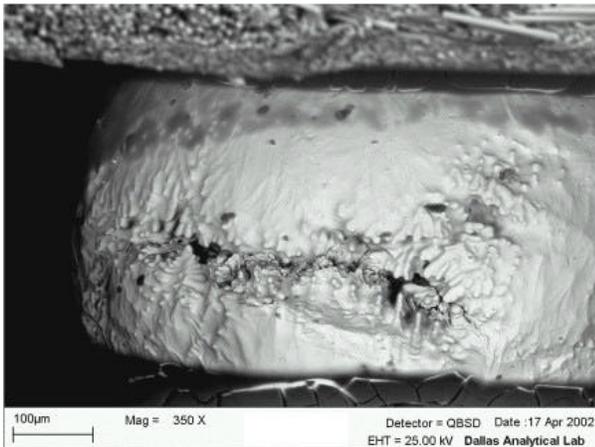
Horizontal cracks were also found along the center plane of several solder balls as shown in Figure 24. The cracks on the outside of the solder balls were often accompanied by an increased surface coarseness and by “shrinkage voids” or “sink holes”. These terms attempt to describe the appearance of the solder that may have melted away at the locations leaving a hole surrounded by needle-like formations and spherical nodes with smooth surfaces. The phenomenon has been reported previously.<sup>26</sup> More often than not, no fracture surfaces were found in and around the shrinkage voids. It is possible that these features were initiated as cracks and the fracture surface was modified

**Figure 24 - A horizontal Crack in a Sn/Ag Solder Joint after 6500 Cycles**

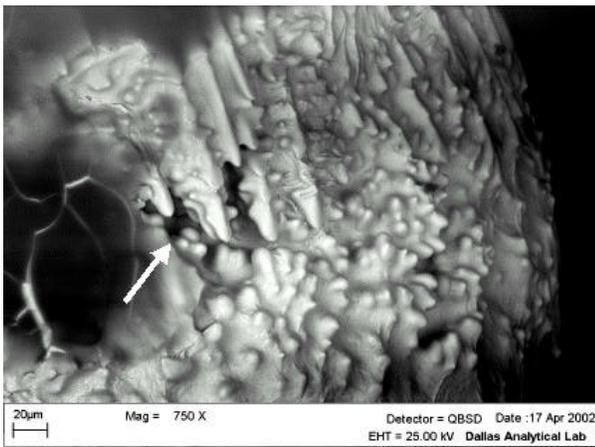
over time in thermal cycling. An example of the typical surface roughness and needle like formations surrounding a sinkhole is shown in Figure 25.

**Figure 25 - Typical Surface Roughness on Sn/Ag after 6500 Cycles - Arrow indicates the Location of a “Sink Hole”**

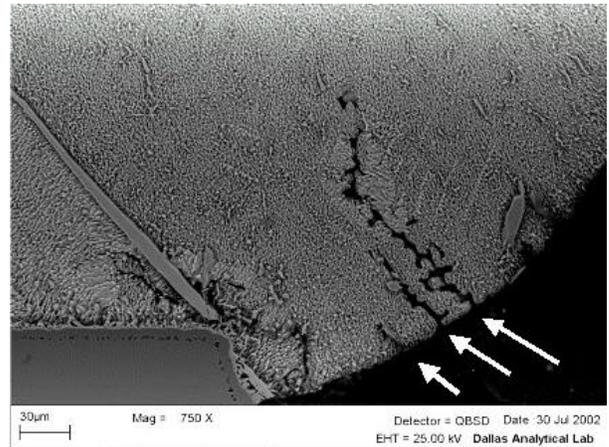
Cross sections of the sinkholes showed no fractured surfaces; rather the surfaces are populated with the rounded shapes of Sn dendrites. Figure 26 shows in cross section that the sinkholes can progress to a significant depth in the solder joint. Three sinkholes of ranging from approximately 25µm to 150µm are shown in a SAC/ENIG solder joint after 6500 cycles. The spherical or rounded structure of the Sn near the sinkholes is shown in Figure 27.

**Figure 26 - “Sink Holes” in a SAC on ENIG after 6500 Cycles - Solder Surface is Etched**

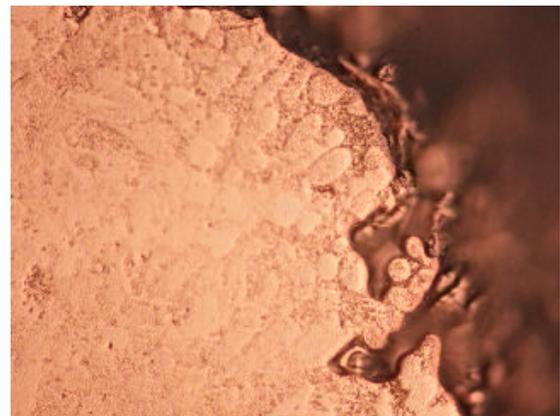
**Figure 27 - The Metallographic Image of an Etched Sn/Ag Solder Joint at 500x shows the Spherical Structure of the Sn in and Around the Sinkholes**

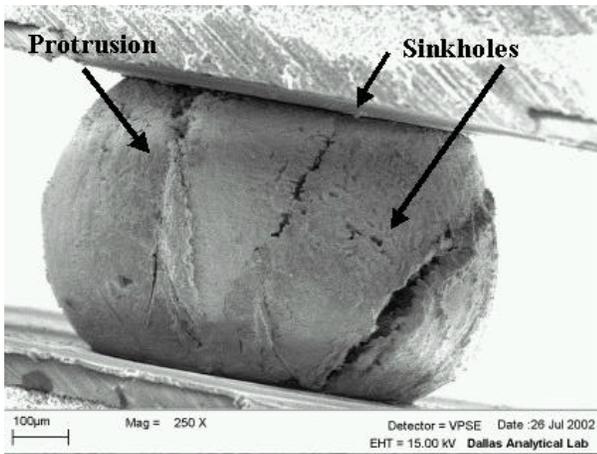
Flux residue was removed and the samples were etched in a solution of HCl and methanol to highlight the solder joint structure corresponding to the location and orientation of the cracks and sinkholes. After etching the exterior of both SnAg and SAC solder balls, it was readily apparent that the fracture locations and the sink holes were often associated with large angle grain boundaries in the solder joints. For example, the left center solder ball in Figure 15 is shown in Figure 28 after etching. Arrows indicate the protrusion growing from the solder ball at one large angle grain boundary and sink holes in the central grain boundary. The exterior views however, give little indication as to the contribution of intermetallic plates to the location of the cracks. Cross sections were examined to try and determine if the  $(Ag,Cu)_3Sn$  plates provided stress concentrations that led to the horizontal and vertical cracks. Findings indicate that the large angle grain boundaries are the preferred path for crack propagation with or without the intermetallic plates.

**Figure 28 - Vertical Cracks and Sinkholes in SAC/OSP Solder Ball - shown after Etch (See Figure 16)**

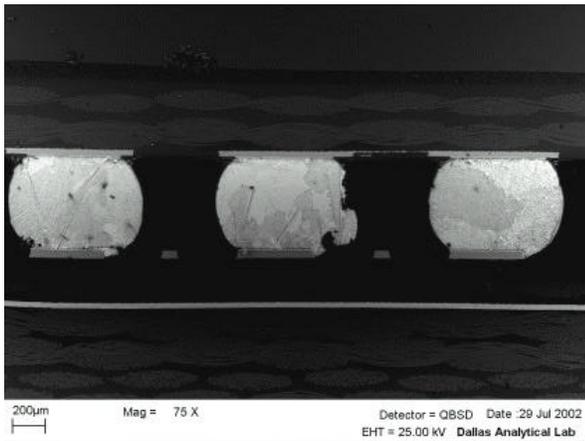
Figure 29 shows a representative sample of the variations that can occur in grain boundary orientation and location in adjacent solder joints. An enlargement of the center joint is shown in Figure 30. Numerous Sn/Ag and Sn/Cu intermetallic formations and their position in relation to the large angle grain boundaries are shown in the cross section. The solder joint has been through 6500 temperature cycles. A crack was initiated near the outside edge of a (Ag,Cu)<sub>3</sub>Sn plate near the upper left. Although the intermetallic plate runs almost parallel to the solder pad, the crack did not propagate along the intermetallic plate. Instead, the main damage to the joint occurred vertically in proximity to a large angle grain boundary and a (Ag,Cu)<sub>3</sub>Sn plate. Many larger intermetallic formations are found to some extent in the large angle grain boundaries but they do not precisely follow the boundary. Others transcended several large angle boundaries and sometimes lie perpendicular to the boundaries while others lie wholly within the grain colony.

**Figure 29 - SAC Solder Joints after Etching show Variations in the Locations of Large Angle Grain Boundaries after 6500 Temperature Cycles**

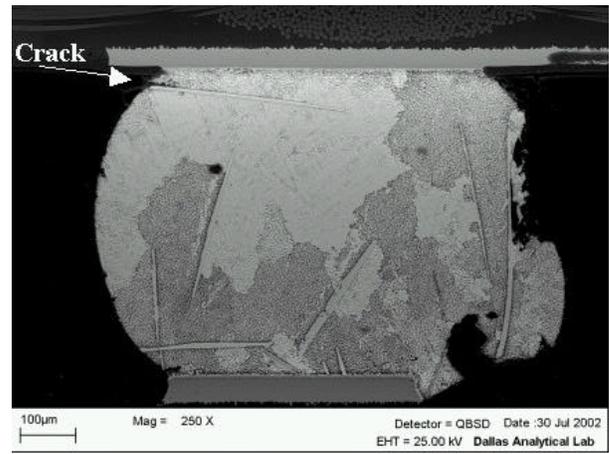
**Figure 30 - Magnification of the Center Solder Joint**

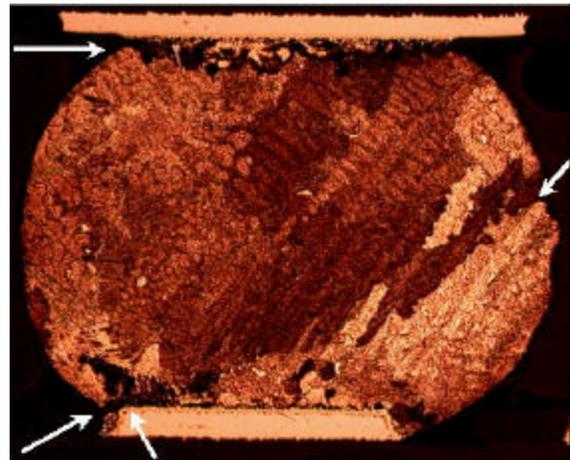
The findings show that the main factor in producing the horizontal and vertical cracks is the large angle grain boundaries. Sn/Ag solder joints produced very few large Ag<sub>3</sub>Sn plates yet horizontal and vertical cracks formed in the bulk solder of many of those joints as well. Crack propagation can be seen at several locations in Figure 31 corresponding to large angle grain boundaries without large intermetallic plates. This solder joint failed at the component after 1138 cycles.

**Figure 31 - Metallographic Image of a Sn/Ag on Ni/Au Solder Joint after 1138 Cycles - Arrows Indicate Crack Locations and Direction of Progress**

A crack extending through the bulk solder near the component interface drops into the solder following large angle grain boundaries. Cracks have also initiated at large angle grain boundaries indicated by the arrows at the base and middle of the solder joint. Cracks run roughly parallel to the direction of the arrows along the grain boundaries. No large intermetallic plates were found in this cross section.

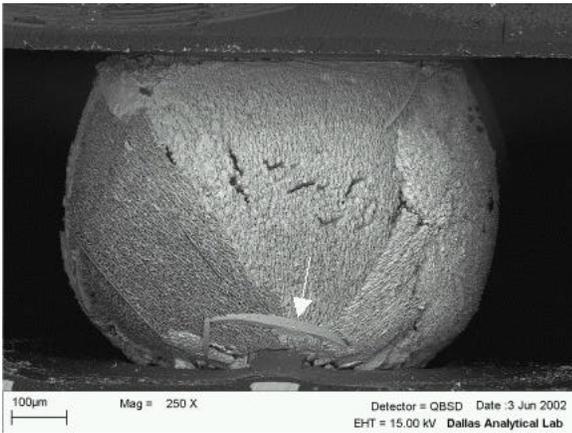
The (Ag,Cu)<sub>3</sub>Sn plate at the base of the joint in Figure 32 shows how the intermetallic plates often cross the large angle grain boundaries. Sinkholes can also be located away from the large angle grain boundaries.

**Figure 32 - A (Ag,Cu)<sub>3</sub>Sn Plate Transcends Large Angle Grain Boundaries on the Outside of a SAC/ENIG Solder Joint after Etching**

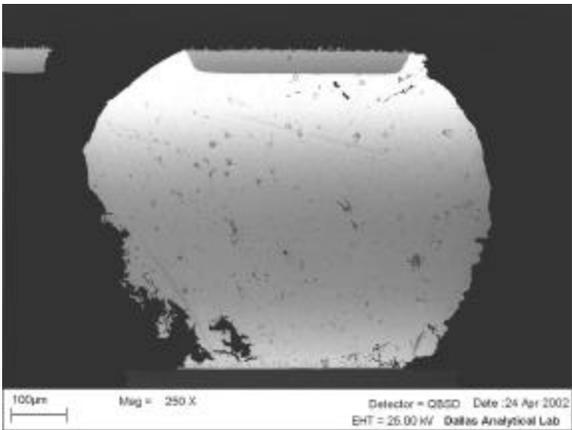
Spalling of portions of the solder joint may be a problem for applications with long life requirements. Figure 33 shows a SAC solder joint that appears to be missing a portion of the original solder ball after 6500 cycles. Although a (Ag,Cu)<sub>3</sub>Sn plate is located near the fracture, the crack did not propagate along its surface. Solder missing in this and other joints led to additional x-ray inspections to locate solder that spalled off the solder balls and inspection of the exterior of the solder balls. No spalled pieces of the solder joints were found using x-ray analysis. However the boards were tested, stacked, and transported on edge and spalled portions of solder could have fallen out through normal handling. It was not determined if the missing portion actually spalled off or if the plane of the sections corresponds to the location of vertical cracks. Further studies will need to be done to verify the risk of spalling.

**Figure 33 - This Cross Section may Indicate the Potential for Spalling of Sections of Solder from the Joint (SAC/OSP, 6500 Cycles)**
