Reliability Implications of Pinhole Defects in Soldermask

Bhanu Sood

Center for Advanced Life Cycle Engineering (CALCE)

February 25, 2015

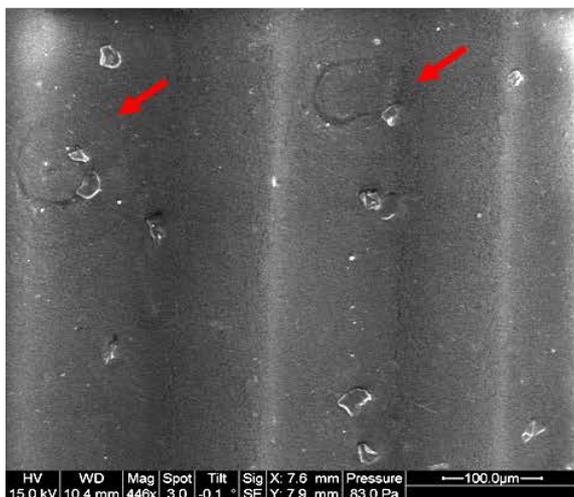
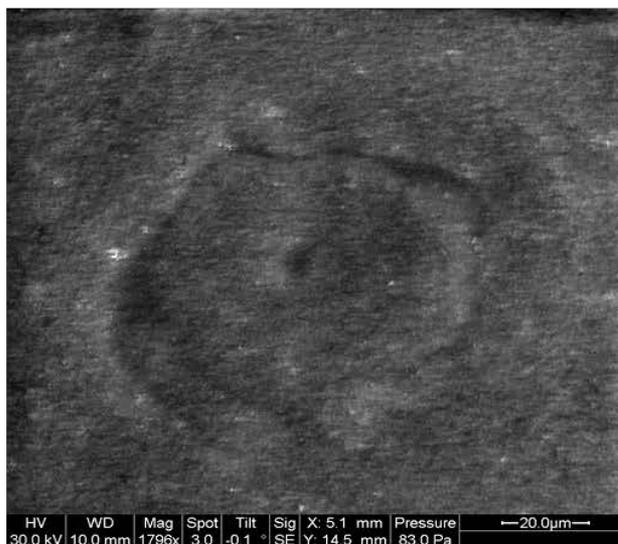
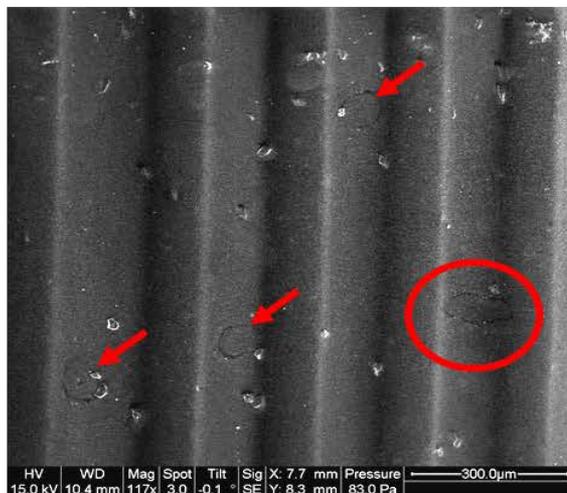
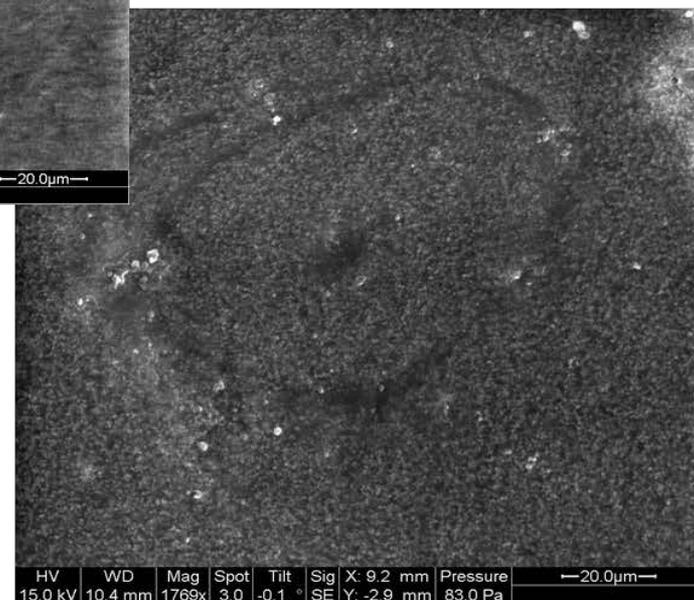
Blowholes in Solder Mask

- Solder mask blowholes are localized at specific regions of PCB
- Most consist of a ring and a dot in the center.
- In many instances, the blowholes are located on top of the traces (see circle).

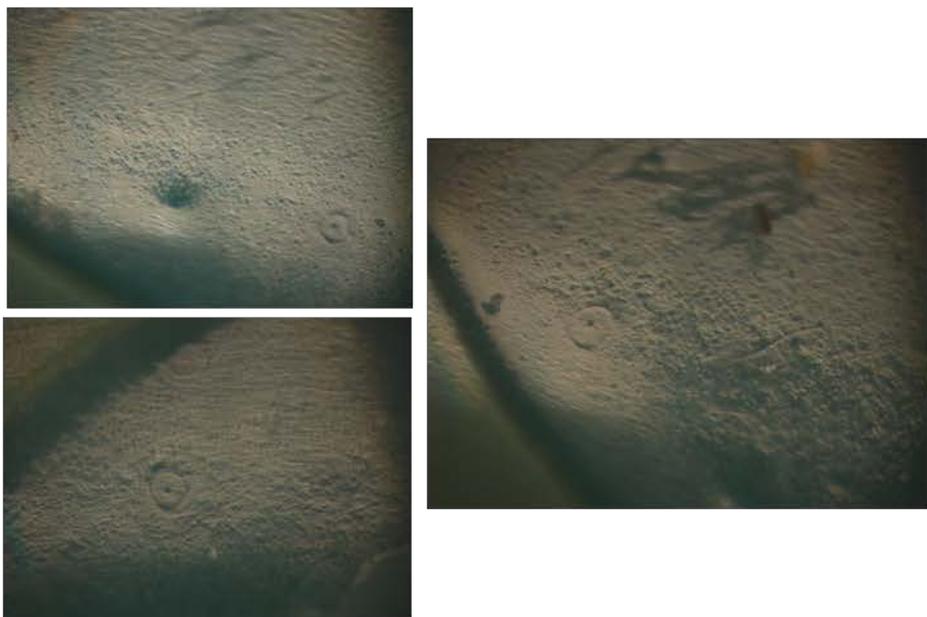
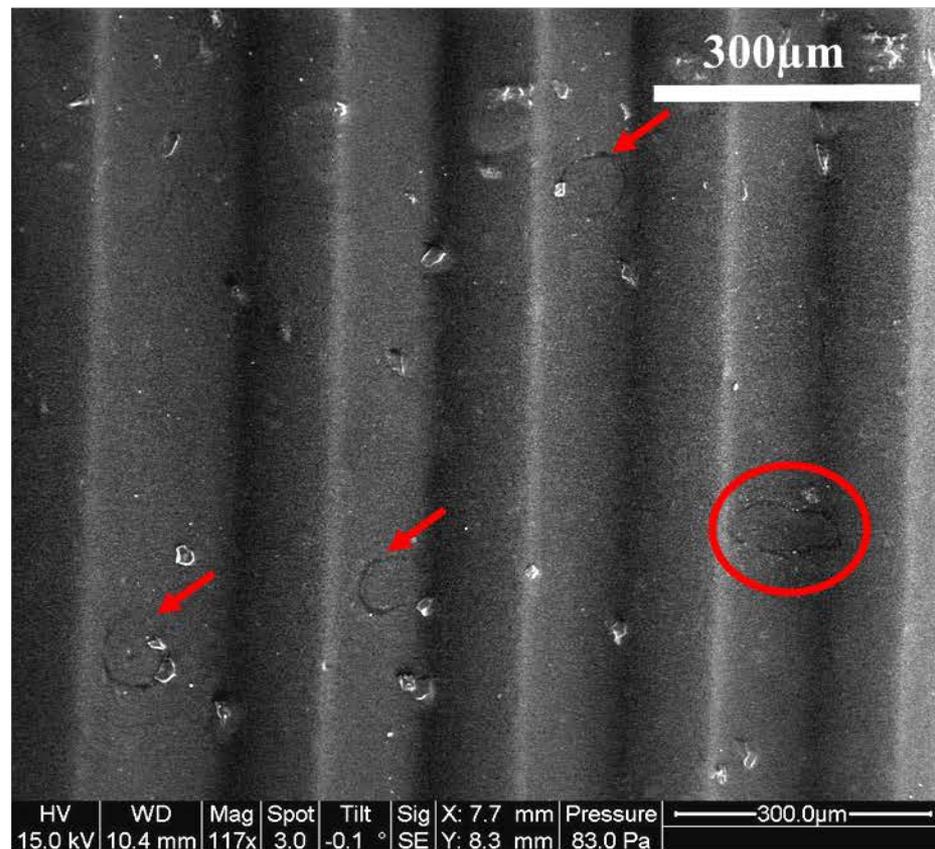
Formation of Soldermask Blowholes

- Blowholes, can form at any location on the PCB, can be localized
- Blowholes can be located on top of a conductive trace.
- Worse, blowholes can be located between conductive traces.

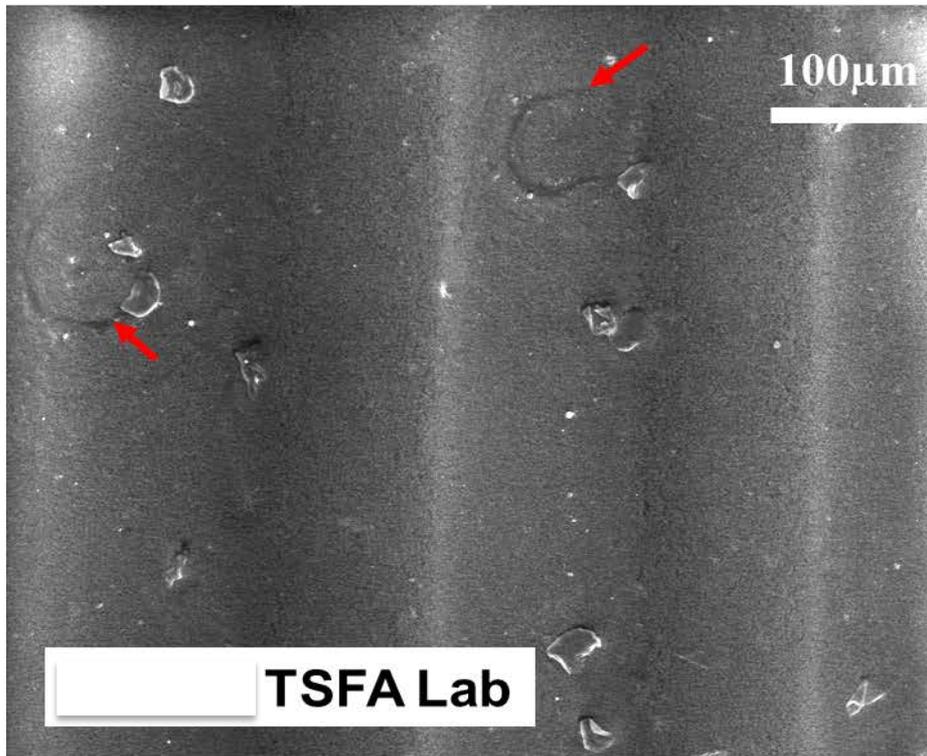
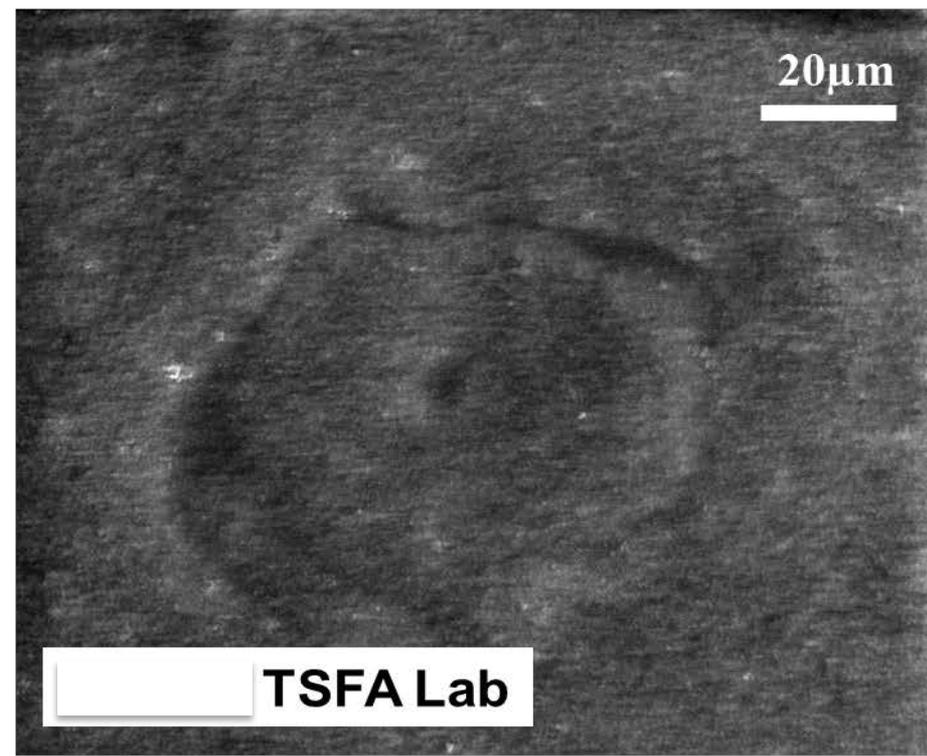
Implications of Blowholes in Solder Mask

- In assembly, soldermask blowholes can allow in moisture, process cleaners and chemicals along with flux to wick between the soldermask and the conductive traces. This can cause fracture, or lifting of the soldermask at the edge.
- In field use, the blowholes can allow ambient contaminants, dust and potentially corrosive gases to accelerate the degradation process.

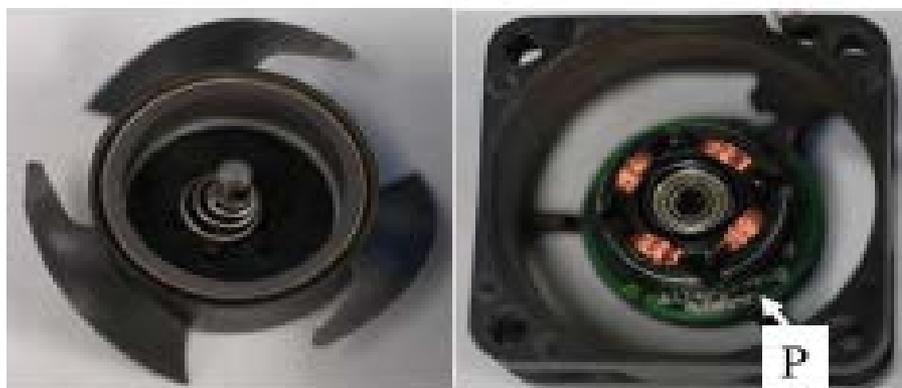
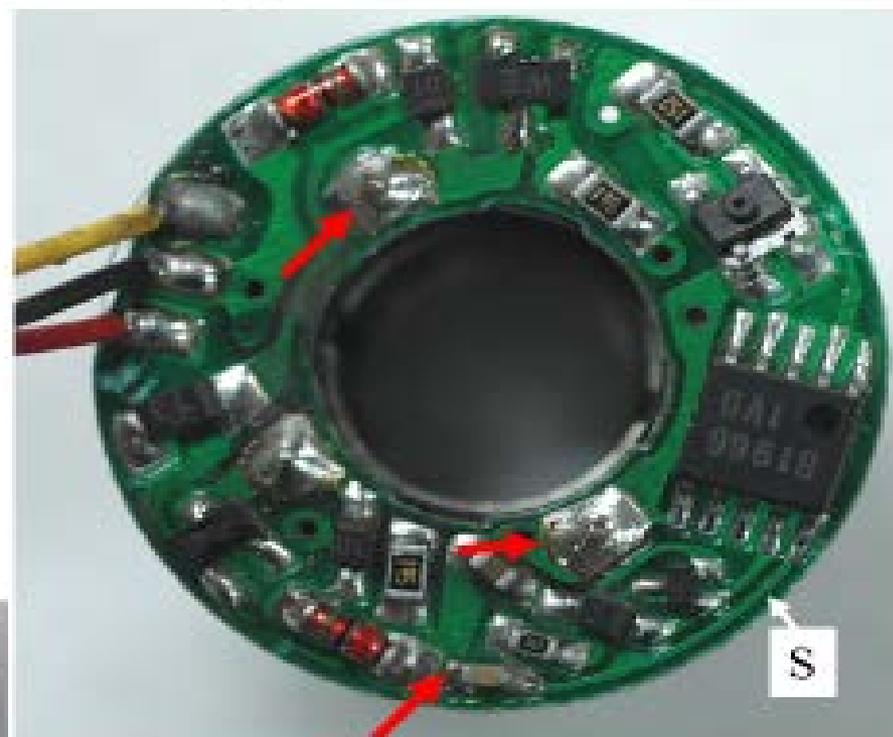
Disassembly and Inspection

- After disassembly, dust accumulation was observed on both the primary (P) and secondary (S) side of the fan PCB.
- EDS showed presence of Sulfur in the dust.

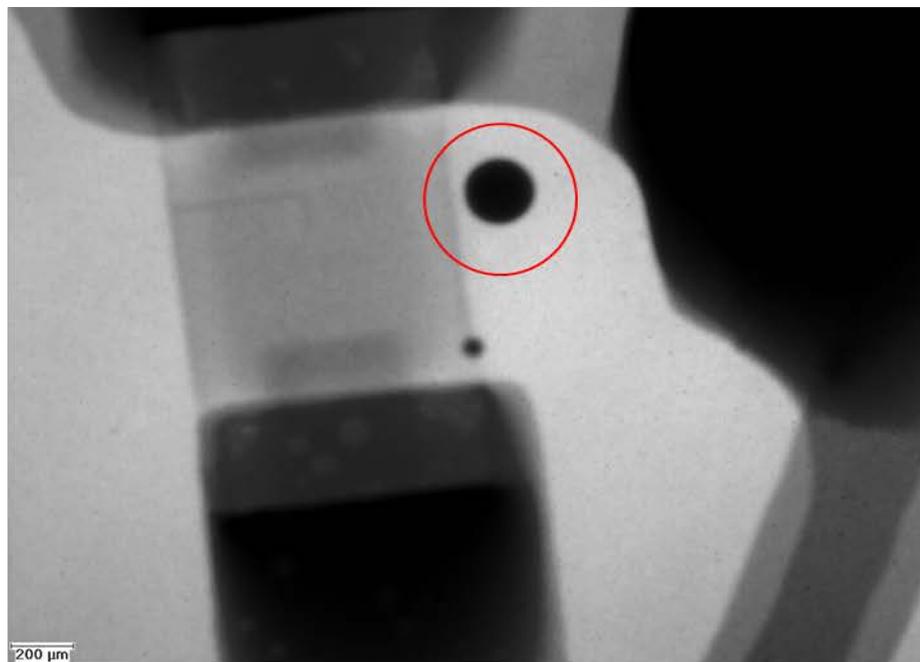
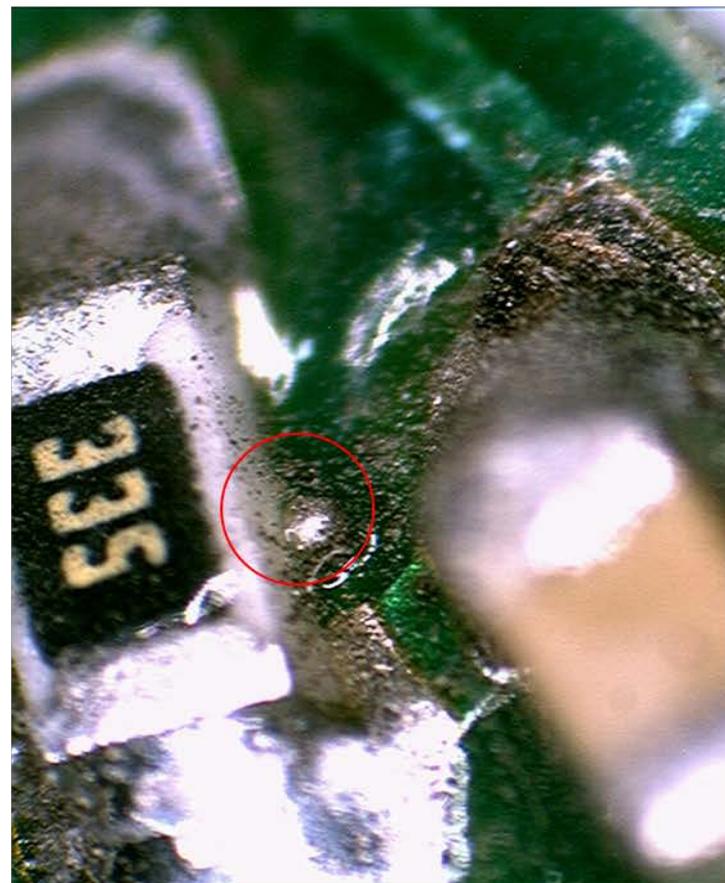
X-ray/Optical Inspection of C2-D04XL-12PU B

- Stray solder balls were observed on PCBA at several locations. Representative images shown.
- This is a workmanship quality indicator.

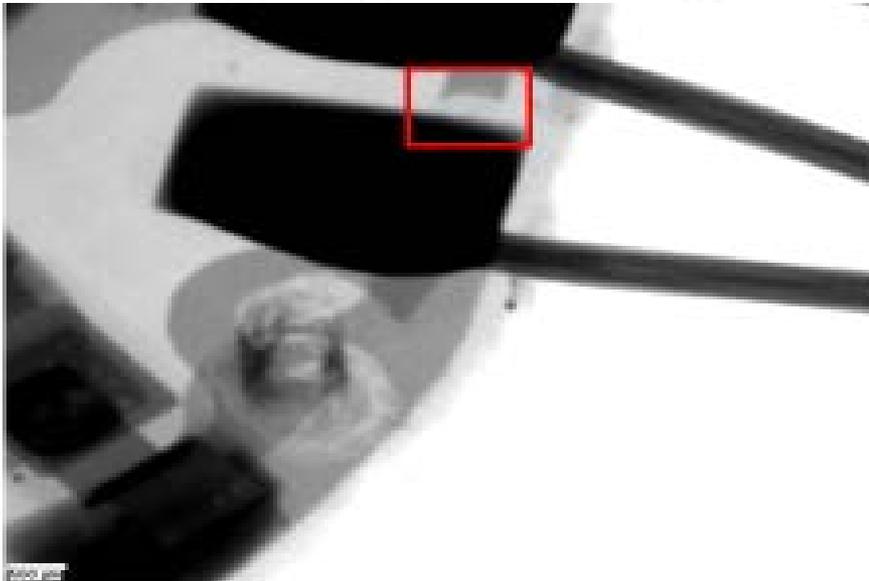
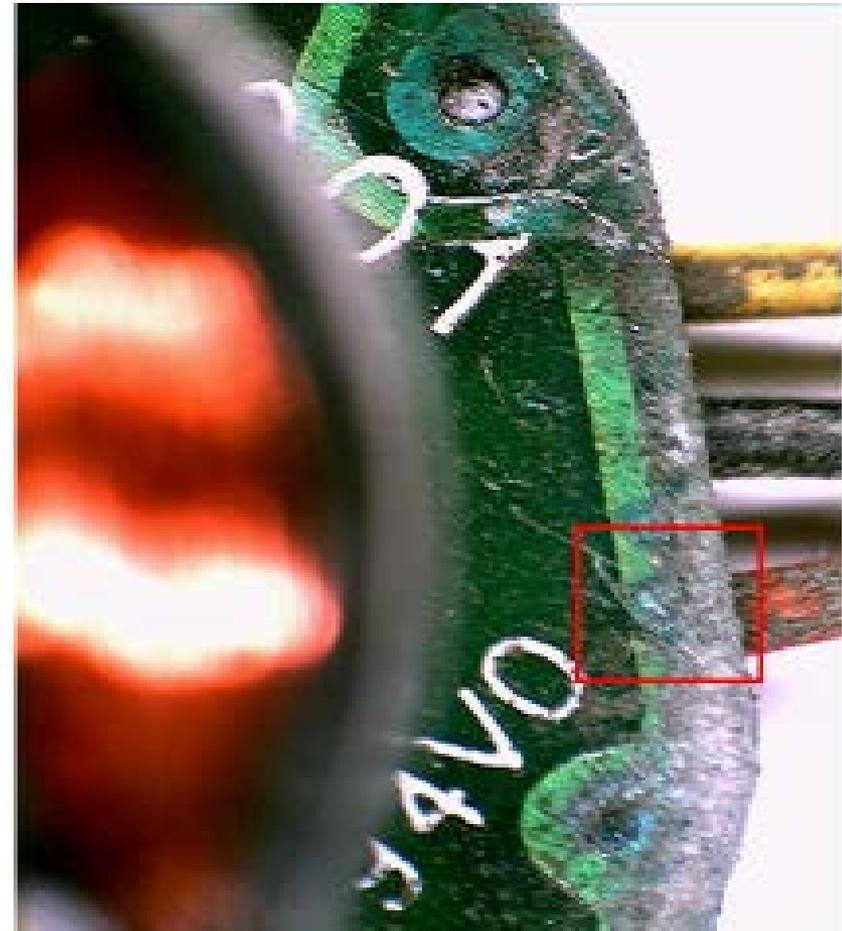
X-ray/Optical Inspection of C2-D04XL-12PU B

- Open circuit trace was observed in x-ray.
- Corresponding region on PCBA is shown in optical image on right.

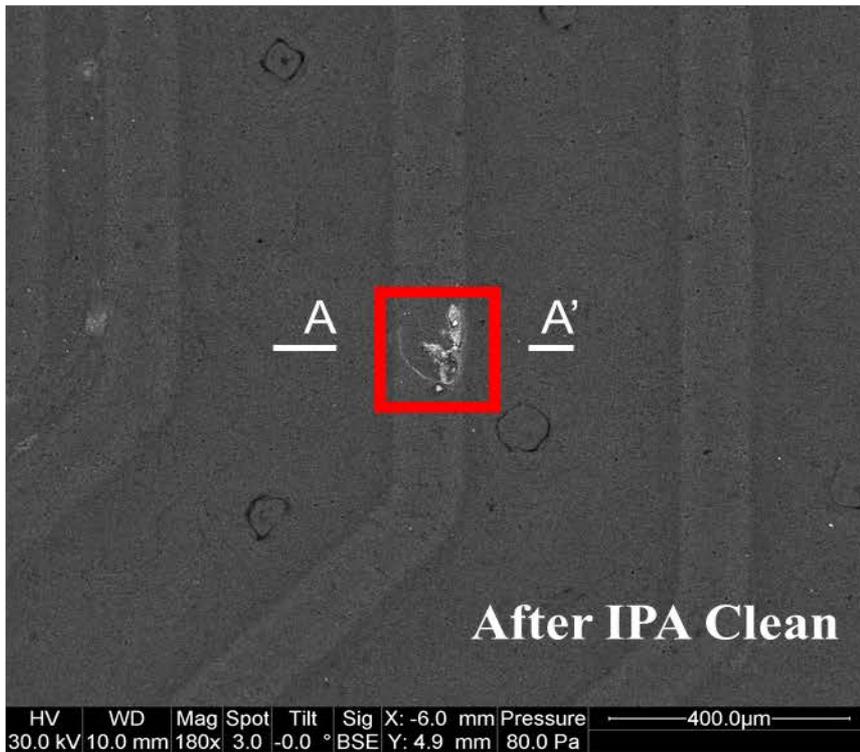
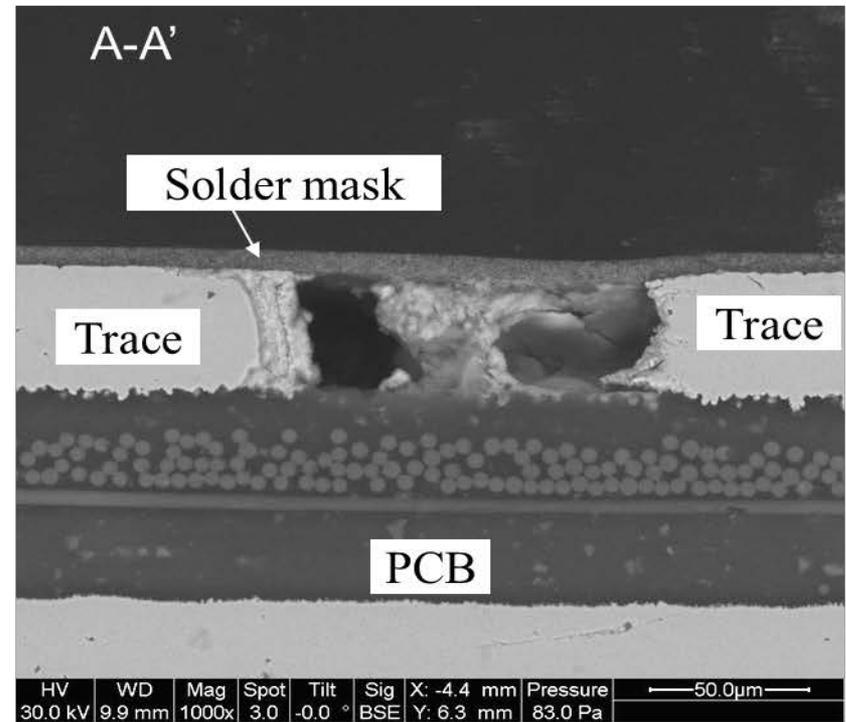
Holes Solder Mask and Trace Corrosion (Study 2)

- After residues were removed with a swab, a crack/opening was observed in the solder mask.
- Residues were initially located on top of this opening, suggesting that the source was underneath the solder mask, the metallic trace.
- Note the location of blowholes close to the cracked surface.

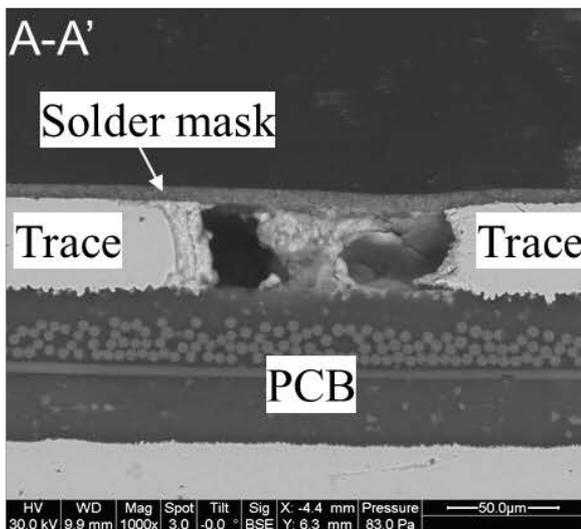
Cross-section of Trace With Damaged SM

- Solder mask appears to be tented above the corroded trace.

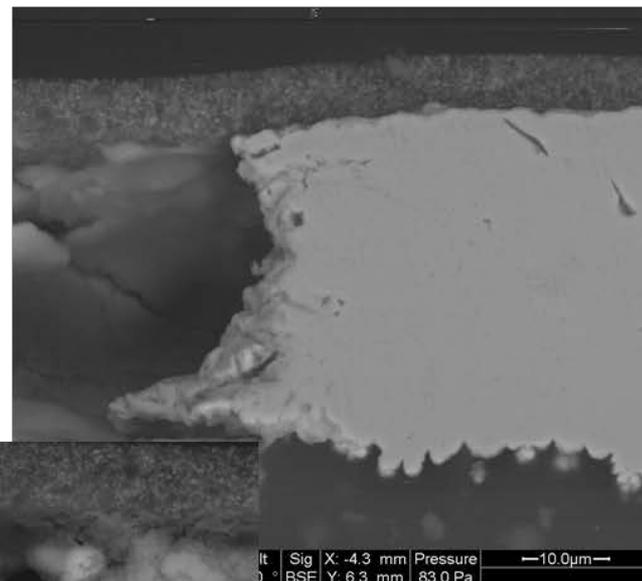
- The corrosion product was “pushed” out from underneath the soldermask to the surface.

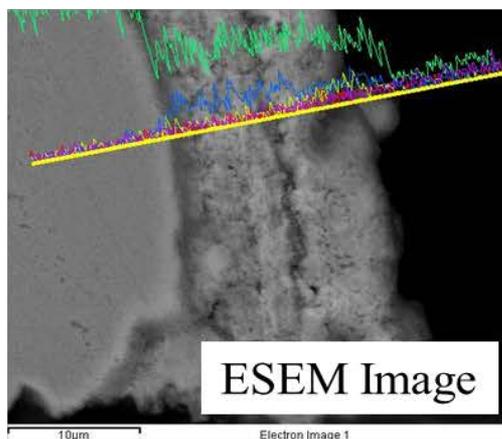
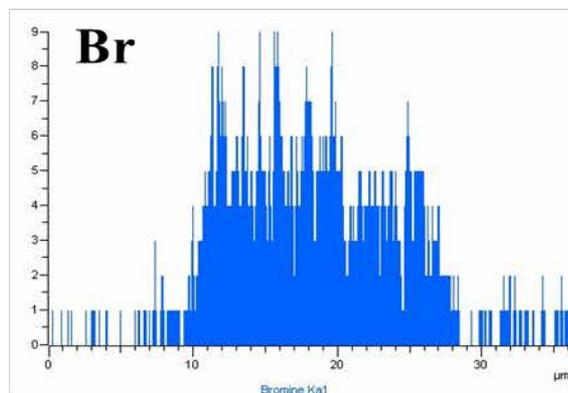
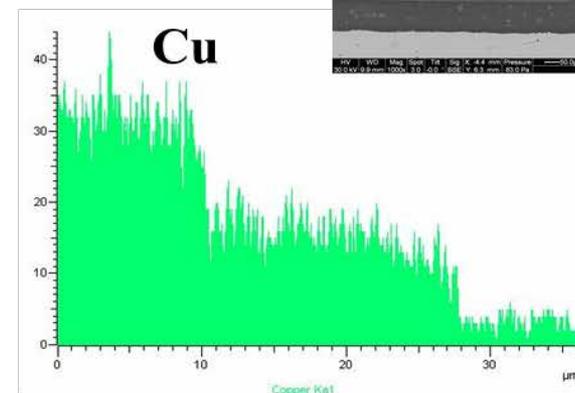
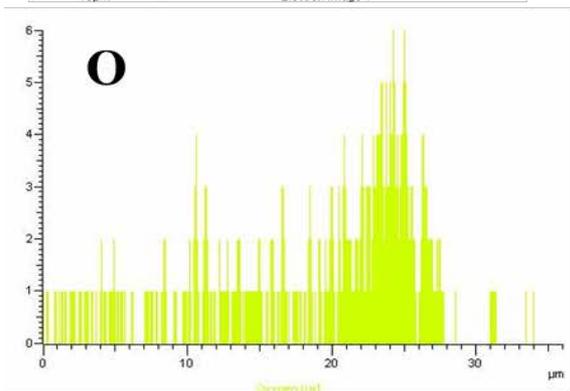
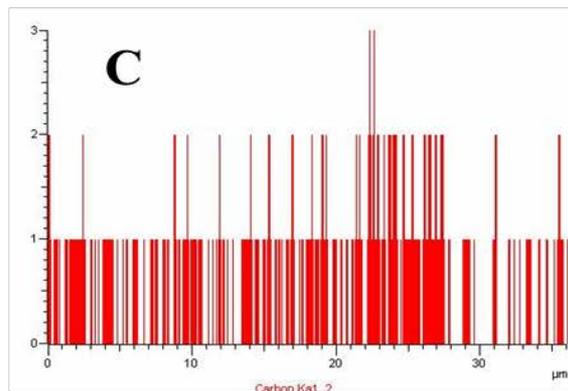
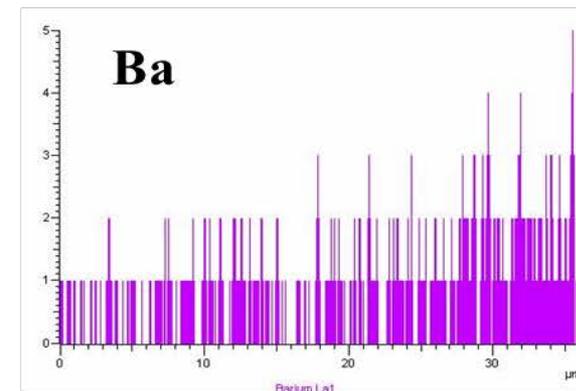
EDS Line Scan on Corroded Trace

- The corrosion product was “pushed” out from underneath the soldermask to the surface.

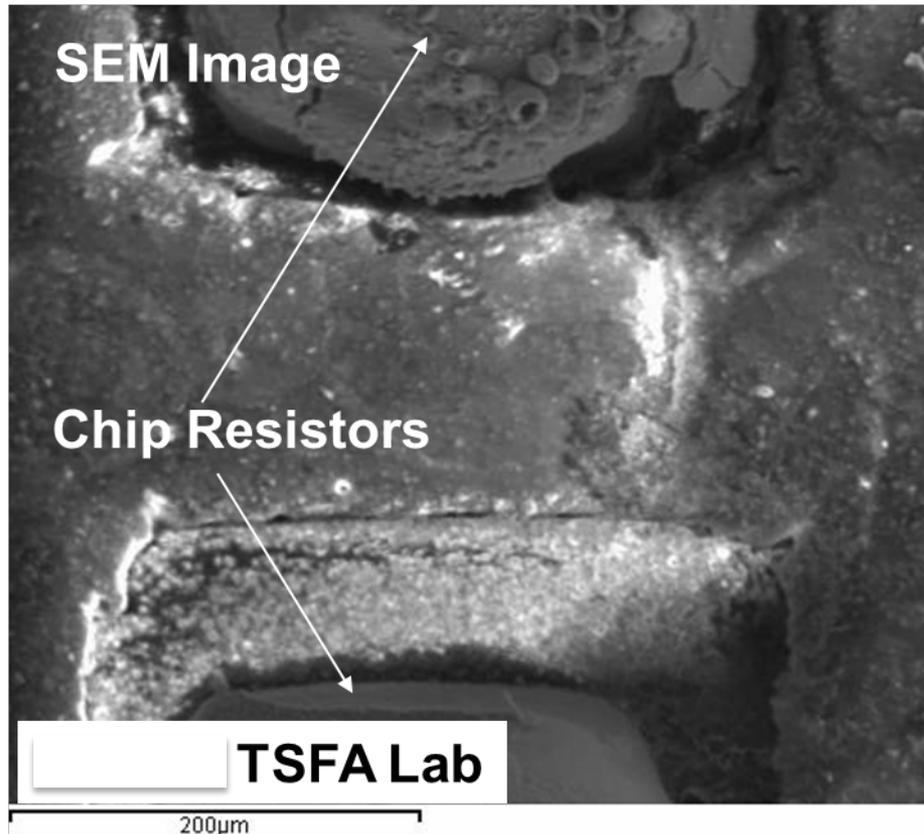
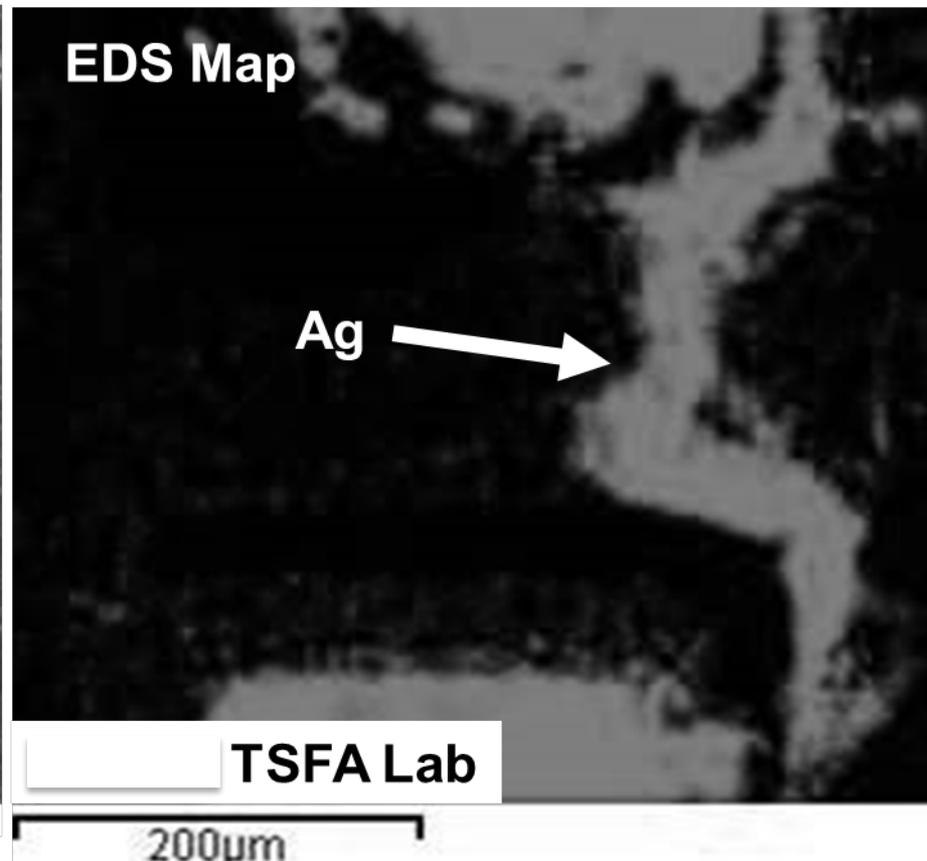
Soldermask Defect Assisted ECM Failure (Study 3)

- Energy dispersive x-ray spectroscopy (EDS) mapping of a dendrite shows that it is composed of silver.
- Silver from Sn-3.5Ag solder.
