Reliability Study of Low Silver Alloy Solder Pastes

Jennifer Nguyen, David Geiger and Murad Kurwa

Flextronics International

Abstract

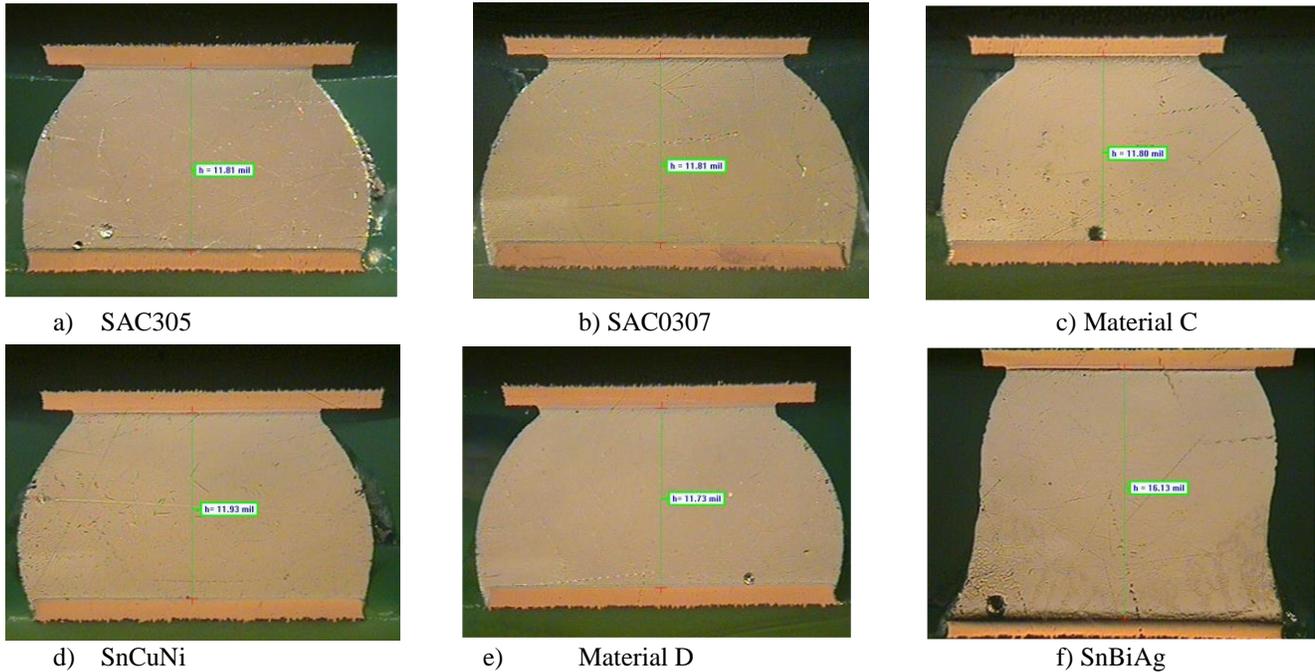
Figure 9. Cross Section Images of BGA 196 components after Reflow Process

The cross-sections of all components were performed after the reflow process. In general, good solder joints were observed for alternative alloys. Incomplete mixing was seen for the most BGA components reflowed with the SnBiAg solder paste. The inhomogeneous solder joint was observed due to the low temperature profile used for SnBiAg solder paste. Head in pillow (HiP) solder joint was also seen for the large components such as BGA1156 reflowed with SnBiAg solder paste. The cross section images of BGA solder joint reflowed using alternative alloy solder pastes are shown in Figure 9.

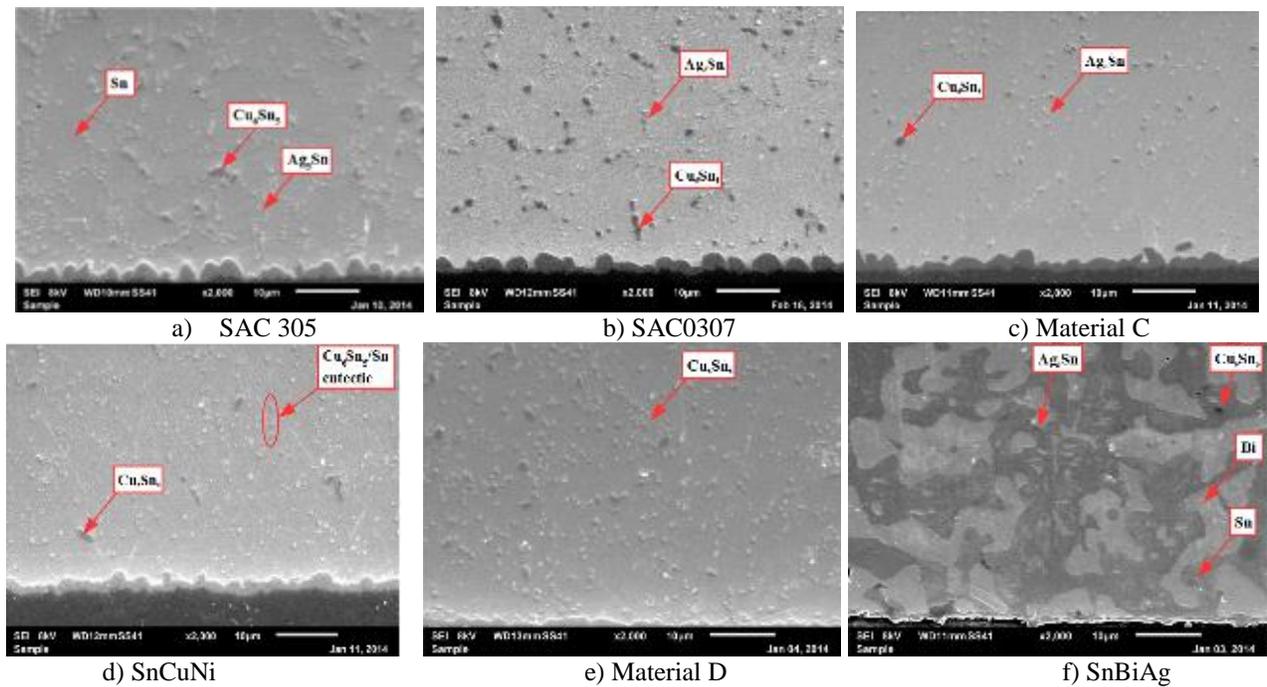
Figure 10. SEM Images of QFN solder joint reflowed with various alloy solder pastes. a) SAC305; b) SAC0307; c) Material C; d) SnCuNi; e)Material D; f) SnBiAg

The solder joint microstructure of the alloys were further analysed using a scanning electronic microscope (SEM). Cu_6Sn_5 intermetallic layer was the common feature for all alloy solder joints. For SAC305 solder joint, Sn IMC were mostly seen in the solder joint, along with Ag_3Sn and Cu_6Sn_5 intermetallic species (Figure 10a). Areas of both the Sn/ Ag_3Sn binary eutectic and the Sn/ $\text{Ag}_3\text{Sn}/\text{Cu}_6\text{Sn}_5$ ternary eutectic were visible at grain boundaries of the Sn dendrites. The presence of the Sn/ Ag_3Sn binary eutectic suggesting that Cu_6Sn_5 was the last phase to solidify. In samples reflow with SAC0307 solder paste, the reduction in Ag content of SAC0307 solder paste resulted in a reduction in the number of Ag_3Sn particles in the solder joint microstructure, accompanied by the formation of larger Sn dendrites (Figure 10b). Large areas of $\text{Ag}_3\text{Sn}/\text{Sn}$ binary eutectic were not visible. The microstructure of Material C solder joint after reflow showed that Cu_6Sn_5 particles in the bulk of the solder appeared smaller in Material C than in SAC0307 (Figure 10c). However, compared to SAC0307, the doped alloy did not show any statistically significant difference in the composition or thickness of the intermetallic layers. The BGA solder joints of both alloys were also similar, closely resembling those of the all-SAC305 assembly, though in both cases there was a slight reduction in the size of the Ag_3Sn particles.

The microstructure of SnCuNi and Material D solder joints are shown in Figure 10d and Figure 10e, respectively. Both alloys contained no silver in the solder paste. Cu_6Sn_5 intermetallic layer was seen in the solder joint. Material D solder joints displayed an even distribution of Cu_6Sn_5 particles, and the grain size of the Sn dendrites was small compared to the other high-temperature alloys. The Cu_6Sn_5 grains were typically larger than in SnCuNi, which is an Ag-free alloy with a higher concentration of Cu than Material D. This implies that Cu_6Sn_5 formed as the primary phase with less undercooling than would be expected.

In the SnBiAg solder joint microstructure, the majority of the solder joint consisted Bi and Sn dendrites (Figure 10f). Small grains of Ag_3Sn were visible at grain boundaries, as were Cu_6Sn_5 particles near the solder pads. It was noticed that Bi dendrite boundary was not well defined after the reflow process.

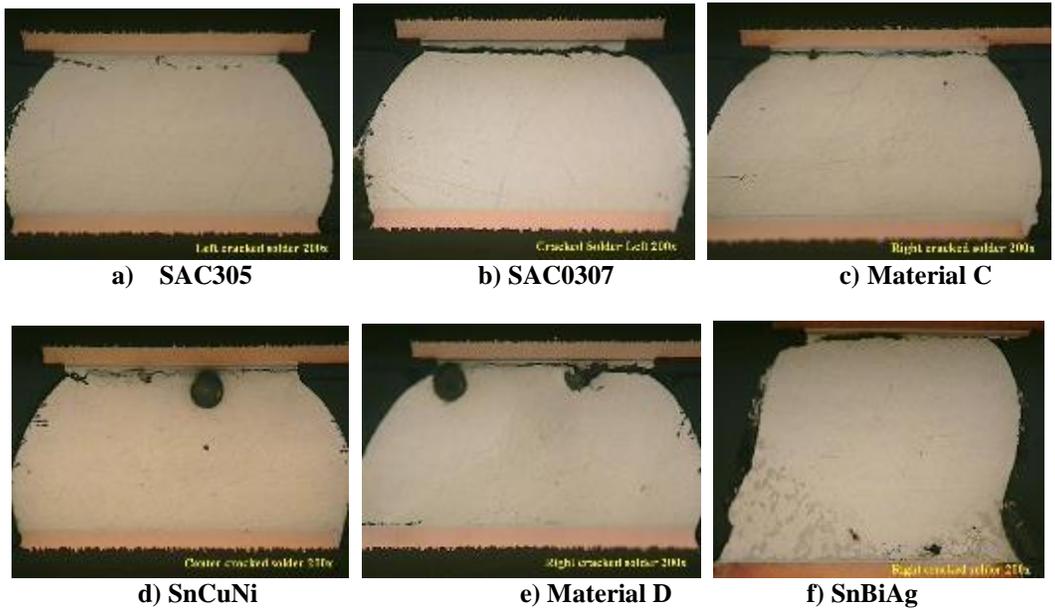
Figure 11. Cross section images of BGA196 components after 3000 thermal cycles. a) SAC305; b) SAC0307;c) Material C; d) SnCuNi; e) Material D; f) SnBiAg.

Table 3 summarizes the thermal cycle test results of different components reflowed using different lead-free alloy solder pastes. In general, SAC305 had a better thermal reliability than alternative low Ag alloy materials. The thermal reliability performance depended on the component types and the component design/material. Complete failure was observed for some BGA 196 components, BGA228 components, BGA97 components and resistor 2512 components after 3000 cycles (0°C to 100°C). Major cracks were seen at their solder joint. The cross section images of BGA196 solder joint after thermal cycling test are shown in Figure 11. Most cracks happened at the component side of the package although some cracks were also observed at the PCB side. Solder joint reflowed with SnBiAg also had cracks at the interface of SAC305 solder ball and SnBiAg solder paste. The cross sections of 2512 resistors and QFN88 components after thermal cycle test were shown in Figure 12 and Figure 13, respectively. Severe cracking in the solder joint were seen for these components.

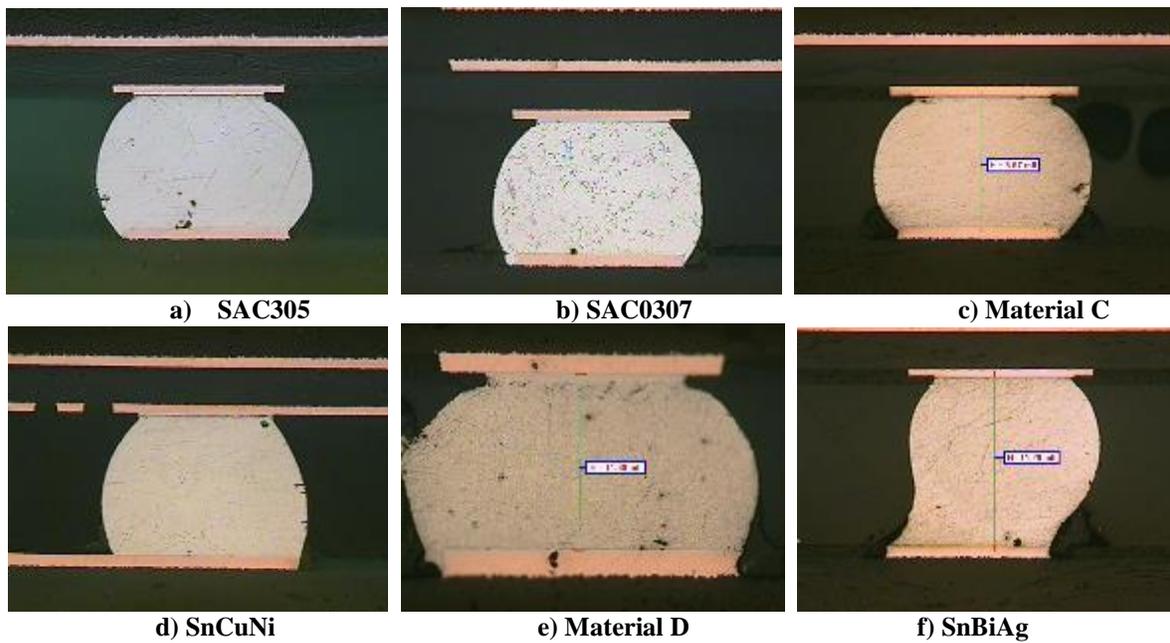
Figure 14. Cross section images of BGA1156 solder joint after thermal cycle testing. a) SAC305; b) SAC0307; c) Material C; d) SnCuNi; e) Material D; f) SnBiAg

No failure was observed for some BGA components such as BGA1156 (1.0mm pitch, 35mmx35mm) and BGA64 component (0.8mm pitch, 8mm X 8mm) after thermal cycle testing. Only minor cracks were seen. The cross sections of BGA1156 component are shown in Figure 14. Minor cracking and no failure was also observed for QFP components in this study (Figure 15).

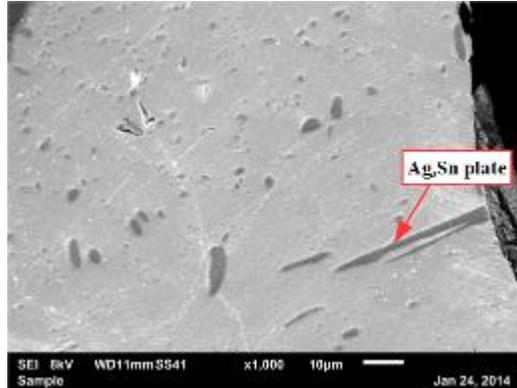
Microstructure of various alloys after thermal cycle testing was analysed with SEM equipment. Within SAC305 solder joints, blocky Cu_6Sn_5 particles formed and Ag_3Sn particles had begun to elongate (Figure 16). Some inter-granular cracking was visible at the boundaries between Sn dendrites as well as between dendrites and intermetallic species. Cracking along the intermetallic layers was also observed.

Figure 16. Ag_3Sn plate formation in QFP solder joint assembled using SAC305 paste after thermal cycle testing.

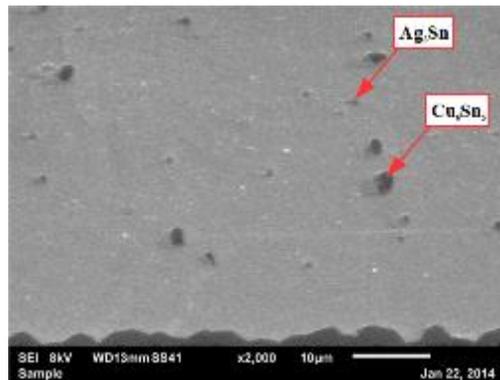
Using SAC0307 solder, the number and size of the Ag_3Sn grains was reduced. Unlike SAC305, thermal cycling did not result in the formation of large Ag_3Sn plates (Figure 17). However, dislocations along grain boundaries were visible, and more extensive than for SAC305, indicating that the coarsening of Sn dendrites does increase their tendency to crack.

Figure 17. Microstructure of QFN88 solder joint assembled using SAC0307 paste after thermal cycle testing.

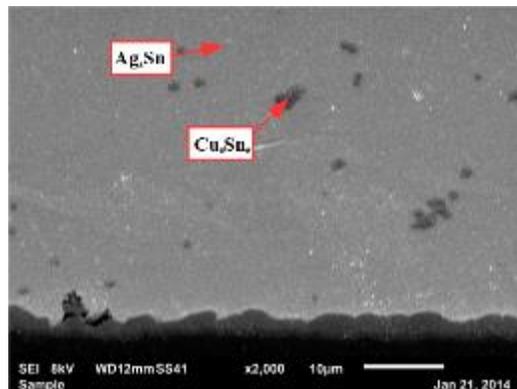
Material C behaved in a similar fashion to SAC0307, showing extensive cracking along grain boundaries in almost all samples. The BGA solder joints showed a reduction in the growth rate of Ag_3Sn particles compared to SAC0307. In the lower half of the Material C BGA solder joints, larger particles of Cu_6Sn_5 were observed (Figure 18).

Figure 18. Microstructure of QFN88 solder joint assembled using Material C solder paste after thermal cycle test.

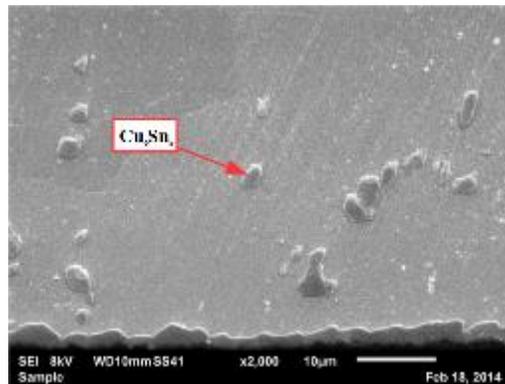
The layer of Cu_3Sn adjacent to the PCB pad was thinnest for solder joints composed of SnCuNi solder, suggesting that the insertion of Ni into the intermetallic layers reduced the rate of diffusion within the crystal structure (Figure 19).

Figure 19. Microstructure of QFN88 solder joint assembled using SnCuNi solder paste after thermal cycle test.

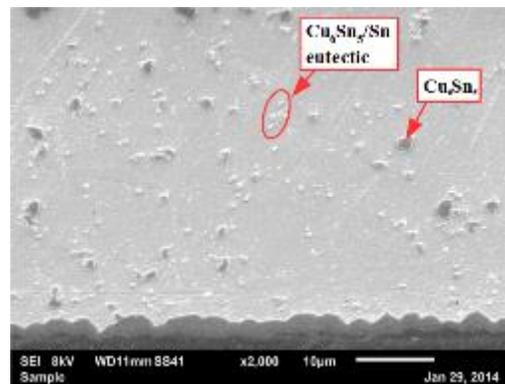
Relatively little coarsening of the microstructure of Material D solder joints occurred after thermal cycle testing. Sn dendrites and Cu_6Sn_5 were visible (Figure 20). There are several possible explanations for how little coarsening was observed. Firstly, Co has previously been shown to substitute for Cu in Cu_6Sn_5 grains, introducing a substitutional defect which inhibits coarsening [6]. The presence of a low concentration of Bi is known to have a Zener pinning effect on Sn grains, which increases the energy barrier to grain growth [7]. Cracking of the BGAs largely occurred at the bottom of the solder joint, as opposed to at the top. Under strain, the more brittle solution-hardened Sn matrix formed by Material D was more likely to crack than the more ductile Sn matrix at the top of the solder joint, which had a composition close to that of SAC305.

Figure 20. Microstructure of QFN88 solder joint assembled using Material D solder paste after thermal cycle test.

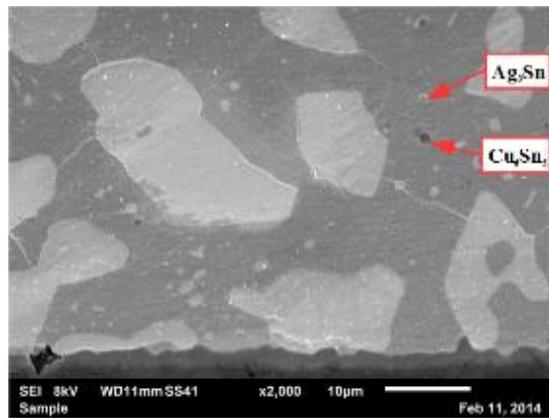
Figure 21 shows the typical microstructure of SnBiAg after thermal cycling. By far the most growth in the intermetallic layers occurred in the SnBiAg solder joints, some of which were more than doubled in thickness during thermal cycle testing. The thickness of the intermetallic layers became comparable to those formed by the other solder alloys, suggesting that the thin layers observed prior to thermal cycle test were at least in part a result of the low reflow temperature. The concentration of Sn in the solder appeared to have little effect on the intermetallic layer thickness. A Cu_3Sn layer formed, similar in thickness to that of the SnAgCu alloys. Coarsening of the Sn and Bi dendrites occurred. Both Ag_3Sn and Cu_6Sn_5 particles increased in size. Cu_6Sn_5 particles, found close to the Cu solder pads, were also more frequent, indicating further dissolution of Cu from the solder pads into the bulk of the solder occurred during thermal cycle testing.

Figure 21. Microstructure of QFN88 solder joint assembled using SnBiAg solder paste after thermal cycling.

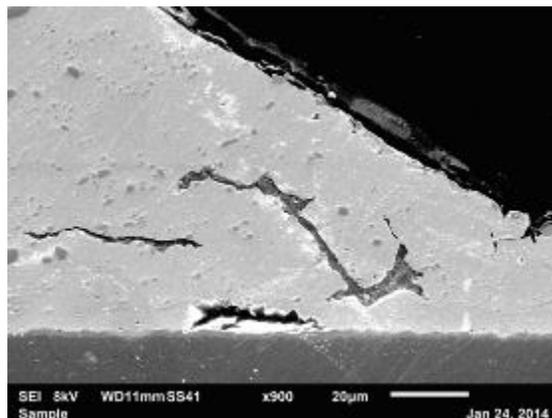
For the single-alloy QFP and QFN components, four different typical failure modes were observed. For SAC305 solder joints, cracking was primarily propagated along Cu₆Sn₅ and Ag₃Sn intermetallic particles in the bulk of the solder (Figure 22). The single-alloy solder joints assembled with SAC0307, Material C and SnCuNi, in which far fewer intermetallic species were present, all showed evidence of ductile fracture at the grain boundaries between Sn dendrites, as shown in Figure 23. This was typically more severe than the cracking observed using SAC305 in the same components. Material D displayed a lesser degree of cracking than these three alloys. Cracking appeared to propagate at Sn grain boundaries (Figure 24). The SnBiAg solder joints displayed a different failure mode. Cracks were formed primarily as a result of grain boundary sliding (Figure 25). Some cracking through Sn grains also occurred as a result of the embrittlement caused by dissolution of bismuth in the tin matrix.

Figure 22. Typical cracking in QFP208 solder joint assembled using SAC305: ductile fracture propagating along grain boundaries of intermetallic species

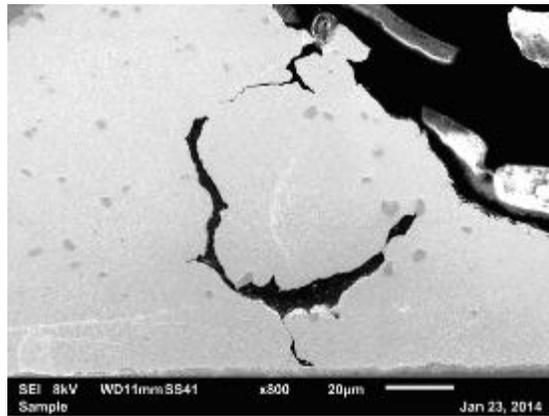
Figure 23. Cracking along Sn grain boundaries in QFP208 solder joint assembled using SAC307

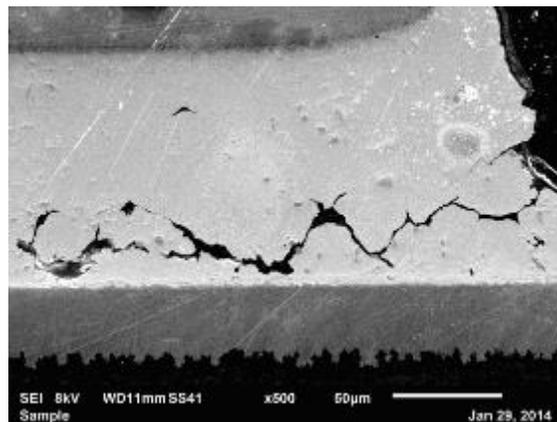
Figure 24. Cracking along Sn grain boundaries in QFN88 solder joint assembled using Material D

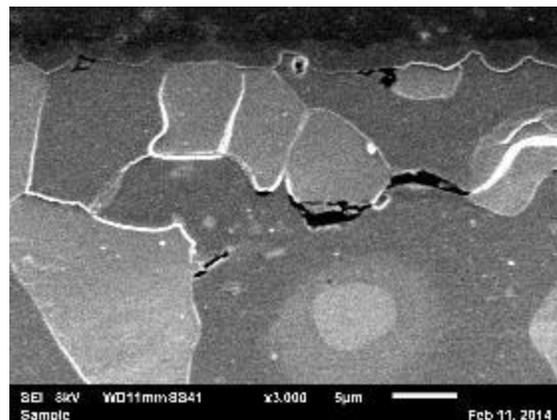
Figure 25. Cracking in QFN88 solder joint assembled using SnBiAg solder paste.

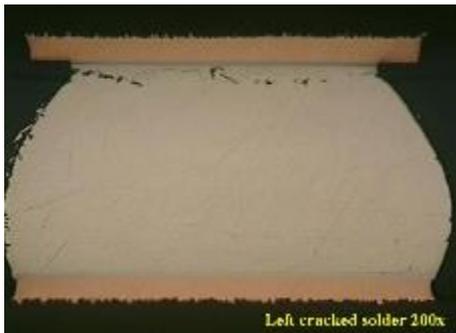
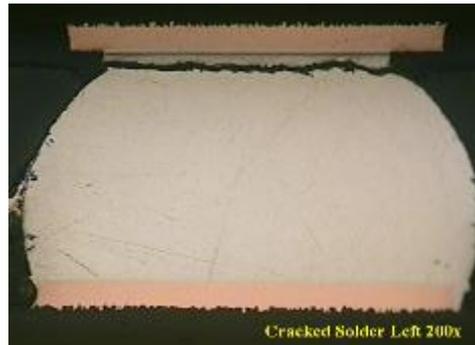
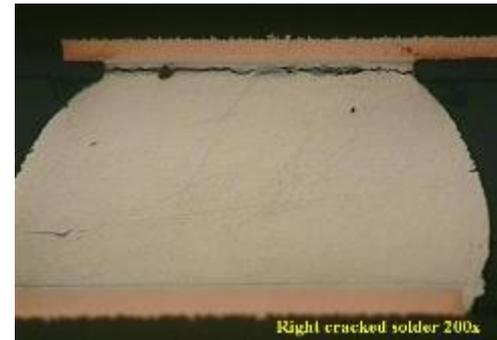
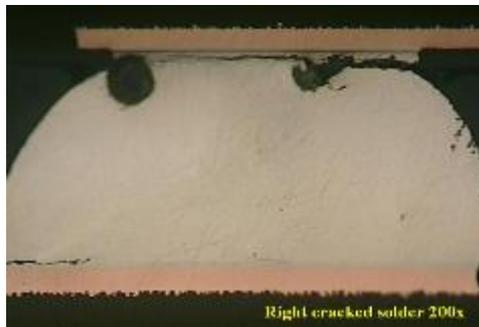
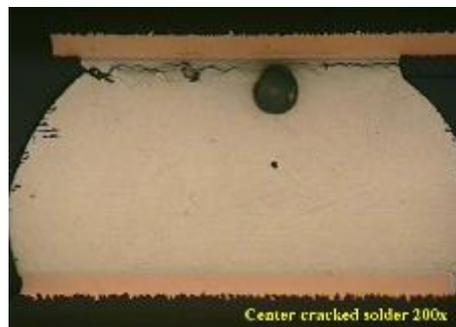
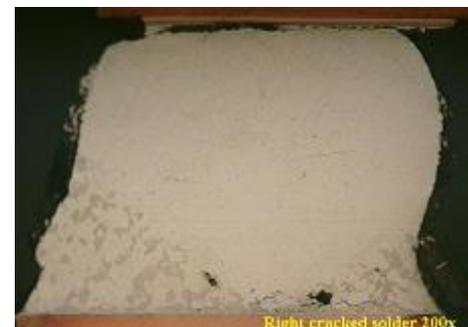
- BGA 196

- Severe cracks were seen.
- Most cracks happened at the component side.

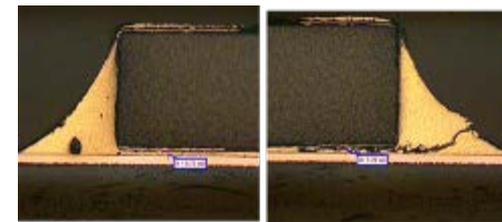
- 2512 Resistor

- Severe cracks and failure were seen.

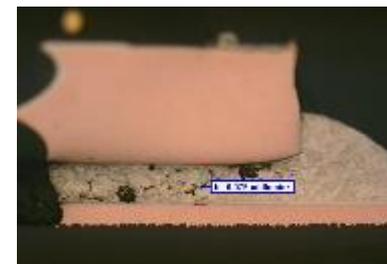
- QFN88

- Severe cracks and failure were seen.

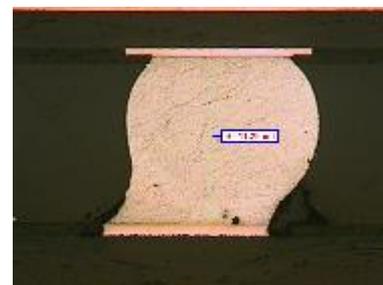
- BGA1156

- No major cracking was seen. Material D showed a little more cracks than other alloys. Cracks were mostly seen at the component side.

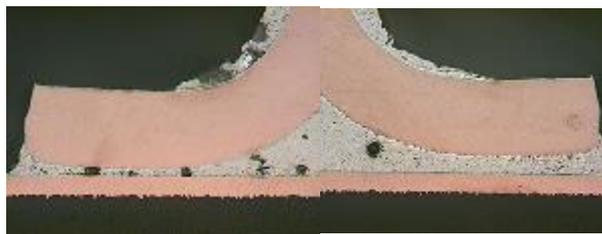
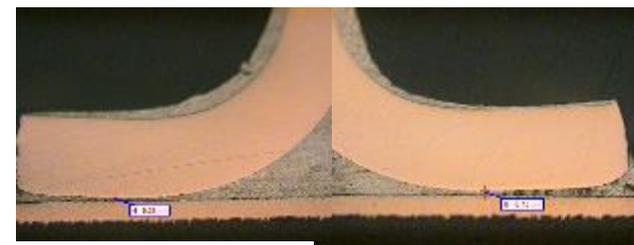
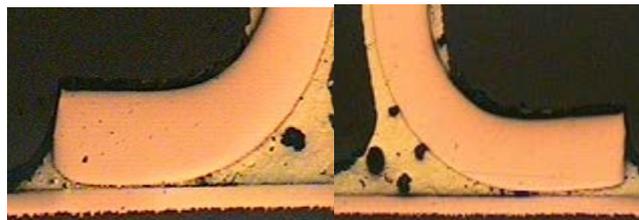
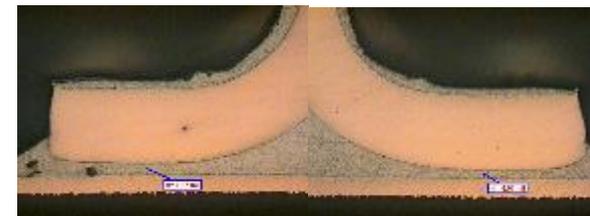
- QFP208 Components

- Minor cracks were seen.

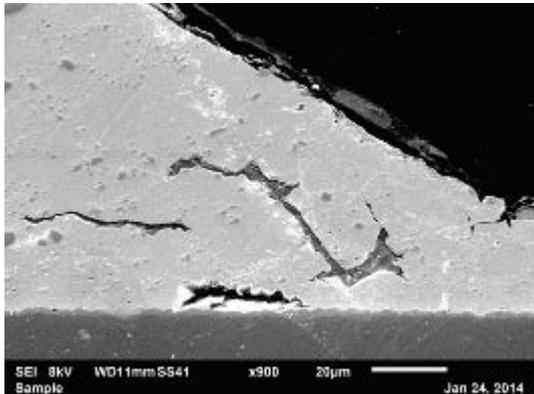
SAC305: ductile fracture propagating along intermetallic grain boundaries

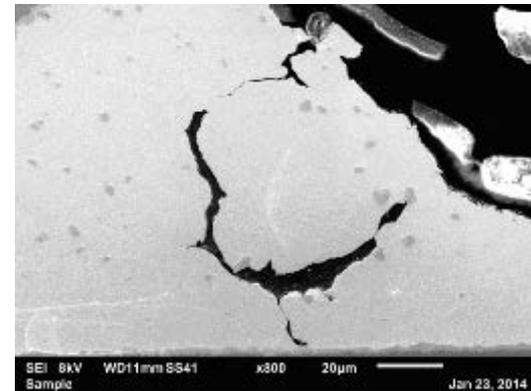
SAC0307, SnCuNi, Alloy C: ductile fracture along Sn grain boundaries

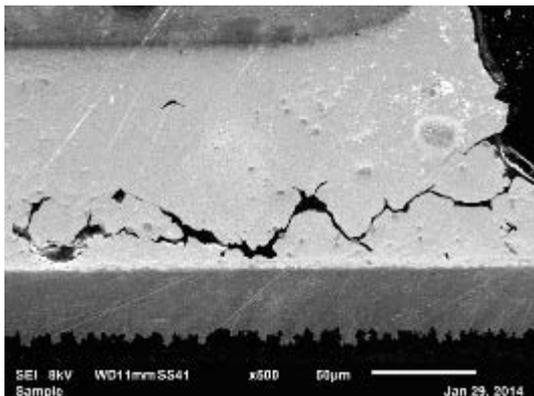
Alloy D: ductile fracture along Sn grain boundaries

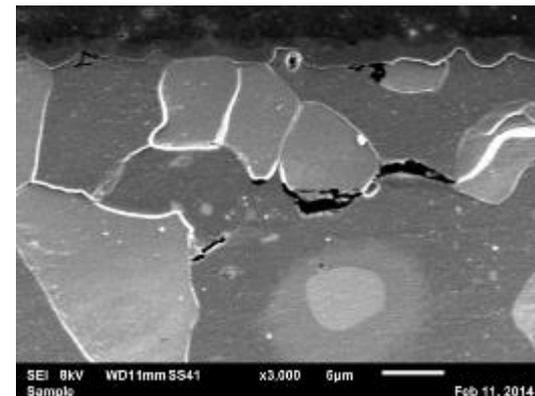
SnBiAg: grain boundary sliding between Sn and Bi dendrites
