# **Influence of Salt Residues on BGA Head in Pillow (Hip)**

J. Servin, C. Gómez,  
M. Domínguez, A. Aragón  
CONTINENTAL CUAUTLA  
Av. Ignacio Allende Lote 20  
Parque Industrial Cuautla  
Cd. Ayala, Morelos 62749, México  
E-mail: [jose.servin@continental-corporation.com](mailto:jose.servin@continental-corporation.com)  
[cynthia.gomez@continental-corporation.com](mailto:cynthia.gomez@continental-corporation.com)

## **Abstract**

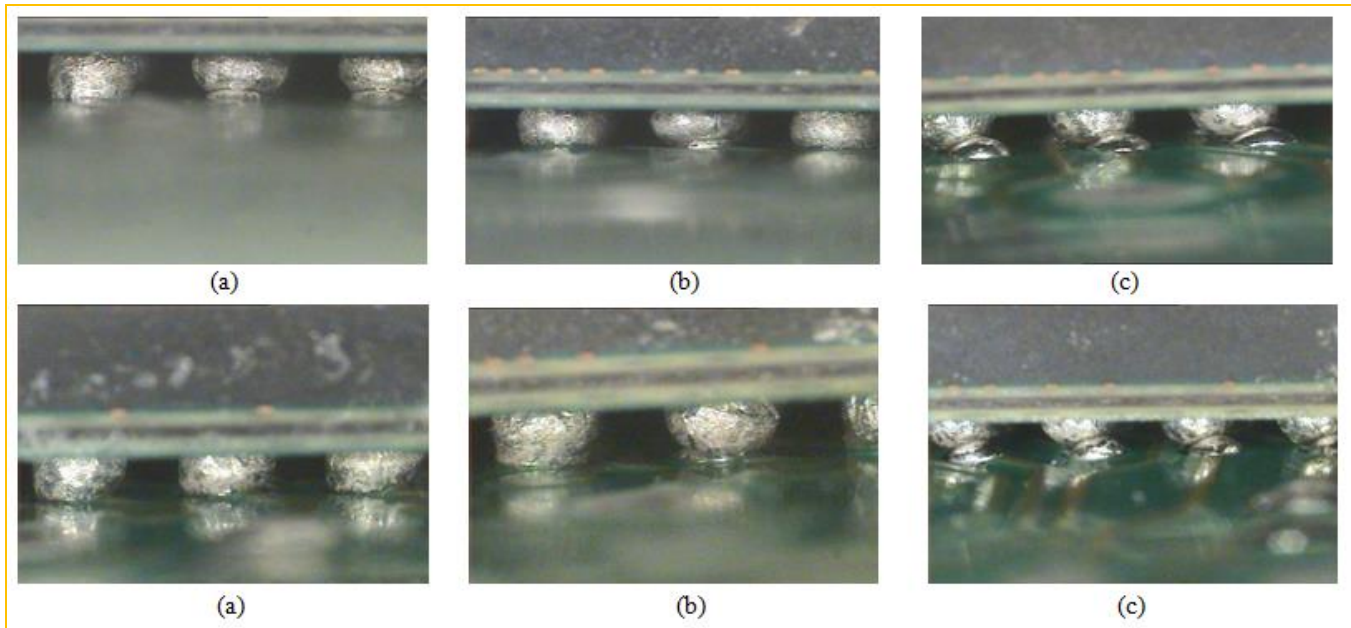
The images in Figure 5 show the HiPs resulted in DOE 1. The images, Figure 5(a), are the test at a time of 4 hours and did not have many defects of HiP. The Figures 5(b) are the components with a steam time of 8 hours, and more defects are seen. Finally, Figure 5(c) are the components at 16 hours of steam. These components got misplaced due to the number of HiPs. According to the results and comparisons, we can consider that the longer the time, the more defects.

**Figure 5. DOE 1 Results: (a) Components at 4 hrs of steam, (b) Components at 8 hrs of steam, and (c) Components at 16 hrs of steam, the components are misplaced due to number of HiPs**

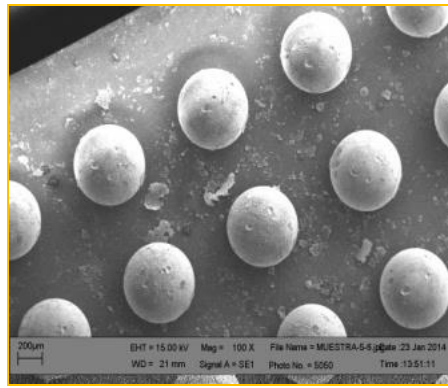
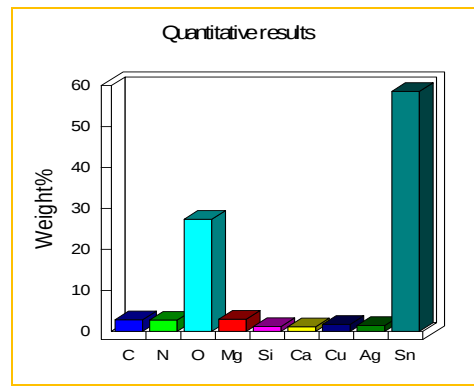
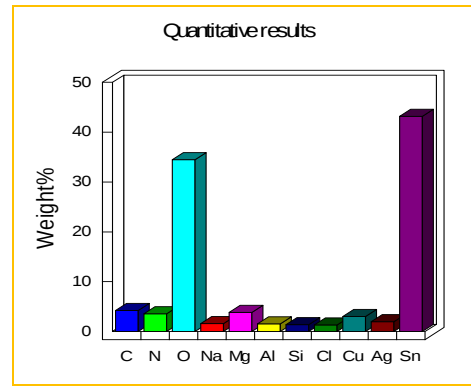
In the analysis of SEM/EDX, components have the presence of several elements on the surface. Figure 6 shows the results for the components at 16 hrs steam. Several elements are found (Mg, Ca, Al) beside Na and Cl. It is interesting to mention the solder balls have specific spots of the elements. Only components with 16 hrs of steam show more uniform distribution of the elements on the surface.

(a) 16hrs in 10% NaCl in tap water-Sample 1-

(b) 16hrs in 10% NaCl in tap water-Sample 2-

Figure 6. SEM Images of components at 16 hrs of steam, Samples 1 and 2 (A and B), EDX results (a and b)

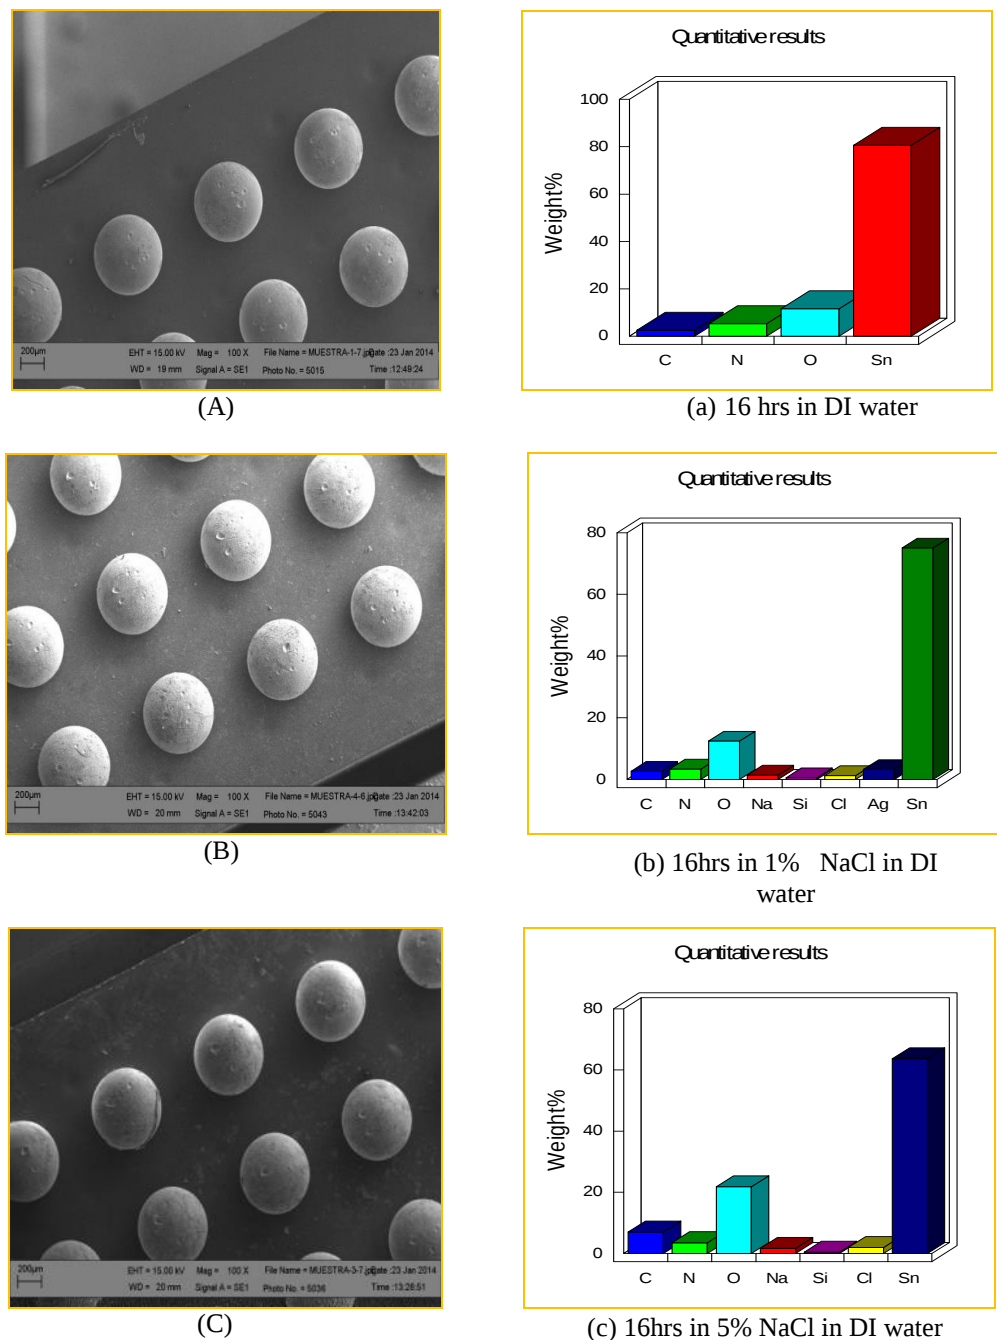
Several components were analyzed before soldering with SEM/EDX. The results are in Figure 10. The BGA images are in “raw” material after steaming. The EDX results are from specific areas where salt was detected and not general analysis. SEM images do not see the presence of NaCl presence until it is too high a value. This means analyzing images is not so reliable as expected to detect Cl presence because the NaCl presence exist but the detection is too low as would expect. However, we can get HiPs with low amount of NaCl under experiment conditions. In case of EDX analysis, Cl presence (in the form of salt) is dispersed and not uniformly distributed over the solder ball surfaces. The analysis had to be done checking specific points where Cl (NaCl) presence is detected. This means NaCl is accumulated in specific spots. In case of components steamed with only DI water, no Cl or Na presence was detected.

Figure 10. DOE 2. SEM Analysis Influence of NaCl in several conditions

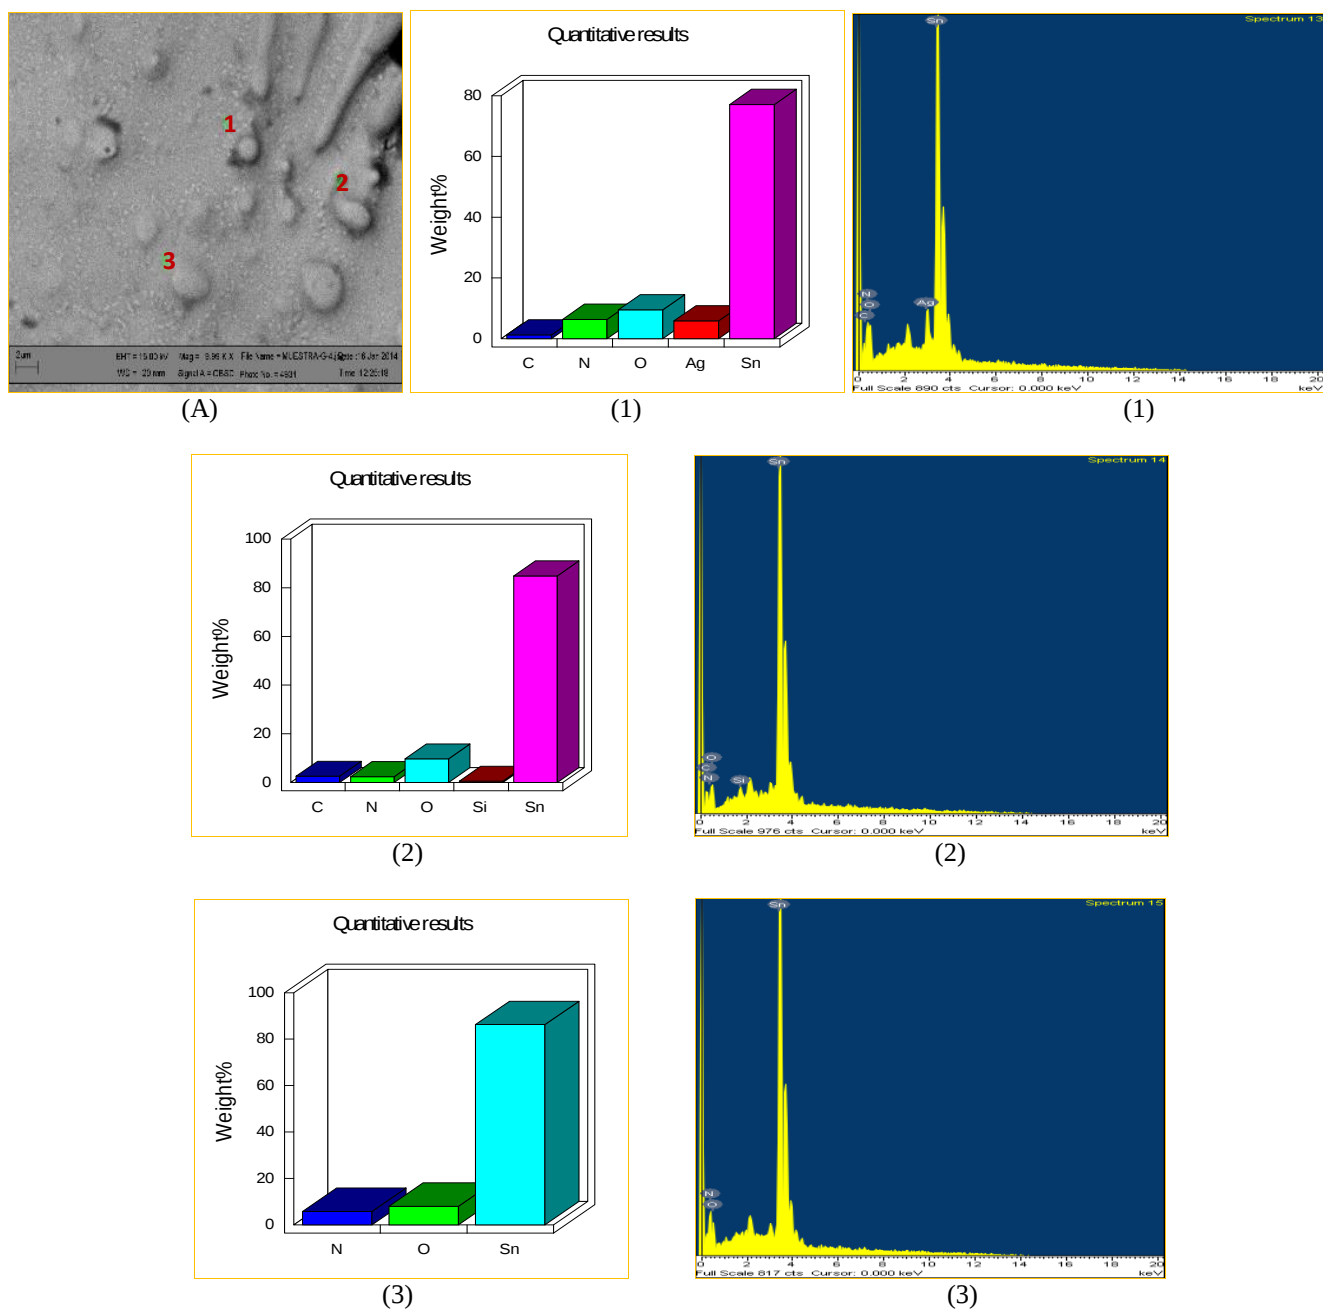
Figure 15. (A) shows three red numbers representing the punctual areas. (1) corresponds to the analyzed point 1, (2) to the analyzed point 2, and (3) to the analyzed point 3. The sample comes from 16 hrs test and DI water

The BGA sample has no NaCl presence. Point 1, 2 and 3, Figure 15, contain only tin, nitrogen and silver. The surface, Figure 16, has similar elements to the analyzed specific points.

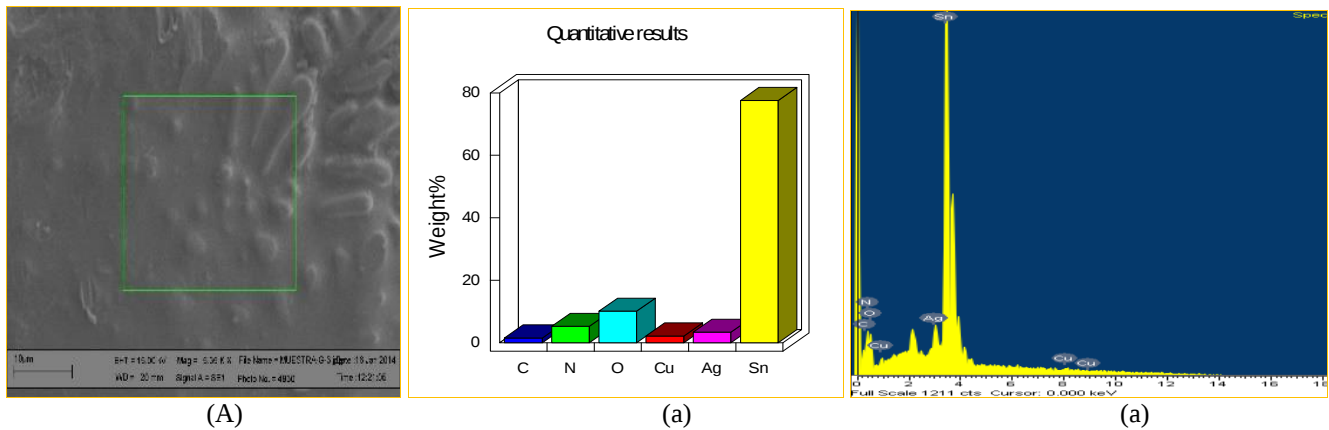
Figure 16. (A) is a general SEM Analysis. Sample comes from 16 hrs and DI water

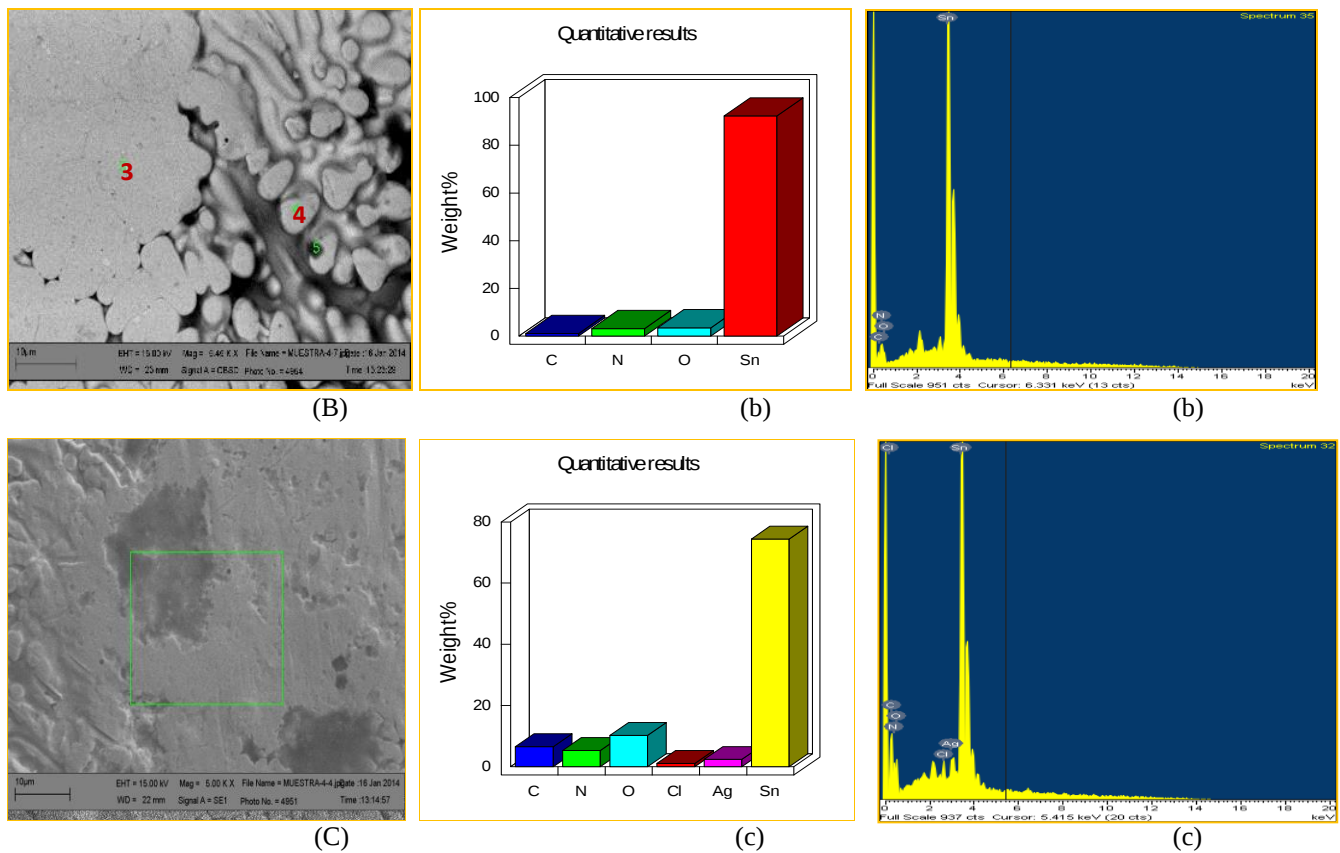
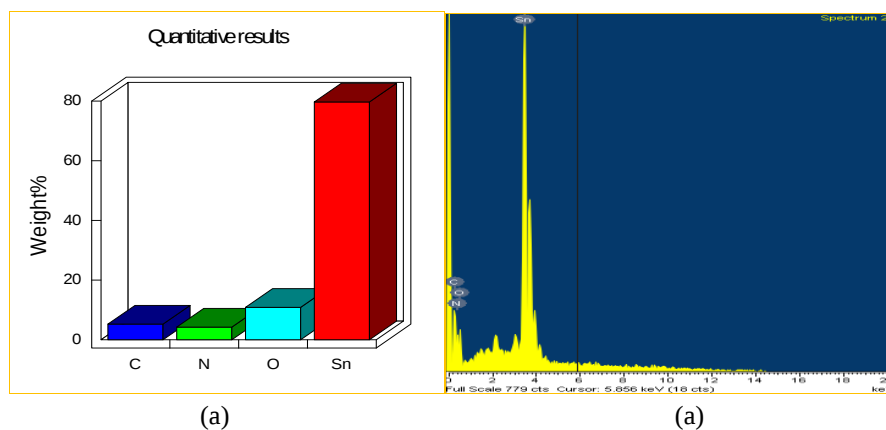
In this case, the results show a small concentration of chloride on the surface of the tin, see Figure 17; however, the presence of these chlorides is not evenly distributed across the surface of the ball but is found at specific points around the same; these points are located randomly.

Figure 17. The Images (B) and (C) are analyses of the sample with deionized water and 0.5% NaCl for 4 hrs

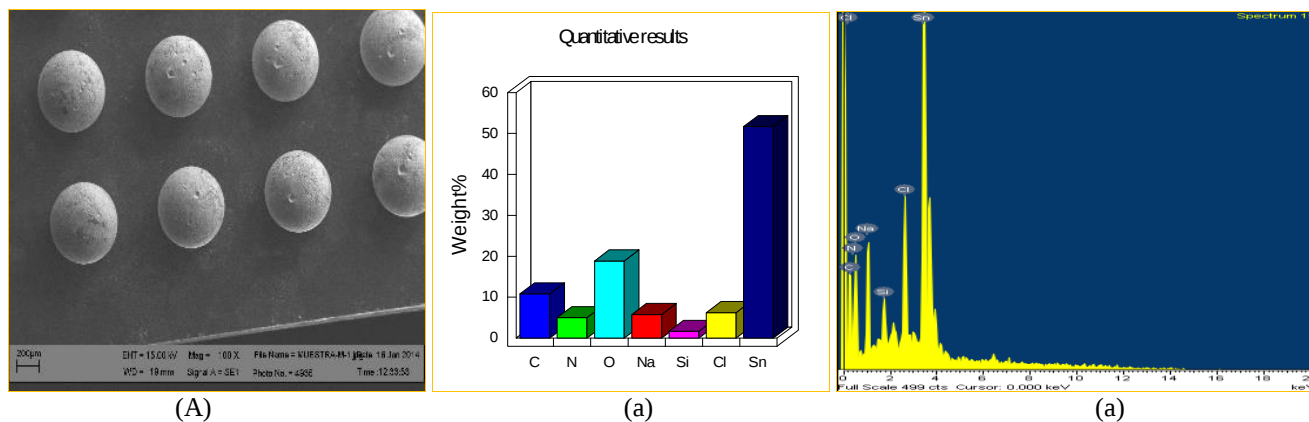
In Figure 18, the sample of analysis comes from deionized water and 1% NaCl at 4 hrs of steam. The samples are more contaminated with NaCl than BGA in Section III.4.2. The results show higher sodium chloride concentrations at specific points around the ball.

Figure 18. (A) Results SEM Analysis (NaCl),  
Sample deionized water at 4 hrs

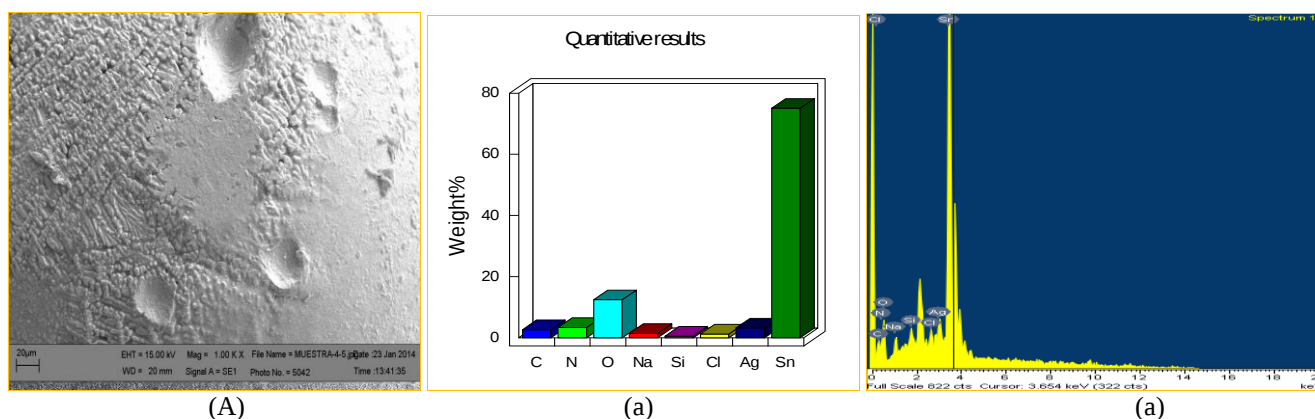
Although the component is exposed to a longer time, see Figure 19, than the component shown in the figure above, the sodium chloride concentrations are not substantially increased but the specific points with sodium chloride increases its presence in number.

Figure 19. (A) Results of test-deionized water at 1% for 16 hrs. The sample presents disperse areas with NaCl

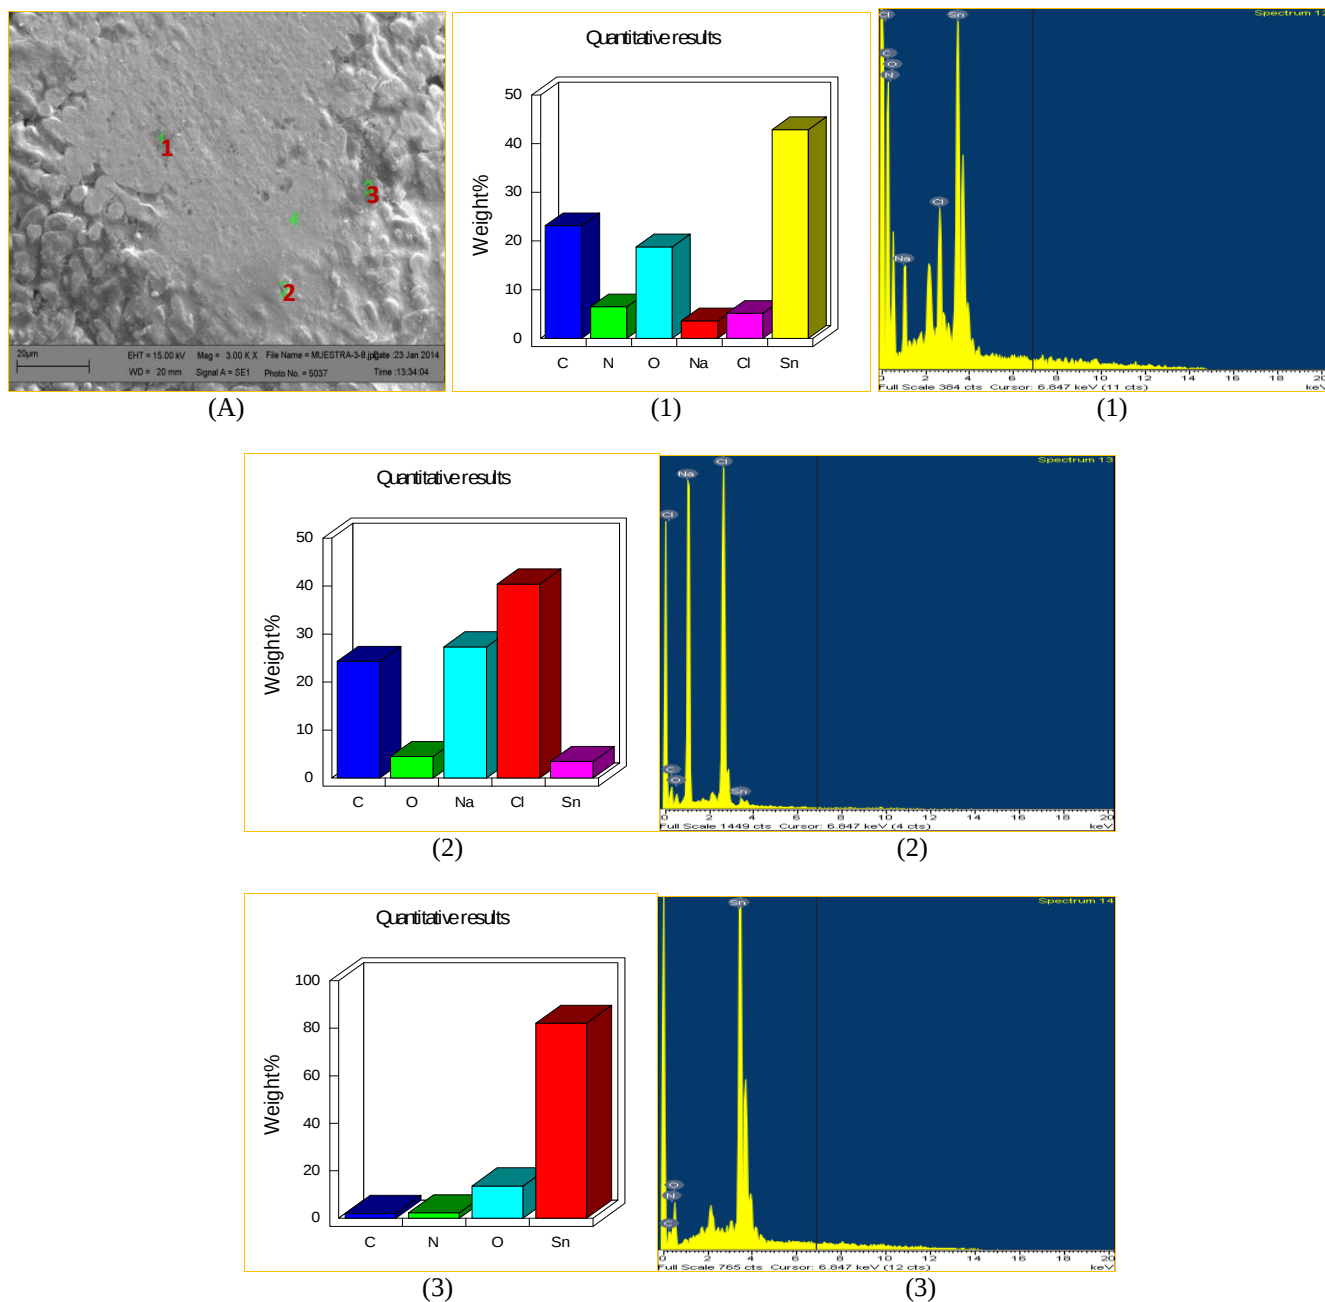
The results, Figure 20, show similar behavior to the previous sample, in which stains on the surface area increase. These areas are those containing a higher concentration of sodium chloride but do not cover the entire area of the ball but certain regions.

Figure 20. (A) Presents analysis showing three analyzed points. The analysis was performed with deionized water at 5% (NaCl) for 16 hrs

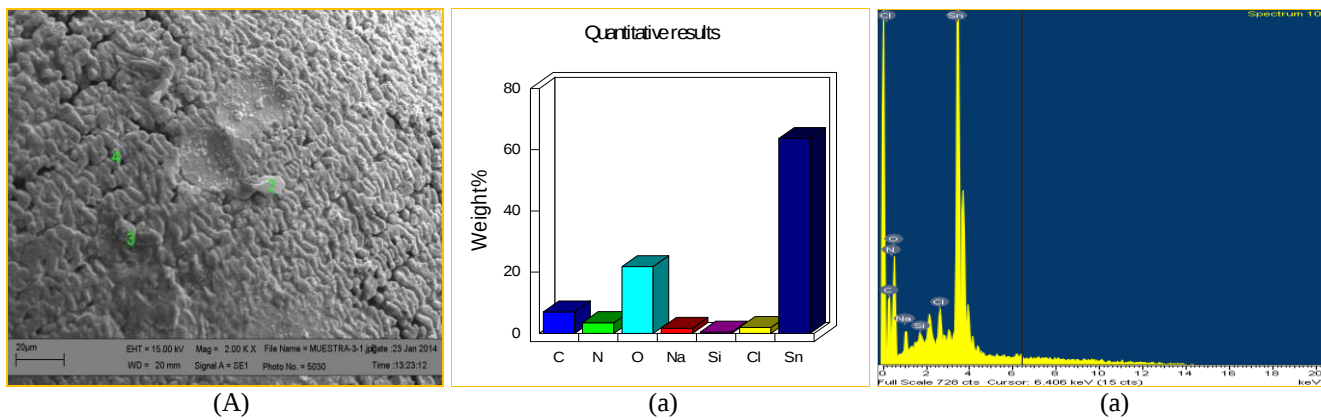
Figure 21. (A) is a general Analysis SEM. The sample was steamed with deionized water at 5% (NaCl) for 16 hrs

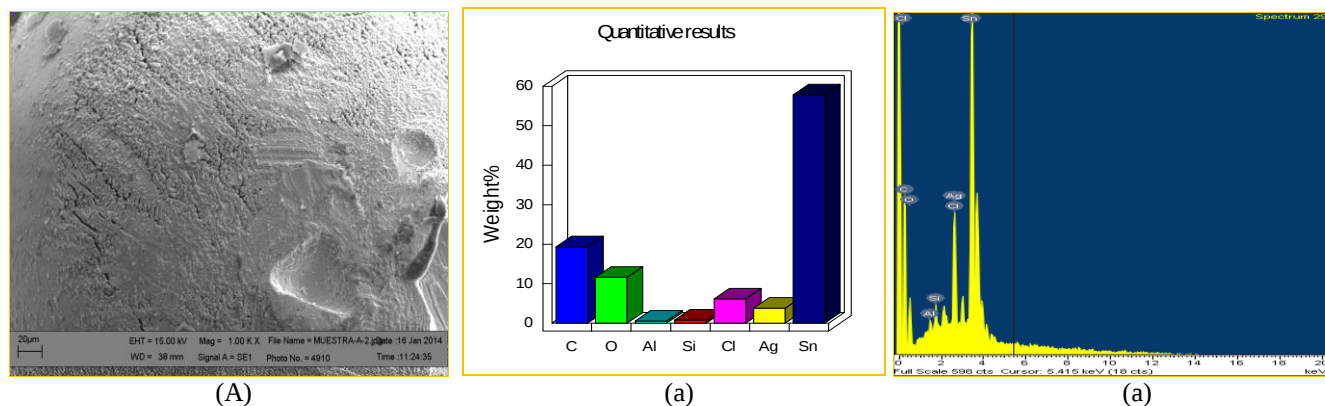
This sample, Figure 22, presents spots in larger surface areas. Additionally the presence of NaCl looks very marked in the component body. This case would be inadmissible in normal production, further the level of defects created with this NaCl concentration is very high.

Figure 22. (A) is a general analysis with SEM. Test in tap water at 10% (NaCl) for 4 hrs. The sample presents Cl and a high percentage of Oxygen

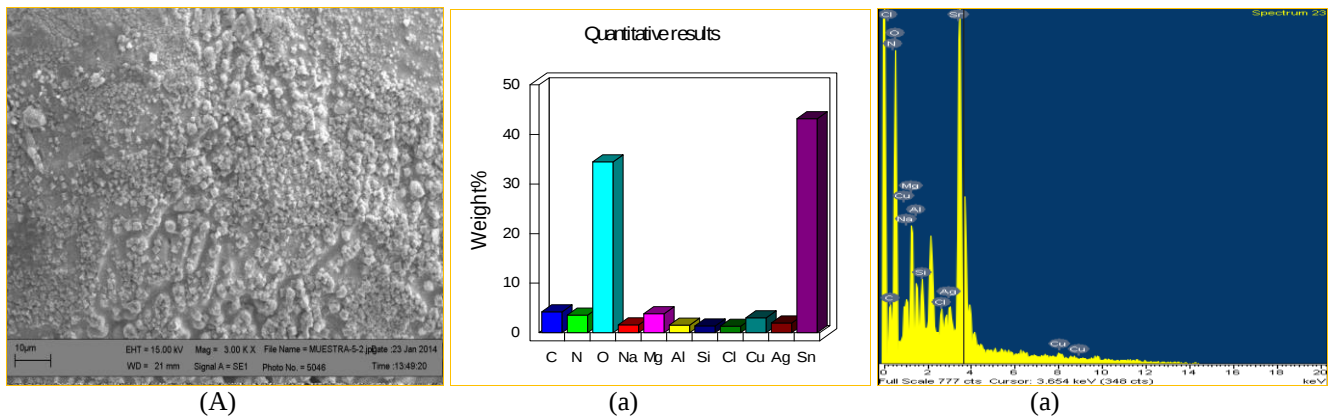
The analysis of this sample presents a large concentration on the surface of the ball in several chemical elements not only NaCl. See Figure 22 (A). These elements are Aluminum and Magnesium which also decrease the solderability of the balls.

Figure 23. (A) Sample in tap water at 10% for 16 hrs. Aluminum and Magnesium are present elements, which can affect the solderability

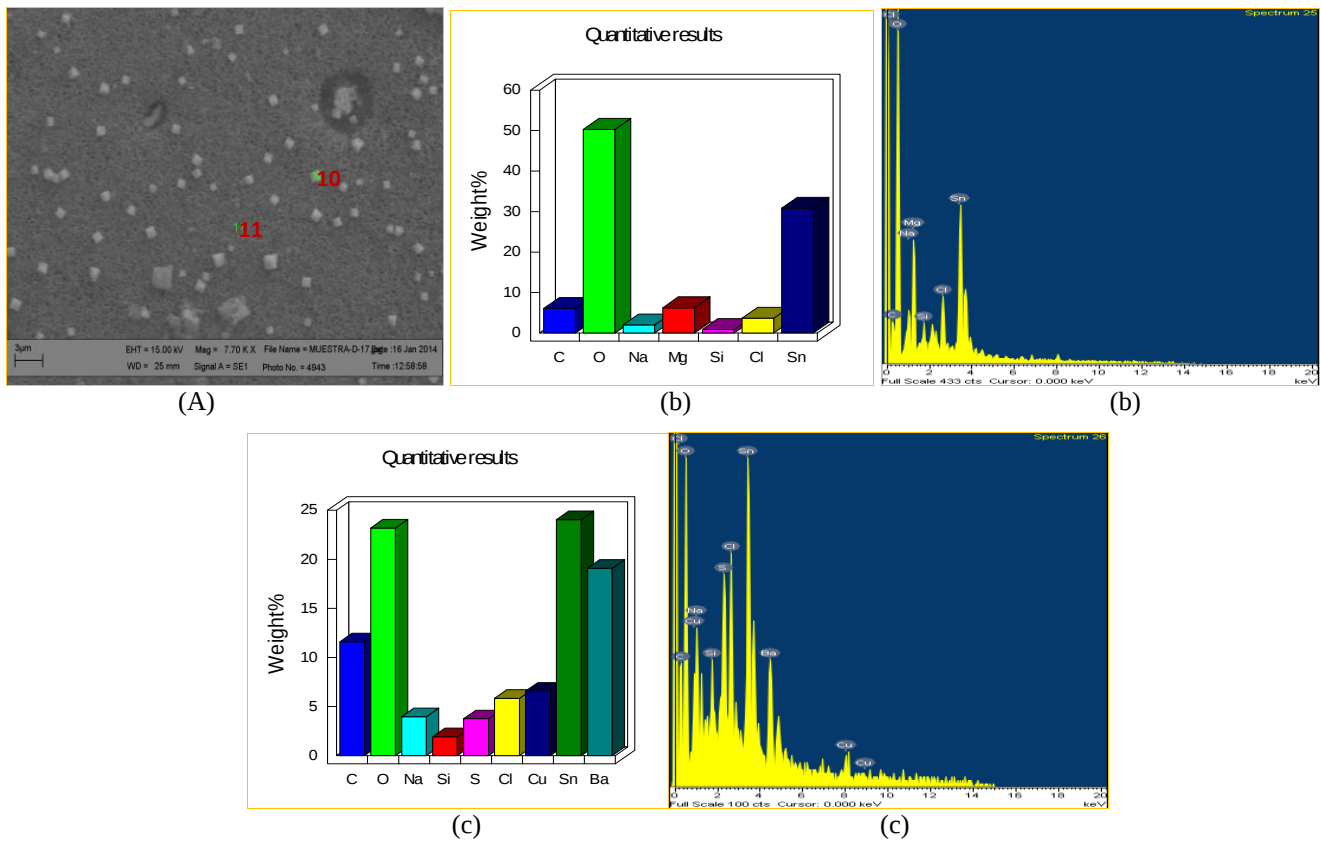
The SEM analysis shows contamination of NaCl in the BGA body in this case, see Figure 24. The contamination is in the form of small squares..

Figure 24. (A) General analysis body component (b) corresponds at point 10, and (c) at point 11

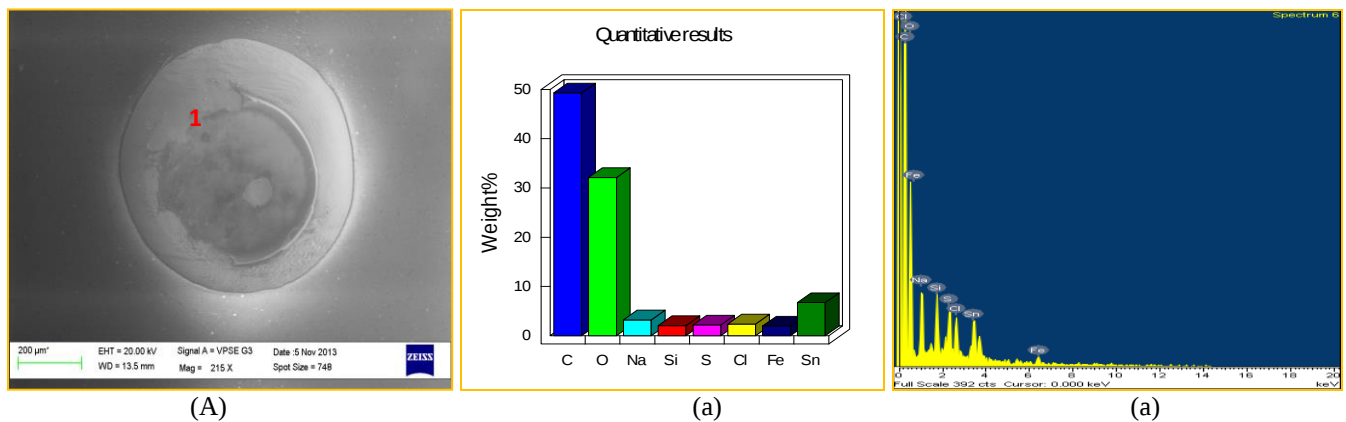
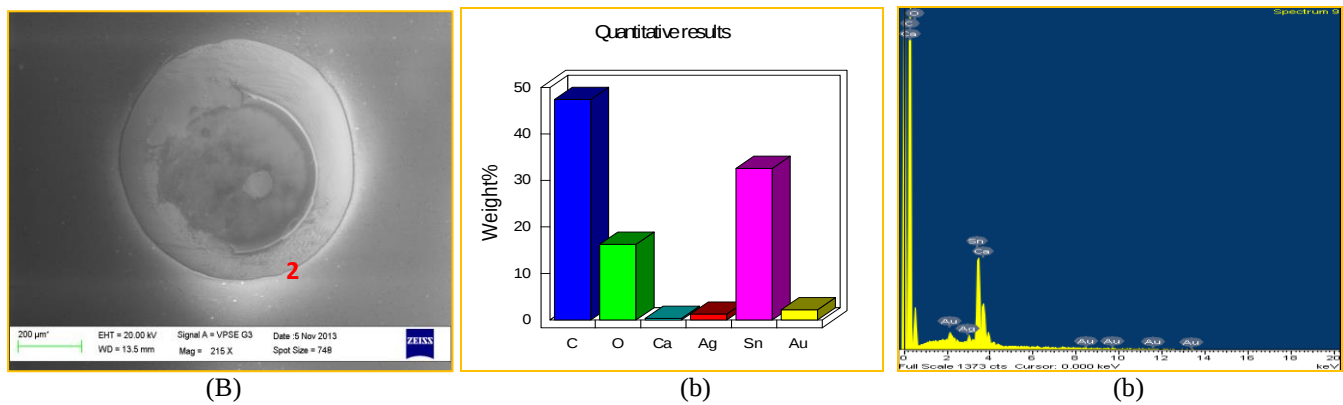
Ball 1: HiP defect

The next analysis points out an actual HiP rejection from production lines. The analysis shows that in some areas Cl concentrations are present and in other areas do not show similar to cases analyzed above. Cl concentrations are found around the component in specific areas. Although the reject would be related to other possible causes, it is interesting to mention the relationship between the experiments and this real case.

**Figure 25. (A) The analysis of analyzed point 1 presents Cl; (B) is the analyzed point 2 which does not show Cl in a real HiP**

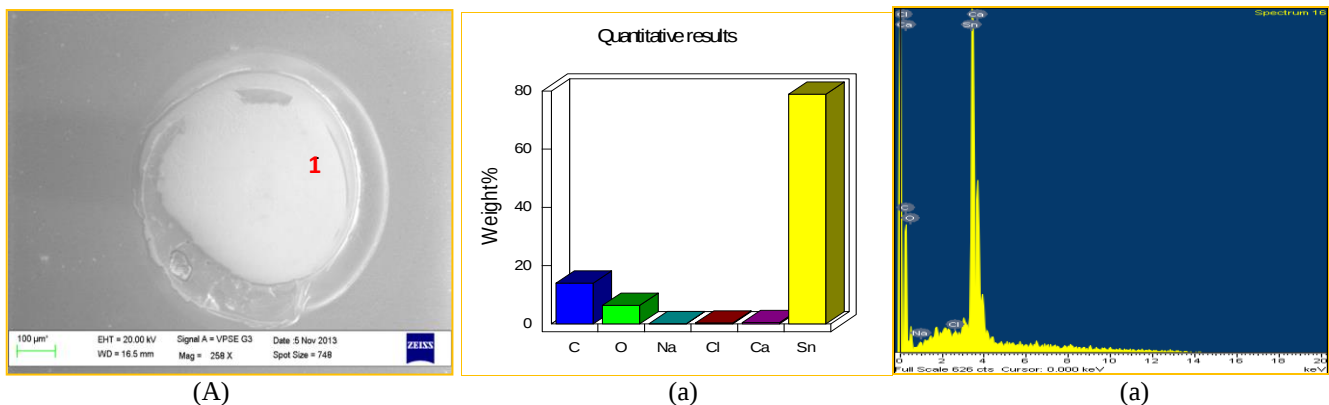
The following images show HiP SEM/EDX Analysis made on the pad. There are only small residues of NaCl left on the surface.

**Figure 26. (A) There is NaCl presence on the pad**
