Nondestructive Inspection of Underfill Layers Stacked up in Ceramics-Organics-Ceramics Packages with Scanning Acoustic Tomography (SAT)

Justin Zeng, Françoise Sarrazin, Jie Lian, Ph.D., Zhen (Jane) Feng, Ph.D., Lea Su,
Dennis Willie, David Geiger
Flex International Inc.
Milpitas, CA, USA
Masafumi Takada, Natsuki Sugaya
Hitachi Power Solutions Co., Ltd.
Tokyo, Japan
George Tint, Ph.D.
HDI Solutions, Inc.
Santa Clara, CA, USA

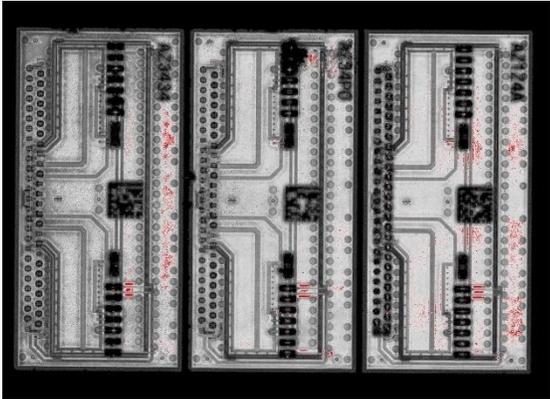
Figure 7(b). C-scan image from Gate #2, interface of HTCC1 top of UF1 at 100MHz probe frequency. All 3 units show very similar images. The inspection algorithm is set so that red color paint will highlight whenever a delamination of void is detected.

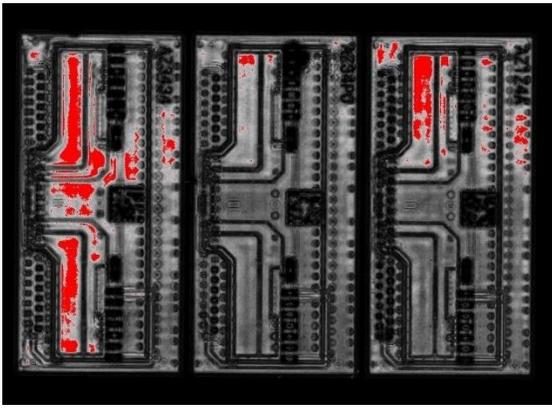
Figure 7(e). C-scan image from Gate #5, UF2, organics interfaces at 100MHz probe frequency. Both Left and Right units show significant delamination or less material regions.

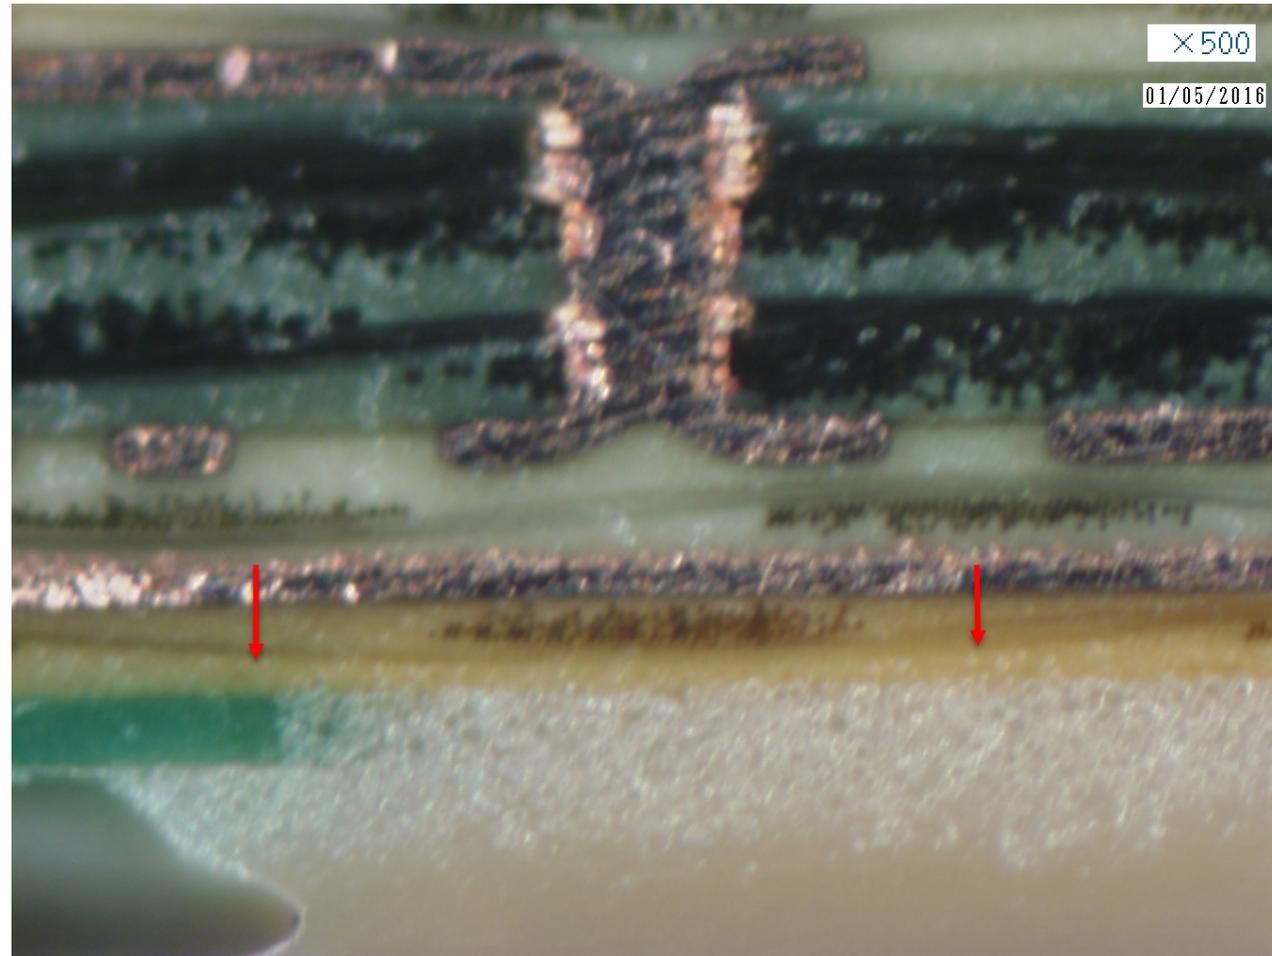
Deeper layer/ good joint
