# **A Structured Approach for Failure Analysis and Root Cause Determination for a Complex System Involving Printed Wiring Assemblies**

**Wade Goldman P.E.<sup>1</sup>, Alisa Grubbs<sup>1</sup>, Edward Arthur<sup>2</sup>**

<sup>1</sup>The Charles Stark Draper Laboratory, Inc., Cambridge, Massachusetts

<sup>2</sup>Raytheon Company, Space and Airborne Systems, El Segundo, California

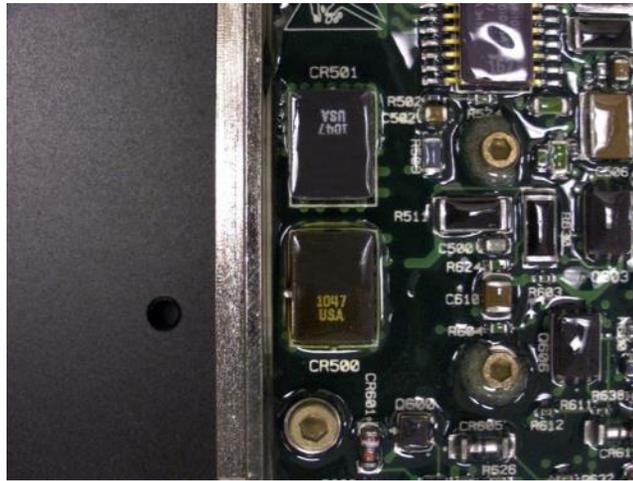
identified here as PWA1, had a component CR500, Figure 2, that had a brown appearance on the part and a solder glob, Figure 3, on the external side of the component. The second PWA, identified here as PWA2, had a severely burned area near reference designator R517, Figure 4. On the backside of the PWA, opposite to the burned mark, there was evidence of discoloration near reference designator C22, Figure 5. Approximately three months after the test failure, the entire CSA, with all PWAs, was returned to the design activity for further analysis.

**Figure 2 - PWA1 Discolored CR500**

A SEM, using Energy Dispersive X-ray Spectroscopy (EDS), analyzed the solder ball on the side of the component CR500. It was determined to be tin/lead solder, similar in composition to the solder used to assemble the PWA. This confirmed that the gold/tin braze, used to assemble the component CR500, did not reflow. The initial eutectic temperature of the Gold/Tin braze material is approximately 280C. However, both the lid and package are gold-plated, so that increases the melting temperature somewhat. The next step was to send the component to an independent failure analysis laboratory<sup>[1]</sup>. There, SEM imaging, as well as CT X-ray techniques, were used. The CR500 Dual Schottky diode, when electrically tested, exhibited a short circuit. It was found to have one diode catastrophically damaged, likely from an electrical overstress event (EOS).

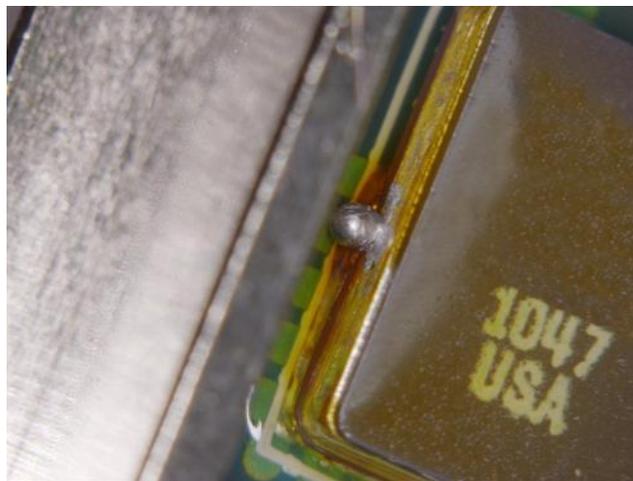
**Figure 3 - PWA1 Solder Blob on Edge of Component CR500**

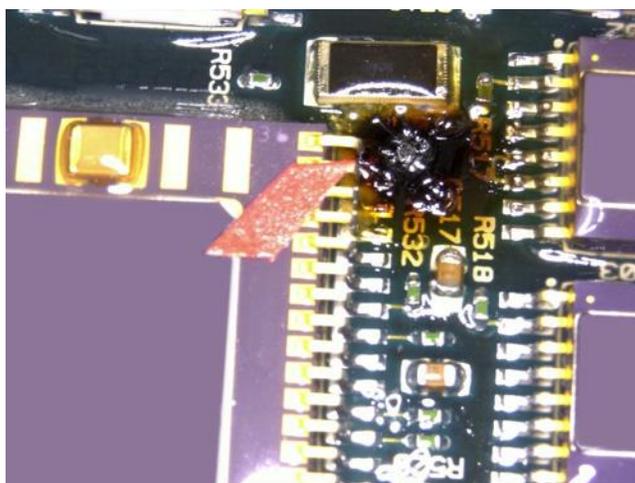
**Figure 4 – PWA2 Burn Mark near R517**

Some preliminary work was performed, such as reviewing the defects on the two PWAs, relative to the circuitry within the PCBs. Much focus was placed upon the PWA2 burned area and the buried vias in the vicinity. Both PWAs also had real-time X-rays taken. A solder ball was noticed under the CR500 Schottky diode component on PWA1, and the solder blob on the side of the component was evident as well, Figure 6. Isolation tests between all power outputs and grounds were conducted on PWA1. All measurements were nominal, except results confirmed a short on the diode CR500. Isolation tests between all power outputs and grounds were also conducted on PWA2. This confirmed a short (0.8 ohms) between a 3.3V power plane and ground. The path that was checked is typically 5K-6K ohms. Other measurements were nominal. The short certainly warranted further attention. This ended up being the focus of the failure investigation. It was believed that the solder ball under CR500 was a result of overheating the component. The overheating of CR500 was later to be determined to be a result of the short on PWA1.

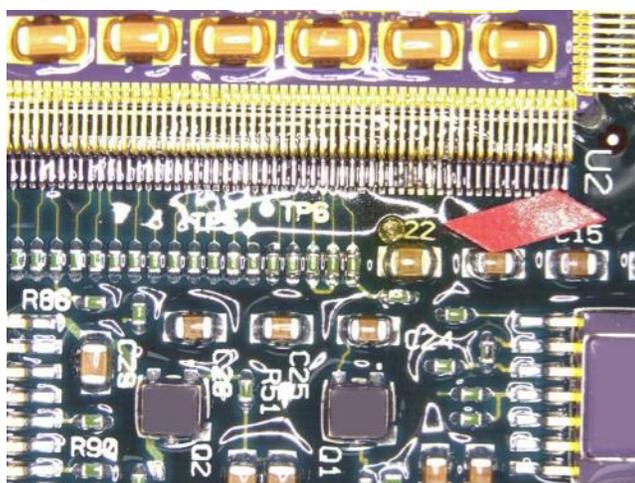
**Figure 5 - PWA2 Opposite side of PWA Burn Mark C22**

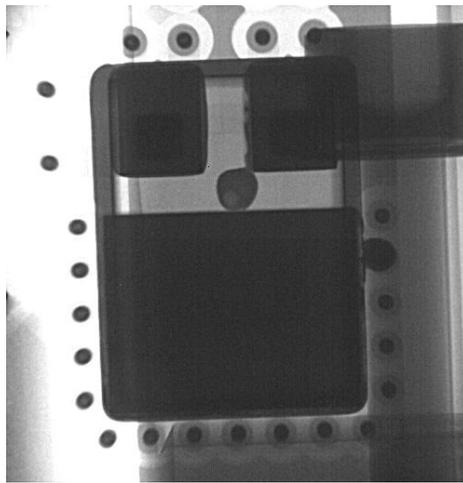
**Figure 6 - PWA1 CR500 Real Time X-ray**

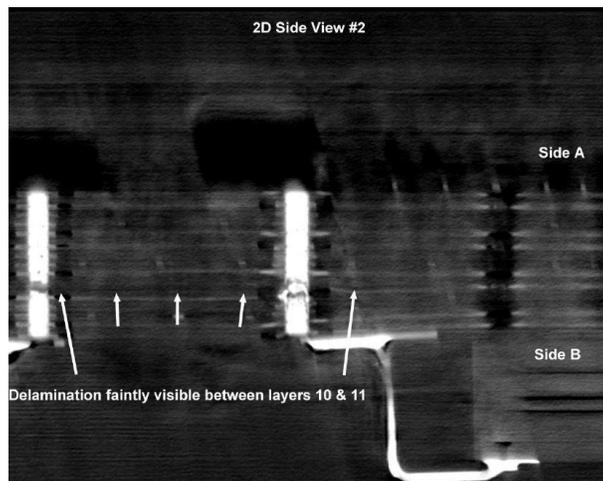
After particular components were cleared from being a cause, the PWA2 was CT scanned. The information provided by the CT X-ray was extremely beneficial in defining a plan for micro-sectioning the PWA2. The scan clearly showed a separation of vias, as well as delamination of layers, Figure 8. A number of other activities centered around evaluating the PWA2 and its PCB. A thermal simulation of the PWA2 was performed, with the goal of duplicating the thermal damage of the PCB due to a suspected short between the 3V plane and ground. The simulated temperature levels were found to correlate with the observed thermal damage on the PCB. The simulated temperature levels were consistent with the solder re-flow patterns observed by visual inspection on the outer layers of the PCB. Also, the thermal transient simulations actually reached expected temperatures in a period consistent with test data fault code timing diagrams obtained from the field failure. Another path of inquiry led us to a visit with the PCB manufacturer. A thorough review of all documentation associated with the 8-panel lot was conducted from looking at material certificates, floor travelers log books and anything remotely associated with this lot of panels. Nothing unusual was found during this exhaustive review at the supplier. Another process initiated during this microsection evaluation was that an assembled PWA (from the same panel 070 as our failure) was placed on long-term bench testing, for monitoring purposes. The team also resolved that the EOS condition on the CR500 on PWA1 was determined to have been caused by the short between the 3.3V plane and ground from PWA2.

**Figure 8 - PWA2 CT Scan**

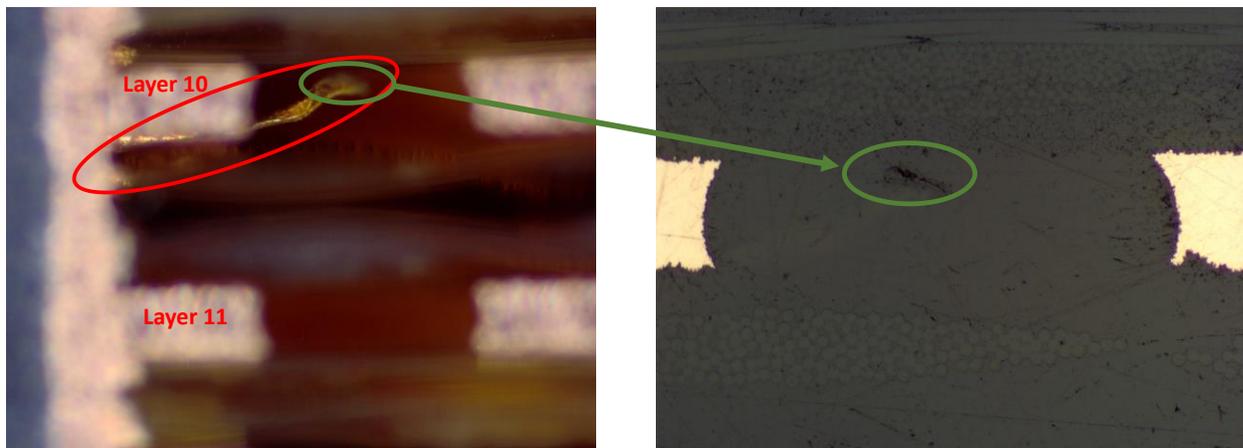
The justification for the failure mechanism was based upon a number of observations. Foreign inclusions exceeding the acceptable length in IPC 4101 were found in both the conformance coupons of panel 070 (the manufacturing panel that the failed PWB came from) and the three coupons removed from the failed PWA2. When other conformance coupons from this date code were reviewed, there were some foreign materials (possibly the result of Automated Optical Inspection AOI rework) found through dark field and SEM analysis. Figure 9, below, shows the locations where the three sections were taken. Figure 10 indicates resin-like inclusions found in one of the conformance coupons from panel 070. The right photograph is bright field, and the inclusion was found to be resin-like material. It is important to note that it was just slightly noticeable using standard light field illumination, but when dark field was used (which is not a current requirement), the defect could be seen more clearly in the left photograph. After some grinding and polishing, that inclusion was determined to be copper. IPC 4101 does not allow any encapsulated metallic particles of any size, whether in a core or prepregged material. Figure 11 is another example of a nonconforming inclusion, found in one of the two control coupons from PWA2. This was also determined to be a resin-rich, crack-like inclusion.

Figure 10 – Panel 070 Acceptance Coupon (Dark Field on left, Bright Field on Right)

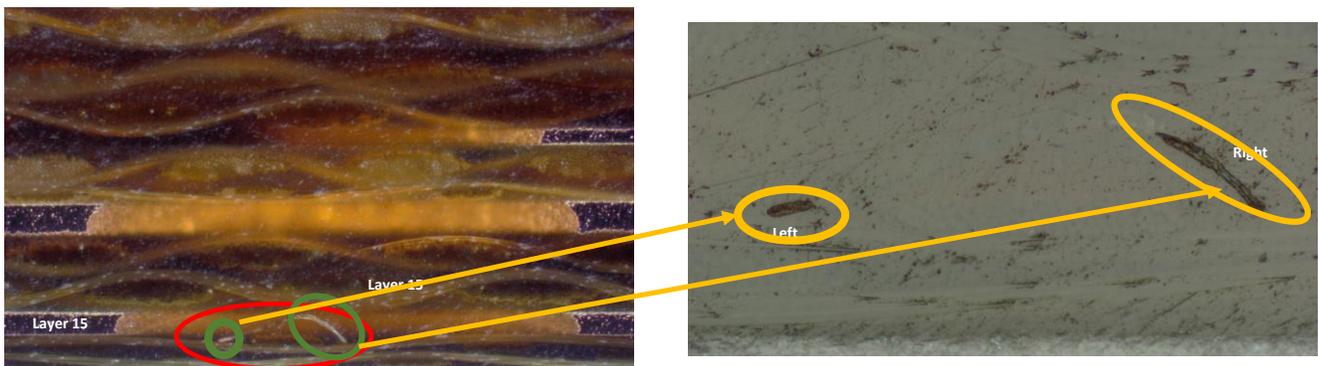
Figure 11 – Laboratory Control Mount [1] (Dark Field on left, Bright Field on Right)

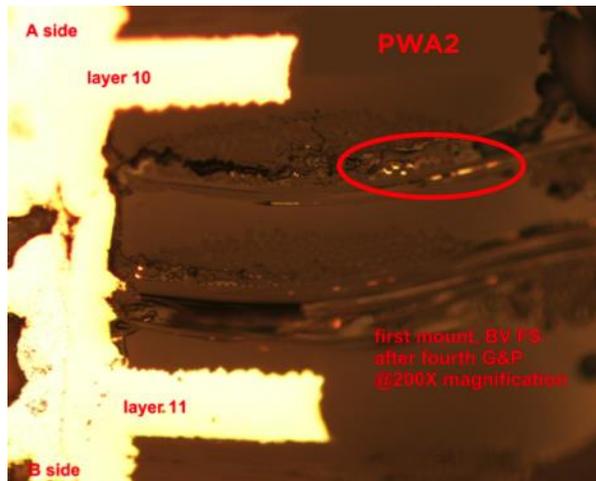
Sectioning of the failure site coupon revealed copper within the fiber bundles, along with chlorine and believed to be a result of copper-plating residues.

Figure 12 is a dark field illumination picture of fiber bundles with the copper plating residues. Use of SEM and EDS, Figure 13 and Figure 14, shows the presence of copper, chlorine and sulfur in the glass bundles. The only mechanism that accounts

**Figure 12 - Failure Site Coupon Mount (Dark Field)**

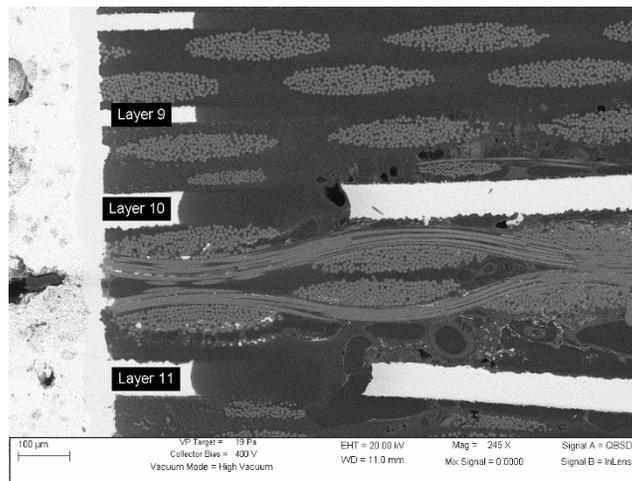
for the presence of all three is a defect in the resin (inclusion with crack) that allows for the wicking of the plating solution for a plated via. The presence of moisture was also discovered within some of inclusions with cracks during this evaluation.

**Figure 13 - Failure Site Coupon Mount (SEM view)**

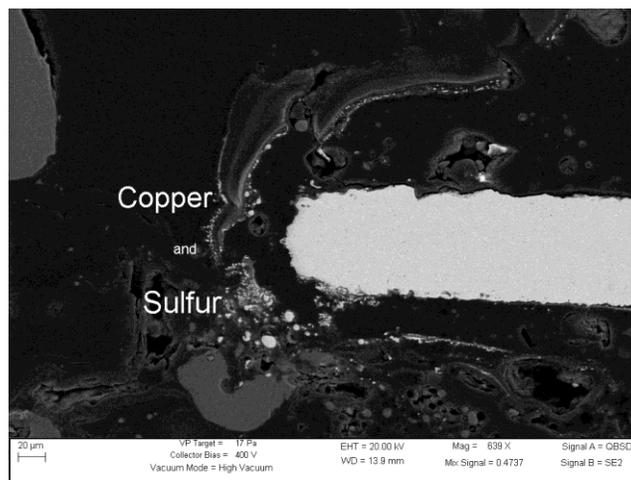
**Figure 14 - Failure Site Coupon Mount (close up SEM View)**

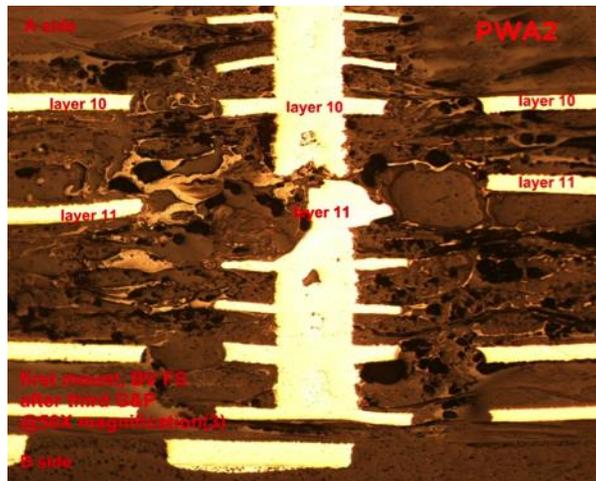
The sectioning of the failure site mount provided evidence that the epicenter of the failure is the buried via (signal: GND), under an unused pin 36 of U508, Figure 15. This buried via is the only one with melted copper and melted conductive via fill material. Layer 11 plane (signal: 3.3V) shows melted copper at the right edges of the via around the clearance area, around

Figure 15 - Failure Site Buried Via (showing melting, Dark Field)

The filament that breached the reduced clearance between the ground buried via and the power plane is CAF (Conductive Anodic Filament) facilitated by plating residue. Conductive Anodic Filament is an electrochemical process involving the transport of a metal through, or across, a nonmetallic medium under the influence of an applied electric field. A filament formed from the end of the foreign inclusion from the ground buried via to the power plane (P3.3V). This resulted from the combination of electrical bias (P3.3V and GND), plating residues, moisture (RH {relative humidity}) and time.

1. Add PWB inspection requirements of acceptance coupons to include dark field inspection
2. Require a minimum number of CS 'burn-in hours'. The sister PWA was on test with no issues for twice as long as the PWA2 was tested within the CS.

3. Recommend flowing down cleanliness requirements to PCB suppliers for the lamination booking. There was some FOD found during our investigation in coupons, and this would be an attempt to reduce that.
4. Change PCB material with multi-functional epoxy.
5. Add controls on supplier inner layer AOI rework.

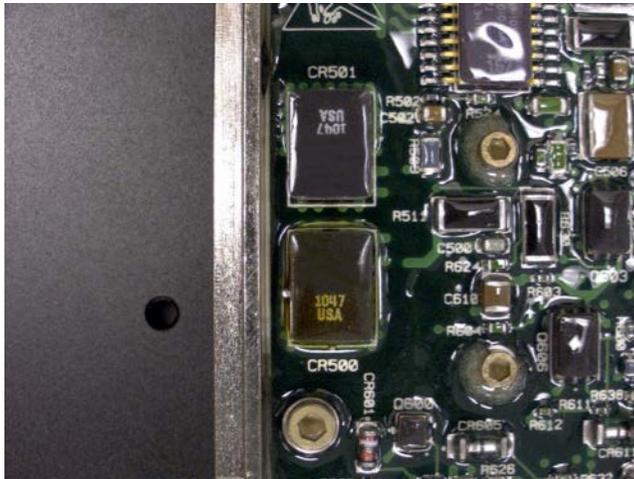
- PWA1: CR500, a dual Schottky diode had a brownish appearance, indicating over an overheated condition. A solderball was also seen attached to the package side.

Overheated  
Component

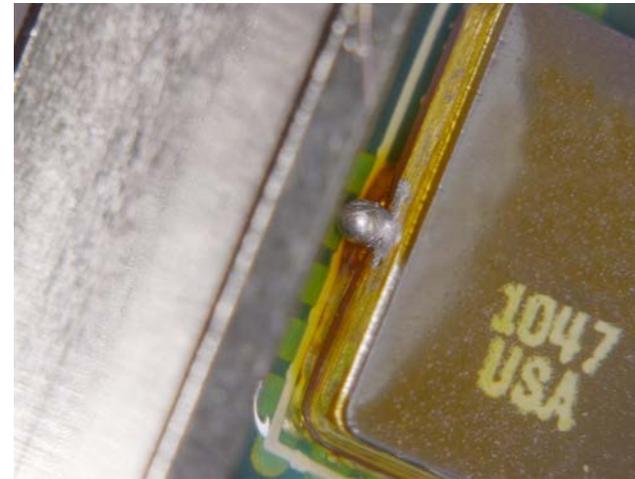
Solder Ball

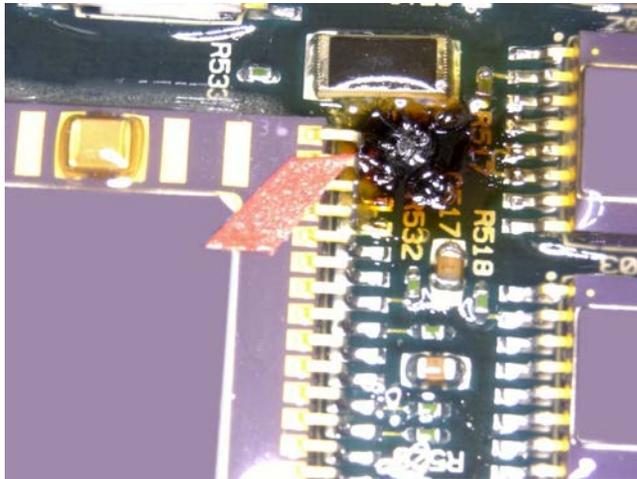
- PWA2: Top side had a severe burn mark near R517. Opposite side had discoloration near C22.

Burn mark  
near R517

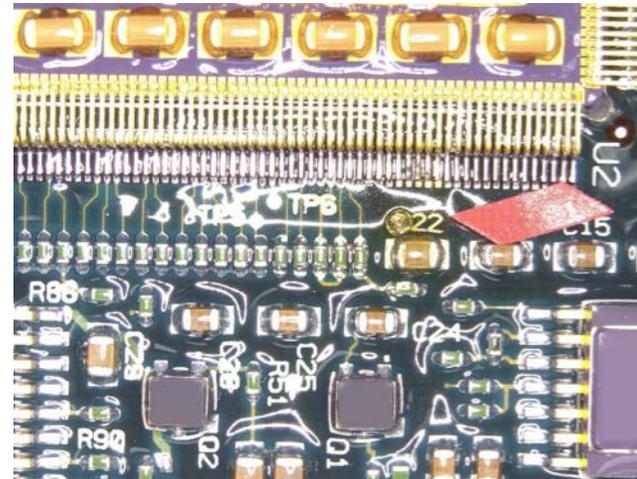
Discoloration  
opposite  
side C22

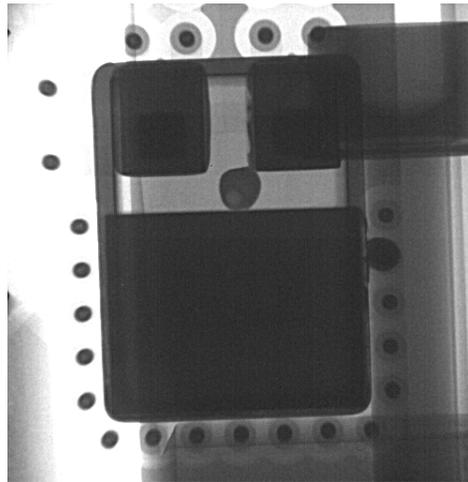
CR500 Real  
time X-ray

- The real time X-ray of PWA1 indicated a solderball underneath the component, likely causing the short.
- Did PWA1 cause the condition on PWA2 or vice versa?

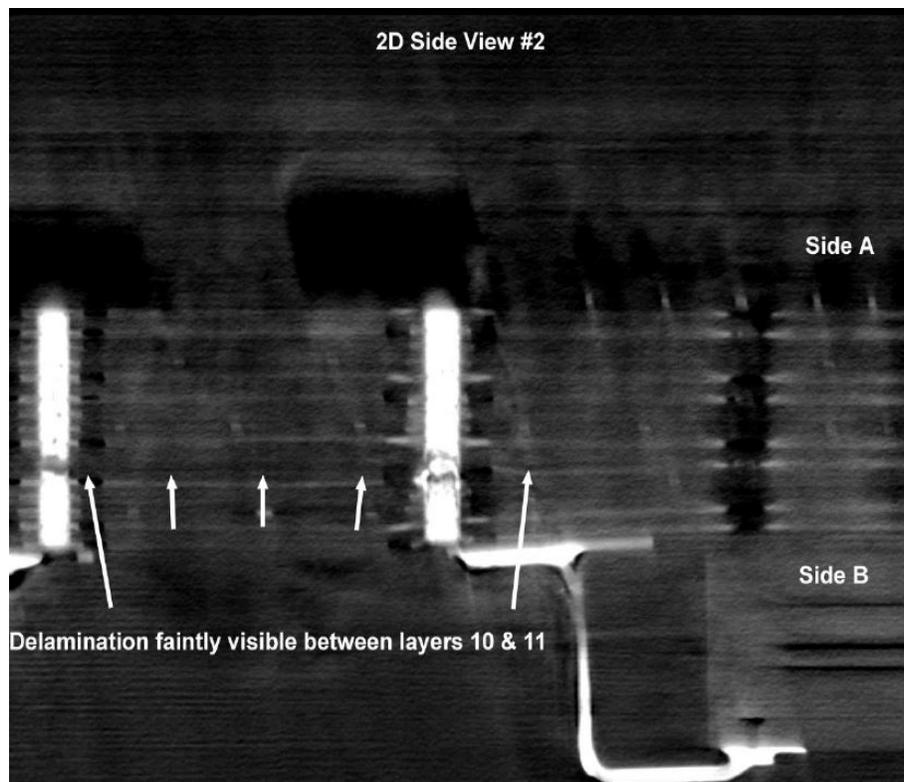
## PWA2 CT Scan

- Performed CT scan. The scan clearly showed a separation of vias, as well as delamination of layers. The information provided by the CT scan was extremely beneficial in defining a plan for micro-sectioning the PWA2. The same amount of material (about 0.08  $\mu\text{m}$ ) was removed at each polishing step prior to examining it under a microscope.

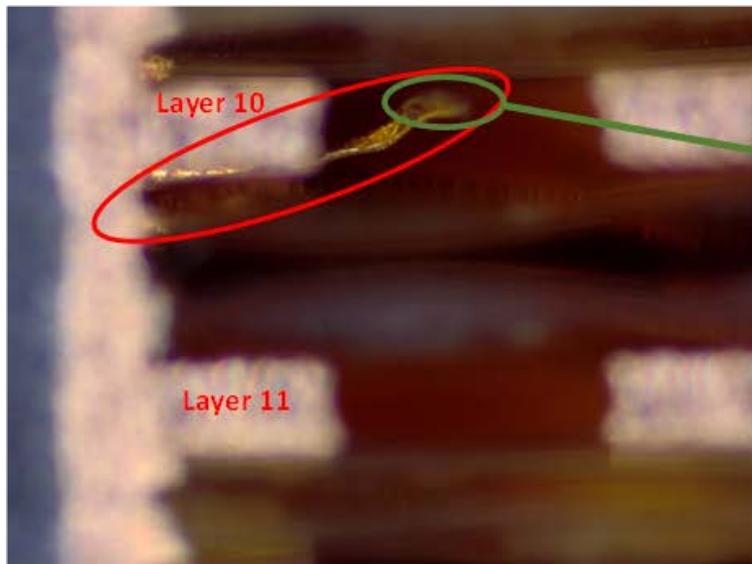
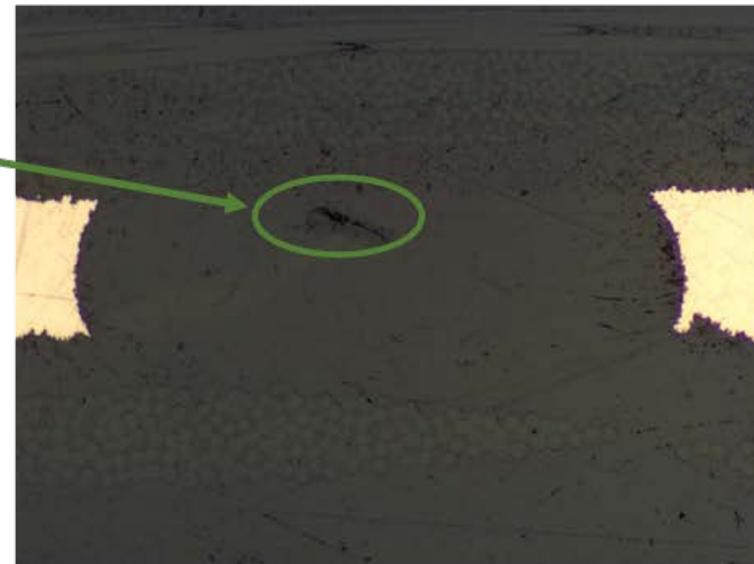
- An independent review of a control mount from the failed PWA2 panel 070, under dark field (left photo), indicated inclusions violating IPC 4101 requirements. Inclusion was determined to be copper.

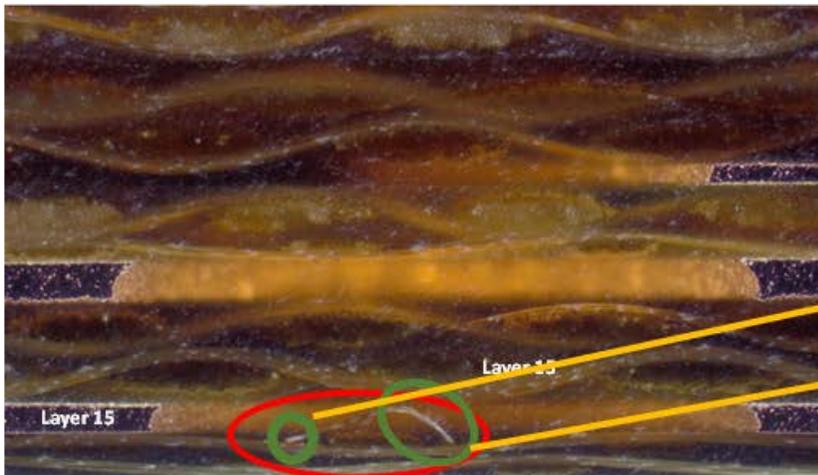
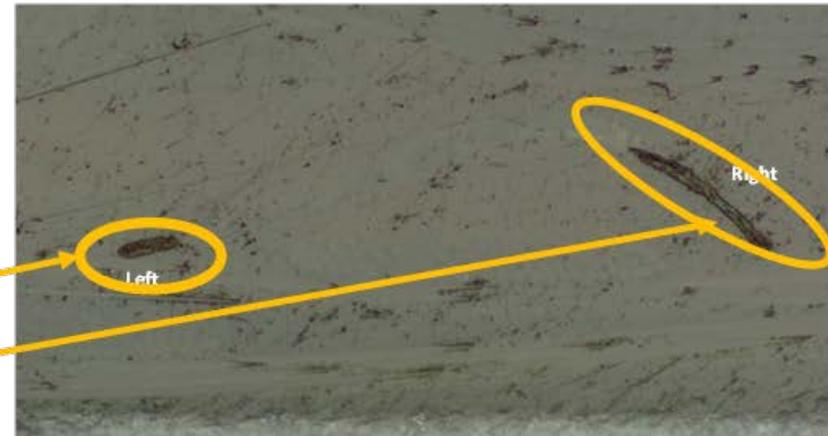
- An independent review of one of two control mounts from the failed PWA2, was determined to be a resin-rich, crack-like inclusion.

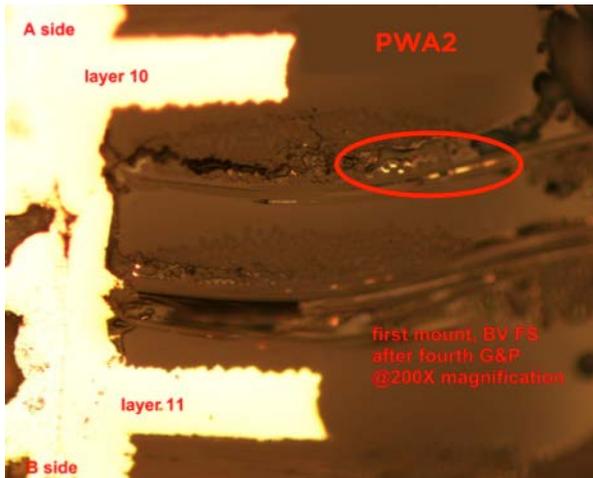
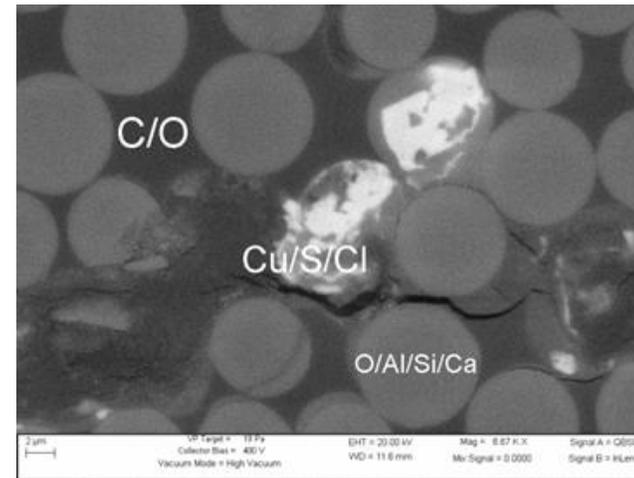
- Sectioning of the failure site revealed copper within the fiber bundles, along with chlorine and sulfur that we believe to be a result of copper-plating residues. The mechanism that accounts for all three elements is a defect in the resin (inclusion with a crack) that allowed for the wicking of the plating solution.

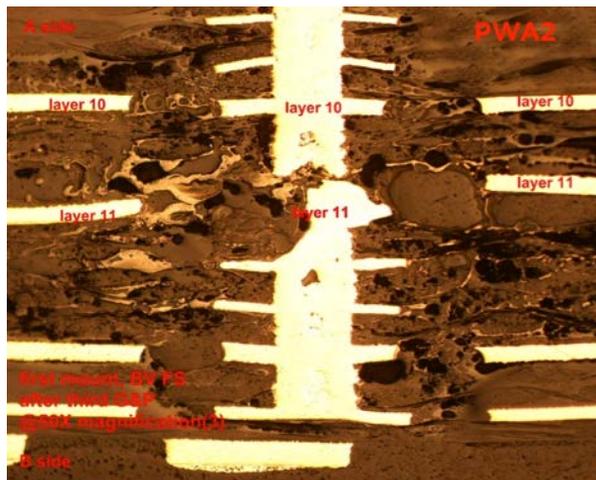
- Failure site mount shows epicenter of the failure as a buried via (signal Ground) left photo. Shows melted copper and melted conductive fill material. Other buried vias show complete separation but no melting.

Failure site Dark Field

- Add dark field inspection requirements
- Require CS burnin hours
- Flow down cleanliness requirements to approved suppliers for lamination booking
- Consider PCB material change to multi-functional epoxy
- Tighten supplier controls on inner layer AOI rework

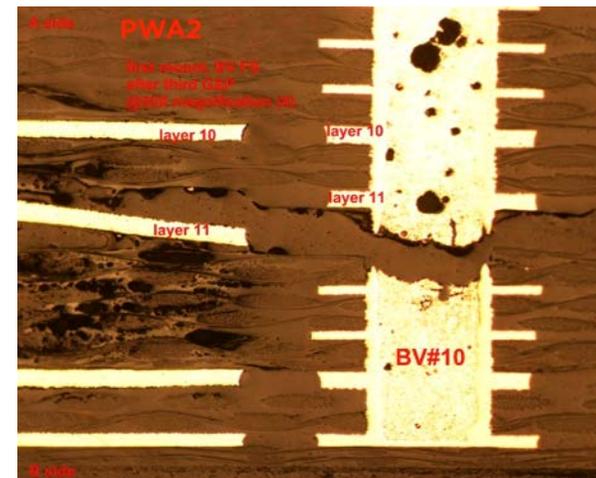
Blind Via Dark Field
