Identifying and Combatting Counterfeiters

Edward Laliberte

Northrop Grumman Systems Corporation
Charlottesville, Virginia

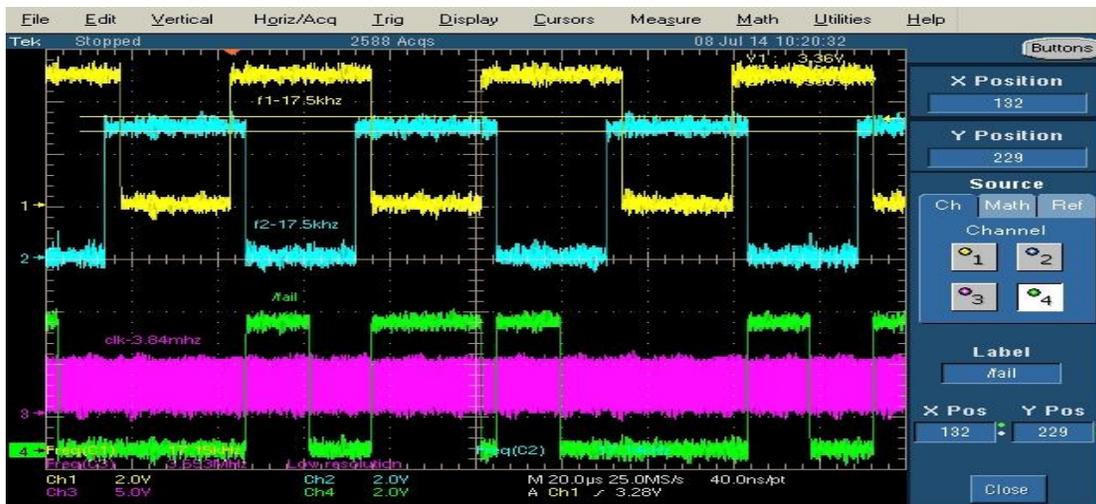
Figure 3: EPLD Failure # 1

If the test technician experiences a higher than usual failure of a particular device during board test, he should ask an engineer to investigate the component failure. Before investigating the electrical anomalies, the engineer should review the latest manufacturer’s datasheet and research latest PCNs and counterfeit risk as discussed above. Continuing with the EP610DI-30 UV EPLD component example, the test technician experienced a high failure rate during test. The engineer compared the output signals of the problematic EPLD parts as shown in Figures 3 and 4 to the output signals of a known good EPLD part in Figure 5. Comparing the timing of the two output signals of Figures 3 and 4 to Figure 5, the timing of “F1_17.5KHz” and “F2_17.5KHz” output signals is slightly different causing the /FAIL output signal to pulse.

Both EP610DI-30 UV EPLD components depicted in Figures 3 and 4 verified at the Data IO Programming Station with the correct checksum. The engineer erased one of the problematic EPLD components in the UV eraser for 25 minutes. The EPLD component was then reprogrammed and verified successfully. However, the part timing appeared even worse than the original condition, shown in Figures 3 and 4. The EPLD component was then put into the UV eraser for 1 hour and reprogrammed. Finally, the EPLD component started to perform similar to the known good EPLD component. Even though

the parts were programmed and verified, apparently some internal fuse links were not cleared during the erasing of the EPLD component resulting in unpredictable behavior. Also, UV erasing a “new” EP610DI-30 EPLD component for 1 hour prior to programming the part is not a standard procedure. Typically, only 10 to 20 minutes under the UV lamp is all that is needed to do a reliable erasure. Therefore, further investigation into the authenticity of the components needed to be performed.

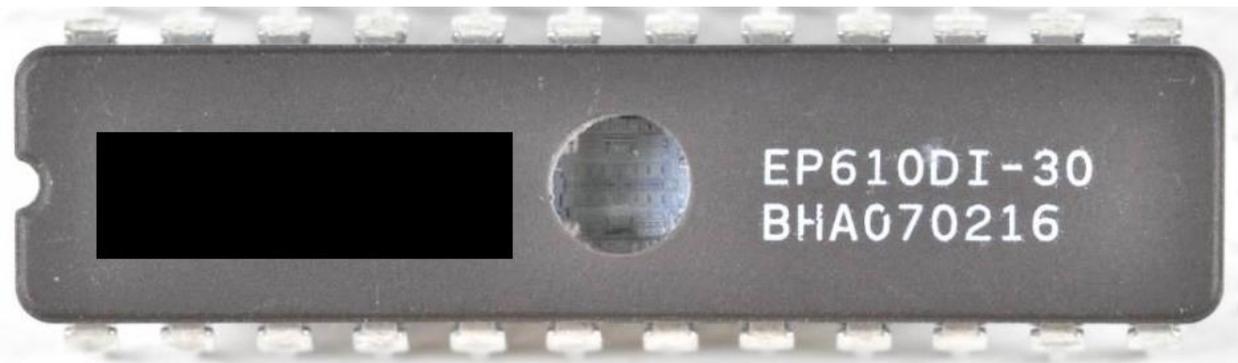
Figure 6: EP610DI-30 EPLD Part Markings

As shown in Figure 6, the parts in stock with date code of BHA070216 are not valid since the date code of 0216 is work week 16 of 2002 and the two additional characters are not included.

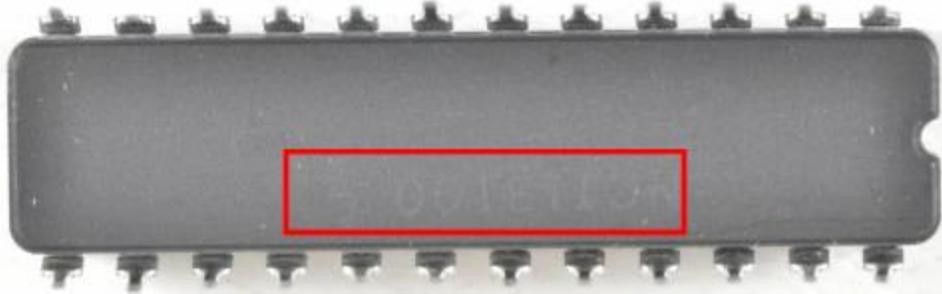
that the package top and bottom ceramic pieces vary in color and texture. Initial inspection of the component bottom surface revealed no markings. As shown in Figure 7, several components were found to have surface alterations as well as the remains of prior markings, referred to as herein as 'ghost markings'. As shown in Figure 8, several EP610DI-30 components with date code BHA070216 had imperfections in the glass window indicating tampering. As shown in Figure 9, the scanning electron microscopy (SEM) indicated possible resurfacing and remarking. Additionally, visual inspection and x-ray analysis of the die through the package glass window revealed die to be different in size and shape.

Figure 7: Ghost Marking Appeared on Several EP610DI-30 with Date Code BHA070216

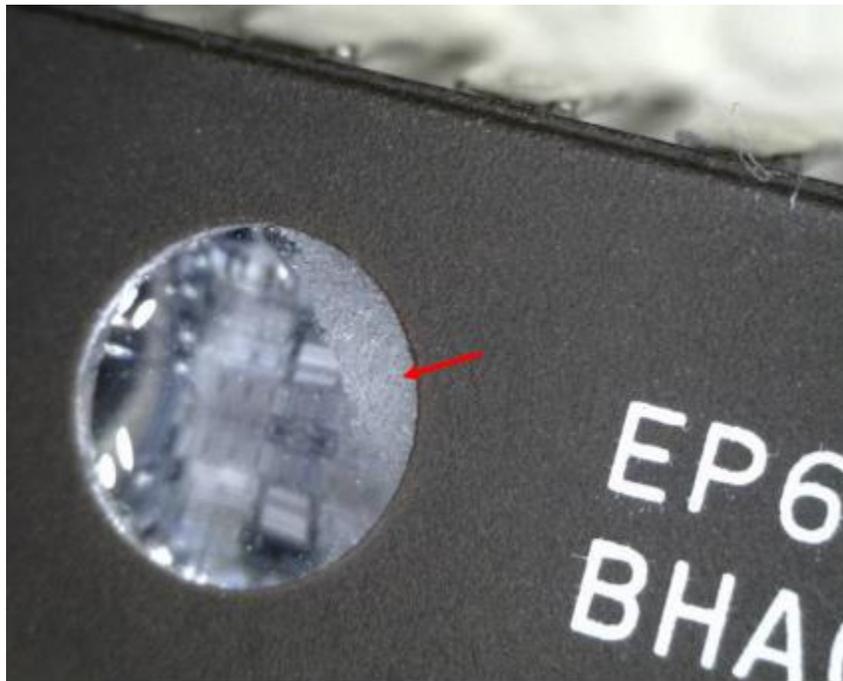
Figure 8: Imperfection in Glass Window on Several EP610DI-30 with Date Code BHA070216

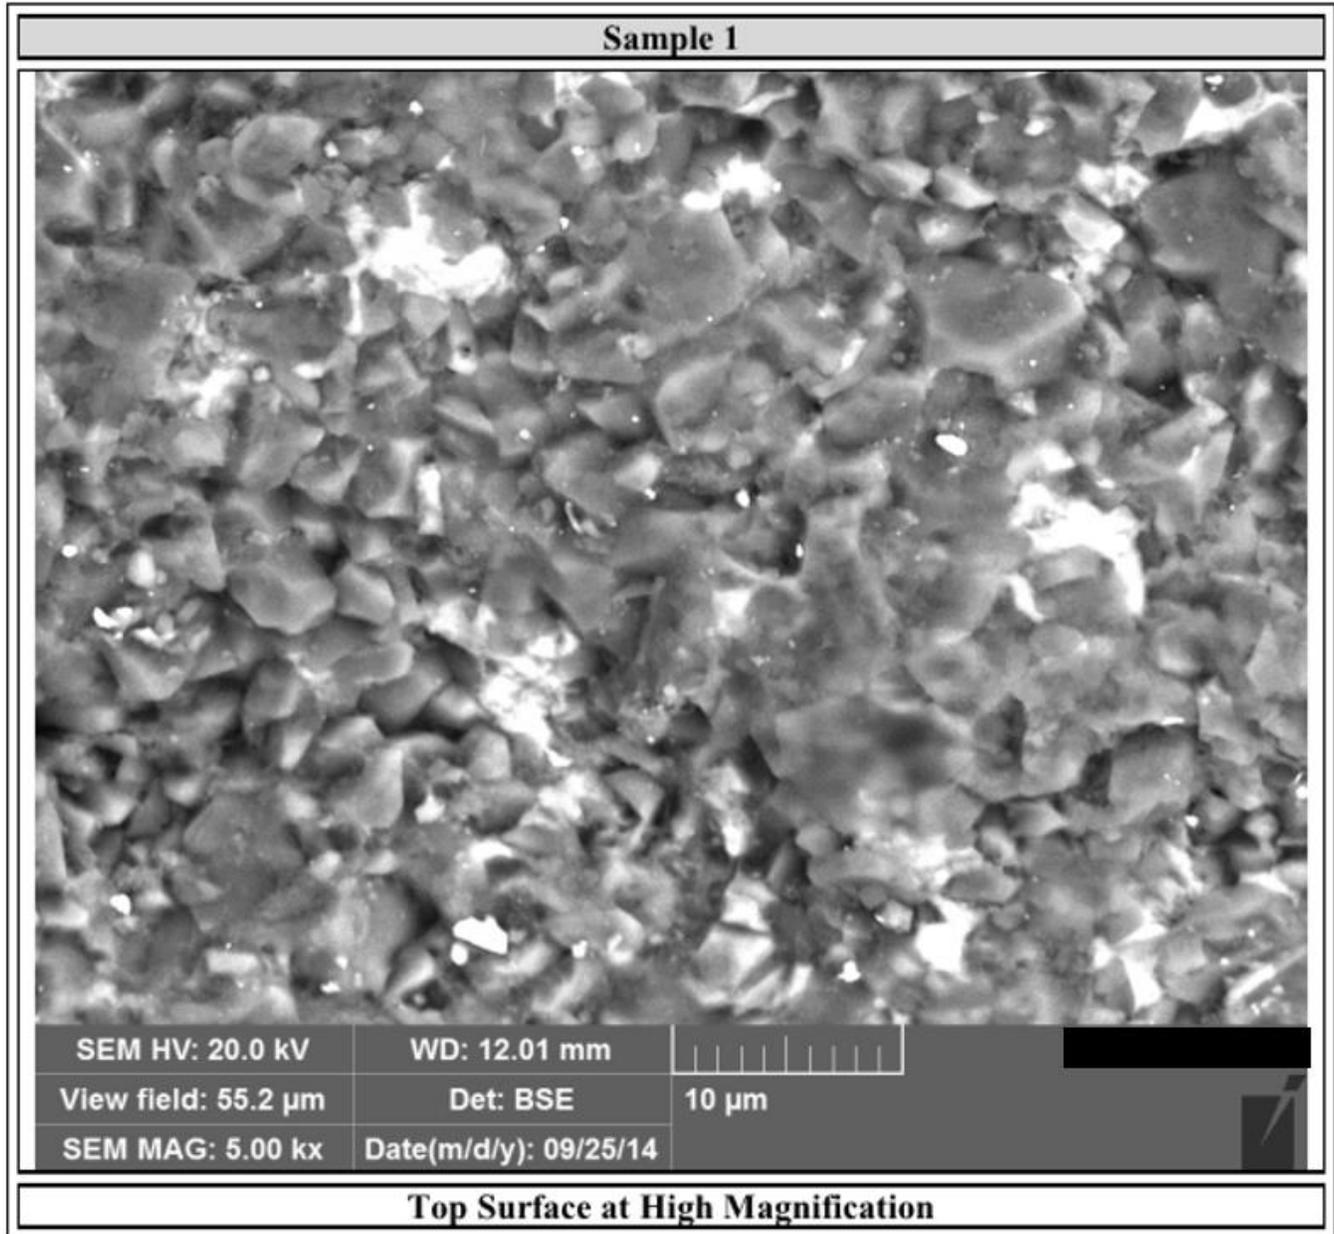
Figure 9: Scanning Electron Microscopy (SEM) Test of Date Code BHA070216

Result	Indications of:
NO	Sandblasting
YES	Resurfacing
YES	Remarking

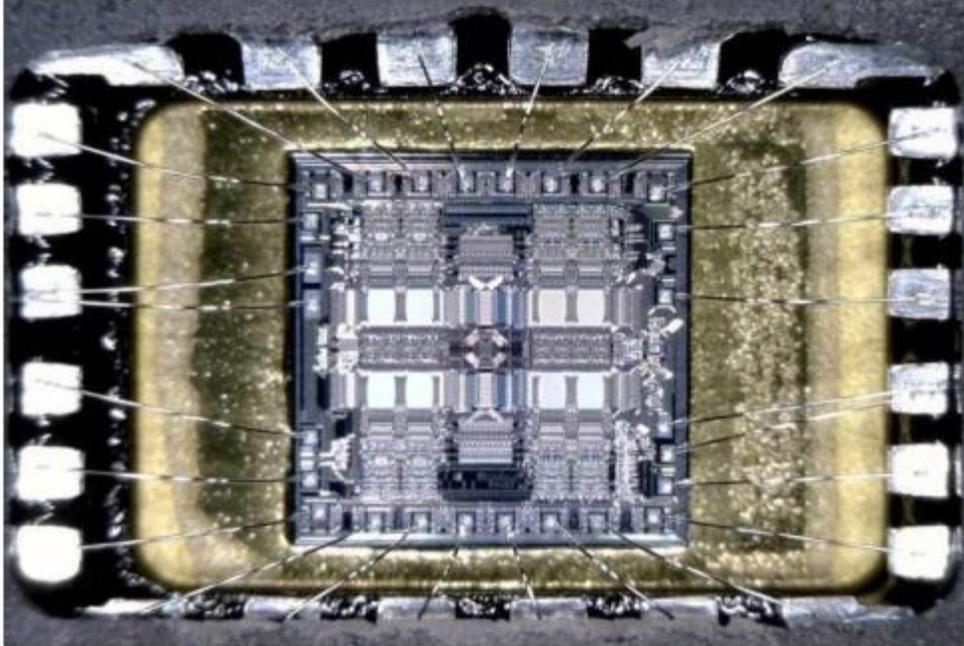
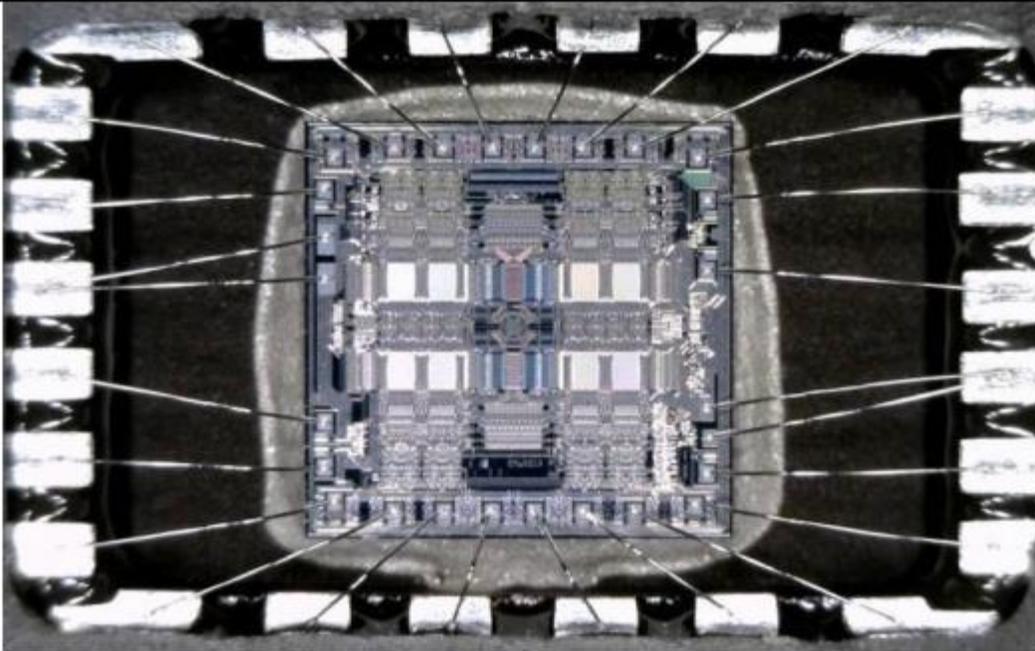
Figure 10: Different Die Paddle/Attach

Three component samples were cut open (for Delidding and Die Microscopy) and the analysis indicated variations in die, lead frame, and die paddle/attach as shown in Figure 10. As shown in Figure 11, all three of the die samples revealed die marking from 3 separate manufacturing sites where one had “CNW62”, the second had “WaferScale”, and the third had “CNWA01A” marked on the die. As shown in Figure 12, samples 1 and 2 had a die developed year of 1987 while sample 3 had a die developed year of 1990. No die markings were found that could be verified against the manufacturer’s part number. However, it is considered very unusual to have multiple die changes in the same date coded parts.

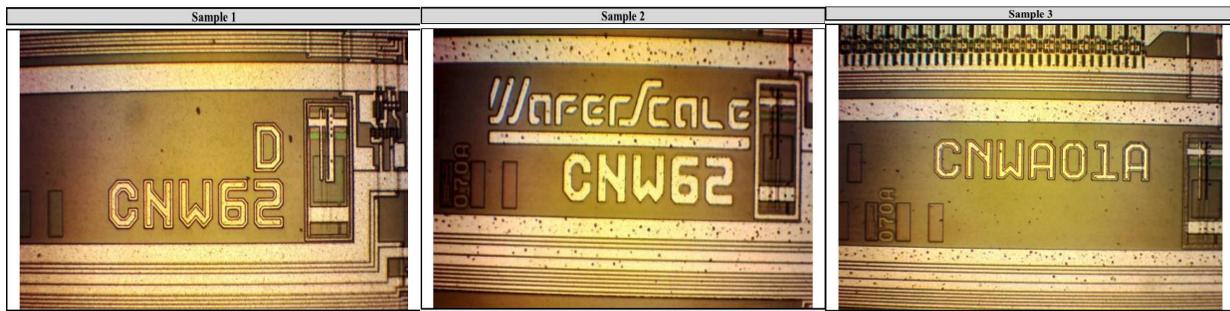
Figure 11: Die Marking Indicating Three Separate Manufacturing Locations

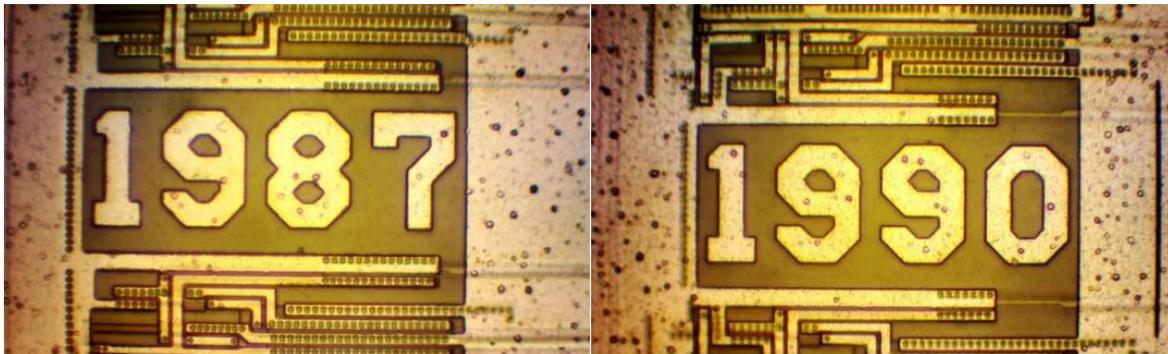
Figure 12: Different Die Year of Development

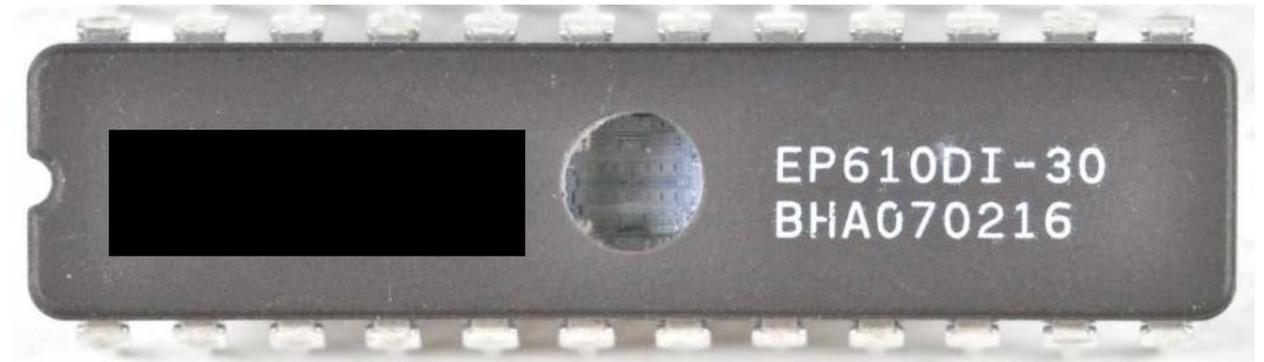
As shown, the parts in stock with date code of BHA070216 are not valid since the date code of 0216 is work week 16 of 2002 and the two additional characters are not included.

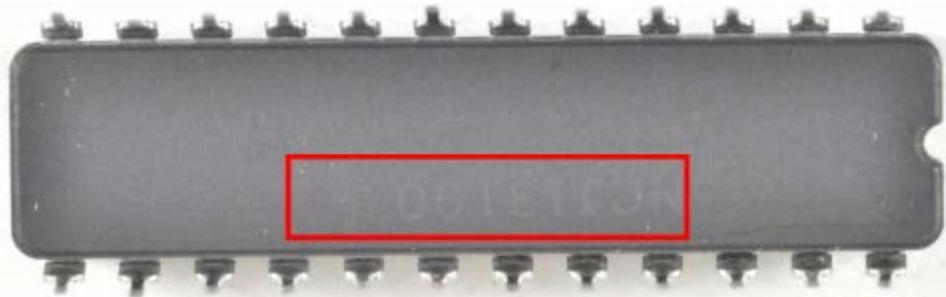
Ghost marking appeared on several EP610DI-30 components.

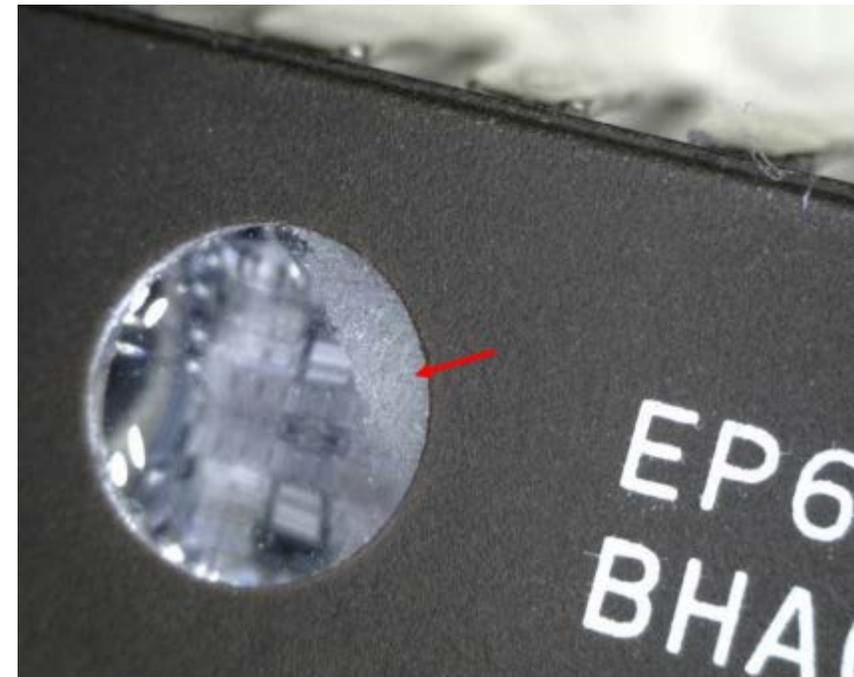
Imperfection in glass window was noticeable on several EP610DI-30 components.

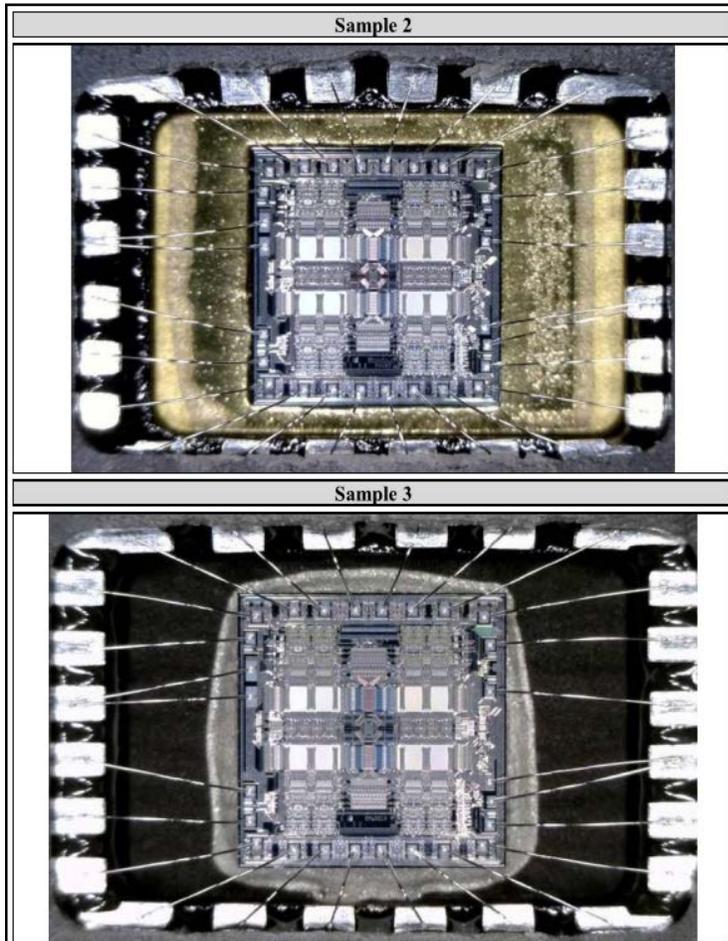
Different Die Paddle/Attach

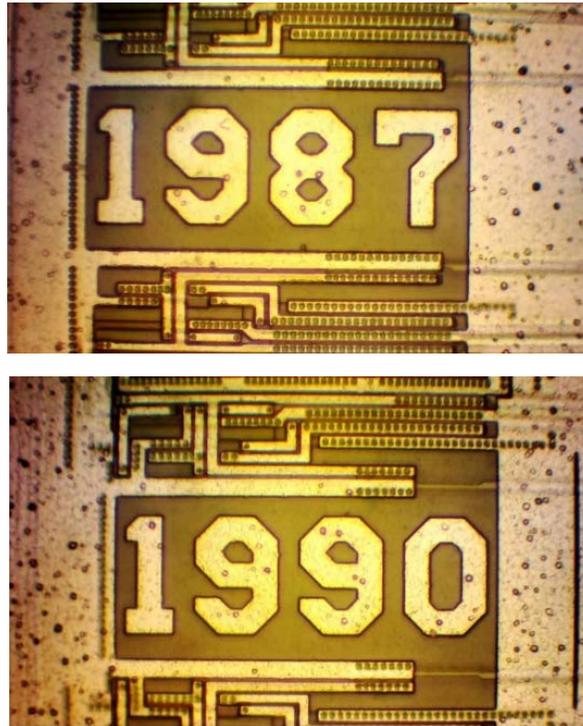
Different Die Year of Development

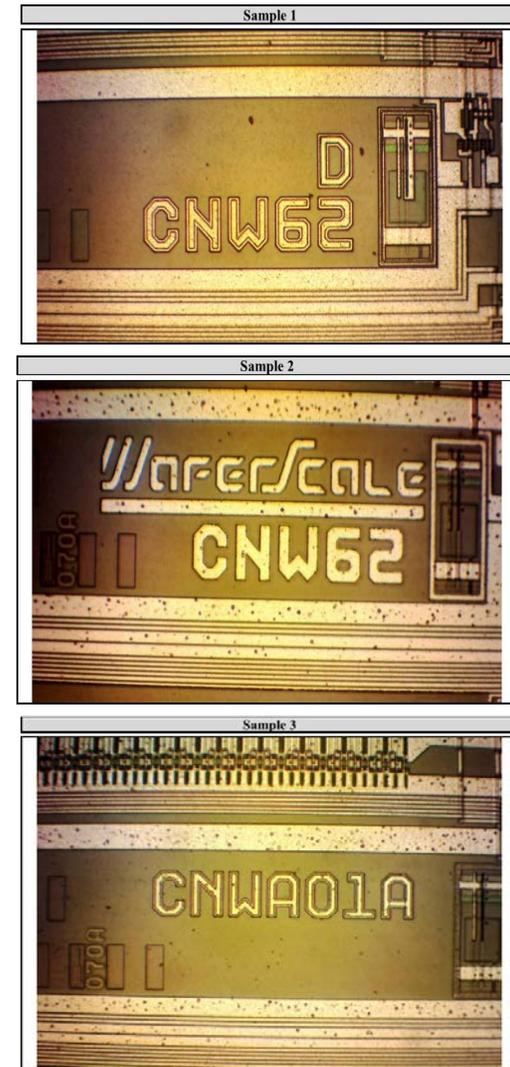
Different Die Manufacturing Locations
