# Solder Joints Failure Under Low Strain-rate Cyclic Loading

Jie Lian, Ph.D., Dennis Willie, Jada Chan, Francoise Sarrazin, Ph.D., Kelvin Wong, Christopher Vu, Wesley Tran, Tuyen Nguyen, Tu Tran, Anwar Mohammed, Ph.D., Michael Doiron  
FLEX International, Milpitas, CA

## Abstract

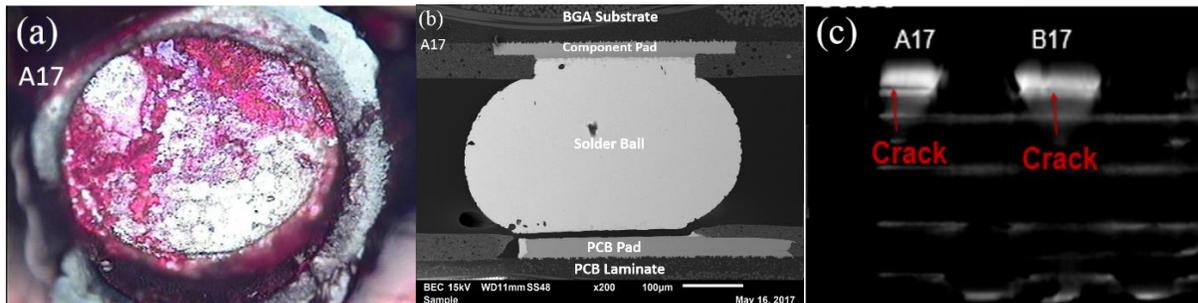
From the dye and pry test on sample 1 from group 1, the solder joints in A14-17, B16,17, C17, E17 and G17 were identified with failures, where either full or partial red colored regions were observed. Figure 3 (a) shows one representative solder ball A17 in sample 1 at the PCB side after Dye and Pry testing. The presence of red dye indicates cracks in the area of interest. To further understand the failure mode of the solder joint, the BGA package in sample 2 from group 2 was cross sectioned in row A17-Q17 and column A1-A17, where failures were found from Dye and Pry tests. Figure 3(b) shows the cross section

image of a Sn-Cu solder joint A17 in sample 2. A brittle crack was observed all across the solder ball on the PCB board side. Non-destructive X-Ray analysis was also performed on the BGA of sample 2, which also clearly show cracks in the solder ball of A17 and B17, as shown in Figure 3(c). A similar fracture mode between the solder joint and the board pad was observed in row A17-Q17 and column A1-A17, which was identified as the cause of the product failure.

Figure 3. (a) Solder ball microscopy image after dye and pry on the PCB side; (b) SEM image of the cross-section area of a solder ball; (c) X-ray image of the cross section of the solder ball showing cracks.

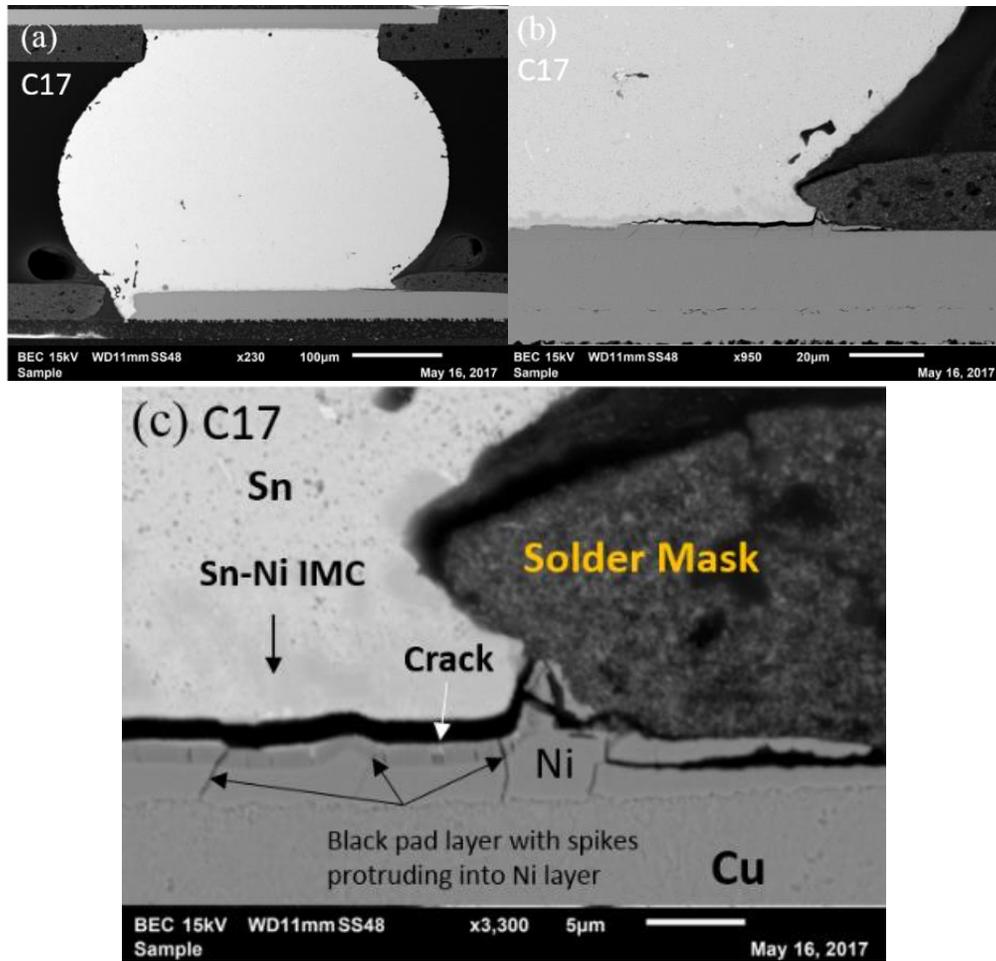
Figure 4 (a) and (b) show the cross section image of solder ball C17 in sample 2, where a crack just initiated from the edge between the solder ball and the pad on the PCB side. By using a back scattered detecting mode, clear contrasts between different compositions were seen. Figure 4 (c) shows the image of the crack at a high magnification of 3300X. The crack was observed located between the Nickel-Tin (Ni-Sn) Intermetallic Compound (IMC) and the nickel layer of the Electroless Nickel Immersion Gold (ENIG) surface finish on the Copper (Cu) Pad. On top of the nickel surface, a thin dark grey nickel layer with identifiable spikes and corrosion cracks was observed. This is a symptom for the “Black Pad” defect that was usually observed in the PCB with the ENIG surface finish. Several mechanisms contribute to the “Black Pad” defects, i.e. creation of a thick Phosphorous enriched Ni<sub>3</sub>P layer at the electroless nickel (EN) surface, extensive corrosion of the exposed nickel surface and entrapment of EN plating residues beneath the gold coating. A combination of these mechanisms renders difficulty in wetting and the formation of a proper IMC layer during soldering. As a result, the solder joint becomes weaker when exposed to stress, and a fracture may occur between the IMC layer and nickel surface. This defect is called black pad since the nickel surface at which a crack occurs is usually dark grey to black due to the phosphorous enrichment. [ref.1-3]

Figure 4. SEM image (back scattered mode) of solder C17 in sample 2 at magnification of (a) 230X; (b) 950X; (c) 3300X. The IMC, Ni layer and the black pad area are marked.

In summary, the “Black Pad” failure was mainly caused by the not well-controlled ENIG process and the brittle phosphorous-enriched Ni-P thin layer. Several approaches are proposed to minimize or eliminate this failure. One approach is to improve the whole ENIG process, including careful pre-treatment before nickel gold deposition, and well-controlled processes in the EN plating and the immersion gold plating. In the pre-treatment process, it is vital to ensure a clean surface after micro-etching of the copper, and the PCB needs to be properly dried to prevent localized corrosion of the copper pad. In the process of EN plating, slower deposition rates are preferred to minimize deep crevice formation at grain boundaries, so that corrosion during immersion gold plating can be reduced. It is also important to control the reaction temperature and pH to achieve a uniform surface morphology with minimum crevices at grain boundaries. In addition, the aggressiveness of the gold bath can be prevented by controlling gold plating thickness within 0.05-0.10  $\mu\text{m}$  per the IPC-4552 specification. The plating rate should also be controlled to not be too fast. [ref.1-4]

Since “Black Pad” failure is usually associate with ENIG surface finish, several alternative plating methods can be used to eliminate the “Black Pad” failure. For example, Electroless Nickel Electroless Palladium Immersion Gold (ENEPIG) showed substantial advantages to meet multiple requirements of miniaturization, thinness, solder joint reliability, gold wire bondability, and excellent shelf life. It plates a layer of electroless palladium onto the nickel prior to immersion gold plating, which eliminates the potential for excessive gold plating solution attack on the EN surface. However, ENEPIG is costly, which involves a more complicated plating process. Other alternative surface finishes could also be considered, such as OSP (Organic Solderability Preservative), or IAg (Immersion Silver). Both surface finishes have advantages and disadvantages, so careful decisions need to be made considering the applications. For example, with OSP, the thickness cannot be measured, because it is clear and transparent. It also has short shelf life, and it exposes copper on final assembly. Also Immersion Ag is more susceptible to corrosion attack at elevated temperatures and humidity environments. [ref.4]

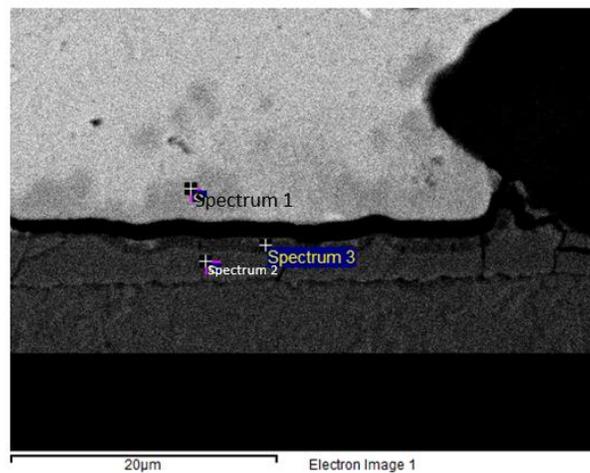
To further confirm and understand the “Black Pad” defect, SEM imaging combined with EDX analysis was performed on sample 2 in solder joint C17. Comparisons of composition were made among the IMC area between the solder joint and the ENIG surface finish (spectrum 1), the “Black Pad” layer (spectrum 3) and the nickel layer on top of the copper (Cu) pad (spectrum 2), which is shown in Table 1. Figure 5 shows a SEM image of these three regions. In the intermetallic region Spectrum 1, gold was found in the Sn-Ni IMC layer. This indicates that during the soldering process, solder melts on the top layer of the ENIG surface finish, and the gold plating dissolves into the molten solder. In Spectrum 2 on the electroless nickel layer, a Phosphorus (P) content of 6.99 wt% was obtained, while in Spectrum 3, a higher P content of 10.09 wt% was found. This confirms an enrichment of P at the uppermost EN surface, which was caused by the extensive nickel dissolution into the molten solder. From the SEM image shown in Figure 4(c), several cracks were observed penetrating deeply into the Ni layer. This is an indication of extensive corrosion of the exposed nickel surfaces, where over-etching occurs with more Ni cations released into the immersion gold. Several studies have found that the main cause for the nickel corrosion is the not well-controlled EN plating that deposited nickel with an irregular topography [ref.1-4]. In the EN coating, an irregular topography with distinct crevices has a great tendency for corrosion compared to an even topography. Irregular topography can be caused by a nickel bath running outside its control limits, contaminated copper pad surface or inadequate pre-treatment. In Spectrum 2 and 3, tin (Sn) was found in the EN layer, and this is thought due to the deep penetration of molten solder following the gold plating into the nickel corroded area.

Figure 5 SEM Image of Sample 2 Solder C17 showing different regions for EDX analysis

Table 1. Comparisons of compositions in the IMC layer (spectrum 1), black pad layer (spectrum 3), and the Nickel layer (Spectrum 2)

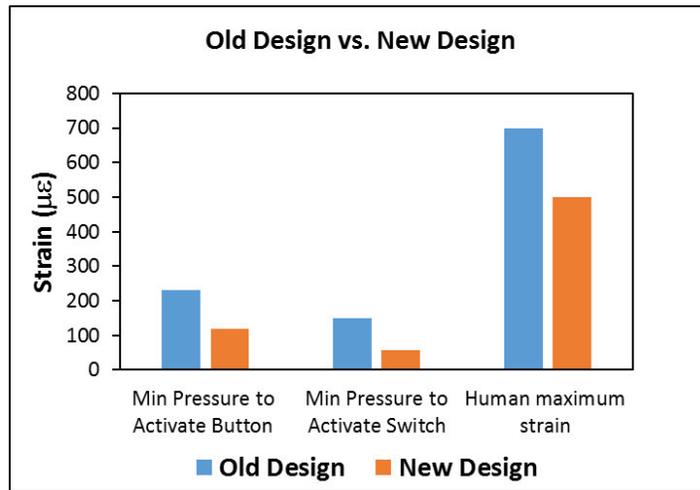
Figure 8 shows the strain variation with the one cycle button push. When there is a load drop and a strain drop, the maximum force before the drop was recorded as the minimum force to activate the button. For human operating tests, a few button push tests were performed by two persons, and the maximum strain was recorded. Figure 9 shows the strain variation upon a few cycles of human button push tests for both the old design and new design. Figure 10 compares the strain at the minimum force activating the button, switch and in real operation conditions. For all three conditions, the new design shows a much lower strain level than the old design, which indicates an improvement in structural design to lower the impact of board bending. Because the plastic materials in the new button are less rigid than the rubber materials in the old button, the stress applied to the new button can be much lower, thus the strain levels are usually lower in the new button push tests. The strain at the minimum force activating the button and switch fall within the IPC/JEDEC-9704 standard [ref. 5] for both the old

design and new design. However, the strain level of 700  $\mu\epsilon$  in the old design and 500  $\mu\epsilon$  in the new design for human operation conditions are approaching the limit of IPC/JEDEC-9704 standard, which could be a potential risk for failures.

Figure 10. Strain at minimum force to activate the button, switch and in real operation conditions

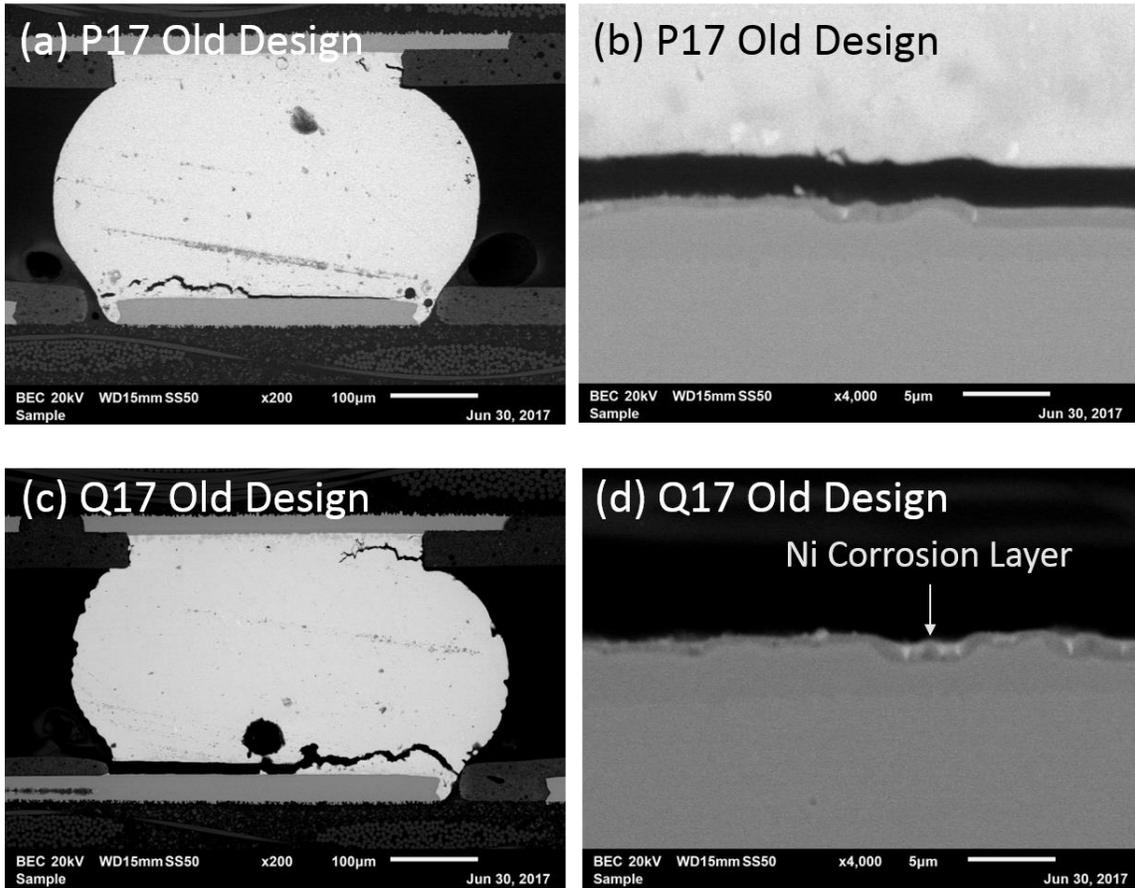
Figure 11 (a) and (b) shows the strain changes during the low strain-rate cyclic button push tests for the old design and new design. Four strain gages were installed around the four corners of the BGA, which were labeled as strain gage 1,2,3,4. The strain gages that show the highest level of strain were used for comparison studies. The strain differences in the different strain gage indicate that the BGA experienced non-uniform strain and stresses. Figure 12 (a) and (b) show the cracks in the solder joints in the old design product, and Figure 13 (a)-(d) show the cracks in the solder joints in the new design product. Three failure modes were identified. The first failure mode was the same as seen from Figure 3 (b), i.e. a brittle crack between the solder joint and the copper pad, which is because of the “Black Pad” effect. The corroded Ni layer made it weak at the interface between the IMC layer and the pad, thus cracks are prone to initiate in this area. The second failure mode is the ductile fracture in the bulk solder part that is close to the pad on both board side and component side. The third failure mode is the crack in the IMC at the board side. Figure 12 (a), (b) and Figure 13 (a) show a mixture of the failure modes mentioned above. The brittle cracks were thought to be first formed at early stages of the cyclic button push tests, and the ductile cracks were later formed at longer cycles of button push tests. Similar failure modes were also observed in Sn/Pb Solder joints from thermal cycling tests. [ref.6] Figure 13 (b), (c) and (d) show the ductile crack mode that initiated after long cycles of bending from the button push. Cracks tend to initiate at the edge of the pad that connect to trace lines, which are thought to be due to the high stress concentrations in these regions.

The differences of the three failure modes were attributed to several factors, i.e. strain rate, loading angle, and the IMC layer roughness. A ductile-to-brittle transition was observed with increasing strain rate [2, 3]. At low strain rates, the fracture mainly occurs through the solder, while at high strain rates, the crack path transferred into the IMC layer or at the interface between the IMC and the solder. The brittle cracks observed from the two failed samples are thus more possibly formed during a high strain rate event, such as during drop or vibration. In addition, in the button push tests, the solder joints were subjected to compressive stresses. In real applications, mix-mode loading conditions, e.g. mixed compressive and shear forces were usually applied to the solder joints. A few studies found that an increase in the loading mode-mixity (loading in multiple directions) could enhance the proclivity of a solder joint towards brittle failure. [ref.7] This might also explain why more brittle cracks were found in the failed samples. Furthermore, the IMC roughness was found to affect the fracture mode of the solder joint. The crack is more prone to propagate through the ductile solder with smooth IMC, while a brittle crack is more likely to form in a rough IMC layer. From Figure 12 and Figure 13, the cracks were mostly located inside the bulk solder, which indicate relative smooth IMC was formed.

Figure 12. SEM images of the solder ball (a) P17 and (b) Q17 in the old design product after 40,000 cycles of low strain-rate cyclic button push tests.

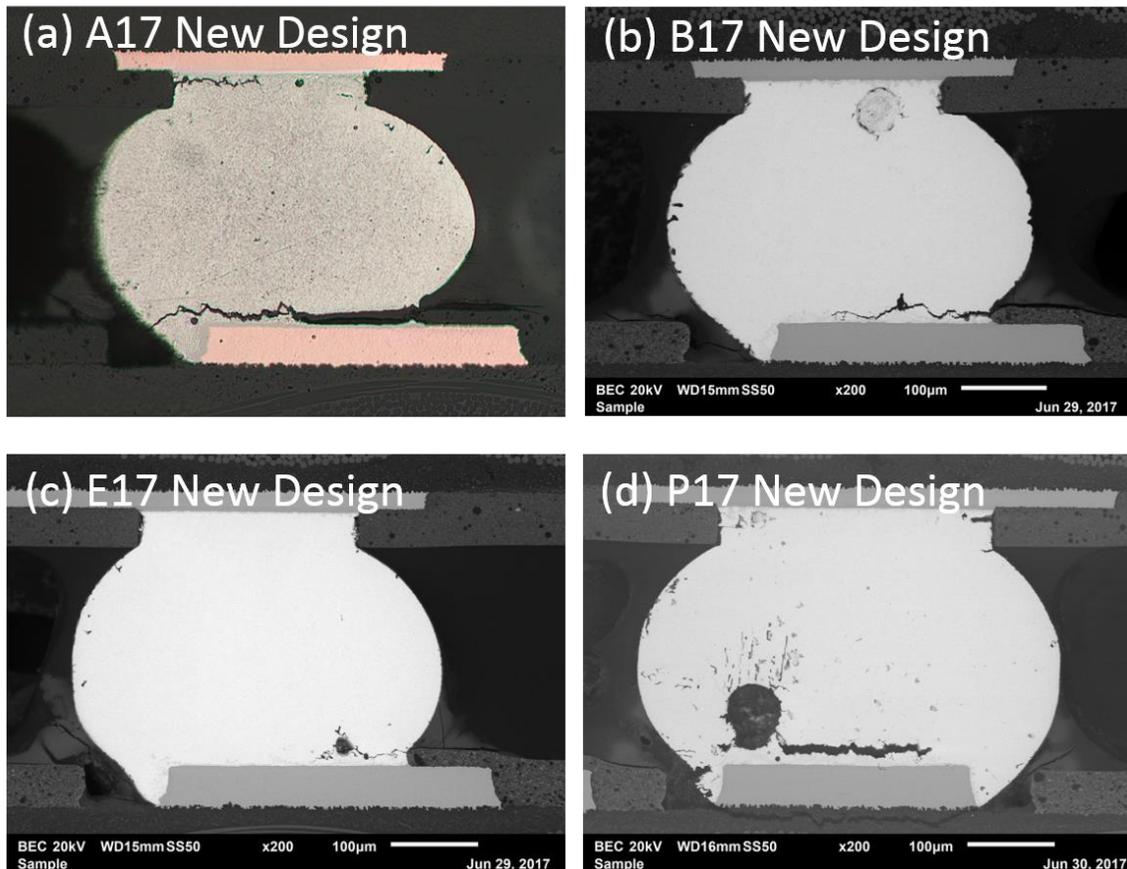
Figure 13. SEM images of the solder ball (a) A17, (b) B17, (c) E17 and (d) P17 in the new design product after 40,000 cycles of low strain-rate cyclic button push tests.

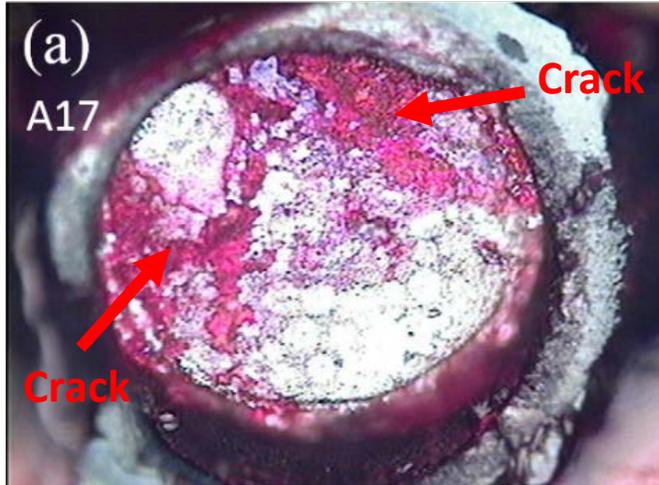
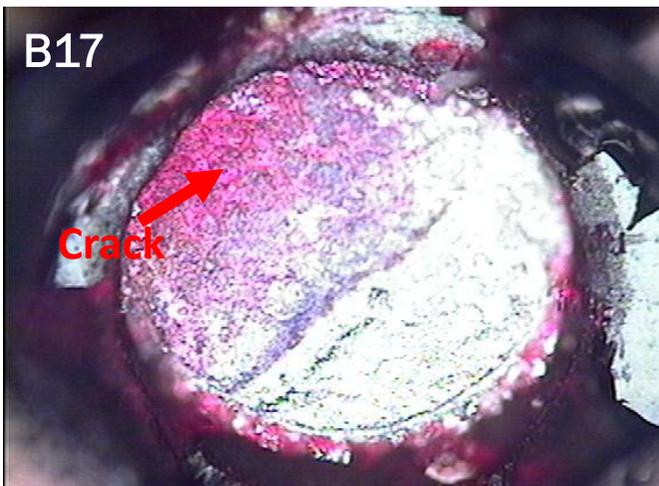
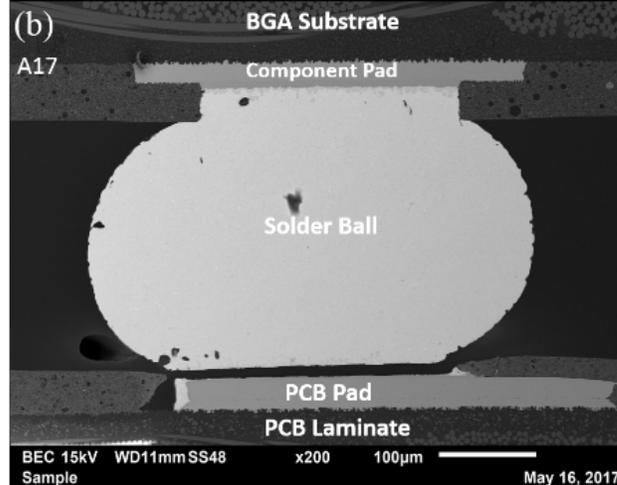
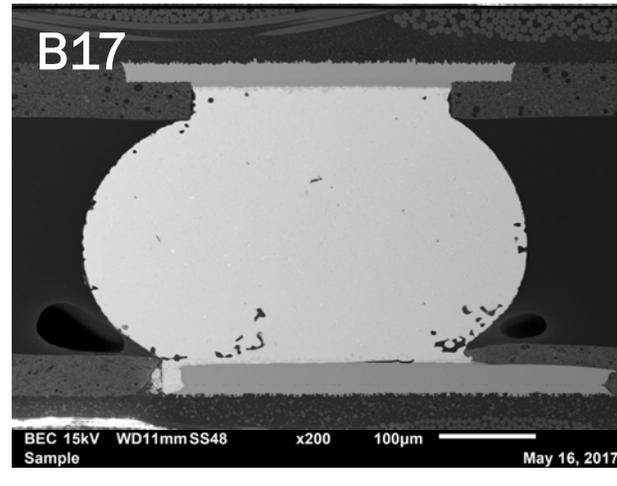
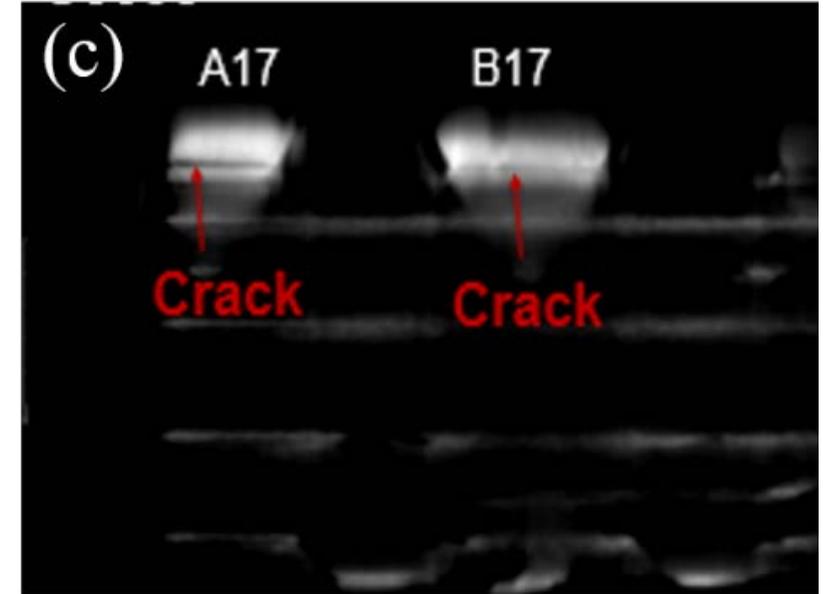
- Partial fractures were observed from Dye and Pry Tests in Sample 1
- Full and partial brittle cracks were observed from cross section and X-Ray Images

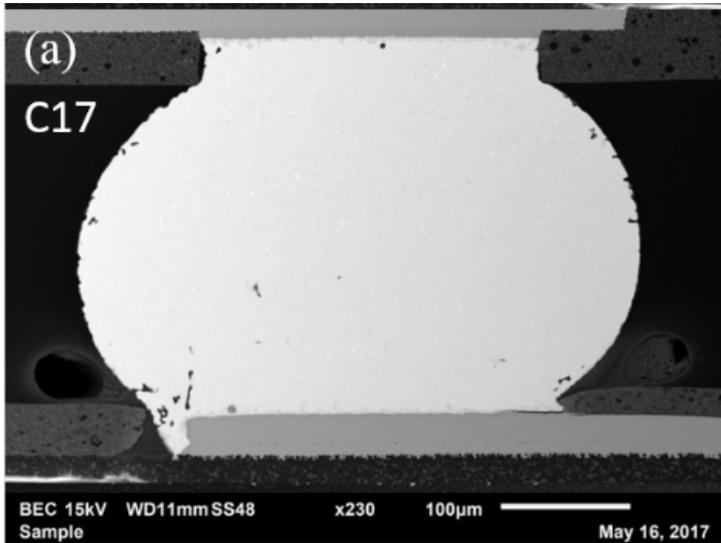
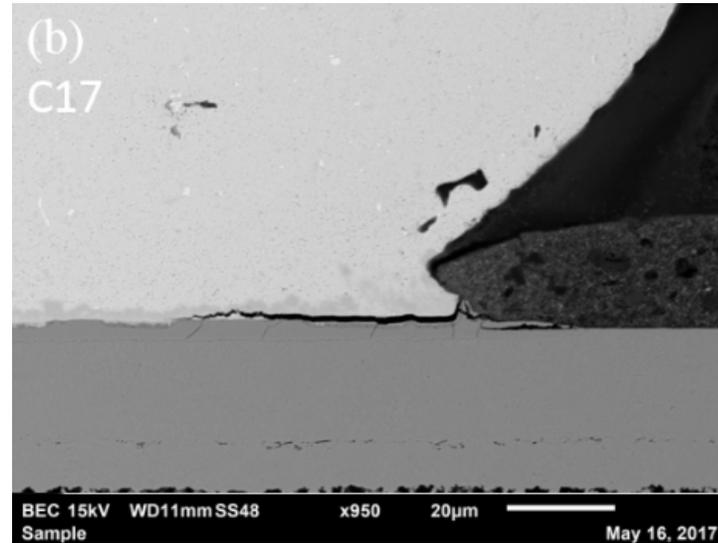
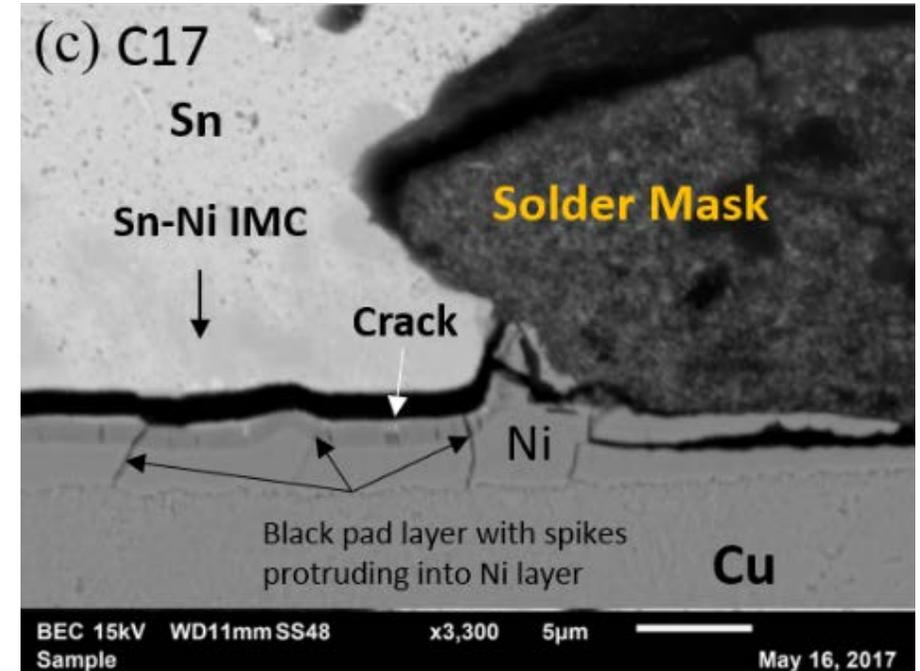
- The brittle crack was observed located between the IMC and the ENIG surface finish
- “Black Pad” failure was identified from the thin dark grey Ni layer with identifiable spikes observed

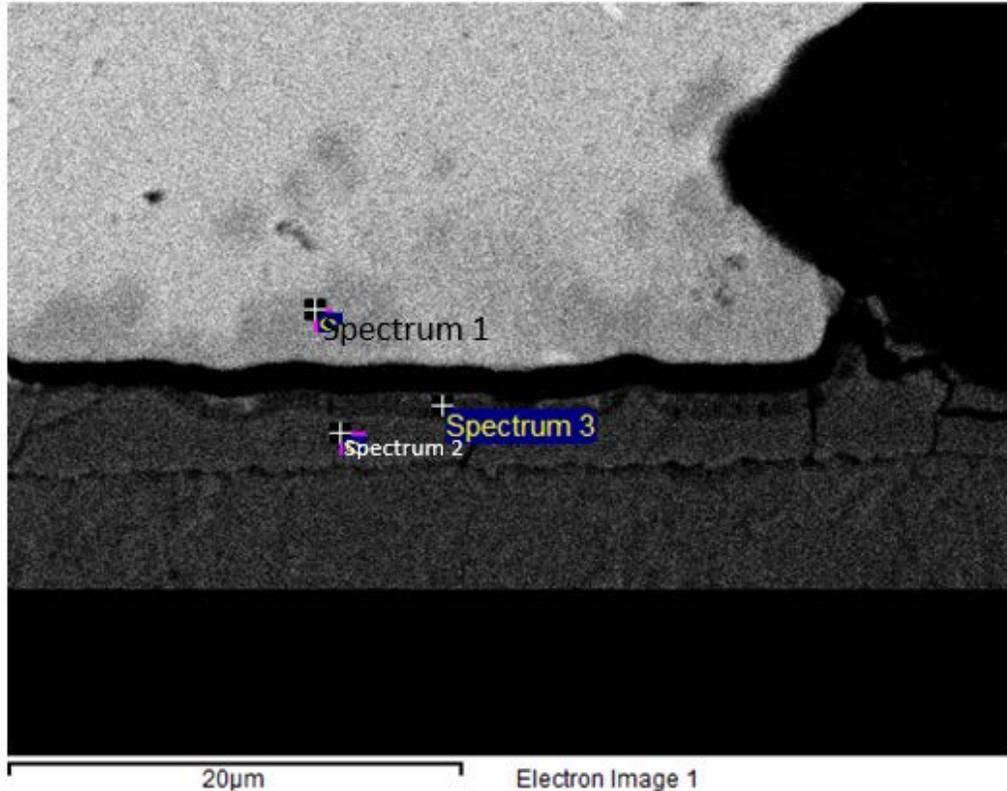
- **Spectrum 1 (IMC layer):** No P in the Ni-Sn intermetallic layer
- **Spectrum 2 (Electroless Ni plating layer):** P content of 6.99 wt%
- **Spectrum 3 (“Black Pad” layer):** higher P content of 10.09 wt%

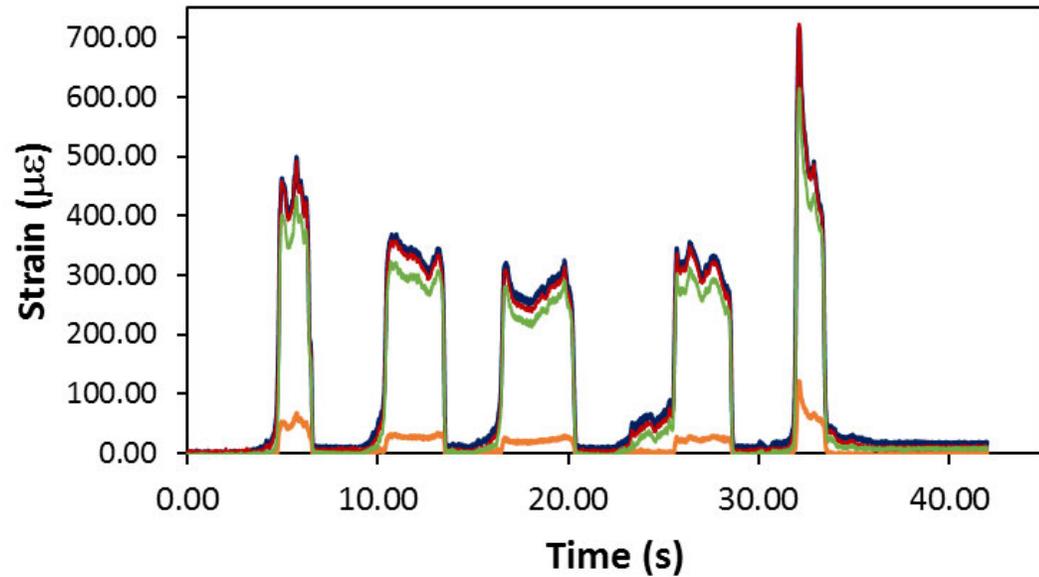
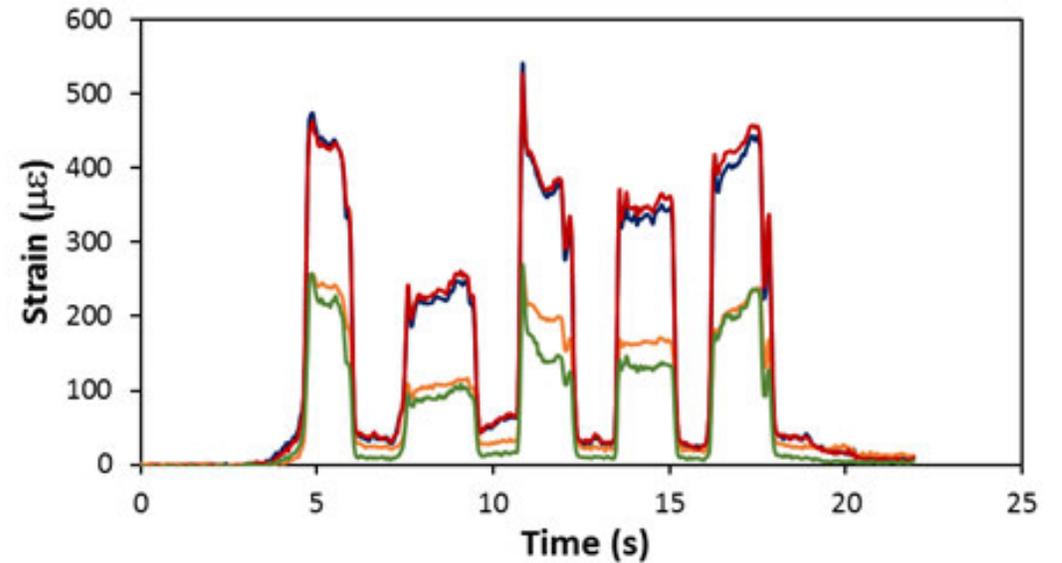
- The max strain for old design is about 700  $\mu\epsilon$ , average strain is 432  $\mu\epsilon$
- The max strain for new design is about 500  $\mu\epsilon$ , average strain is 362  $\mu\epsilon$
- Both max strain and average strain were reduced in the new design

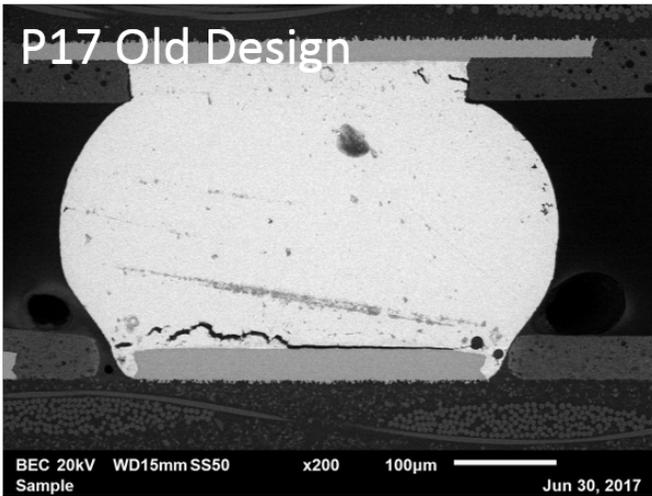
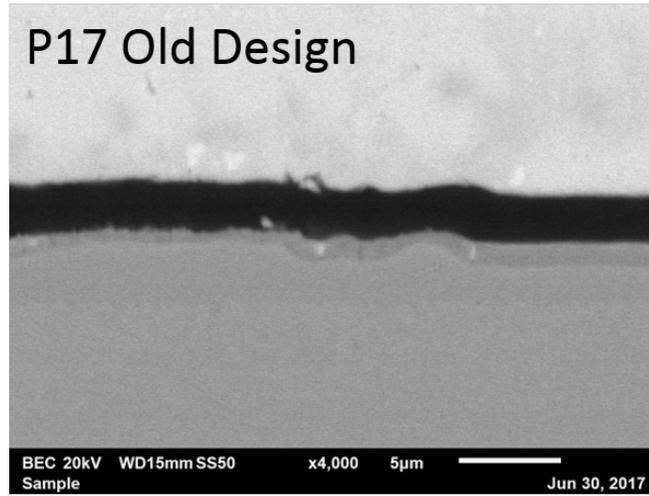
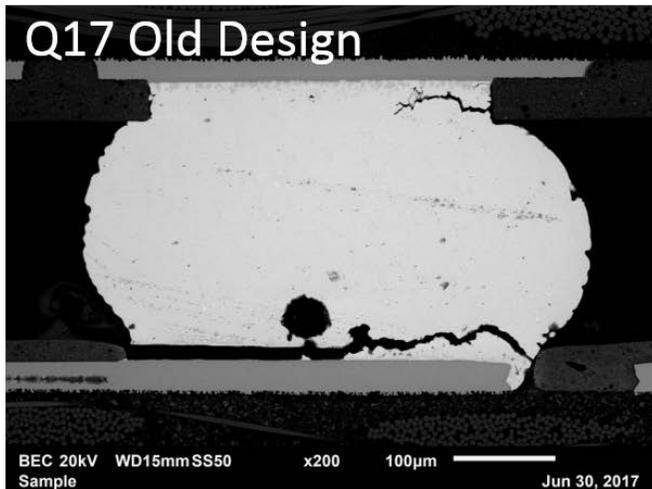
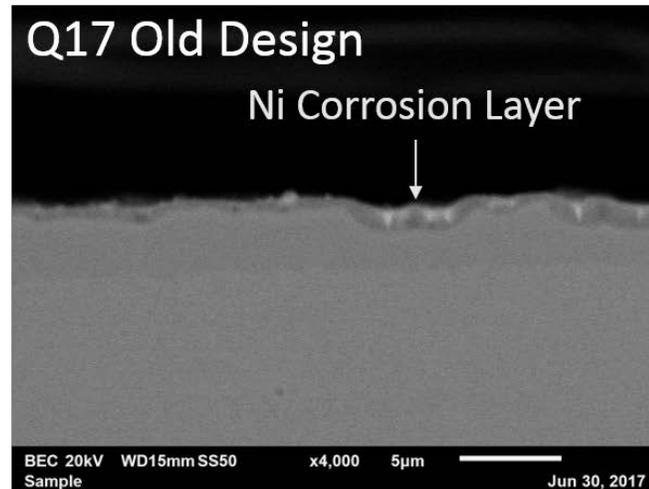
- P17 and Q17 shows similar failure modes with a mixture of brittle fracture at IMC/Cu pad interface, and ductile cracks inside bulk solder
- The brittle cracks were thought to be first formed at early stage of the cyclic button push tests, and the ductile cracks were later formed at longer cycles of button push tests.
- Cracks tend to initiate at the edge of the pad that connect to trace lines, which are thought to be the high stress concentrations in these regions.

**Impact Factors:** strain rate, loading angle, and the IMC layer roughness.

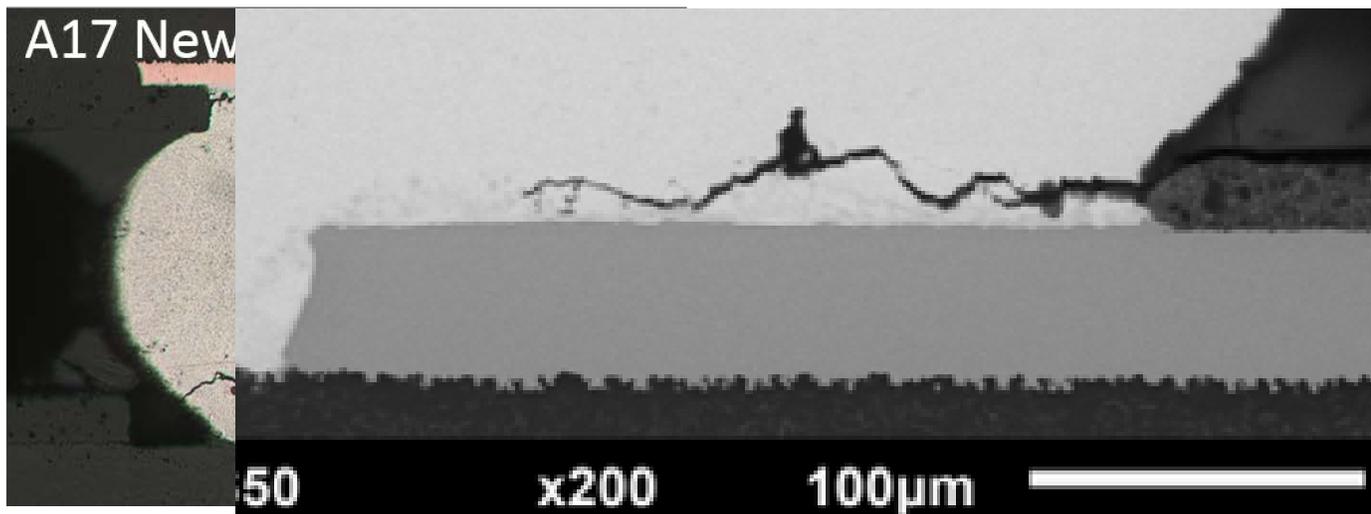
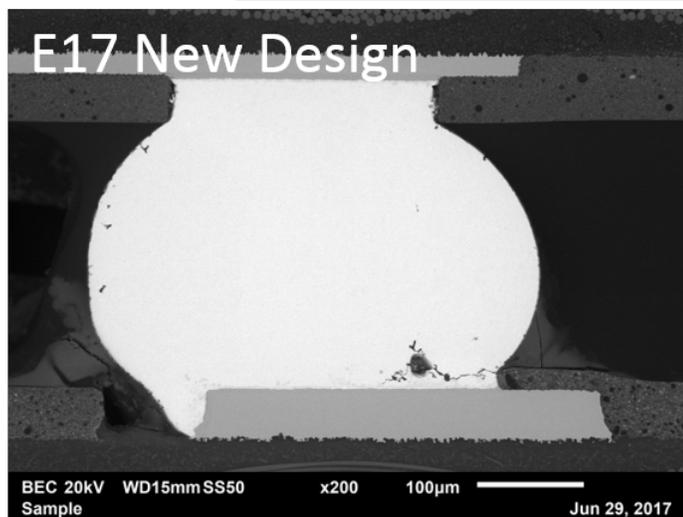
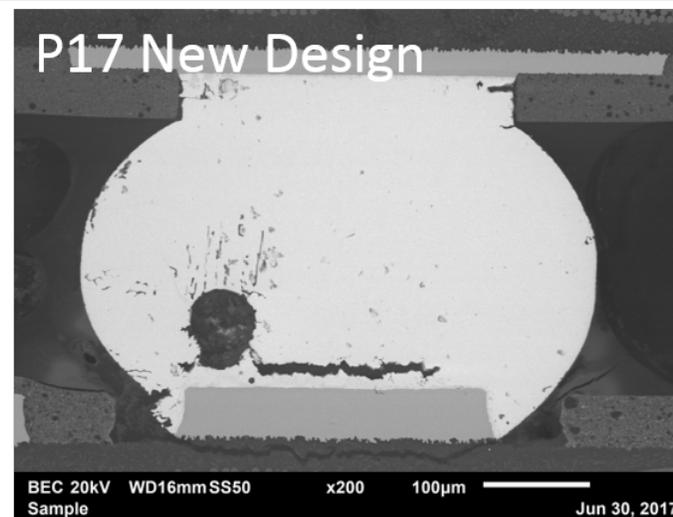
- A17 shows a mixture of brittle fracture at IMC/Cu pad interface, and ductile cracks inside bulk solder
- B17: Crack in the IMC on board side
- E17: Crack initiates from the edge and propagates into bulk solder
- P17: Crack initiates and propagates inside bulk solder

**Impact Factors:** strain rate, loading angle, and the IMC layer roughness.
