Analyzing a Printed Circuit Board Weave Exposure Condition and its Effects on Printed Wiring Assembly Functional Performance

Wade Goldman P.E.¹, Andrew Dineen¹, Hailey Jordan¹, Curtis Leonard¹,
Timothy Redling¹, Edward Arthur²

¹The Charles Stark Draper Laboratory, Inc., Cambridge, Massachusetts

²Raytheon Company, Space and Airborne Systems, El Segundo, California

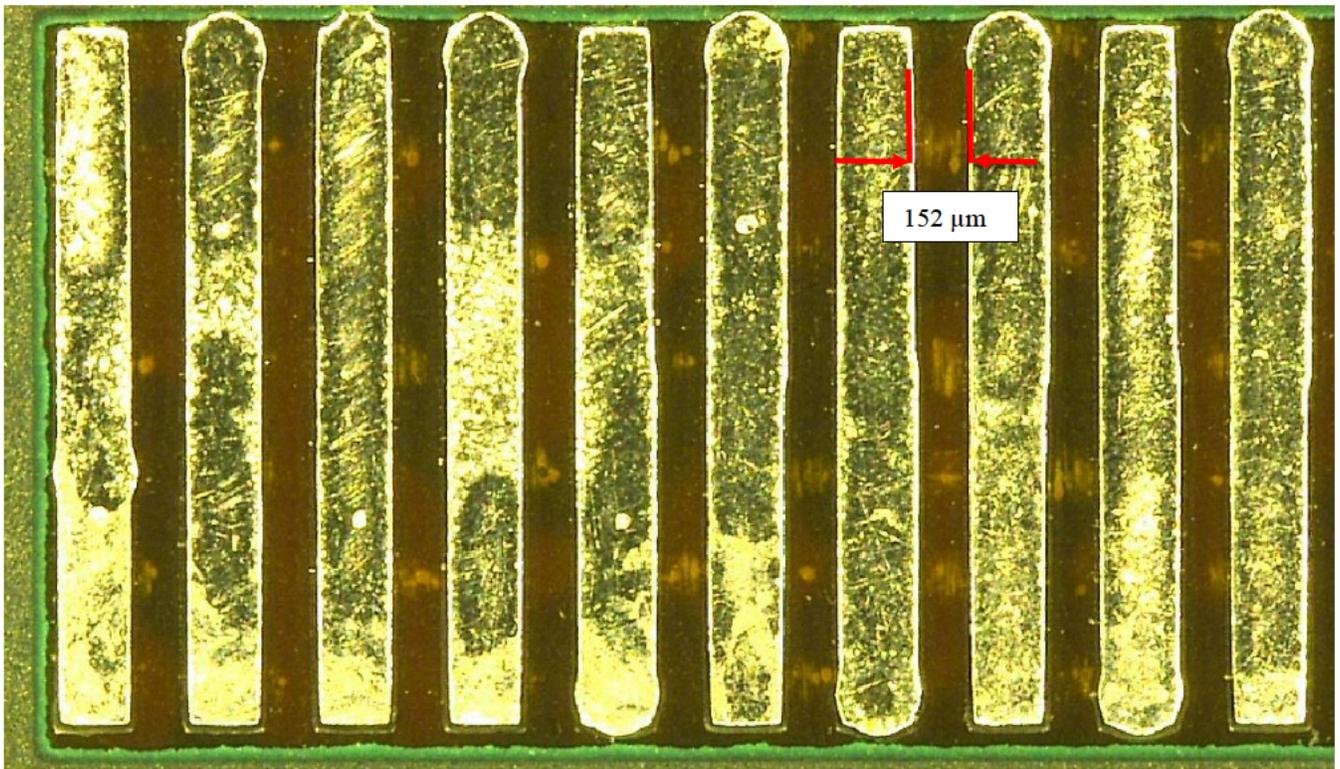
Figure 2 – PCB Component pads (no soldermask) – weave texture

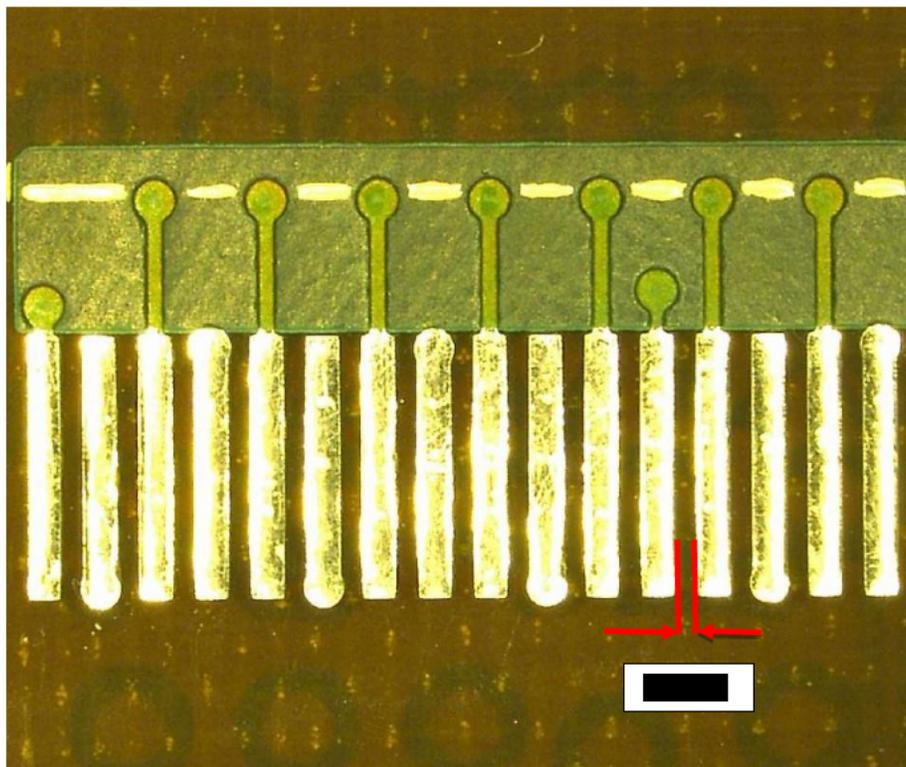
Figure 3 – PCB connector pads and adjacent areas (no soldermask) – weave texture

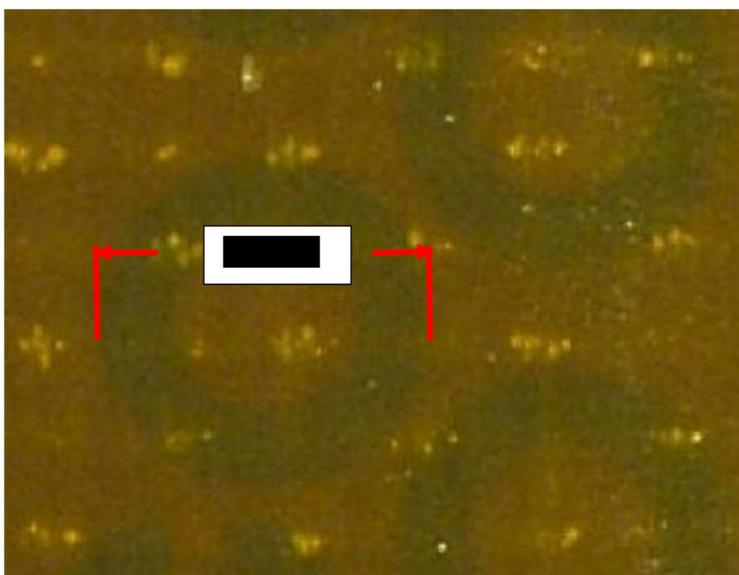
Figure 4 – Knuckle pattern of perpendicular glass bundles at intersection – weave texture

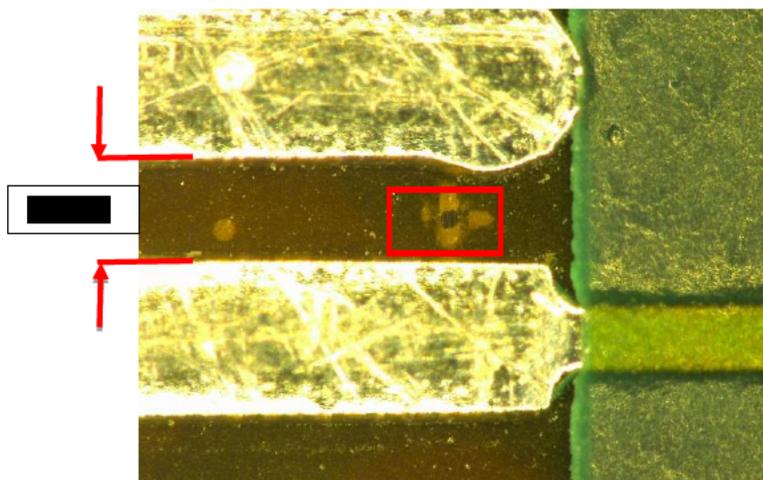
The original PCB manufacturer as well as the procuring activity reviewed results (remotely) and confirmed the PWA manufacturers observations. There was a concern raised that the weave texture condition could potentially reduce the minimum electrical spacing between conductors (especially the component leads). Typically for this design, the minimum conductor clearance is $127\mu\text{m}$ (0.005 in.). Several unassembled PCBs were provided for evaluation. Very high magnification (200X and 400X) was used to view the weave condition. The result was a confirmation that not only weave texture existed, but also the more problematic condition of weave exposure. Weave exposure is when there are openings in the resin of the surface layer of the PCB that actually expose the glass fiber bundles. Weave exposure is acceptable to MIL-PRF-31032/1 as long as 1) exposed or disrupted reinforcement fibers on the horizontal surface of the PCB do not bridge conductors, and 2) the minimum conductor spacing is not violated due to the condition. In IPC-6012, weave exposure is also acceptable for Class 1 & 2, but is not allowed for Class 3. See Figure 5 and Figure 6 for high magnification photos. The weave exposure condition was in violation of minimum conductor spacing requirements.

Figure 5 – Exposed weave between connector lead pads

Since it could not be determined at this point as to the real impact of this condition on the functionality of the PWA and CS, it was recommended to place product on hold for further analysis.

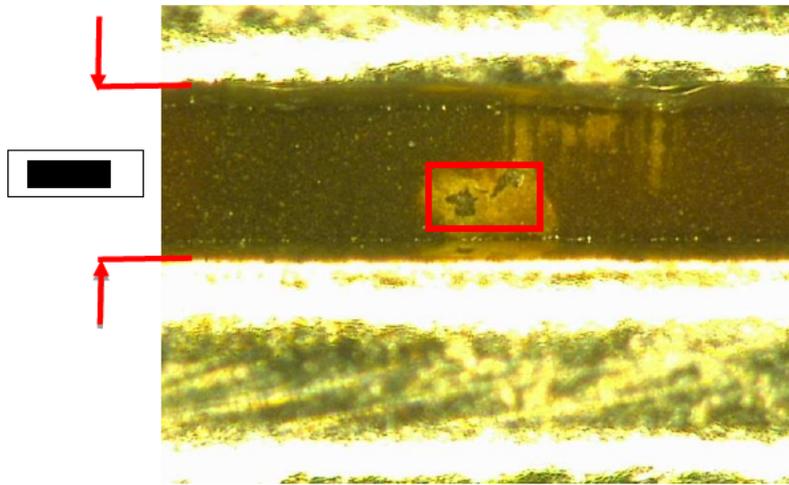
Figure 6 – Exposed weave between component lead pads

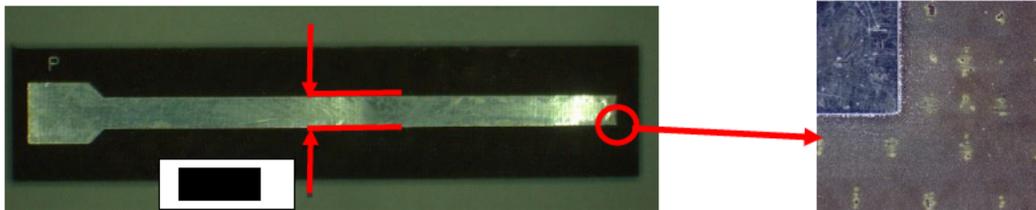
As described above, visually examining areas of a PCB (or a panel conformance coupon) at high magnification that contains no soldermask was one of the initial techniques used. Figure 7 depicts the peel strength conformance coupon previously discussed. As seen in the figure, there is no soldermask so high magnification of the coupon is a reasonable method to screen for the condition on a panel without necessarily inspecting the actual PCBs. Maintaining the use of industry acceptable inspection standards was not a driving requirement. Rather, using a method required to positively identify the condition of either weave texture or weave exposure was of paramount importance. For example, to confirm the condition, the inspection magnification was increased from industry standards of 7X to 40X to as high as 200X and 400X. This was performed on the four additional lots the PCB manufacturer identified as having gone through the cured soldermask strip process as described previously.

Figure 7—Visual Inspection of Peel Strength Coupon (31.25X)

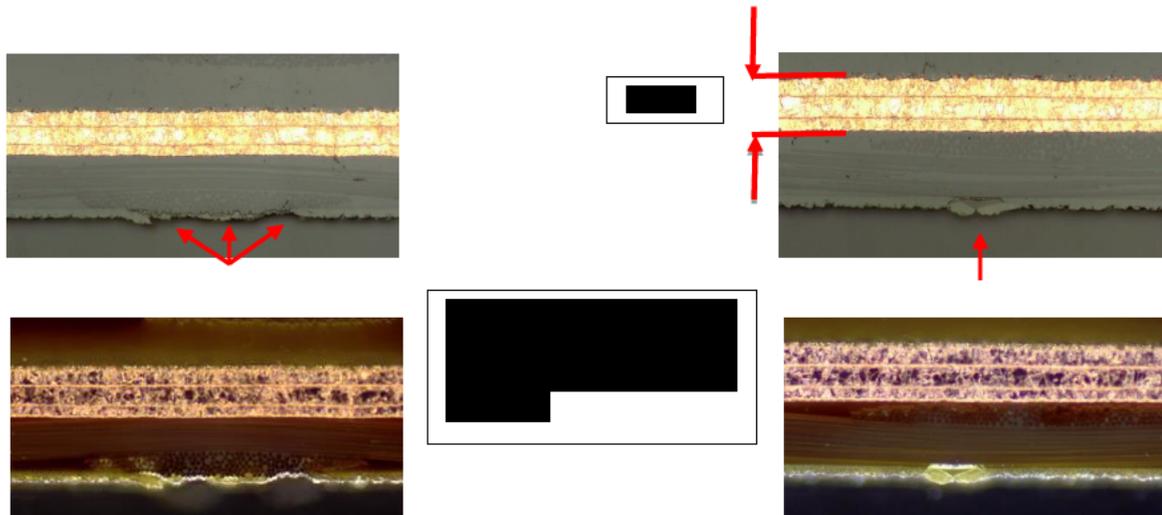
In addition to inspecting the peel strength coupons, buried via conformance coupons were reviewed. The coupons from the affected lot underwent additional microsectioning where additional evidence of exposed weave was found. In general, areas under the soldermask had less damage to the resin than those areas of the surface laminate that had no soldermask. This is likely due to the fact that the soldermask, when originally subjected to the stripping solvent, masked that part of the laminate and prevented the damage from being as extensive as those areas with no soldermask. See Figure 8 for example of a buried via microsection conformance coupon.

Figure 8—Buried via microsection evaluation (top-bright field, bottom-dark field, 250X)

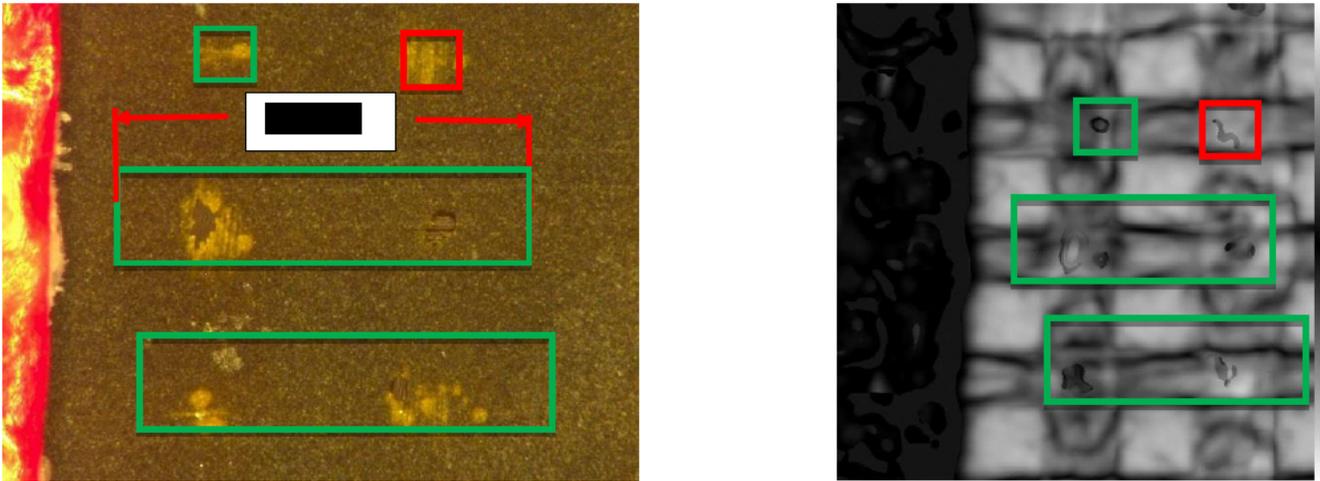
This is a non-destructive technique often used in failure analysis. It uses reflected ultrasound scanning pulses, to penetrate solid objects, and is able to image internal features, such as cracks, delaminations and voids. In this case, a PWA, with weave exposure, was submerged in a shallow bath of water while an ultrasonic transducer was used to generate the reflected ultrasound pulses. There was no protection afforded to the PCB or electronic parts. This was performed on a PWA that had been rendered as no longer fit for purpose simply to see if this was a viable method of analysis. No control sample was used. The green squares in Figure 9 indicate weave exposure conditions that was seen optically (on the left) as well by the acoustic microscopy device (on the right). The red square indicates what maybe a void or other internal defect (seen with the acoustic microscopy method) but not able to be seen optically. The actual extent/depth of this anomaly is indeterminate without a great deal of work by repeatedly indexing the ultrasonic transducer by a height distance, acquiring sonographs and correlating images. For the purposes of this investigation, no additional acoustic microscopy was pursued.

Figure 9–PWA (optical view on left, sonograph on the right)

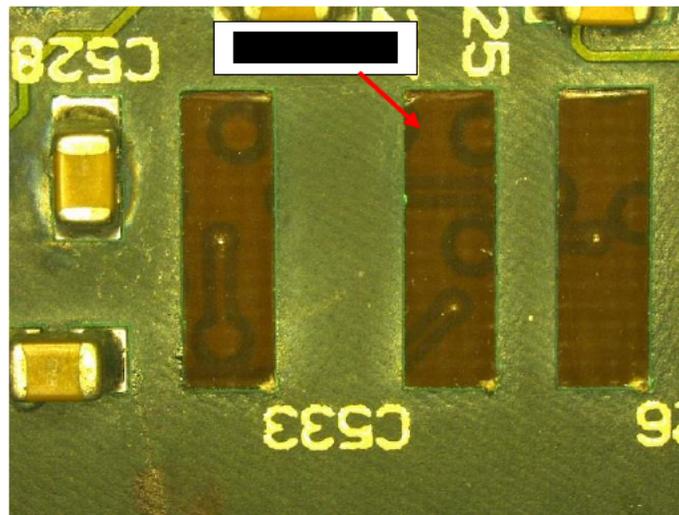
The pad removal was done to prove out the theory that the root cause was the soldermask removal process that caused the breakdown of the dielectric material and not something earlier in the manufacturing process, prior to plating. Since the soldermask removal process would not impact the dielectric under the copper, if the damage was present in the dielectric under the copper, then the condition had to be present prior to copper plating. A total of 6 surface pads were removed from an affected PWA. Upon visual inspection of the areas where the pads were removed, there was no evidence of dielectric erosion or exposed weave present at those pad locations. See Figure 10. This finding was also validated by our testing agent.

Figure 10 – Laminate condition after pad removal

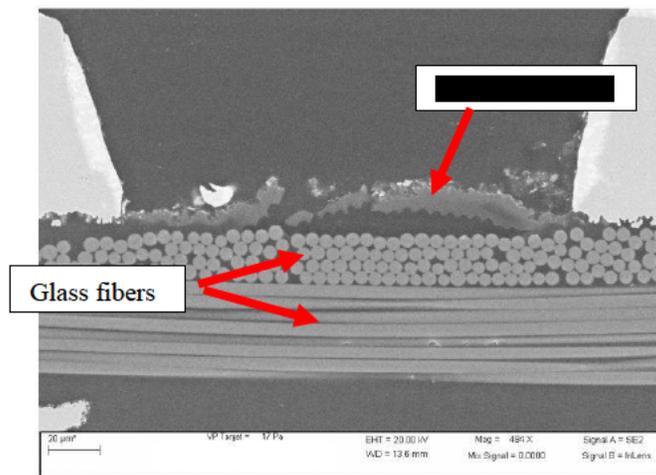
A section of an affected PWA was subjected to SEM analysis. This section was comprised of a row of pads from the multi-leaded component shown in Figure 1. The analysis focused on random areas between pads where the reinforced glass fibers were overlapping (or perpendicular) to each other. See Figure 11 and Figure 12. The results depicted a number of areas where the surface laminate was separating and lifting from the PCB weave. It also shows areas where the surface laminate had ruptured. These findings provided confirmation that not only did weave exposure exist, but also lamination separation occurred, which is not a desirable outcome.

Figure 11– SEM photograph of area between surface pads, surface delamination, 484X

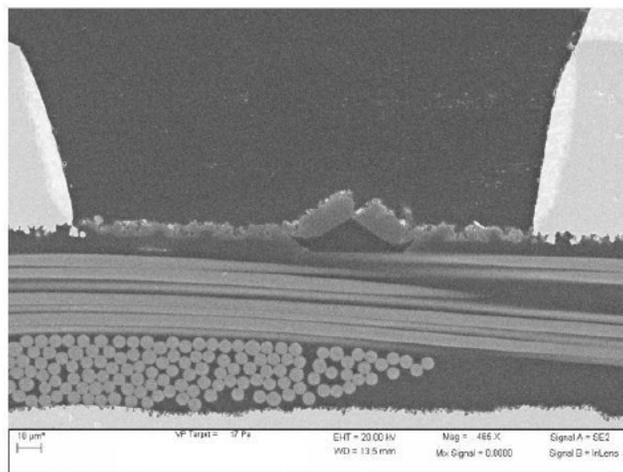
Figure 12 - SEM photograph of area between surface pads, surface rupture, 465X

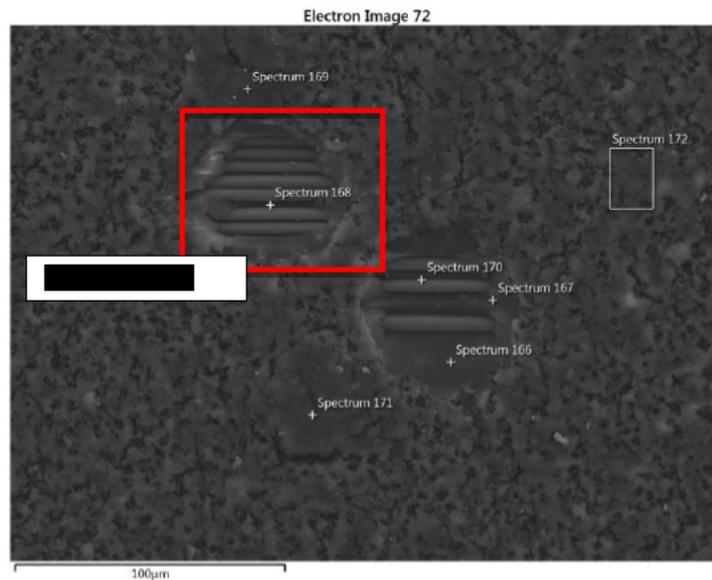
Sections of the same PWA were sent to our testing agent where they performed SEM with EDS. No control sample was used. Specifically, areas of the open weave were analyzed. EDS provides elemental analysis of the areas being examined. See Figure 13 and Figure 14 below. The analysis showed unusually high concentrations of silicon, calcium and bromine. This sample had previously been subjected to assembly processing as well, acoustic microscopy and it had been micro sectioned, so it was difficult to determine at what stage these high concentrations may have been deposited. It would have been beneficial to have run a control such as a piece of affected PCB that had not seen assembly and other post assembly handling. A control sample was used in mock assembly and cleanliness testing which is described later to better determine if the weave exposure trapped cleaning and assembly solvents.

Figure 13 - SEM EDS Sample of Open Weave

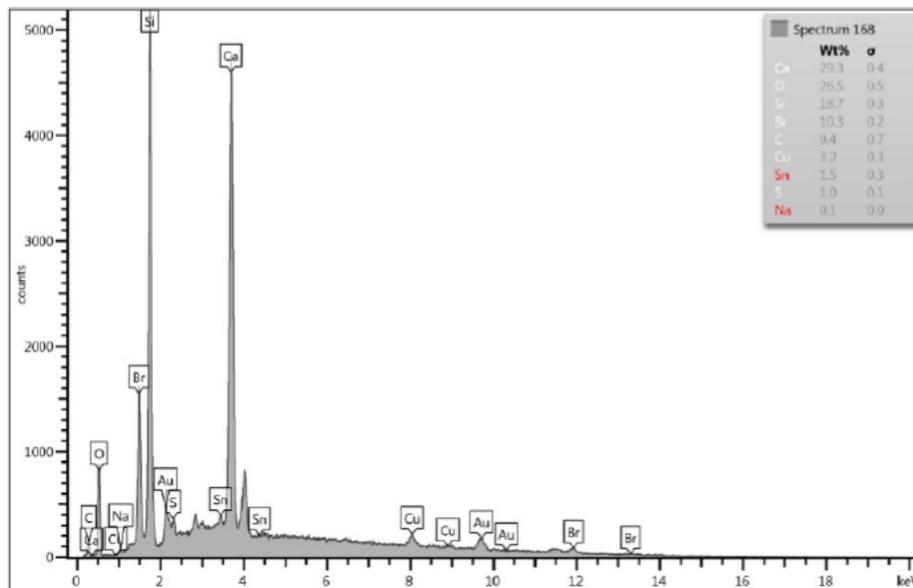
Figure 14-EDS analysis of Spectrum 168

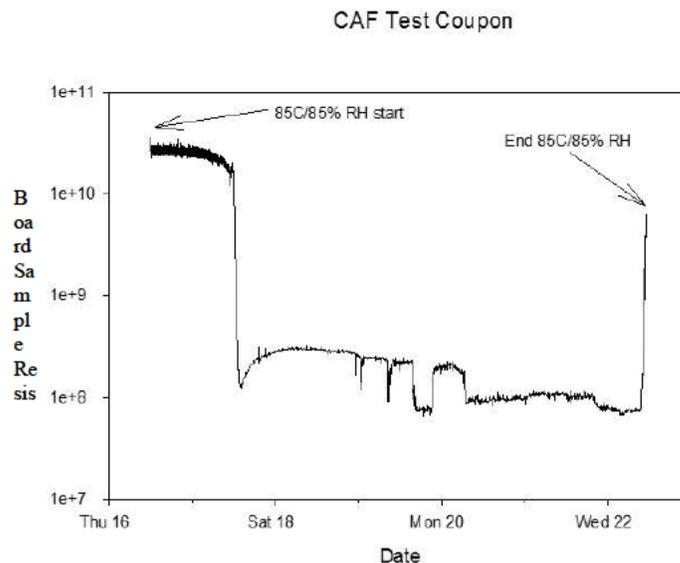
Similar to the dielectric breakdown test described above, this test utilized an affected PWA that was sectioned, and specially configured. It was prepared identically to the dielectric breakdown test, Figure 15, except the leads, pads and buss wire were conformally coated. The test was performed to IPC-TM-650, method 2.6.25 using 100V, 85% RH and 85°C. We used the criteria in the test method that specifies a decade drop in insulation resistance as a result of applied bias, is a failure. Utilizing these conditions, the test lasted for 6 days then failure occurred. See Figure 16.

Figure 16– Results of CAF testing

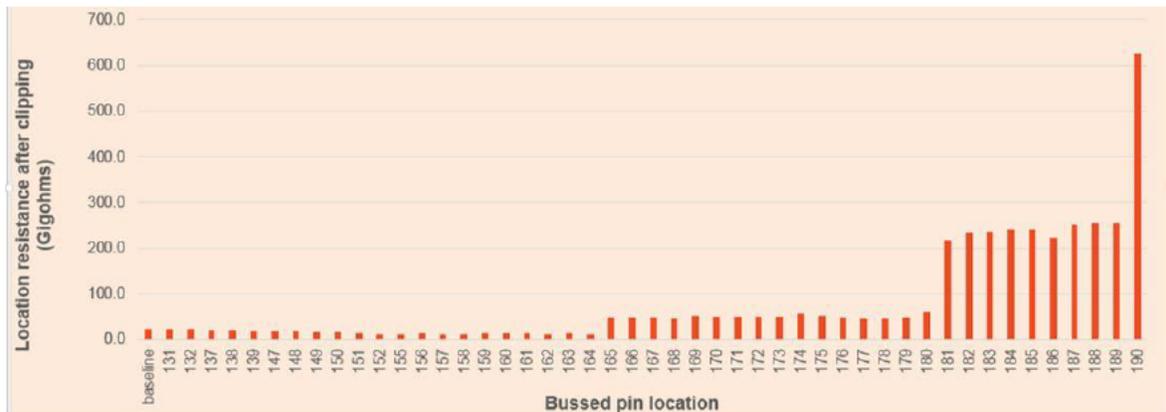
decade box was measured to ensure measurements on the test vehicle were accurate. The sample had varying stages of dielectric breakdown along the pad pattern, so as the leads were cut to determine location of CAF, the lower end pin count (130s/ 140s/ 150s) didn't show a resistance change when leads were cut so CAF was not in these locations. In the graph, when the resistance jumps with a pin cut, this indicates that CAF is present, so locations 164 & 165, 180 & 181 and 189 & 190 all had some CAF present.

Figure 17 – Location of CAF failure

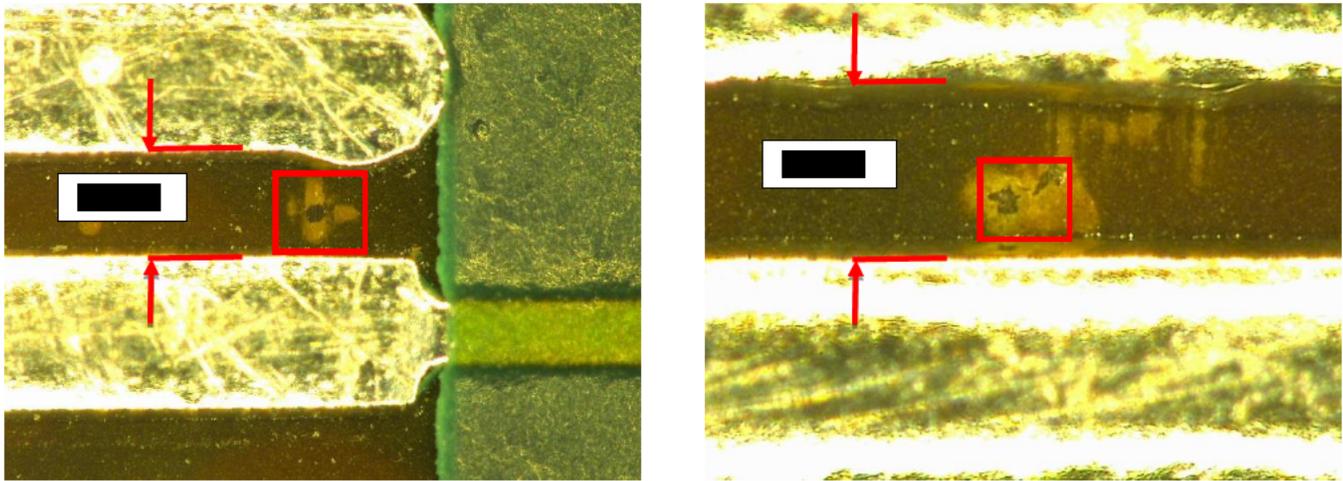
Figure 18 – PCB Exposed Weave – Connector pad (left), Component pad (right)

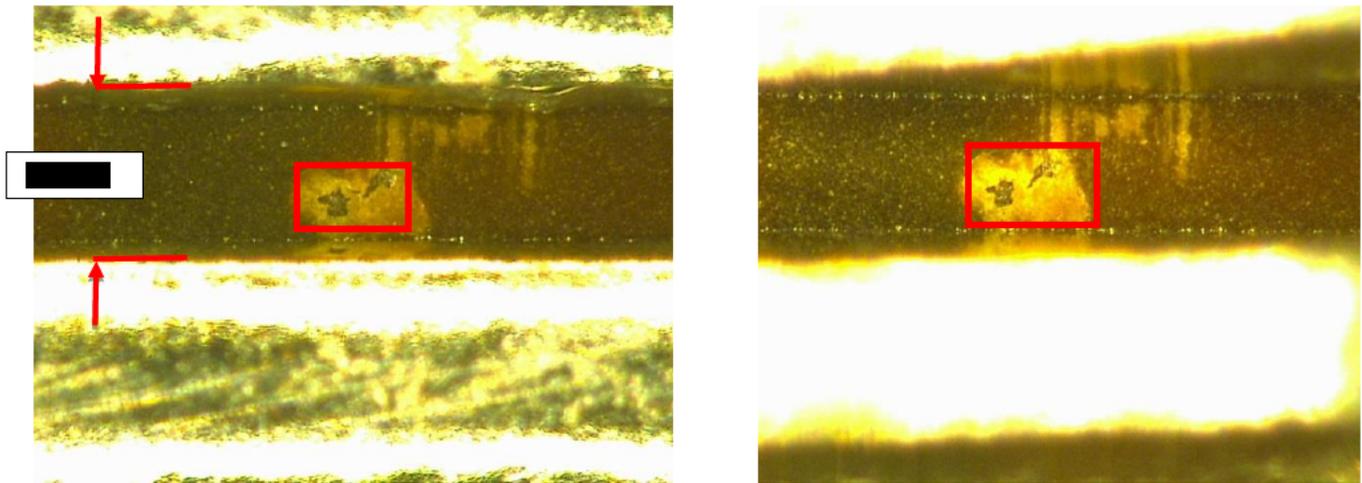
The next step consisted of a reflow operation to attach the component using reflow techniques that exactly simulated all aspects of the reflow operation at the subcontracted supplier that performs assembly operations for this PWA. The same solder flux, solder paste and reflow profiles were used. Also the same aqueous cleaning, using the same machine and saponifier was used. Again, photos were taken and compared to the baseline, pre-assembly condition. See Figure 19 and Figure 20. No discernable visual changes were noted.

Figure 19 – PCB Exposed Weave (Component pads) before (left) and after (right) assembly

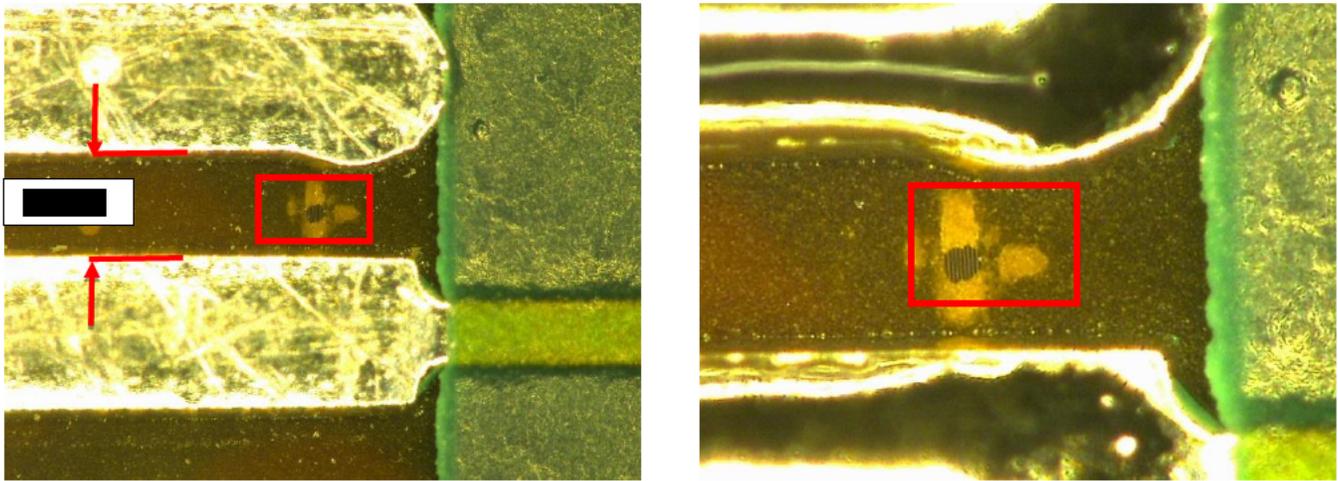
Figure 20 - PCB Exposed Weave (Connector pads) before (left) and after (right) assembly

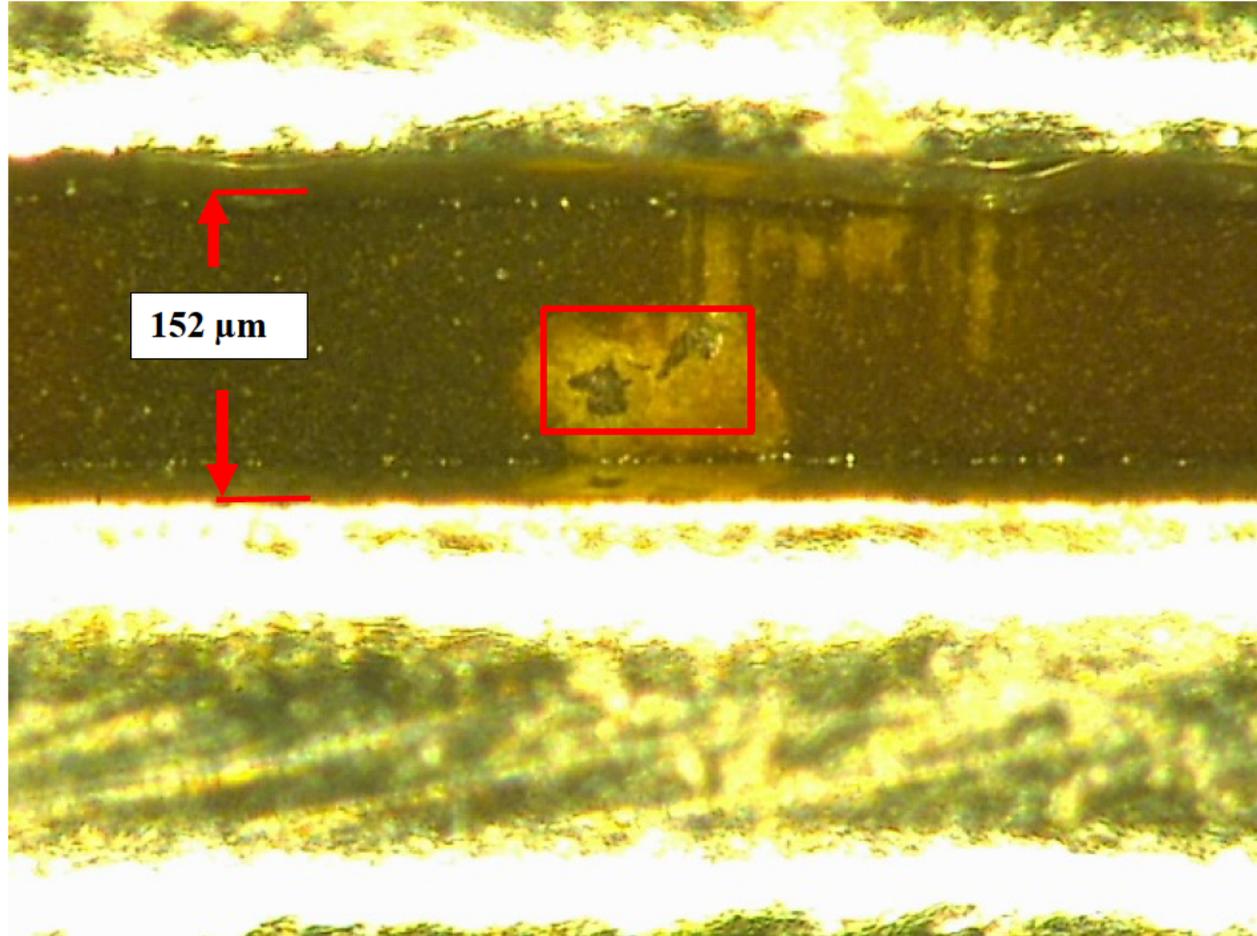
Weave exposure – Component lead pads

- A concern was raised by the design agent that the weave texture could potentially reduce the conductor spacing to an unacceptable value or $< 127\mu\text{m}$.
- Several loose PCBs were examined closely at 200X and 400X magnification.
- Weave texture was confirmed. The more problematic weave exposure was also confirmed.

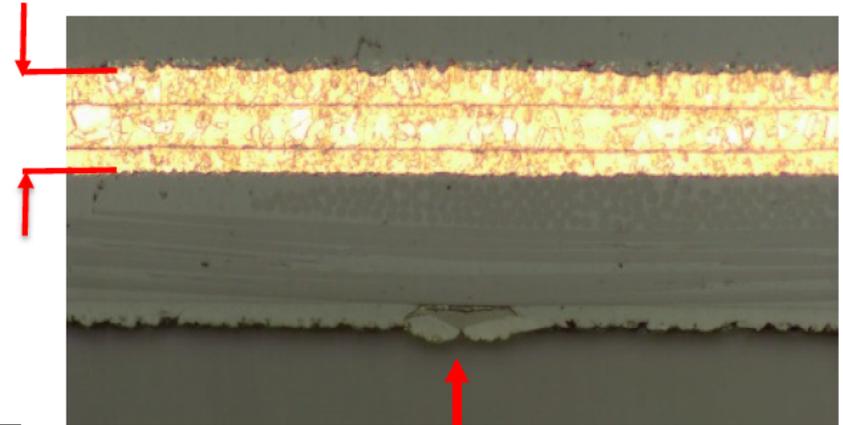
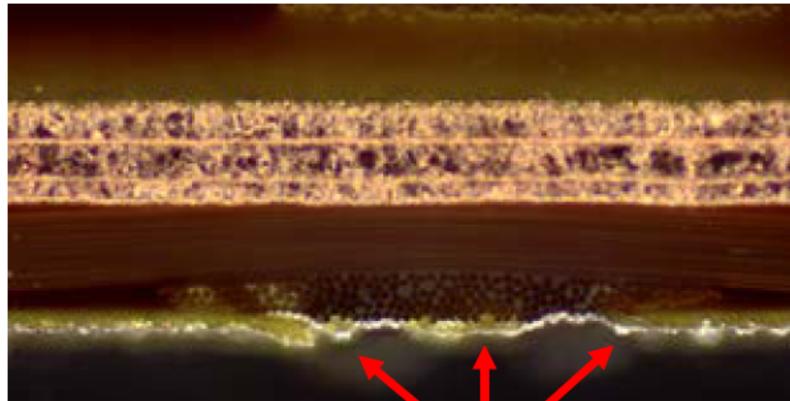
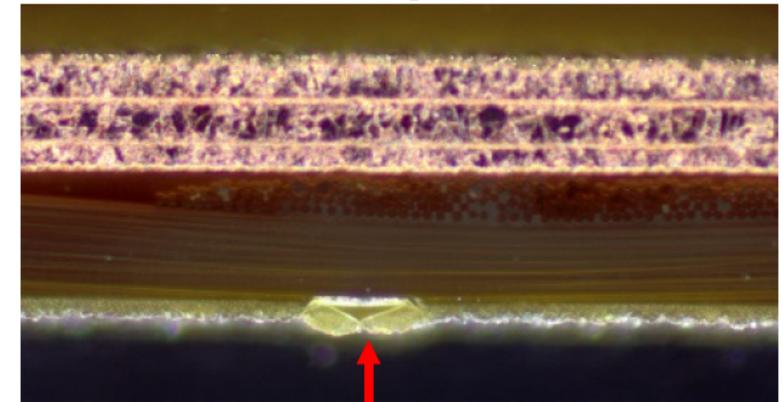
The red arrows indicate disruptions in the surface laminate creating weave exposure.

Buried via microsection evaluation (top-bright field, bottom-dark field, 250X)

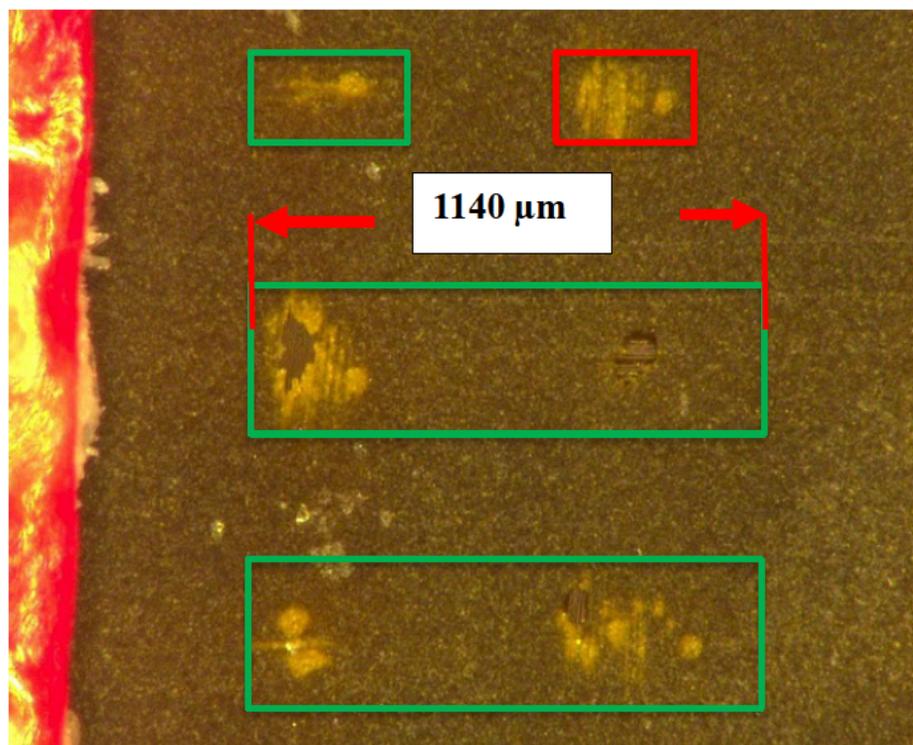
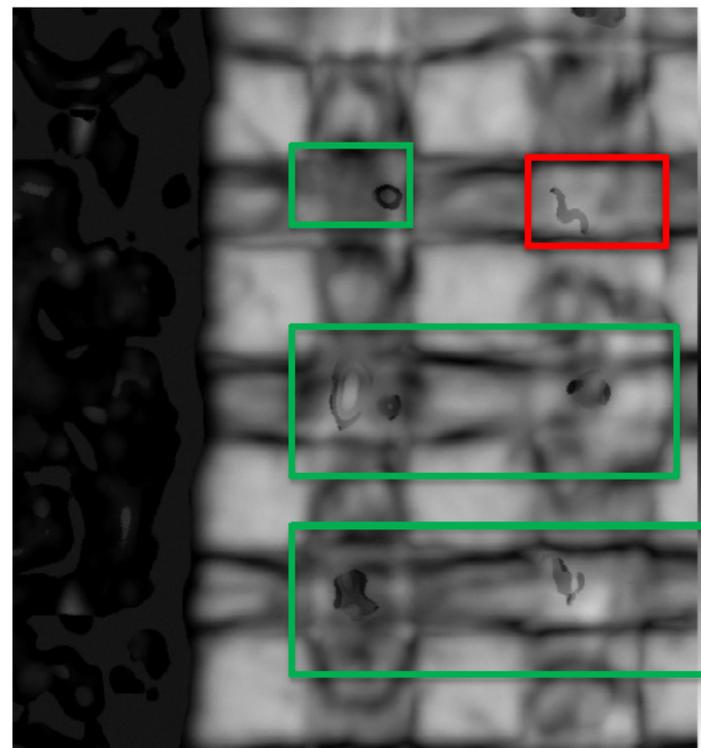
- Acoustic Microscopy uses reflected ultrasound scanning pulses to penetrate solid objects and images features such as cracks, delaminations, or voids.
- An affected PWA was subjected to this test. No control sample was used.
- The actual extent/depth of any anomaly is indeterminate without a great deal of work by repeatedly indexing the ultrasonic transducer (in the z direction) by a height distance, acquiring sonographs and correlating images.

PWA (optical view on left, sonograph on the right)

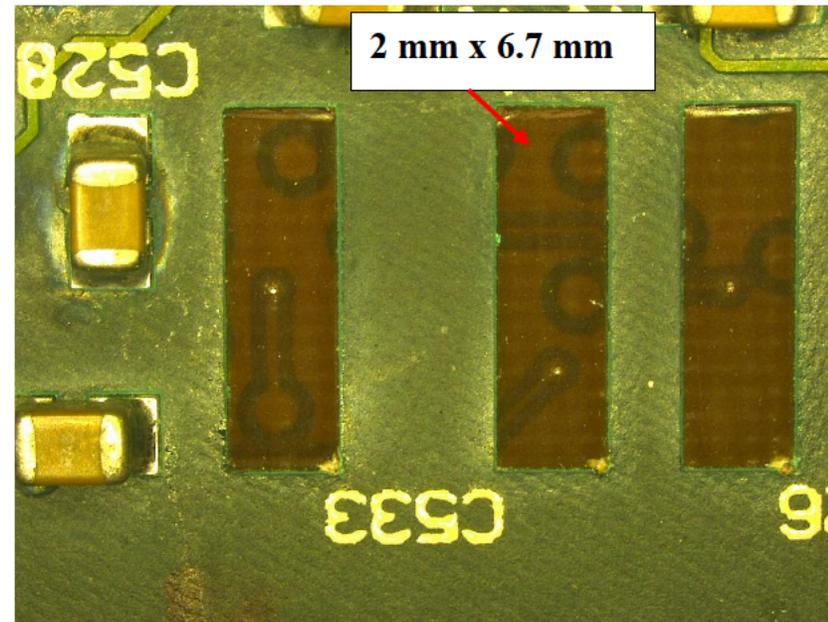
- To validate that the strip process did not disturb areas of the laminate underneath plated copper, surface pads were removed from an affected PWA.
- There was no evidence of dielectric erosion or exposed weave present at those pad locations.

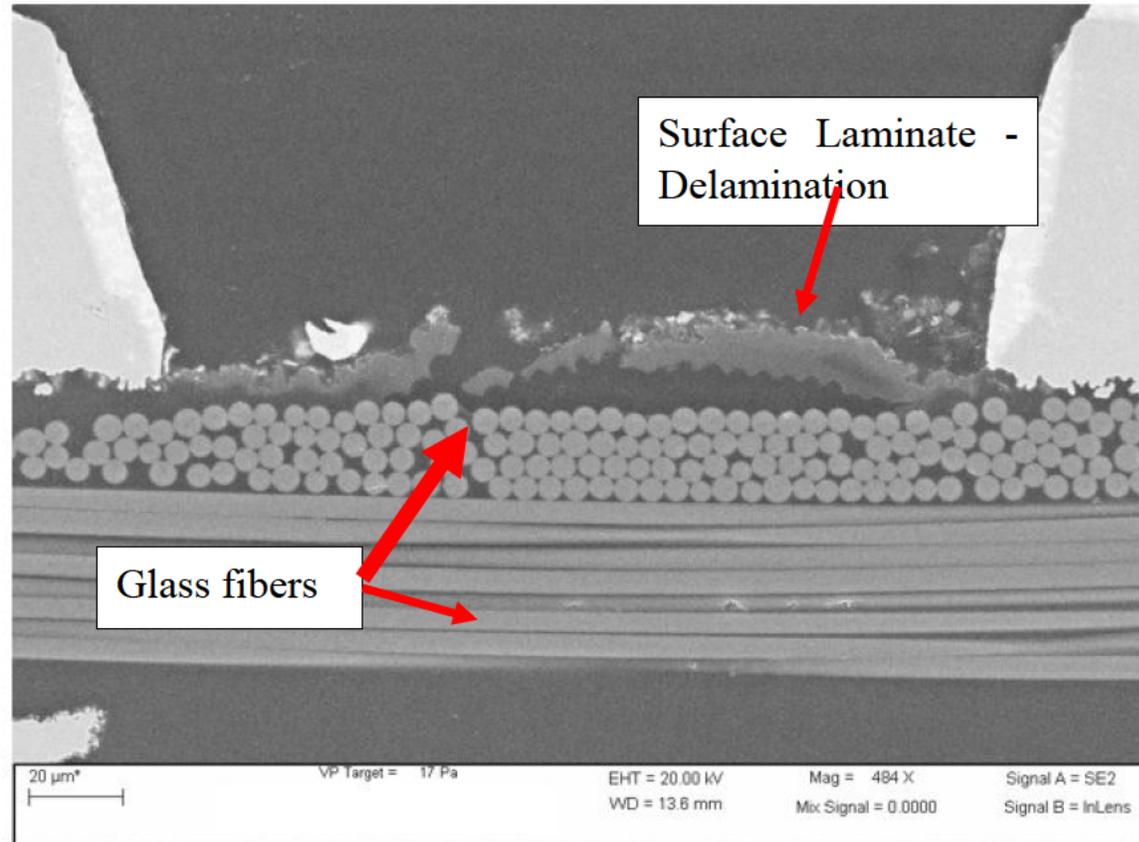
- A section of an affected PWA was examined between pads of a leaded component.
- The results depicted a number of areas where the surface laminate was separating and lifting from the PCB weave. It also shows areas where the surface laminate had ruptured.

**SEM photograph of area between surface pads,
surface delamination, 484X**

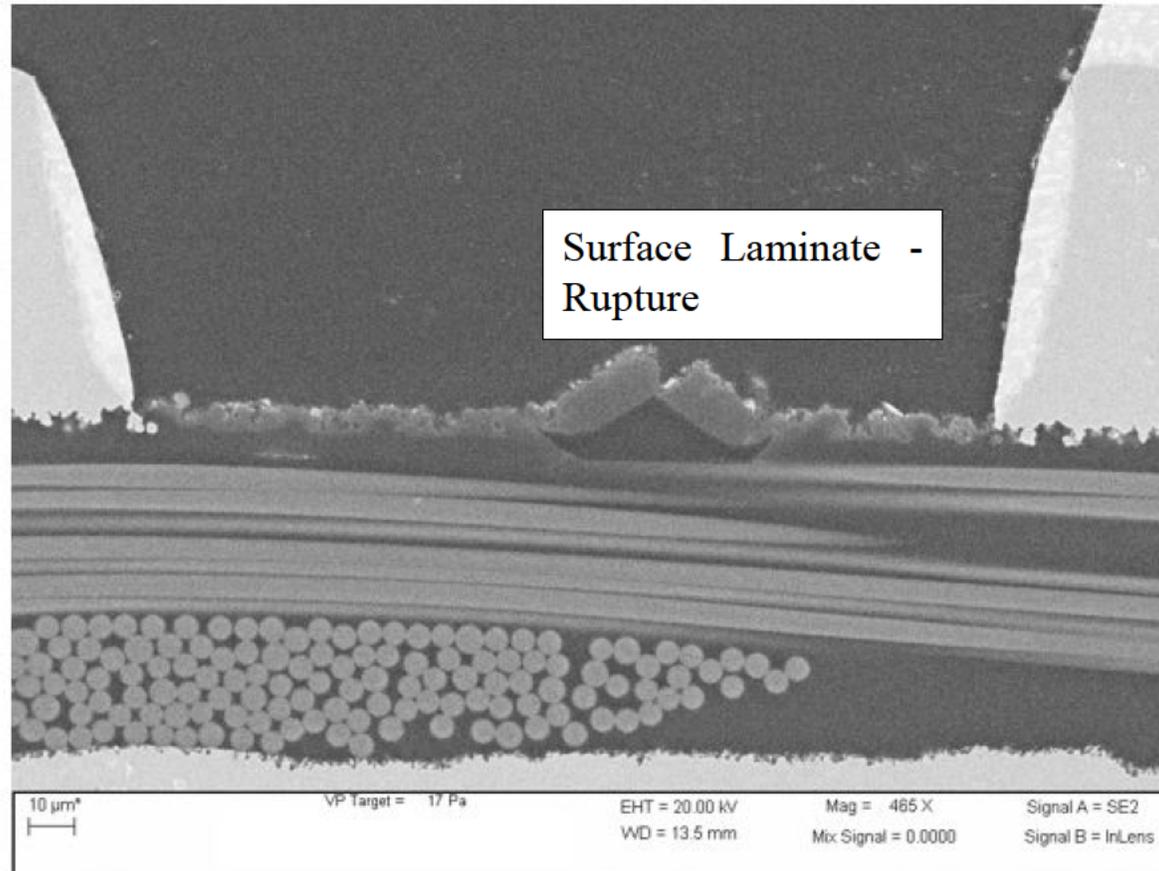
SEM photograph of area between surface pads, surface rupture, 465X

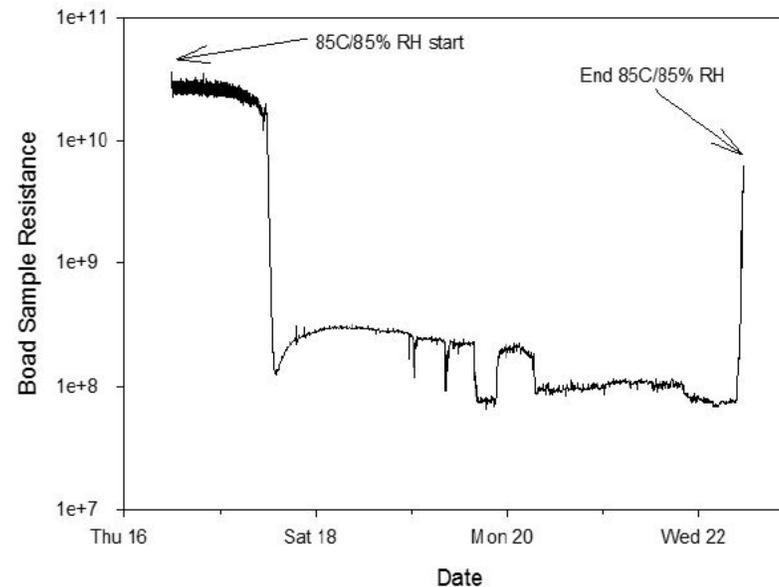
CAF Test Coupon

- Test performed per IPC-TM-650, method 2.6.25 using 100V, 85% and 85C. Similar configuration as dielectric breakdown. A decade drop in insulation resistance as a result of applied bias constituted a failure.
- Test lasted for 6 days then failed. Baseline testing not shown below.
