# Investigation of Pad Cratering in Large Flip-Chip BGA using Acoustic Emission

Anurag Bansal, Cherif Guirguis and Kuo-Chuan Liu  
Cisco Systems, Inc.,  
San Jose, CA  
anurbans@cisco.com

Electronics assemblies with large flip-chip BGA packages can be prone to either pad cratering or brittle intermetallic (IMC) failures under excessive PCB bending. Pad cratering cracks are not detected by electrical testing or non-destructive inspection methods, yet they pose a long term reliability risk since the cracks may propagate under subsequent loads to cause electrical failure. Since the initiation of pad cratering does not result in an instantaneous electrical signature, detecting the onset of this failure has been challenging. An acoustic emission methodology was recently developed by the authors to detect the onset of pad cratering [1, 2]. The instantaneous release of elastic energy associated with the initiation of an internal crack, i.e., Acoustic Emission (AE), can be monitored to accurately determine the onset of both pad cratering and brittle intermetallic (IMC) failures.

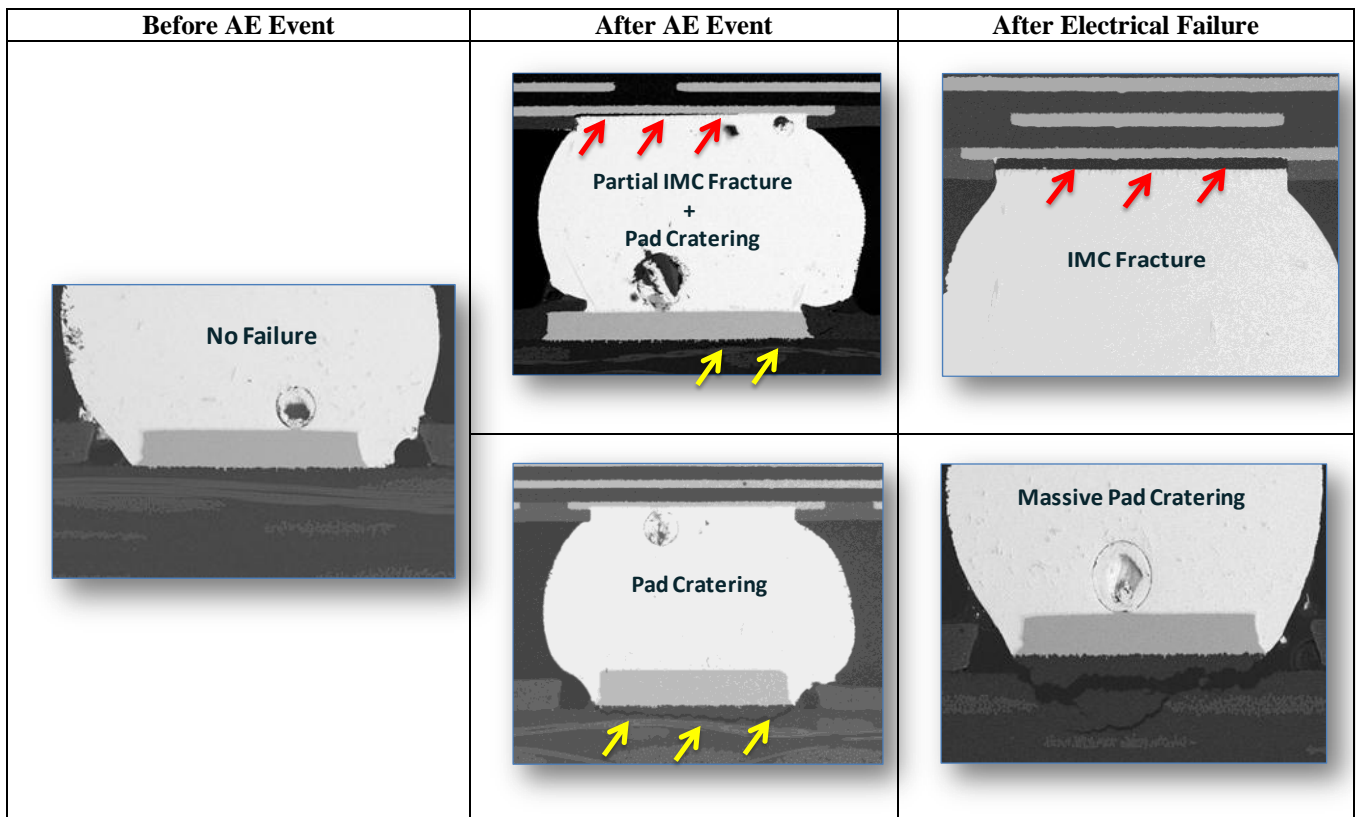
**Figure 10 - Typical BGA Cross-sections with Full NSMD and Corner SMD Pads**

Following the bend tests, cross-sections and dye-and-pry were performed to determine the failure modes. The samples with 0° BGA orientation were cross-sectioned along the edges (parallel to the fixture anvils). The samples with 45° orientation were cross-sectioned diagonally along the direction perpendicular to the fixture anvils. In order to validate the effectiveness of the acoustic methodology, a few bend tests were terminated before any AE events were detected. Some bend tests were terminated after AE events were detected, and in most cases the tests were terminated after electrical failure. Figure 10 shows typical cross-section results after various stages of bend testing. If no AE event was detected, cross-sections did not show any signs of failure. This result was critical for validating the AE test methodology and similar validation was performed in our previous work on different types of components [1]. Also shown in figure 10 are cross-sections of samples where tests were terminated after AE event detection, but before electrical failure. The failure modes were found to depend on the PCB pad design. In the case of full array NSMD pads, the failures were always due to pad cratering on the PCB side. In the case of boards with corner SMD pads, there were three different failure modes. The solder joints with corner SMD pads had partial IMC fracture at either the BGA package side or PCB side. In some cases the joints with partial IMC fracture also showed partial PCB pad cratering. This result clearly demonstrates that the AE methodology is an effective tool for detecting the onset of different failure modes, i.e., BGA side IMC fracture, PCB side IMC fracture, or pad cratering. As seen in figure 10, the partial nature of the IMC fractures explains why these failures did not result in instantaneous electrical failure of the daisy chain circuit. In samples cross-sectioned after electrical failure, the same failure modes had progressed to a greater extent. The IMC fractures of joints with corner SMD pads showed complete separation along the joint diameter, and PCB side pad cratering showed a larger extent of cracking which may have ultimately ruptured a trace in the daisy chain circuit.

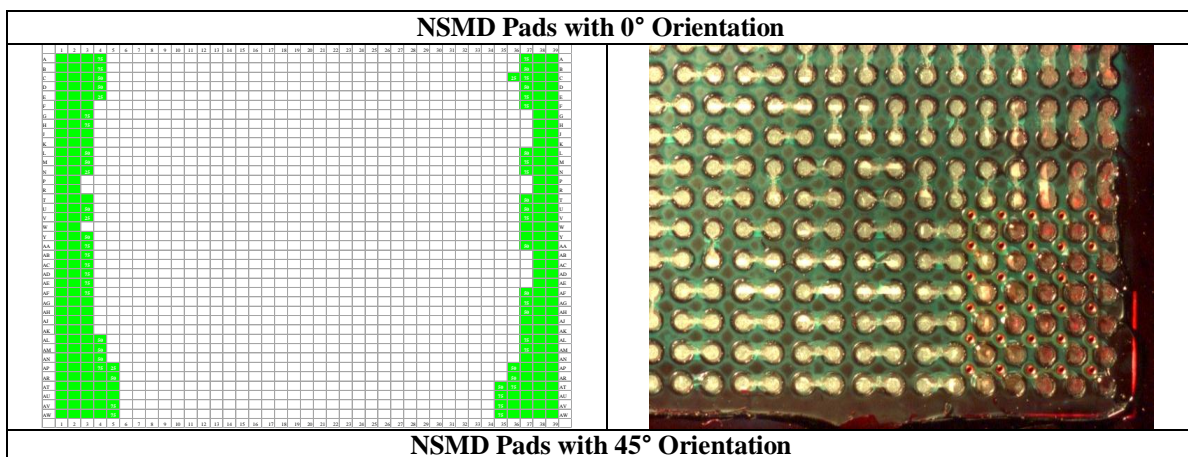
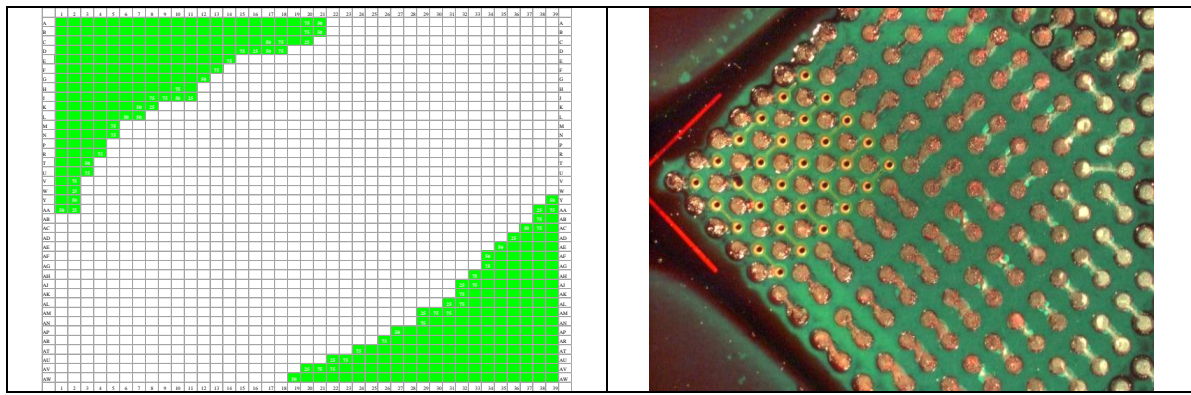
**Figure 11 - Typical Dye and Pry Result with Full NSMD Pads (Green - PCB Pad Cratering)**

The dye and pry tests showed the same failure modes observed by cross-sections. Dye and pry images and a schematic mapping of failure modes are shown in figure 11. As expected, the area of solder joint failures was strongly impacted by the component orientation. In 0° samples the damage was along the left and right edges, whereas in 45° samples the damage was along diagonally opposite corners of the package. The failure mode was completely dependent on the PCB pad geometry. With NSMD pads the failures were always due to pad cratering in the PCB laminate. In the case of corner SMD pads at the PCB corners, the failure mode shifted to IMC fracture at either the PCB side or the BGA substrate side (Figure 12). It is interesting to note that within the samples with corner SMD pads, the predominant failure mode in the remaining solder joints with NSMD pads was still PCB side pad cratering.

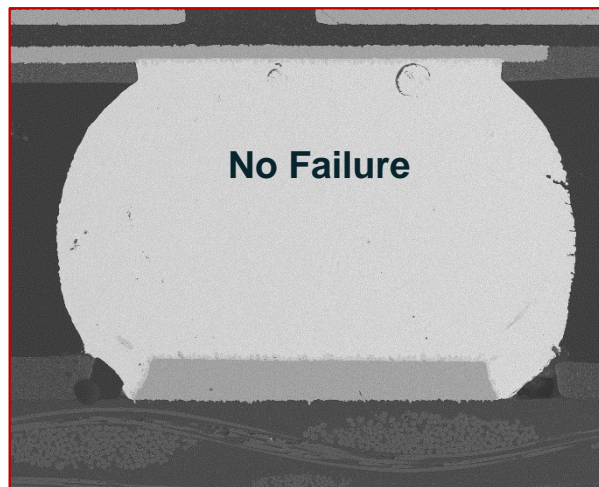
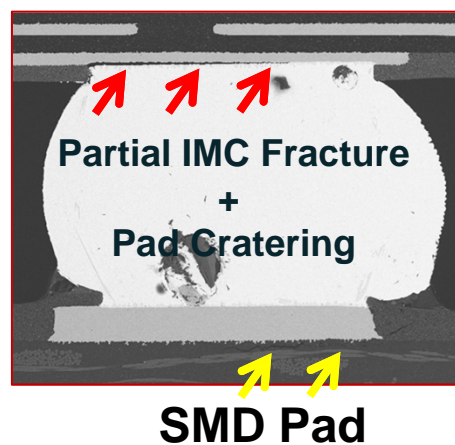
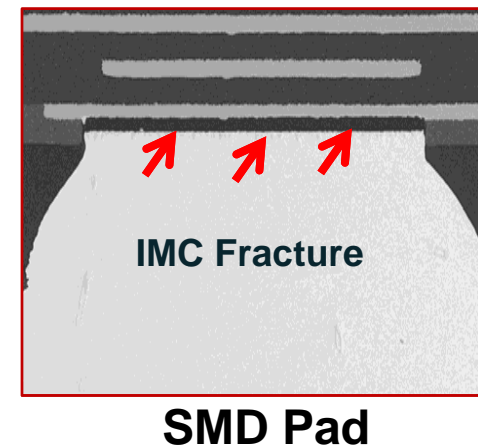
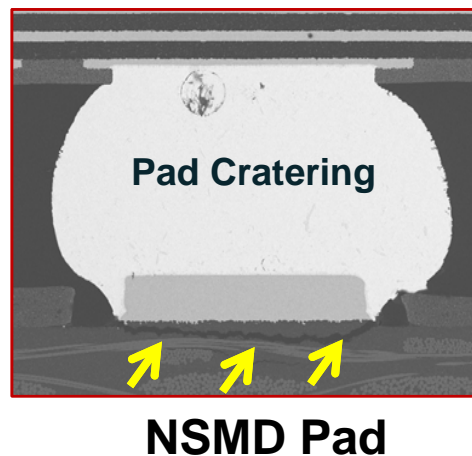
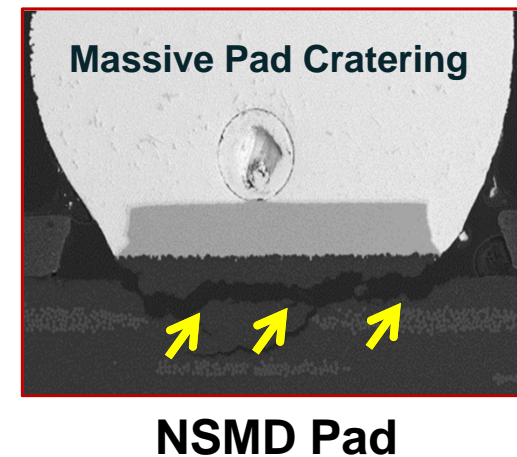
**Before AE Event**

**After AE Event**

**After Electrical Failure**

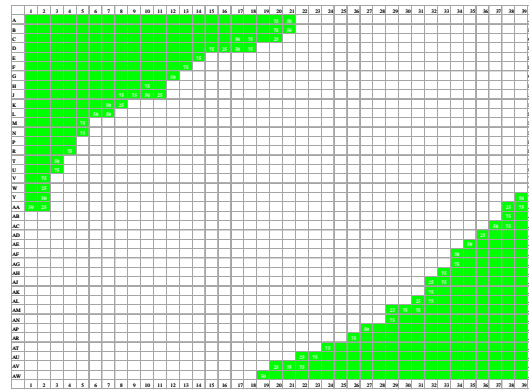
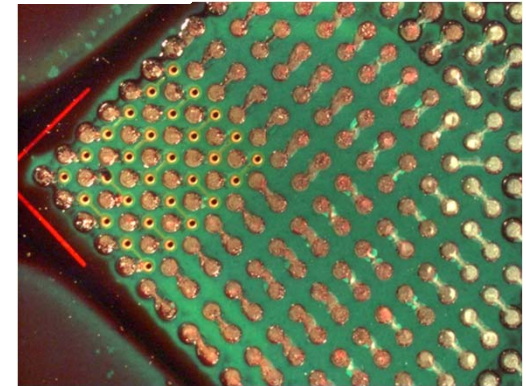
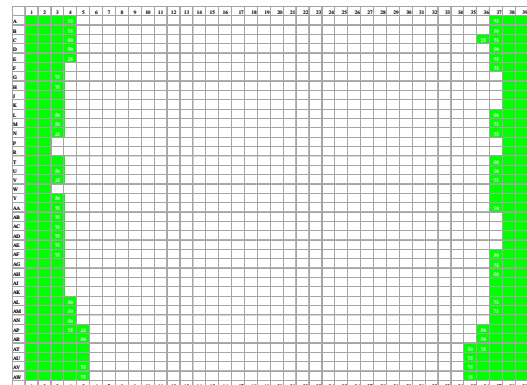
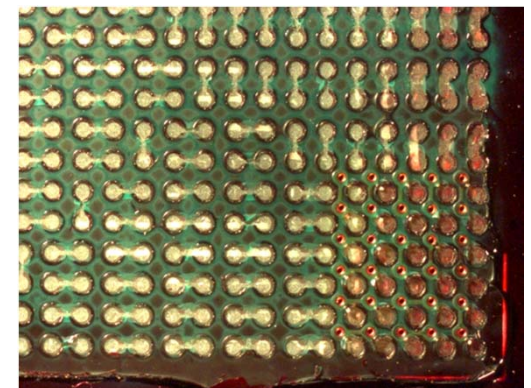
# Dye and Pry Result (NSMD)

Only PCB pad cratering with full array of NSMD pads

Damage region depends on BGA orientation

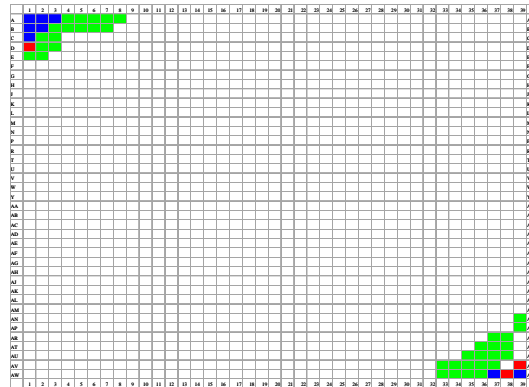
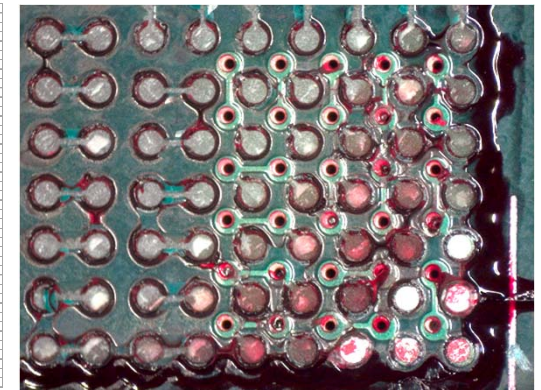
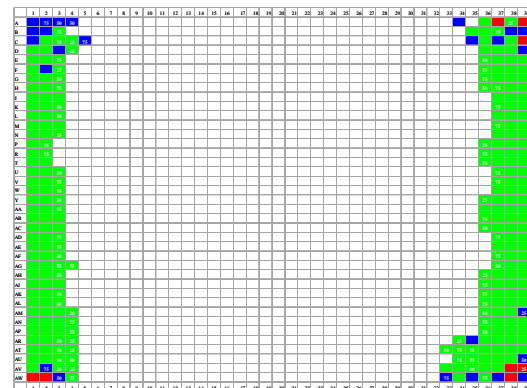
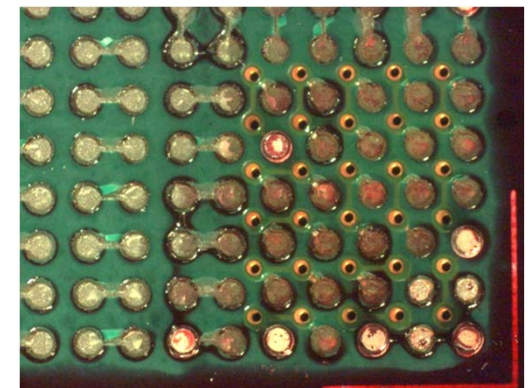
# Dye and Pry Result (Corner SMD)

- PCB Pad Cratering
- BGA Side IMC Crack
- PCB Side IMC Crack

SMD Pads had  
IMC Fracture

NSMD Pads had  
Pad Cratering
