# **The Effects of Lead-Free Reflow on Conductive Anodic Filament (CAF) Performance of Materials**

Kim Morton, Viasystems, China  
Joe Smetana, Alcatel-Lucent, Plano, TX  
Gordon Qin, Viasystems, China  
Thilo Sack, Celestica, Toronto, Canada

## **Abstract**

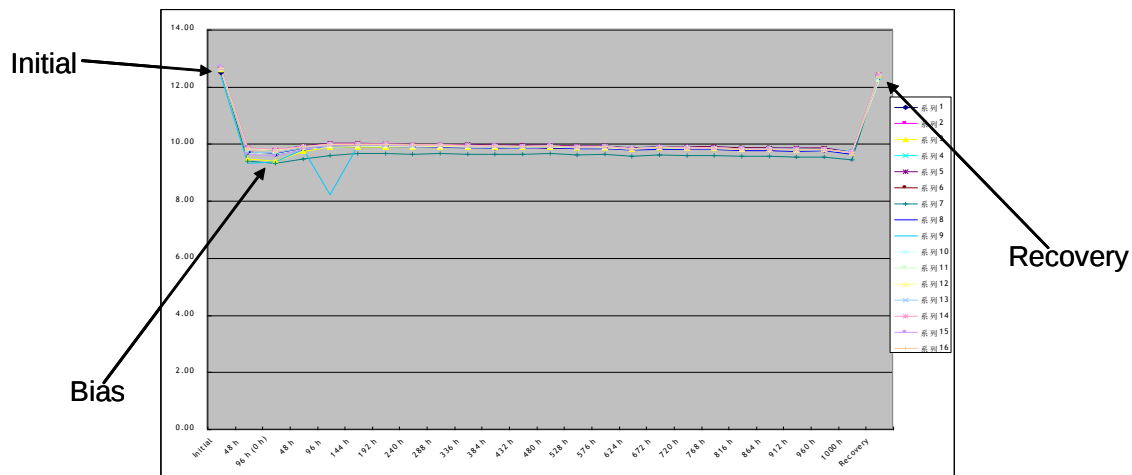
Figure 16: No Hard Leaks at 1000 hrs - Before Reflow – (HF Material-O)

- 1) Figure 16 is a good example of a single Soft Leak (both graphically and tabular form as 10E8).
- 2) Figure 18 is an excellent example of immediate failure just after the bias voltage is turned on. This is indicative of a material build that already has the full pathway present and ions are moving freely as Ionic Migration immediately with enough moisture present for the ion movement. The CAF solid Cu filament is most likely not formed at this point. However, this is a good example of an immediate failure that can knock out controllers and electrical circuits. Note that you do not need reflow to have catastrophic failure. Thus there is definite concern for any PCB that does not see any thermal transients in assembly such as Backpanels. Material choices may be severely limited unless improvements can be made.

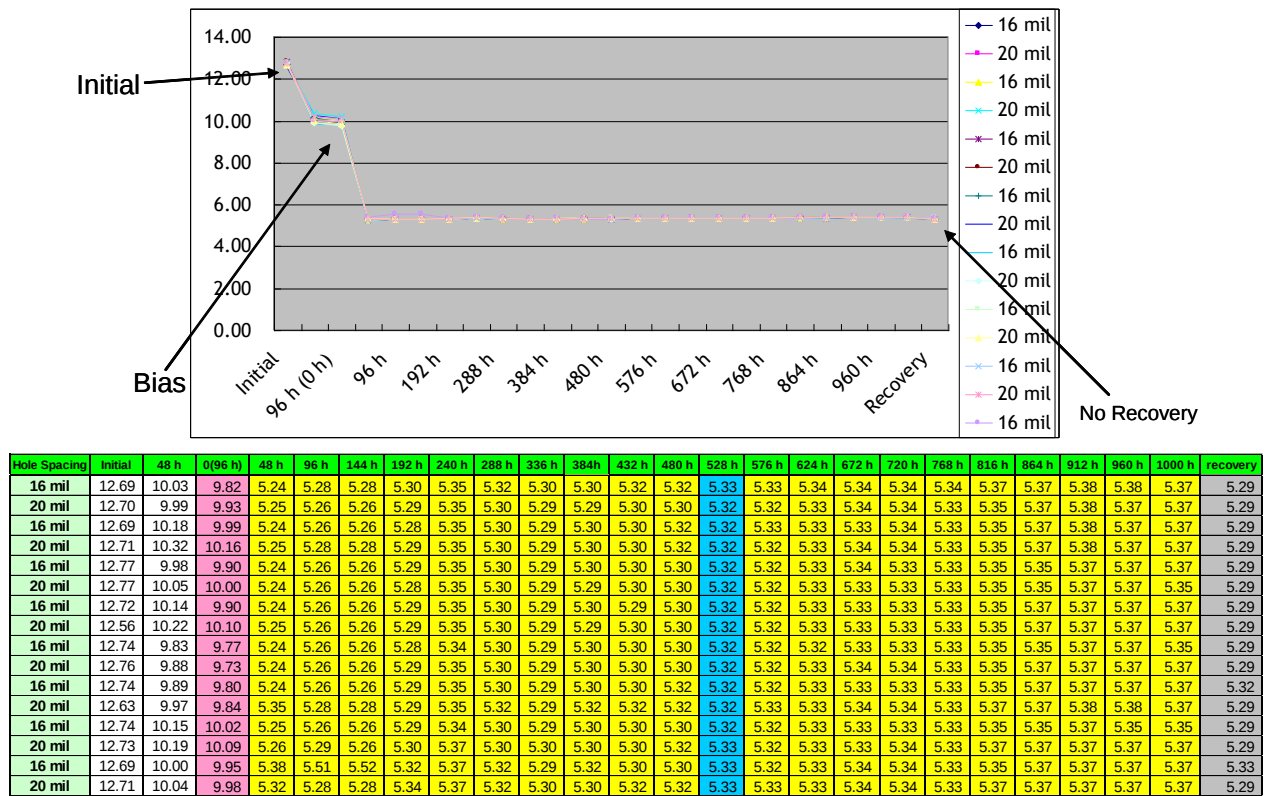
Figure 18: All Hard Leaks at 1000 hrs – Before Reflow – (FR4 Material-E)

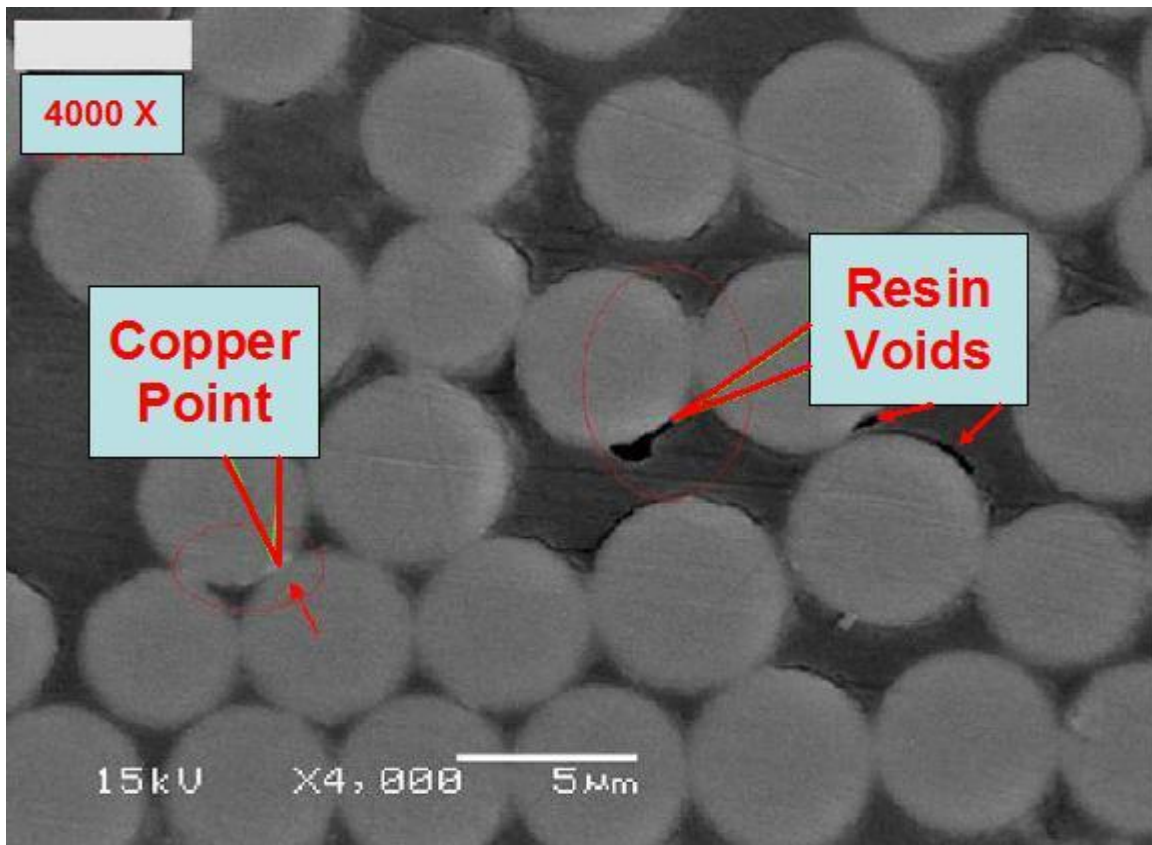
Figure 22: CAF Failure Before Reflow - FMA vertical X-sect Picture by SEM - (HiSpd Material-U)

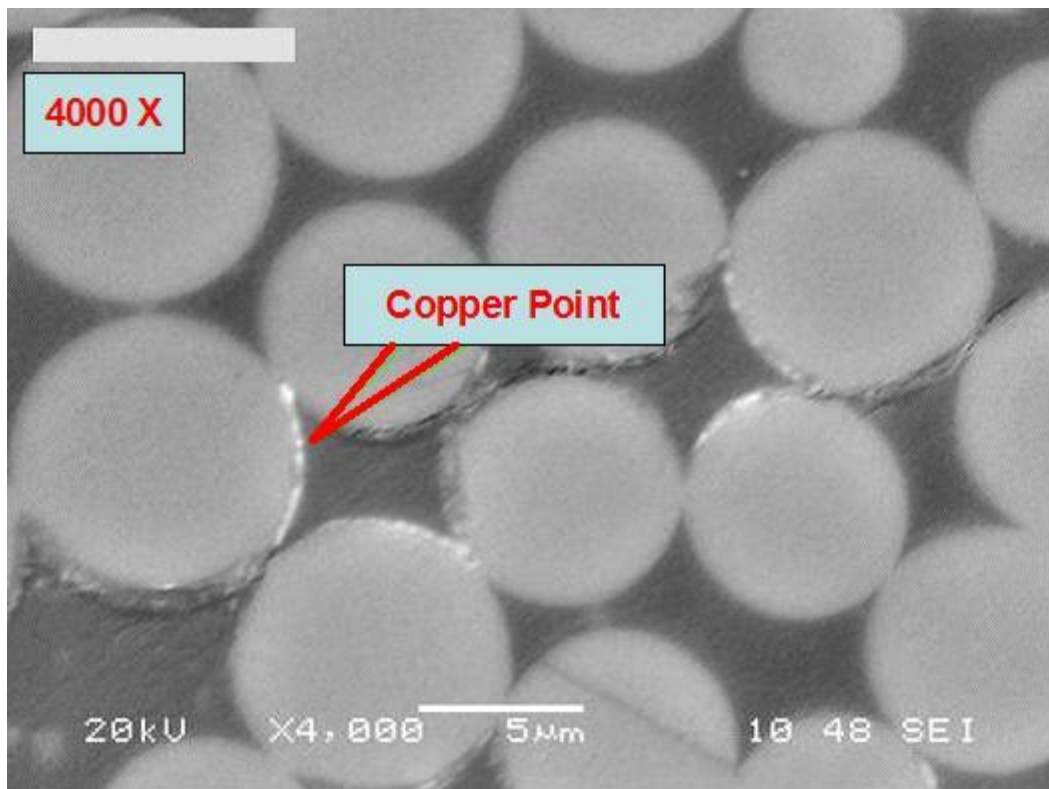
Figure 23 : CAF Failure Before Reflow - FMA vertical X-sect Picture by SEM - (FR4 Material-I)

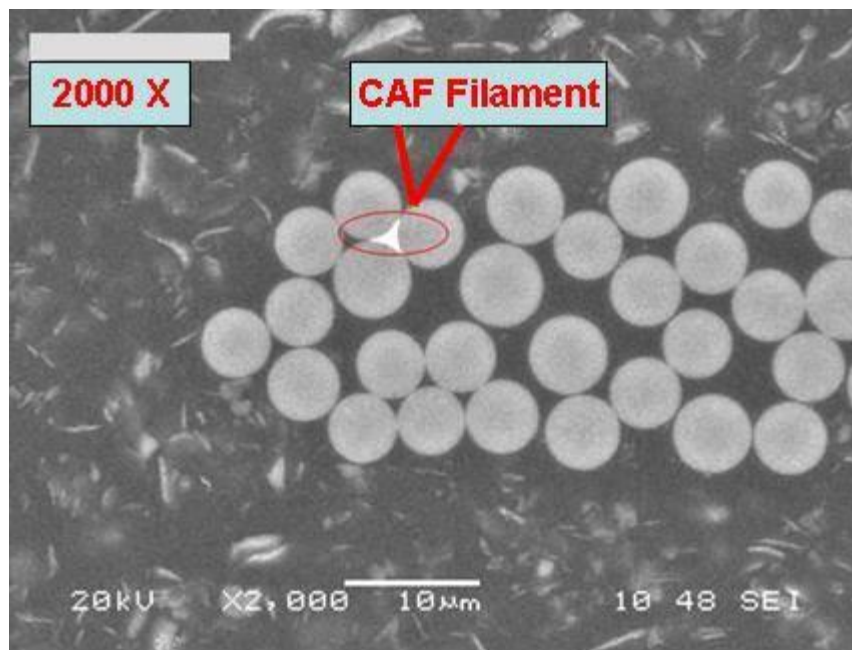
Figure 24 : CAF Failure Before Reflow - FMA vertical X-sect Picture by SEM - (FR4 Material-I)

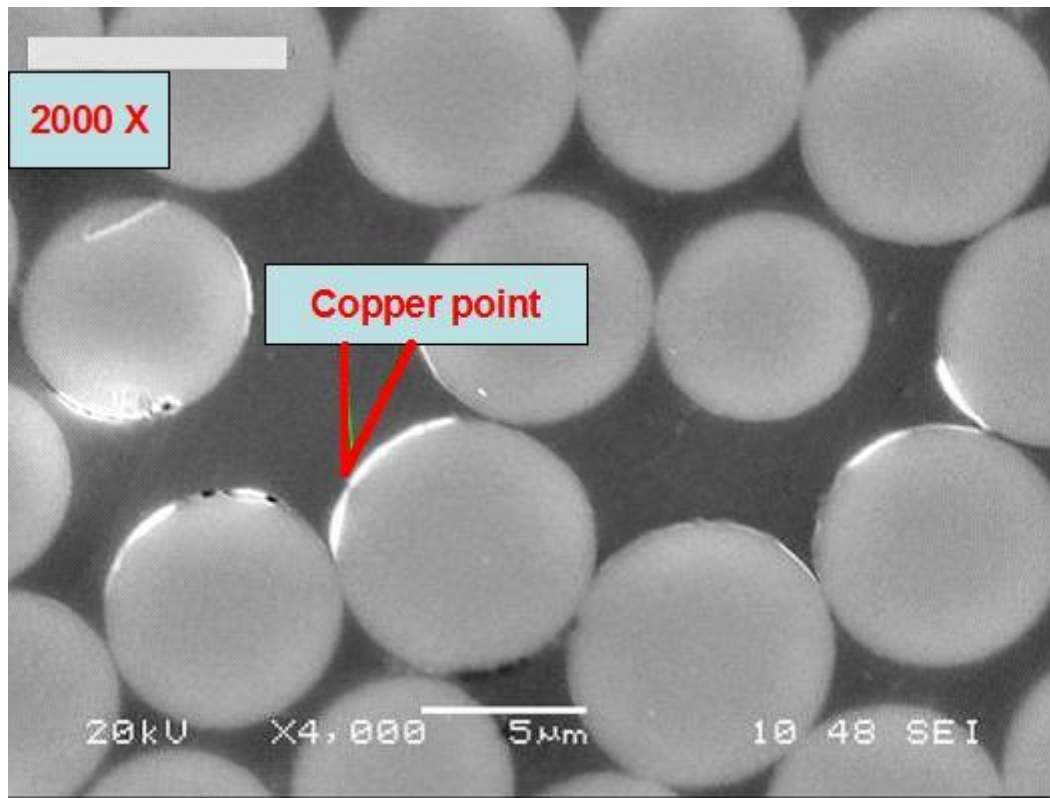
**Figure 25 : CAF Failure Before Reflow - FMA vertical X-sect Picture by SEM - (HF Material-N)**

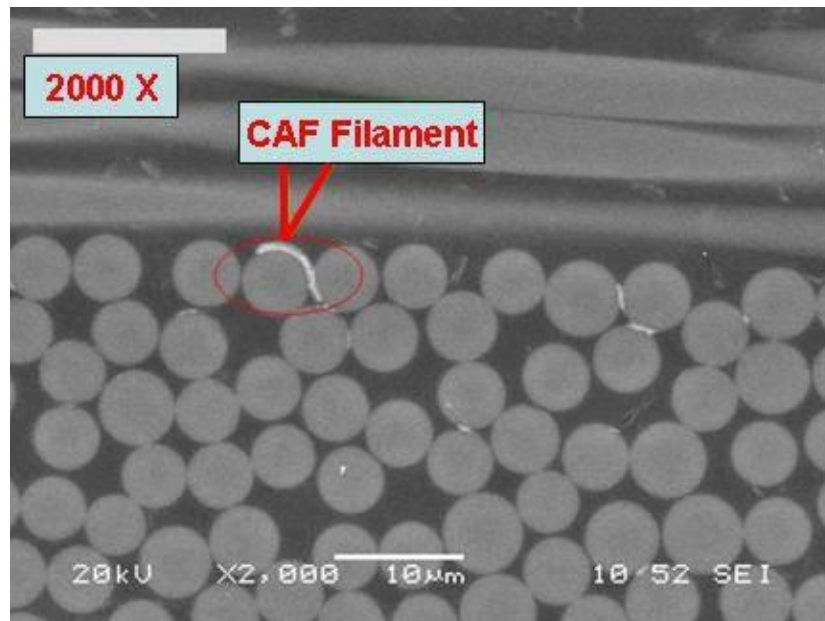
**Figure 26 : CAF Failure Before Reflow - FMA vertical X-sect Picture by SEM - (HF Material-N)**

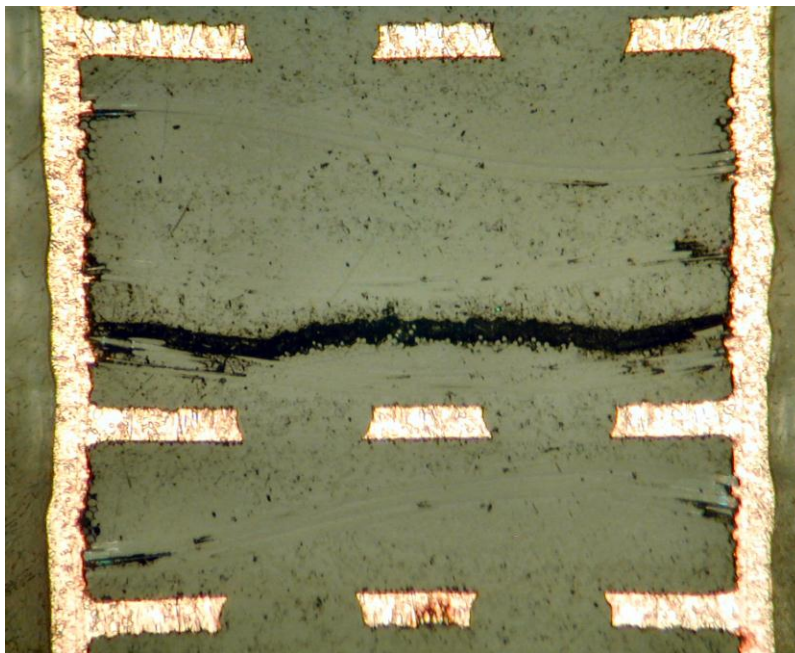
**Figure 27: Example internal longitudinal cohesive delamination**

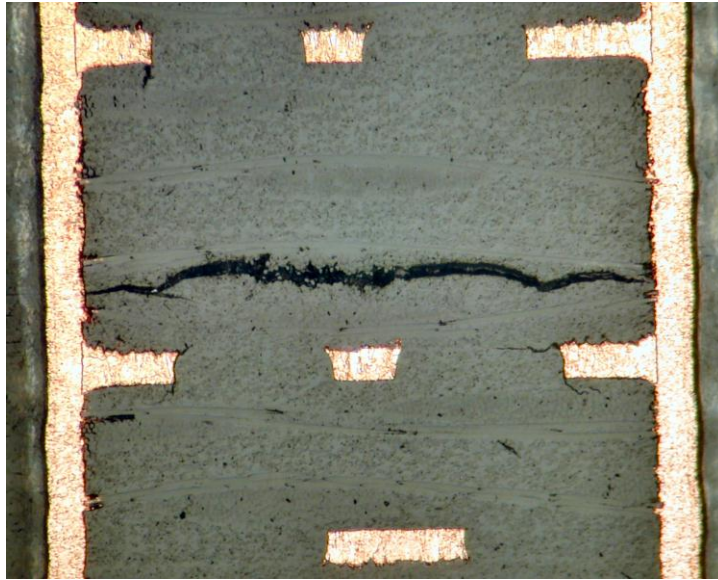
**Figure 28: Example Snake Delamination**

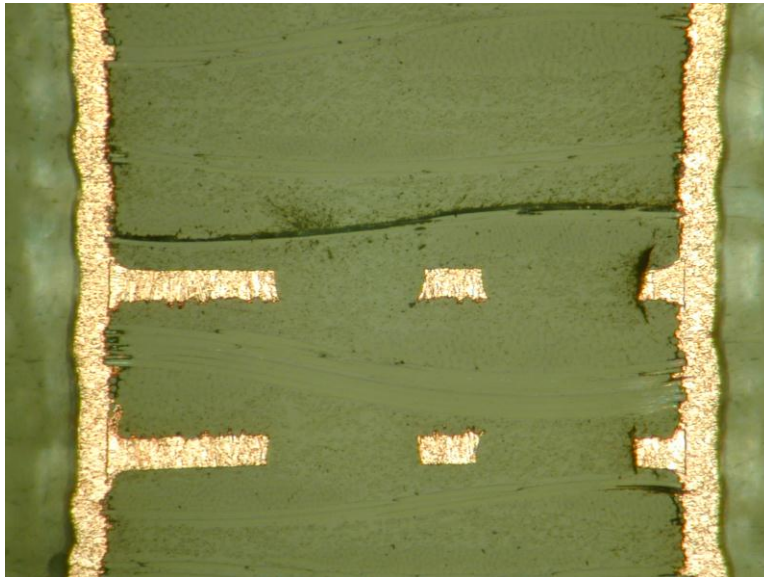
**Figure 29: Example of Eye-Browning**

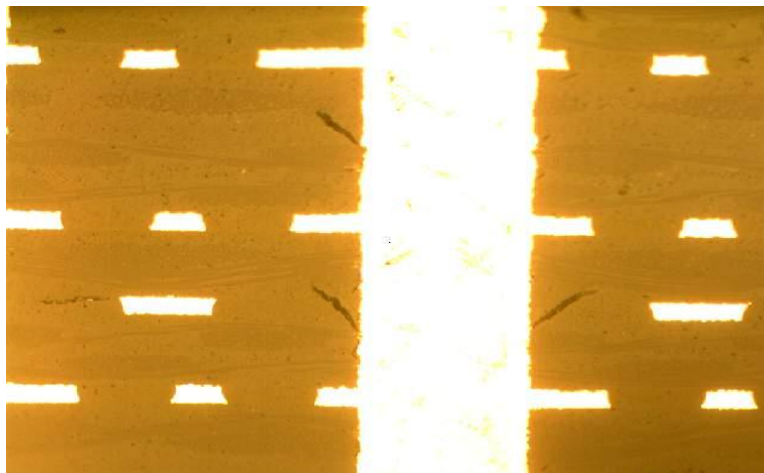
**Figure 30: Example of cigar voids**

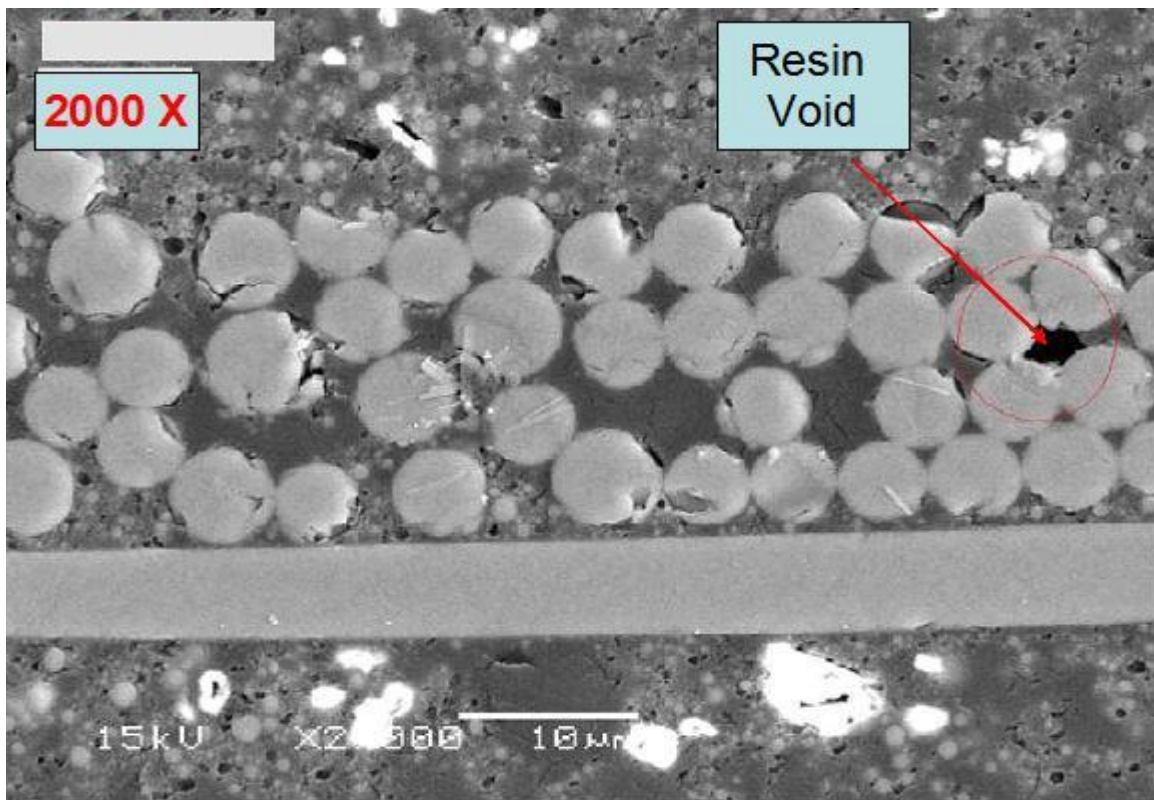
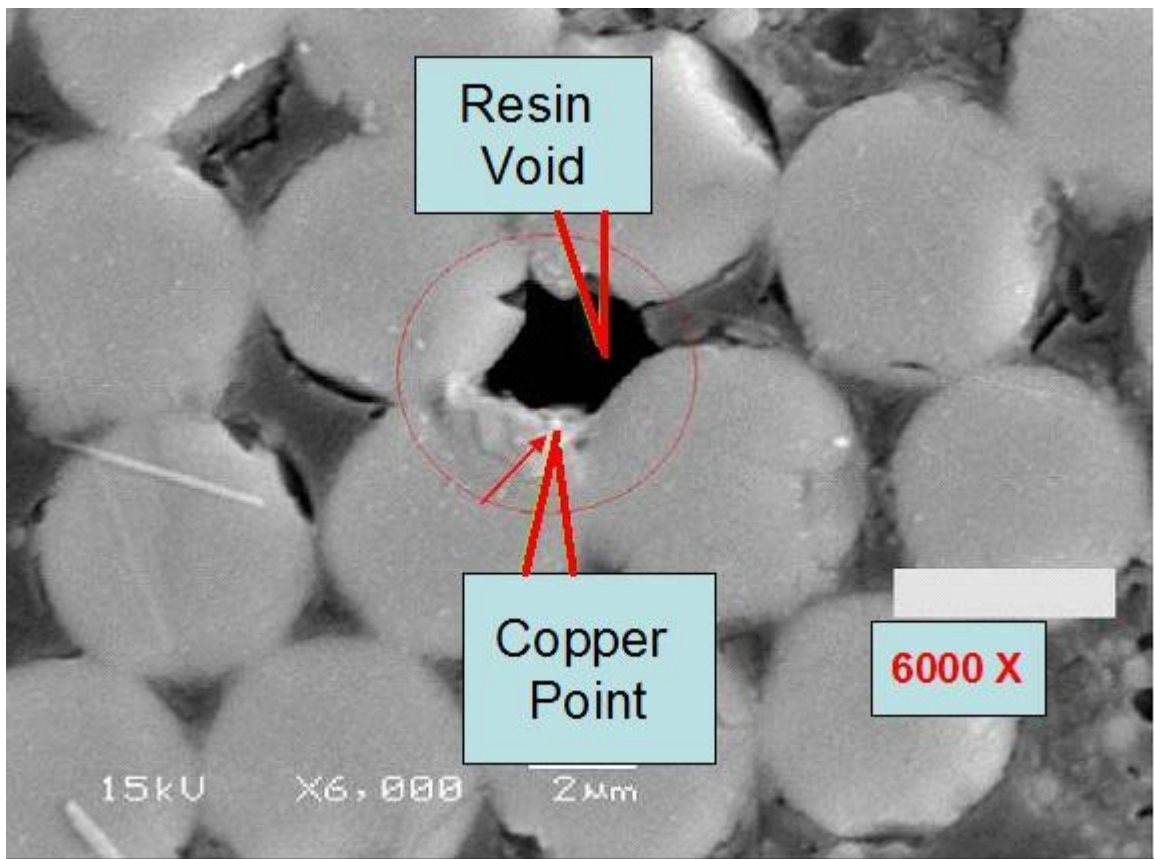
Figure 35a (top) 2000X and 35b (bottom) 6000X (The 106 Glass Effect)  
CAF Failure (with 106 glass core) After Reflow - FMA vertical X-sect Picture by SEM - (HiSpd Material-T)

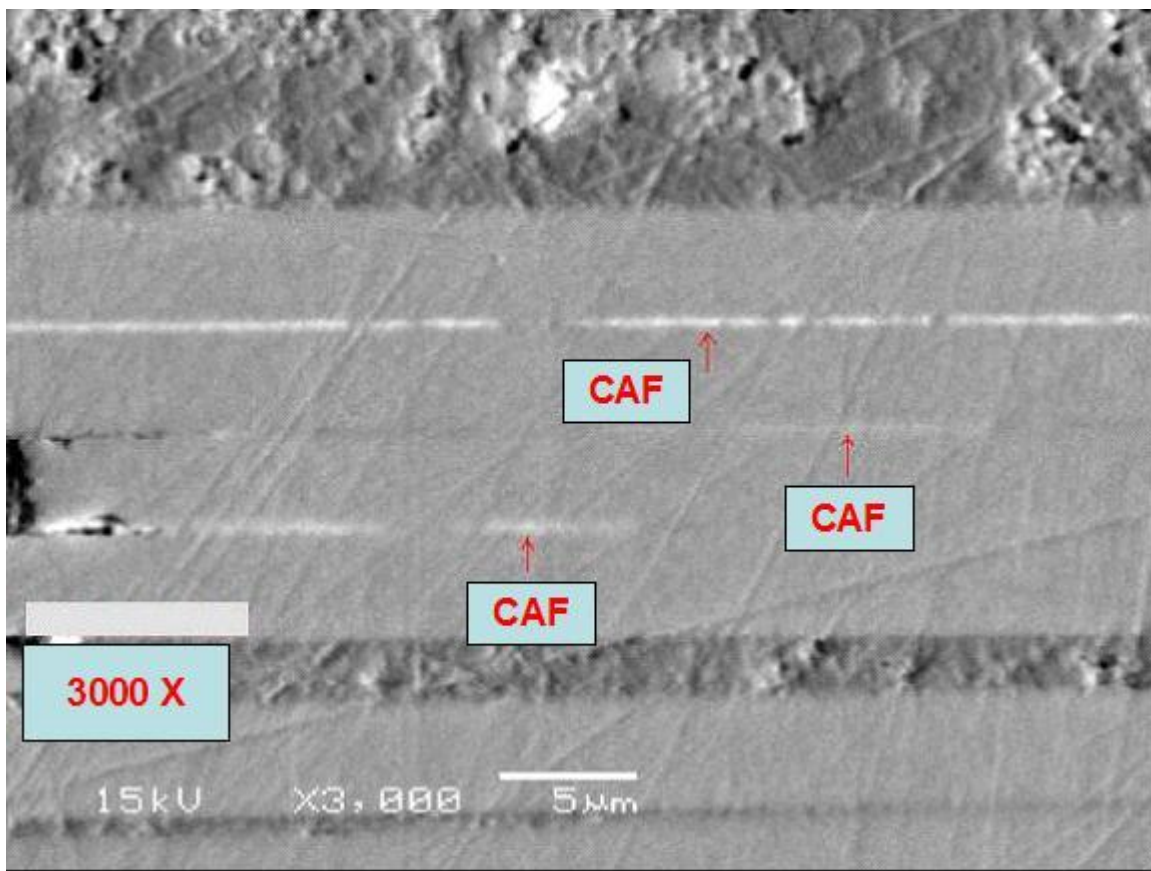
**Figure 36 (The 106 Glass Effect)**

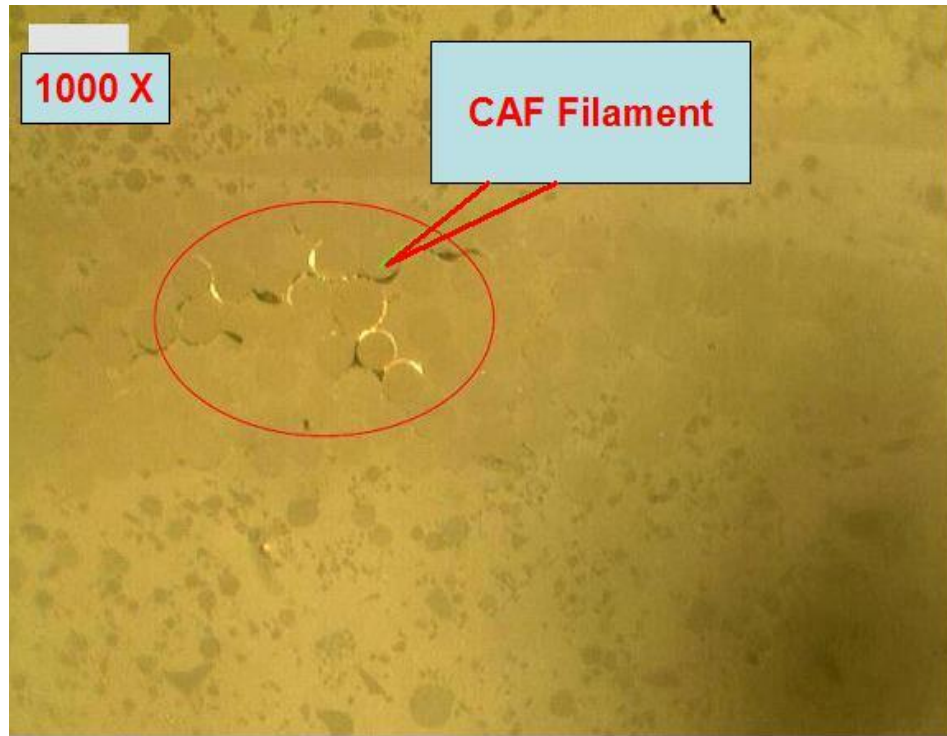
**Figure 39 (The Low Bulk Resistivity Effect)**  
 CAF Failure Before Reflow - FMA vertical X-sect Picture by Microscope – (HiSpd Material-U)

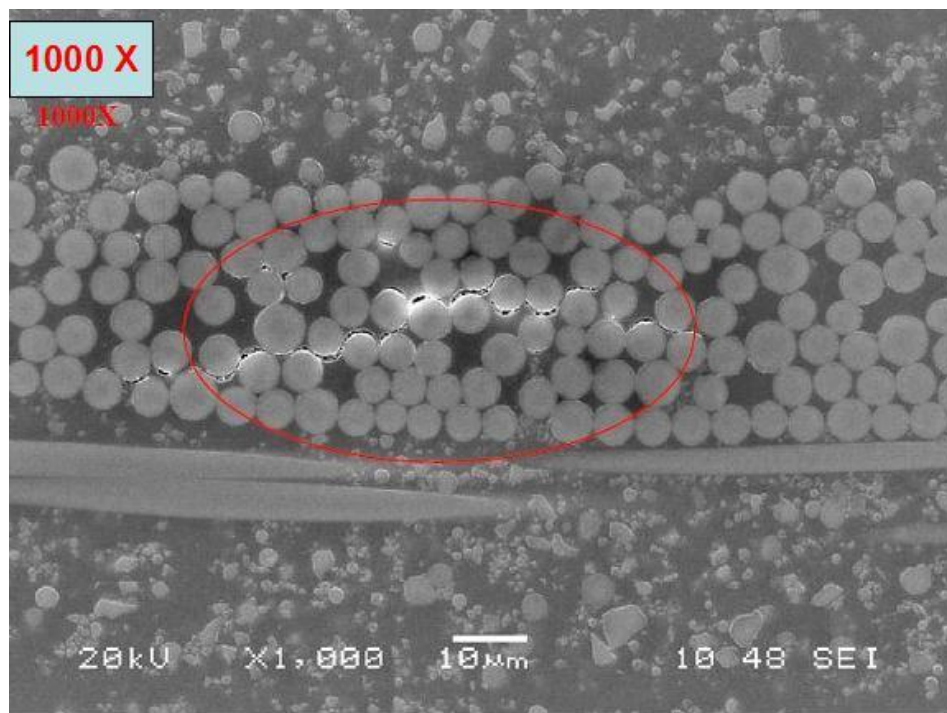
**Figure 40 (The Low Bulk Resistivity Effect)**  
 CAF Failure Before Reflow - FMA vertical X-sect Picture by SEM – (HiSpd Material-U)  
*Note: Evidence of a very Large Pathway present Before Reflow →  
 Can lead to overall resistivity problems besides CAF/IM failures*
