# Drop Test Performance of A Medium Complexity Lead-Free Board After Assembly and Rework

P. Snugovsky, J. Bragg, E. Kosiba, M. Thomson, B. Lee, R. Brush, S. Subramaniam, M. Romansky  
Celestica International Inc.

# Drop Testing of a Pb-Free Board After Assembly and SnPb-Rework

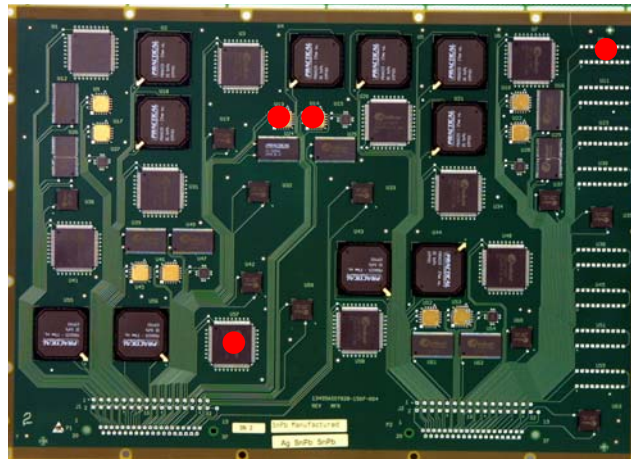
**Figure 4: Location of Non-BGA Component Resistance Failures**

Although 477 non-PBGA components were drop tested, only 4 had any increase in net resistance after 20 drops (see Figure 4). The 4 non-PBGA components with electrical failure had the following rework histories:

- Board SN 84, CLCC-20, U14 was **not** reworked
- Board SN 85, TQFP 144, U57 **was** reworked **once**
- Board SN 85, PDIP-20, U8 **was** reworked **once**
- Board SN 86, QFN-20, U15 **was** reworked **twice**

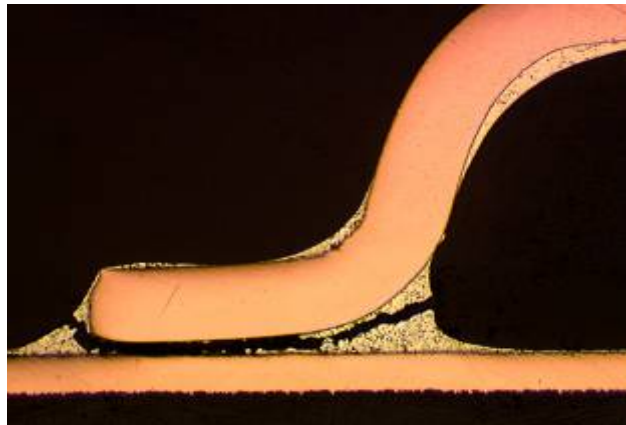
Pad cratering occurred in all package types (CLCC-20, QFN-20, TQFP-144, TSOP-50) but was less prevalent in the TQFP-144 in which pad cratering was observed on only one out of nine dye-and-pry samples and was not at all found through cross sectioning. This is likely due to the structure of the part, which has compliant copper leads on all four sides, ensuring efficient stress distribution. However, in one part, the lead was found to fail through the solder in a fatigue failure mode (see Figure 9).

**Figure 9: Fatigue failure of TQFP-144 with 1x rework as seen through cross sectioning**

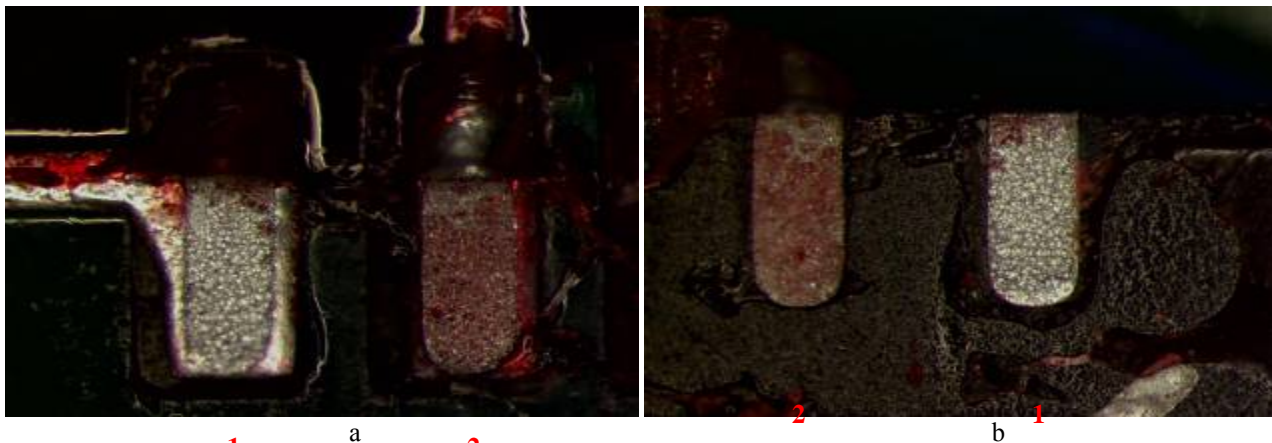
Partial solder joint cracks and pad cratering were both observed on the QFN-20 part, at approximately the same frequency. For example, in Figure 10, pin 1 of this QFN-20 package, shows some evidence of dye penetration through the bulk solder, indicating that a fracture was present prior to prying the component from the board. The penetration covers less than 25% of the solder surface near the top edge of the joint. Pin 2 shows almost complete dye penetration across the whole pin. The fracture appears to include the intermetallic surface.

**Figure 10: Dye and Pry results of a QFN-20 showing dye penetration through the bulk solder: a- board side; and b- component side**

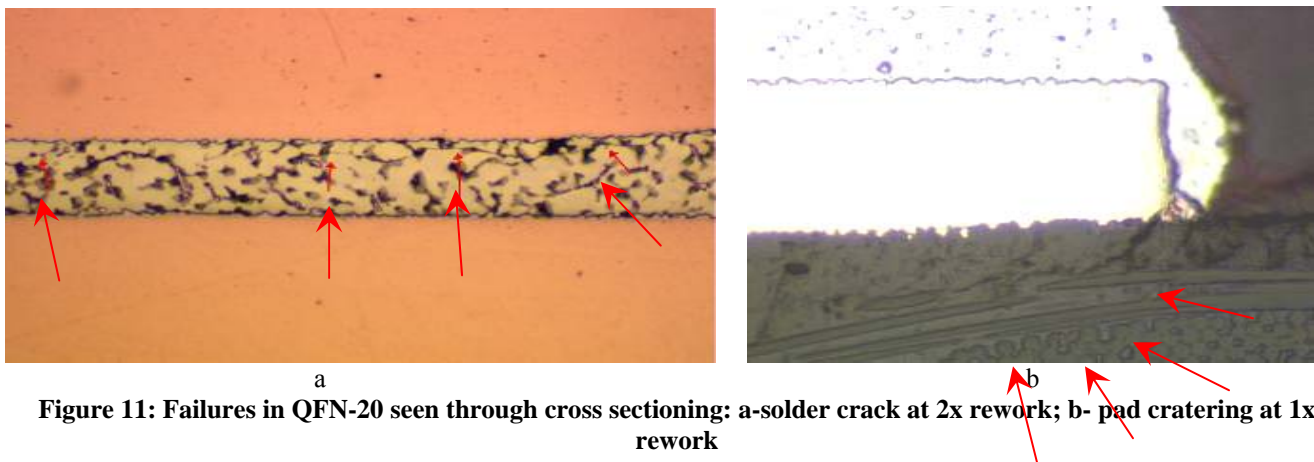
Figure 11 shows cross sections which reveal both a fine crack through the bulk solder and pad cratering in a QFN-20 package.

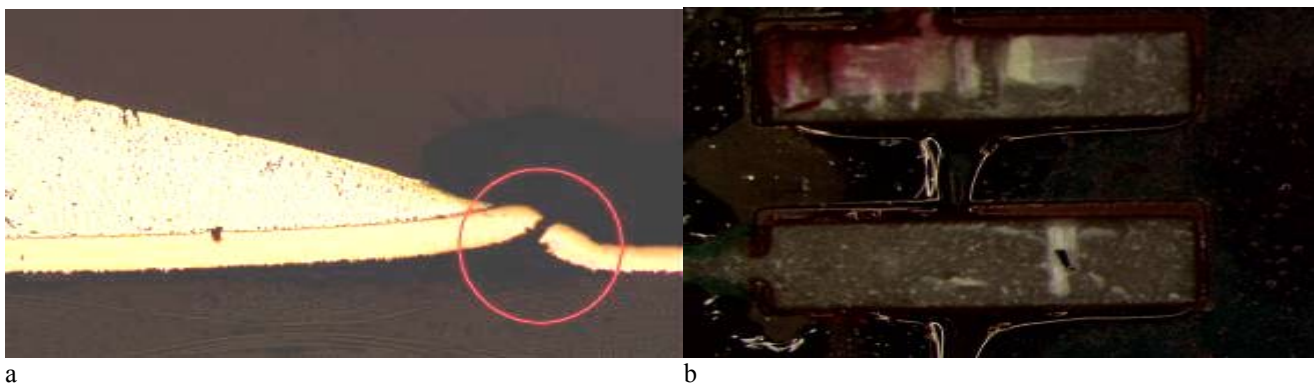
Both the CLCC-20 parts tested and most of the TSOP-50 parts destructively analyzed show some degree of pad cratering. The cross section in Figure 12(a) illustrates an example of cratering that resulted in a broken trace which can explain the corresponding electrical failure. Figure 12(b) shows the typical pad cratering of a CLCC-20 viewed through dye-and-pry testing.

**Figure 12: Pad cratering seen on CLCC-20 through: a- cross sectioning; b- dye-and-pry**

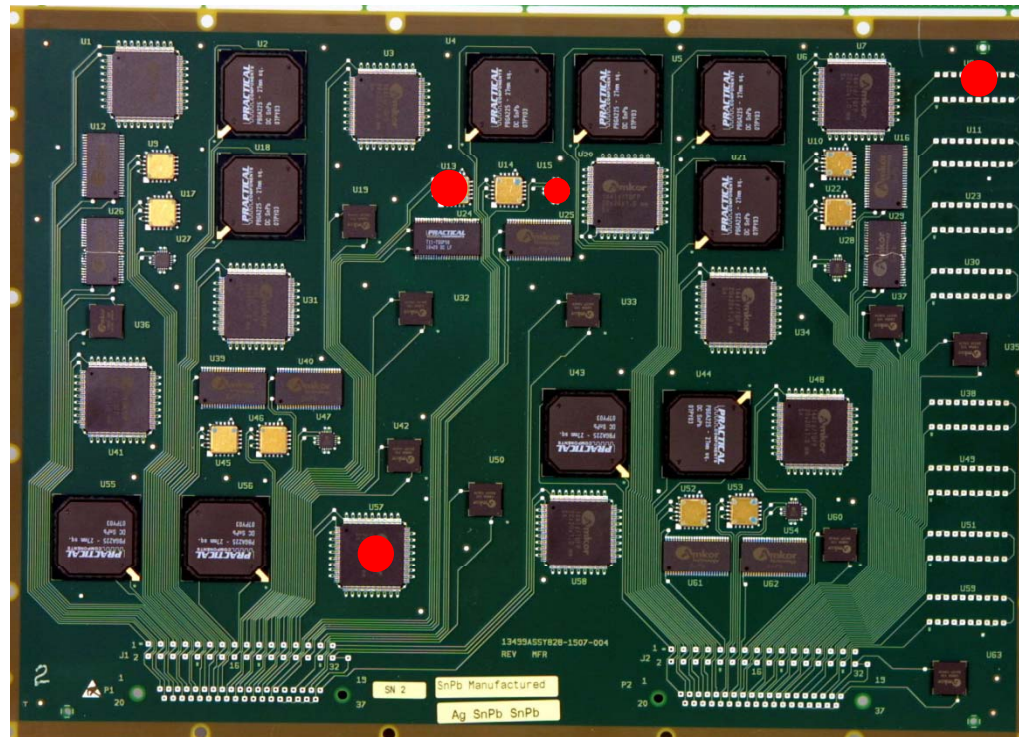
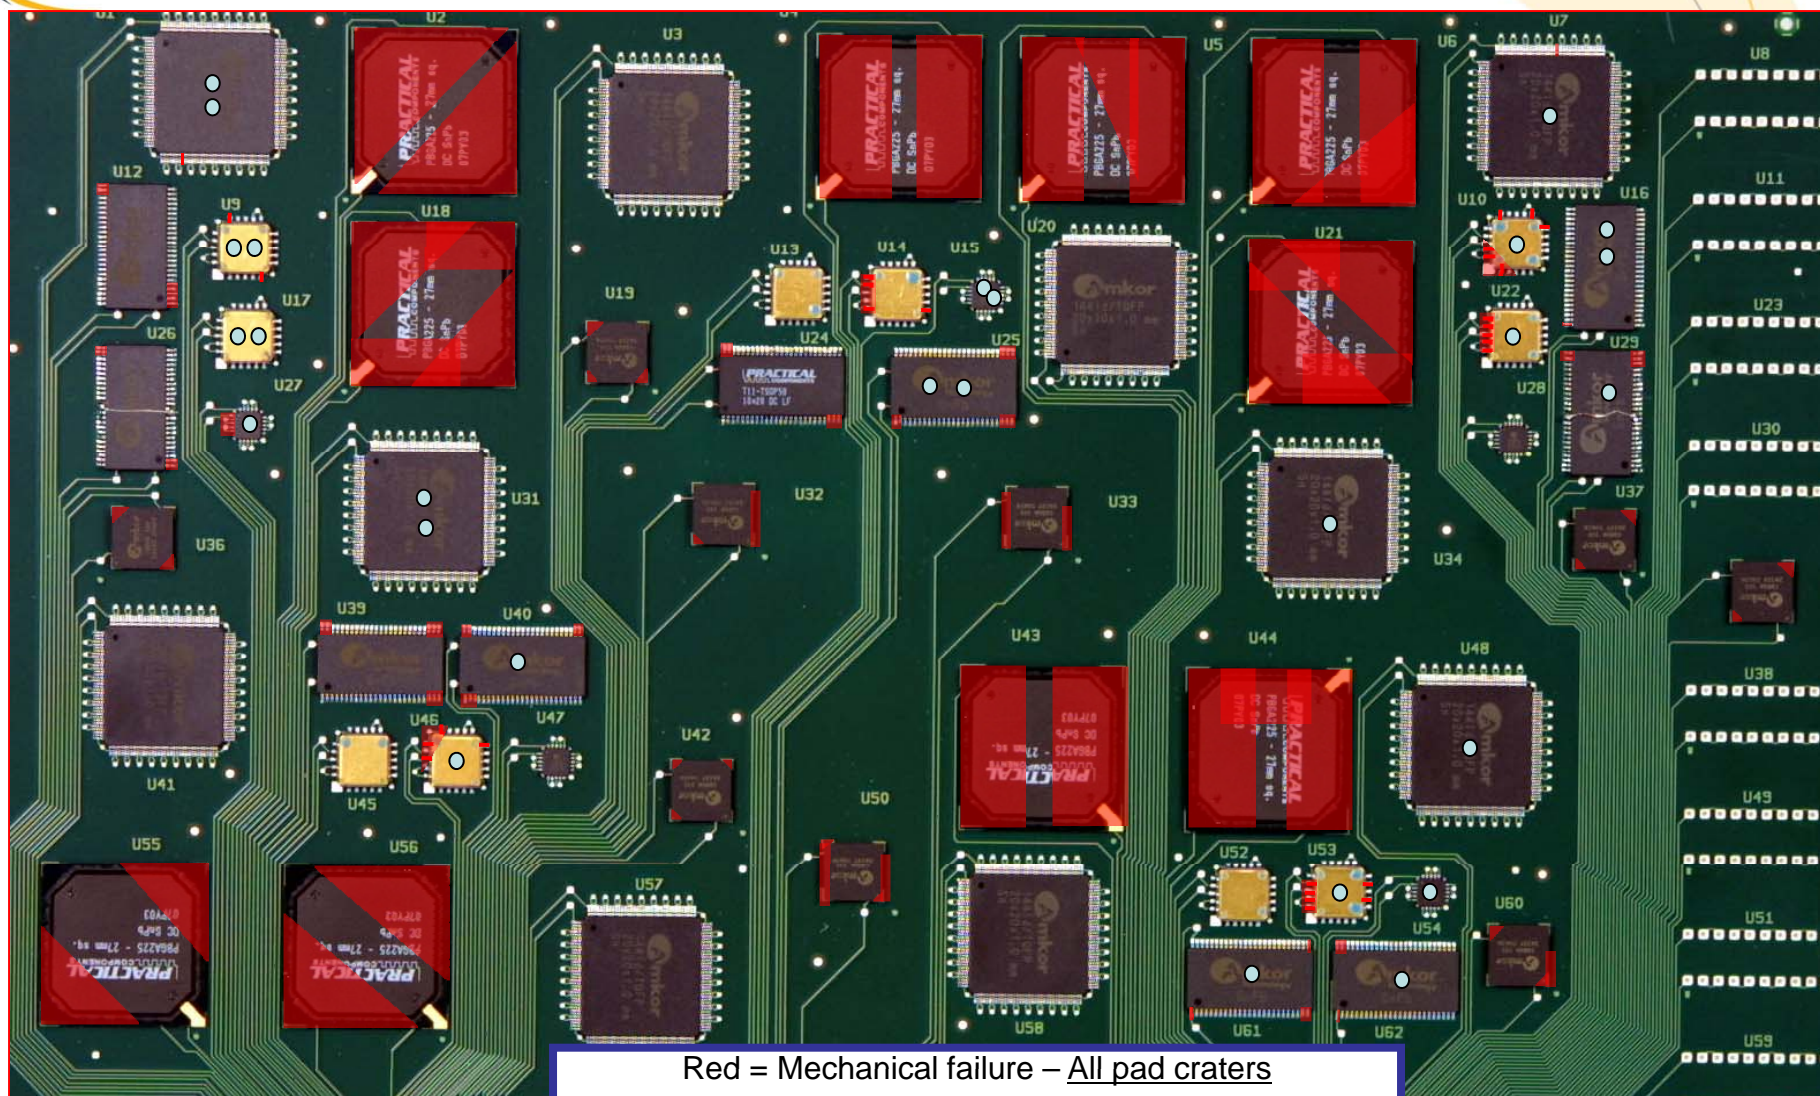
- Only **4** non-BGA electrical fails (< 1%)
  - Board SN 84, CLCC-20, U14 was **not** reworked
  - Board SN 85, TQFP 144, U57 **was** reworked **once** with SnPb
  - Board SN 85, PDIP-20, U8 **was** reworked **once** with SnPb
  - Board SN 86, QFN-20, U15 **was** reworked **twice** with SnPb

Red = Mechanical failure – All pad craters

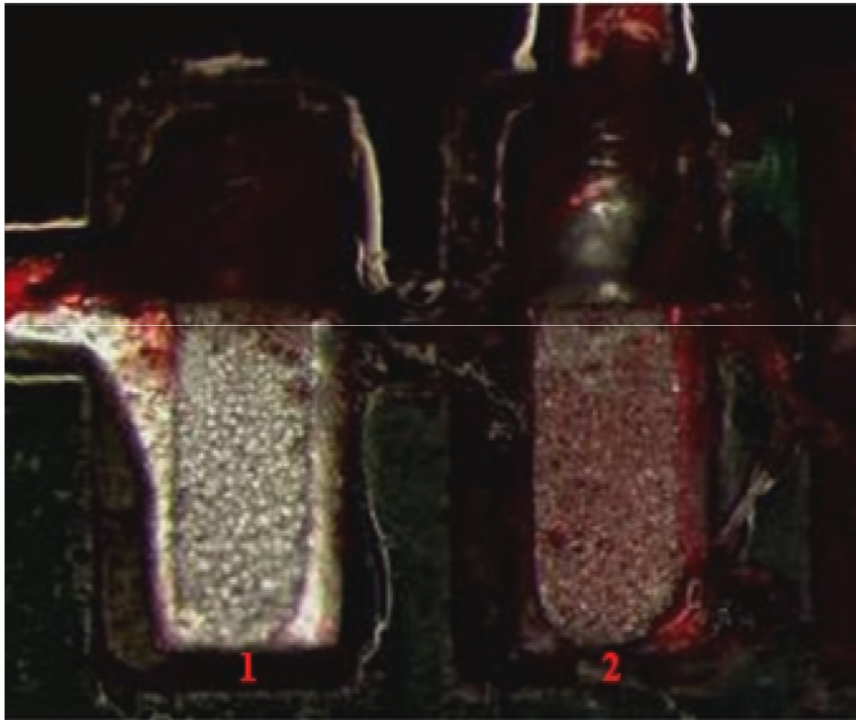
Solder Fracture,  
Full Dye Penetration  
(QFN, lead 2)

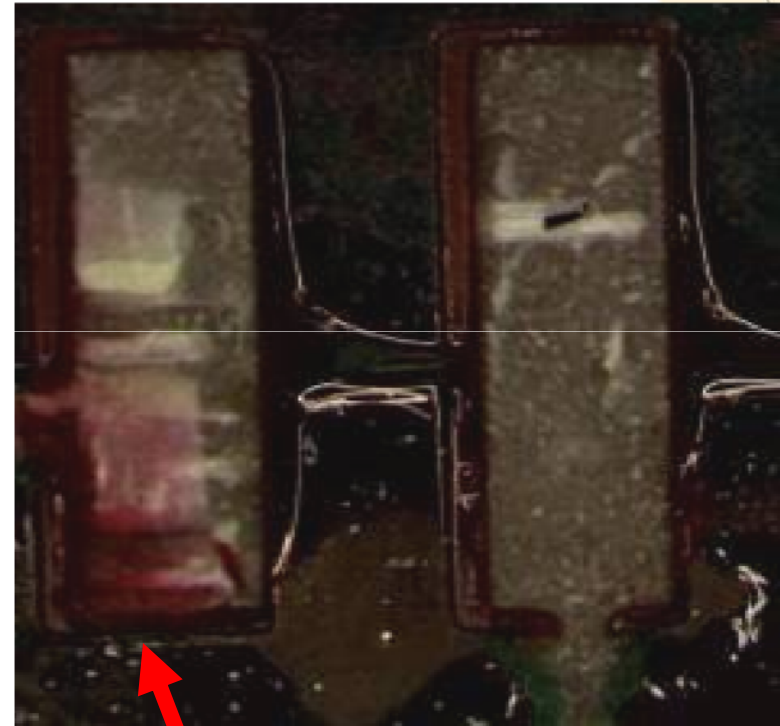
Pad Crater,  
Partial Dye Penetration  
(CLCC)

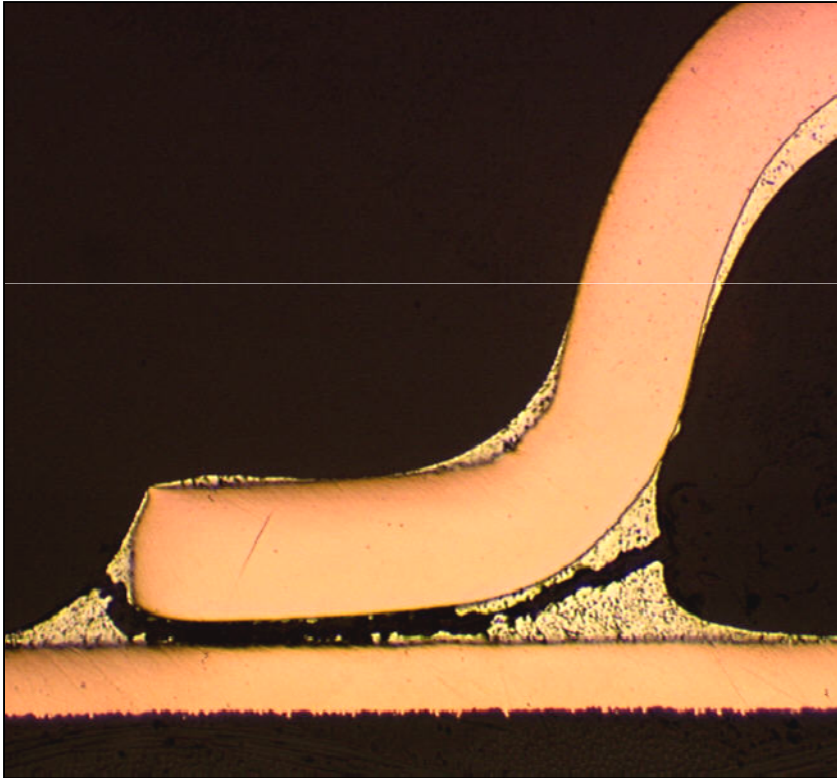
Solder Fracture  
(TQFP-144, 1x rework)

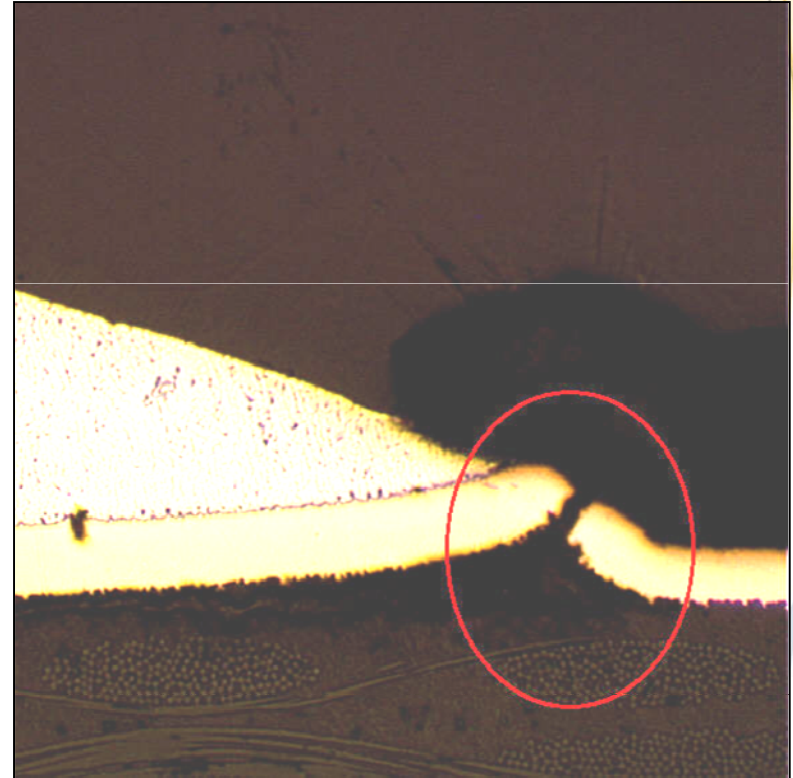
Pad Crater with Trace Break  
(CLCC)

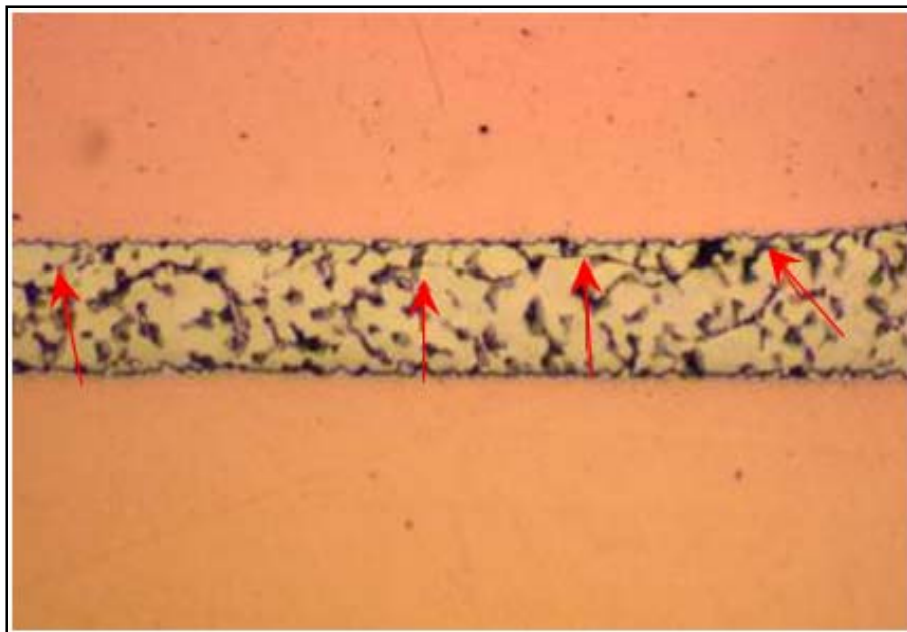
Partial Solder Fracture  
(QFN-20, 2x rework)

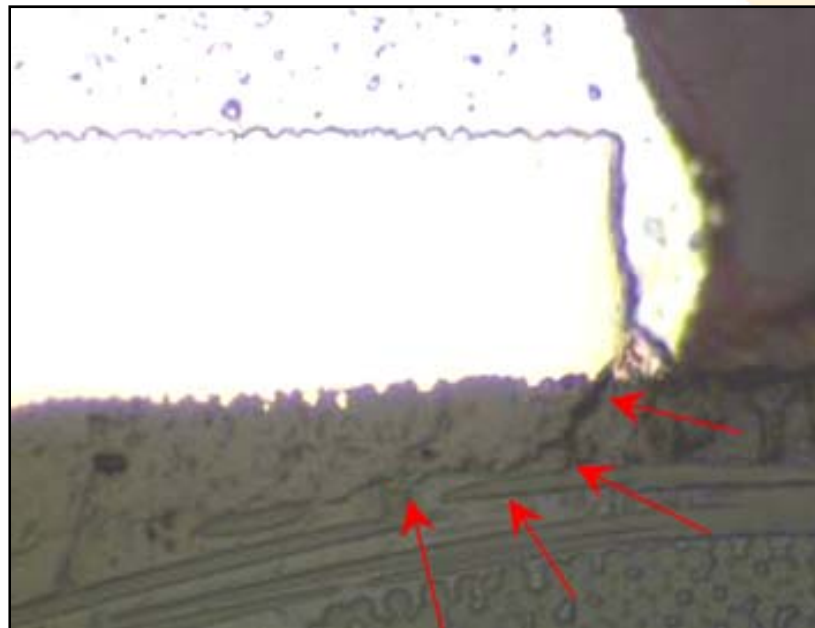
Partial Pad Crater  
(QFN-20, 1x rework)
