“Metal Whiskers”

Does Surface Contamination Have an Effect of Whisker Formation?

Terry Munson / Paco Solis
Foresite Inc.
Kokomo Indiana

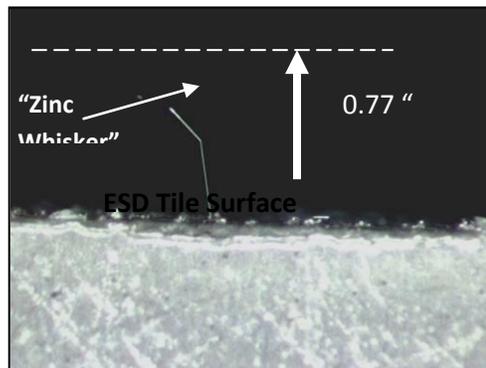
Figure 1 - Tin whisker on zinc alloy ESD floor tile

- These whiskers are the result of a highly Sulfonated / Amine bearing mop water solution (validated by Ion Chromatography testing). ESD Soap!
- On tiles where these ionic residues have been removed by remedial cleaning and rinsing (with proper chemistries), the whisker formations are greatly retarded or completely eliminated.
- Contaminated tiles in our lab continue to produce whiskers to this day.

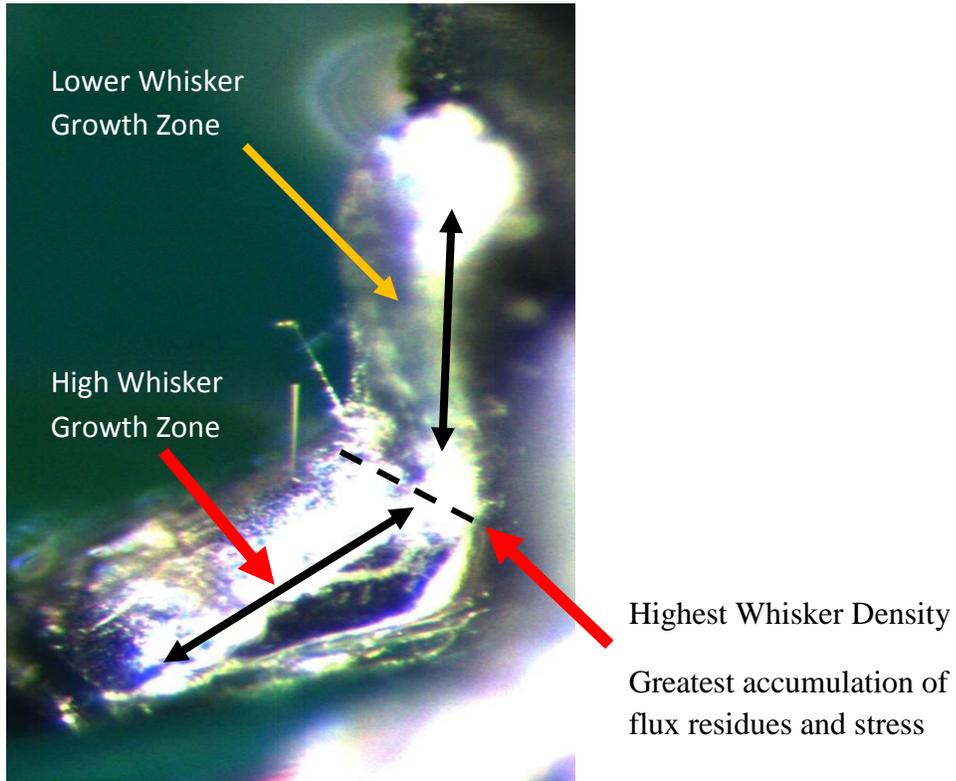
Figure 2- Whiskers on SOT gull lead with SAC 304 alloy termination

During reflow, high concentrations of flux residues flow up the termination and accumulate at the gull wing bend. Although solder reflow occurs from toe to shoulder, the flux accumulation settles at the lead bend. A second item noted was the discovery of nano-whiskers which form from the flux line extending over 200 μm in serpentine length and under 1 μm in width.

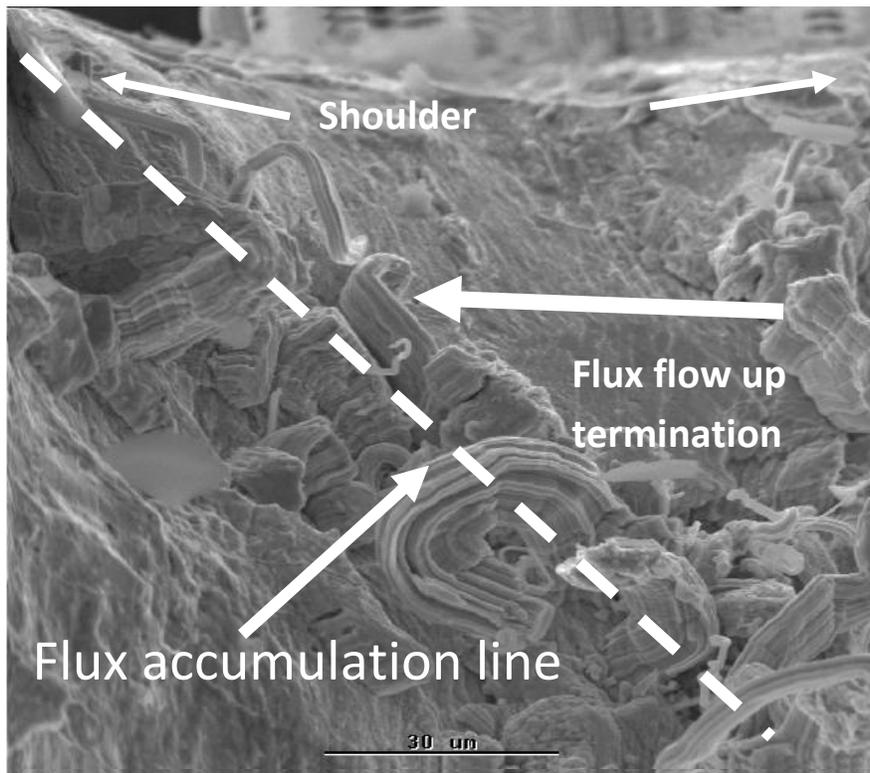
Figure 3 - SEM Image of SOT gull wing termination

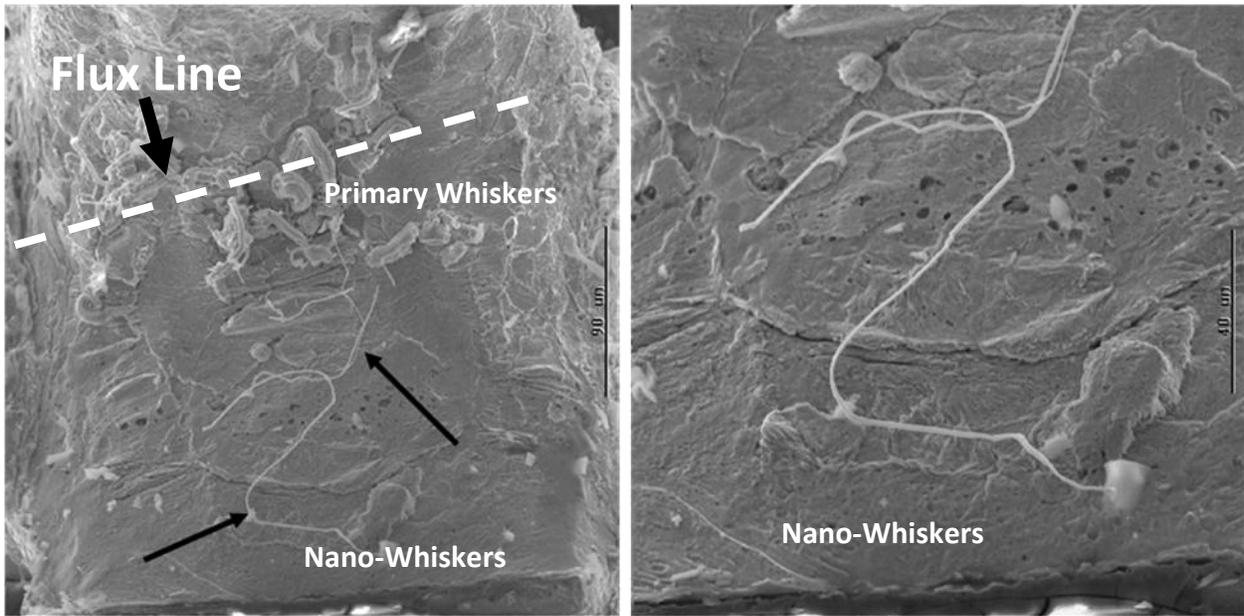
Figure 4 & 5 - SEM Image of primary and Nano-Whiskers

These nano-whiskers continuously extrude from the surface as well as from the larger primary whiskers. They settle on the surface and are freely fractured and fall away with little force.

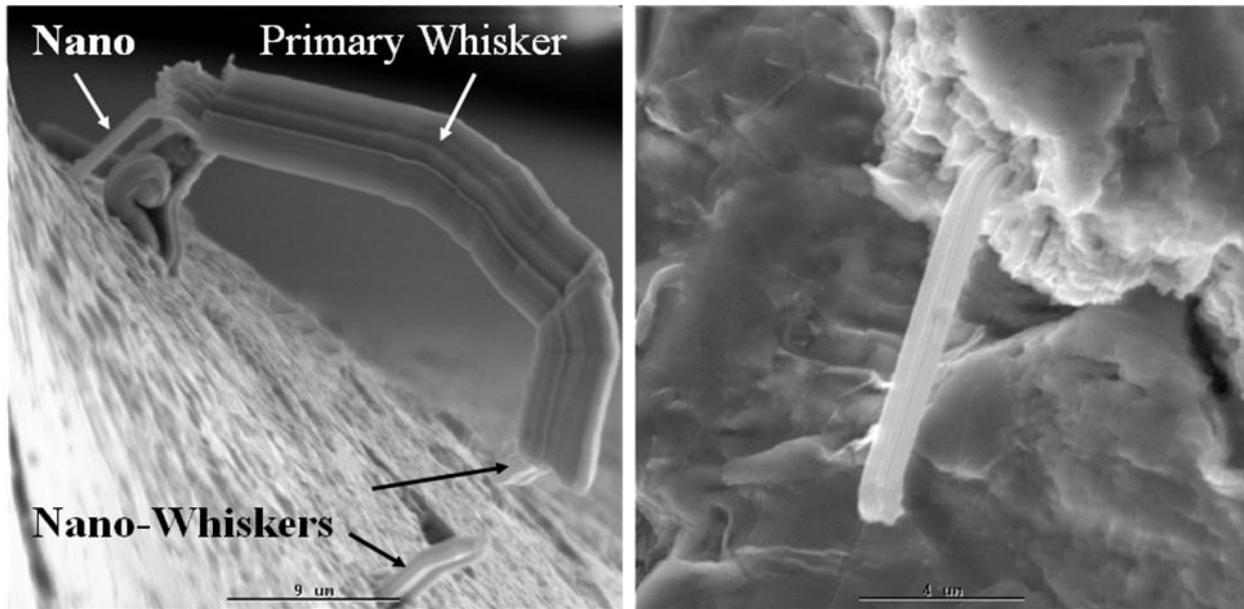
Figure 6 & 7 - SEM Image of primary and Nano-Whiskers

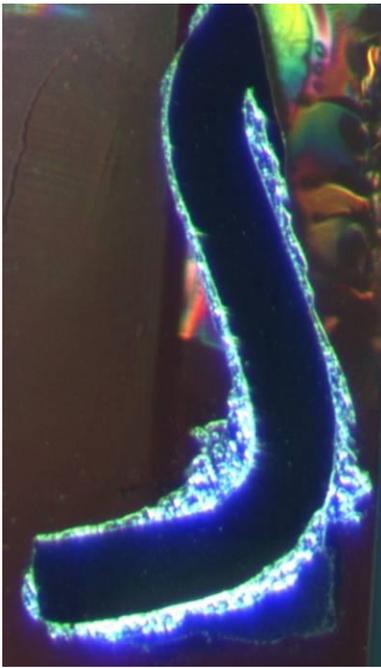
Figure 8 – Optical Image of primary whisker in cross-section

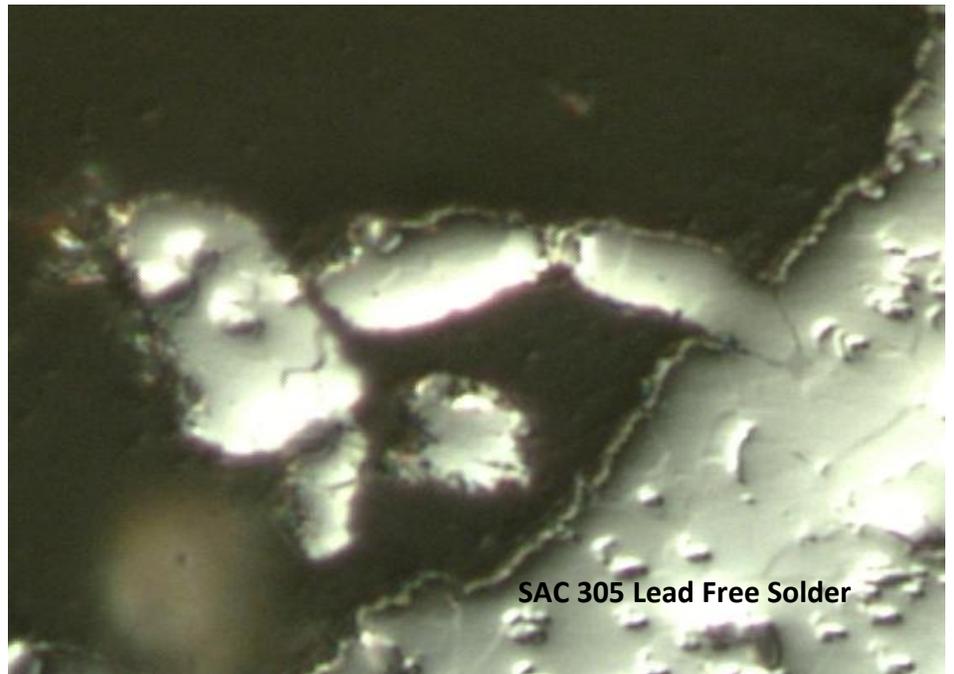
Figure 9 – Optical Image primary whisker in cross-section at 1000X

In cross-section a single grain dislocation can be seen at the whisker extrusion site. More samples like these are needed to further study this condition. This sample was prepared with pH 9 gamma colloidal silica slurry for grain delineation. The sample was unfortunately compromised before it was submitted to SEM analysis.

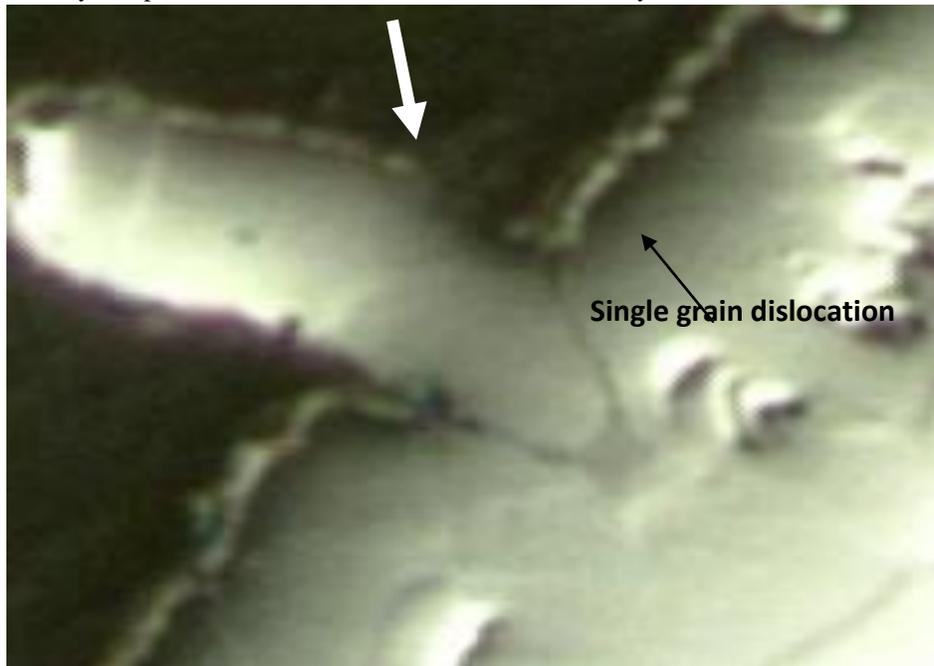
Figure 10 – Optical Image of primary whisker in cross-section at 1000X (digitally magnified)

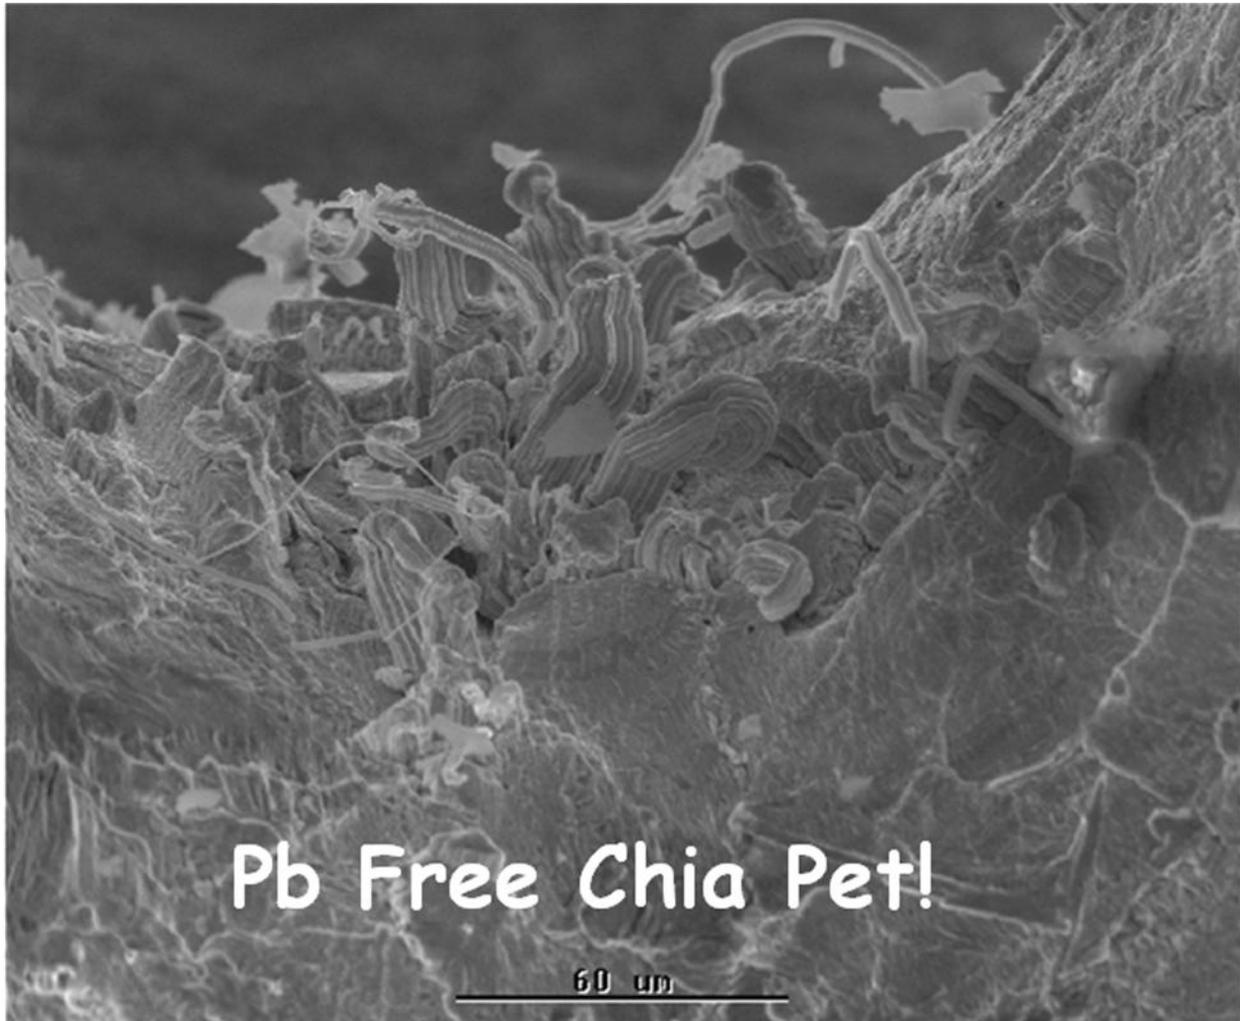
- Localized D.I. steam cleaning with a saponifier has proven effective at preventing reoccurrences when total ionic contamination has been reduced.
- Inversely - areas doped with high levels of ionic contamination show a significantly higher occurrence of whisker formations.

Figure 16 – Results of accelerated whisker growth from select doping of terminations

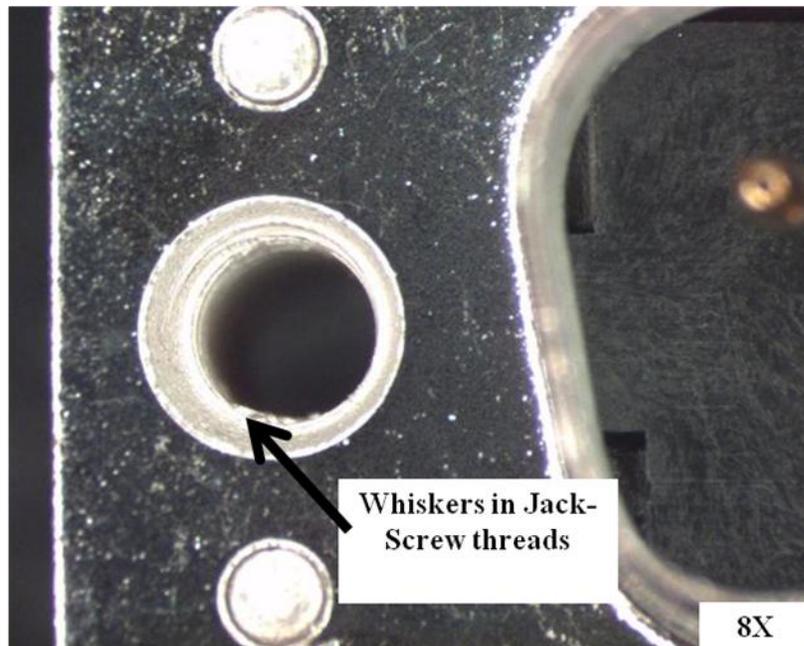
Whiskers are forming in the jack screws of lead free connectors. Preliminary data has shown high levels of Chlorides, Sulfates, and Amines are present in the Jack Screws. Analysis is ongoing to study the contamination effects in these locations and the retardation effects of cleaning. Data on this analysis is will published in updates to this paper.

Figure 17 – optical images of whiskers on jack screw threads

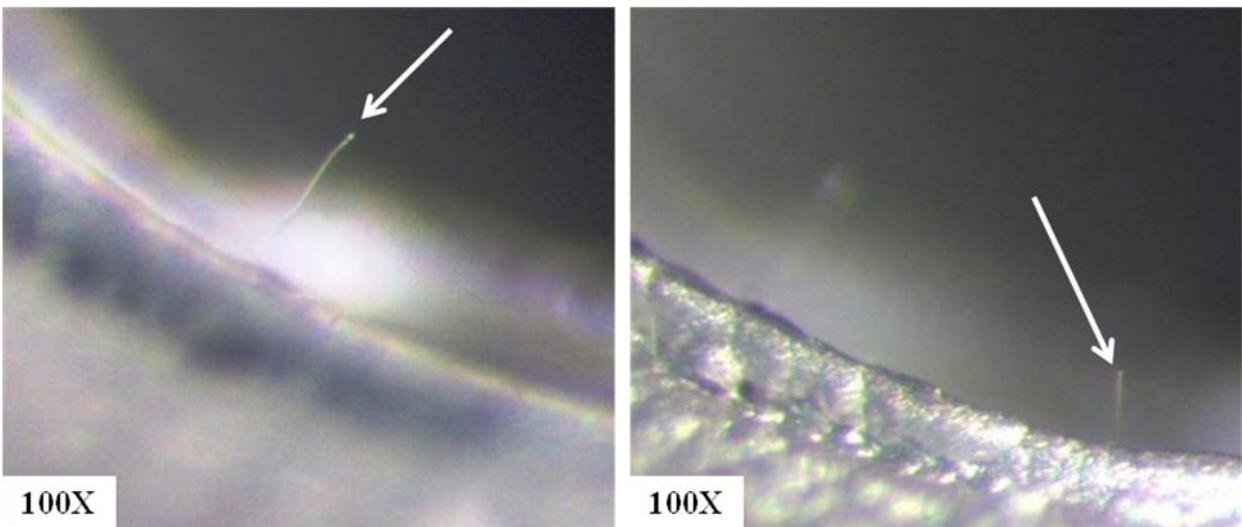
Figure 18 & 19 – optical images of whiskers on jack screw threads

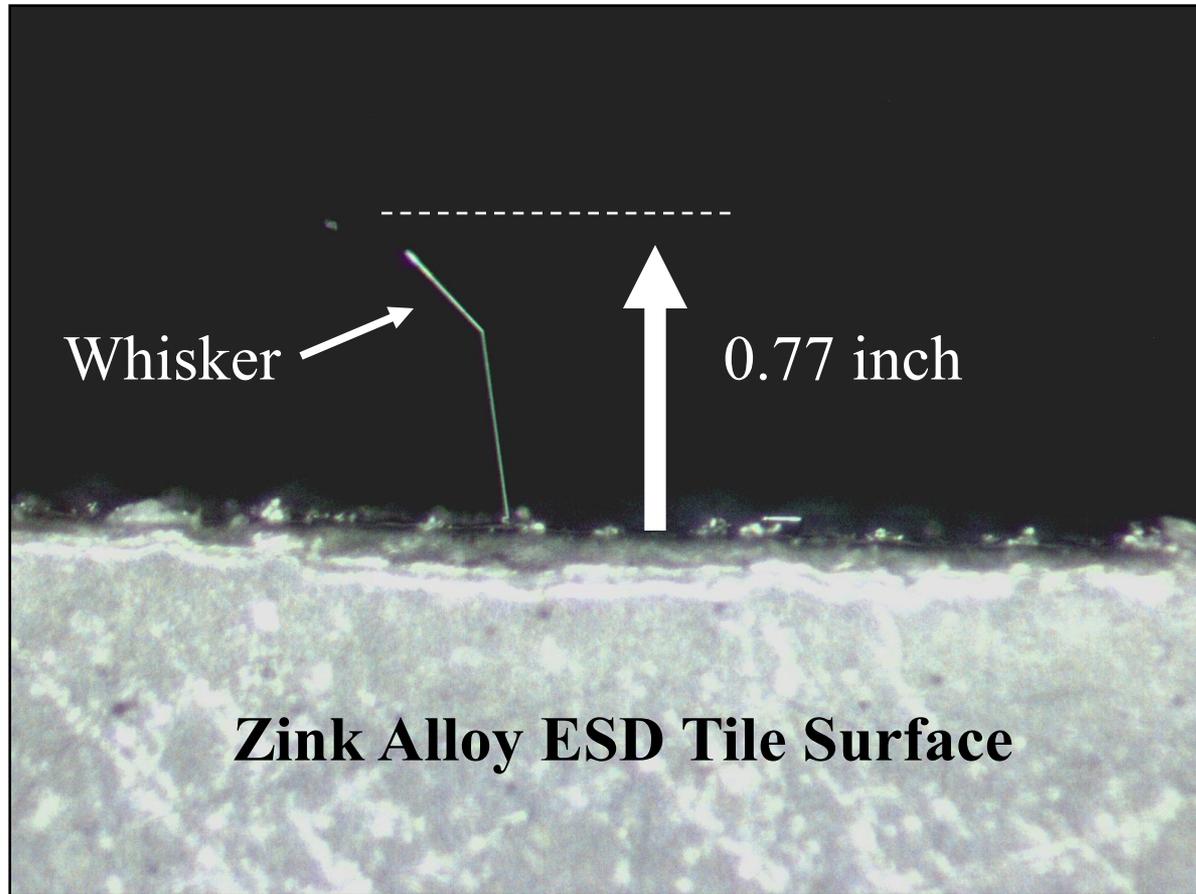
Zinc Whiskers from raised ESD Floor Tiles

- These whiskers are the result of a highly Sulfonated / Amine bearing mop water solution (validated by Ion Chromatography testing). ESD Soap!
- On tiles where these ionic residues have been removed by remedial cleaning and rinsing (with proper chemistries), the whisker formations are greatly retarded or completely eliminated.
- Contaminated tiles in our lab continue to produce whiskers to this day.

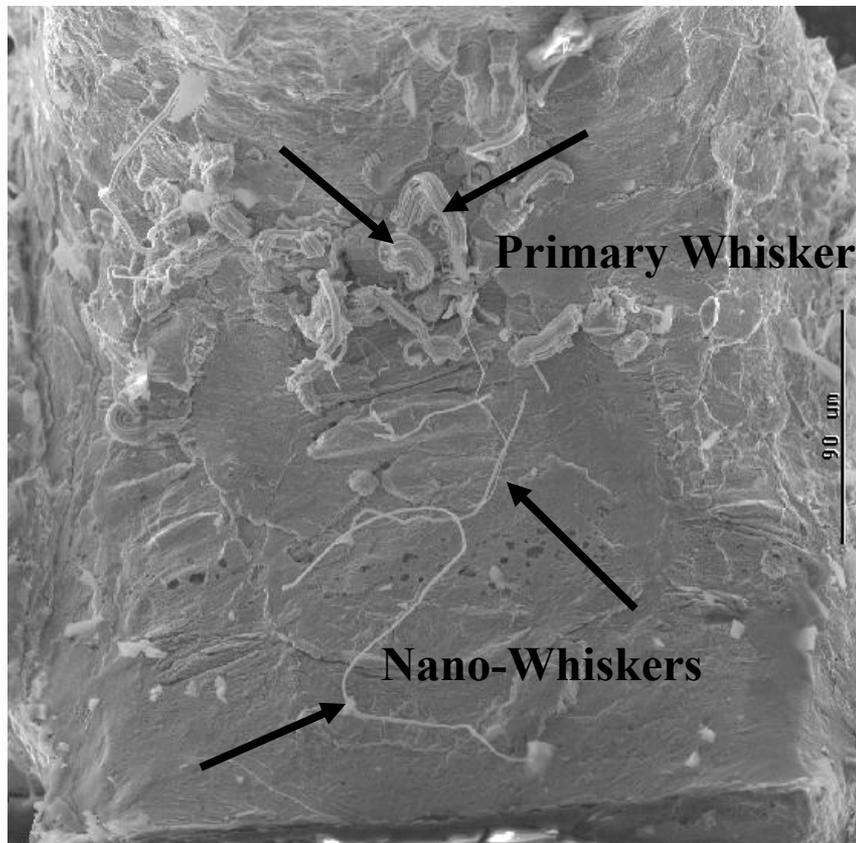
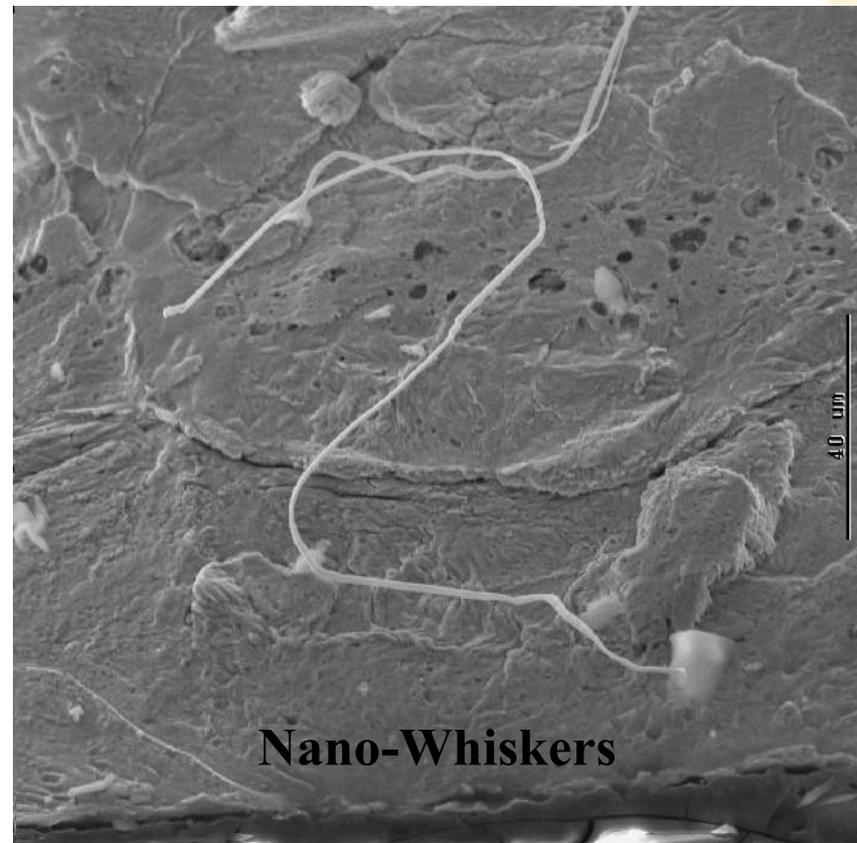
Nano Whiskers!

Serpentine length > 200 μm

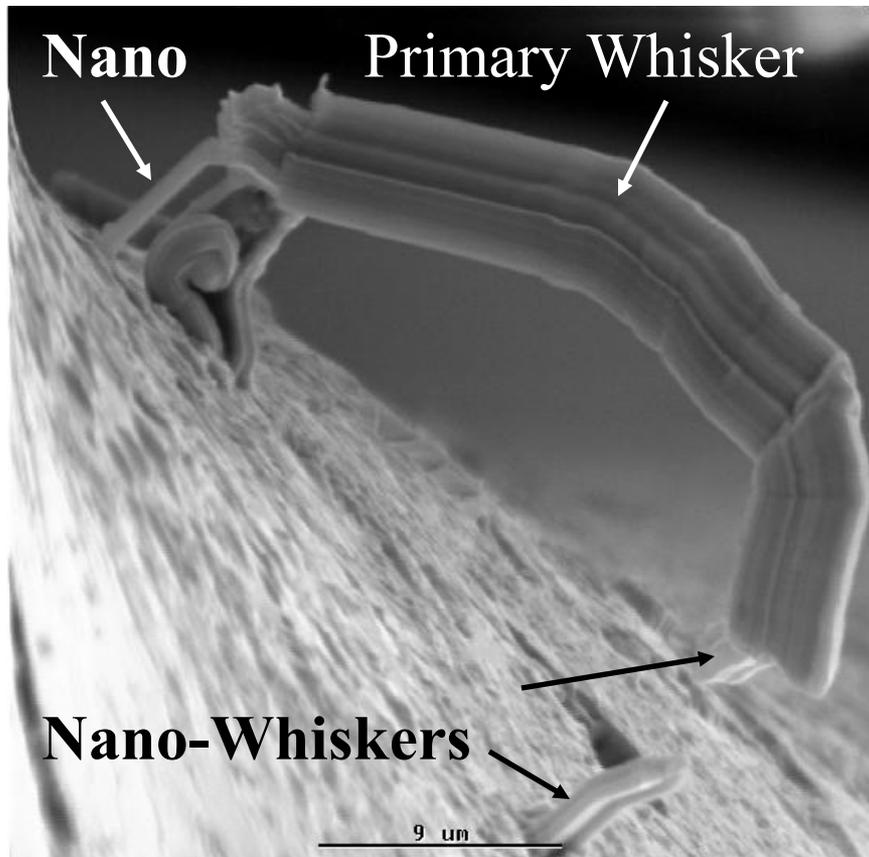
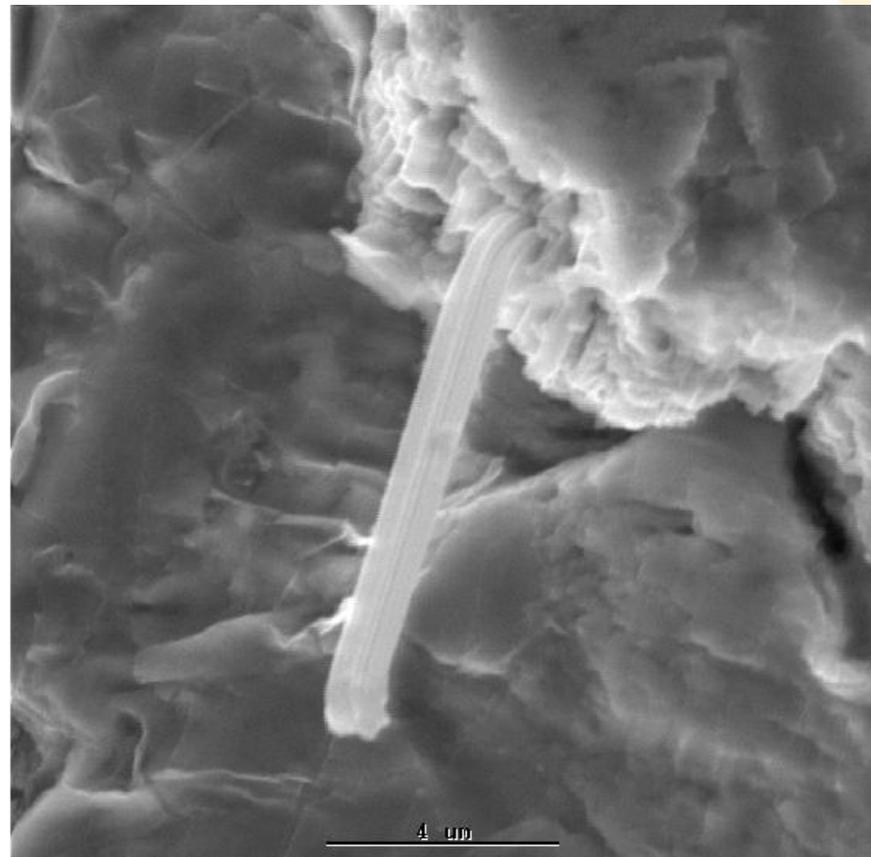
More Nano-Whiskers

Nano-Whiskers have been measured $<1\mu\text{m}$ in width

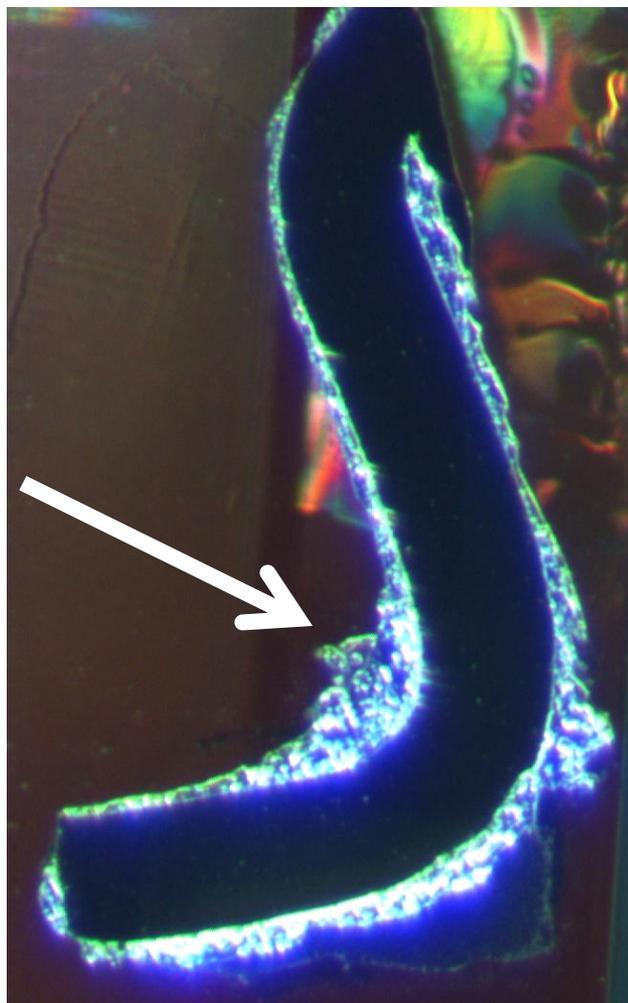
Termination in Cross-section

Highest Whisker Density.

Greatest accumulation of
flux residues, stress, and
solder slump

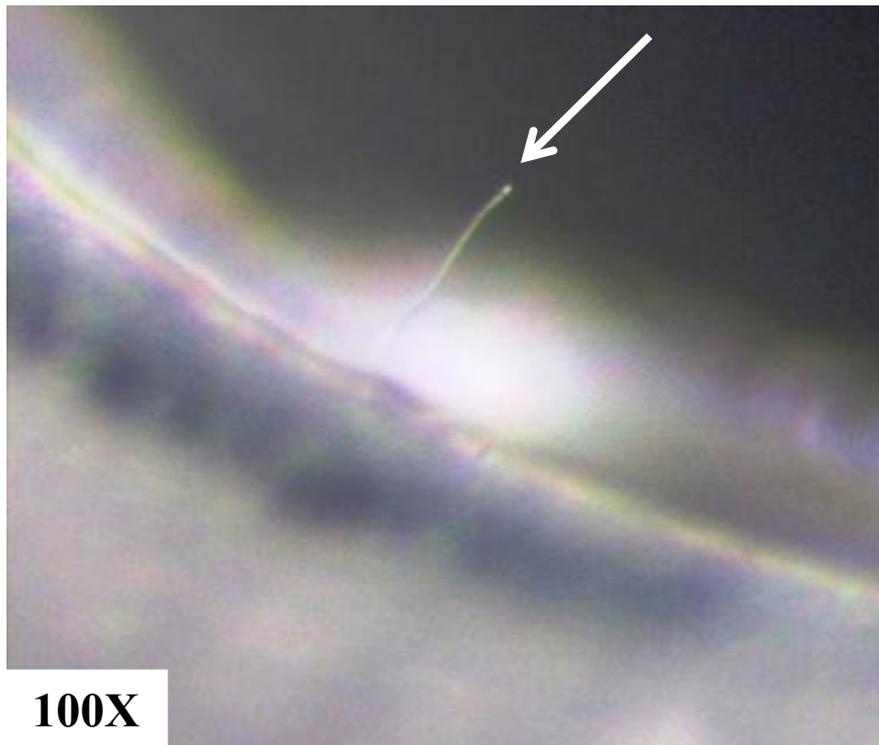
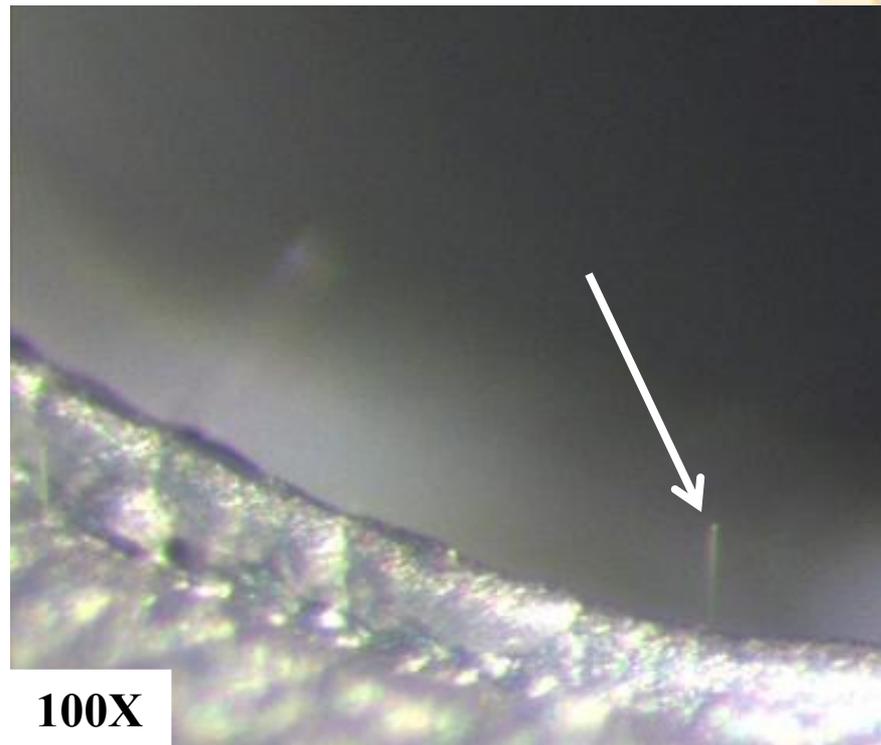
D-Sub Connector Sn Whiskers on Jack-Screw threads
