Reliability and Failure Mechanisms of Laminate Substrates in a Pb-free World

Kevin Knadle
Endicott Interconnect Technologies, Inc.
Endicott, NY

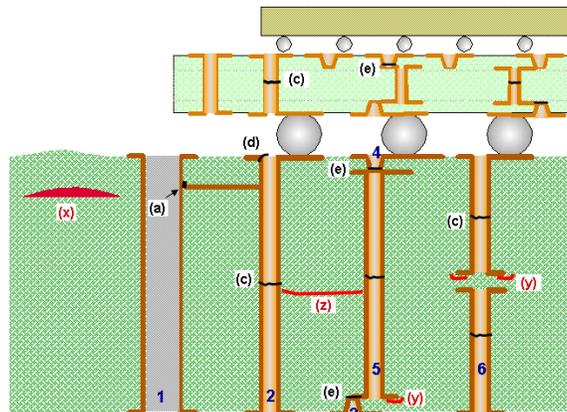
Figure 1—The “PTH” family and related failure mechanisms for today's boards and chip carriers.

The first significant change to the PTH occurred in the 1980-1990's with the advent of surface mount technology (SMT) where plated thru vias shrunk in diameter and were no longer solder filled, resulting in the “wiring via” (Figure 1 via 2). As

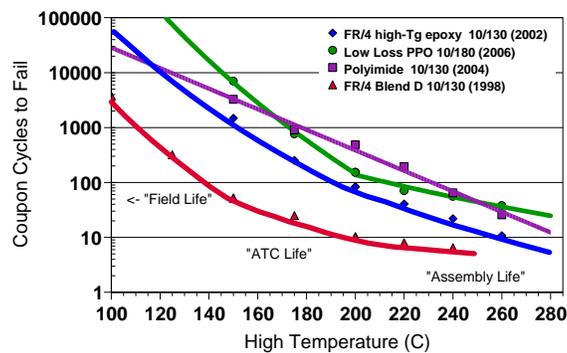
The place to start a discussion of today’s PTH and laminate problems is with a review of the standard wiring thru via— barrel life as a function of temperature, and video clips of barrel and laminate deformed state at reflow temperatures. The “PTH life curve” has been used by the author for over 15 years to characterize new materials or PTH structures, and to calculate via life for any combination of temperatures^[1-4]. Figure 3 depicts some select recent and vintage life curves to review the problem that is behind all others—the CTE mismatch between copper barrel and the surrounding laminate at reflow temperatures can produce deformation of such magnitude that even well plated vias can survive only a handful of assembly passes without cracking. The 1998 red curve FR/4 (10 mil vias/130 mil thick PWB) is from a mixed resin system (note the 2 Tg deflection points in the curve) that is no longer commercially available, and which was the cause of several cases of PTH cracking based on industry discussions. The reason for such fails is clear from the curve at the “assembly” life end of the curve— well constructed coupons lasted less than 8 reflow cycles. Since 1-2 reflow cycles are required for SMT attach, and an additional 2 reflows for each rework (remove & replace), 8 reflow cycles to 220°C could be envisioned during assembly. But more importantly there is no “safety factor” in 8 reflows—any increase in thermal exposure, or any form of thin plate or defect in the vias could easily account for assembly driven cracks, as was confirmed by industry experience. Failure analysis of the 8 cycle 23-220°C CITC fails showed significant laminate and copper deformation. Note that if the same product could be shipped to the field without any reflow, it would survive (by extrapolation) over a million cycles of 23 to 75°C!

Figure 3-- Select CITC PTH life curves to illustrate challenge of unfilled wiring vias.

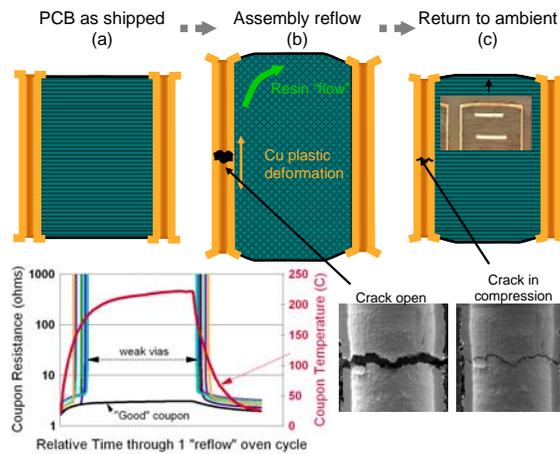
While Figure 3 shows the reason for assembly driven failed vias, Figure 4 illustrates why they can be a serious reliability concern as latent opens in the field. At reflow temperatures above the Tg of the laminate material, the z-axis expansion of the laminate is an order of magnitude much greater than that of the copper, which forces the copper in tension where it plastically deforms—i.e., the copper barrel becomes permanently longer than it was. Similarly, the laminate sees significant compressive forces in the zone around the PTH barrel because the barrel acts as a rivet to constrain it from expanding as it would away from the PTH. These considerable compressive forces create a pressure gradient that causes the laminate, now well above Tg, to “flow” away from the barrels. “Flow” is used in quotes because cross-linked thermoset polymers are not supposed to flow as other polymers, but some form of movement or reshaping is indicated by the permanent deformation seen in laminate x-sections after reflow or solder shock—the laminate is now longer between vias than in the zone directly next to them (Figure 4c). The combination of these permanent deformations (longer barrel, shorter laminate) means that any crack formed at the peak temperature will be forced in slight compression on return to room temperature. In addition to the illustration, figure 4 includes 1) ESEM photos of a barrel crack open at 230°C and the same crack closed tightly again after cooling to ambient, and 2) electrical measurements of 8 coupons (left axis) with intentionally very weak barrels through a single simulated reflow cycle in a convection oven showing them open completely during heating (temperature, red line and right axis) between T = 140-185°C, and close solidly to original resistance value starting between T=175-110°C.

Figure 4-- Illustration, electrical data, and ESEM photos of deformations on a wiring via during assembly cycle.

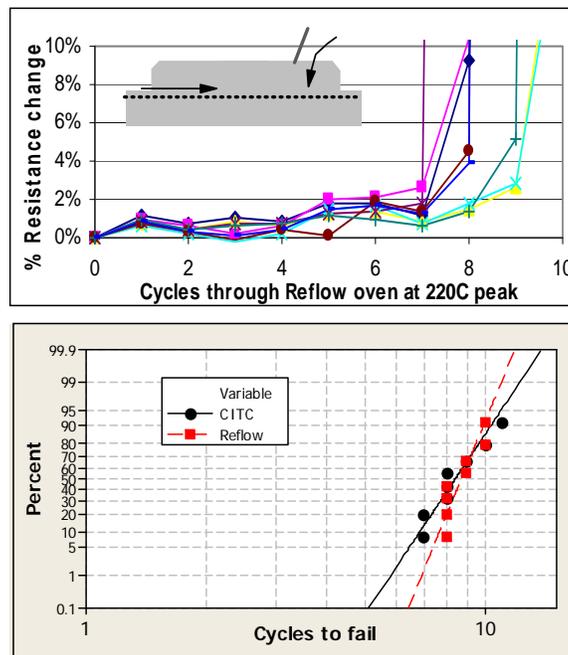
to allow hand probing of the coupons right after the heating peak. That is, at the correct point (by timing) of each pass, the panel was removed and the part quickly measured with 4 wire resistance while still hot. Before pass 1, the oven was profiled with an identical block to 220°C peak using the same timing and panel removal. The part was cooled to room temperature, and this process repeated up to 10 passes. Figure 5a plots the hot resistance by coupon and reflow cycle. A 3% failure criterion was used in this case, instead of 5 or 10%, because of the difficulty of reading all the coupons simultaneously while still hot, and because it appears to best fit the sharp slope change of the data. The final results are plotted in Figure 5b— the curve for cycles to fail from actual 220 reflow passes is almost identical to the 220°C CITC cycles to fail curve.

Figure 5-- -- Reflow verification for CITC data of Figure 3; (a) Coupon resistance vs. cycle measured inside reflow oven. (b) Probability plot showing identical cycles to failure between CITC and reflow.

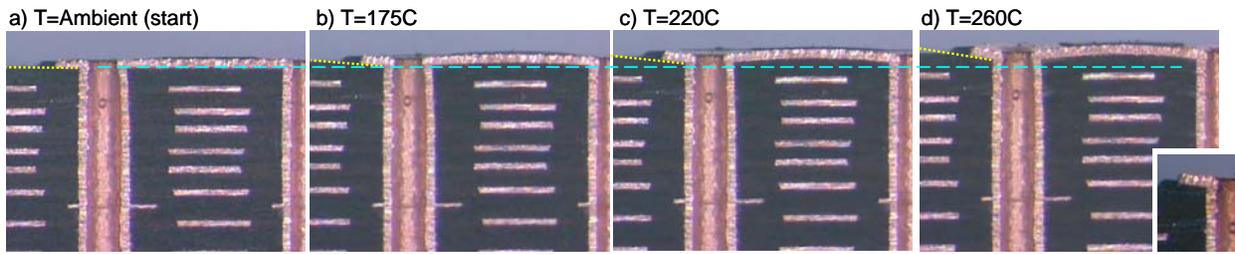
Figure 6-- Select frames from video of CIRC coupon cycled ambient to 260°C, 10mil via/180mil thick PWB.

The magnitude and slope of the PTH curve at Pb free temperatures, as well as the challenge of Pb free assembly in general, is further portrayed by real time video of a coupon cross-section during a Pb free reflow. Figure 6 shows four select frame captures from the video of a high T_g epoxy coupon similar to that of the blue curve (this one was 10 mil via on 180 mil thick board) in a simulated single cycle from room temperature to 260°C. Sample preparation and procedure was as shown earlier in Figure 2: sample was dry-sectioned to row 1, wired, and placed PTH-up in a glass frame under the camera. For this video, N₂ gas was leaked into the glass enclosure to limit oxidation of the copper during heating. The first observation from the figure is the significant deformation of the laminate, barrel, and lands at 260°C. The difference in the two center frames between Pb free 260 and conventional 220°C is staggering, but is consistent with the slope of the Figure 3 blue curve as discussed above, let alone general industry experience with Pb free assembly. The yellow dotted lines indicate measurements of the angle of deflection for the external lands: the lands deflected about 10 degrees at 260, 6.5 degrees at 220°C and 5 degrees at 175°C. The inset photo shows the permanent deflection of that same land (no longer adhered to the laminate) after on return to ambient after only a single 260°C cycle, measured at 7.7 degrees, suggestion significant plastic deformation of the rim copper. Additional cycles at 260°C are known to exaggerate the angle and/or protrusion of the land even further.

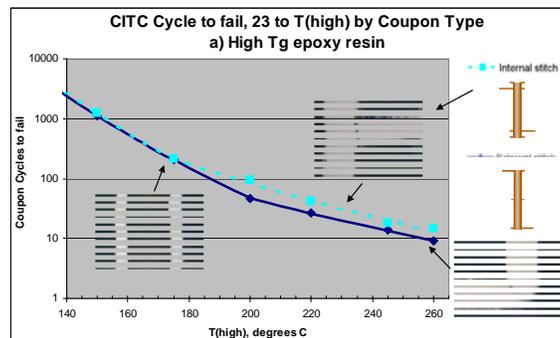
Finally, as if the Pb free situation was not complex enough, the magnitude of deformations at Pb free temperatures are so significant that they often trigger different and competing failure mechanisms along the life curve. While this fact does not invalidate the curves, it could have design implications, and it certainly sheds further light on the Pb free challenge. For example, Figure 7 is a life curve for a high T_g epoxy (more recent build than in Figure 3, though same aspect ratio) constructed with 2 different and independent CIRC coupons—one with the daisy chain stitch external (top and bottom surfaces) and one with the stitch on the nearest 2 internal planes, top and bottom. The two coupon types yield exactly the same cycles to failure at 150°C and 175°C, and the same failure mode (center barrel crack), but they diverge slightly at higher temperatures—the external coupon with lower life in this case, fails at the external rim, while the internal coupon lasts a little longer but fails at the inner plane connection, at least at 260°C. Note that inner plane fails observed at 260°C are not related to poor barrel to innerplane connection, but rather appear to be ripped apart in a bending mode due to the same laminate deformation that bends the lands (only a few mils above where the first innerplane connection is located) as seen in Figure 6. Of course, the rim crack mechanism that activates on the external coupon at 260°C in Figure 7 is similarly related to the same observations of Figure 6.

Figure 7—Failure mode shift vs. temperature for a High Tg epoxy resin, 10mil drill on 130mil thick board.

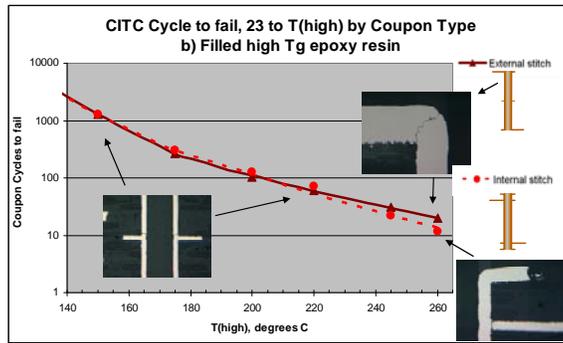
As a second example, Figure 8 compiles the results of the same experiment for a High T_g filled resin. The same 3 failure mechanisms “compete” again, this time with the inner plane failing slightly earlier than the rim at 260°C, but both different than the center barrel crack than at conventional reflow temperatures. Note that none of the curves differ significantly, and a repeat of either test could yield a different result by material depending on plating thicknesses, etc, but these examples are otherwise provided as one more case for the complexity of assuring laminate boards for Pb free assembly.

Figure 8—Failure mode shift vs. temperature for a High Tg filled epoxy, 10 mil drill on 130 mil thick board.

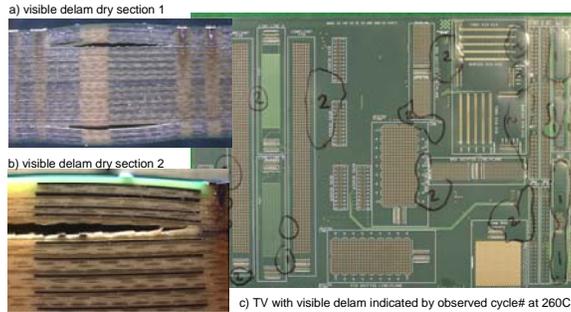
Thermally induced internal delamination is one of the original and ever-present failure mechanisms for laminate substrates and boards. The root cause is generally linked to the “explosive” vaporization of entrapped moisture at high temperatures, especially reflow. The alternate names of blistering or popcorning not only reflect the mechanism but also hint at another fortunate attribute— when they occur within laminates of any thickness they create a measureable opening within the substrate that is almost always visible at the surface as a raised and/or discolored area. “Visible delamination” as such is typically observed in open areas with few vias, and/or in regions surrounding vias such as is shown in Figure 9c for a 130 mil thick 10”x7” test vehicle (TV); cases of visible delamination on the TV are circled and numbered during reflow passes at 260°C . The number is the pass after which it was observed (i.e., “2” = delamination was observed by inspection immediately upon removing card from reflow pass 2 at 260°C). Note how the delamination rarely encroaches on via grids. The (a) and (b) insets show dry-section examples of visible delamination, typically cohesive within laminate material at glass to resin interfaces, near but not into vias seen further back in the section.

Figure 9-- "Visible Delamination" during Pb free reflows on a high Tg resin board.

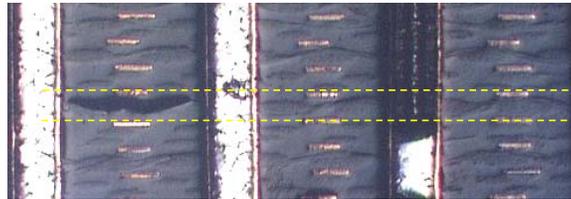
not at glass interfaces, and is highly dependent on the aspect ratio and grid of those vias. That is, for any given board thickness the mechanism would trigger above a certain hole density (below a certain grid), and usually near the center of the board^[13]. The author prefers to call this new form after its most pragmatic difference and challenge—the significant void or hole it creates in the board, often spanning entire vias, is completely invisible from the surfaces. And except in a specially designed coupon where it can be detected as a capacitance change, it can only be found by x-sectioning. That is, there is no visible difference between a board module site that has this delamination versus one that does not. While most believe that at the very root both mechanisms are due to expansion/vaporization of trapped moisture with temperature, the unique nature of “invisible delamination” is so striking as to demand a greater understanding. Figure 10 shows a unique photo of invisible delamination found by x-section (in this case induced by solder shock, but otherwise the same as that found with oven reflows, and not a time-0 condition) that vividly answers why this mechanism is invisible—despite the large rupture between the two vias, there is otherwise little or no change to the surrounding material, planes, or dimensions. But this answer only raises new questions—how does the material within the rupture disappear as if to violate “conservation of mass”, and how does this happen with little affect to surrounding laminate?

Figure 10—“Conservation of mass” dilemma with Invisible delamination—where does the material go?

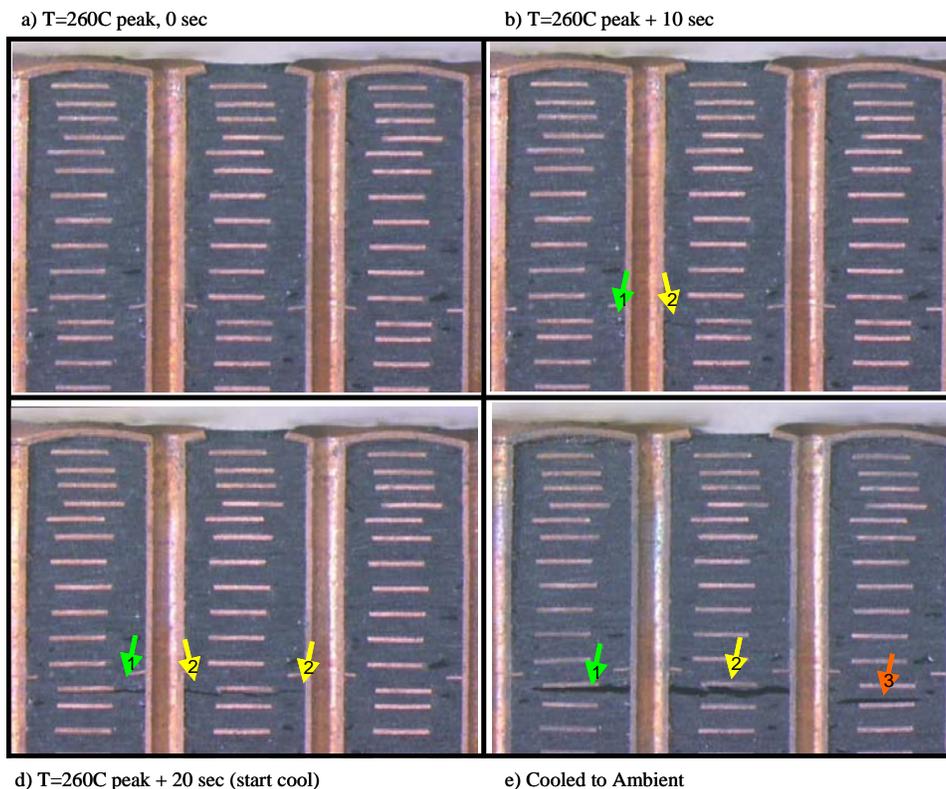
To help answer these questions and further explore the root mechanism, the CITC video technique (Figures 2 and 6) was again employed in an attempt to record the formation of invisible delamination. The same type of coupon and setup was used except that the camera view must include the center of sample and more than a single cycle from 23 to 260°C was required to activate the mechanism. During the peak dwell of the 7th cycle delamination was observed about 10 seconds after stable dwell at 260°C, as shown by some frame captures in Figure 11. At point “2” in the figure, a sharp crack grew more than half way across the span quickly, within a second. At the same time a small crack grew on the other side at point “1”. By 20 seconds, just before cooling was started, both cracks had grown, especially “2” which now spanned the distance between PTH’s. As cooling started (fans), the cracks progressively opened until they appeared as the typical wide ruptures at ambient,

Figure 11--Frame capture from video showing formation of Invisible delamination.

as shown in the 4th frame of Figure 11. At the same time, a new rupture at point 3 appeared during cooling; apparently it also was created during the dwell, but not visible until cooling. The other randomly shaped small black spots in the laminate are artifacts of the dry section polishing, and should be ignored except that it is interesting to note that they shrink somewhat with cooling, as expected, unlike the cracks formed by this mechanism. Also note the significant permanent deformation of the copper and laminate even after cooling, as discussed in the previous section.

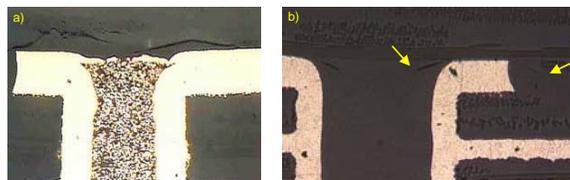
As discussed earlier around Figure 1, HDI technology has introduced several new via structures and via-induced failure mechanisms to laminate packaging. One of the most interesting though elusive HDI failure mechanisms is the eyebrow crack, as shown by a couple examples in Figure 13. Though the origin of the name is unknown, the name becomes self evident to all who observe them. Eyebrows cracks form above, below, and between buried vias of sufficient size whether they are filled, capped, or not. The cause of eyebrows cracks is best understood by referring (once again) to the significant deformations involving and surrounding wiring vias, as illustrated in Figure 4 and video captured by Figures 6 and 11. If such thru-via related deformations can cause so many problems— PTH life reduction, lifted lands, IP cracks, and invisible delamination— then placing such structures inside a PWB is an example of how one cannot simply “bury his problems”. At least in Figures 4, 6, and 11 the only stress on the surrounding laminate is compressive. But when thru vias become buried vias, laminated inside a composite structure, the same deformations result and can lead to tensile zones in the resin directly above and below the vias.

Figure 13-- Classic examples of eyebrow cracks after assembly

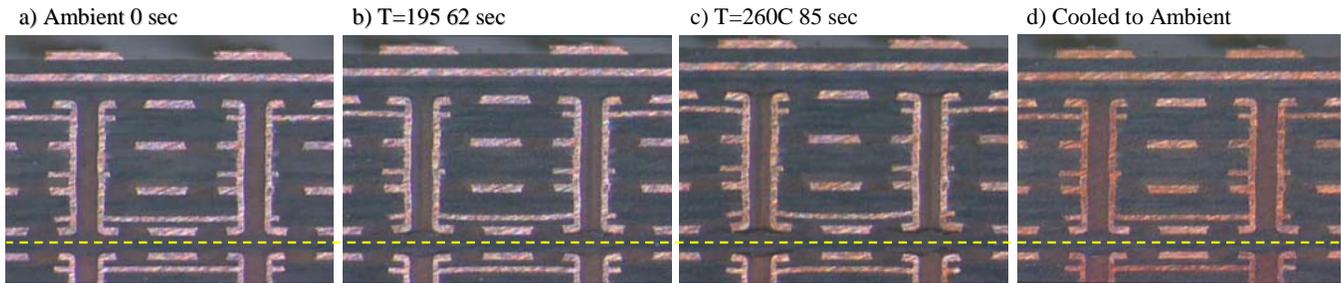
To illustrate, the CITC test is again used to capture with video the formation of eyebrow cracks in a worst case double subcomposite structure with a full grid of top and bottom buried vias. Figure 14 shows a macro view of 4 frame captures starting and ending with ambient; note that N₂ was not used in the glass enclosure, therefore copper will appear oxidized after the peak temperature exposure. Figure 14 includes a frame at 195°C when the eyebrow cracks (4 total, above and below yellow center line) were fully formed, and a frame at 260°C peak where they are more evident, somewhat longer, and more numerous (note 2 more at the top of the vias). But here, the difference between 260°C and 195°C is not as striking as with the prior mechanisms, which is consistent with industry experience that eyebrow cracks are by no means exclusively a Pb free problem, but can happen with any reflow. In fact, they may be as much a function of time as of temperature—the author has delaminated an entire module site due to interconnected eyebrow cracks simply by baking for several hours at 195°C.

Figure 14-- Frame captures from video of eyebrow crack formation in a double subcomposite board.

3 and 4 show a somewhat different formation path and look. Crack 3 simply becomes more visible with temperature, without the propagation of 1 and 2. Crack 4 starts as two separate cracks which apparently start far enough apart that, though they grow toward the center, they never join together. All the cracks close back up on return to ambient and are no longer visible, at least at this magnification.

Note the thermal induced deformation of the vias, lands, traces, and laminate in the middle 2 frames of Figure 14, compared to the ambient frames—the magnitude of the deformation is scaled down with aspect ratio, but the same shape as is observed as with thru-vias of Figure 6. But in the case of buried vias observe how the deformed shape, especially the land deflection, would create a tensile zone in the joining resin just above the lands and vias. Resins can withstand reasonable tensile forces below T_g , but above their T_g they tear easily when pulled in tension. This root cause of the eyebrow crack is further illustrated in Figure 16, which is a close-up of the left most via pair in the above Figures at ambient, and at a peak of 245°C . To better compare relative shape and deformation, the 245°C image is shown flipped 180 degrees vertically. Dotted reference lines are drawn at the indicated locations a, b, and c for both temperatures. Note the distinct tensile zone visible in the region of the via rims (at arrows), exactly where the eyebrow cracks were seen to start and grow in the above Figures.

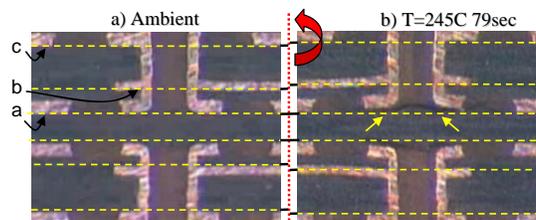
Figure 16— Comparison of $T=245^{\circ}\text{C}$ versus ambient frames to illustrate tensile zone that causes eyebrow cracks.

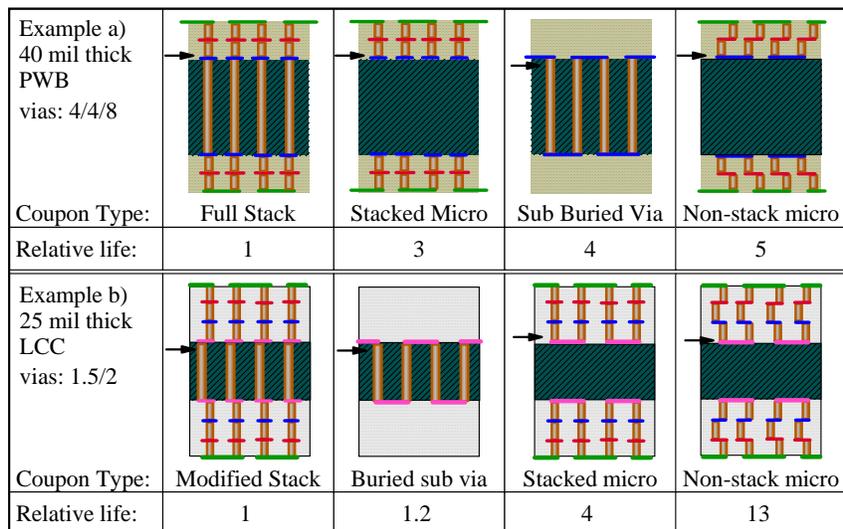
Figure 17 compiles relative via life for 2 different HDI products, one PWB and one dense LCC substrate. Each product had individual CITC coupons covering the 4 different via constructions shown. Relative life is calculated by testing all coupons to fail at CITC 23-220C, and then comparing N50's with a lognormal probability plot. The coupon with the lowest N50 is listed first and defined as with base life =1. In both cases, the first coupon is that structure which most closely resembles a “thru via”, which becomes the first rule of thumb—thru vias or any facsimile see the full force of the Z-axis CTE mismatch as demonstrated by data and photos earlier. That is, the full stack of example a is expected to have about the same via life, and the same propensity for thru via related laminate failure mechanisms if present (e.g. invisible delamination), as would be the equivalent thru via. Therefore in the first example, the full stack structure had the same failure location (indicated with arrows based on failure analysis x-sections) as the next 2 structures, but with cycles to fail 1/3 and 1/4 the values, respectively.

In example b, the first structure is a modified full stack, most similar to a thru via of the four coupons but lacking the full “rivet” nature of a thru via or full stack. Note that though this modified stack is still the first to fail and with the same failure mode as the second coupon, the margin is much closer attributed to the fact that structurally they are more similar than in the first example.

Figure 17-- Relative life by structure for two HDI examples, PWB and LCC.

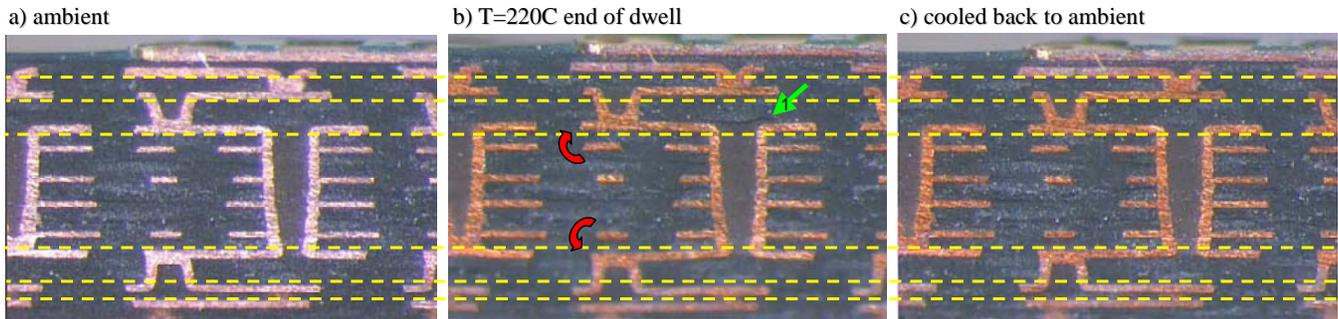
Figure 18-- Frame captures from HDI reflow cycle video

Interestingly, this first rule of thumb also applies similarly on a small scale to microvias. In both examples of Figure 17 the microvias had excellent life, but stacked microvias fail before unstacked microvias, with all else held constant—this is because they are locally more “thru-via” like in geometry and stress state, while the unstacked microvias have an additional degree of freedom in which to flex, reducing the stress on the copper. This situation is illustrated by a final video in Figure 18 for a substrate with 3+3 microvias on a buried via subcomposite. The substrate is cycled from ambient to 220°C and back again (no N_2). The yellow dotted lines are drawn from the build-up layers at ambient to help show both the Z-axis expansion, and more importantly, the flexing of the non-stacked microvias that occurs at °C (red arrows). It is clear how this flexing can reduce the stress on the microvia itself, and explains how unstacked microvias last longer than the stacked microvias, which like small “thru vias” are not able to flex. Note however that an eyebrow crack was formed at the green arrow during dwell at 220°C, which becomes a “reality check” reminder that at least one more rule of thumb is needed: the reduced stress on copper via interconnections in a “less thru-via-like” design comes with a price— possibility of tensile stresses in the resin, and therefore greater risk of eyebrow cracks. Or stated in more general terms, different HDI structures may trade one failure mechanism for another, once again reiterating the need for smart design and evaluations.
