Corrosion Resistance of PWB Final Finishes

C. Xu, D. Fleming, K. Demirkan, G. Derkits, J. Franey and W. Reents
Alcatel-Lucent

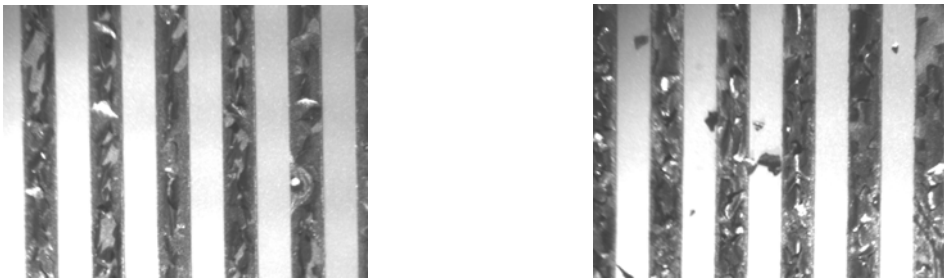
As reference samples, both HASL (SnPb) finish coupons and coupons with bare Cu-lines were included in the matrix. As expected, HASL showed only minor discoloration after 10 days of MFG test conditions, while Cu was severely corroded after only 2 days exposure. Figure 1 shows typical pictures of Cu samples after 2 days MFG test. The corrosion products, consisting primarily of Cu_2S and Cu_2O , flake readily. It is noteworthy that the flakes of the corrosion products are highly conductive and can cause short circuit between adjacent conductive lines. These shorts can be brief and temporary, leading to intermittent failures in products.

Figure 1 – Coupons without final finishes after 2 days MFG

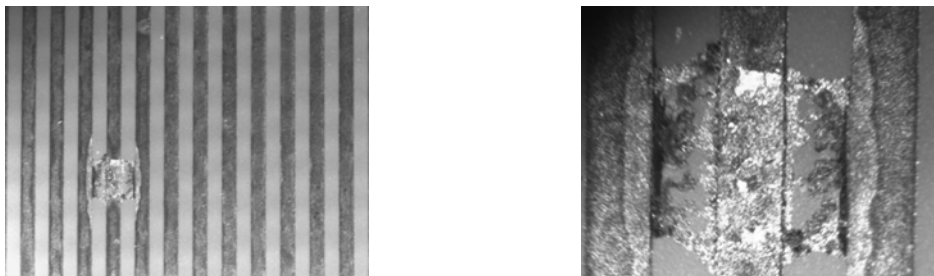
Seven different ImAg processes from several suppliers were tested in this experiment. After two days MFG exposure, all the ImAg surfaces are covered with grayish corrosion products, primarily due to Cu_2S . However, creep corrosion across the laminate was seen only at one location in a single sample. This is shown in Figure 2. This rather localized creep corrosion is most likely due to local contamination, probably due to a droplet of some kind of liquid as indicated by the shape of creep corrosion.

Figure 2 - Short due to creep corrosion

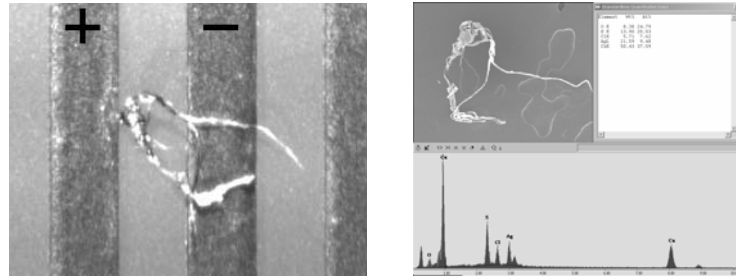
For the biased samples, an electrical short of 26 k Ω was detected on one sample after 2 days MFG exposure. The short was traced back to a foreign object (filament) across the adjacent lines. The filament was then removed for EDS analysis, which was done at various locations of the filament. Figure 3 shows the SEM image of this filament and EDS result for one location. As one can see from Figure 3, the filament is partially covered with a metallic film. EDS analysis shows that the metallic layer consists of Cu, Ag, S and Cl. The EDS analysis on the area without metallic film reveals only C and O, indicating a polymer fiber, most likely introduced during sample handling. It is also interesting to note that the metallic layer extends from positive biased Cu-line to negative biased Cu line. This is very similar to the widely studied phenomena of conductive anodic filament (CAF) formation, which occurs on glass fiber imbedded in the laminate and also has the characteristic of the metallic film growing from anode to cathode. In the case of ordinary electrochemical migration (ECM), the growth of the metallic filament occurs typically from cathode to anode. To differentiate this phenomenon from the CAF and ECM, we term it as fiber-assisted electrochemical migration (FAEM). Apparently, the laminate surface of our coupons is very clean/inert and does not allow the electrochemical migration to occur. On the other hand, the inadvertently introduced fibers have picked up enough moisture or corrosive gases to allow electrochemical migration to occur over it. The implication of this result is two-fold. First, the fibers, which can be introduced into the equipment from various sources, could potentially introduce a

Figure 3 - Short due to fiber assisted electrochemical migration after 2 days MFG

permanent or intermittent short circuit. The intermittent short circuit failure mode is difficult to pin-point in the real world and can often lead to a no-trouble-found failure report since it often is destroyed upon causing a failure. Secondly, any contamination on the surface or imperfection of the materials could provide a pathway for electrochemical migration on a circuit board with ImAg as PWB finish.

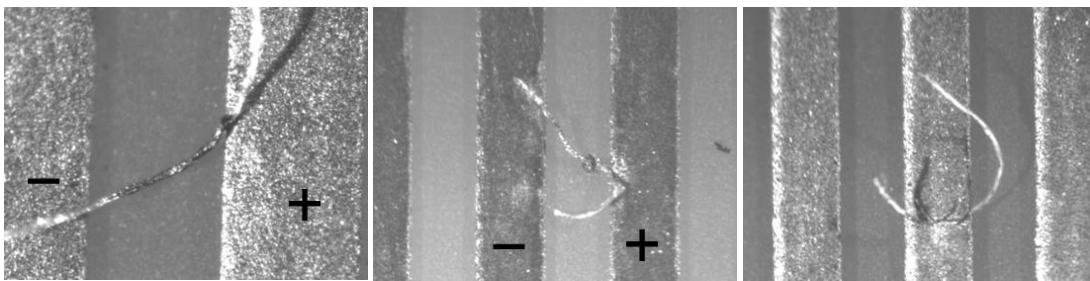
After 5 days MFG exposure, four out of seven ImAg finishes show fiber-assisted electrochemical migration (FAEM). After 15 days MFG exposure, two additional ImAg chemistries show FAEM. Only one ImAg does not show FAEM, even after MFG exposure for 40 days. However, for this latter chemistry, creep corrosion along the fiber (Fiber-Assisted Creep Corrosion, FACC) was observed, which was also seen on a second ImAg chemistry. On the other five ImAg, no FACC was seen. In Figure4, FAEM on ImAg after 5 days MFG test (left) and after 10 days MFG test (middle) was shown. In the right picture of Figure4, a case of FACC is seen.

Fig.4 FAEM after 5 days (left) and 10 days (middle). FACC

(FAEM) observed in this work falls also under this category. As the fiber is typically only weakly attached to the circuit board, it could cause intermittent electrical short as well as no-trouble-found type of failure in the field.

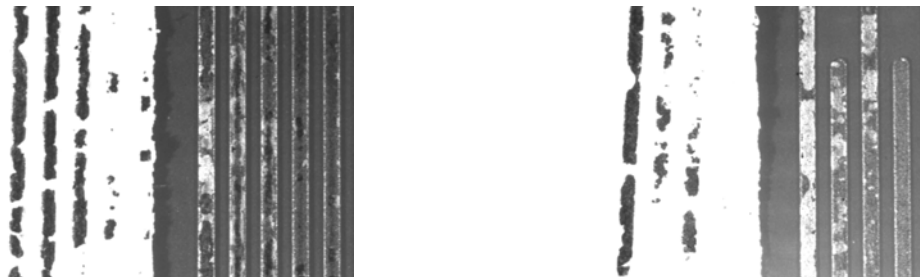
A second issue associated with ImAg is the blistering or peeling of the conductive corrosion products from the surfaces. After 10 days MFG test, most of the samples only show minor blistering. Peeling and flaking were only observed after 40 days MFG exposure. However, a qualitative adhesion test using 3M “Post-it®” paper can be used as a deliberately weak standard adhesive. When applied to samples after 15 days MFG exposure, the corrosion products can be easily removed by the adhesive on post-it paper, thus proving they are only weakly attached to the substrate. This is true for all seven ImAg PWB finishes tested in this work. Figure 5 shows pictures for three of the seven ImAg chemistries. In all three pictures, the left part shows the post-it paper with corrosion products, while the right part is the substrate surface after adhesion test.

Fig.5 Three ImAg samples after adhesion test: post-it paper (left part) and substrate (right)

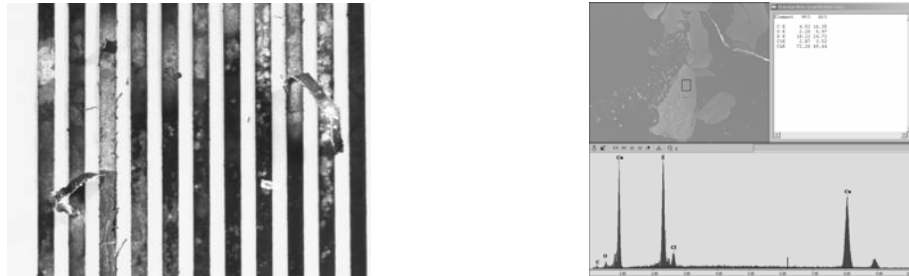
After 10 days MFG exposure, either flaking or sliver formation are observed on all the samples. Both flakes and slivers are due to conductive corrosion products and can cause short circuit between the adjacent leads. As matter of fact, the first electrical short ($26\ \Omega$) was detected after 6 days MFG exposure and was attributed to peeled films of the corrosion product bridging adjacent lines (See Figure6). EDS analyses on the flakes indicate that it consists primarily of Cu_2S .

Fig.6 - Short circuit due to the flakes of corrosion products (Cu_2S) bridging to the adjacent lines.

The second key finding in this work is the ability of corrosion products to cause electrical shorts through either flaking or sliver formation. Although cupric oxide is an insulator, cuprous oxide is a semiconductor with a band gap of 2.0eV. The bonding in copper sulfides cannot be correctly described in terms of a simple oxidation state formalism because the Cu-S bonds are more covalent than ionic in character and have a high degree of delocalization, resulting in complicated electronic band structures. The majority of its members are semiconductors. Several nonstoichiometric compounds with Cu:S ratios between 1.0 and 1.4 also contain both monosulfide as well as disulfide ions. Depending on their composition, these copper sulfides are either semiconductor or metallic conductors. Furthermore, the EDS analysis also showed presence of metallic Cu in the flakes and slivers, which further contributes to the conductivity of the peeled films.

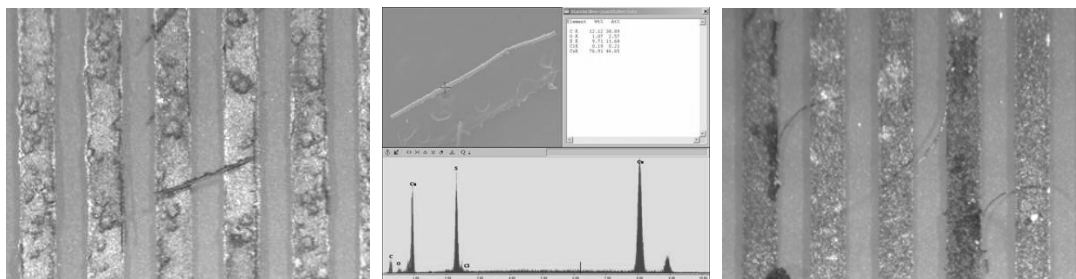
Several high resistance shorts in the range of several $\text{k}\Omega$ to few hundred $\text{k}\Omega$ were also detected and have been found to be due to bridging across adjacent leads by conductive slivers. Figure 7 illustrates the short circuit due to the slivers.

Fig.7 - High resistance short due to sliver formation on OSP.

EDS analysis performed on the sliver shows that it consists primarily of Cu_2S . Apparently, there is extensive corrosion along the edge of the Cu lines and results in the corrosion products detaching from the edge to form conductive slivers.

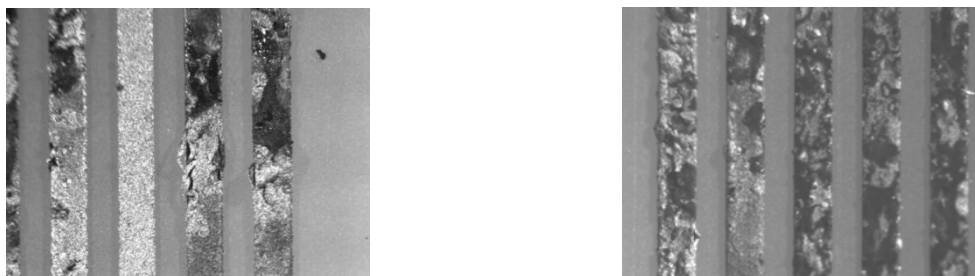
Three different ENIG processes were tested in our work. For two of the ENIG processes, the corrosion occurs preferentially through pores in the finish, while the third process shows corrosion preferentially occurring at the edge of lines. After 10 days MFG exposure, the corrosion products cover the majority of the surface. However, spontaneous flaking is observed only after 15 days MFG exposure. Again, both flaking of the corrosion products and sliver formation were observed (See Figure 8). FAEM was observed on two of the three ENIG chemistries after 15 days MFG exposure. The third ENIG sample showed FAEM first after 40 days MFG exposure. FACC was also seen on two samples after 40 days MFG exposure.

Fig.8 - ENIG after 15 days MFG test.

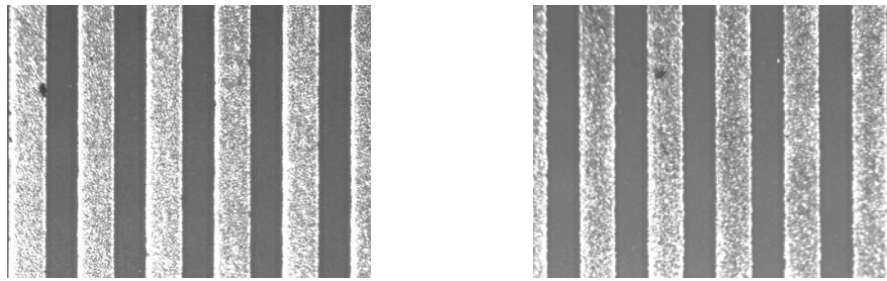
Three different ImSn processes were tested in this experiment. No significant corrosion was observed on samples after 2 and 5 days MFG test. Samples after 10 days MFG test start to show corrosion due to porosity. Figure 9 shows optical images of samples after 20 days MFG exposure. However, no reliability concern associated with corrosion is seen on ImSn, even after 40 days MFG exposure.

Fig.9 - ImSn after 20 days MFG test.
