Novel SACX Solders with Drop Test Performance Outperforming Eutectic Tin-Lead

Dr. Weiping Liu and Dr. Ning-Cheng Lee
Indium Corporation of America

A family of SACX alloys has been developed with significant improvement in drop test performance on NiAu surface finish. Dopants such as Mn, Bi, Ti, Ce, and to a less extent Y for SAC105 have been observed to show very positive effect when used alone or in combination, with Mn exhibiting the most profound effect. SAC+Mn outperformed not only SAC alloys, but also Sn63, thus completely altered the shaky position of SAC systems caused by fragility of solder joints. The melting and intermetallic formation properties are not affected by the dopants. Mn tends to migrate toward IMC and accumulate near IMC layer in the form of MnSn_2 particles. Thermal aging results in further improvement of drop test performance.

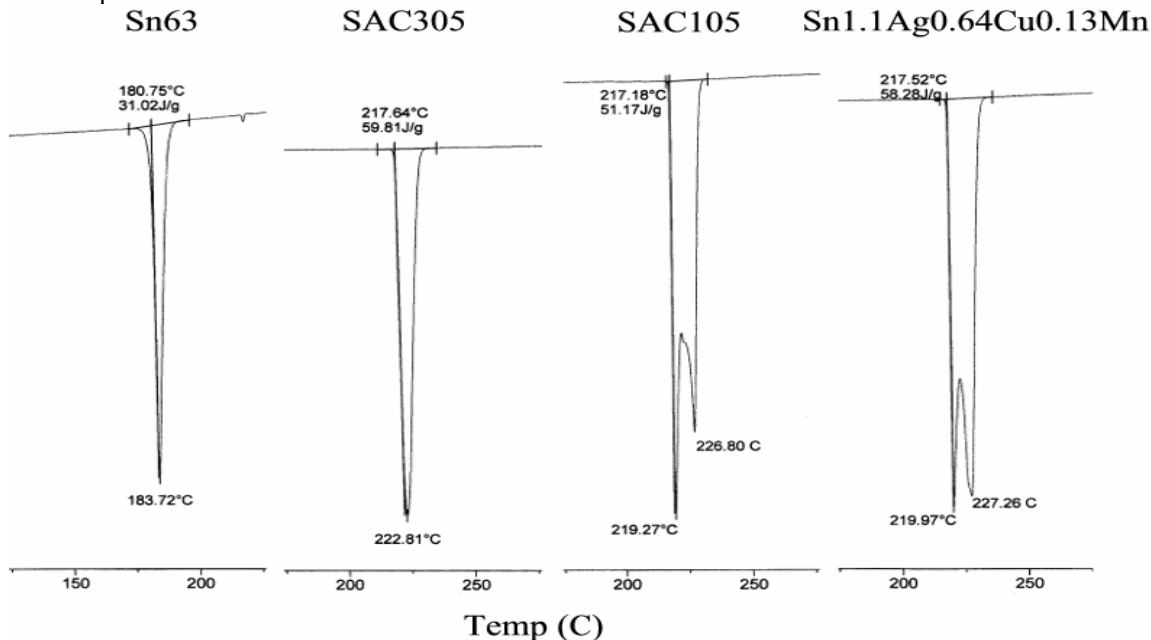
Figure 3 - DSC thermographs of second scan for Sn63, SAC305, SAC105, and Sn1.1Ag0.64Cu0.13Mn.

Addition of small amount of additives appears to have negligible effect on the melting behavior of SAC alloys. Table 1 exemplifies the melting temperature of some solder alloys determined at the second scan of DSC analysis. Figure 3 shows the DSC thermographs of second scan for Sn63, SAC305, SAC105, and Sn1.1Ag0.64Cu0.13Mn (SAC0.13Mn).

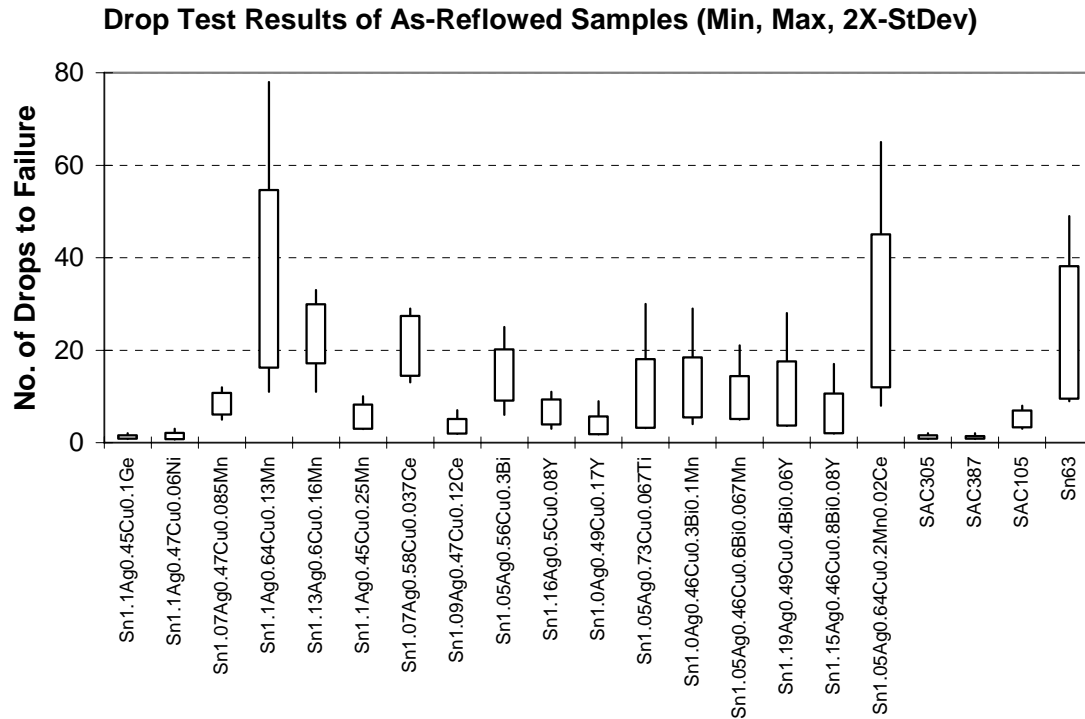
Figure 4 - Drop test results of as-reflowed samples. The thin line represents minimum and maximum values; the box represents two standard deviations, with mid point being the mean value.

The drop test results of as-reflowed samples are shown in Figure 4. SAC387 and SAC305 survived in average only 1.1 and 1.2 drops respectively before failure. SAC105 exhibits a mean drop number of 5.1, hence is considerably better than SAC387 and SAC305. This is consistent with work of Date et al. [8]. However, compared with Sn63, with a mean drop number 23.8, SAC105 is still significantly inferior.

The effect of dopants depends heavily on the dopant chemistry. Ni and Ge cause adverse effect on SAC105, exhibiting a mean value of 1.4 and 1.2, respectively. Y is insignificant. Ti, with a mean value of 10.6, exhibits a moderately positive effect on drop test. The effect of Ce is interesting, with test results showing a mean value of 20.9 and 3.5 for SAC105 with 0.037Ce and 0.12Ce, respectively. This high sensitivity of SAC alloy toward Ce dopant level is repeatable in another

confirmation run of tests. Bi, with a mean value of 14.6, and Mn displayed a positive effect. In the case of Mn, the impact is fairly sensitive to the content of Mn. The drop test performance improves with increasing Mn content, reaching a maximum mean value of 35.4 at 0.13Mn content, then decreases with further increase in Mn content. Addition of more than one elemental dopant does not bring in synergistic effect, as demonstrated by SAC105+BiMn and SAC105+BiY systems. SAC105+0.2Mn0.02Ce showed a mean value of 28.5, higher than both 0.16Mn and 0.25Mn cases. Due to the large standard deviation of test, the actual effect of dual dopants needs to be further clarified.

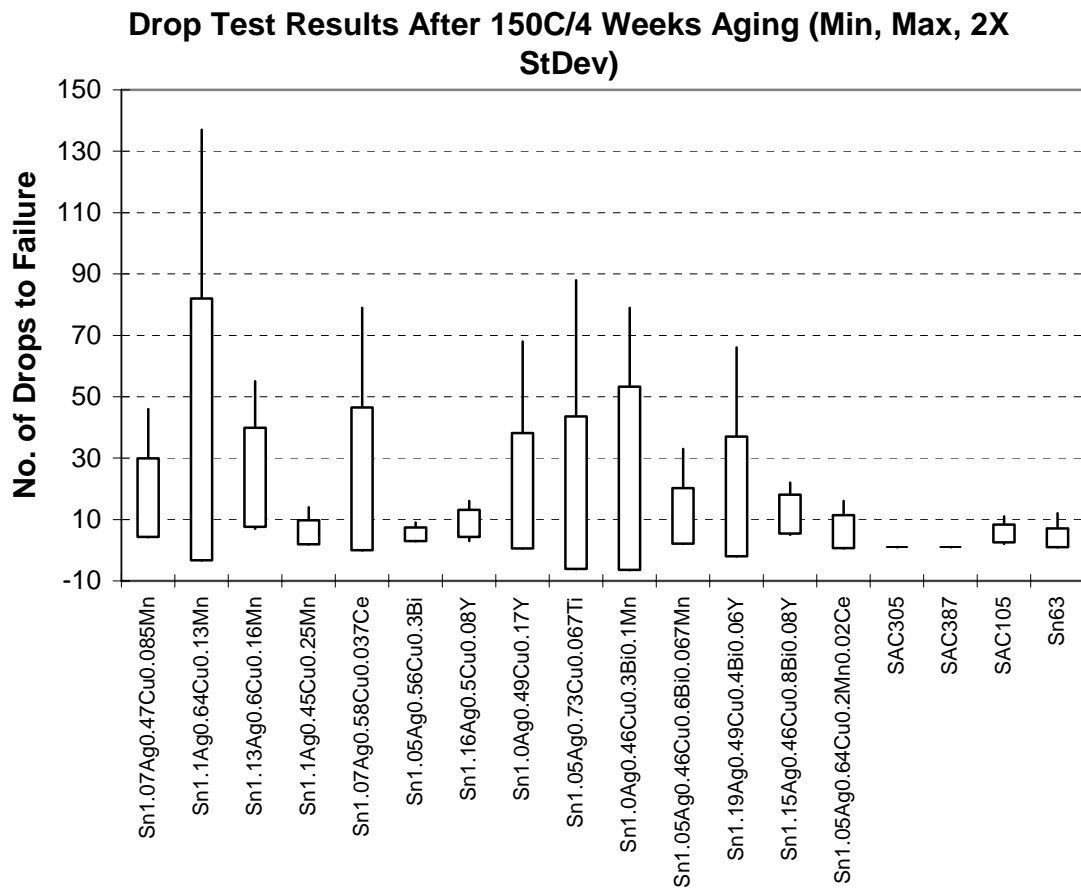
Figure 5 - Drop test results of samples after thermally aged at 150°C for 4 weeks. The thin line represents minimum and maximum values,

The drop test performance was also studied for samples thermally aged at 150°C for 4 weeks, with results shown in Figure 5. Comparing the data of as-reflowed versus thermally aged, as shown in Figure 6, it is interesting to note that while the mean value of Sn63 deteriorates significantly down to 4.0, many SACX alloys exhibit a higher drop test mean value after aging. Considering both as-reflowed and aged data, Sn1.1Ag0.64Cu0.13Mn (SAC0.13Mn), Sn1.13Ag0.6Cu0.16Mn (SAC0.16Mn), and Sn1.07Ag0.58Cu0.037Ce are the most promising in drop test performance.

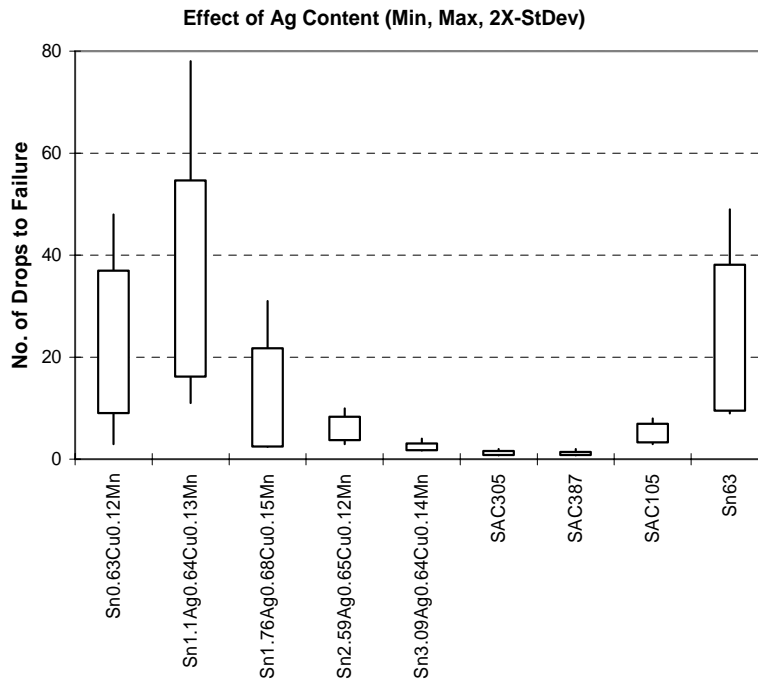
Figure 7 - Effect of Ag content on drop test performance for as-reflowed samples.

The effect of Mn dopant on SAC alloys with various Ag content was also investigated for as-reflowed samples, with results

shown in Figure 7. At about 0.13% Mn content, the mean value of drop test was 23, 35.4, 12.1, 6.0, and 2.4 for SACX alloys

with Ag content 0, 1.1, 1.8, 2.6, and 3.1%, respectively. Except for 3.1%Ag sample, all other samples with a lower Ag content exhibit a mean value greater than that of SAC105 (mean value 5.1), not to mention SAC305 (mean value 1.20) and SAC387 (mean value 1.1). Although a lower Ag content generally results in a better drop test performance for SAC alloy system [8], use of Mn dopant essentially elevates the drop test performance of 2.6Ag alloy to that of SAC105.

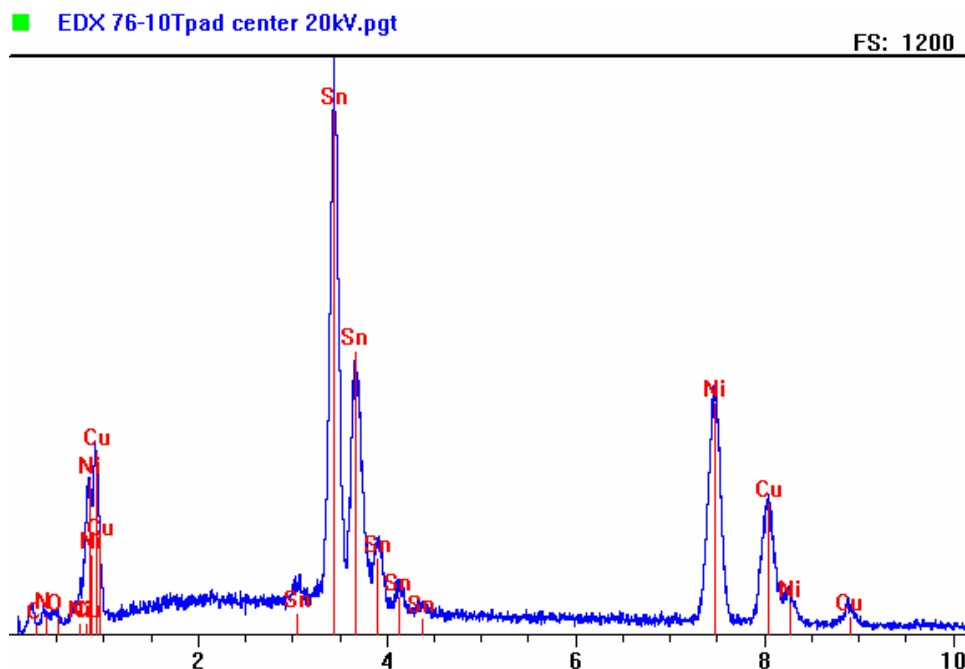
Figure 13 - EDX of pad center of fracture surface of drop test sample of SAC0.13Mn. Besides Ni, presence of Cu and large amount of Sn is observed.

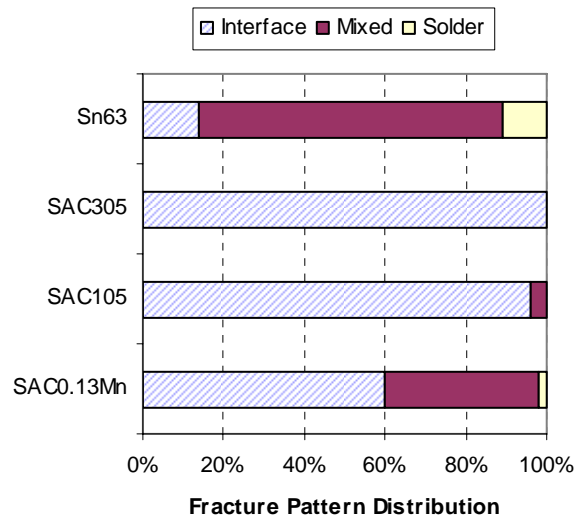
Figure 18 Effect of alloy on fracture pattern for as-reflowed drop test samples.

The fracture pattern of alloys was investigated by examining the location of fracture site. All fracture surfaces were classified as one of the three fracture modes: (1) fracture at interface between solder and pad, (2) fracture within solder, and (3) a mixed mode of interface and solder. Figure 18 shows the fracture pattern distribution of Sn63, SAC305, SAC105, and SAC0.13Mn for as-reflowed drop test samples. The drop test performance, as shown in Figure 4, in general improves with increasing percentage of mixed mode and solder mode. This relation reflects that a tougher interface is crucial for a better drop test performance. However, this relation is not applicable when comparing Sn63 with SAC0.13Mn.

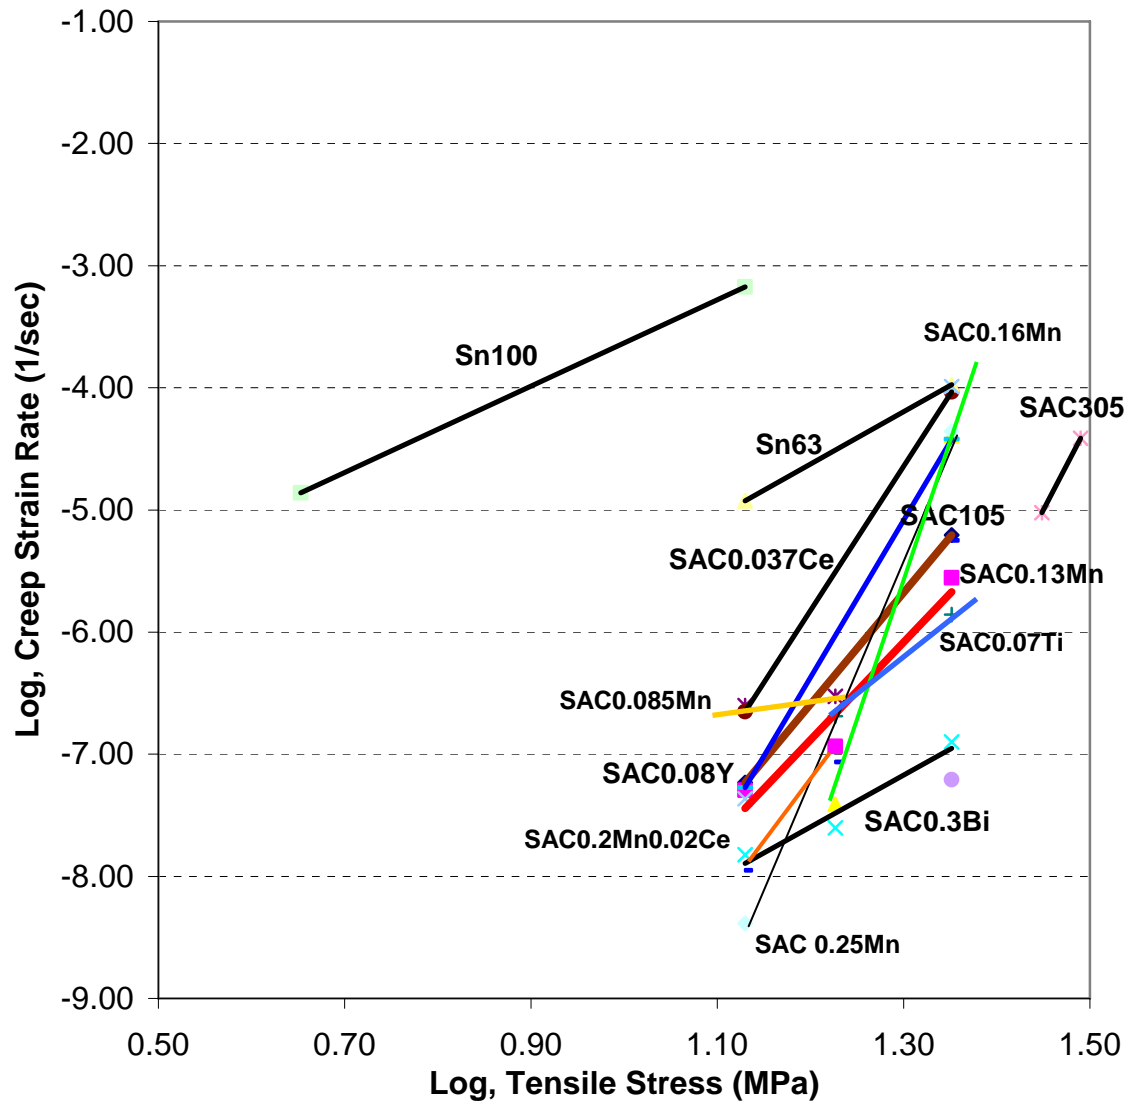
Figure 26 - Creep test results of solder alloys determined at room temperature

The room temperature creep properties of the lead-free alloys were studied, with results shown in Figure 26. Majority of the SAC(X) alloys, including SAC0.13Mn, exhibit a lower creep rate than Sn63 at low stress condition. However, their creep rate increases rapidly with increasing stress, and at high stress condition, most of the SAC(X) show a higher creep rate. A lower creep rate often suggests a longer fatigue life. In other words, at low stress condition, many of the SACX alloys not only exhibit a drop test performance better than SAC alloys or even better than Sn63, but very likely also exhibit a fatigue life better than Sn63.
