A DOE to assess PCB fabrication material design and process using IST (Interconnect Stress Testing) to improve fine pitch BGA via reliability

Mahesh Narayanaswamy and Reinaldo Gonzalez
GE Healthcare

GE Healthcare – Testing Fab Reliability using IST

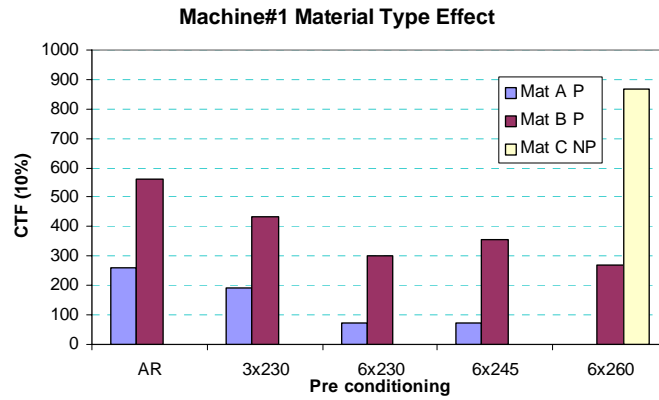
Figure 5 - 10% cycles to failure for the three materials tested. Materials A and B have NFP and Material C did not have NFP.

No failures were observed on Material C at the other preconditions. The test was stopped at 1000 cycles. The Weibull plots show that material B is superior to material A, it has higher Beta values and higher 10% CTF. Material C without NFP is superior to material B.

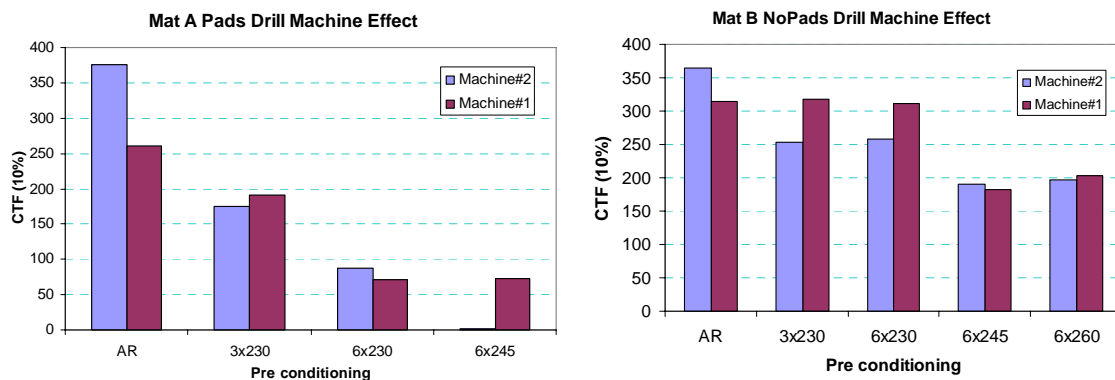
Figure 8 - Comparison of Machine drill for Mat A with pads (left) and for Material B without pads (rights)

The effect of drilling machine is not pronounced. Machine#1 is slightly superior to #2. See figure below for comparison

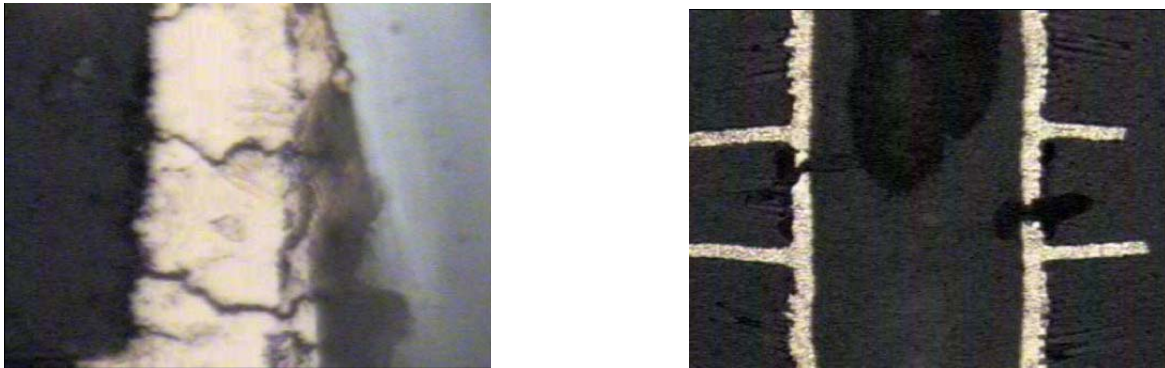
Figure 10 - On left metal fatigue on Material C, drill#1, with NFP after 1000 cycles. On right barrel crack on Material A, drill#1 with NFP, 6x230 condition, 79 CTF.

Metal Fatigue: Some of the cracks observed in these sections would be classified as metal fatigue. Metal fatigue cracks usually transverse the copper at a 20 to 50 degree angle. A metal fatigue crack will typically propagate between copper crystals; cracks are frequently closed at ambient temperatures. This type of failure mode is consistent with slowly accumulating resistance that accelerates over time.

Barrel Cracks –Barrel cracks are typically at right angles to the plane of the drilled holes; the crack runs through copper crystals and the crack is open, or gaping, at ambient temperature. The gaping crack imparts a degree of hysteresis in the coupon. In the cooling phase of the thermal cycle the resistance does not turn to the original measurements. A reluctance to return to the original condition is called hysteresis. Barrel cracks are observed in coupon with reduced IST cycles to failure.

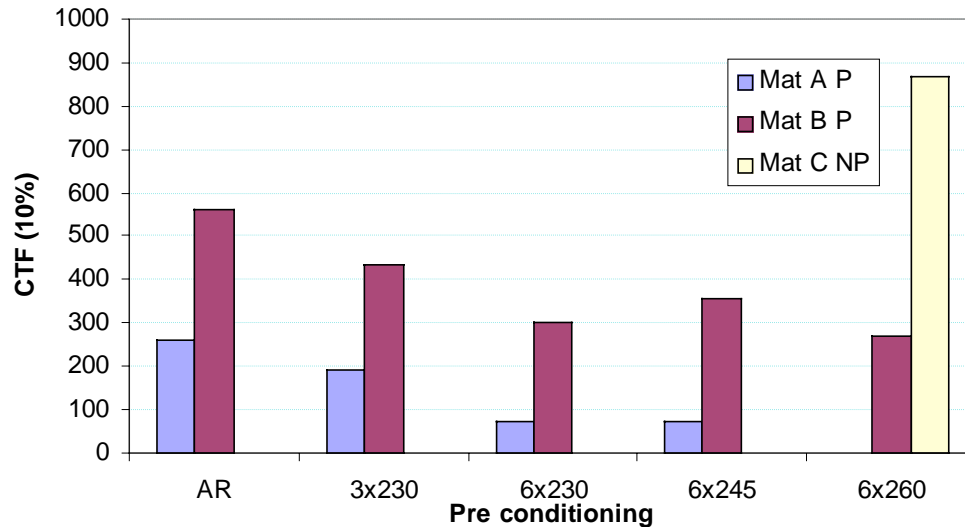
Machine#1 Material Type Effect

- Material C outperformed Materials A & B
- No failures observed with Material C at all preconditionings except 6x260C
- Material B superior to Material A (higher Beta, CTF (10%) values)

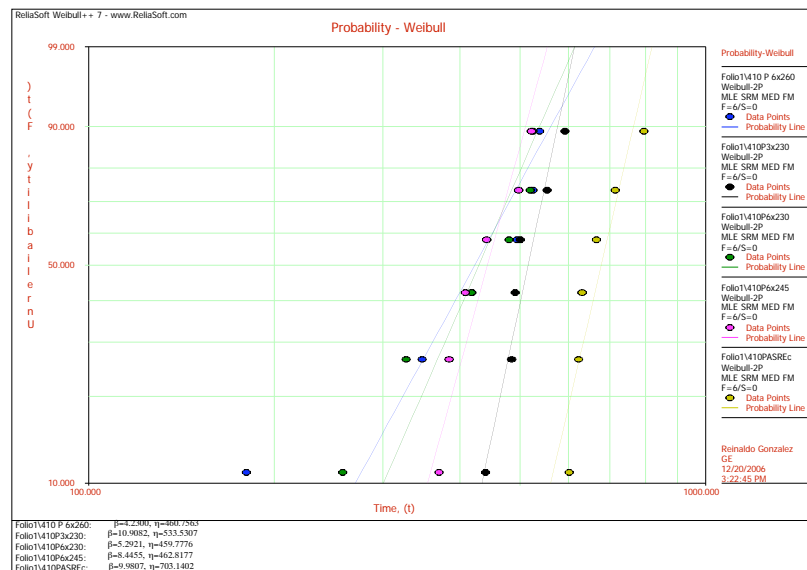
Mat B Machine#1 Pads Presence Effect

- Material B with NFP slightly superior to Material B without NFP, higher CTF (10%) .

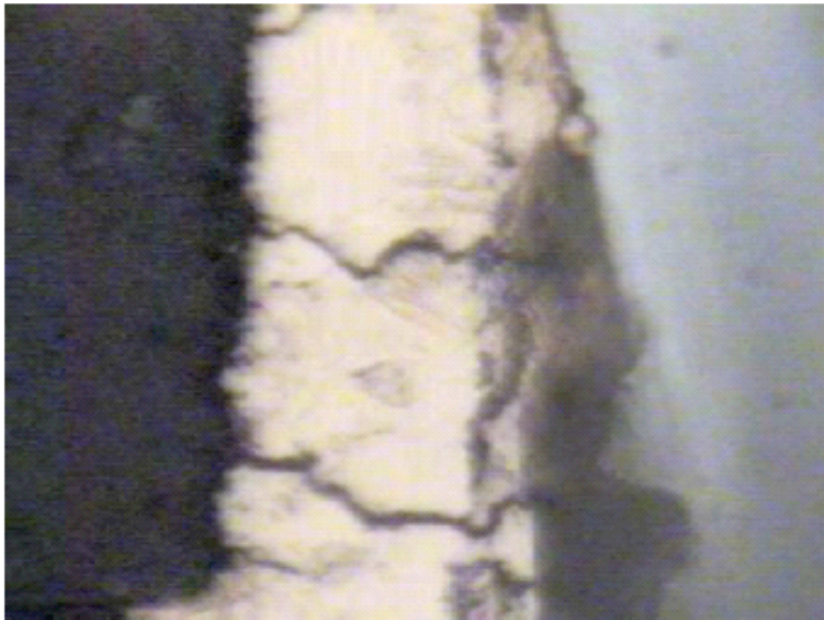
Photo 2

Metal Fatigue – Some of the cracks observed in these sections would be classified as metal fatigue. Metal fatigue cracks usually transverse the copper at a 20 to 50 degree angle. A metal fatigue crack will typically propagate between copper crystals; cracks are frequently closed at ambient temperatures. This type of failure mode is consistent with slowly accumulating resistance that accelerates over time.

Material C, NFP Included, no failure at 1000 cycles

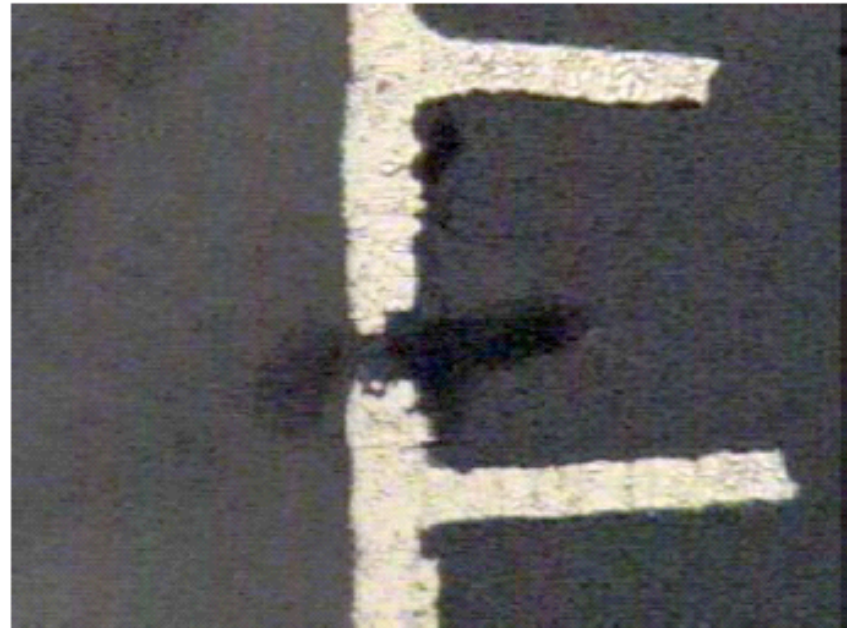
Photo 4

Barrel Cracks –Barrel cracks are typically at right angles to the plane of the drilled holes; the crack runs through copper crystals and the crack is open, or gaping, at ambient temperature. The gaping crack imparts a degree of hysteresis in the coupon. In the cooling phase of the thermal cycle the resistance does not turn to the original measurements. A reluctance to return to the original condition is called hysteresis. Barrel cracks are observed in coupon with reduced IST cycles to failure.

Material A, NFP Included, failure at 79 cycles

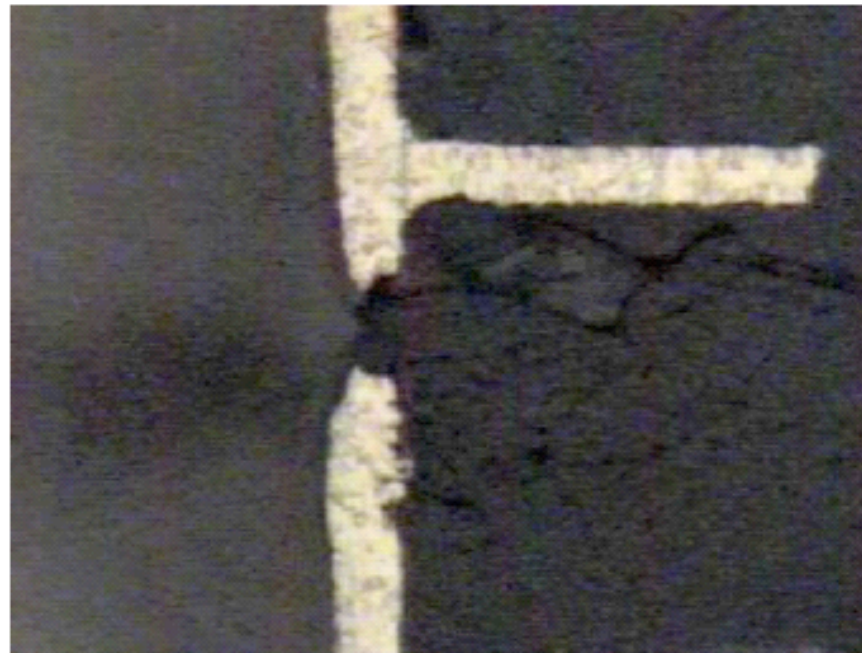
Photo 6

Copper Elongation – There are times when the Z-axis expansion is aggressive enough to produce an area thinning copper at the edges of a gaping crack. It appears that the copper is elongated prior to a rupture. This condition is seen when copper is being stress to its' limit by the Z-axis expansion of the dielectric during thermal excursions. The failure is usually abrupt in one or two cycles after onset.

Material A, NFP Included, failure at 4 cycles

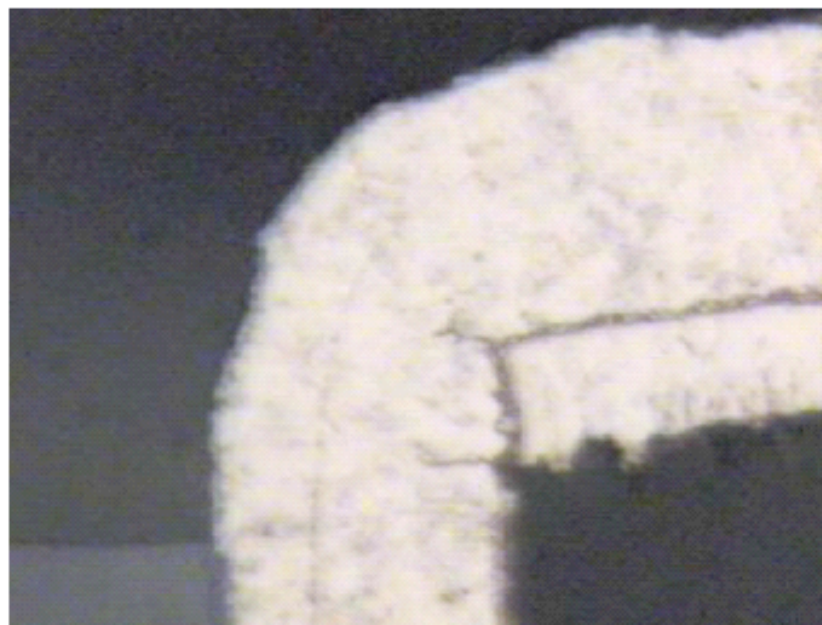
Photo 8

Corner Cracks and Pad Rotation— Corner cracks may be a result of pad rotation due to Z-axis expansion. The expansion of the dielectric material puts strain on the corner of the PTH producing a fracture line the proceeds up the face of the surface foil and then across the plated copper at a 45-degree angle. Relatively small cracks can cause a 10% increase in resistance. With the advent of lead free assembly failure modes are shifting from barrel cracks to corner cracks. Corner crack failures can be “wear-out” type failures where the copper at the corner is fatigued over time due to pad rotation from repeated Z-axis expansion associated with thermal cycling. Corner cracks are seen in many of the coupons preconditioned to 6 X 260C.

Material B, NFP Included, failure at 180 cycles

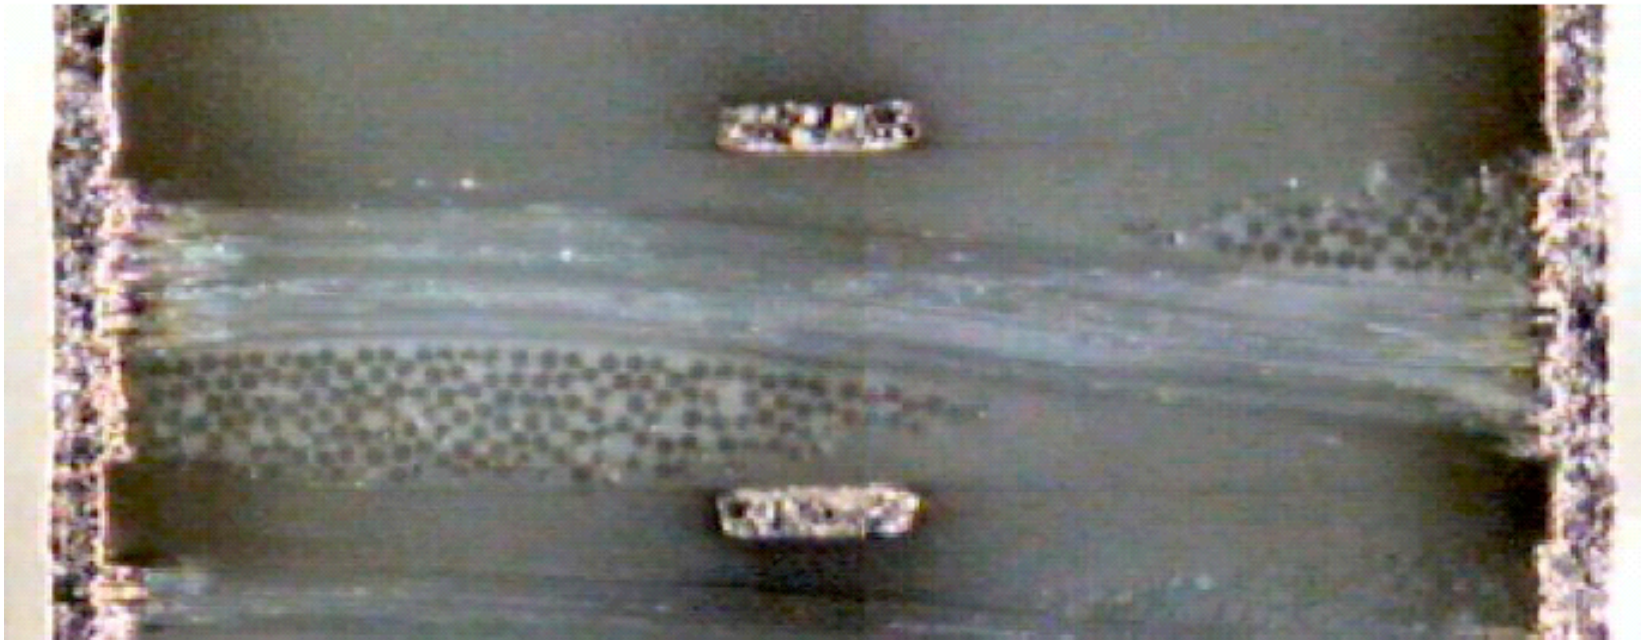
**Dark Field Microscopy
Photo 12**

Crazing - Fine cracks in the bond between the glass fibers and the dielectric produce a condition described as crazing. This condition is rejectable to IPC-A-600 if the crazing bridges the space between two conductors. In this study we believe that the presence of a significant amount of crazing has stress relieved the PTH and artificially extended IST cycles to failure.

Material B, NFP Included, 6x260C, failure at 246 cycles
