Investigation into the Mass Imaging aspects of 0.3mm Wafer Level Chip Scale Package solder paste deposition.

Clive Ashmore
Dek Printing Machines
Weymouth, UK

Abstract

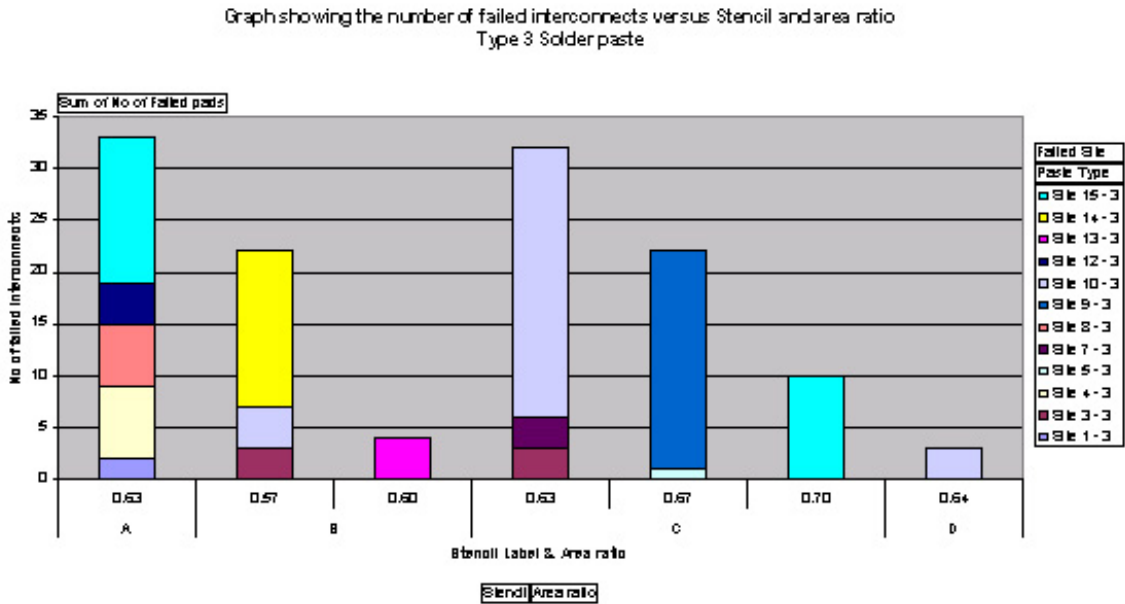
Graph 3: No of failed interconnects versus stencil type and area ratio, type 3 solder paste

The graphs above graphically show the data presented in table 7 together with the area ration associated with the failed aperture designs, it is clear to see the impact that both the area ratio and solder paste type has on the assembly process.

The data from Graph 3 shows the impact that stencil fabrication has on the assembly process. It can be seen from Graph 3 that all stencils produced a number of defects but it is clear that stencil C produced the majority. All aperture designs associated with stencil C was kept within the ≥ 0.66 rule therefore it can be concluded that the poor assembly results are due to the induced quality issues.

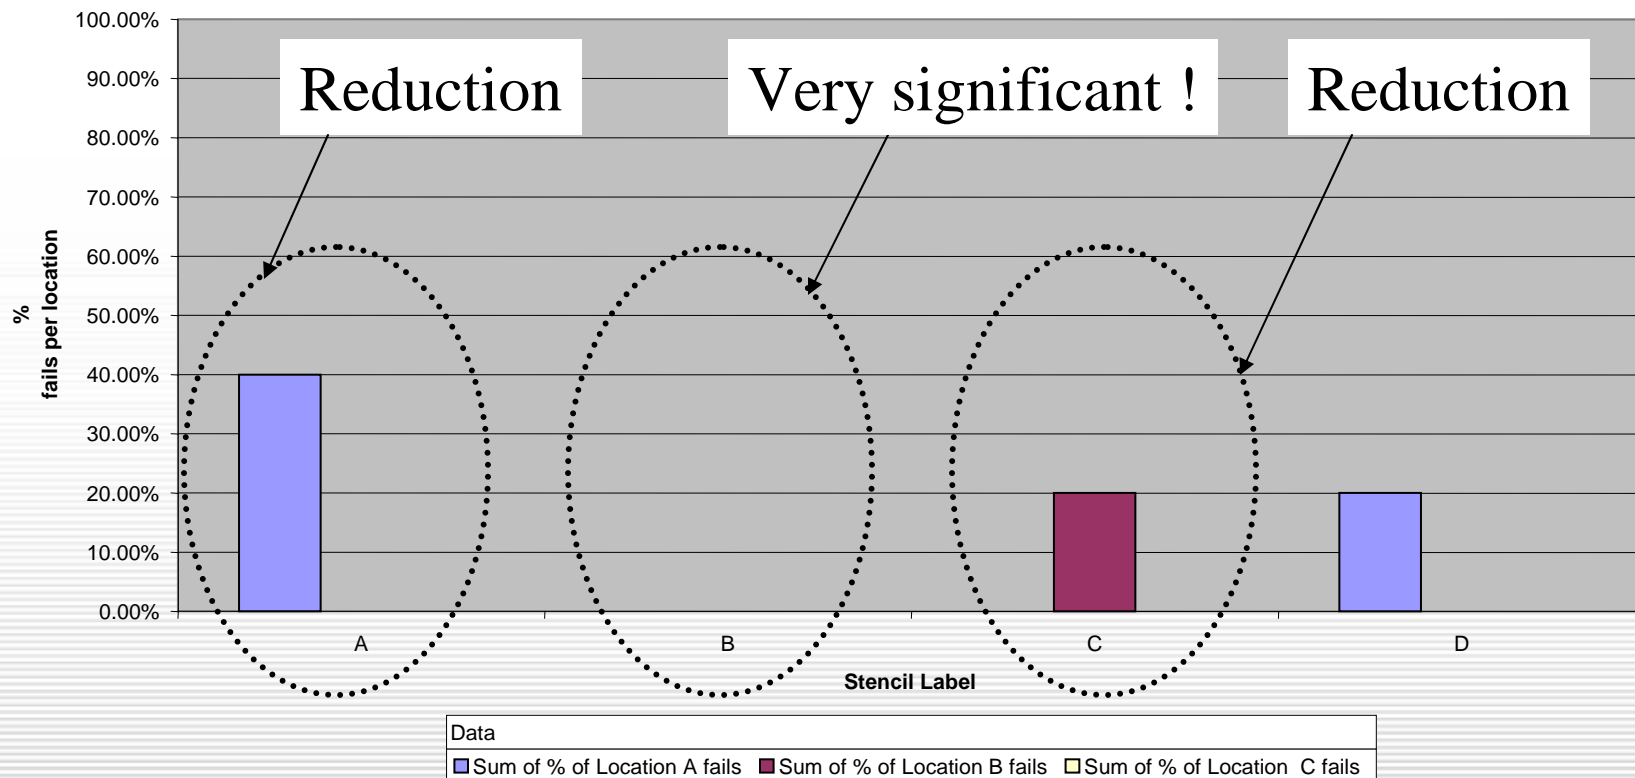
Continuity testing - Type 4

Graph showing Fails for type 4 paste

Type 4 = reduced number of failed interconnects

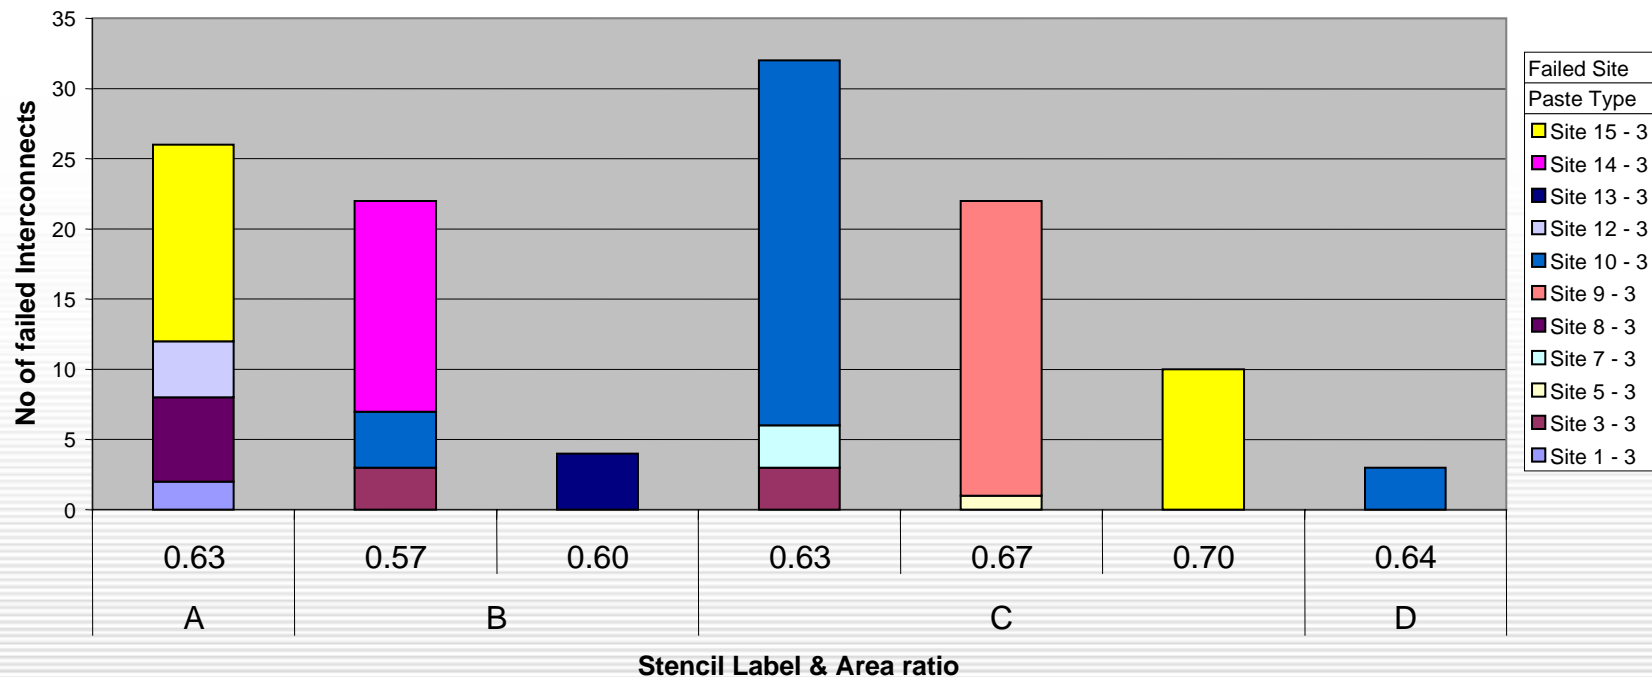
No. of failed interconnects Versus Area ratio – Type 3

Graph showing the number of failed interconnects versus Stencil and area ratio
Type 3 Solder paste

General Observation – Area ratio of 0.66 still needs to be observed.
Stencil C shows poor quality = poor results

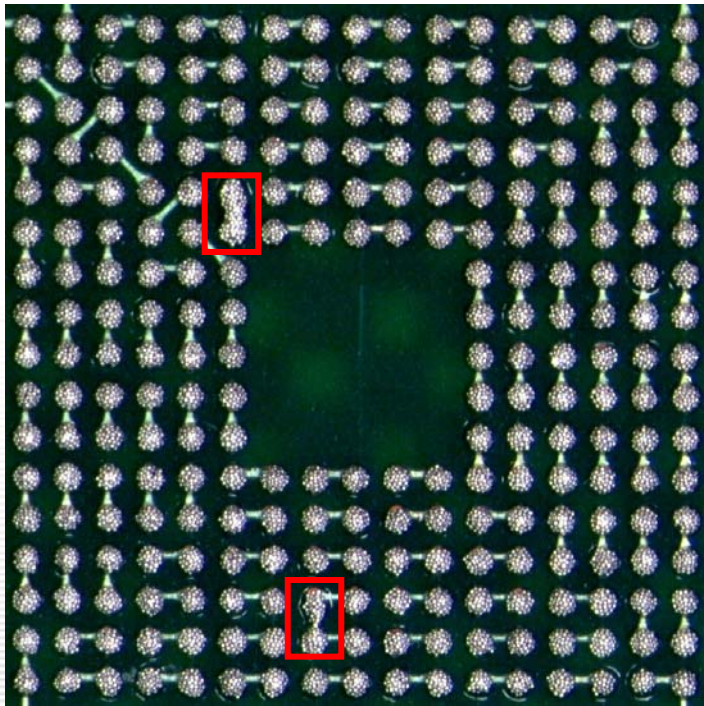
X-Ray

The solder paste bridge did not manifest itself into a
post reflow solder bridge
