# Suspect / Counterfeit Electronic Components and Risk Mitigation

By: Rick Stanton

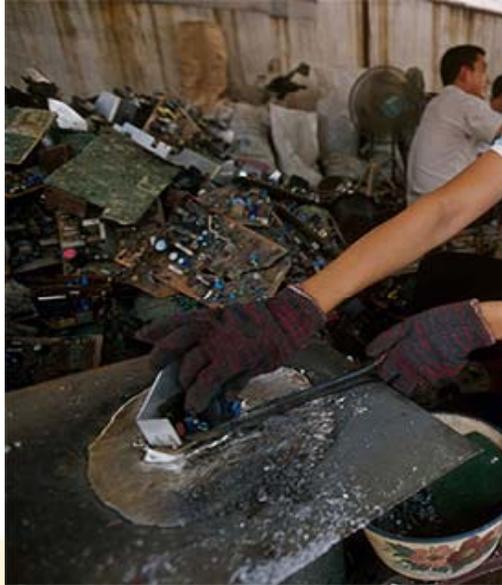
**Electronic components being scraped off a circuit board assemblies using molten solder. In China thousands of men, women and children make a living from processing electronic waste form North America and Japan every day.**

**Using a wok type coal burning furnace, electronic scrap assemblies are heated, until solder becomes molten, components are pulled/scraped off then cleaned in a nearby river for re-claim-re-sell processing in China.**

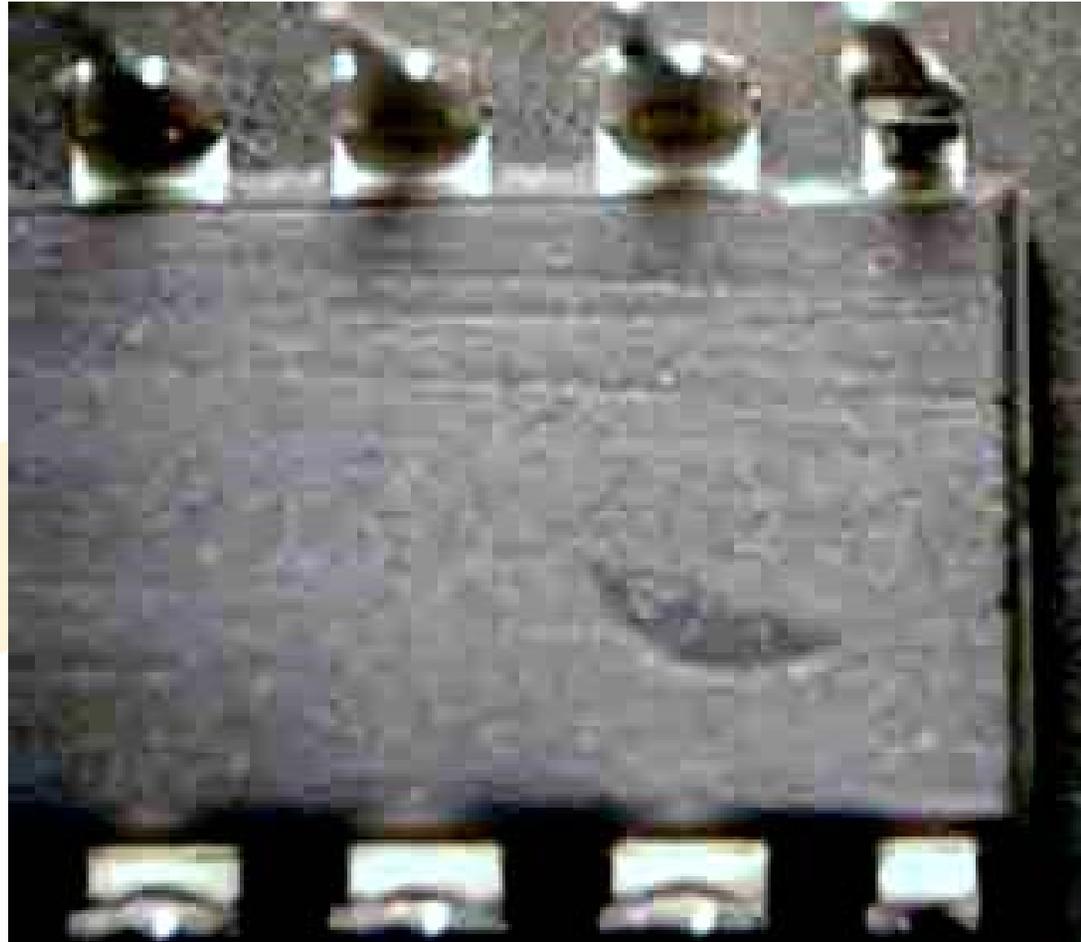
**SUSPECT / COUNTERFEIT**

**PART HAS BEEN SANDED, PARTIAL MARKING IS THAT OF COUNTRY OF ORIGIN.**

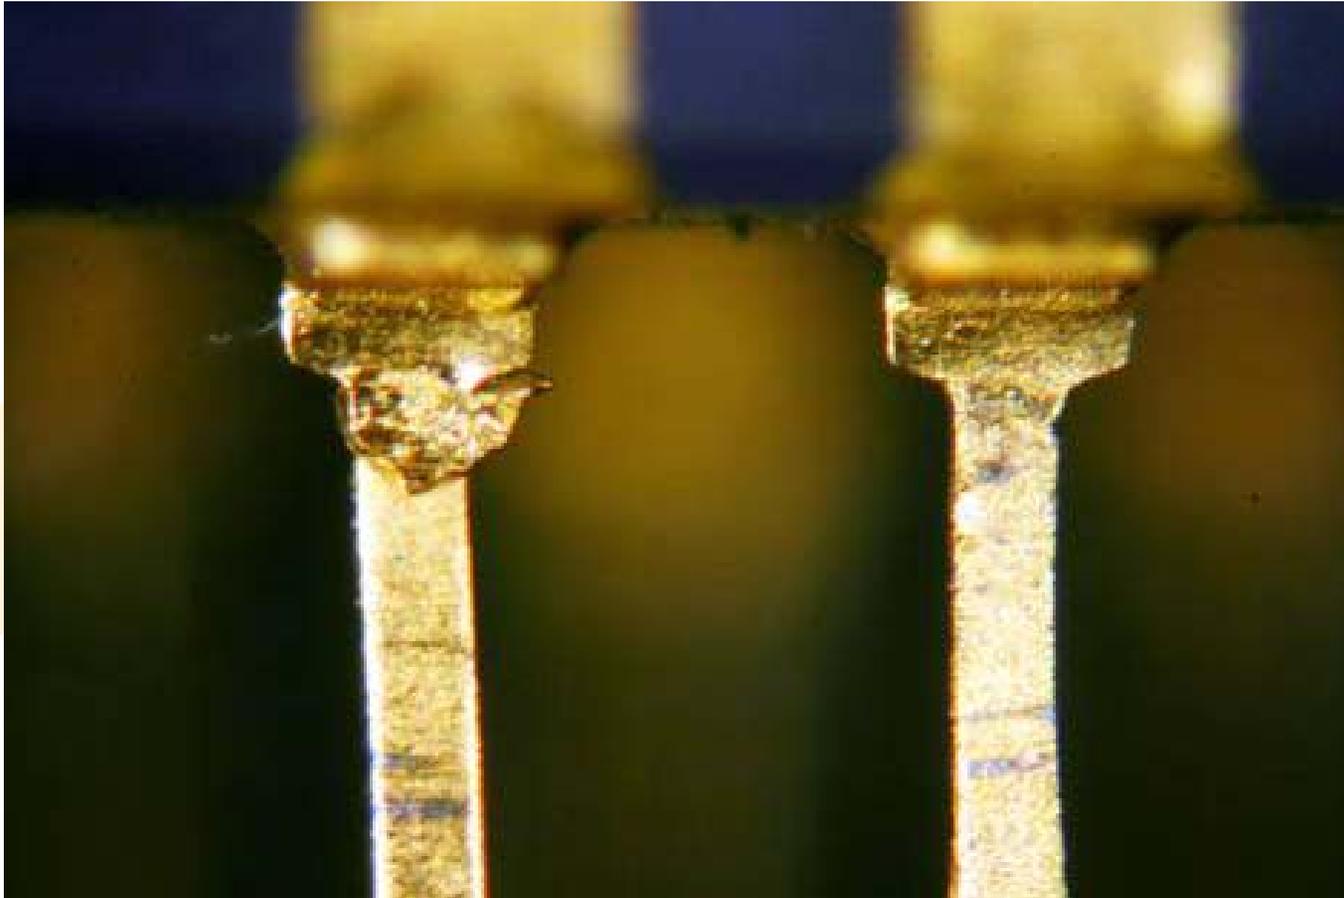
**SUSPECT / COUNTERFEIT**

**GOLD LEADS RE-ATTACHED/RESOLDERED – GOLD PLATED**

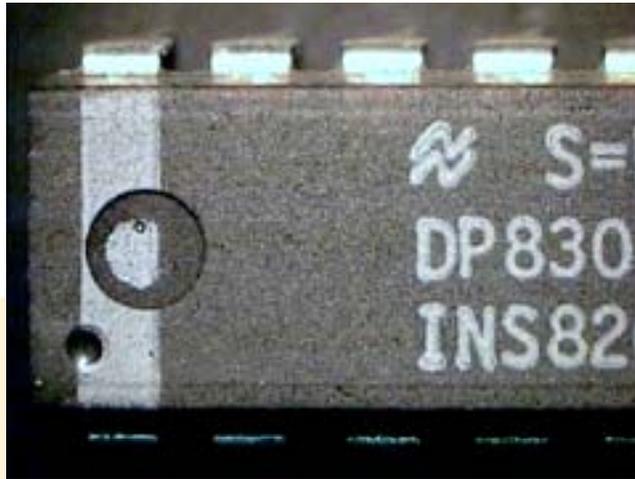
## SUSPECT / COUNTERFEIT

OEMs are particularly careful with their standards during manufacturing. Paint in the indent or mold indent cavity is not the intent therefore making this a suspect counterfeit.

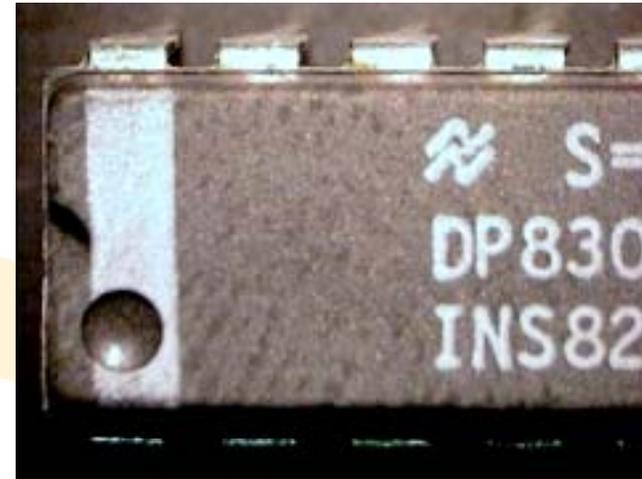
This part is from the exact same lot code as the adjacent part. Differences in the indents are evident. One is much larger and the other is non-existent. This validates a suspect counterfeit

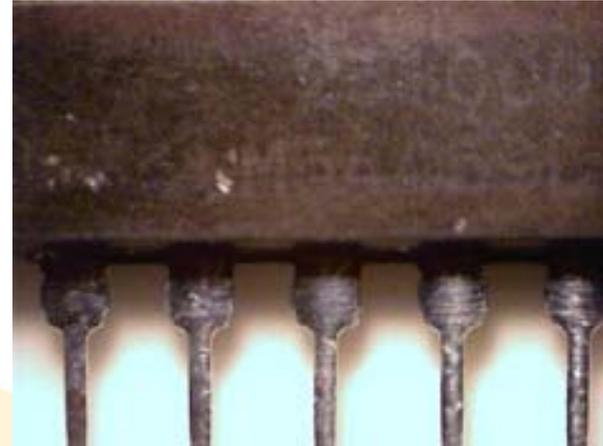
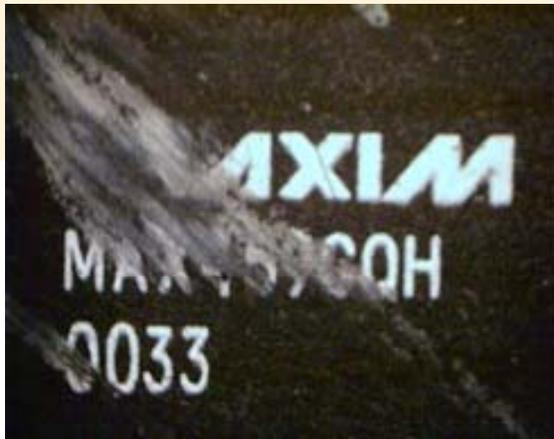
## SUSPECT / COUNTERFEIT

Part failed marking permanency test per, MIL-STD-883, using 3 parts mineral spirits and one part alcohol this easily removed the markings.

Part failed marking permanency test per MIL-STD-883. Maxim parts after 2002 are not paint marked, they are etch marked. If you receive Maxim parts painted with a date code newer than 2002 you have a suspect counterfeit component.

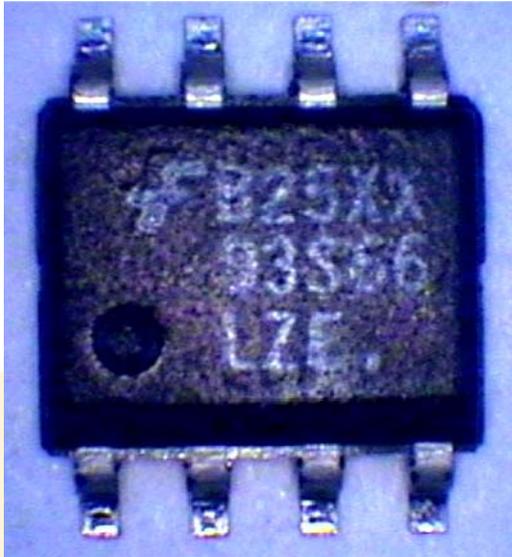
## Blacktopping

Part has been blacktopped and painted/printed over with a new part number. Etching is still evident.

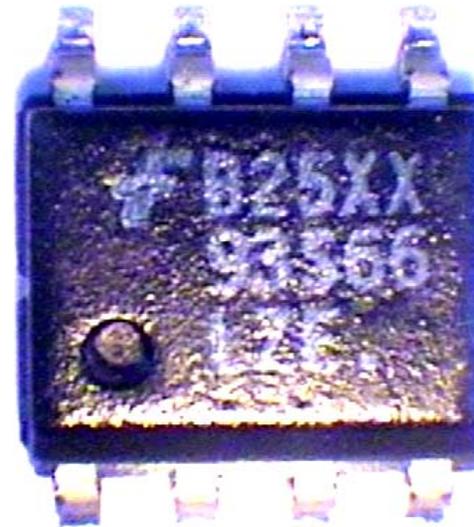
Part has been blacktopped, Polarity Mold Cavity/Indent is not zeroed or aligned properly. Note abnormal shine on the top of component, another suspect indication.

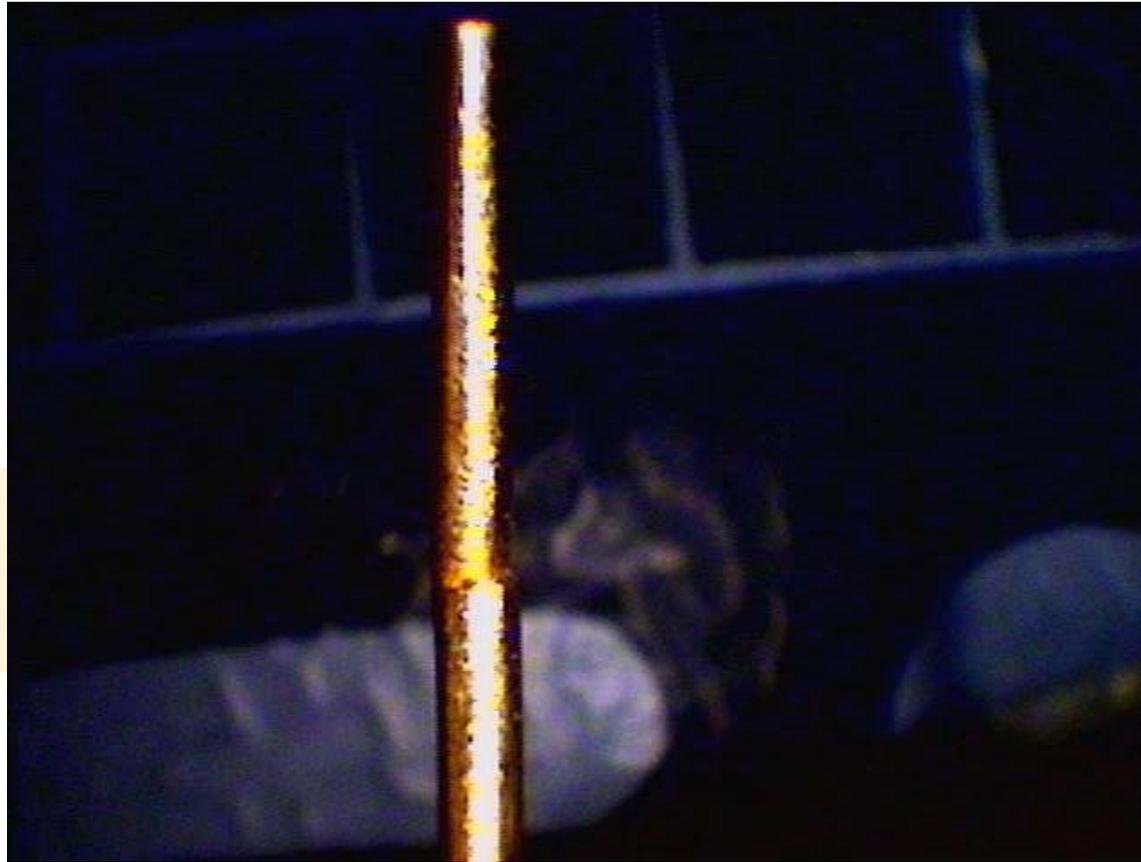
## COUNTERFEIT Component-Module

OEM had cut leads and scrapped part due to major revision change. Counterfeiter re-attached leads on this \$800. module. The detection was easy, the counterfeiter attached wrong diameter leads, all six (6) of them.

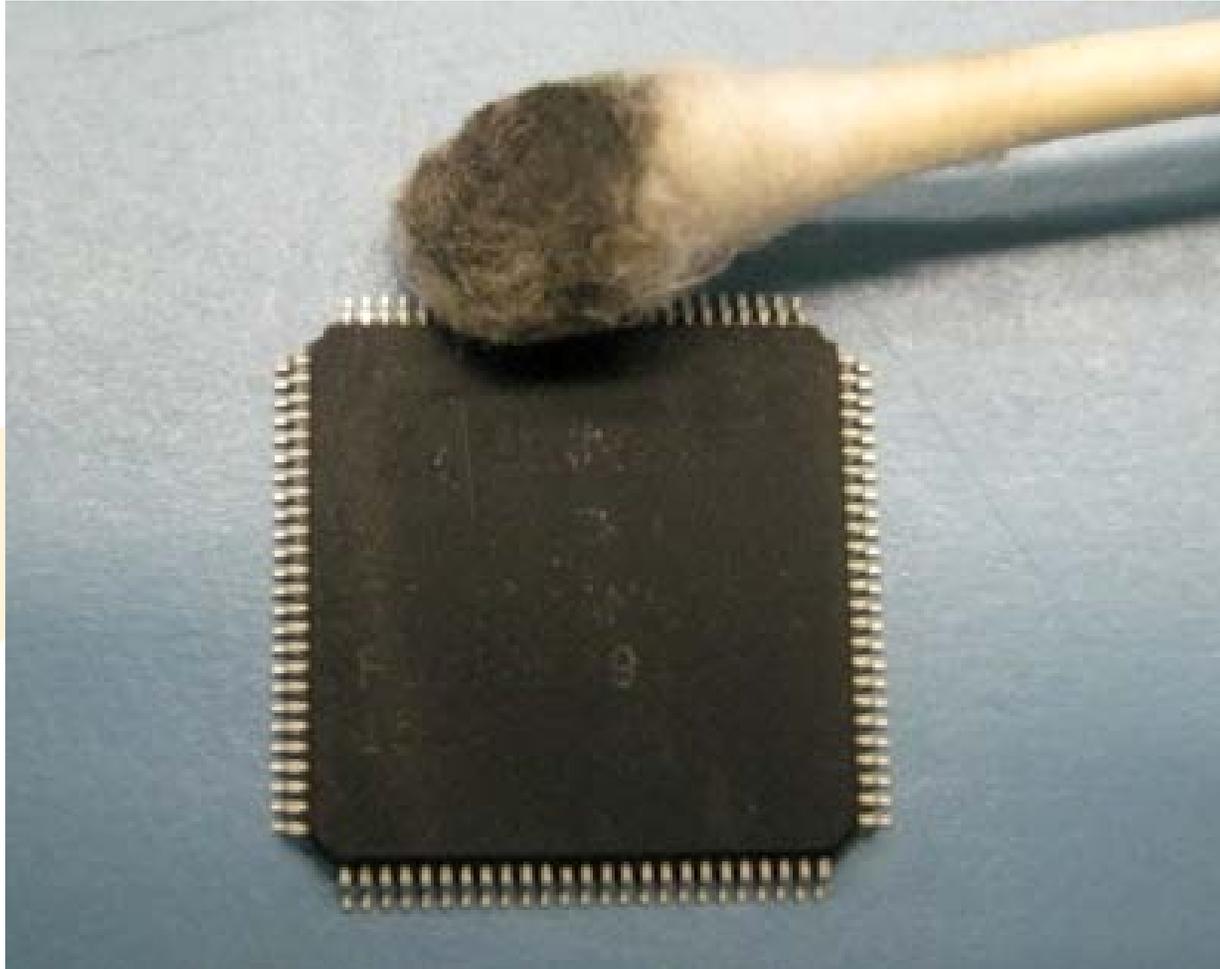
**SUSPECT / COUNTERFEIT**

**FAILED PART MARKING PERMANENCY TEST**

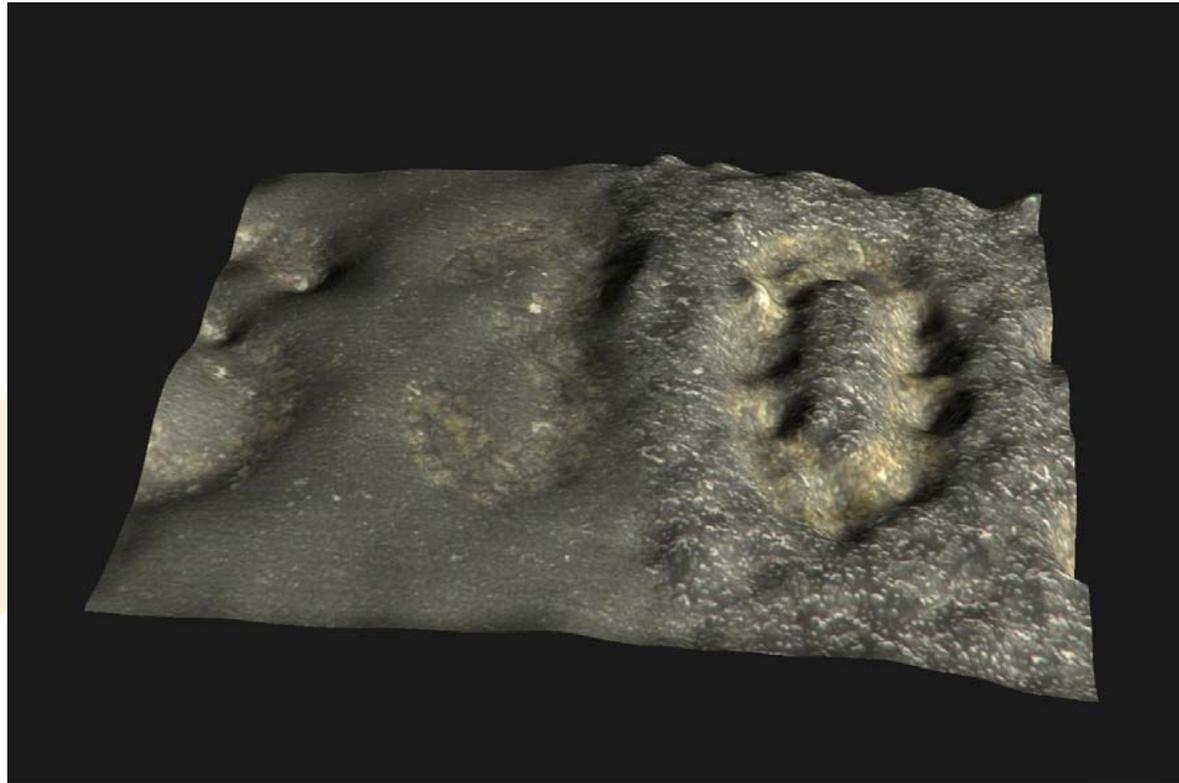
**SUSPECT / COUNTERFEIT**

**NOPE...IT'S NOT LASAGNA, IT'S A THREE DIMENSIONAL TOPOGRAPHICAL MAPPING SHOWING MAJOR DIFFERENCES IN TEXTURE AFTER A MARKING PERMANENCY TEST / CHEMICAL WASH, NOTE THE DIFFERENCES IN DEPTH OF THE DIGITS.**

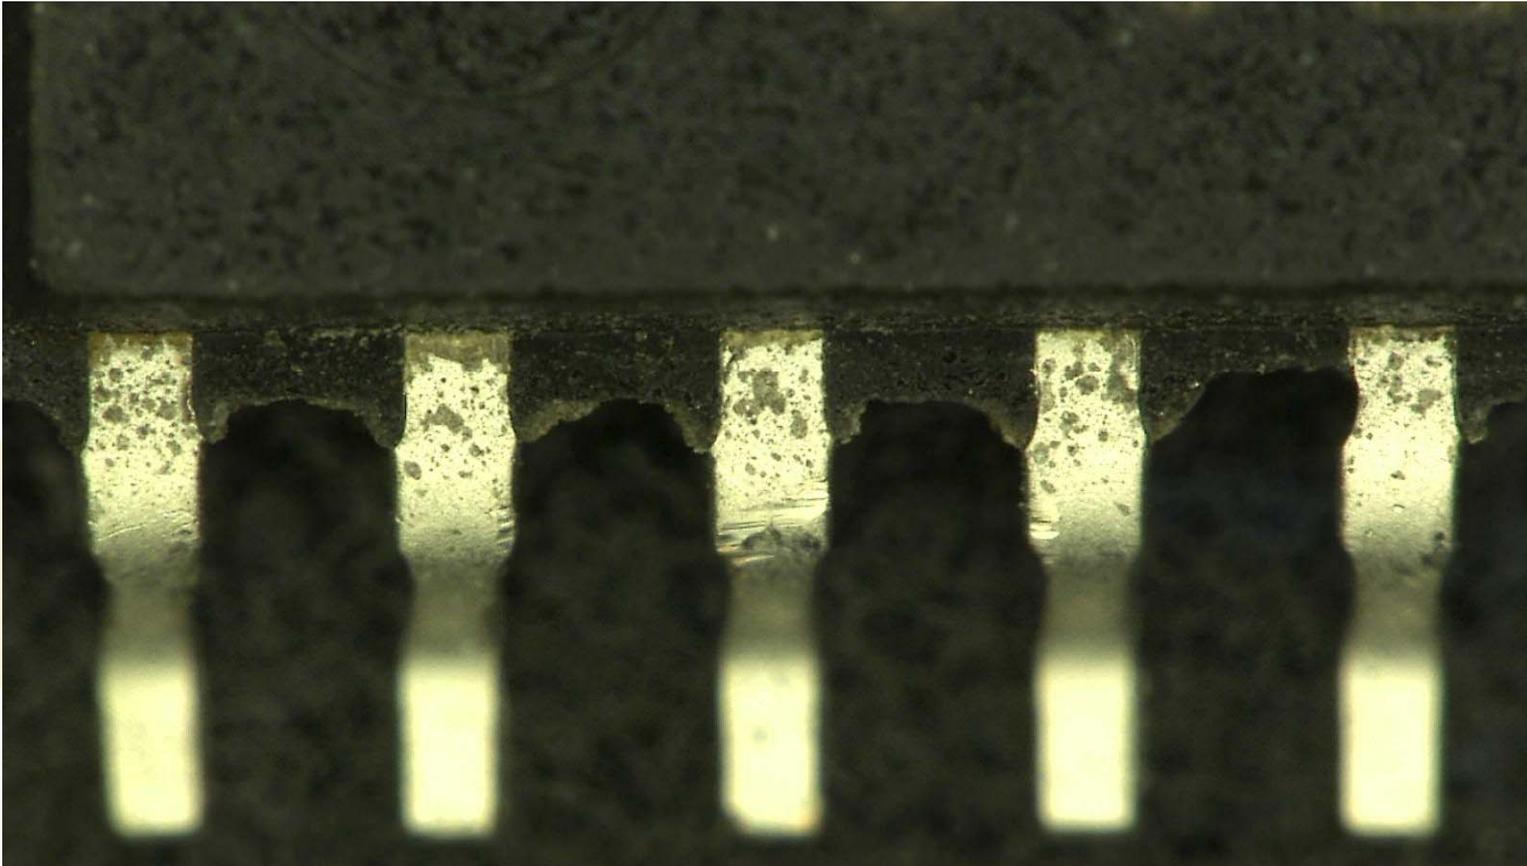
**SUSPECT / COUNTERFEIT**

**LEADS ARE CONTAMINATED WITH PAINT OVERSPRAY, AN EFFECT FROM CARELESS BLACKTOPPING**

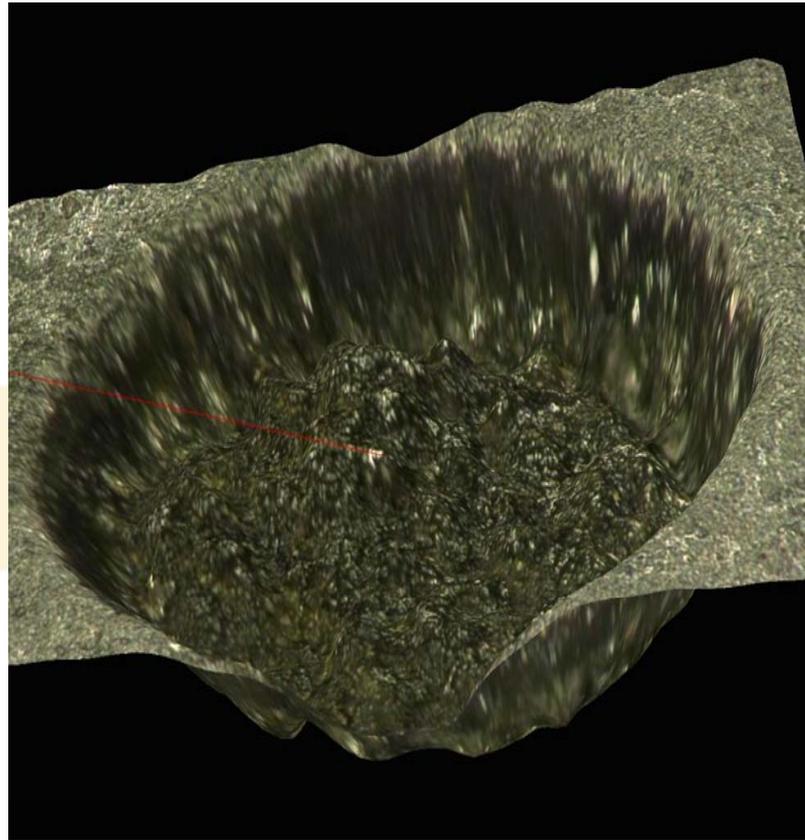
**SUSPECT / COUNTERFEIT**

**THREE DIMENSIONAL INSPECTION OF PIN 1 MOLD INDENT SHOWS EVIDENCE OF SANDING AROUND EDGE, NOTE BLACKTOPPING FILL PILED IN THE CENTER OF INDENT, THIS AREA SHOULD BE SMOOTH.**

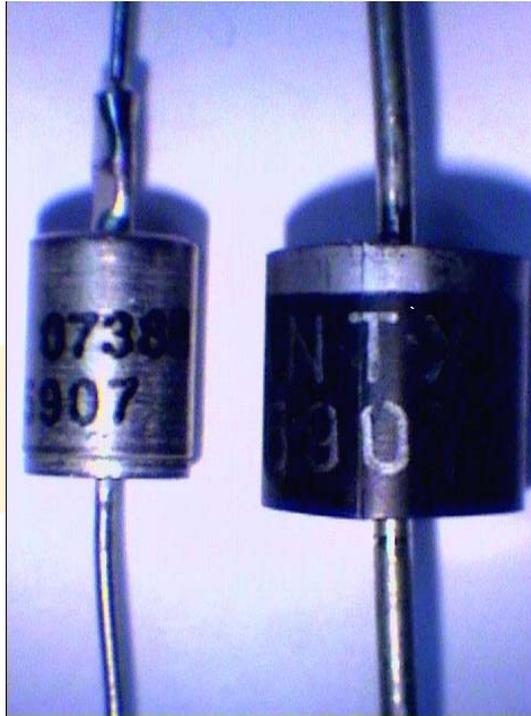
**SUSPECT / COUNTERFEIT / FRAUD**

**MAJOR FRAUD, COUNTERFEITERS MARKED THIS COMMERCIAL PART (right) AS A MILITARY JNTX PART (Left) , THE DATASHEET CLEARLY STATES MILITARY GRADE SHALL BE ENCLOSED IN A METAL CASE, THE COMMERCIAL PART IS ENCLOSED IN A MOLDED PLASTIC, WRONG DIMENSIONS ARE EVIDENT.**

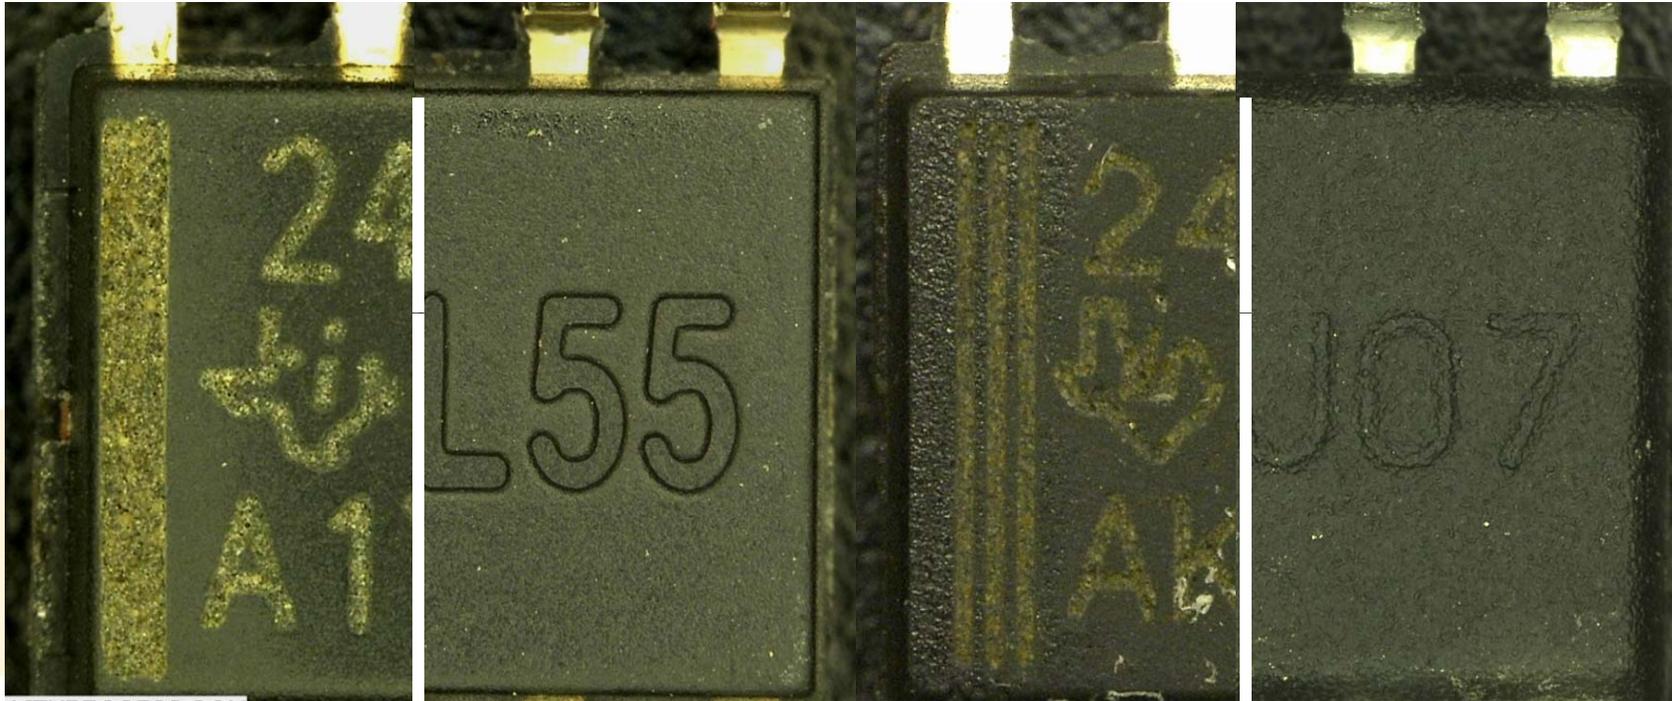
**SUSPECT / COUNTERFEIT**

**GOOD PART-NOT REMARKED  
AUTHENTIC OEM LOGO, BOTTOM  
SIDE SHOWS DIGITS AND LETTERS  
CLEAN AND WELL DEFINED.**

**SUSPECT/COUNTERFEIT PART OEM  
LOGO IS DISTORTED, CHARACTERS  
ON BOTTOM OF PART SHOW  
ROUGH EDGES,**

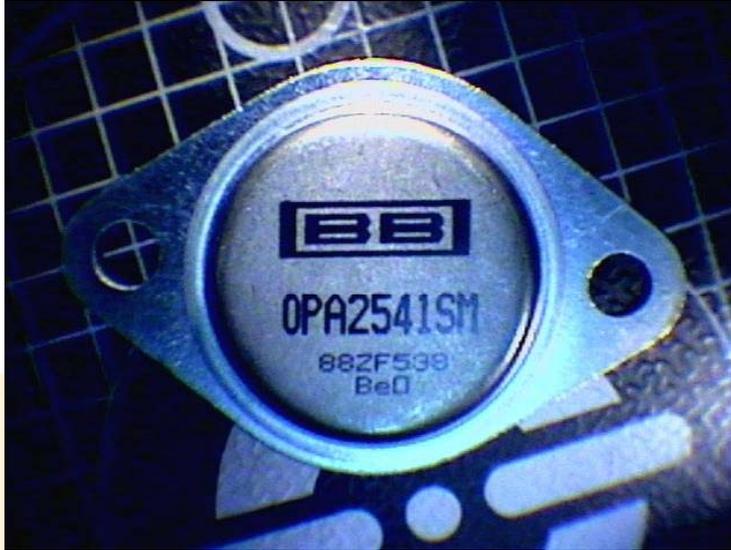
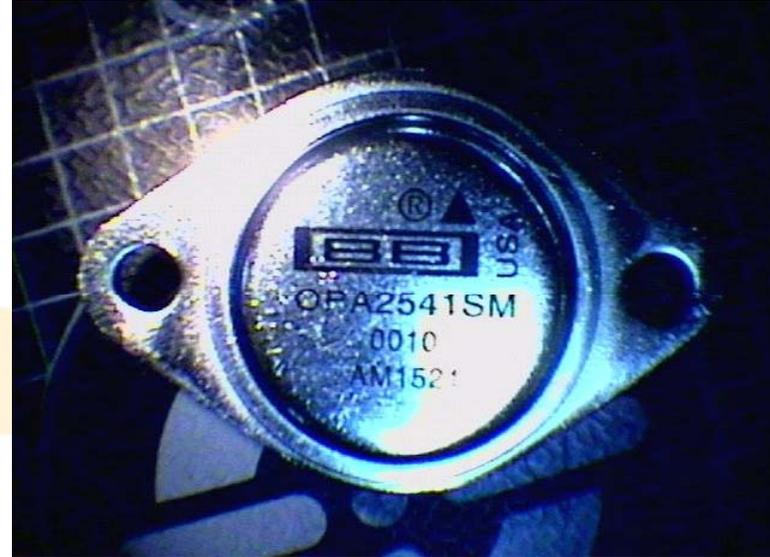
**Authentic Part**

**Counterfeit Part**

The authentic part on the left is part marked with the acronym BeO. This symbol represents Beryllium Oxide, letting the consumer know the composition of the internal die contains this disease causing material, an Osha requirement . The manufacturer is required to Part Mark/Stamp this symbol on the outside of the part. The part on the right is void of it, resulting in a counterfeit part.
