Pb-Free Reflow, PCB Degradation, and the Influence of Moisture Absorption

Kerin O'Toole, Bob Esser, Seth Binfield,
Craig Hillman, Cheryl Tulkoff and Joe Beers
DfR Solutions / Gold Circuits

IPC Midwest 2009

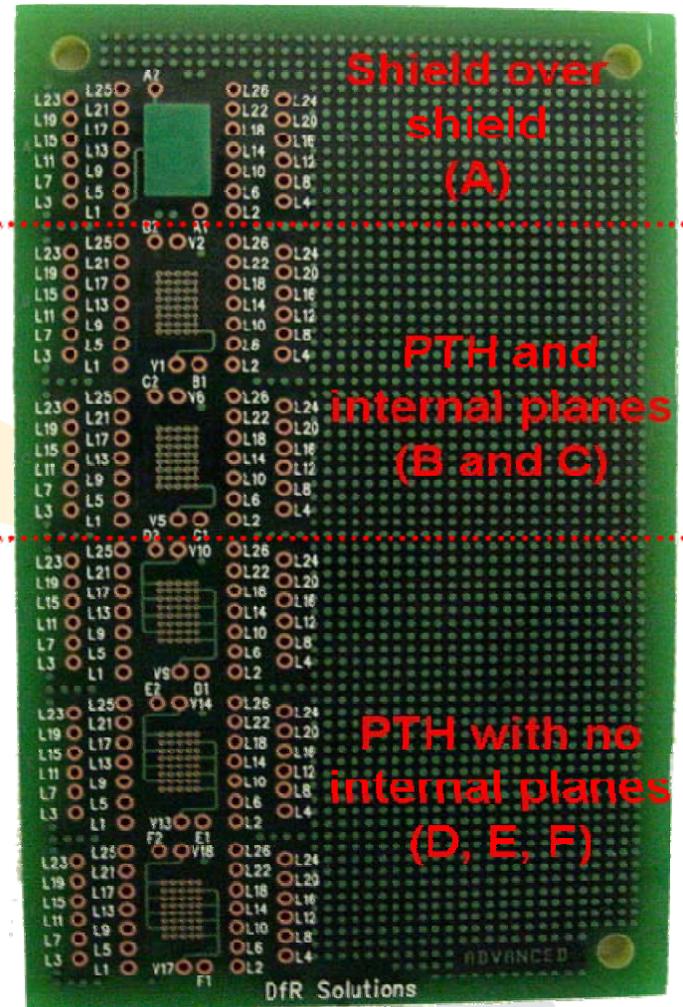
Coupon Design

- Two coupon designs (Standard / Advanced)
 - Each coupon design has three sections and six test structures
- **Section 1:** 'Shield over shield' (Test Structure A) **1**
 - **Plane-to-plane spacing:** See slide 4 (same for both standard and advanced designs)
- **Section 2:** PTH with internal planes (Test Structures B and C) **2**
 - **Plane-to-plane spacing:** See slide 4 (same for both standard and advanced designs)
 - **Drill diameter:** Standard: 15 mil; Advanced: 12 mil
 - **Clearance:** Standard: Drill + 10 mil; Advanced: Drill + 7 mil
 - **Pitch:** 78 mil (same for both standard and advanced)
 - **Pad diameter:** 27 mil
- **Section 3:** PTH with no internal planes (Test Structures D, E, & F) **3**
 - **Drill diameter:** Standard: 15 mil; Advanced: 12 mil
 - **Pitch:** Standard: 40 mil; Advanced: 32 mil
 - **Pad diameter:** 27 mil

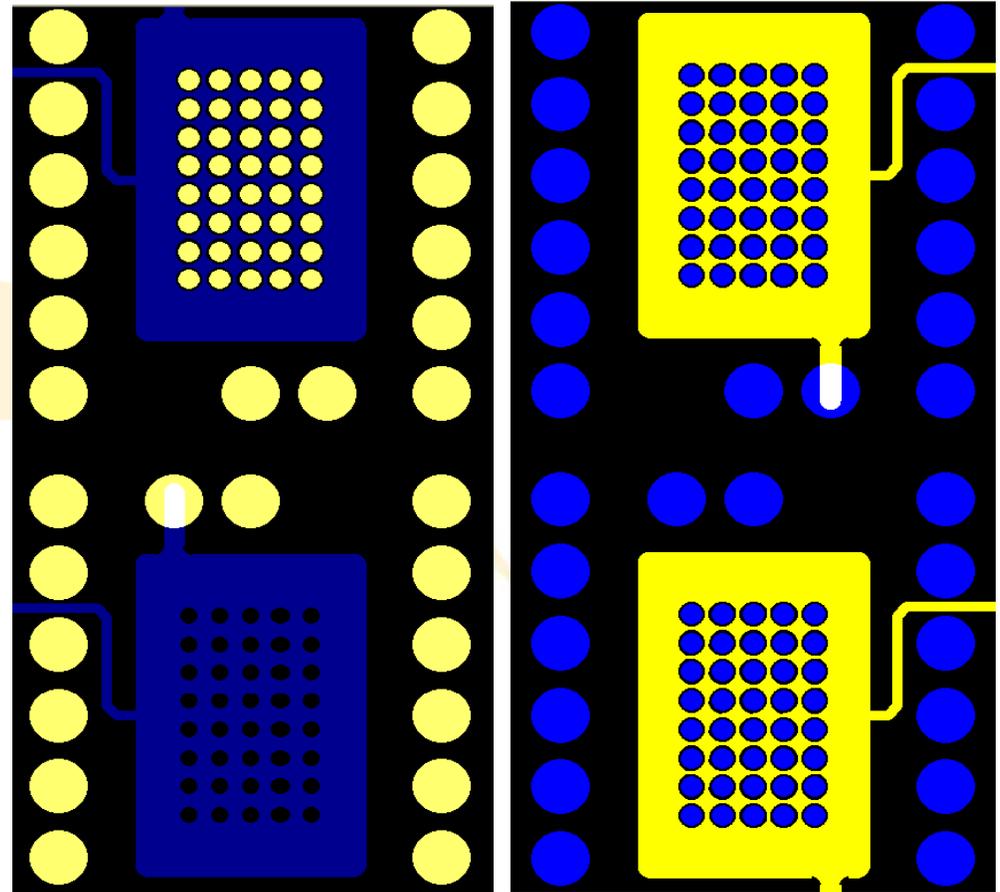
Test Structures B and C (Example)

- Test structures B (top) and C (bottom)
 - Layer 19 (left)
 - Layer 20 (right)
- Note how non-functional pads are present in both layers for test structure B, but are absent in layer 19 for test structure C

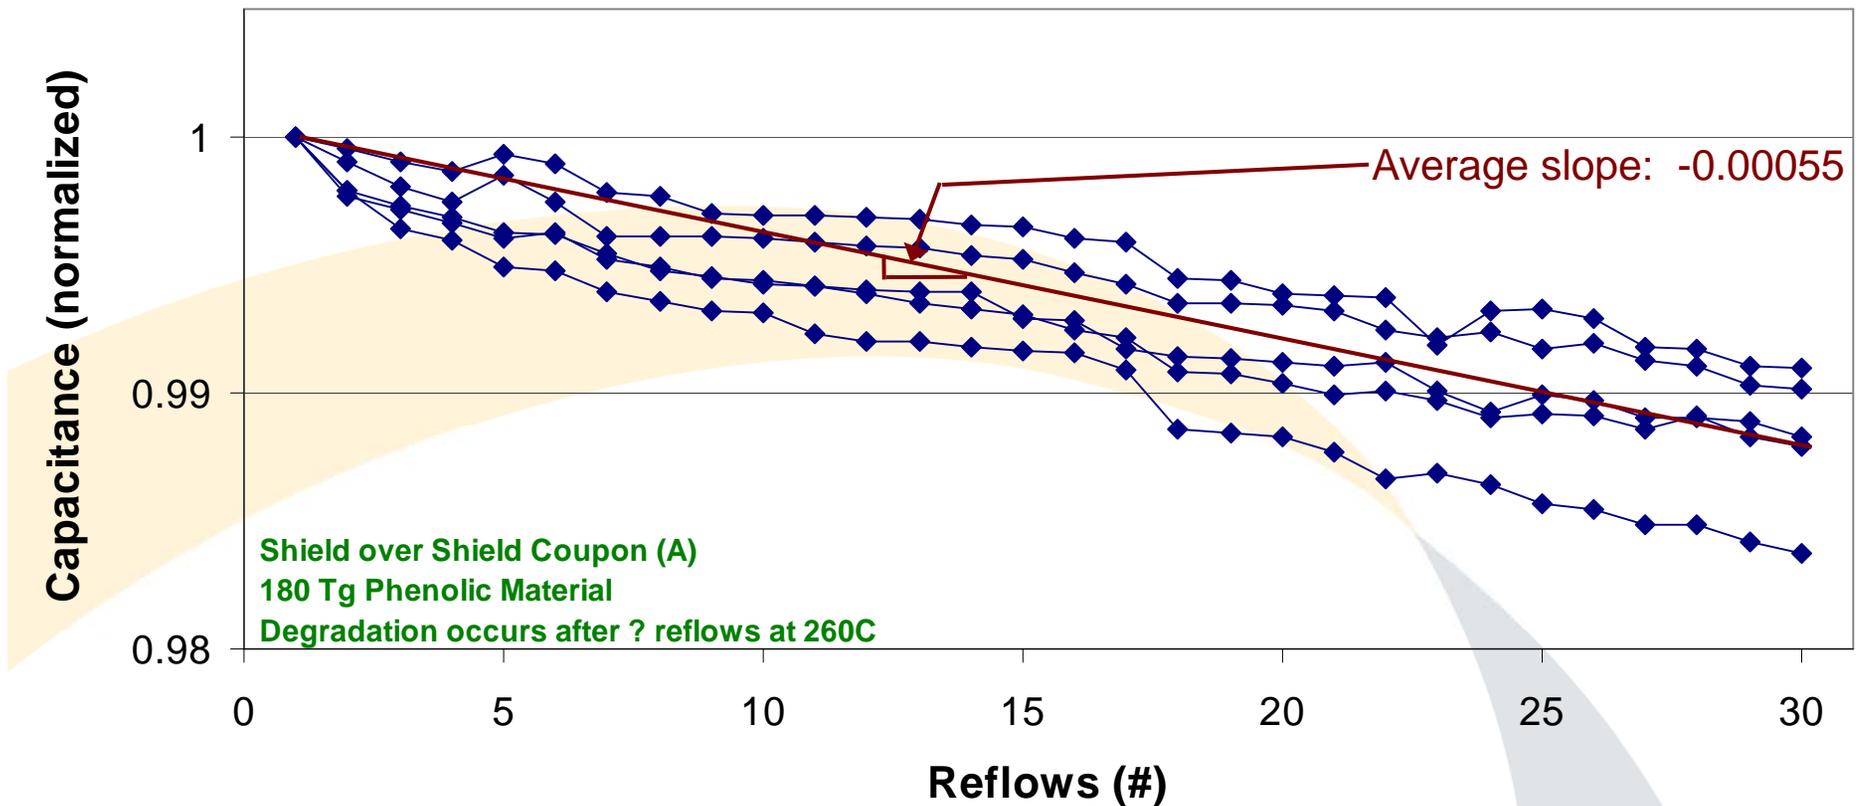
Normalized Capacitance vs. Number of Reflows,
260°C Peak

Phase 1: 260°C Reflow Results, Test 1

- Steady decrease in shield over shield (S-S) capacitance at 260°C, but no clear roll-off point
- Test structures A, B, and C degrade at different rates, with B showing the greatest change in capacitance
 - Test structure B has an average degradation rate almost 5X greater than that of test structure A
 - Test structure C has an average degradation rate almost 3X greater than that of test structure A
- 280°C samples show a stronger (~0.5% average) decrease in shield over shield capacitance after 4 reflows, but gradual degradation continues with each subsequent reflow cycle
 - Average degradation rate of the 280°C samples was approximately 50% greater than that of the 260°C samples

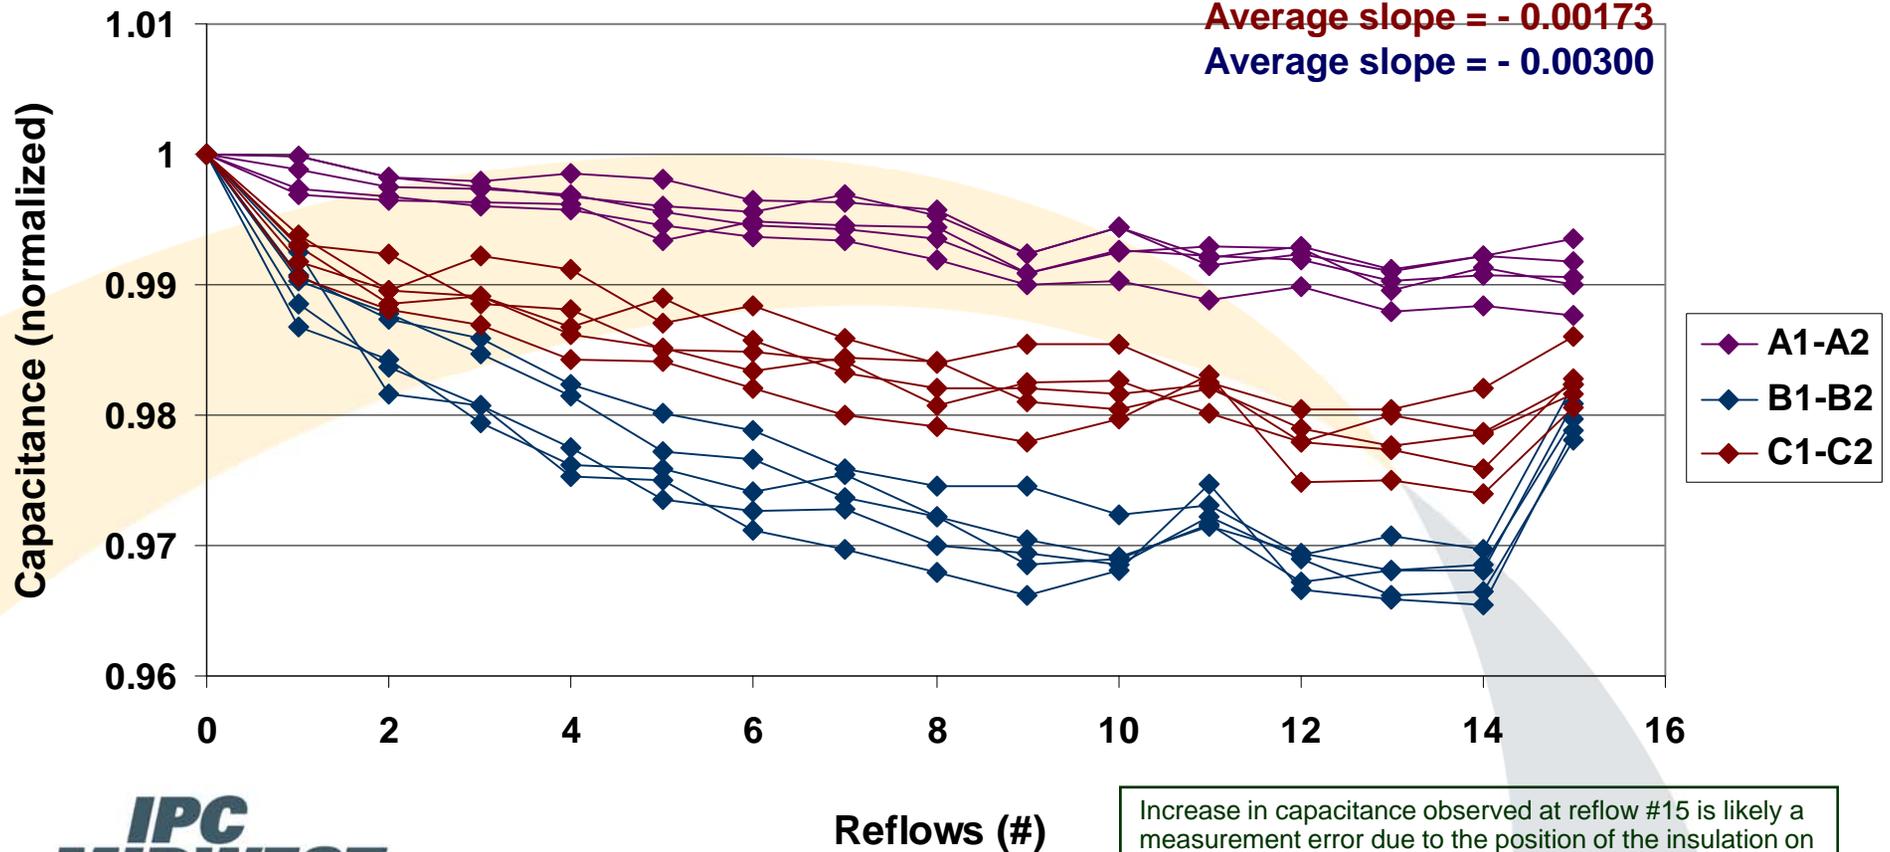
S-S Capacitance vs. Number of Reflows, 260°C Peak

Increase in capacitance observed at reflow #15 is likely a measurement error due to the position of the insulation on the leads of the measuring device.

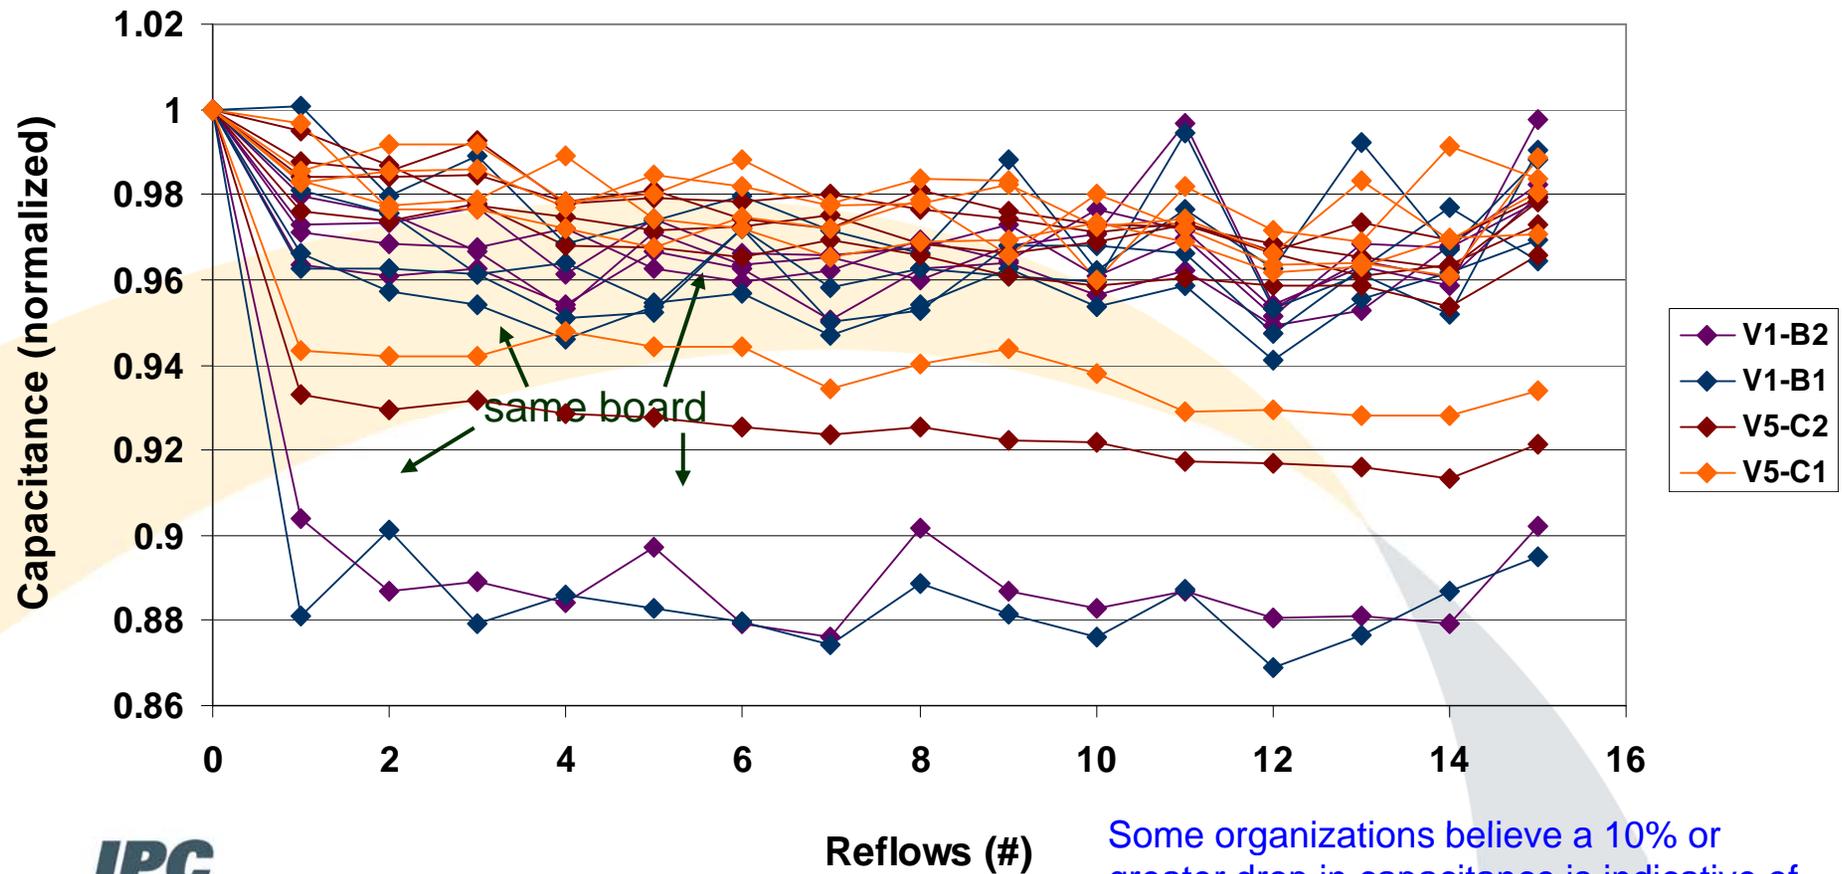
S-PTH Capacitance vs. Number of Reflows, 260C Peak

Some organizations believe a 10% or greater drop in capacitance is indicative of cracking or delamination

- Shield to PTH (S-PTH) capacitance:
 - A higher degree of degradation compared to shield over shield
 - After just one reflow cycle, the degradation in S-PTH capacitance is comparable to that of the S-S capacitance after 15 reflow cycles.
 - Very significant decrease in capacitance after 4 reflow cycles, followed by very gradual degradation with an extensive degree of variation
 - One board had a much larger decrease in capacitance on all S-PTH nets

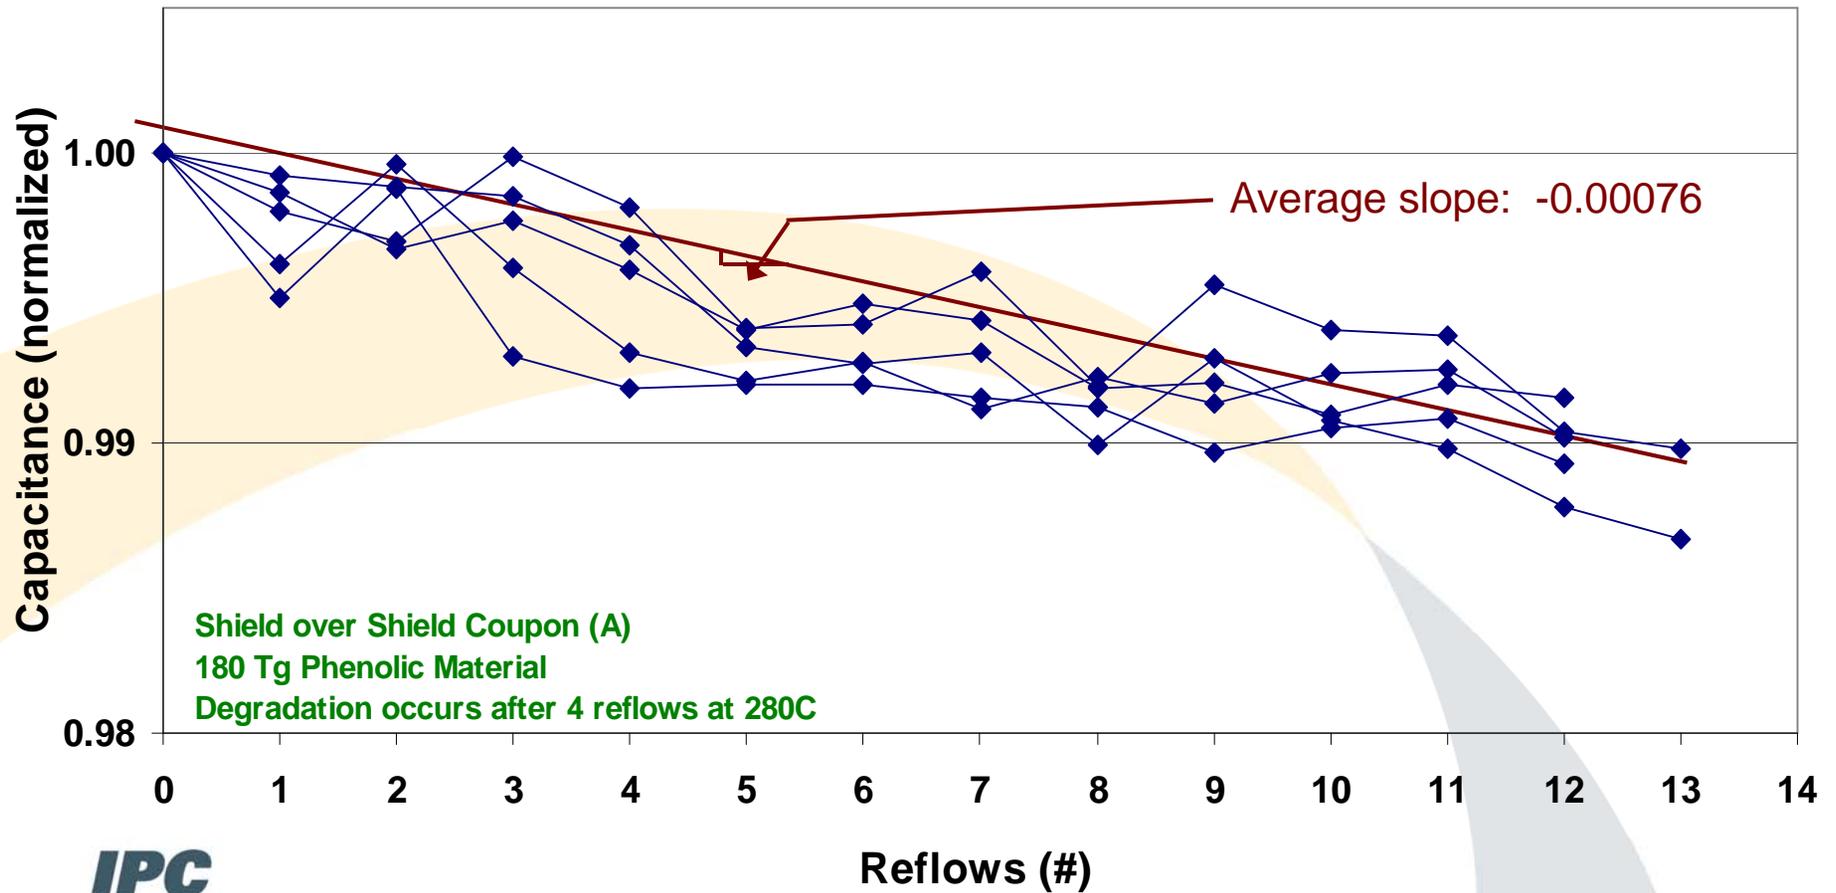
Normalized Capacitance vs. Number of Reflows,
280°C Peak

Phase 1: 280°C Reflow Results

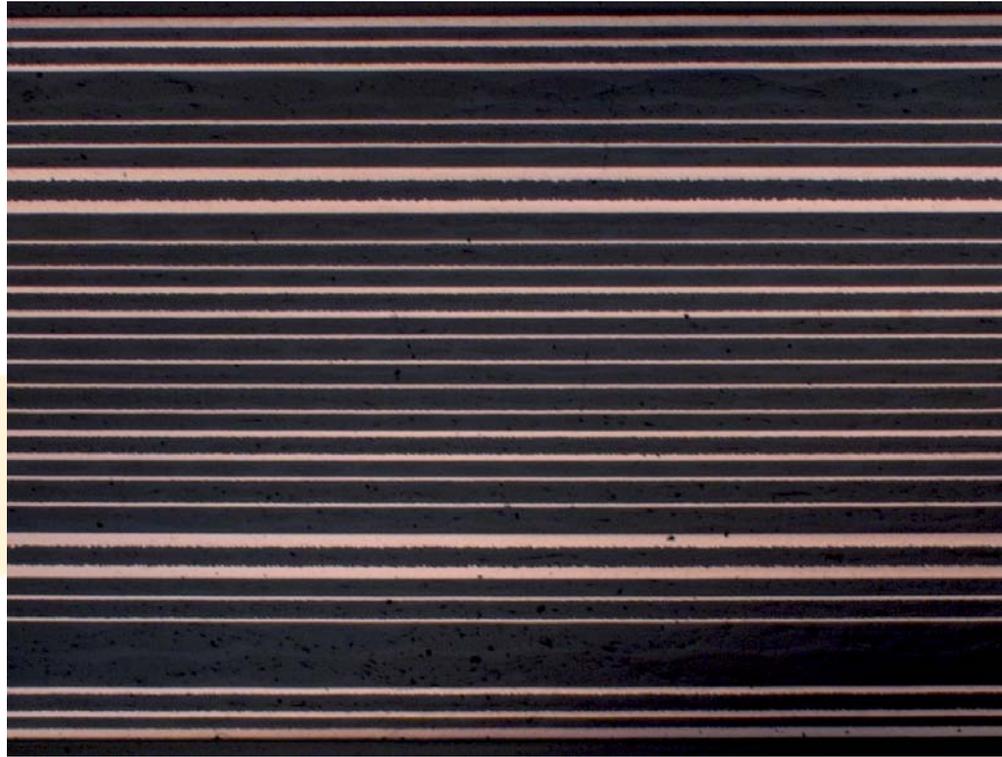
Phase 1, Part 1: Cross Section

- Cross section of sample after 33 reflows at 260°C peak
- Low magnification: no cracking observed

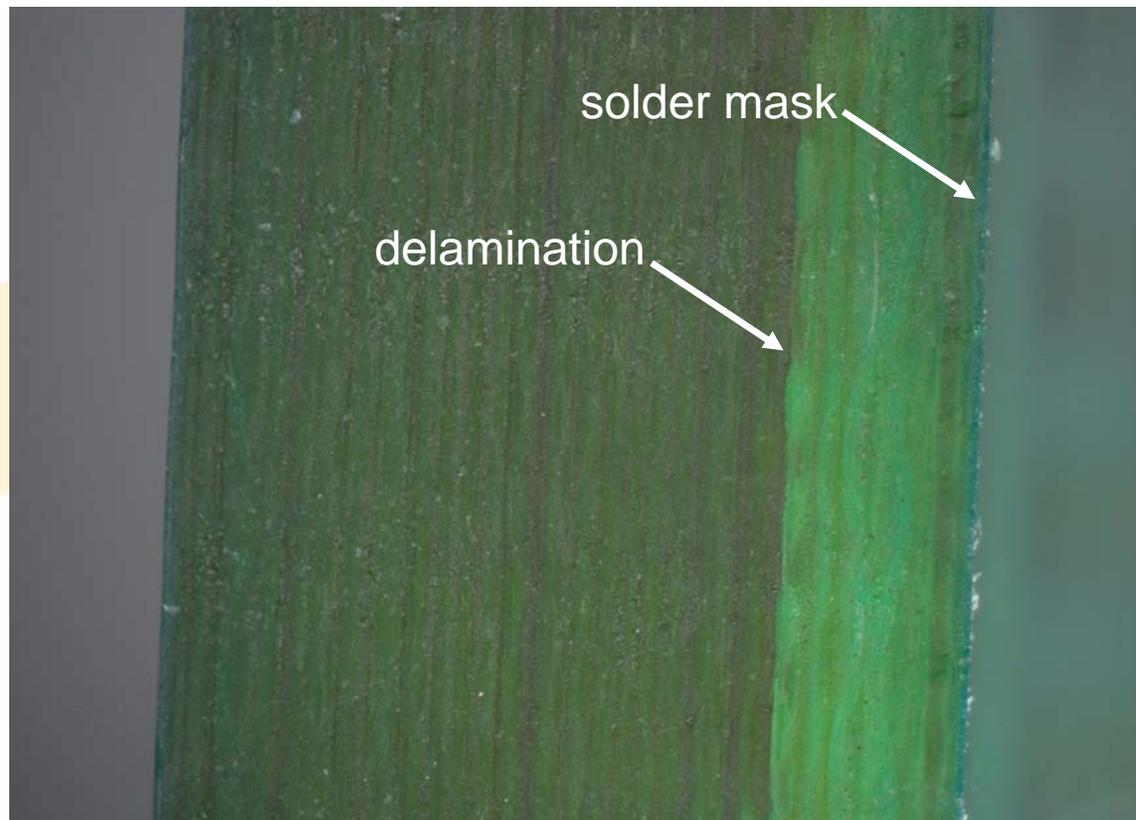
Delamination observed in 85°C/85%RH test boards

2.5X side view of 85°C/85%RH board after 3 reflows at 260°C peak

- Delamination occurred primarily in featureless areas
- Evidence of failures only in specimens tested as per MSL1 (85°C/85%RH, 168 hours)
 - These samples had the highest % weight gain
- No visible delamination in MSL2 (85°C/60%RH, 168 hours) and MSL2a (60°C/60%RH, 120 hours) samples
- No observable delamination in any “dry samples” from phase 1

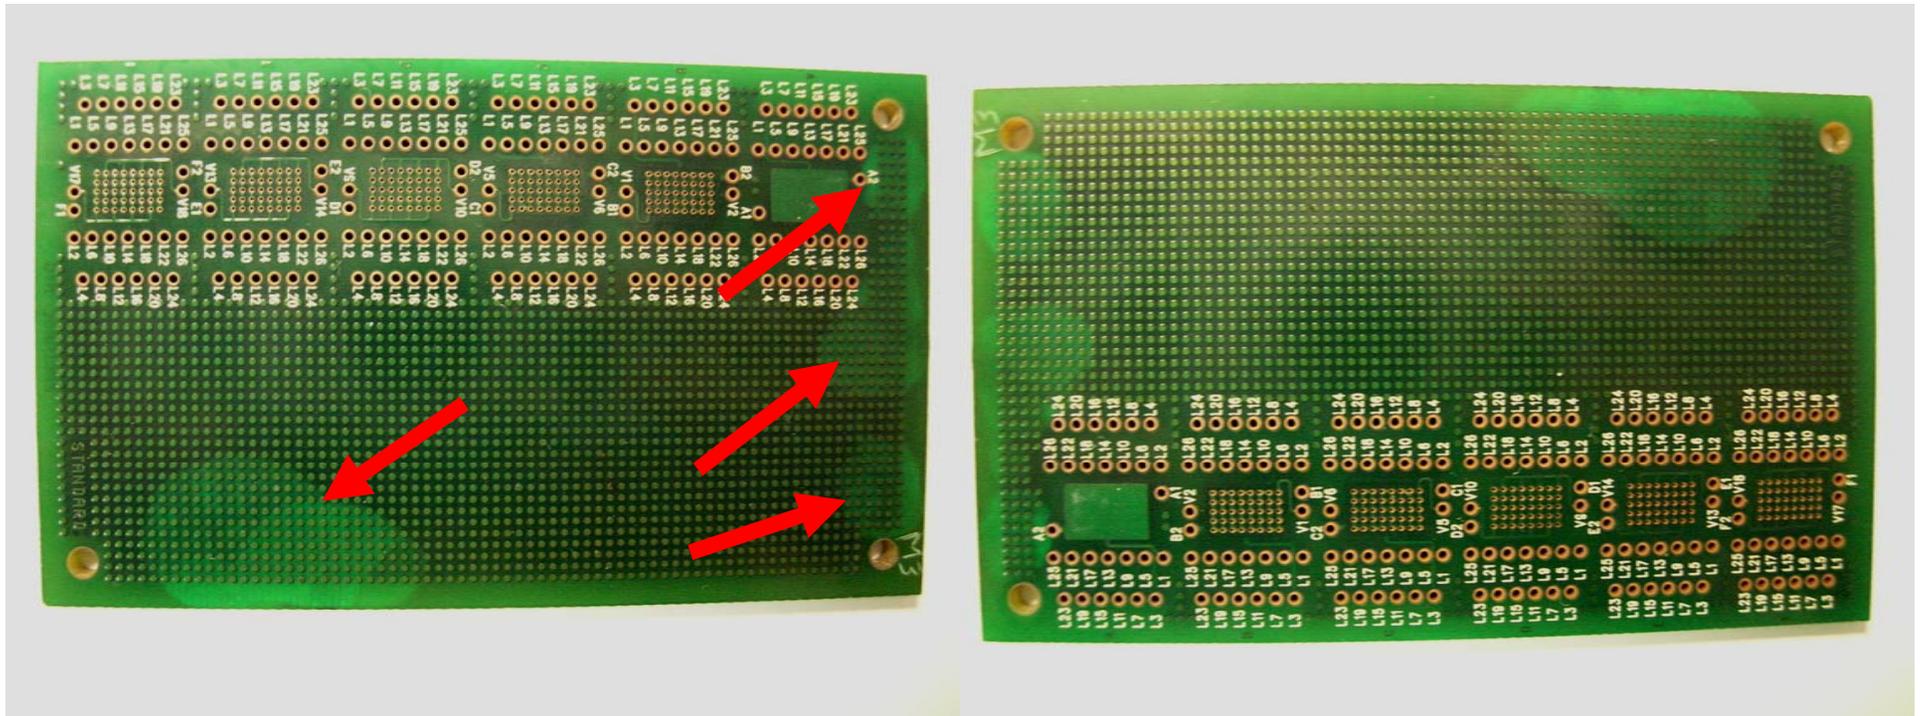
Coupons after 85C/85%RH + 3 Reflows

Red arrows mark internal delamination
