# Microvia Reliability Failure Modes

**Paul Reid**  
**PWB Interconnect Solutions**  
**Nepean, Canada**

## Microvia - Reliability Failure Modes

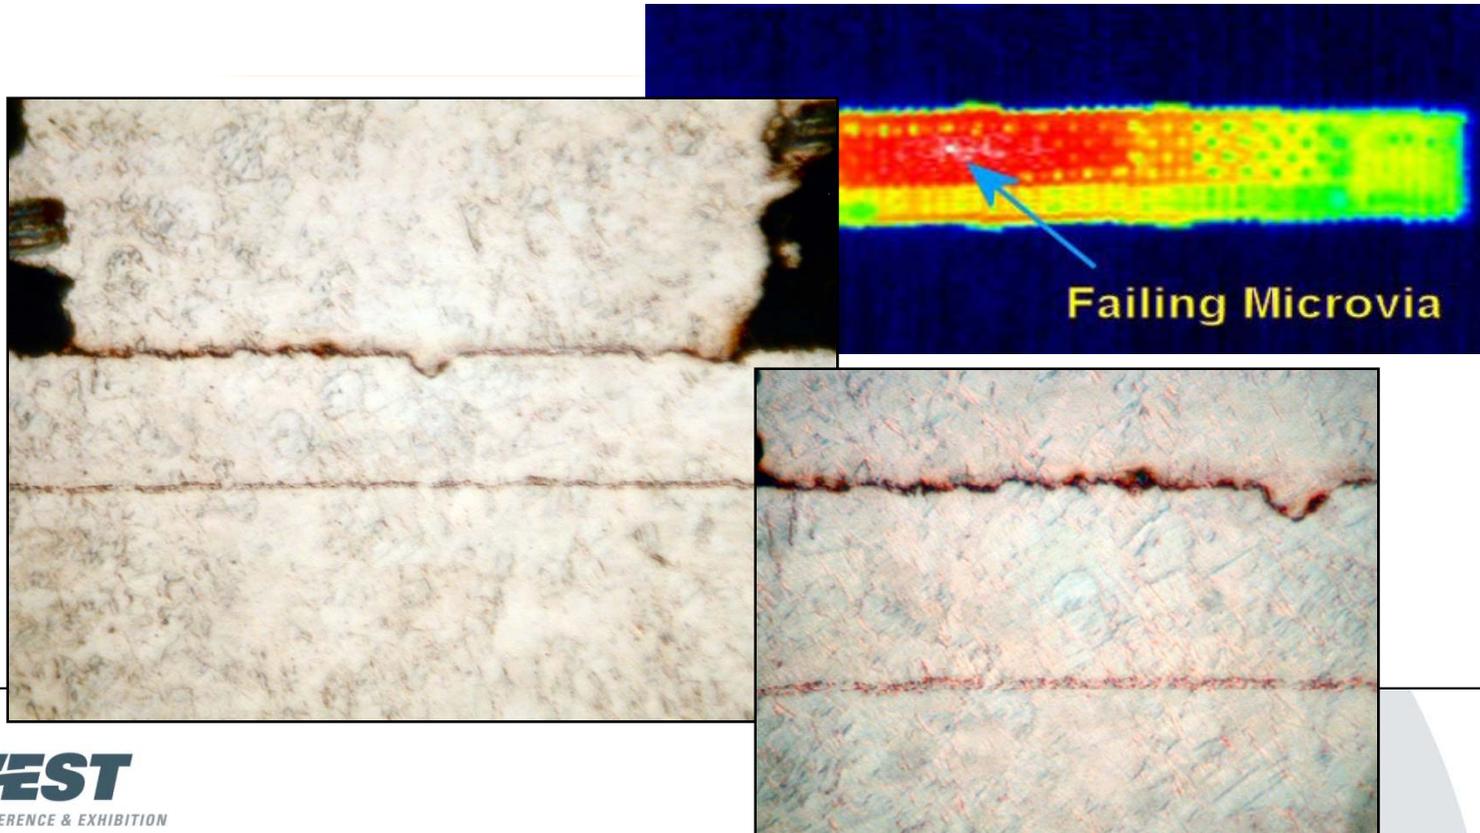
# Microscopic Examination

- Testing stop at 10% increase in resistance
  - Allow failure location with a thermal camera
  - Allows evaluation of a failing microvia not a catastrophic failure

In this test method testing stops at a 10% increase in resistance, and in doing so, prevents catastrophic failures that could be a challenge to interpret by microscopic examination. Since the increase in resistance is an objective reflection of damage accumulating in the circuit one can related the resistance increase to the physical damage observed in microscopic examination. This method bridges the gap between objective evidence (resistance change) to the subjective observations associated with microscopic evaluations. This feed back loop of objective evidence and subjective interpretation hones the skill and accuracy of the examiner improving the interpretation of damage in the interconnection and its' reliability implications. At a 10% increase in resistance cracks in the microvia are beginning to develop but have not progressed to a point of an open. That the microvia has failed is established objectively by electrical test which allows the observer to learn what is significant in microscopic examination. It turns out that what may be considered as subtle damage by microscopic examination previously, may be found to have a significant impact on reliability.

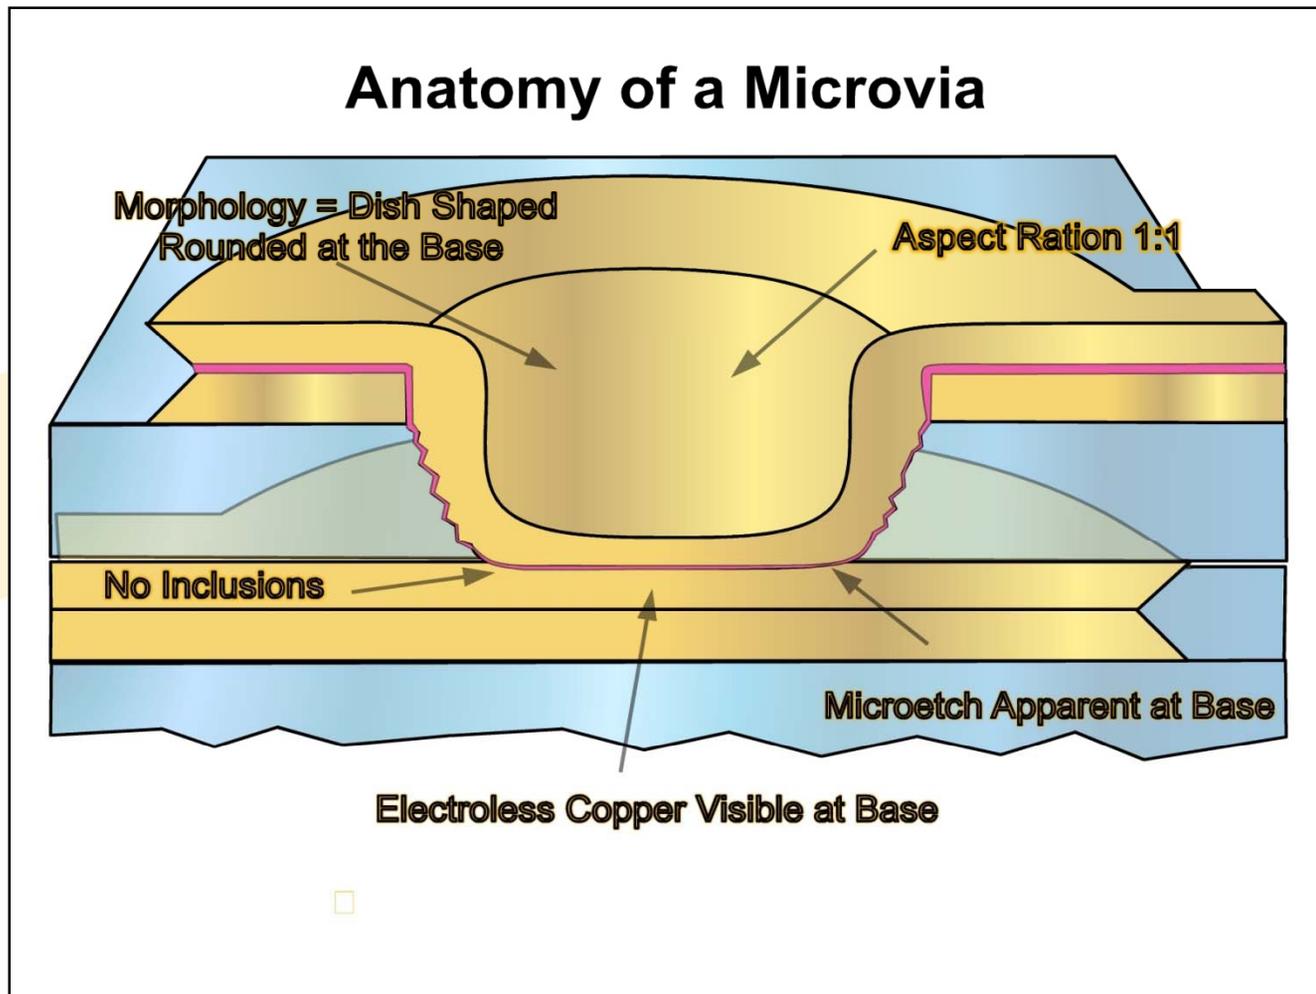
# Anatomy of a Microvia

- The anatomy of a well fabricated microvia is a blind hole that has a dish shaped profile
- Distribution of electroless and electrolytic copper is uniform
- The side wall are smooth with few glass fibers protruding
- The top layer the capture pad
- The bottom layer target pad.
- Aspect ratios greater than 1:1 are a challenge

- Powering on microvia allows the power supply stop test in real time.
- A robust MV, dish shape, good microetch at the target pad, uniform distribution of the electroless and electrolytic copper, and typically has an aspect ratio of 1:1 or less.

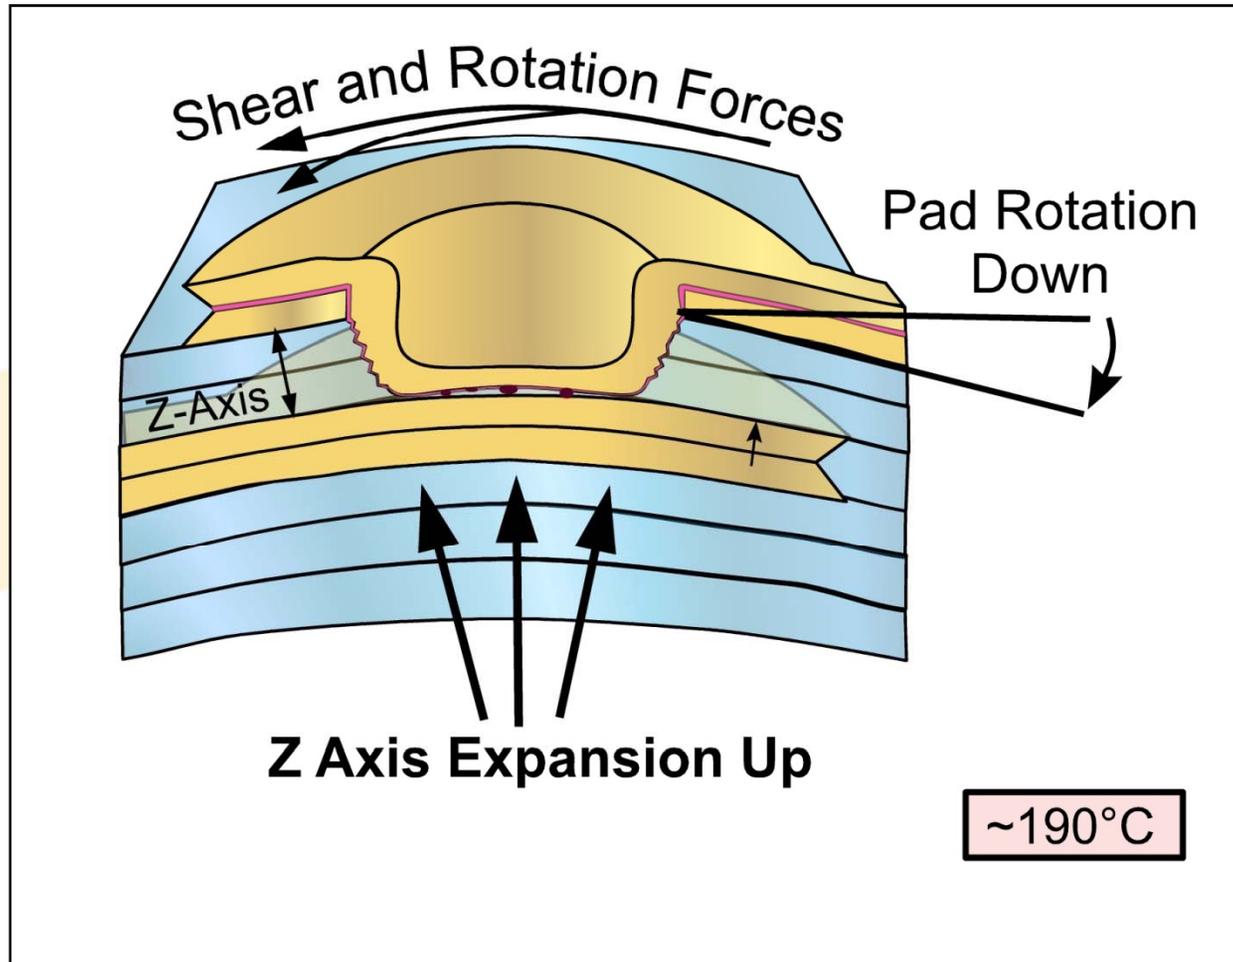
# Thermal Expansion – Isolated MV

- Isolated MV are not influenced interconnect structures
- Pad rotation response to z-axis expansion is down
- In a micro section elastic material shows not pad rotation
- I observe pad rotation the material must be plastically deformed
- The pads are rotated inward as the dielectric expands pushing up on the microvia.
- The further the microvia is from the center of the PWB the greater the displacement

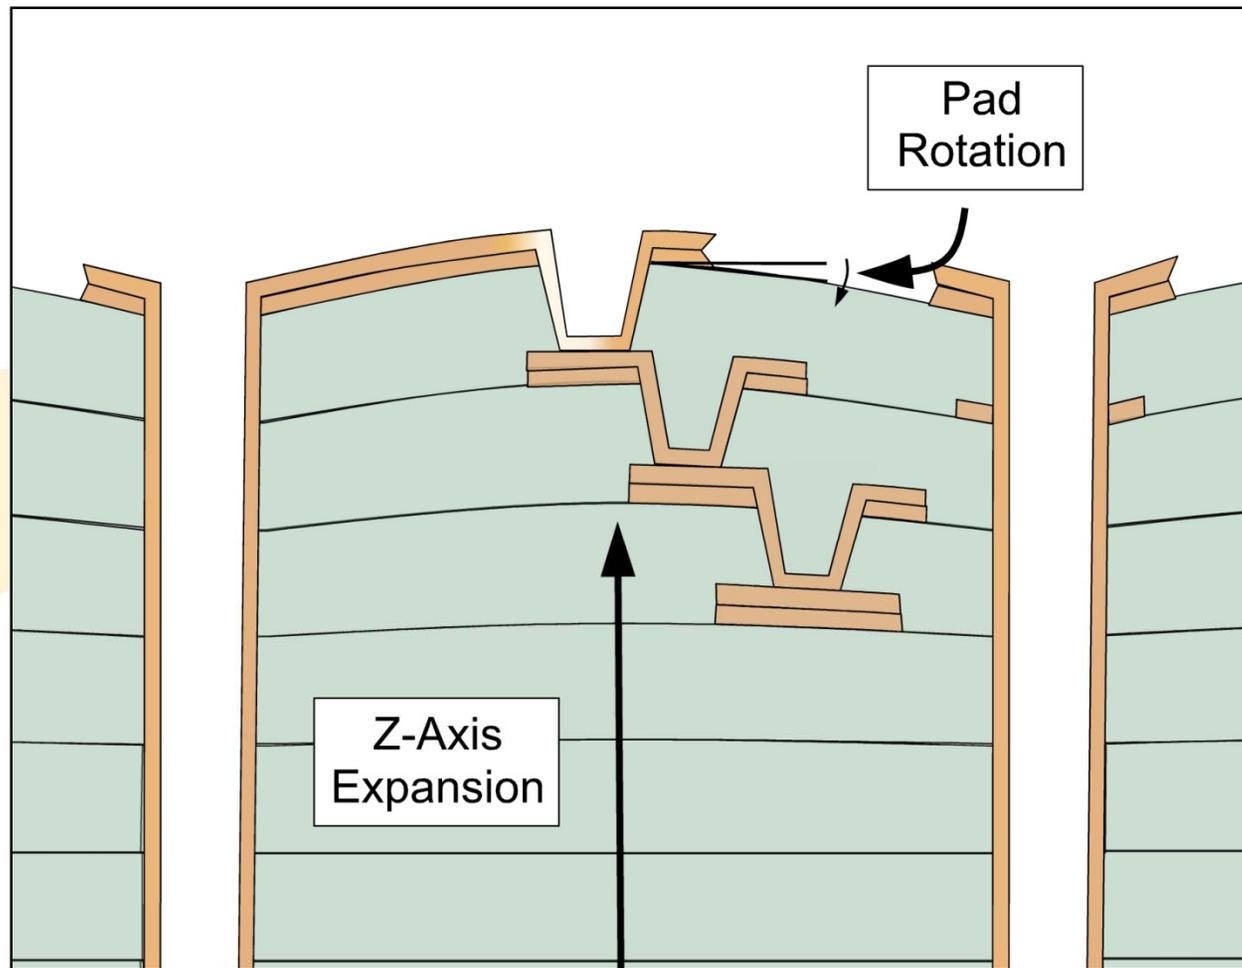
# Thermal Expansion – Staggered MV

- Staggered microvias are offset from each in a manner that allows interconnections between layers without requiring a microvia fill or copper cap.
- Generally pad rotation will be downward in staggered microvias. The forces acting on staggered microvias are similar to those acting on isolated microvias.

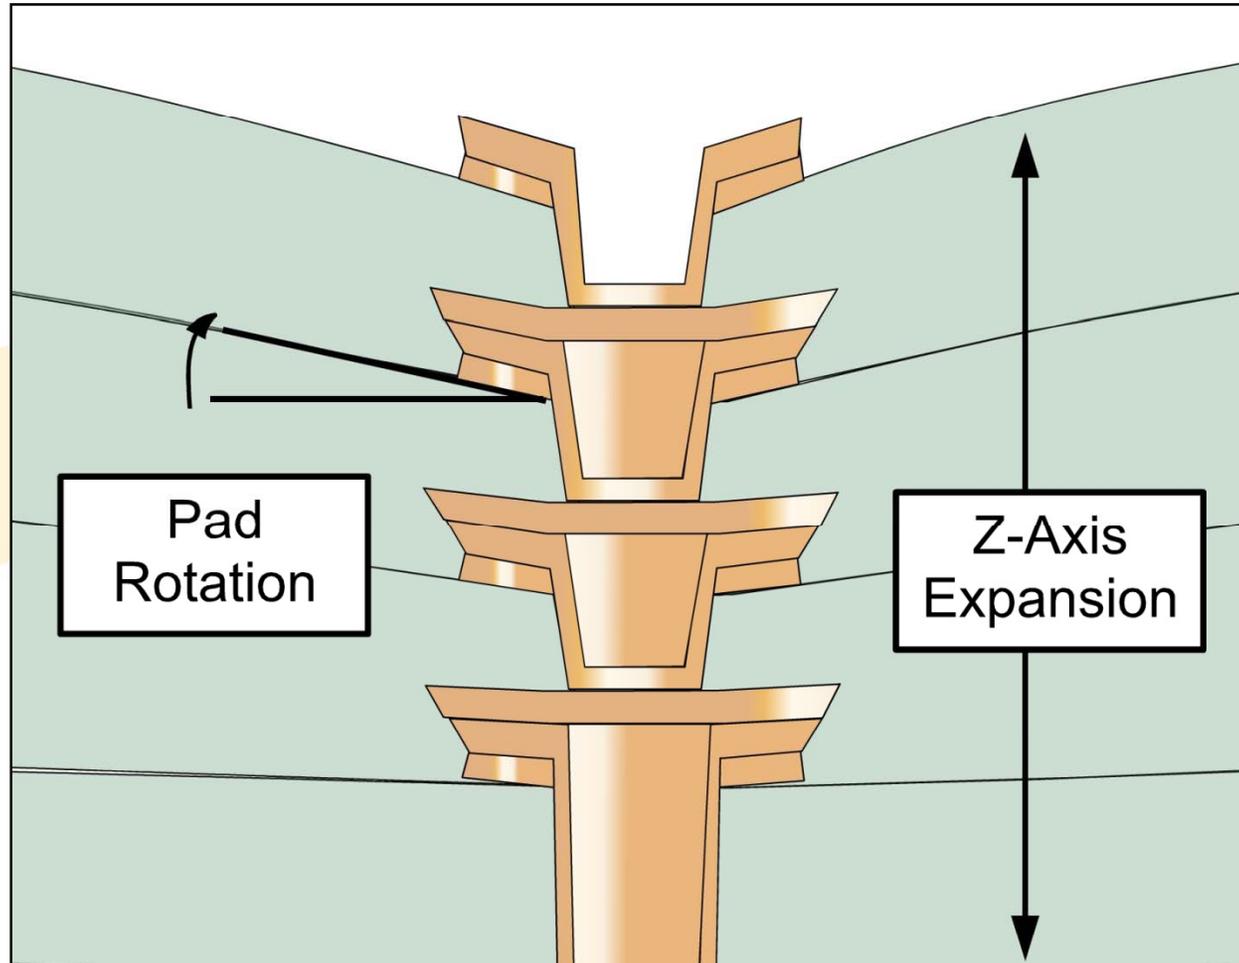
# Thermal Expansion – Stacked MV

- Stacked microvias are arranged on top of each other.
- This requires that internal microvias within the stack are filled and capped.
- Stacked microvias on the outer layers may be connected to buried vias to produce a continuous structure that spans the full thickness of the printed wire board.
- Multiple stacked microvias can produce a long enough structure to resist the z-axis expansion resulting in an outward (upward) pad rotation.
- The microvias lower in the stack tend to failure due earlier to interface separation than microvia on outer layers.
- Outer layer microvias have greater pad rotation than the microvia lower in the stack.

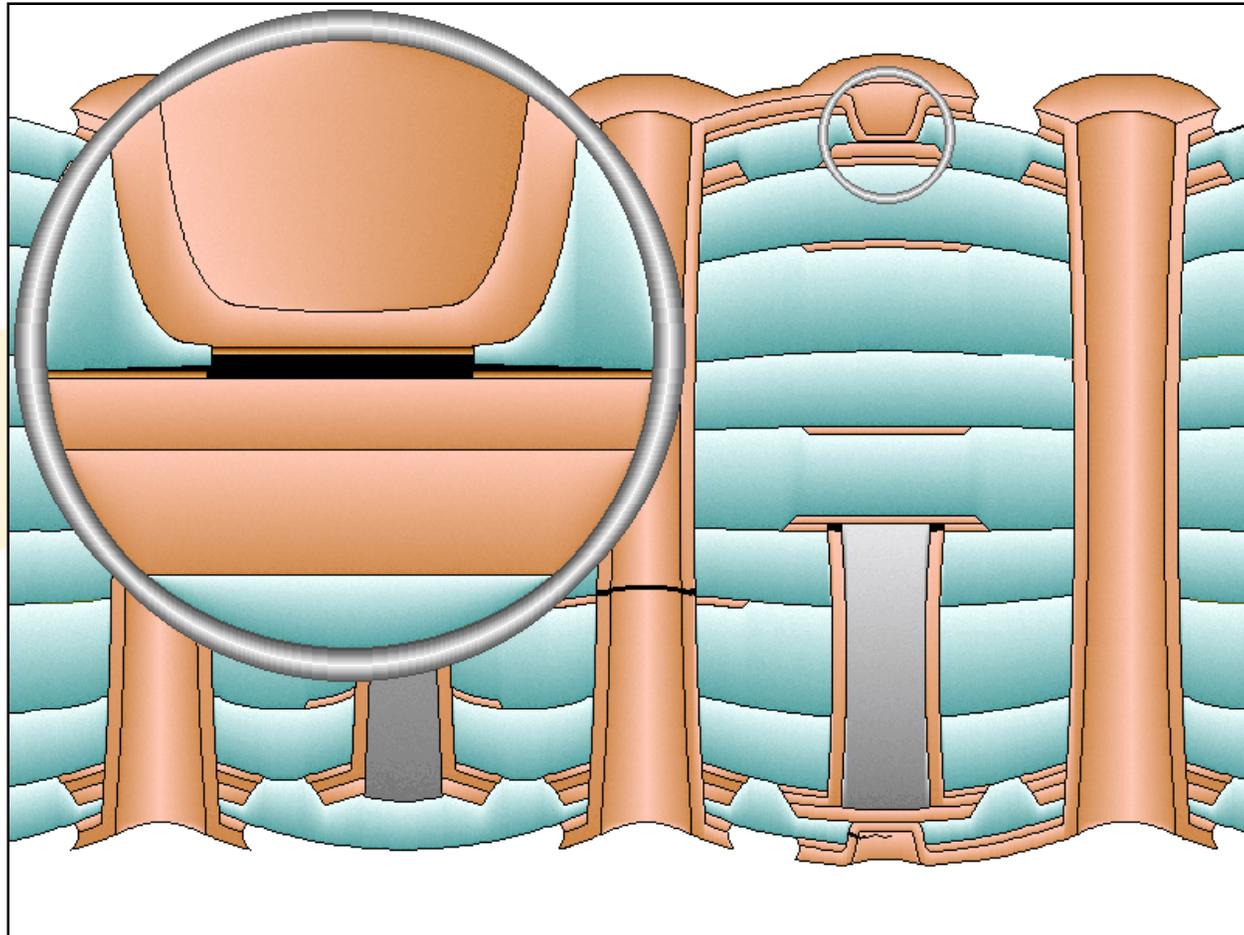
# Failure Mode – Interface Separation

- The most common microvia failure mode
- The crack is between the base of the microvia - target pad
- This failure mode presents as a catastrophic failure
- The failure is usually expressed in the cooling cycle
- The cracks may initiate from inclusions at the base of the MV
- Small cracks will coalesce into a larger crack
- Cracks can initiate at the dielectric “foot” at the base of the MV
- Determine if the crack is above or below the electroless copper
- Frequently direct metallization is too thin to be observed
- Given that an electroless copper layer is visible, cracks below the electroless copper reflect inadequate hole preparation and cleaning before metallization.
- Cracks above the electroless copper suggest that investigation should be directed after hole preparation and metallization.

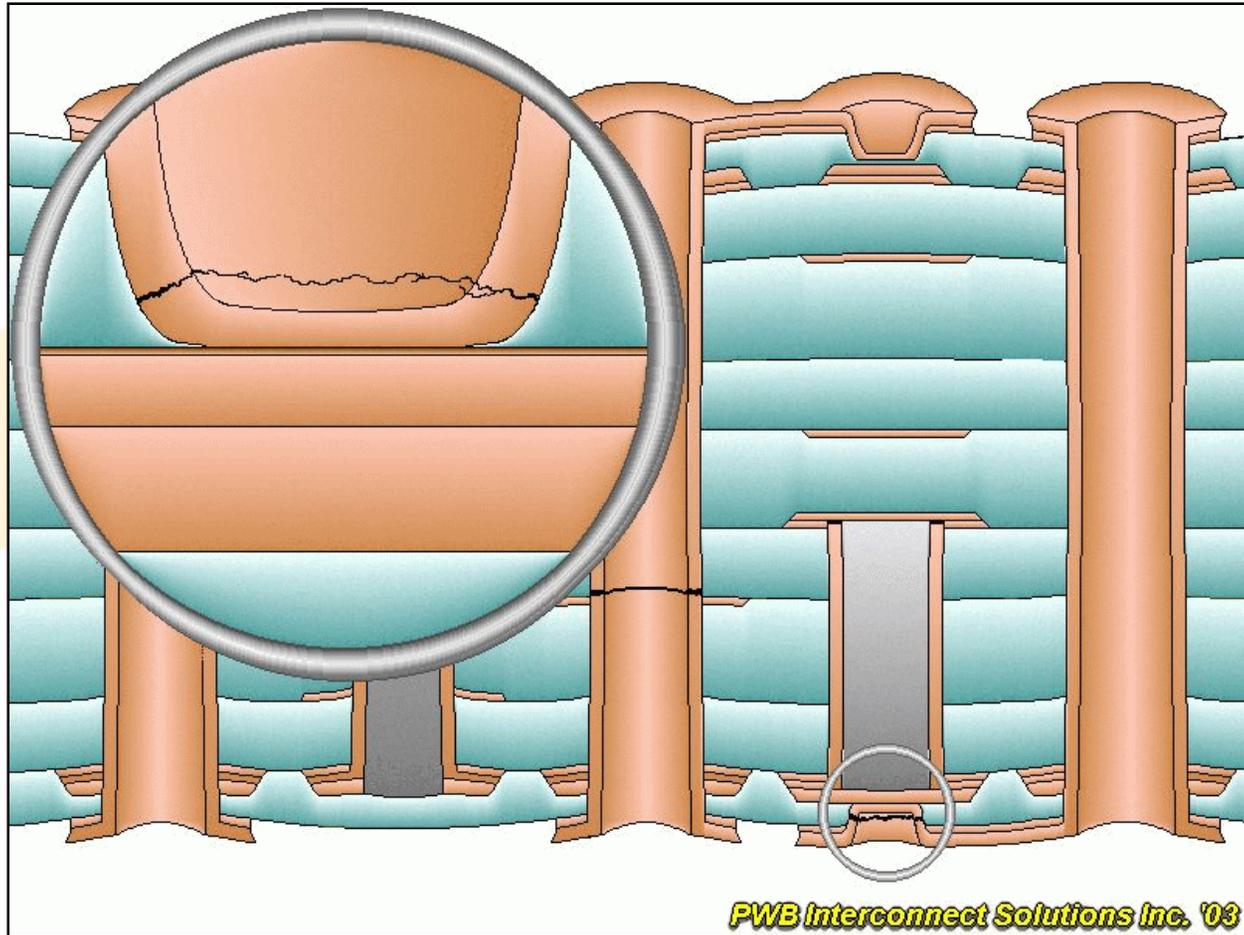
# Failure Mode – MV Barrel Crack

- A MV barrel may be a wear out or catastrophic failure
- Failure often occurs during the heating cycle.
- Frequently the barrel crack is associated with thin copper plating in the lower section of the microvia.
- Wedge and step plating may be associated with thin metallization in the barrel of the microvia.
- Macro-throw or “leveling” electrolytic copper baths frequently create exaggerated “dog bone” distribution in the barrel of the microvia.
- Rough MV with glass fibers in the microvia hole wall can exhibit wedge voids, inclusions and copper folds that may contribute to barrel cracks.
- On occasion a crack will traverse a copper flash and proceed down the interface between a flash and full thickness copper plating.

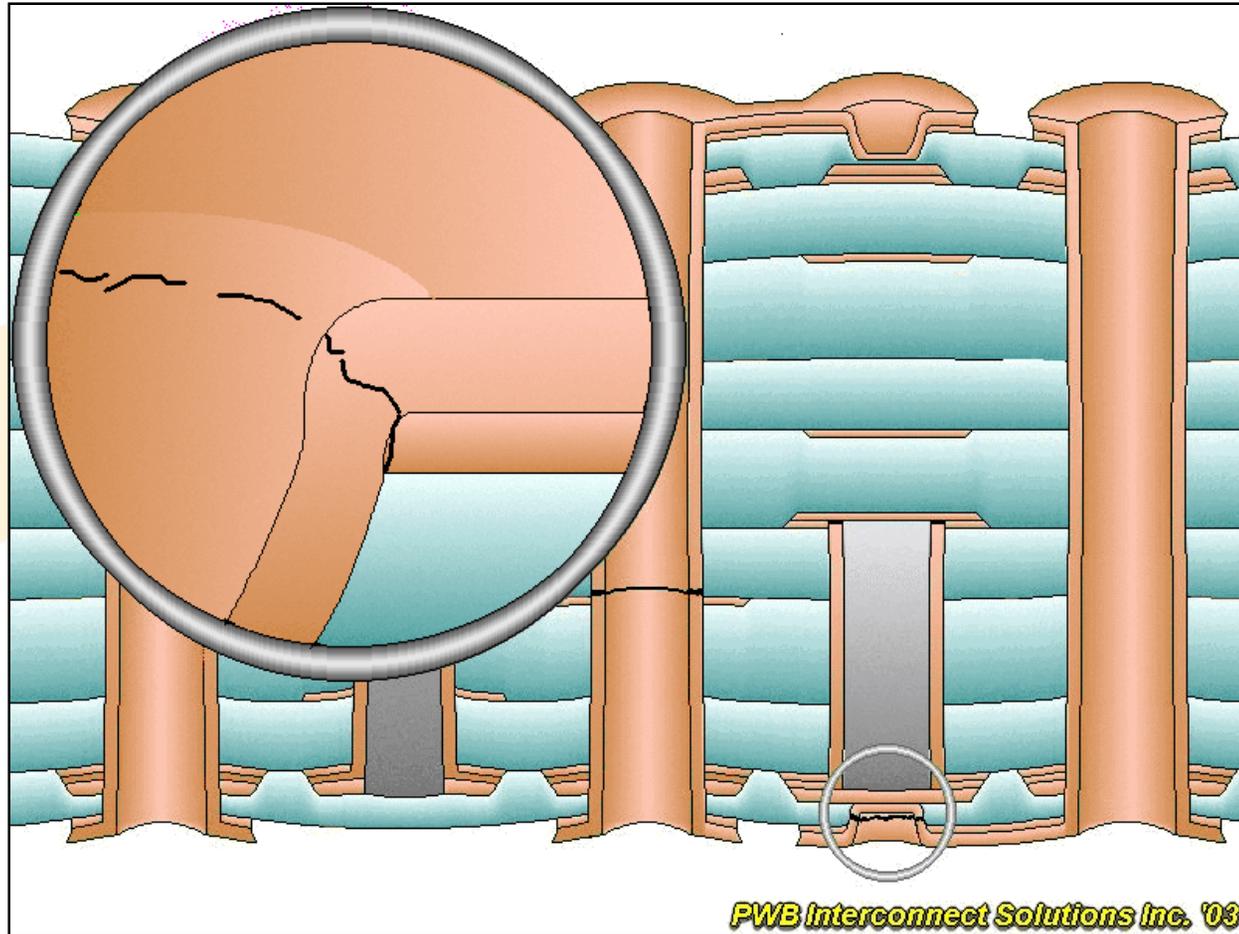
# Failure Mode – Corner Crack

- A microvia corner crack is initiated by the z-axis expansion of the dielectric between the capture pad and the target pad.
- Since the dielectric between the two layers is between .05 mm (.002”) and .15 mm (.006”) it is not likely to produce enough expansion to initiate a crack.
- This is an uncommon failure mode. A microvia corner crack frequently presents a wear out type failure.

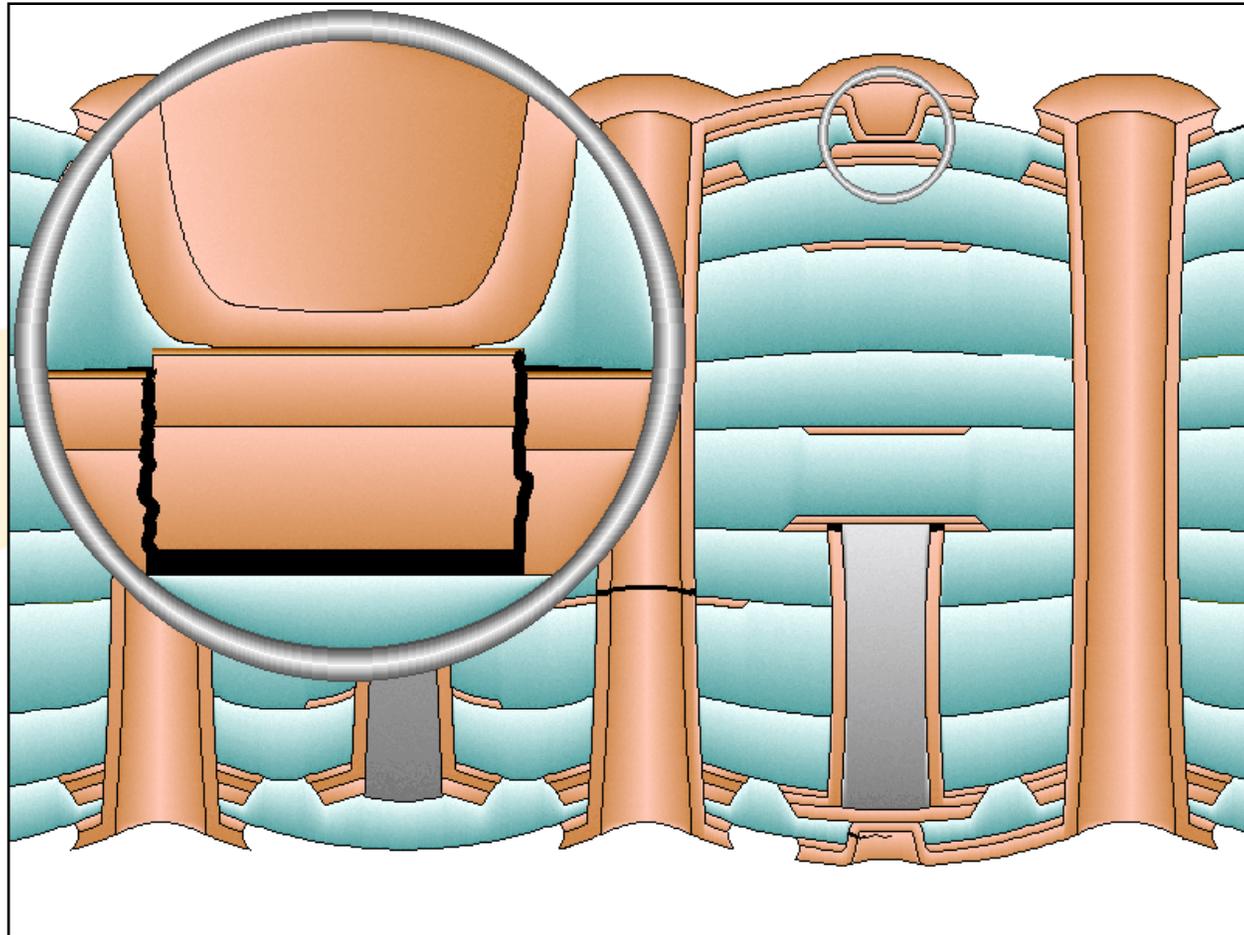
# Failure Mode – Target Pad Pull Out

- Like corner cracks microvia pad cracks, sometimes referred to as microvia “pull out” occurs in response to the z-axis expansion of the dielectric between the capture pad and the target pad.
- The crack propagates vertically through the target pad and circumferentially around the base of the microvia.
- This failure mode is more often observed in flex circuits with an acrylic adhesive which has a high CTE and low glass transition temperature ( $T_g$ ).
- In printed wire board columnar crystalline in the target pad may contribute to this failure mode

- Like corner cracks microvia pad cracks, sometimes referred to as microvia “pull out” occurs in response to the z-axis expansion of the dielectric between the capture pad and the target pad.
- The crack propagates vertically through the target pad and circumferentially around the base of the microvia.
- This failure mode is more often observed in flex circuits with an acrylic adhesive which has a high CTE and low glass transition temperature (T<sub>g</sub>).
- In printed wire board columnar crystalline in the target pad may contribute to this failure mode

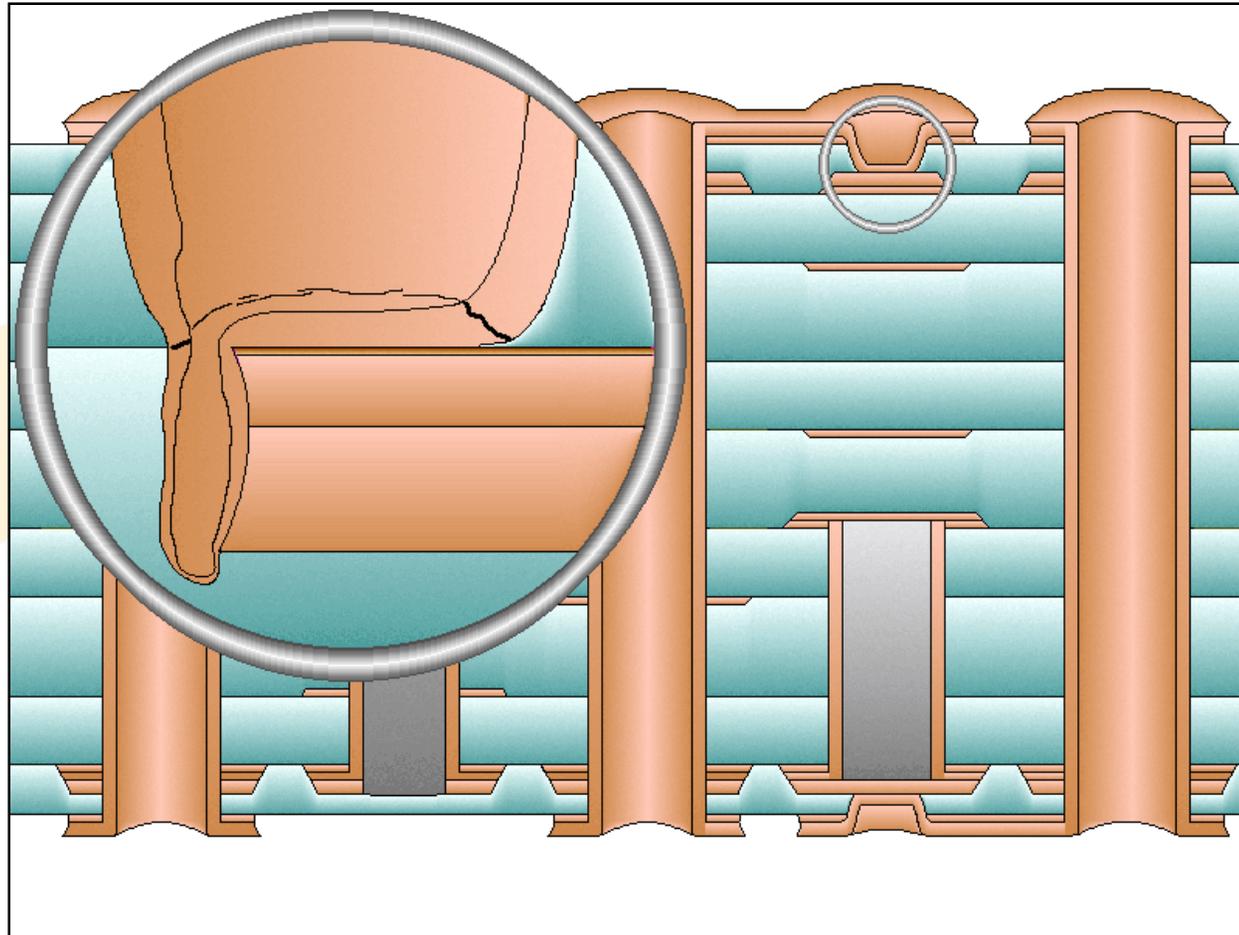
# Failure Mode – Misregistration

- There are two types of microvia misregistration; misregistration of the ablated hole to the capture pad and misregistration of the ablated hole to the target pad.
- In both cases this failure mode tends to produce opens or shorts that is identified by electrical test.
- An associated condition is where ablation pierces the full thickness of the target pad and penetrates the dielectric or interconnects structures below.

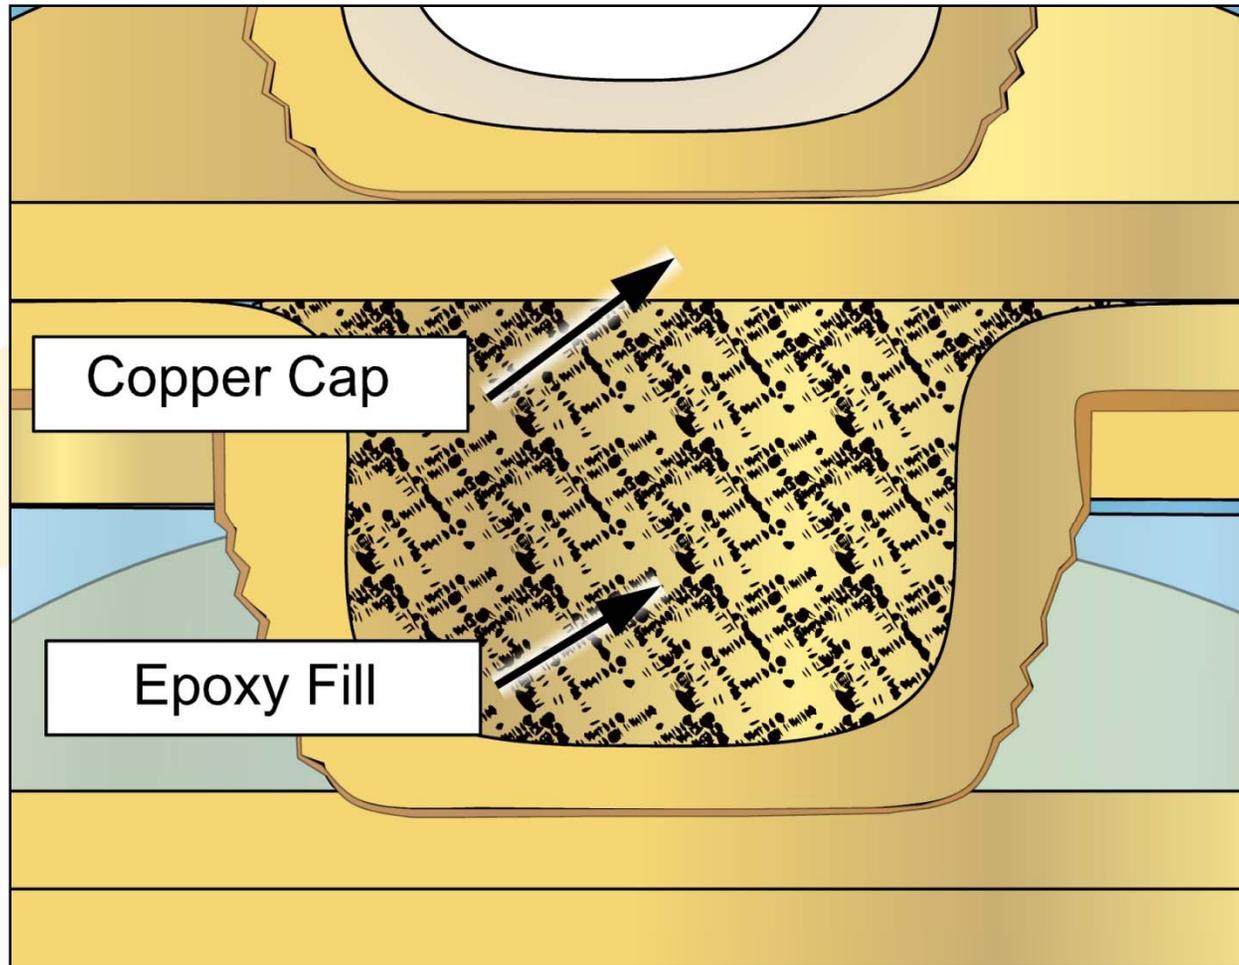
# Filled Capped Microvias

- When a copper cap is used in a stacked MV the cap it is part of the conductive path and, can fail.
- If there is no interconnect structure above the copper cap, then the cap is not part of the conductive path and cannot fail
- Frequently the fill used in microvia has a different coefficient of thermal expansion (CTE) and glass transition temperature (Tg) than the surrounding dielectric materials.
- These mismatches in thermal properties are expressed as stress in the microvia. During thermal cycling an epoxy fill will become less viscous and distribute pressure equally throughout the microvia structure.
- This pressure can result in cracks developing in the interfaced between the bottom of the target pad and the top of the microvia wrap. The result is failure due to a lifted copper cap.

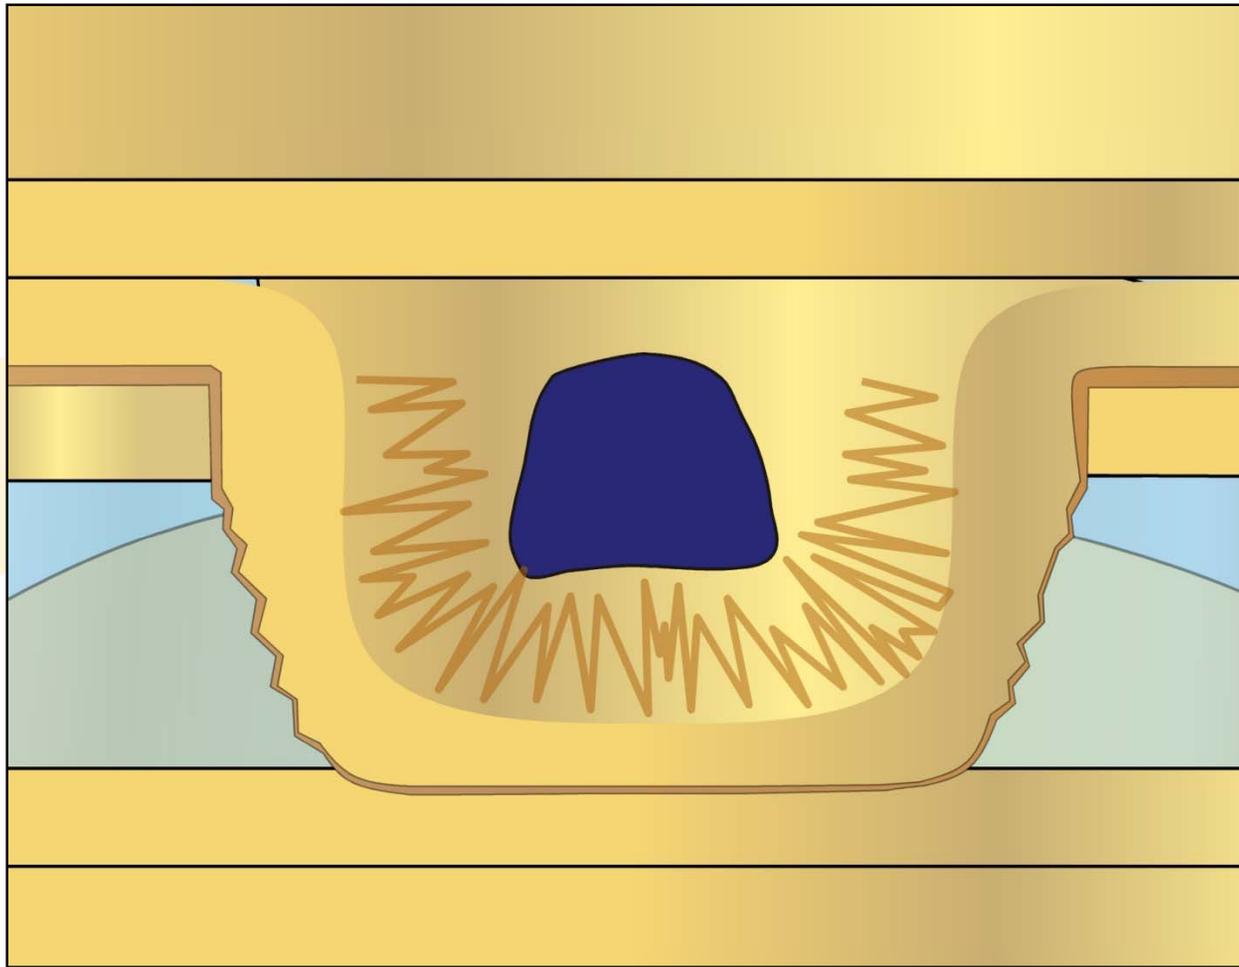
# Filled Microvia – Copper Void

- A common condition of concern with copper filled microvias is voids in the electrolytic copper.
- The voids are usually plated closed. If the void was plated closed then there must be trapped acid copper plating solution.
- The solution appears to corrode the barrel of the copper until the solution is saturated.
- Micro sectioning usually removes the contaminants trapped in the voids. On occasion bizarre crystalline structures are formed as the void is plated closed.
- Copper void may reduce cycles to failure if the copper in the barrel of the hole compromises the hole wall thickness.
- Voids in the middle of the microvia where the copper in the barrel of the microvia is relatively thick may not influence thermal cycles to failure.
