“Reliability of Stacked Microvia”

Hardeep Heer & Ryan Wong

FTG Corp.

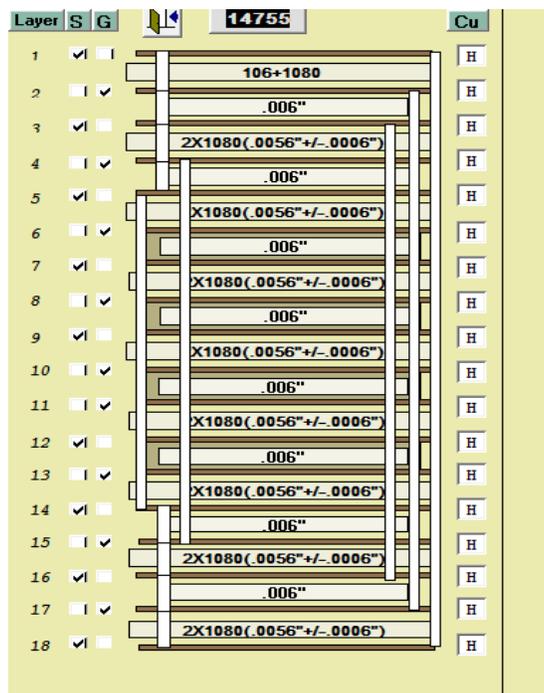
Fig. 1: Design Stackup

A 2.25mm (0.090”) thick eighteen layer board was designed (see Fig.1). Microvias with a diameter of 0.15mm (0.006”) were ablated from layers 1-3 and layers 18-16 for 2 stacks, layers 1-4 and layers 18-15 for 3 stacks and layers 1-5 and layers 18-14 for 4 stacks. Buried vias were between layers 3-16, 4-15 and layers 5-14, respectively. All microvias were plated shut.

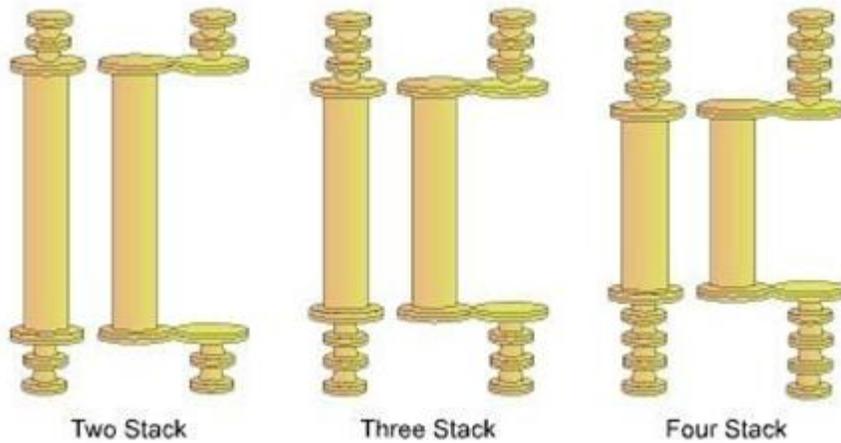
Fig. 2: Via Structure Diagram

Coupons were designed for 2/3/4 stacks (See Fig.2), on and off buried vias and pitches of 0.8mm (0.032) and 1.0mm (0.40") as controlled variables. Each variation was placed in a sub-panel form (see Fig.3). Six of these subs were placed on an 18x24 panel. In all, each panel contained 6 on buried via and 6 off buried via IST coupons. There were a total of 568,512 microvias per panel and 3 of such panels were produced.

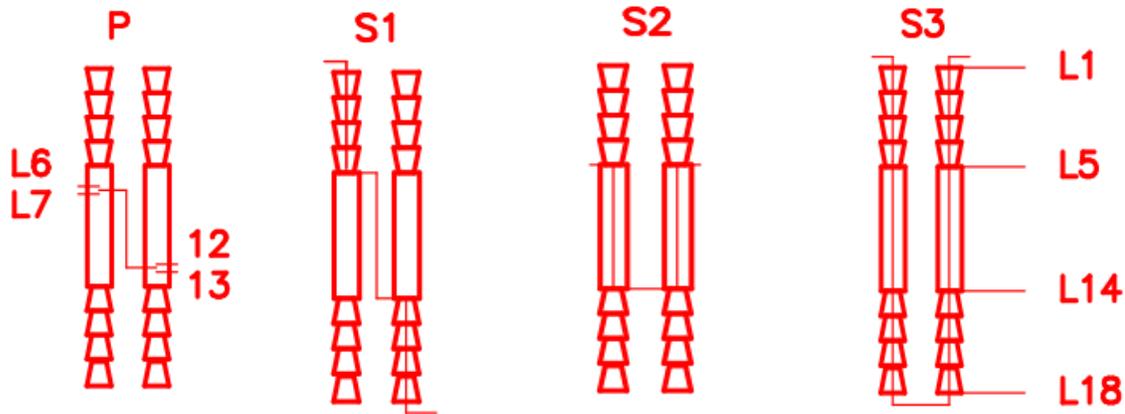
Fig.4: Circuit Sense Summary

Each coupon contained a power sense (P), one circuit of microvia sense (S1), one of buried via sense (S2) and one combined microvia and buried via sense (S3), as depicted in Figure 4. For the scope of this project, only sense P, S1 and S3 were measured.

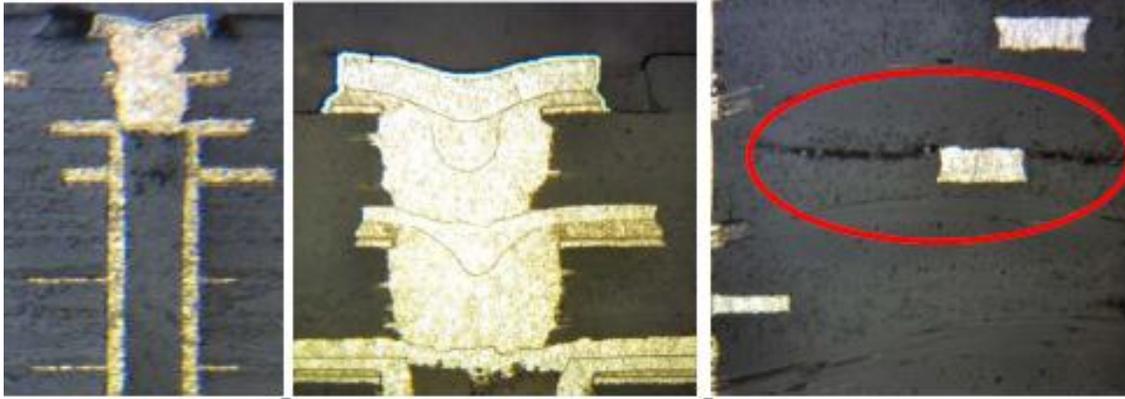
Fig. 5: Two Stack Microvias after 6x@ 260°C Pre-Conditioning and 1,000 cycles at 150°C

Only five 4 stack coupons failed during pre-conditioning at 6x245°C. There were no failures identified during thermal cycling at 150°C. The same test was repeated with a pre-conditioning temperature of 260°C. Out of 236 coupons tested, 24 coupons failed at Sense 3 (combination of buried and microvia) on the 4 stack via structure. The experimental objective was to evaluate microvias and this did not show any microvia failures. Cross-sectional analysis of the coupons showed no failure in via structures but material degradation was observed (see Image 3, Fig. 5 below).

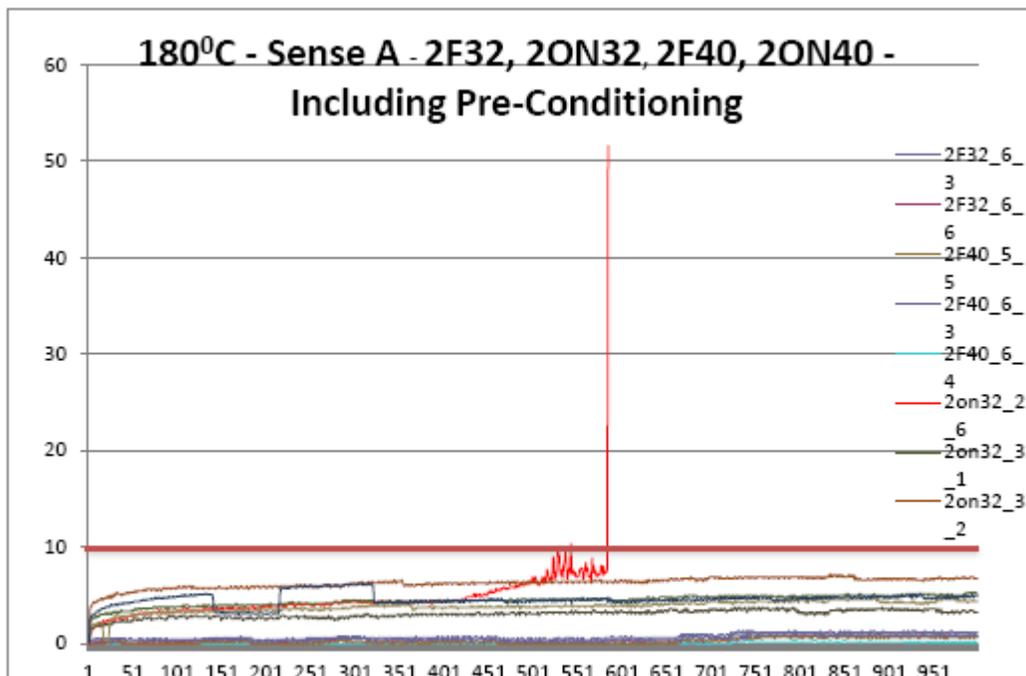
Plot 1 – 2 Stack Microvias off Buried via – Sense A

Plot 1 through Plot 4 shows data for two stack on and off buried vias. Plot 1 includes pre-conditioning change in resistance, whereas Plot 2 is showing data from after pre-conditioning to 1,000 cycles. Sense A has one microvia failure at the 585th cycle. The failure is clearly indicated by a straight vertical line. All other data points are well below 10% resistance change.

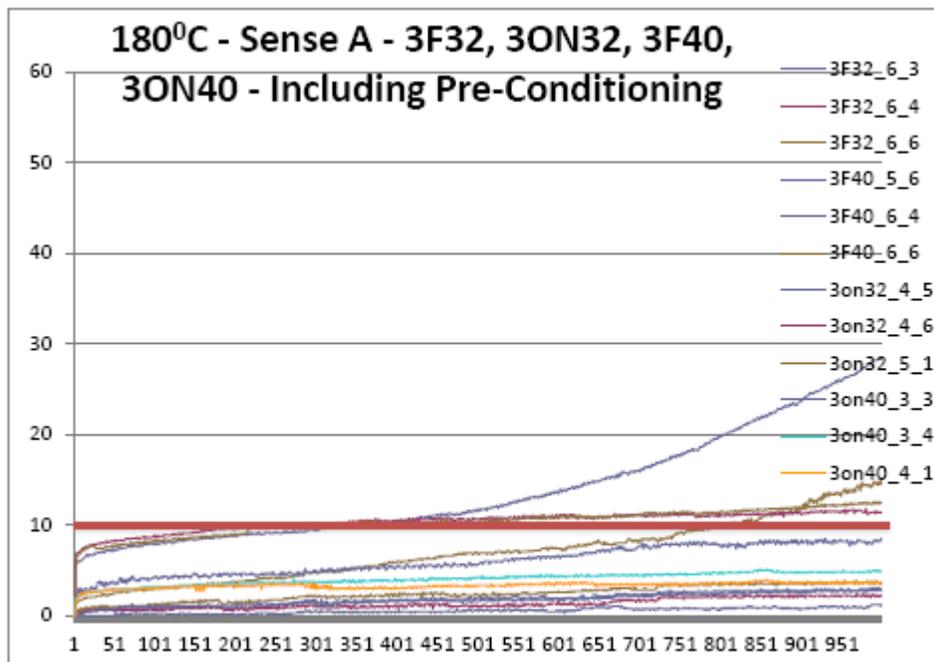
Plot 5 – 3 Stack Microvias on Buried via – Sense A

Results for 3 and 4 stacks were different than what we saw for 2 stacks. The change in resistance for one 3 stack microvia (Sense A) went over 10% at 893 cycles. The change in slope for this microvia is still gradual. All other microvias are still showing a change in resistance below 7%. Similar to 2 stack microvias, Sense B is showing different results than Sense A. Here we see one test coupon starting to degrade at 216 cycles.

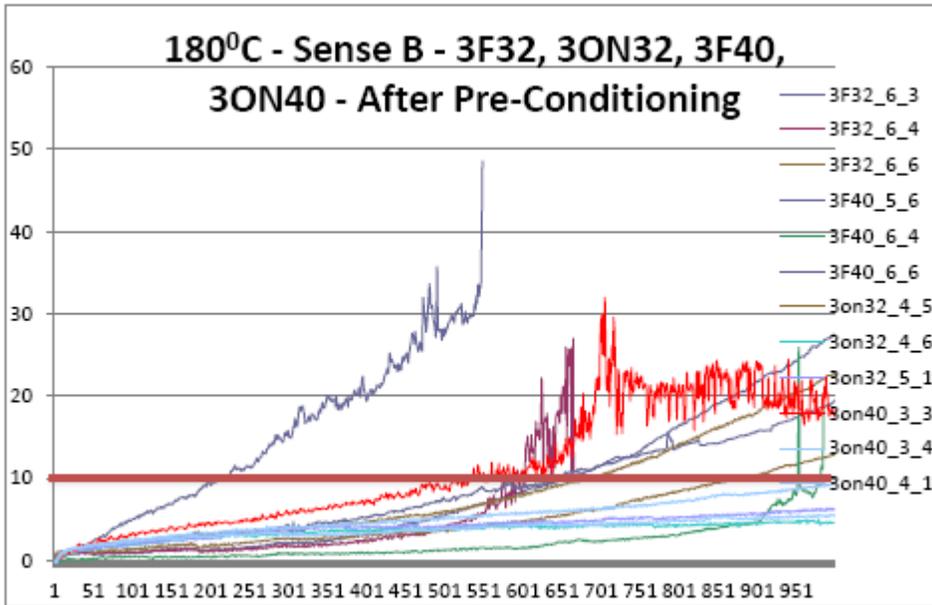
Plot 8 – 3 Stack Microvias on Buried via – Sense B

There are several other coupons starting to move above the 10% threshold resulting in one complete failure at 543 cycles. The other coupon crossed the 10% threshold at 557 cycles and continues to degrade over the remaining test period without completely failing. Only one more coupon had a complete failure at 949 cycles.

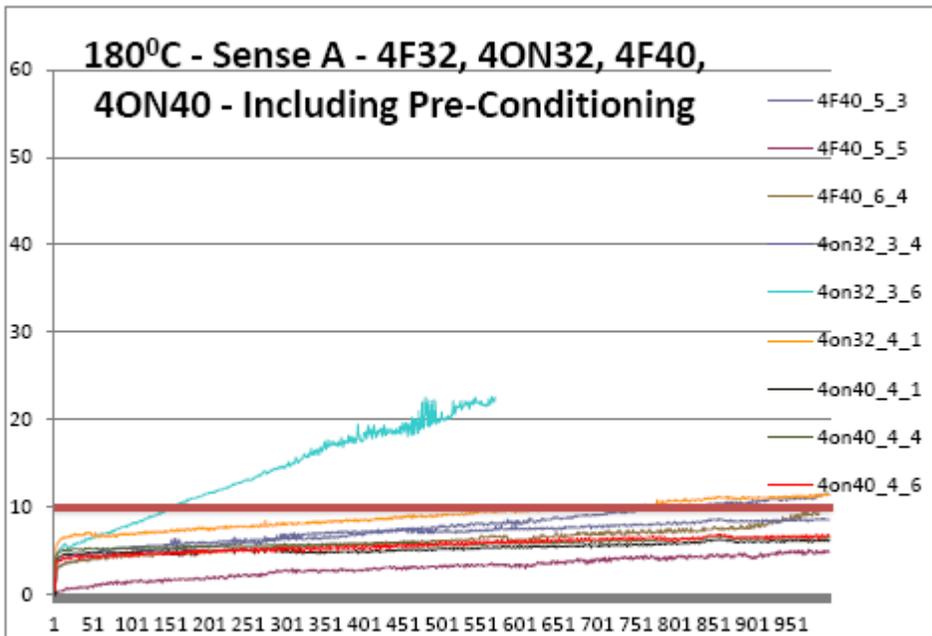
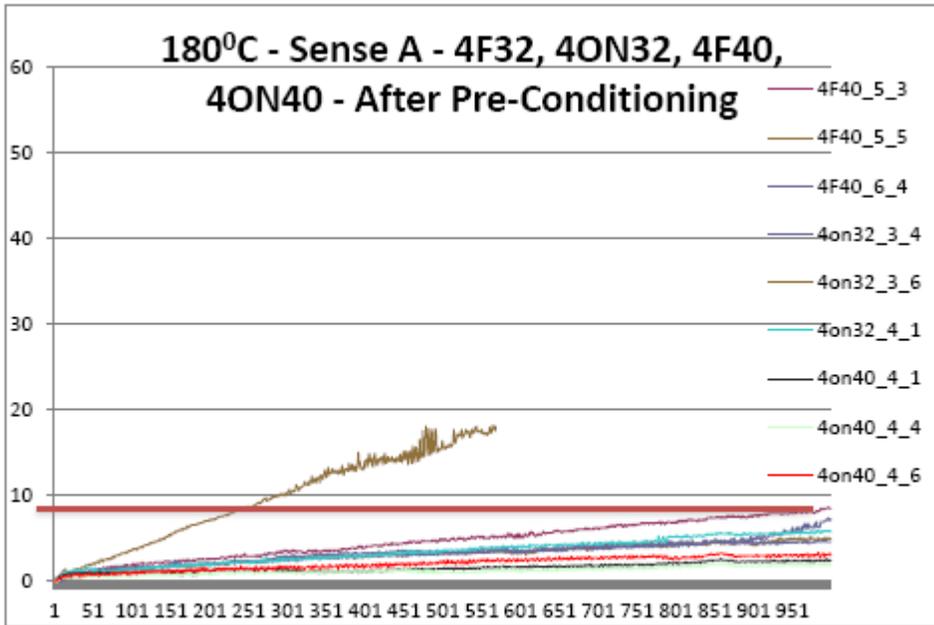
Plot 9 – 4 Stack Microvias on Buried via – Sense A

Four stack microvias show an improvement over 2 and 3 stacks. For Sense A, there is one microvia coupon that starts to show degradation at 280 cycles and has a complete failure at 561 cycles. All other coupons for Sense A stayed below a 10% change in resistance. Sense B also shows improved results over 2 and 3 stack coupons. The first coupon to cross 10% limit had completed 570 cycles but didn't show a complete failure. This coupon reached a maximum resistance change of 28% at 944 cycles. The third coupon reached 695 cycles before crossing the 10% change threshold and showed a failure at 993cycles.

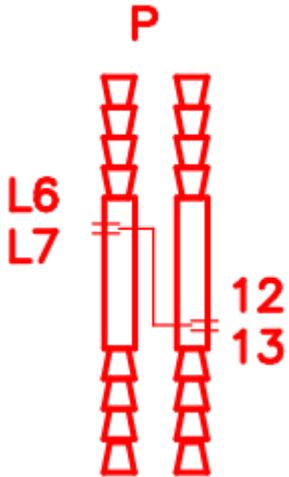
Board Stack up

- 18 Layer construction, all configurations (2/14/2, 3/12/3, 4/10/4) built in single test panel.
- Total board construction 0.090"/2.25mm.
- Lead free compatible High Tg FR4 material used.
- 0.006"/0.15mm ablated into 0.0035"/0.085mm dielectric.
- 0.008"/0.2mm buried via, filled with Non-conductive epoxy.
- Two via to via spacing's: 0.032"/0.8mm and 0.040"/1mm.
- All microvia structures copper plated shut.
- Stack structures ablated on and offset to the buried vias.
- Over 500,000 via / panel (3 panels built).

Layer	S	G	Material	Cu
1	✓	✓	106+1080	H
2	✓	✓	.006"	H
3	✓	✓	2X1080(.0056"+/- .0006")	H
4	✓	✓	.006"	H
5	✓	✓	X1080(.0056"+/- .0006")	H
6	✓	✓	.006"	H
7	✓	✓	X1080(.0056"+/- .0006")	H
8	✓	✓	.006"	H
9	✓	✓	X1080(.0056"+/- .0006")	H
10	✓	✓	.006"	H
11	✓	✓	X1080(.0056"+/- .0006")	H
12	✓	✓	.006"	H
13	✓	✓	X1080(.0056"+/- .0006")	H
14	✓	✓	.006"	H
15	✓	✓	2X1080(.0056"+/- .0006")	H
16	✓	✓	.006"	H
17	✓	✓	2X1080(.0056"+/- .0006")	H
18	✓	✓	.006"	H

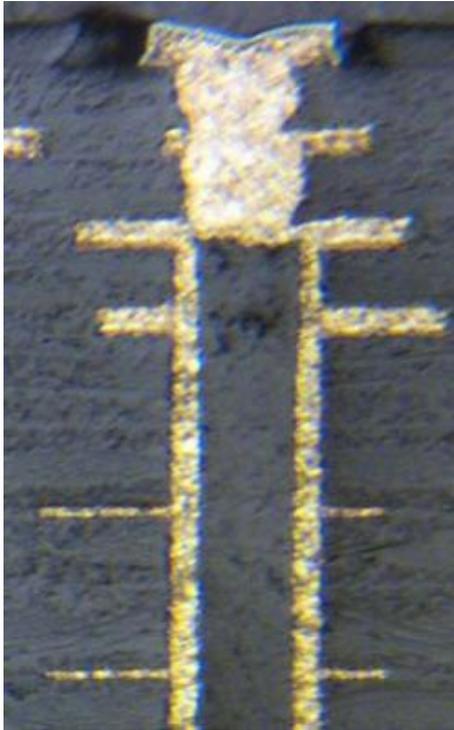
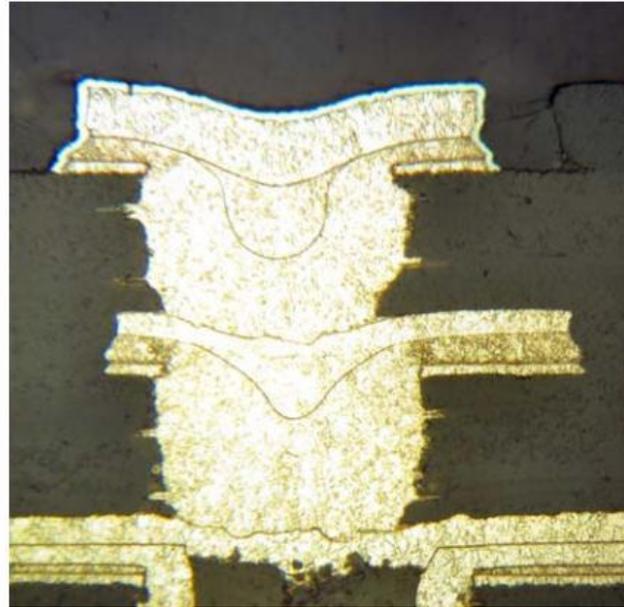
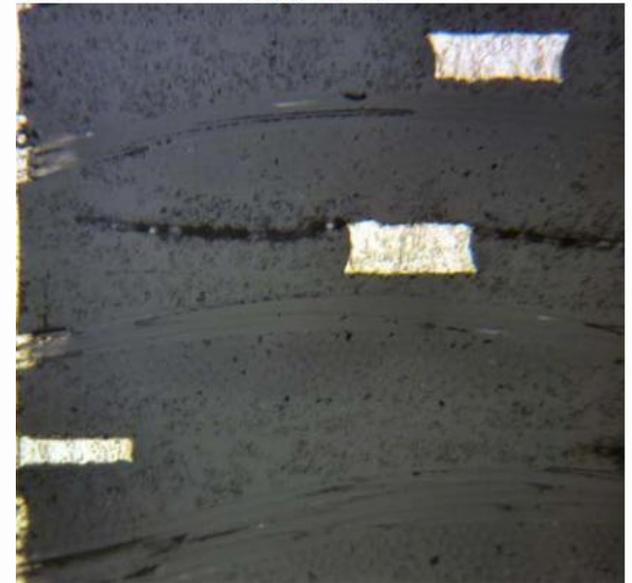
Microsectional Analysis

Two Stack Microvia, no failure after 1,000 cycles
@150^o C after 6x@260^oC

Material degradation observed

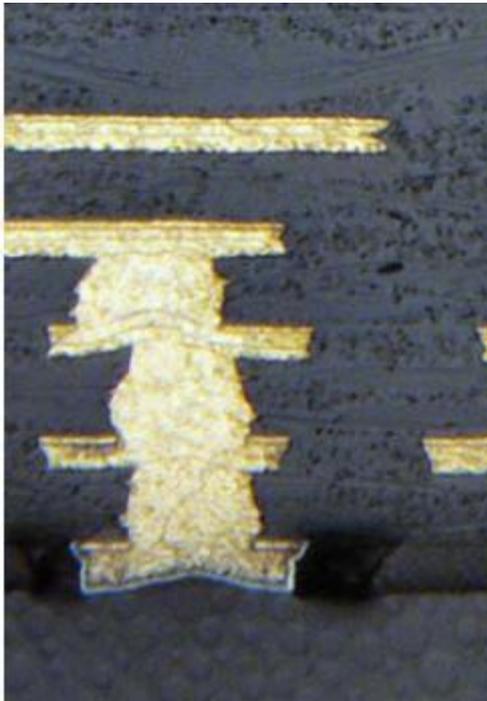
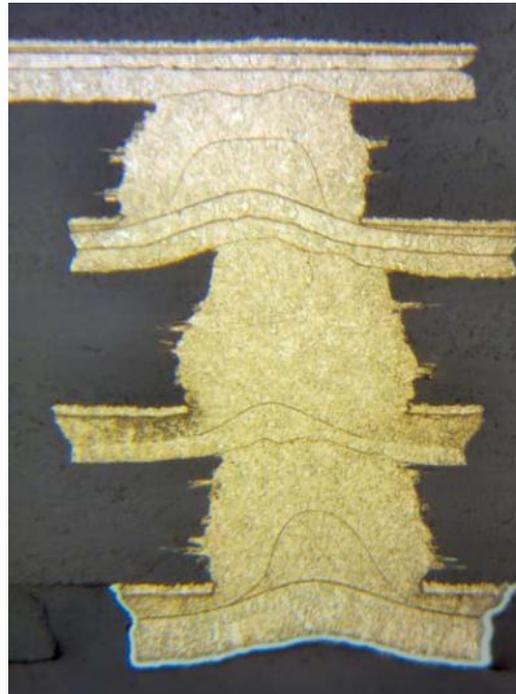
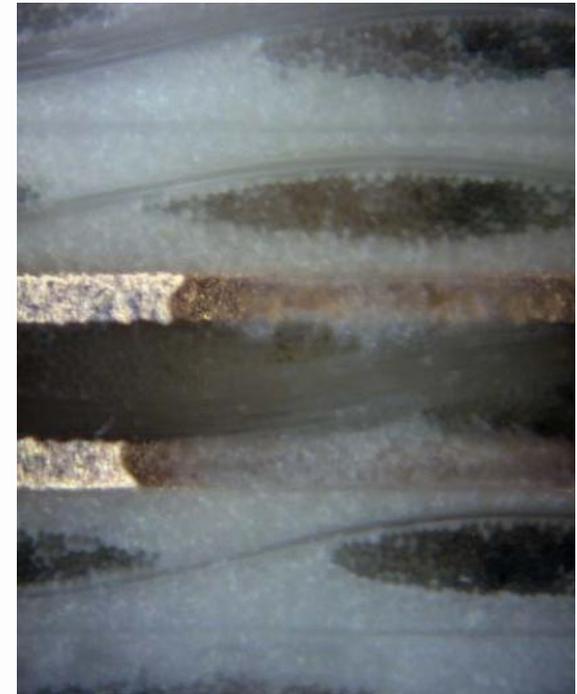
Microsectional Analysis

Three Stack off Microvia, no failure after 1,000 cycles
@150° C after 6x@260° C

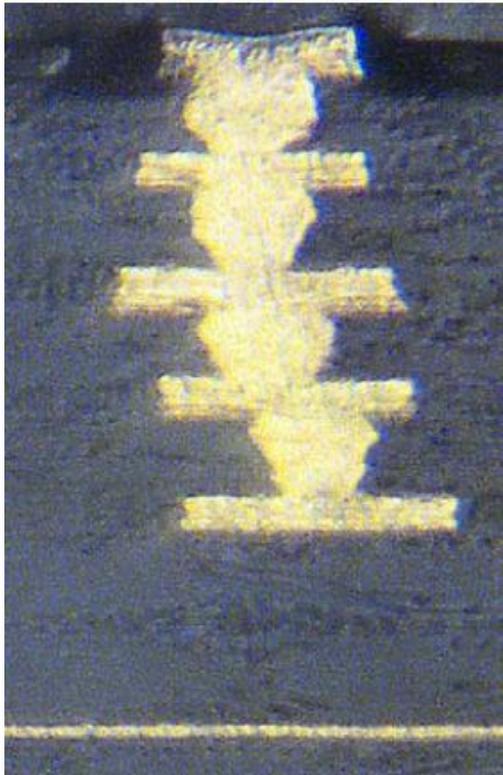
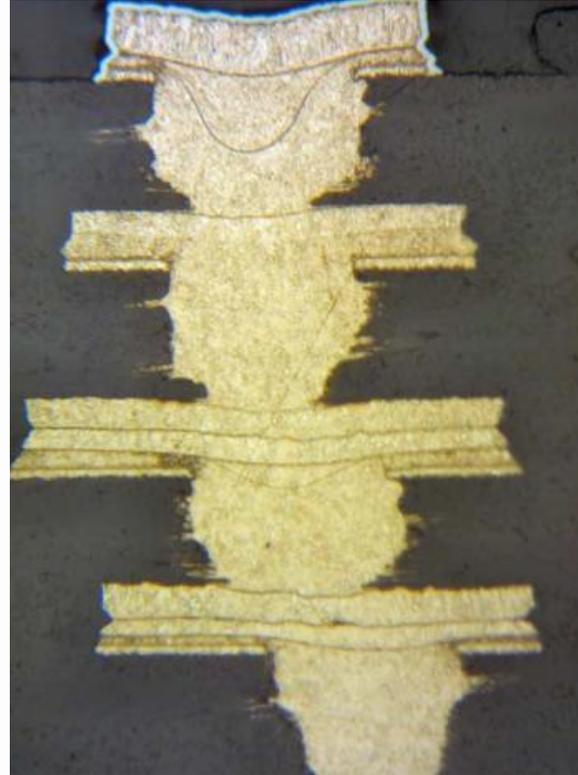
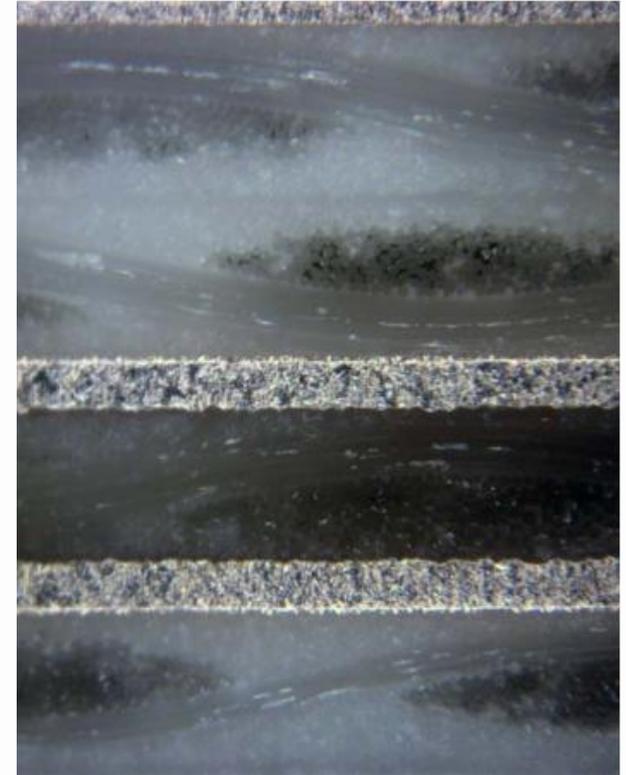
Microsectional Analysis

4-Stack off Microvia, no failure after 1,000 cycles @150° C
after 6x@260° C
