Embedded Components: A Comparative Analysis of Reliability Part II

Guenther Mayr
AT&S AG

Abstract

This paper is the second part in a progressively complex series of comparative analyses, testing the reliability of standard SMT components in comparison to their embedded counterparts.

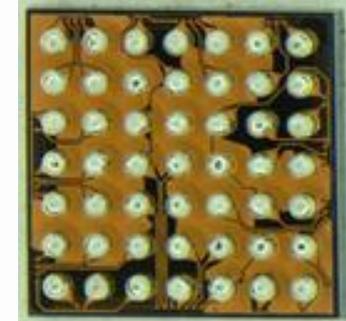
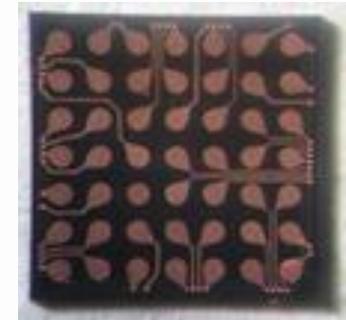
SMT

Embedded PCB

- Standard 3mm x 3mm Daisy Chain
- 49 I/Os with 0.4mm pitch
- Embedded and SMD same in x,y axis dimension
- Difference in z axis (ECs thinner): SMD 550 μ m vs Embedding 165 μ m
- Same manufacturer

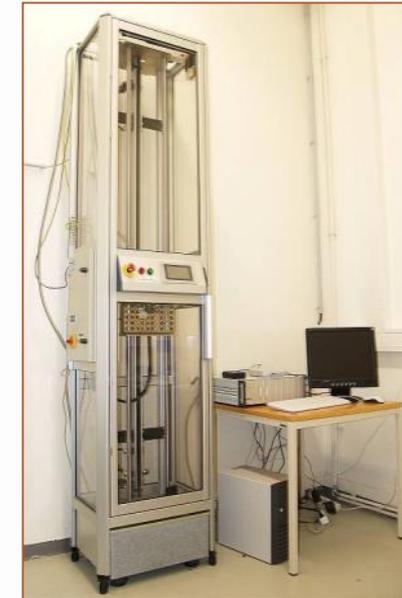
Test device

DT Device – Teknopaja	
AT&S Spec	TI.GR.PH-LAB-33EG
IPC	JEDEC JESD 22B111
Acceleration	1500g ± 10%
Pulse Duration:	0.5ms ± 10% (peak width at 10% of maximum pulse height)
CPK:	>1.3
Measurement Current:	1.0mA
Voltage	1.0V
Resistance:	1000 Ohm
Tested Structures:	SMD and EC – daisy chains (assembled cards)
Pass/ Fail – Criteria	Minimum acceptance criterion for components is 10 drops of lower confidence bound at 5% risk level with 90% confidence interval, or better reliability than this.

- Online test method: Monitoring device soldered to ITE2000EC terminals
- 10 cards tested
- Dropped until a resistance value of >1000 Ohm was registered (an “event”)
- 5 Additional drops after a registered event to verify resistance change

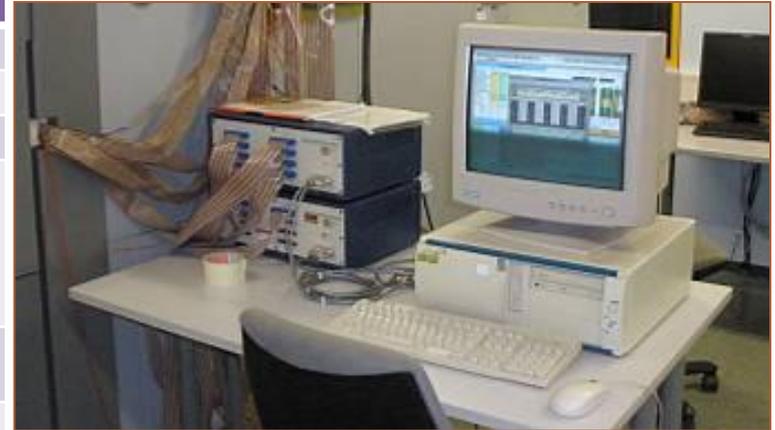
Event monitoring

Step per cycle	Chamber	Sample Temperature	Min. Soak Time	Cycle count ³	1	Cold	-40 +0/-10°C	5min	1000	2	Heat-up	-	-	3	Hot	+125 +15/-0°C	5min	4	Cool-down	-	-
	Step per cycle	Chamber	Sample Temperature	Min. Soak Time	Cycle count ³																		
	1	Cold	-40 +0/-10°C	5min	1000																		
	2	Heat-up	-	-																			
	3	Hot	+125 +15/-0°C	5min																			
4	Cool-down	-	-																				
The heating and cooling rate has to be set in such a way that in total 2 cycles per hour are achieved.																							
Measurement system	Event detection 4-point measurement																						
Test structures	Assembled cards																						
Resistance for fail event	≥2000 Ohm																						
Pass/ Fail – Criteria	Assembled cards: Minimum acceptance criterion for components is 500 cycles of lower confidence bound at 5% risk level with 90% confidence interval, or better reliability than this.

- 10 vehicles tested
- Each vehicle contains 14 daisy chains (7 EC, 7 SMD)
- Total tested DCs: 140 (8 components each)
- Thermal parameters: -40° C ↔ +125° C
- Event registered at resistance >2000 Ohm
- Result: Only SMD components failed
