New Laminates for High Reliability Printed Circuit Boards

Valerie A. St. Cyr
Teradyne, Inc.
North Reading, MA

This paper presents the work in Teradyne to characterize and qualify new printed circuit board ("PCB") dielectric substrates (a.k.a. "laminates") to meet the requirements of lead-free assembly, while providing more reliability and flexibility to design engineering. The paper provides details on: A) the drivers and the objectives of the program; B) some key properties of the laminates selected for testing; C) the tests and the results; and D) some discussion and conclusions.

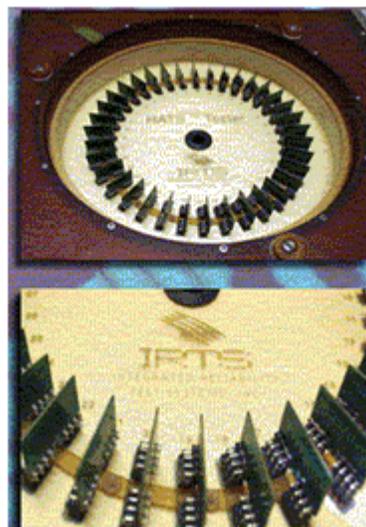
Figure 4 - HATS Test Head Loaded with Coupons (Top View and Close Angle)

thermal cycle test). This test, called Highly Accelerated Thermal Shock, uses a single chamber (Figure 4) in which high volume hot and cold air alternately pass stationary samples, providing rapid thermal transfer. The samples are fixtured to a high-speed precision resistance sampling network, allowing continuous monitoring of the samples during the temperature cycles, commonly run to 500 cycles (although 1000 cycles or cycle-to-failure are also options).³

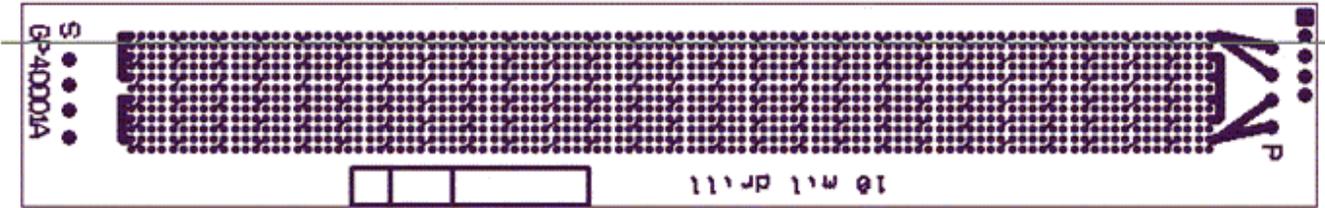
Figure 5 - IST Coupon

Another set of coupons (Figure 5) with daisy-chained 0.25 mm [0.010"] and 0.35 mm [0.0135"] drilled diameters was subjected to 0, 4 or 6 reflow cycles at 230 °C in the conditioning mode of the IST system then cycled from room temperature, ~ 25 °C, to +150 °C until failure [note: this is the "standard" IST test, not the higher temperature "Lead Free" processing conditioning and testing temperatures test recently derived (ref: 260 °C condition and "above Tg" for run time).
