## Assessing the Reliability of New Connector Designs

Heather McCormick and George Riccitelli  
Celestica Inc.  
Toronto, ON, Canada

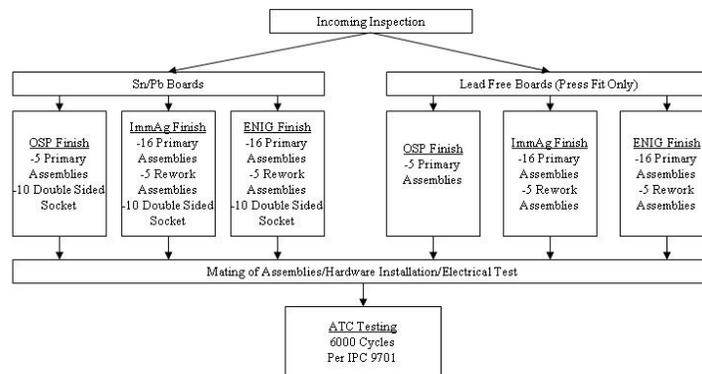
**Figure 1: Test plan for “Metropolis” project**

In addition to the various connector types and sizes, the project also attempts to assess the impact of various surface finishes on the connectors’ reliability. Three finishes – OSP, ENIG and Immersion Silver – were selected for in this study. Forced reworks were also part of the test matrix. Including rework in the test matrix would allow us the opportunity of assessing any impediments that may be encountered during the removal and replacement process. Furthermore, it would allow us to gather important reliability data and compare it to the initial attach data. Figure 1 outlines the test plan and quantities for the “Metropolis” project.

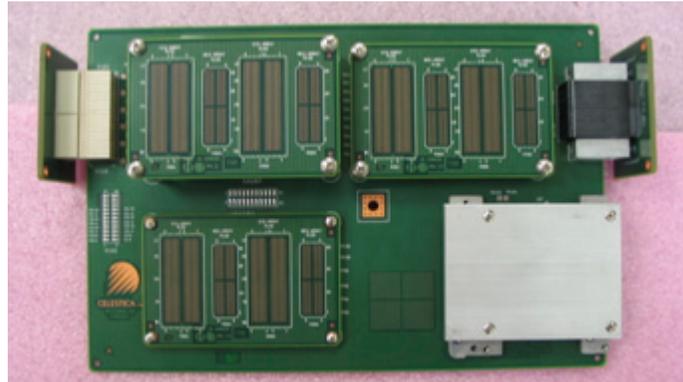
**Figure 2 - Assembled “Metropolis” Test Vehicle**

Figure 2 shows the fully assembled “Metropolis” test vehicle. For a typical packaged component reliability test, the requirements for test vehicle design are governed by IPC-9701. That specification, was not, however, written with BGA connectors in mind. Regardless, many of the primary considerations do not change, and this specification remains a useful starting point in designing test vehicles and test plans for evaluating BGA connector reliability. One of the main differences is in the implementation of daisy chains through the components to be studied. In designing test vehicles for traditional BGA packages, a daisy chained version of the package to be tested is obtained from the supplier. These packages are then mounted

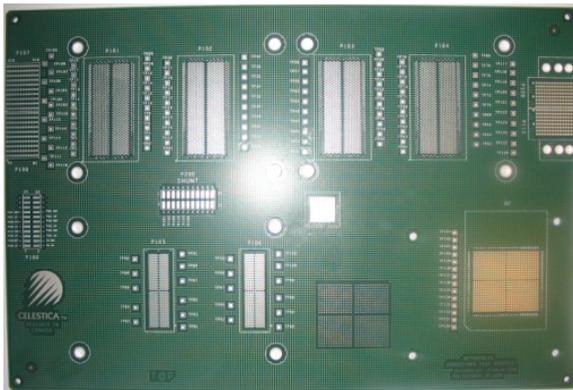
**Figure 3 - Metro Motherboard**

The Motherboard is shown in Figure 3, and the Mezzanine card and the Backplane are shown in Figure 4.

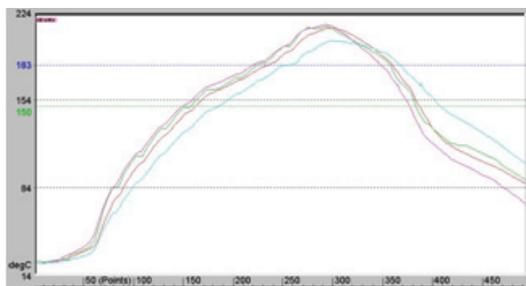
**Figure 5 - Mezzanine Board Reflow**

Profile cards were created for both the Mezzanine card and the Motherboards. Reflow profiles were generated in a 10 zone convection oven, using a nitrogen reflow environment. Representative reflow profiles for the Mezzanine card and the Motherboard are shown in Figures 5 and 6 respectively.

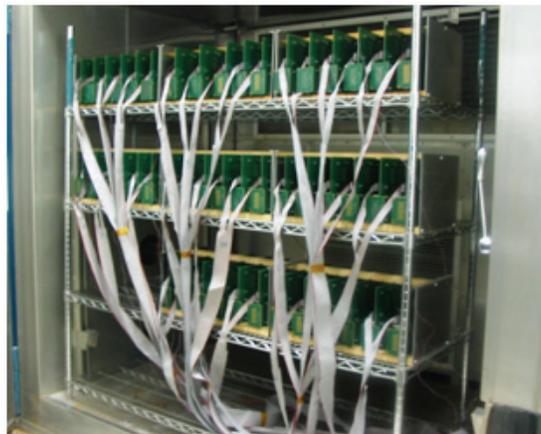
**Figure 7 - Assemblies in Thermal Cycling Chamber**

Following the completion of assembly and rework, all assemblies, including the lead free press fit boards, were subjected to accelerated thermal cycling to assess their reliability. The completed assemblies were then divided into two thermal cycling chambers. The tin/lead assemblies were placed in one chamber, and the lead free press fit assemblies in the second. Fixtures were created to hold the cards in place inside the chamber, and to allow the air inside the chamber to circulate around them as freely as possible. Figure 7 shows the tin/lead assemblies mounted inside the thermal cycling chamber.

The standard, preferred thermal cycle from IPC-9701 was selected for use in this testing, and a profile was developed for a 0°C to 100°C cycle, with a total cycle length of 90 minutes for the tin/lead assemblies, and 60 minutes for the lead free press fit assemblies. A quicker profile could not be attained due to the thermal mass and the complex geometry of the assemblies while still meeting the requirements set in IPC-9701. The design attempted to mitigate the impact of these card features on airflow, but it was not entirely possible to eliminate the restrictions to air flow.

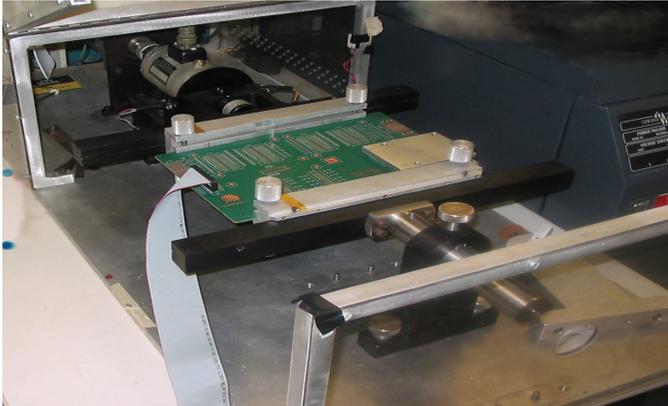
**Figure 8 - Torque Test**

A total of thirty Metropolis motherboards were assembled with a topside SMT socket and heatsink assembly, while the bottom side of the board only had the SMT socket attached. Only the topside socket was monitored during testing. Of the thirty motherboards assembled, fifteen assemblies were tested for vibration while the other fifteen assemblies were torque tested. Three surface finishes were used in the test matrix (ENIG, ImmAg, OSP). The data was collected using the 6000 Strain Measurement System. The torque test was based on Celestica's internal specification of between 0.6-0.75 degrees per inch (length of board) for 25 cycles. All fifteen samples tested passed with no resistance increases. Figure 8 illustrates torque test setup. Figure 9 illustrates the resistance measurements observed during torque testing on the different surface finishes tested.

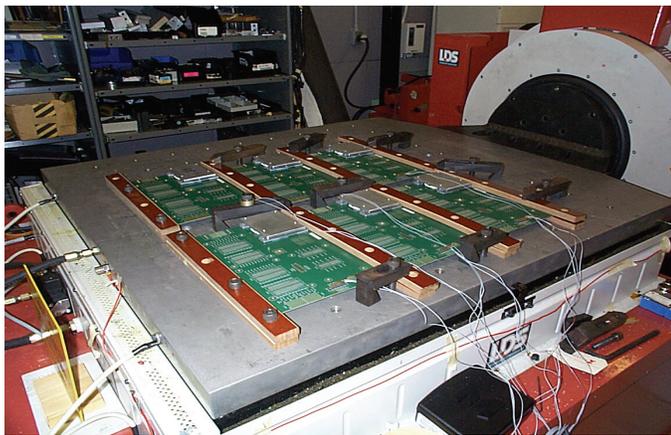
**Figure 10 - Setup of Vibration for X-axis**

Vibration testing was performed using a LDS V894 vibrating table. Tests were performed based on the supplier's specification for shipping and handling. The test parameters were: 3.13GRMS, random 5Hz-20Hz 0.01 g<sup>2</sup>/Hz sloping up to 0.02g<sup>2</sup>/Hz 20Hz-500 Hz 0.02 g<sup>2</sup> 10 minutes/axis, 3 axis (X, Y and Z). The samples were monitored in-situ for resistance

increases during the test. None of the samples tested exhibited any increase in resistance; therefore all the samples passed the vibration test specified. Figures 10 and 11 show the assemblies under test on the vibration table. The vibration spectrum is shown in Figure 12.

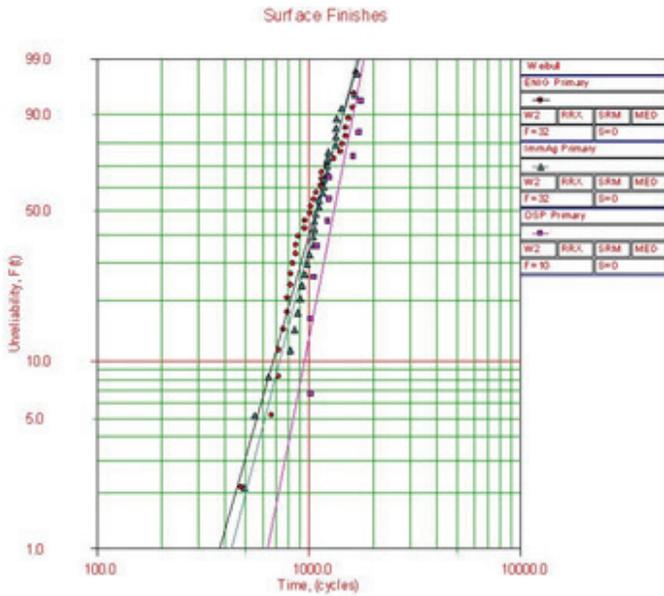
Figure 13 - 2-Parameter Weibull Plots for Mezzanine Connector B on Various Surface Finishes

Figure 13 shows the Weibull curves for the primary attach data on each of the three surface finishes. Figure 14 compares the primary attach results to the rework results for ENIG and ImmAg. Figure 14 shows that little difference was found between the three surface finishes. The curve for the OSP samples appears to indicate slightly better reliability, but the sample size was limited and the fit of the curve to the data was not as good as desired. Therefore, it cannot be concluded that OSP was any better than the other finishes.

The slopes of the Weibulls are similar, and range between 4.0 and 5.8. This indicates that the failures are, as expected, solder joint fatigue failures, which will be verified through detailed failure analysis.

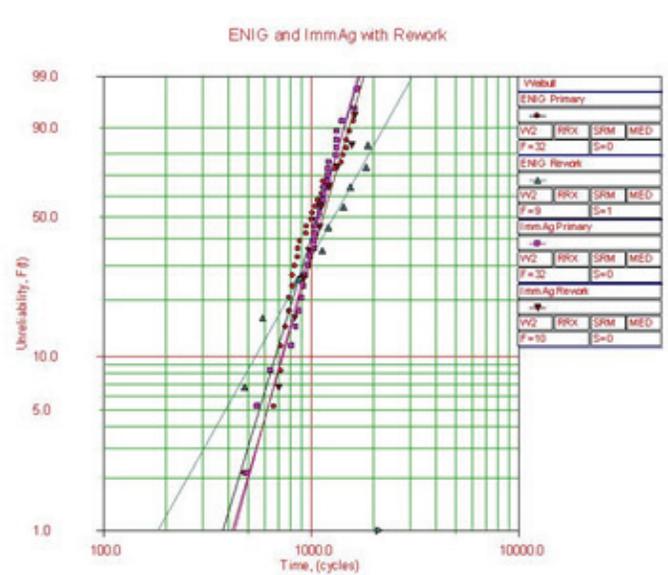
Figure 14 - 2-parameter Weibull plots for Mezzanine Connector B showing Rework vs. Primary Attach

Figure 15 shows that for Immersion Silver, the reliability of primary attached and reworked connectors is similar. For ENIG, the characteristic life of primary attach and reworked connectors was very similar, but the slope of the curves was different, dropping from 4.0 for primary attach to 2.2 for the reworks. As a result, the curve indicates that the N1 (number of cycles at which 1% of the population had failed) for reworked connectors would be significantly lower – less than 100 cycles – than for the primary attached connectors, at just over 300 cycles. This result was unexpected and requires additional failure analysis to determine the root cause

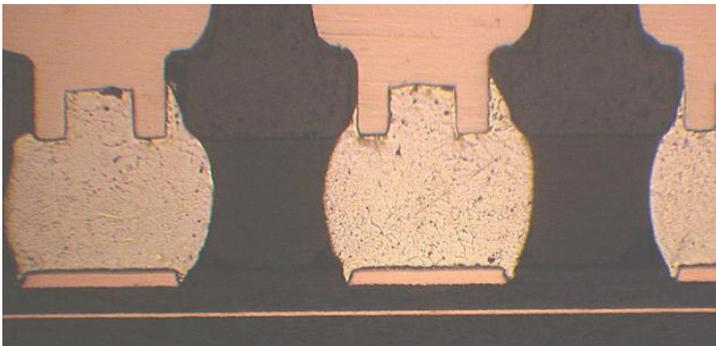
**Figure 15 - Typical Time Zero Mezzanine Connector Solder Joint**

The cracks on the daughter card side were found to be typical fatigue failures, though they formed on the board side of the joint rather than the component side. This is likely due to the unusual ball attach method at the component side – the balls are not soldered to flat pads as they would be in a conventional BGA package, but rather are reflowed onto pins which form part of the contacts. The cracks observed in the failed joints propagated through the bulk solder above the intermetallic layer on the board side. Figure 15 shows typical joints before ATC, with the board side pad and component side connections visible, and Figure 16 shows a typical failed ball on the daughter card.

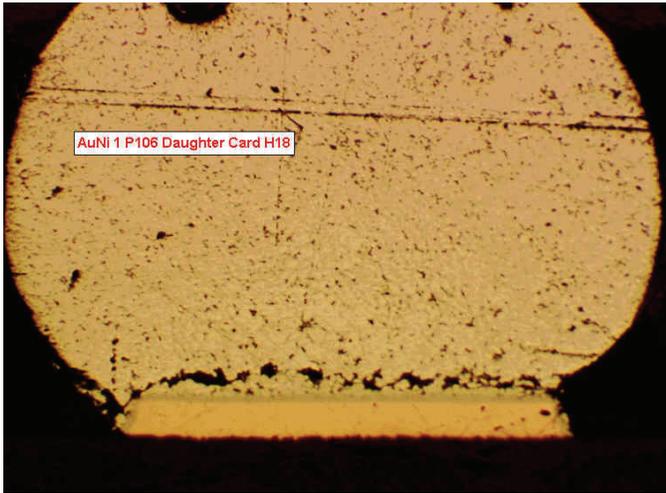
**Figure 17 - Typical Solder Fatigue on Motherboard**

In four cases, it was found that there were cracks on both the Motherboard side and the Daughter Card side. In each case, there was a similar fatigue crack on both sides, again, along the PCB side of the joint. Figures 17 and 18 shows one example of these failures.

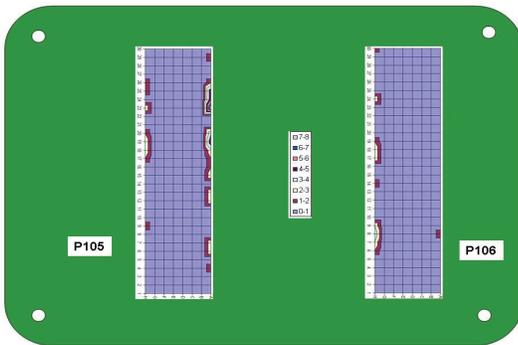
**Figure 19 - Location Map of First Failures for Mezzanine Connector B on ENIG**

As the failure locations were isolated and documented, it became clear that the failures were occurring in a variety of locations that exhibited a vague pattern. To assist in understanding the failures, a map of the locations of these first fails was plotted for each connector site and each surface finish. These are seen in Figures 19 through 21. The diagrams show the number of times a pin was indicated as a failure when first probed. It must be noted that for many connectors, more than one failing ball was identified when first probed. The sample size for ENIG and Immersion Silver is the same, but is smaller for OSP due to the smaller number of OSP assemblies built. In addition, these diagrams show the primary attach data only, so the sample sizes are not equal between site P105 and P106. It is therefore important to consider the general trends in failure location identified in these diagrams rather than the actual number of failures recorded. Each diagram shows both the P105 and P106 locations of Mezzanine Connector B relative to the outline of the daughter card used to complete the daisy chains. Standoff locations are indicated by the white circles in the daughter card corners.

As can be observed from the above diagrams the failures are not limited to the distance from the neutral point, as is expected. The failures tend to be concentrated along the length of the connectors, with some tendency to cluster near the middle of the long edge. Another somewhat unexpected observation was that the failures did not occur symmetrically on both long edges of the connector. Surface finish did not appear to a factor on the failure location. Similar trends were observed for the reworked cards – Figure 22 shows the failure location map for the primary attach and reworked samples on ImmAg. As no strong dependency on surface finish was observed in the rework failure locations, the ENIG rework failure map is not shown.

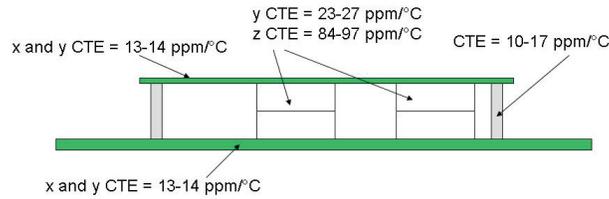
**Figure 23 - CTE Values for Various Components of the Mezzanine Connector B Assembly**

It was noted from the same connector CTE measurements that the CTE in the z direction was relatively high – in the range of 84 to 97 ppm/°C. The CTE of stainless steel, the material used for the standoffs was found to be 10-17 ppm/°C, from reference documents. Figure 23 shows a simple diagram of the Mezzanine Connector B portion of the assembly in cross section. The relevant CTE values are shown for the various components of the system.

Based on these CTE numbers, it is theorized that the system behaves as follows. As the assembly is heated up, the connectors begin to expand in the z-direction. The standoffs also begin to expand, though not as far due to their lower CTE. As the daughter card is thinner and more compliant than the motherboard, it begins to bow upwards as the connectors continue to expand, and a tensile stress is created in the card. Simultaneously, the daughter card, motherboard, and connectors expand in the x- and y- directions. These key movements are shown in Figure 24.

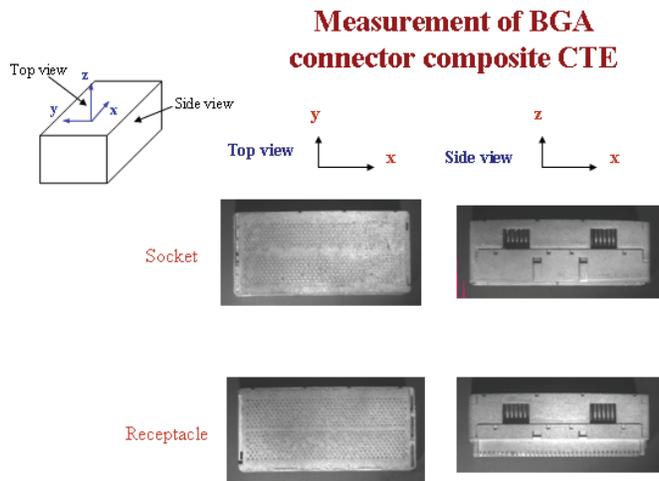
Figure 26 - CTE measurement areas of Mezzanine

Figures 26 and 27 illustrate the locations on the connectors where the CTE measurements were collected by Digital Speckle Correlation method on the Mezzanine connectors.

As can be seen from Table 5, the y-direction (short side of connector) the CTE measured for the "A" type Mezzanine connector was measured to be 21, which is much closer to the CTE of the printed wiring board  $\sim 17\text{ppm/C}$ . Unlike the Mezzanine B connector, the CTE in the y-direction was measured at  $50\text{ppm/C}$  (Table 6). This profound mismatch is the reason on the poor reliability results of this connector versus the larger "A" type mezzanine connector. Secondly, the effect of the pin connection and connector height was another factor that had a profound effect on reliability as illustrated in Figure 28.
