## Interconnection Reliability of HDI Printed Wiring Boards

Tatsuo Suzuki

Nec Toppan Circuit Solutions, Inc  
Shibata-city, Niigata-prefecture, Japan

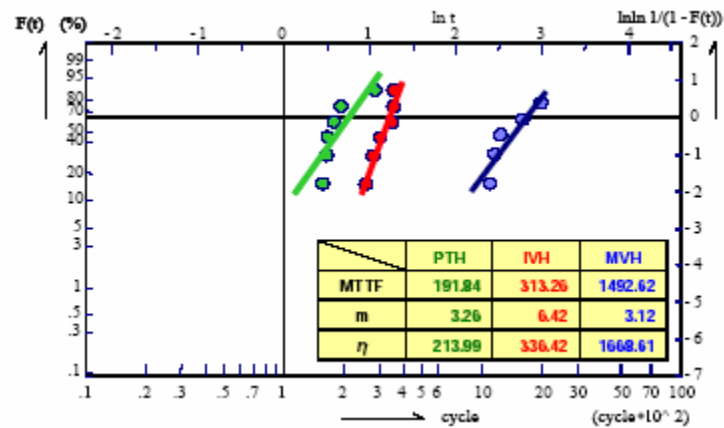
Figure 2 – Weibull Probability paper (Base Material (a) by Via Hole Types

The MTTF (mean time to failure) results obtained for each base material type from the evaluation are shown in Table 3. Failures happened in order of PTH, IVH and MVH. The failure results caused in PTH, IVH and MVH (three-step stack) of the base material (a) are plotted on the Weibull Probability Paper and are shown in Figure 2. Upon comparing the results for various base material types, we confirm that the combination of high-Tg material with low thermal expansion specifications does not cause more failures than using FR-4 material. Furthermore, in the stack-via-hole area, it is assumed that cracks tend to be caused from the increase in distortion resulting from the difference in thermal expansion between the base material and copper when the number of build-up steps increases. When we checked the failure modes, barrel cracks and corner cracks were detected on PTH and IVH (see the Figures 3 - 6). In the case failure on MVH, corner cracks of MVH were also detected (see the Figures 7 and 8).

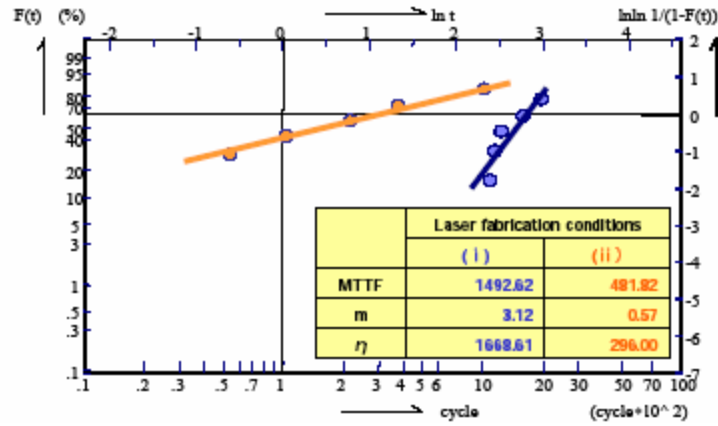
Figure 9 – Weibull Probability paper (Base Material (a); by Via Hole Diameters)

In order to find out the extent of failures as a function of smaller MVH, we made three-step stack via holes using base materials (a) and (c), each under the two types of laser fabrication conditions. The average value of MVH diameters obtained is given in Table 5. The evaluation revealed that the first failures happened during the 10th cycle on base material (a) and during the 58<sup>th</sup> cycle on base material (c). The results of the evaluation of the base material (a) are shown in Figure 9 as an example. Comparing the “m” values (i.e., shape parameters) on a Weibull distribution, we can see that under laser fabrication conditions (ii), when  $m < 1$ , failures occur early. In the case of laser fabrication conditions (i),  $m > 1$ , the occurrence of failures is relative to the elapse of time. Checking the failure mode under the laser fabrication condition (ii), it was found that the copper plated walls of the hole became thinner as a void occurred within the MVH (see Figure 10). The root cause was the difficulty in circulating the foaming solution and copper plating solution within MVH during the copper plating process due to the higher aspect ratio from a decreased MVH diameter. In promoting smaller diameters of MVH, attention must be paid to ensure the setting of the MVH diameter and the dielectric thickness. To achieve a stable volume production, it is also necessary to establish a quality assurance process aimed at eliminating voids within MVH. In order to satisfy the 200 cycle requirement of the DC current induced thermal cycling test, it is necessary to ensure the reliability of PTH or IVH and use either a high-Tg material or a material of low thermal expansion. With regard to MVH, an MVH diameter of approximately 0.100 mm is desirable to correspond with a thickness of 0.06 mm between build-up layers. It is necessary to carefully examine the manufacturing specifications of chip carrier applications since their design rules and base materials are different from those of general printed wiring boards.

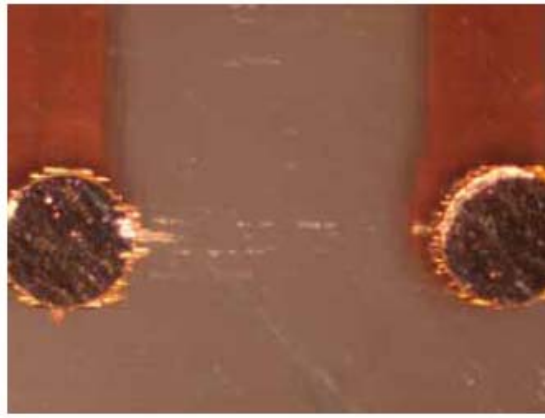
Figure 12 – Location where CAF Happened

The results of this evaluation are provided in Table 7. The evaluation found no failures on any of the samples for the 168 hours of testing that is the standard requirement for the IPC-TM-650 Environmental Test Method 2.6.3F. However, our longer test duration found that 1 out of every 6 samples of base material (a) with a 0.35 mm MVH pitch (a distance between hole walls of 0.25 mm), had a failure after 434 hours. When we checked the defective portion, a conductive anodic filament (CAF) was discovered (see the Figure 12). Because the results well satisfy the standard 168 hour requirement, we conclude that there is no problem with an MVH pitch of 0.35 mm or more (or a distance of at least 0.25 mm between hole walls) on any of the base materials. (See Figures 13-16)

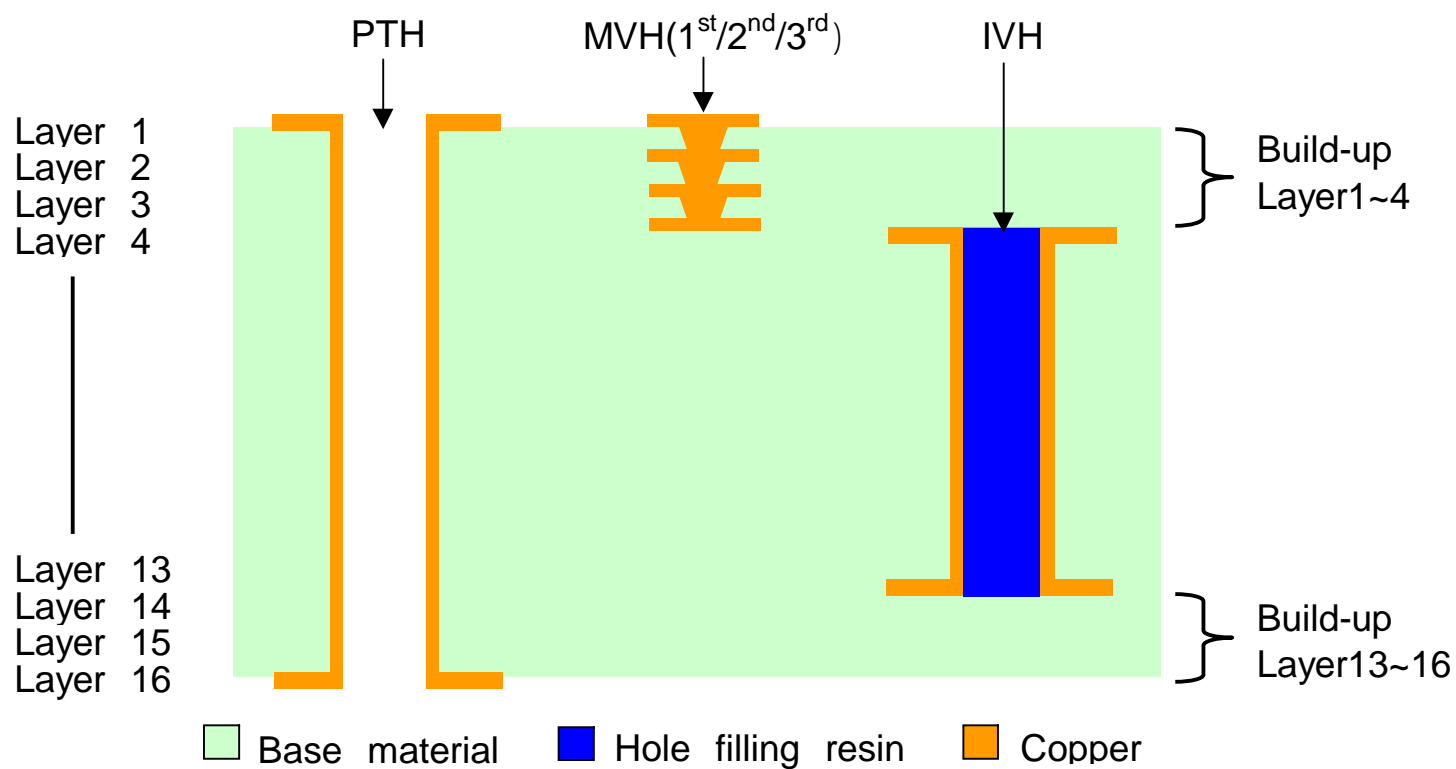
**Total board thickness(layer1 - layer16) : 2.0mm**

**IVH layer thickness (layer4 - layer13) : 1.3mm**

**\* We manufactured the build-up layers using 1 ply 0.06mm prepreg (#1080).  
The maximum thickness was 0.08mm.**

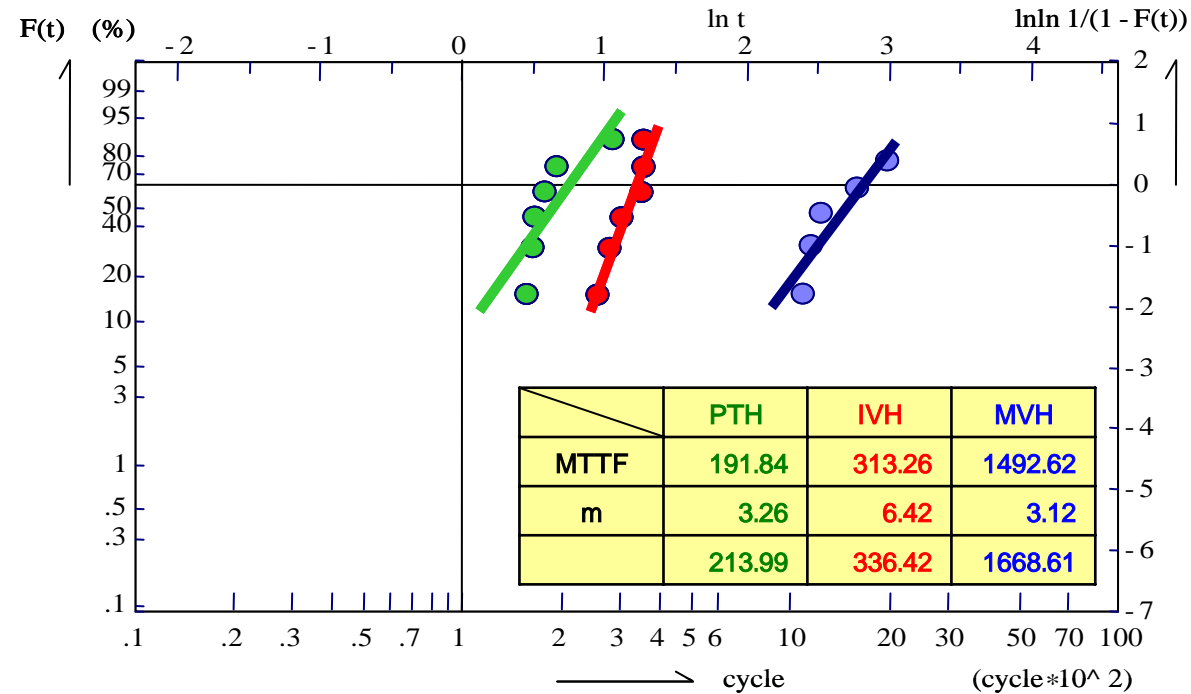
Base material (a)

Failures occurred in order PTH, IVH and three-step MVH.

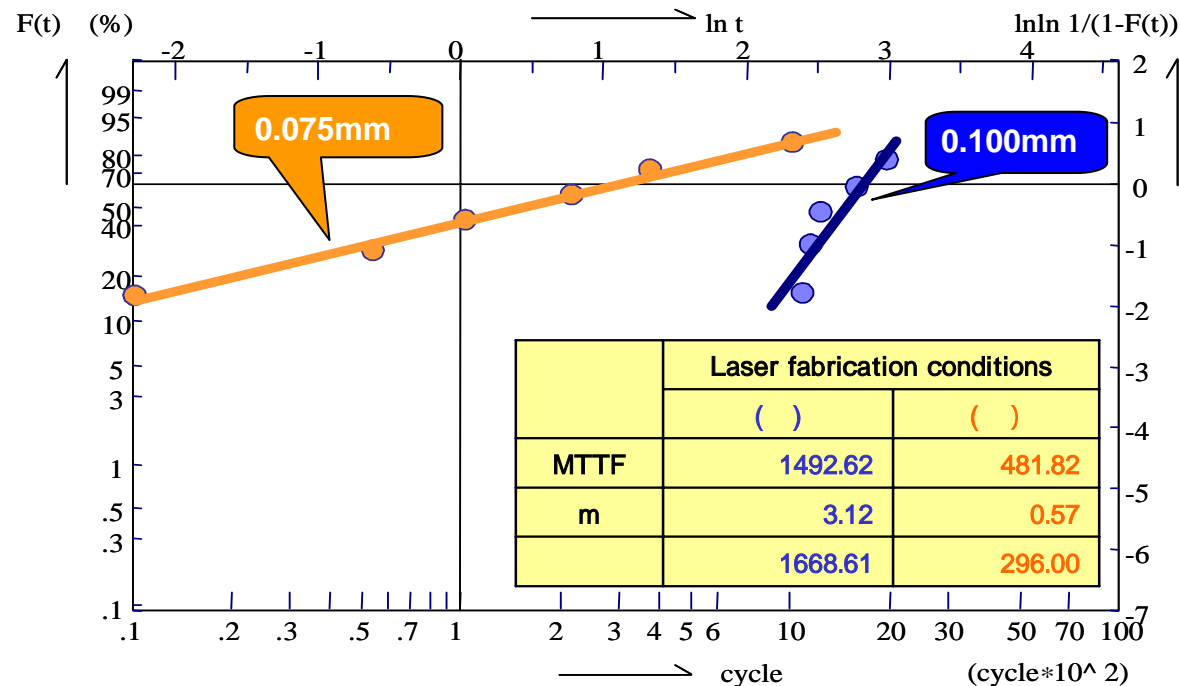
Base material (a)

When MVH diameter is smaller, failures are more likely to occur at the initial stages.

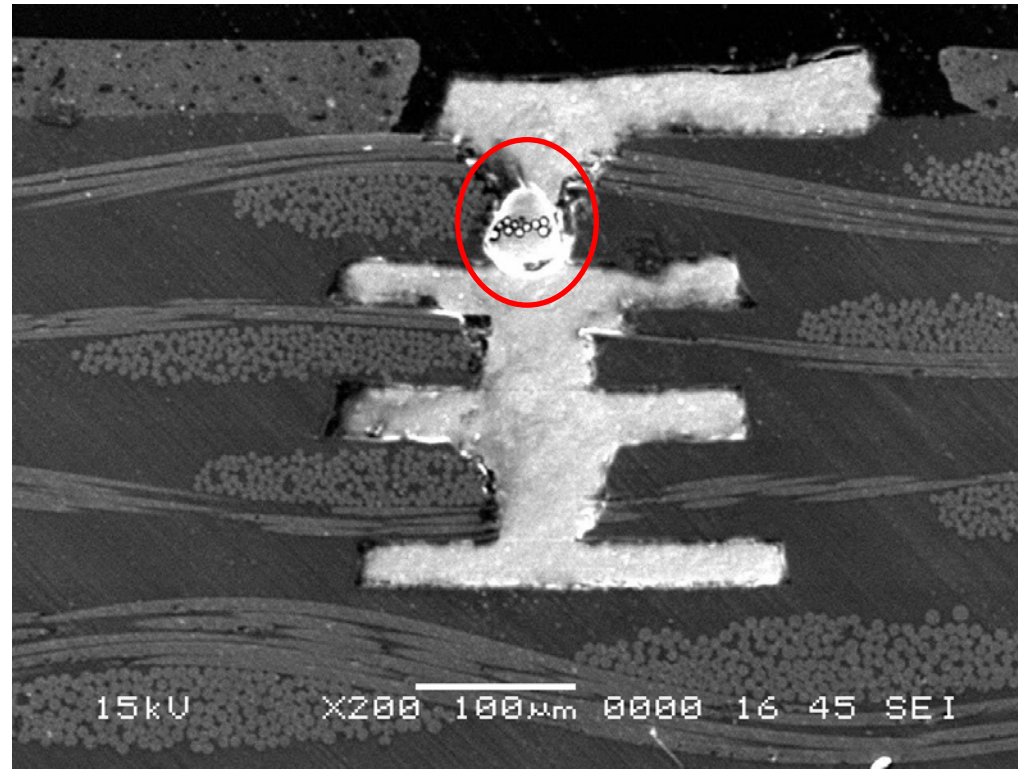
The copper plated walls of the hole became thinner as a void occurred, when the MVH diameter was 0.075 mm.

The liquid circulation and de-foaming method in the MVH during the plating process.

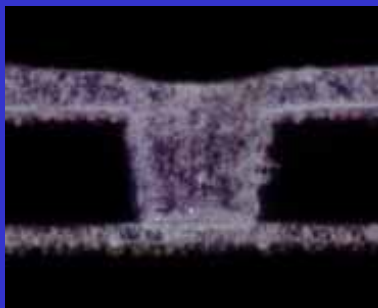
Normal(section)

e.g. The void inspection is possible by using X-rays.

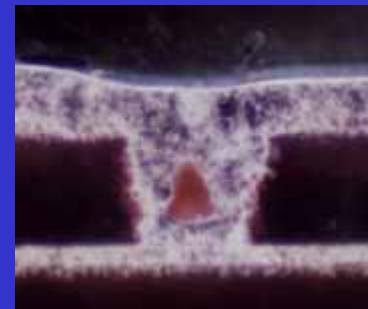
Void(section)

← Void

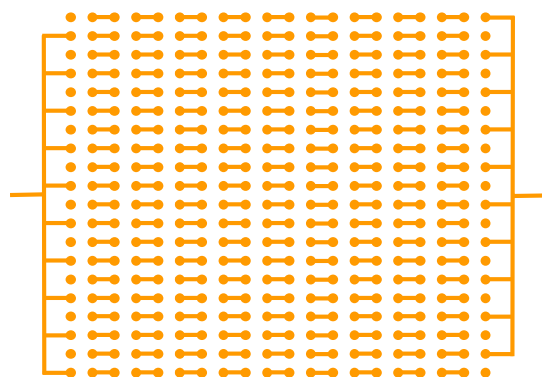
(Outer layer)

The number of MVH:  
Vertical 20 rows  
×  
horizontal 20 rows  
Total 400 places

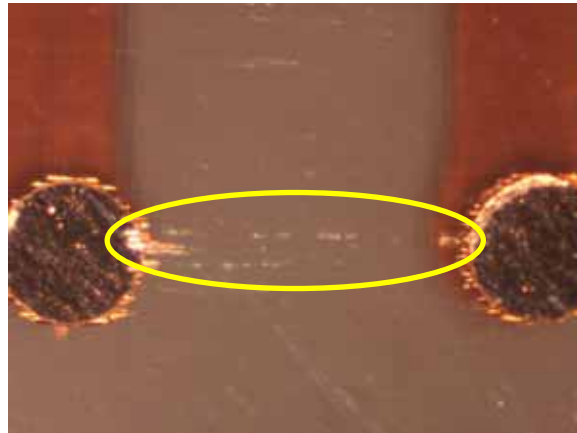
**CAF (conductive anodic filament)  
was found.**

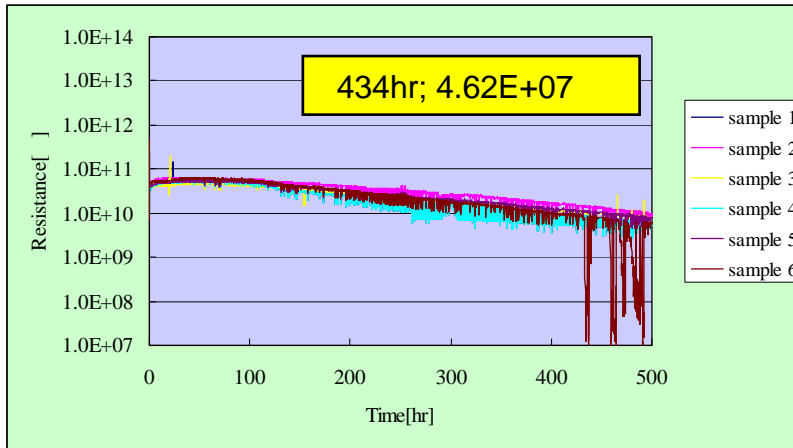
0.35 mm MVH pitch on base material (a)

- The evaluation found no failures for the 7 days of testing.
- Failures occurred in FR-4 after 434-hour progress.

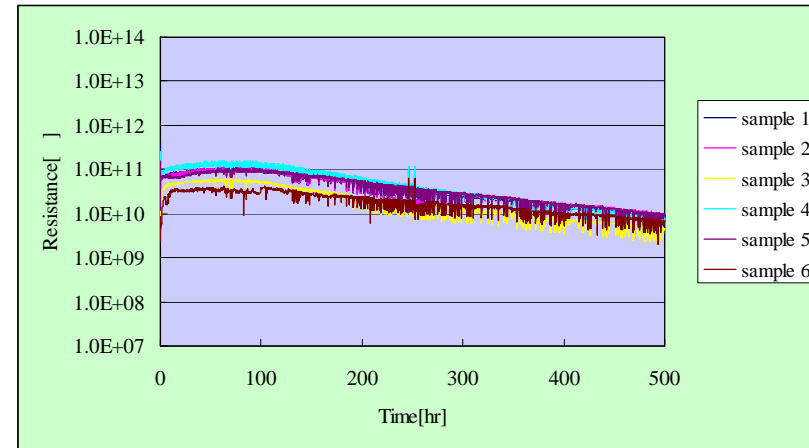
0.35 mm MVH pitch on base material (b)

The evaluation found no failures for the 168 hours of testing.
