“Why Signal Always Be Loss in a High Speed High Frequency Transmission Line”

Albert Chen
Elite Material Co., Ltd.
Taiwan, ROC

Abstract:

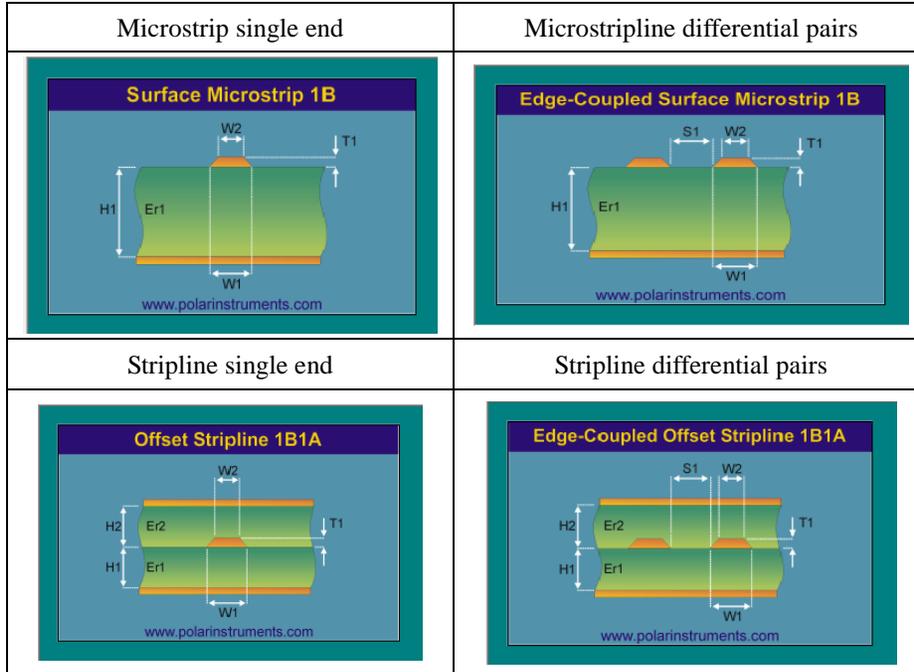
Figure 3 Typical Microstrip and Stripline structure for PCB (source: Polar Instruments Ltd)

The transmission line in a PCB stack up could be represented by following models; every model has specific formula for the

In a multilayer board, a good transmission line should be well controlled that its characteristic impedance is constant everywhere down its length. If a controlled impedance board is that the characteristic impedance of all the traces meets a target spec value, typically 50 Ohms or 85 Ohms. Does it mean that it can always be having good quality all the time, especially for higher speed or higher frequency? The answer is depending on situation.

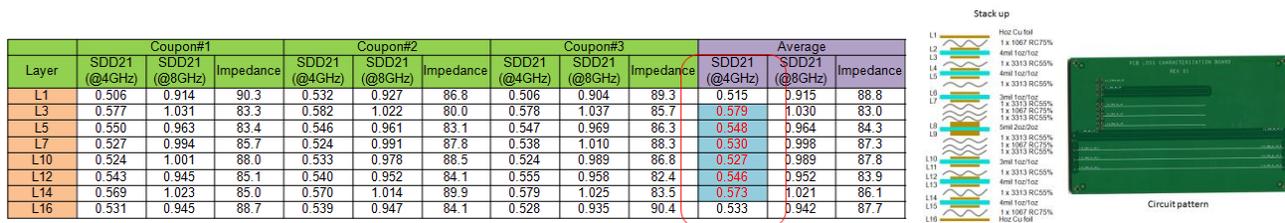
Figure 4 – 16L stackup, circuit pattern and measuring data

Here is an example of 16L SI measurement, a PCB shop did a good controlled impedance board that the characteristic impedance of all the traces meets a target spec value of 85 Ohms. However the insertion loss value of every layer is exceeded -0.48db/in at 4GHz what they expect.

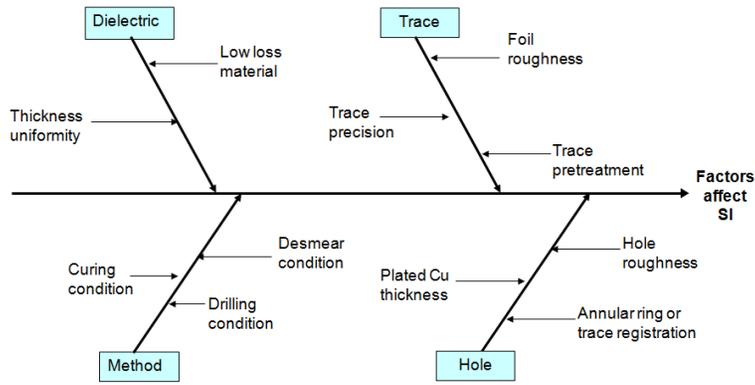
Figure 5 - Fishbone analysis of signal integrity

Elite Material Co., Ltd did following failure analysis in order to find out what's wrong in the measurement.

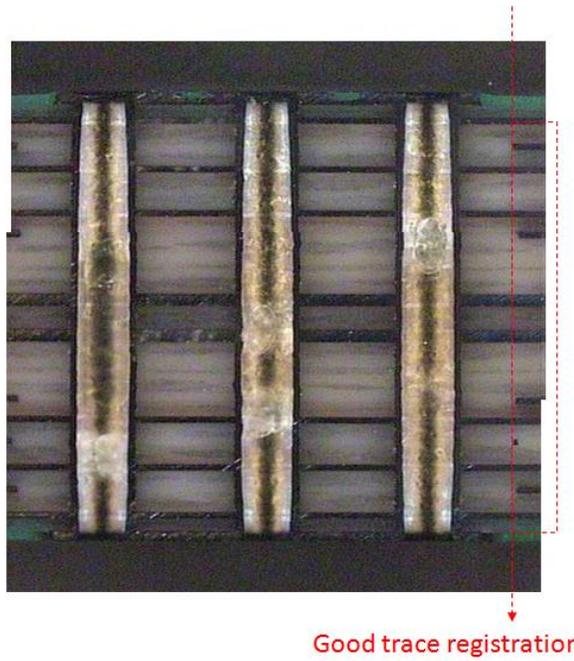
Figure 6 – Layer registration

Then we did cross-sectioning to check the registration, plated copper thickness and resin integrity of the coupons. However we don't see any obvious variation when referring to figure 6 & 7.

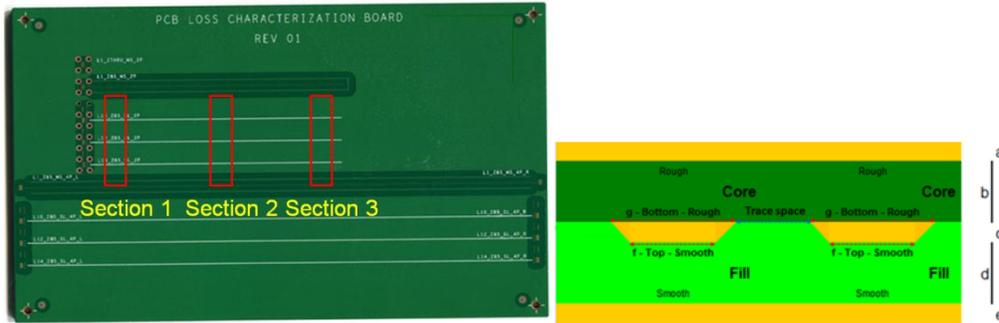
Figure 8 – Cross-sectioning location

We decided to do more cross-sectioning of trace according to below locations;

It looks the prepreg dielectric (d) thinner than the designed value 3.7mils especially at layer 3, 5, 12 and 14.

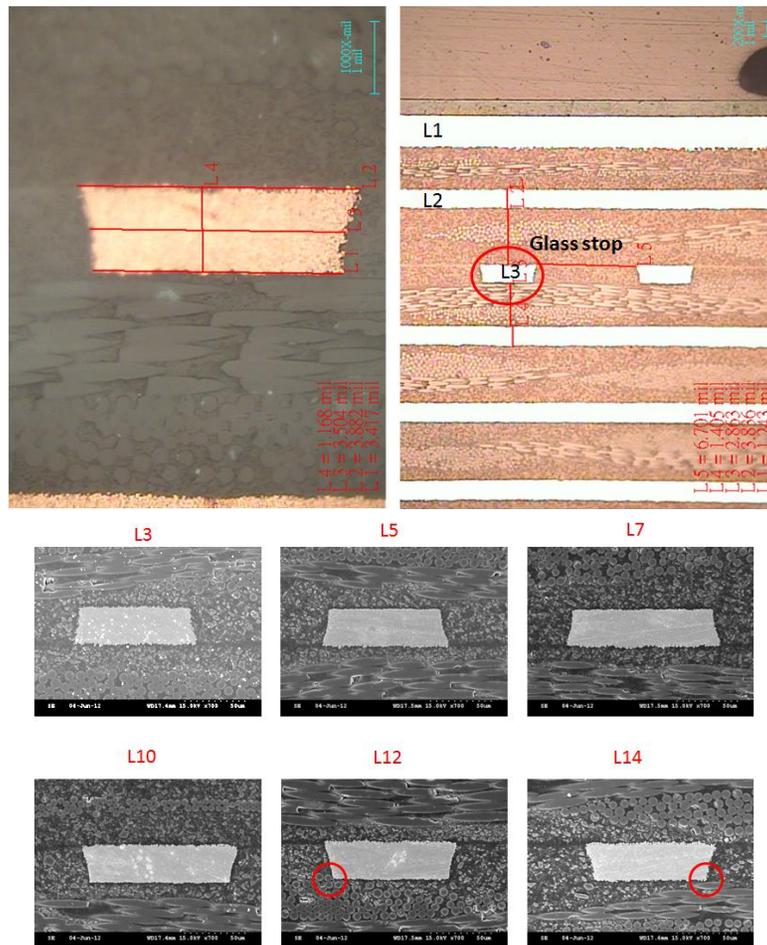
Figure 10 – Glass fiber touch copper trace

We also observe glass fiber touch onto the copper trace without sufficient resin coating at those thinner dielectric layers. As a result, the bulk resistivity of the dielectric would be dropped inevitably to cause signal loss increase.

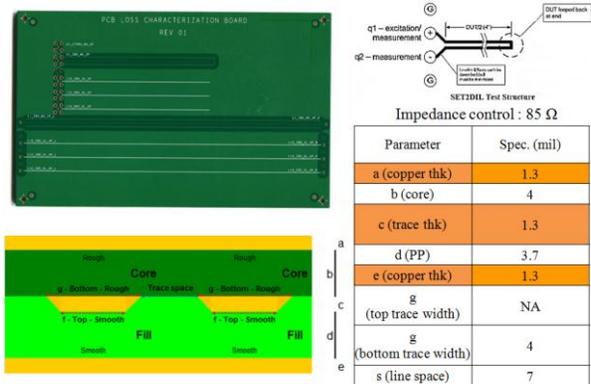
Figure 11 – Circuit pattern design

Here is another example of 16L SI measurement from three different PCB shops. They used the same circuit pattern design and same low loss FR4 material to build the same 16 layers SI test vehicles. We measured them under the same environment condition. Unfortunately we don't see the best result at B shop even she get the best impedance controlled value of 85 Ohms.

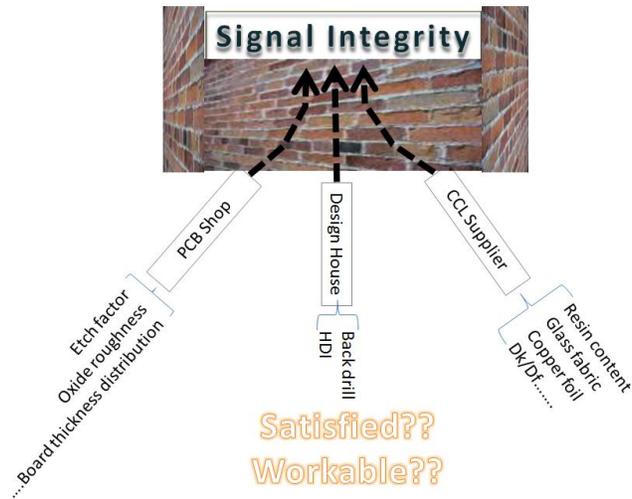
Figure 12 – Signal integrity barrier

The signal total loss could be divided into two parts, dielectric loss and conductor loss. The total attenuation could be expressed as below formula

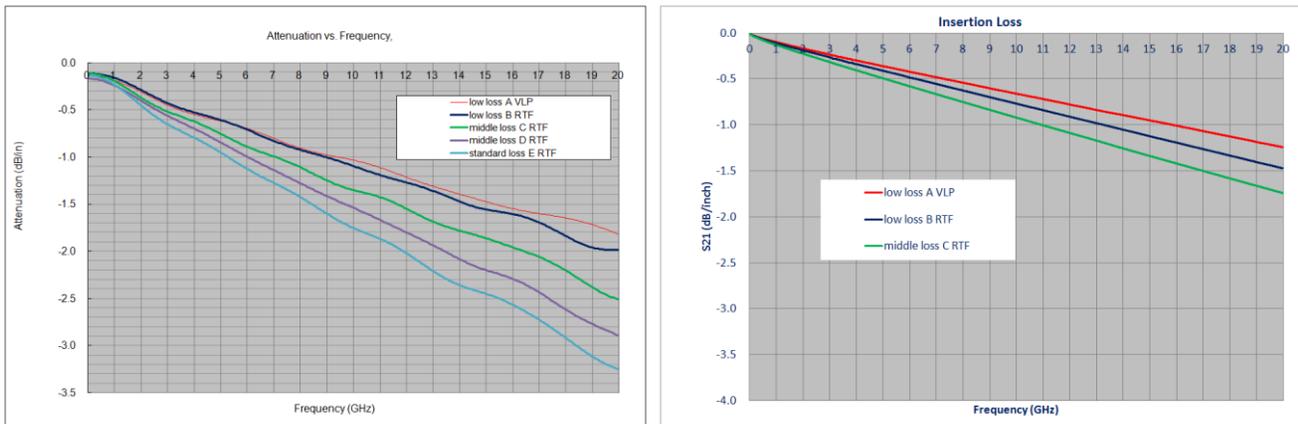
Figure 13 – (left) attenuation result convert by GammaZ from SPP measurement & (right) S21 result measures by VNA from S3 measurement

No matters of SPP or S3 results, PWB base materials always are played a major role for insertion loss performance. The low dissipation factor of material the less loss we can observe in figure 13.

PWB base materials always are played a major role for insertion loss performance. The low dissipation factor of material the less loss we can observe

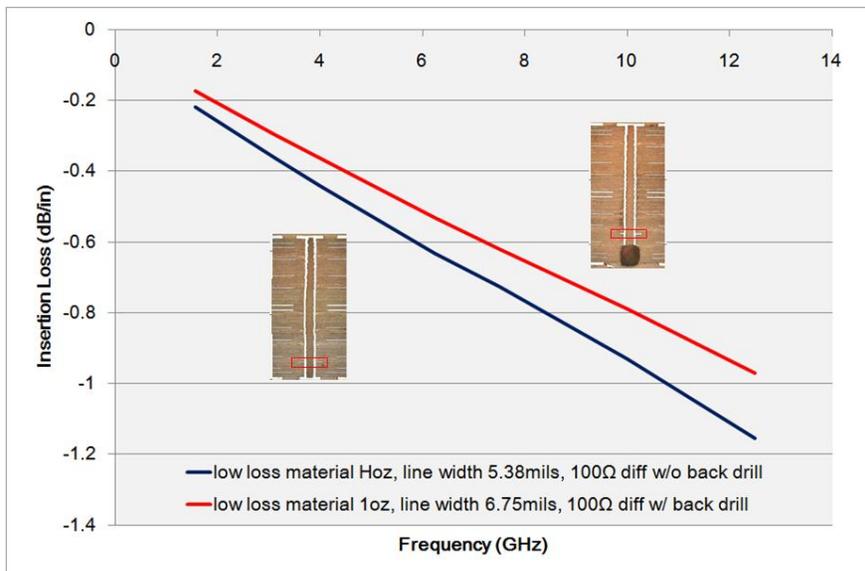
Figure 14 – Insertion loss of a 24 layer SI board

In order to reduce the return path in a transmission line, some PCB manufacturers develop back drill technique to reduce via stub effect. The via stub effect occurred at AC current the signal will travel longer return path than it should go. Back drill could eliminate the inductance on the extra path and should have better loss performance.

3. Considering skin effect of copper, low roughness profile foil should be used in priority for those high speed and high frequency application.
4. The back drill technique can eliminate via stub effect to improve signal integrity.

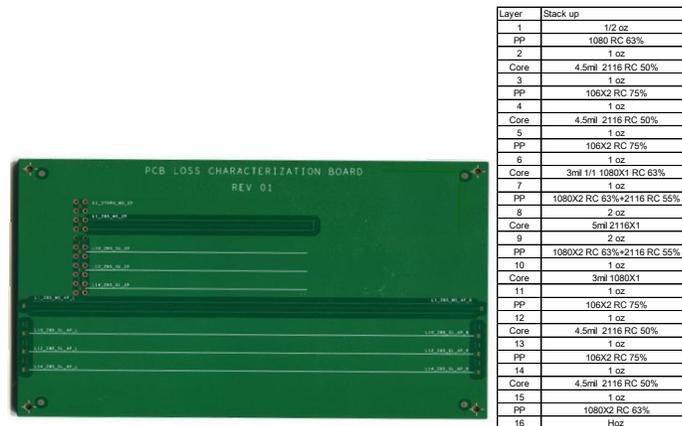
Figure 15 – Test pattern and stackup design of low loss material A

In this experiment we want to find out which factors dominant to signal loss performance by doing SET2DIL measurement. We prepare a 16L SET2DIL stackup each for different set of factors and use low loss A material for the test vehicle.

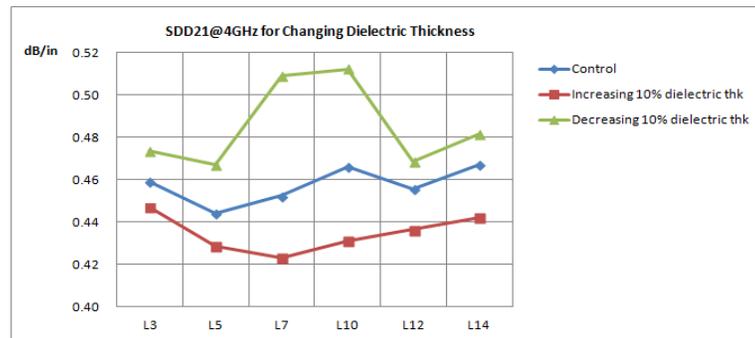
Figure 16 - The relationship between SDD21 and dielectric thickness

The dielectric thickness is an apparent influence factor for SDD21 result. When it is increasing about 10%, it could reduce SDD21@4GHZ about 5%.

5. Regarding with experiment result of SET2DIL measurement,
 - i. The dielectric thickness increase about 10% could reduce SDD21@4GHZ about 5%. This can explain why the multilayer board the insertion loss sometimes is increased even under same stackup and PCB manufacturing if there is insufficient dielectric.

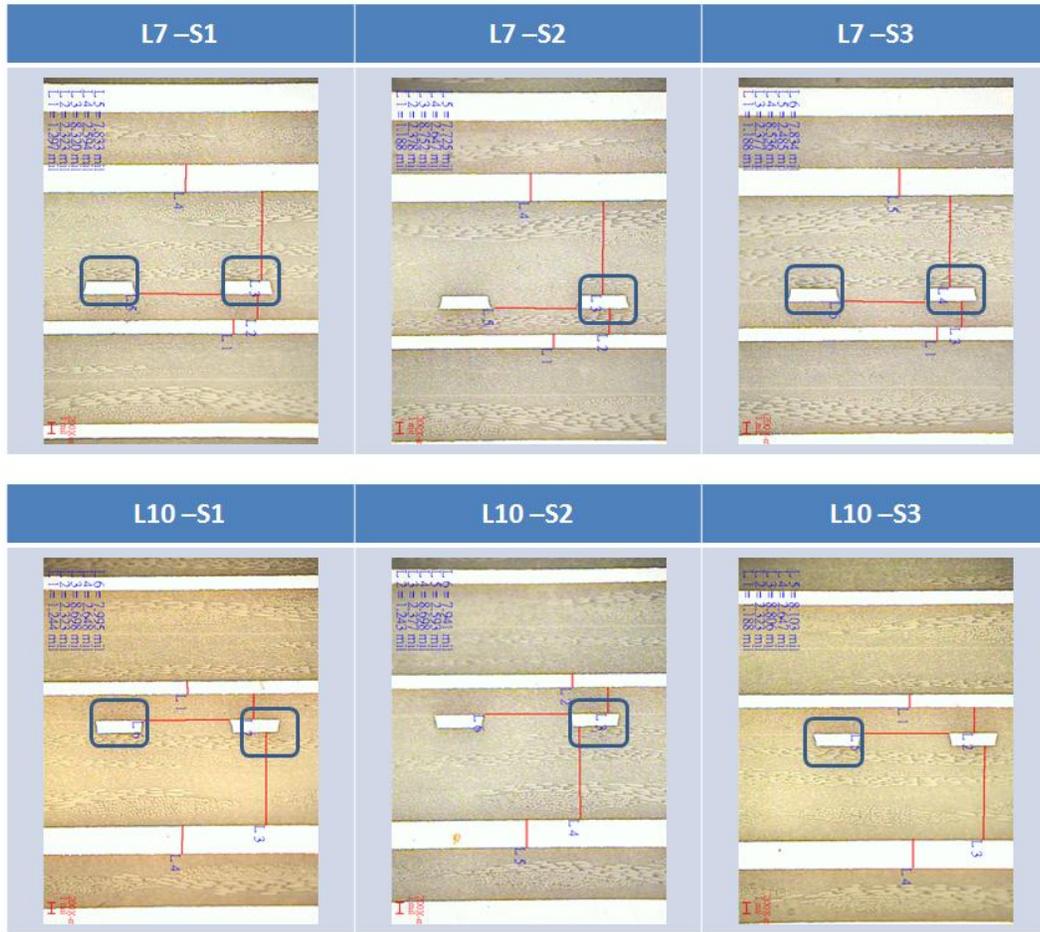
Figure 17 – Resin starvation found between glass fiber and copper trace of the “-10%” specimen

The insertion loss suddenly arise at layer 7 & 10 of the coupon with decreasing 10% dielectric thickness which is caused by resin starvation between glass fiber and copper trace shown as figure 17.

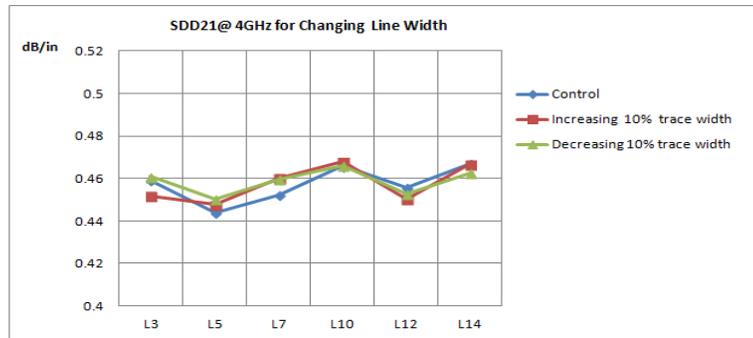
Figure 18 - The relationship between SDD21 and trace width

The trace width varies within +/-10% doesn't affect the SDD21 performance.

- ii. The trace width and space within +/-10% doesn't affect the SDD21 performance.
 - iii. The lower copper roughness is beneficial for SDD21 performance. The HVLP copper foil (1oz / Rz 1.7um) could improve about 5.8% SDD21 compare to the one using VLP copper foil (1oz/ Rz 2.5um)

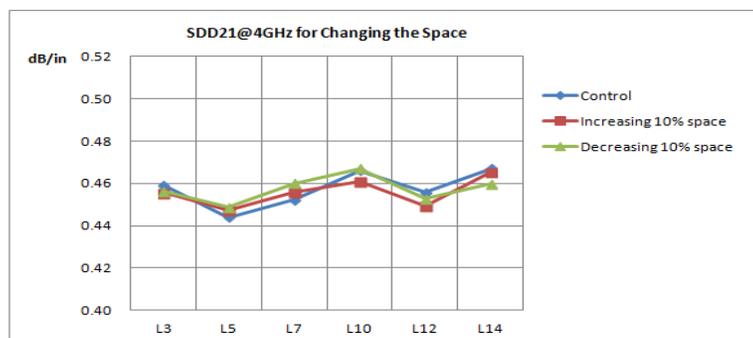
Figure 19 - The relationship between SDD21 and trace space

The trace space within +/-10% doesn't affect the SDD21 performance.

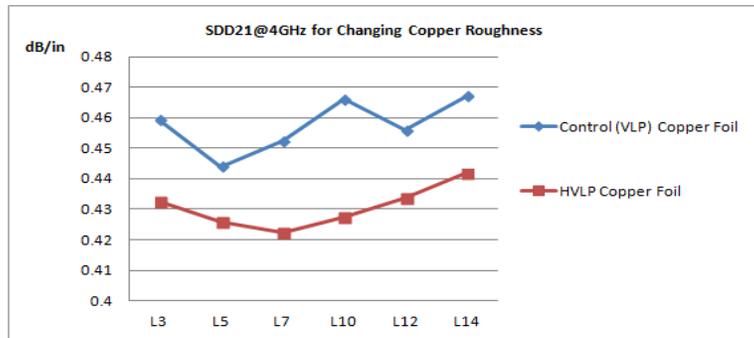
Figure 20 - The relationship between SDD21 and copper foil/roughness

The copper foil roughness is an apparent influence factor for SDD21 result. The lower copper roughness is beneficial for insertion loss. The HVLP copper foil could improve about 5.8% SDD21 compare with VLP copper foil.

HVLP copper profile is more uniform than VLP which is good for signal integrity.

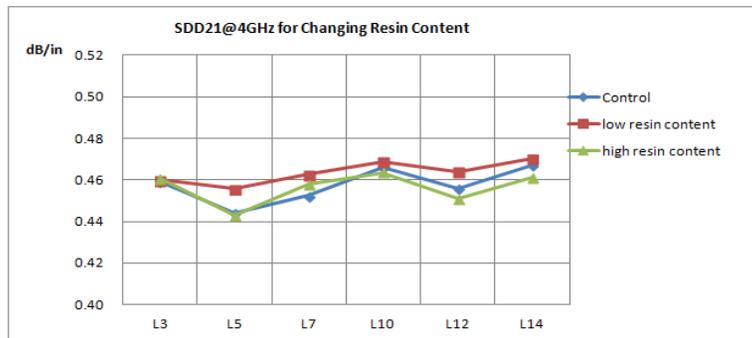
Figure 21 - The relationship between SDD21 and resin content

Changing stack up resin content seems not improve the SDD21 result obviously.

- iv. Changing resin content of stack up with keeping the same thickness (e.g. 2 ply of 106 instead 1 ply of 2116) doesn't affect SDD21 performance obviously.

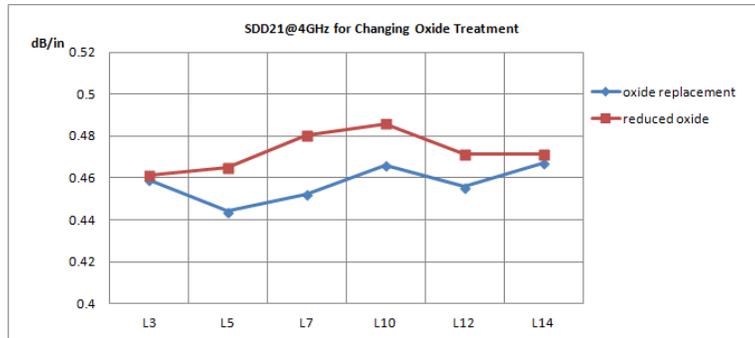
Figure 22 - The relationship between SDD21 and oxide treatment

From the below figure, we could see that black oxide replacement could improve SDD21 slightly compare to oxide alternative treatment about 3%.

The trace at layer 14 of the oxide replacement specimen looks high and close to the one of reduced oxide maybe cause by a glass fiber touch to the copper trace in figure 22. It should take more cross-sectioning for confirmation.

- v. From the result it looks oxide replacement could improve SDD21 slightly compare to reduced oxide treatment about 3%. However we need to do further study for confirmation.

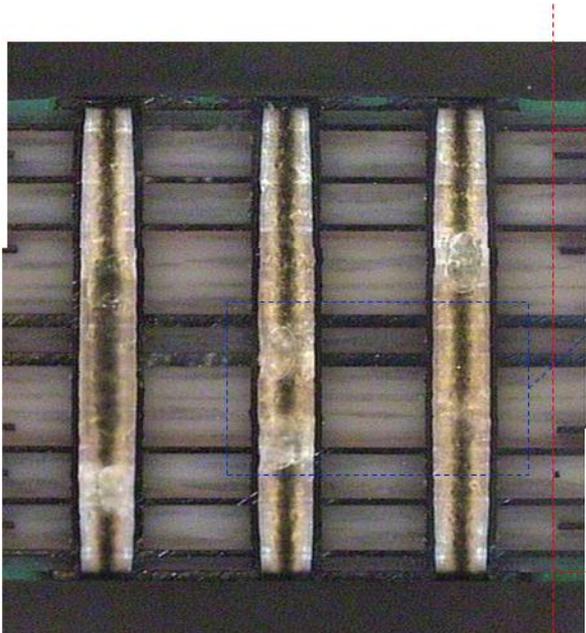
material is already fully cured

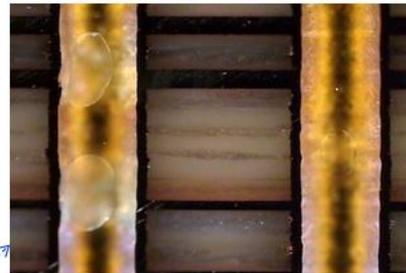
Good trace registration

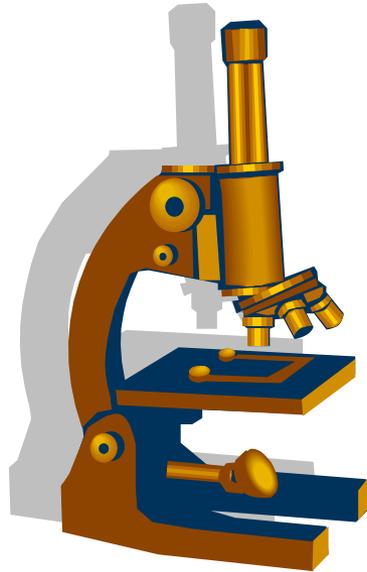
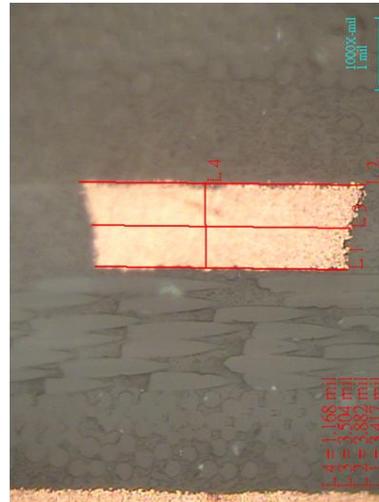
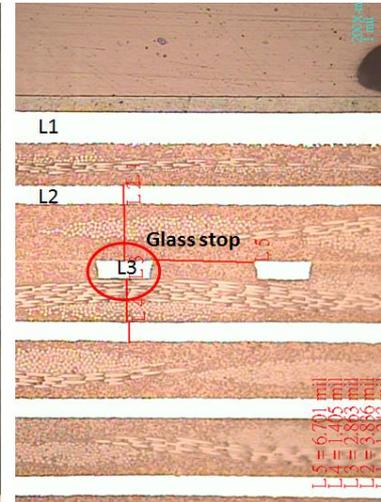
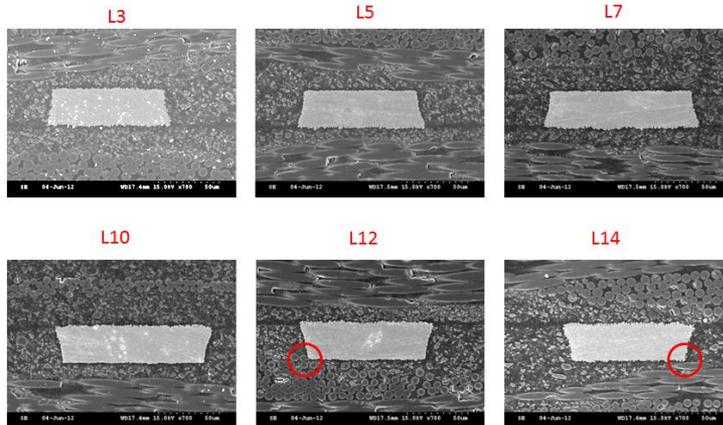
Glass fiber touch onto the copper trace

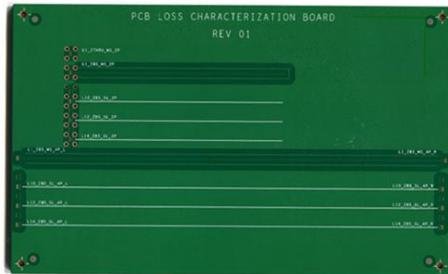
SET2DIL Test Structure
Impedance control : 85 Ω

Parameter	Spec. (mil)
a (copper thk)	1.3
b (core)	4
c (trace thk)	1.3
d (PP)	3.7
e (copper thk)	1.3
g (top trace width)	NA
g (bottom trace width)	4
s (line space)	7

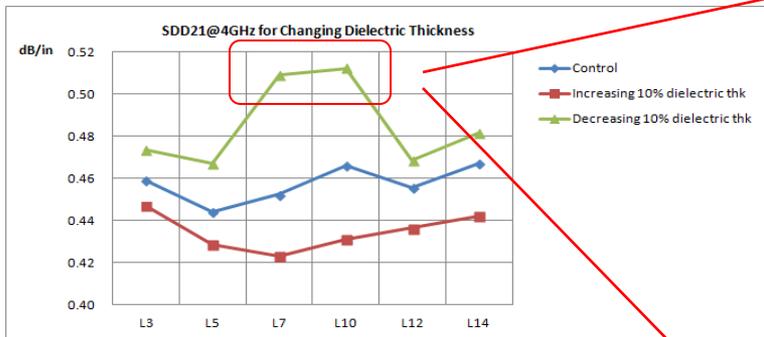
Change +10% of the dielectric thickness

Resin starvation found between glass fiber and copper trace

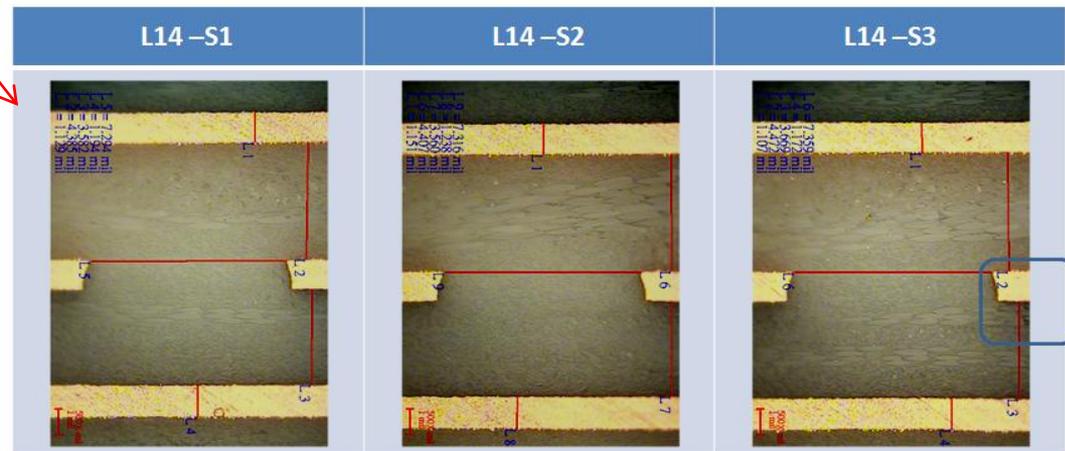
oxide replacement specimen which show a glass fiber touch the copper trace found at L14. It should take more cross-sectioning for confirmation, especially at L3
