Behavior of Materials in the Manufacturing Environment

FIRAN TECHNOLOGY GROUP

Abstract

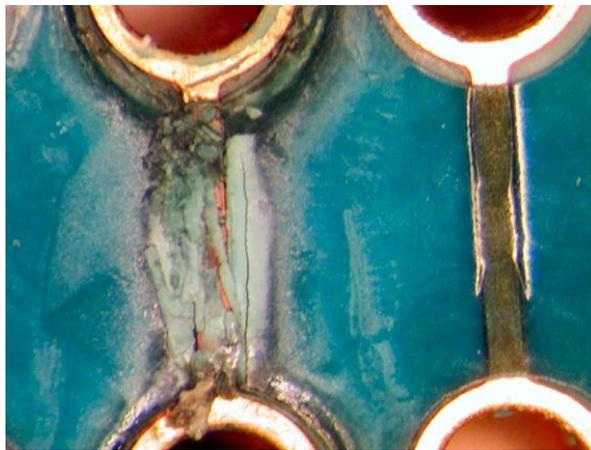
Fig.11

* - Failure due to surface contamination, see Fig. 11

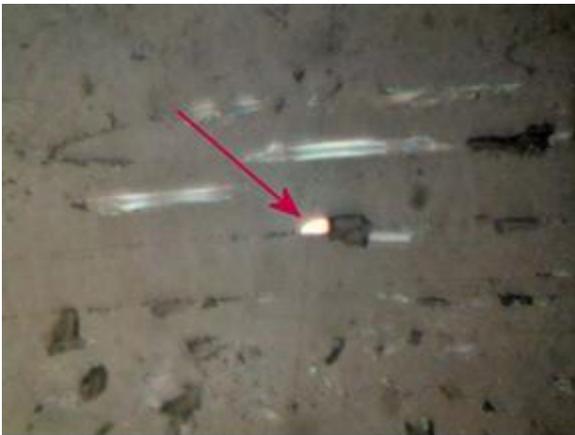
Fig. 12 and Fig. 13, below, show the Typical CAF failures seen on failed coupons.

CAF_data above shows that the CAF failures increase as the pitch reduces. Coupons at 16 mil pitch had 16% higher failures as compared to 20 mil pitch. The failure rate is influenced by both the material and the drilling process. Since this exercise was to compare different materials under the same manufacturing conditions, we evaluated the degree of failures for each material. It is also important to see that materials 'E', 'RA' and 'RB' had 100% failures. These results are in line with IST and Capacitance results. Those materials which had poor performance for IST and Capacitance also showed poor results for CAF.

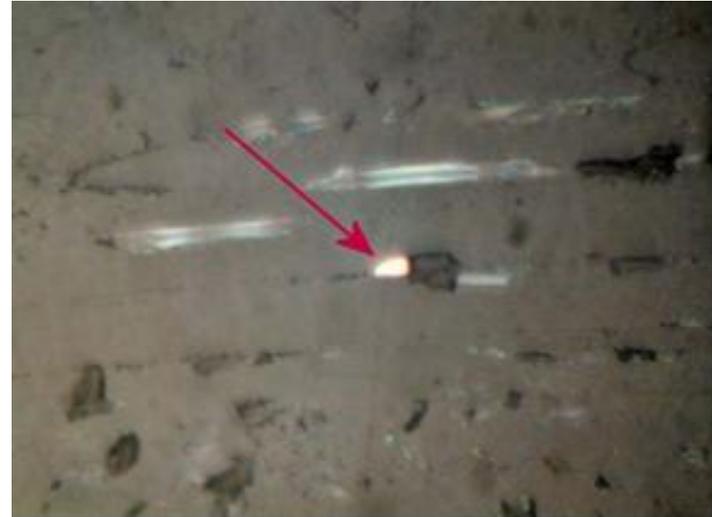
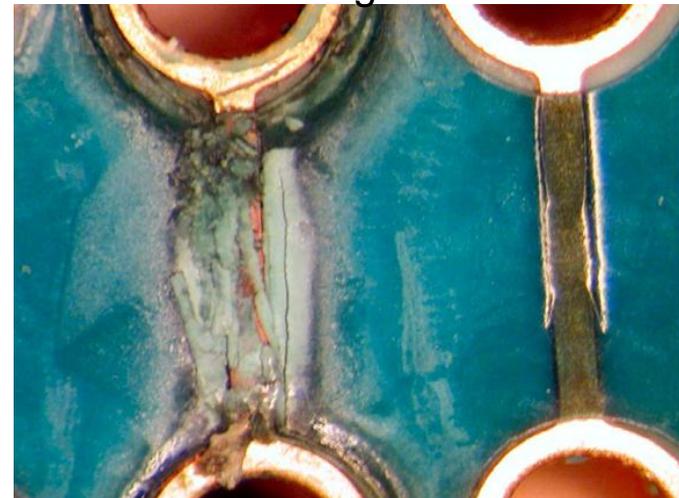
CAF – Typical Failures

- 0.4mm (0.016”) pitch had 17% higher failures than 0.5mm (0.020”) pitch.
- Material ‘B’ only had one failure for 0.5mm pitch at 24 cycles.
- Materials ‘RA’ and ‘RB’ had poor CAF performance. Material ‘E’ had low CAF cycles, only for 0.4mm pitch.
- There was a correlation between poor IST/HATS results and CAF failures.
