# The Effects of Human-Induced Contamination on PCB Assembly Electrical Reliability

**Eric Bastow**  
Indium Corporation  
Clinton, New York

# The Effects of Human Induced Contamination on PCB Assembly Electrical Reliability

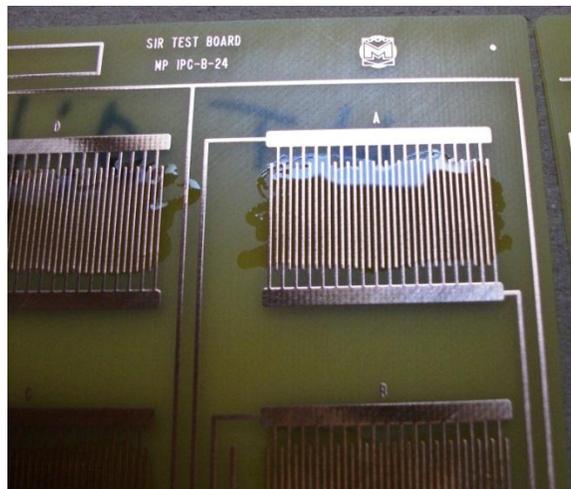
**Figure 7 – High Temperature Reflow Chain Oil on SIR comb pattern as it appeared before or without a reflow cycle**

The typical performance of this contaminant, with and without a reflow cycle, appears to be about  $1 \times 10^{11}$  ohms per square, approximately 1 order of magnitude lower than the controls. When combined with a solder paste, the oil drops the performance 2 orders of magnitude (based only on 1 SIR test coupon). In all scenarios, the oil caused a noticeable reduction in SIR performance; the worst was when it was combined with a solder paste. The oil caused only very minor interference with the solder paste’s ability to wet to the copper patterns.

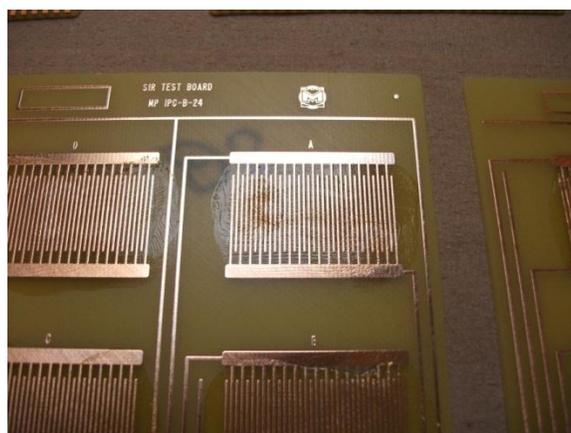
**Figure 8 – Pizza Grease on SIR comb pattern as it appeared before or without a reflow cycle**

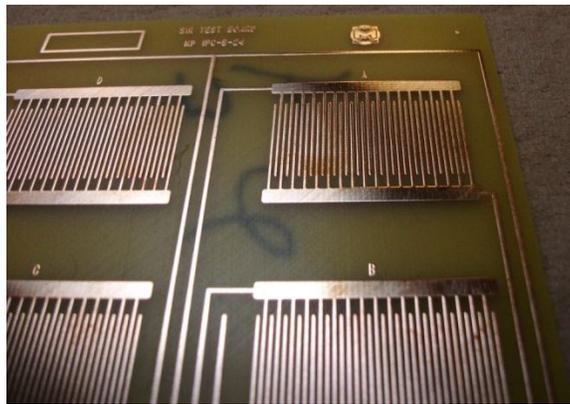
**Figure 10 – Dried Tap Water on SIR comb pattern as it appeared before or without a reflow cycle (visible light staining)**

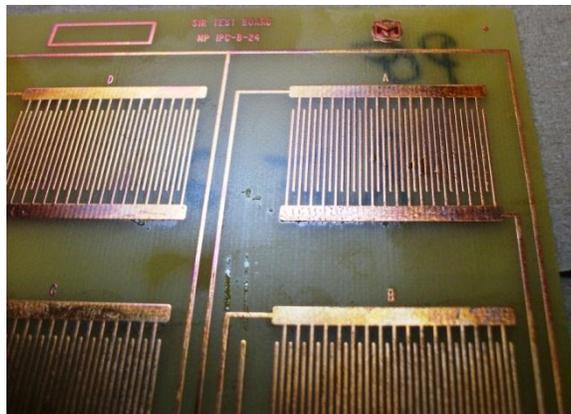
**Figure 13 – Pizza Grease on SIR comb pattern as it appeared after exposure to one reflow cycle**

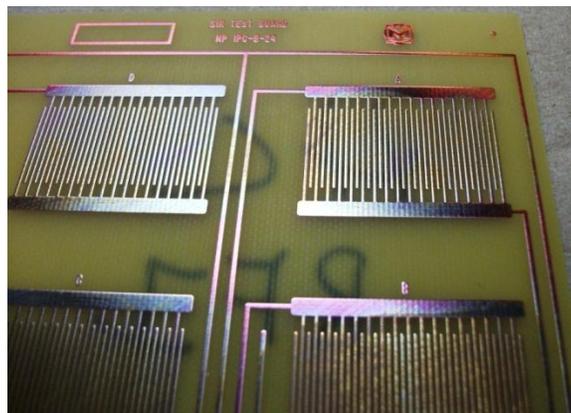
**Figure 14 – Hand Cream on SIR comb pattern as it appeared after exposure to one reflow cycle (visible discoloration)**

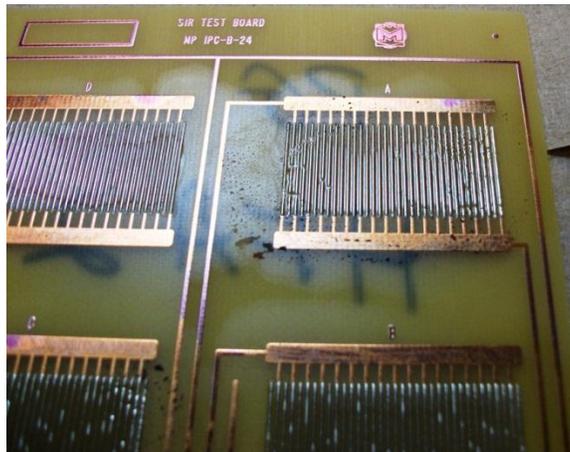
**Figure 18 – Pizza Grease with Reflowed Solder Paste**

Figures 6 through 20 show the SIR test coupons for the various materials at different stages of preparation. It is interesting to note that only the pizza grease and tap water provided any significant interference with the solder paste's ability to wet to the copper comb pattern. (If a photograph for a particular material and/or scenario is not shown, it is because nothing notable was observed or worthy of mention.)

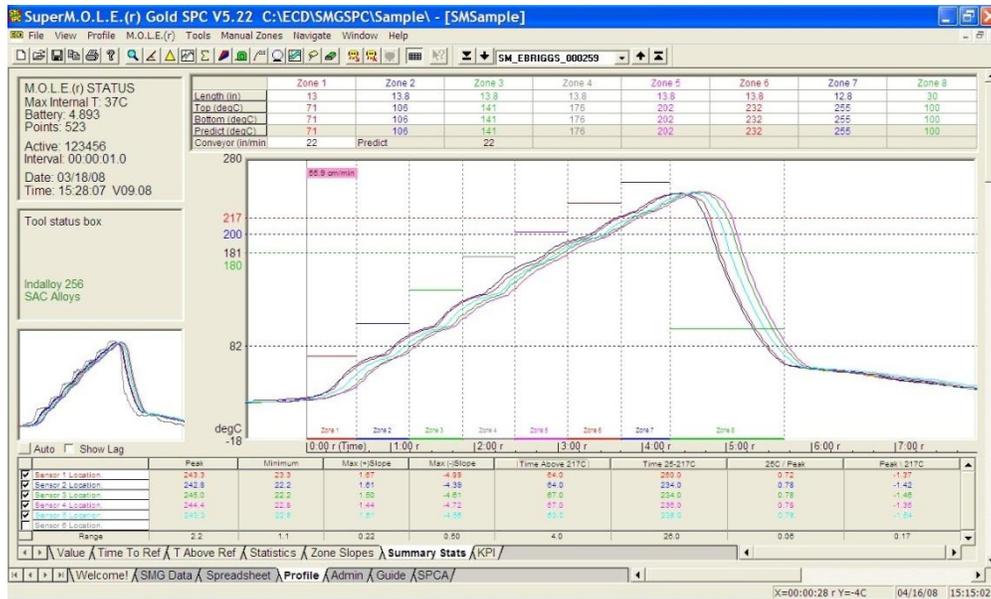
The reflow cycle (profile) used is shown in Figure 21.

Figure 21 – Reflow Cycle (Profile)
