Reliability Performance of Very Thin Printed Circuit Boards with regard to Different any-Layer Manufacturing Technologies

Gerhard Schmid, Martin Fischeneder, Gerhard Stoiber
AT&S Austria Technologie und Systemtechnik Aktiengesellschaft
Leoben, Austria

Abstract

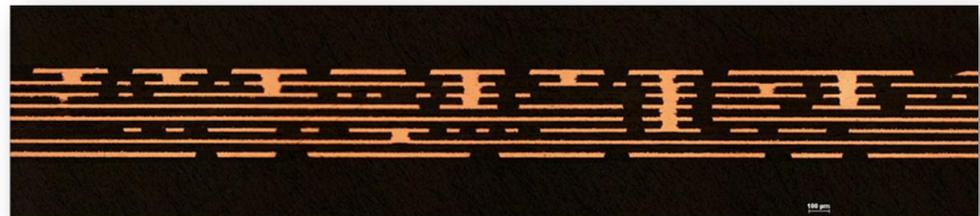
TV3

- Stack up: HDI 3-2-3
- $t =$ approx. 450 μm
- Copper layers thickness approx. 20 μm
- Final dielectrics thickness approx. 40 μm
- Compact structure in filled vias

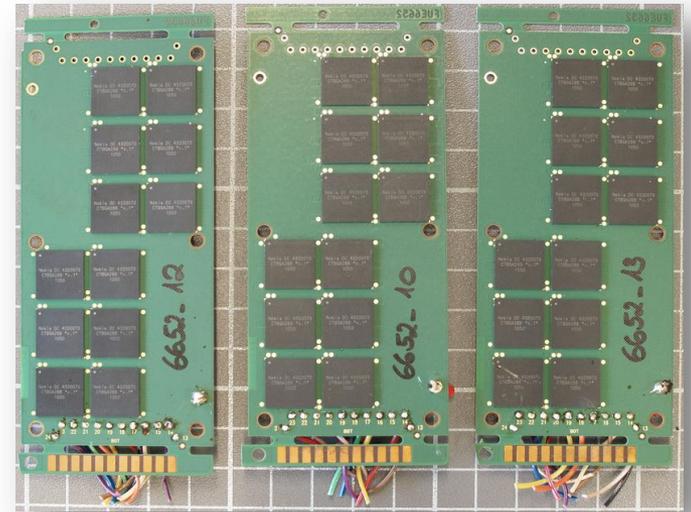
TCT Test

- TCT testing of assembled board
- 1 chamber test setup
- 40 °C to + 125 °C
- 5 min soak time at min/max temperature
- 2 cycles per hour
- 1000 cycles
- 4 samples of each TC tested
- Online event detector

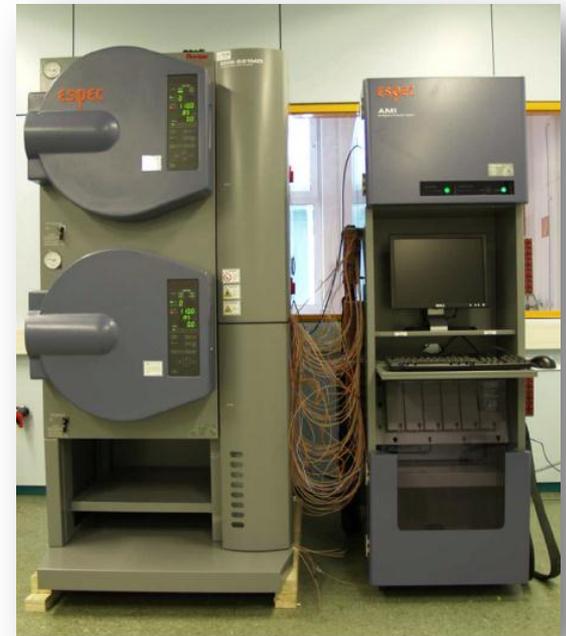
HAST Test Coupons

- Via to Via
- Comb structure Coupon

- Test acc. to JEDEC JESD 22-A101C
- Via 2 Via coupon
- Comb structure coupon on each layer
- Online failure detection with event detector

Parameter	Level
Temperature	130 °C
Humidity	85% r.h.
Bias	3.5 VDC
Test duration	120 hrs
Pass criterion	$R > 10^6$ Ohm after 96 hrs.
