Evaluating the Effect of Conformal Coatings in Reducing the Rate of Conductive Anodic Filament Formation

Westin R. Bent
Alpha Metals
Jersey City, NJ

Dr. Laura J. Turbini
University of Toronto
Toronto, Canada

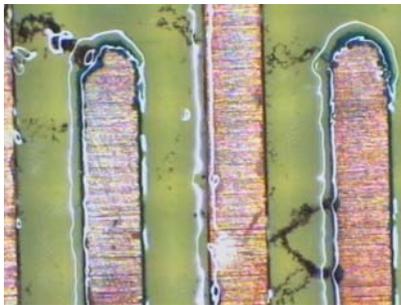
Dendrites were observed on the surface of the acrylic coated PG1-2 coupons and the silicone coated PG1-2 and PG7-5 coupons (Figure 5).

Figure 5 - Dendrites on the Surface of the Acrylic Coated PG1-2 Coupon

The dendrites observed on the surface of the acrylic coated PG1-2 coupons and the silicone coated PG1-2 and PG7-5 coupons imply that moisture was present on localized regions of the surface of these coupons. At least several monolayers of water on the surface of the substrate are required for dendrite growth to occur¹³. The water vapor must first diffuse through the conformal coatings and condense on the surface of the substrate in localized areas between the conductor lines, forming conductive pathways. Hygroscopic substances such as polyglycols or polyglycol derivatives, if present on the surface of these coupons will enhance moisture adsorption onto the surface^{9,10}.

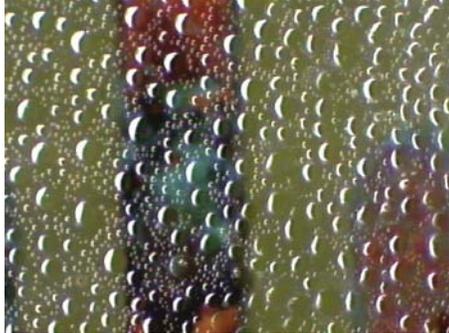
During the visual examination, any defects in the conformal coating were also noted. Bubbles (Figure 7) were observed on all silicone coated fluxed coupons. Blister spots were also observed in the coatings of acrylic coated PG1-2 and PG7-6, as well as parylene C coated PG1-2 and PG7-3 (Figure 8).

Figure 7 - Bubbles in Silicone Coating on Coupon Treated with PG7-5

Bubbles (Figure 7) were not observed in the silicone coatings on control coupons but only on the silicone coating on processed coupons. These bubbles are formed by the diffusion of the polyglycol/flux vehicle out of the substrate material and through the coating. Silicone is very permeable to organic molecules. Due to the thickness of the silicone coating, some of the

polyglycol/vehicle did not have time to completely diffuse out of the substrate and through the coating during the 28 day test period. Thus, it was trapped as bubbles near the surface.

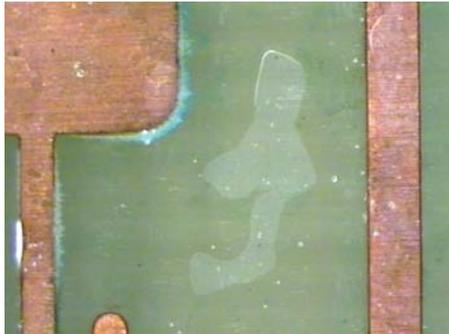
Figure 8 - Blister Spot at the Substrate/Coating Interface of an Acrylic Coated PG7-6 Coupon
