Title:
Pad Cratering

Executive Summary:

Pad Cratering On PCB's

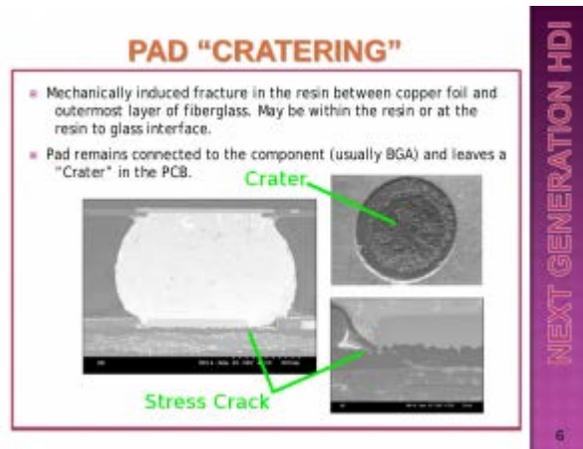
Example of pad cratering provided by Integral Technology.

Lead-free assembly has introduced many challenges and non-conformances. One of the more troubling non-conformances is "Pad Cratering". Pad cratering is when the copper pad completely separates from the laminate. The separation may occur outright at assembly or as the result of the field failure scenario detailed above. Pad cratering is the result of the technology exceeding the capabilities of the materials.

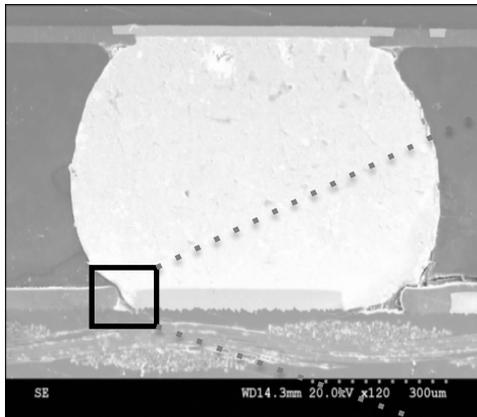
Figure 1

- IPC-9708
 - **1.2.4 Pad Cratering** “The formation of a cohesive (or adhesive) dielectric crack or fracture underneath the pad of a surface mount component, most commonly BGA packages.”

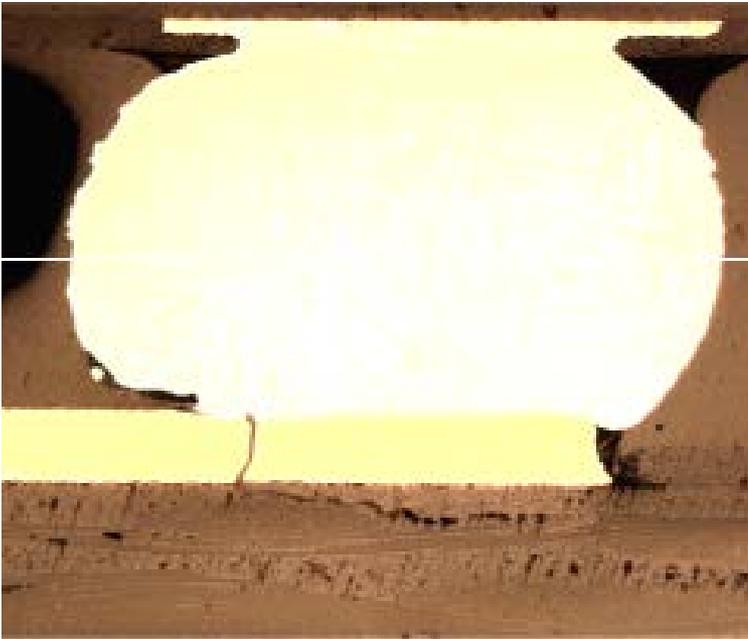
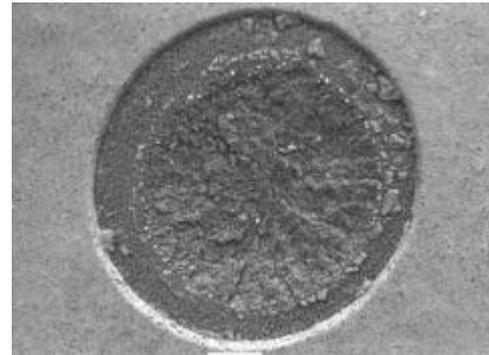
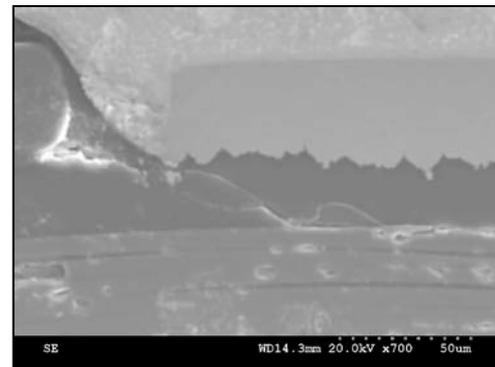
PAD “CRATERING”

- Mechanical in nature, but may be thermally induced.
- Popular lead free solder compatible materials tend to be more brittle.

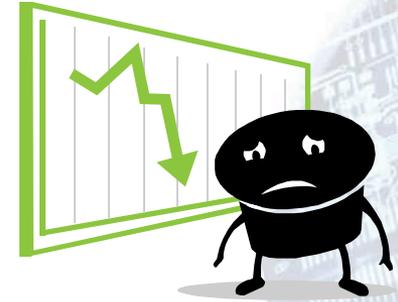
Pad Cratering... Opens Circuits

- This occurs when the resin crack (fracture) migrates through a copper trace or via.
- This happens at assembly, in service or during handling.
- When component is removed, PCB copper pad comes with it, leaving behind a “crater” in the PCB.
- Has become more prevalent with lead free assemblies.
- Contributing factors include board thickness, size, resin type, CTE of the PCB and component, solder type, component position, assembly conditions post assembly handling.

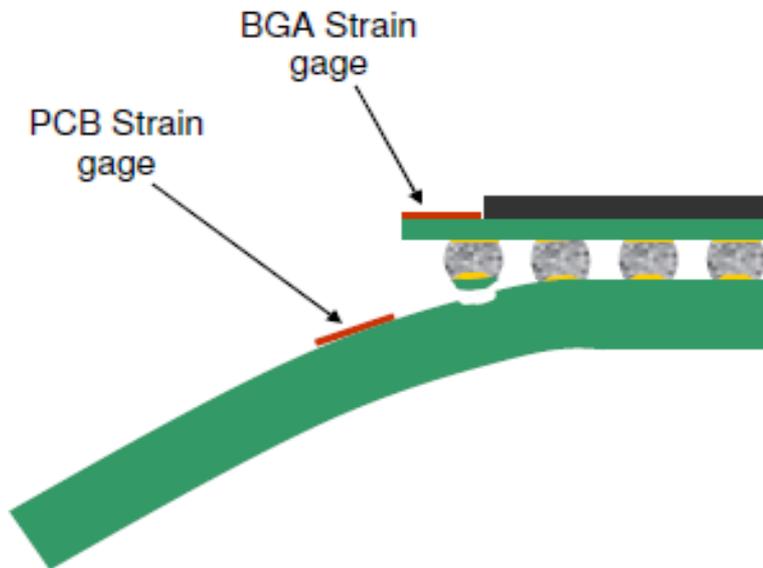
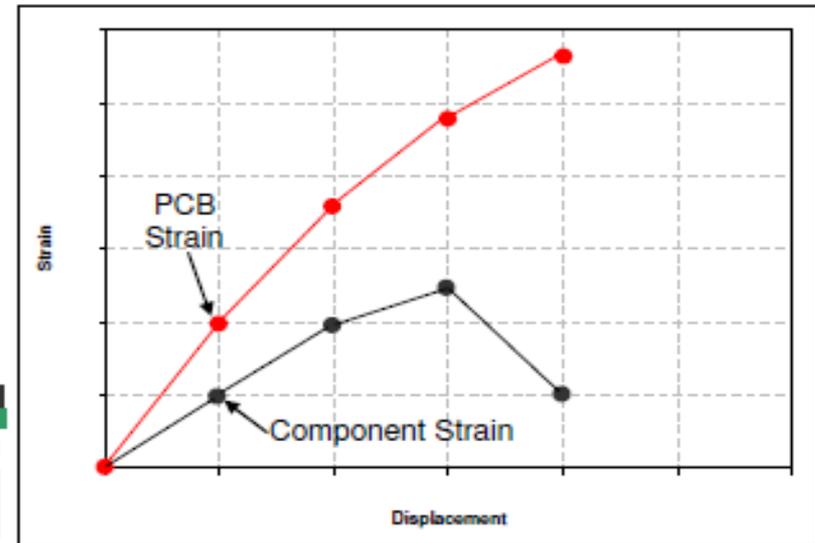
Inflection Strain Approach

- Measure both PCB and Component bending strain at the same time

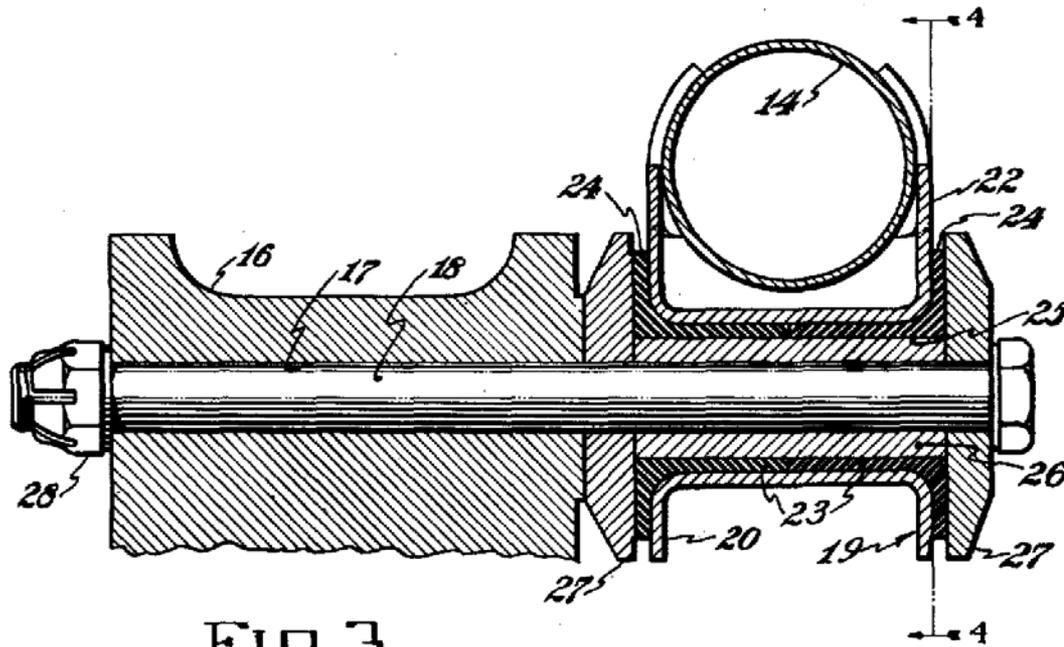
Fig. 3.

- Filed April 12, 1934 US Patent 2,109,329
- Aircraft engine mount with resilient (rubber) layer.
- Prevents fractures in frame from shock and vibration created by engine.

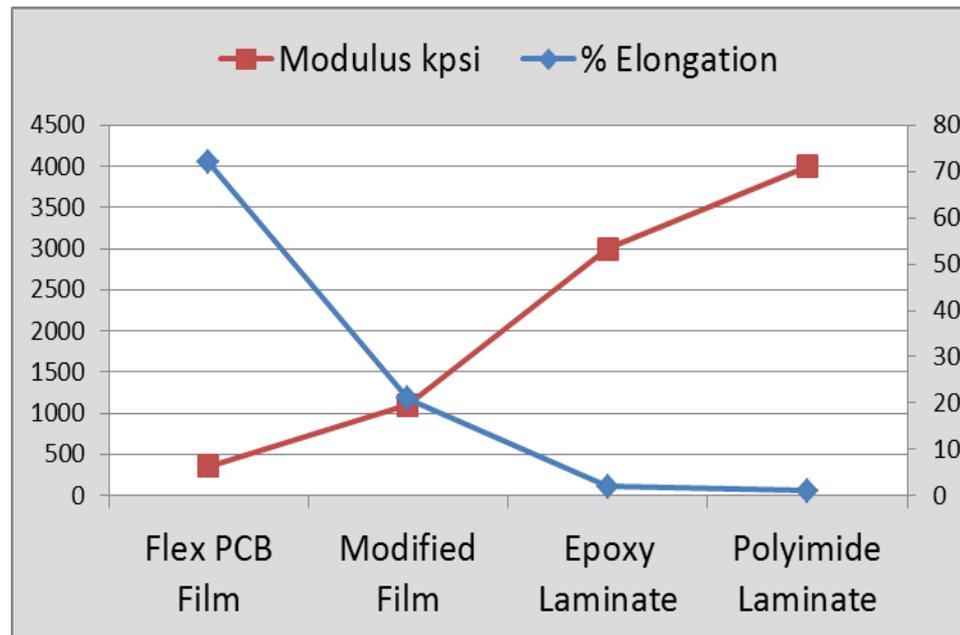
Higher modulus than flex material, yet more flexible than standard rigid materials (see below).

A pad crater resistant structure may be built using a fracture-resistant film on the surface layer. This resilient layer is in direct contact with the copper pad, preventing fractures from starting or reaching the copper trace or via.

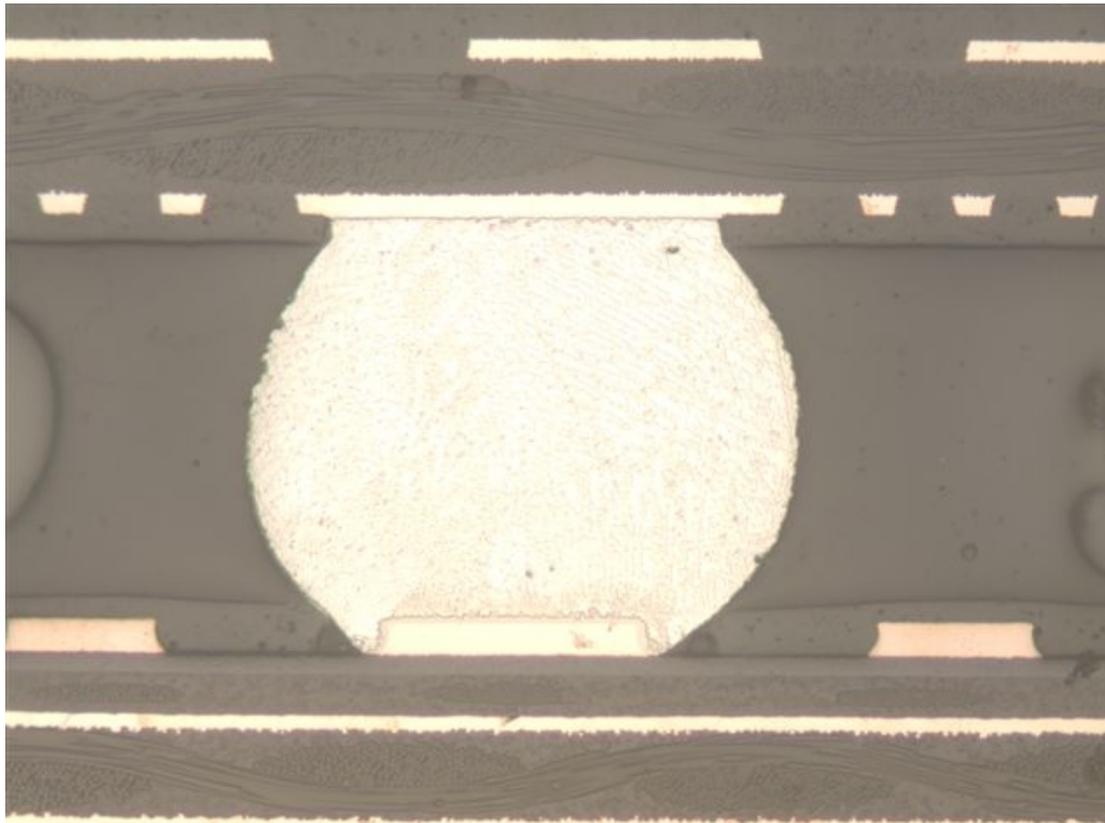
- When used as a cap layer (see below) it becomes the interface between the copper pad and the rest of the PCB.
- The more pliant cap will prevent or block fractures and protect copper connections (traces) to the pad.

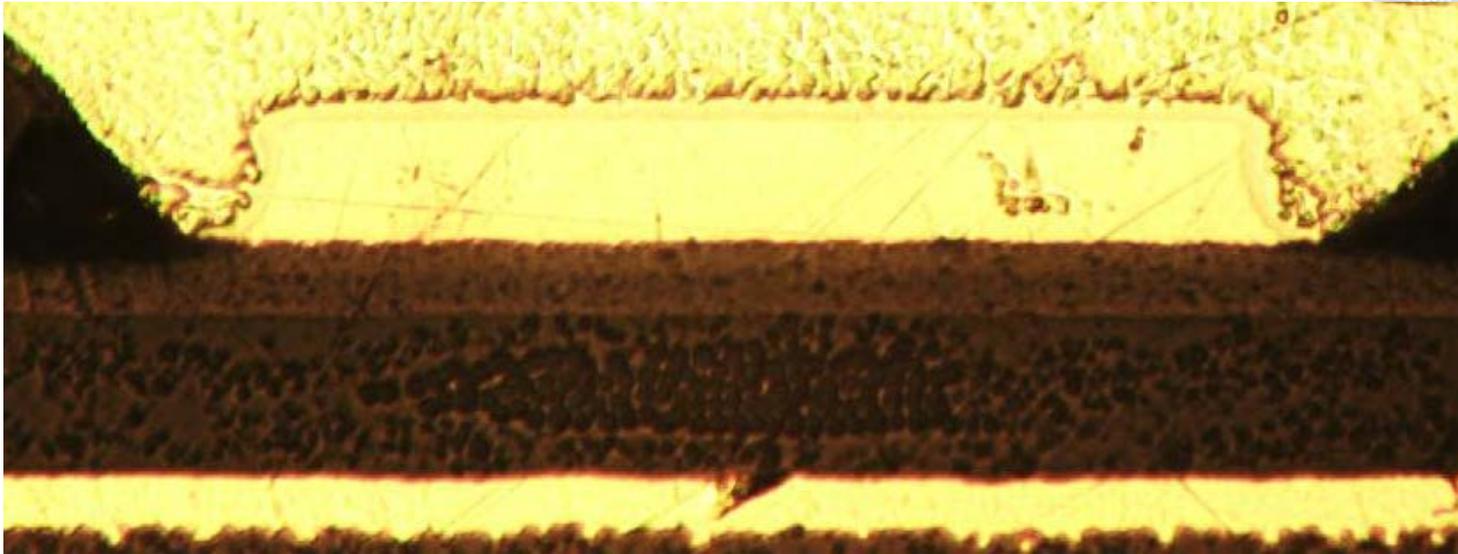
Fracture Barrier

*Courtesy: Murrietta Circuits, Inc.
Anaheim, CA*

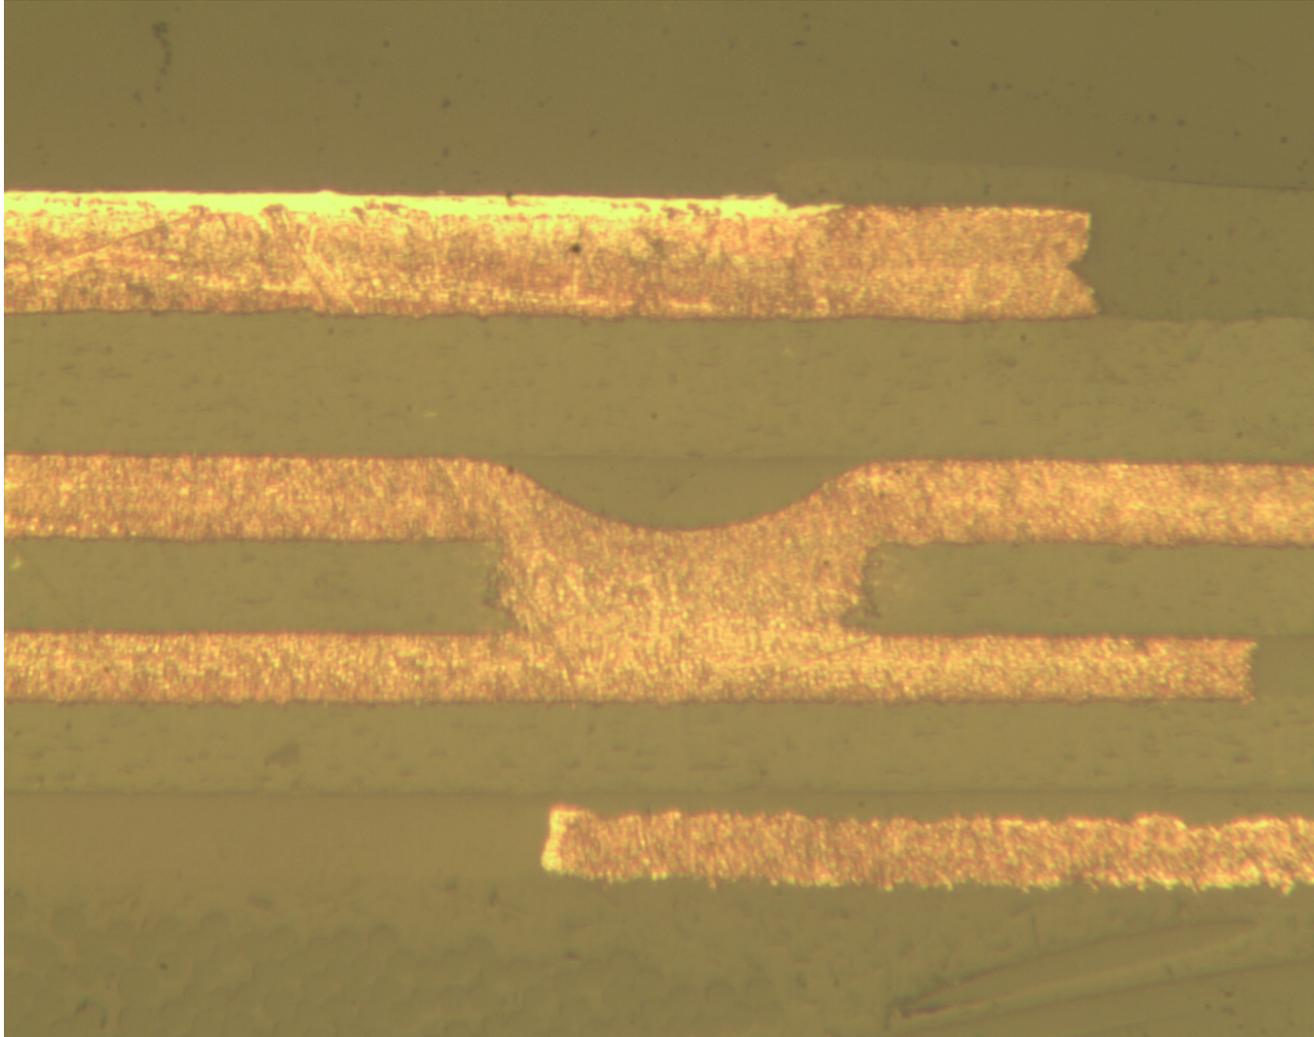
Zeta[®] Lam

8 layers of ZETA[®] LAM in 10 layer PCB

Total thickness – 16 mils

Combined dielectric thickness 6 mils copper to copper

- **Zeta[®] LAM = Zeta[®] Cap + Zeta[®] Bond SE**
 - Complete HDI material package with copper
 - C-stage layer provides a polymer solution to fiberglass;
 - Consistent thickness control after lamination
 - Very high dielectric strength
 - Lower Z-axis CTE than other glass free dielectrics materials
 - Lower Dk, Lower loss, less transmission line variation (no glass bundles)
 - High copper peels at high temperatures
 - B-stage layer provides;
 - Bonding and fill of circuits and vias
 - Various thicknesses of resins are available for fill requirements
 - Curable with standard PCB laminating equipment @190°C (375°F)
 - Non brittle with a long shelf life, 1 year at room temperature
