The Study, Measurement, and Prevention of Tarnish on Immersion Silver Board Finishes

Lenora Toscano and Donald Cullen
MacDermid, Inc.
Waterbury, CT

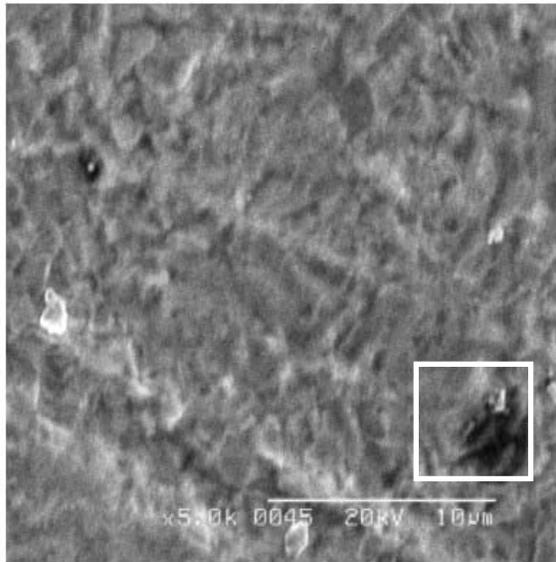
Figure 1 - Low Silver Thickness (0.1 microns)
EDS Area Highlighted

Preliminary testing was conducted to help determine if visible tarnish resulted from the formation of copper sulfate or silver sulfate with respect to deposited silver thickness. Figure 1 is a Scanning Electron Microscope (SEM) image of a thin silver deposit over copper. The thickness of the deposit was 0.1 microns. The image shows dark areas scattered throughout the deposit. Electron Dispersive Spectroscopy (EDS) of the dark areas indicates that these areas are rich in copper (Figure 2). Plating for an increased amount of time results in a thicker silver deposit. The increased plating time enables to silver to cover more area. In turn there is a decrease in copper pore sites as seen in Figure 3. An EDS of this area shows a deposit rich in silver (Figure 4). A small copper peak can be detected as a result of "shoot through" due to the accelerating energy of 20kv of the microscope.

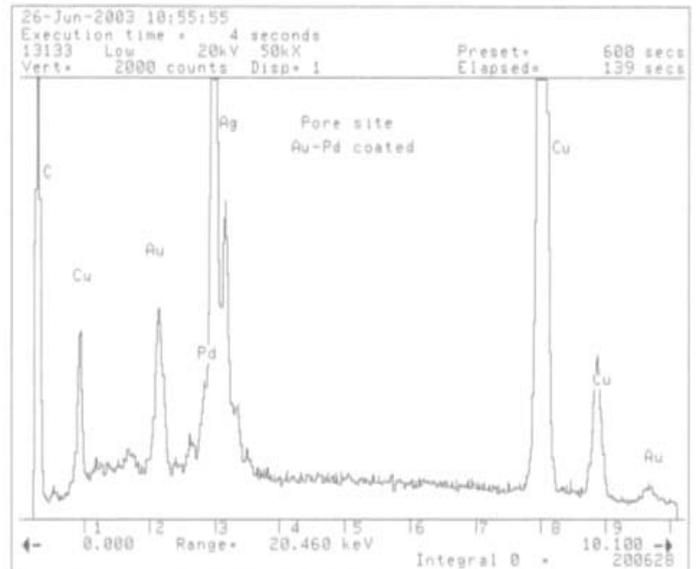
Figure 2 - EDS of Pore in Low Silver Thickness Sample

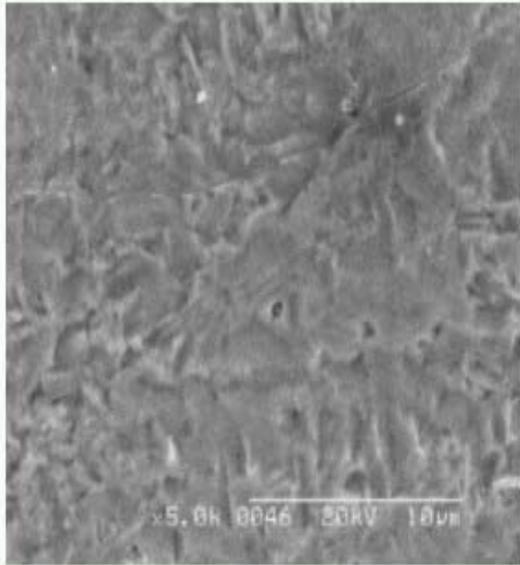
Figure 3 - High Silver Thickness (0.3 microns)
EDS Area Highlighted

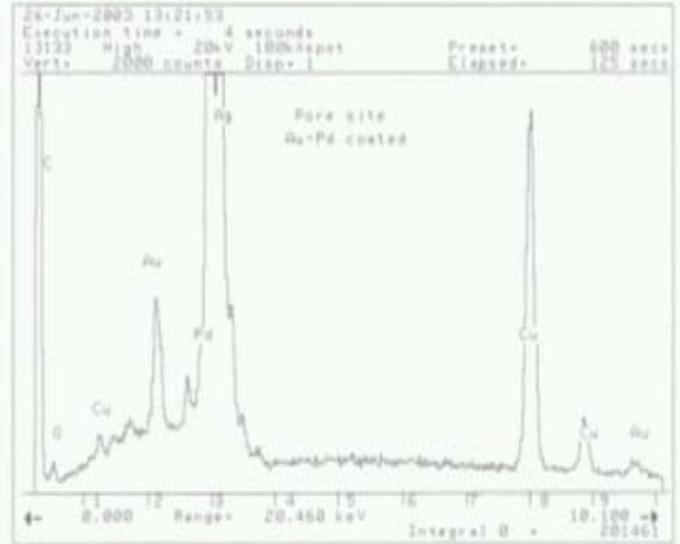
Figure 4 - EDS of High Silver Thickness Sample

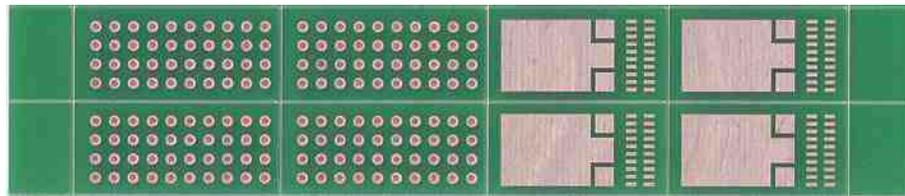
Figure 5 - PTH Test Coupon

Test coupons (Figure 5) containing surface mount pads and eighty plated through holes (PTH) were processed through a standard immersion silver process to achieve an average silver thickness of 0.3 micrometers. Thickness was measured by X-ray Fluorescence (XRF) and produced a range of 0.22 – 0.33 microns. The panels were then enclosed in a chamber containing a sulfur solution and a fan for circulating the air (Figure 6). The sulfur solution used was a mixture of 0.1g/L sodium bisulfide in de-ionized water with 1mL/100mL concentrated HCl. The solution was divided into three containers set on one side of the chamber. The fan directed airflow across the containers parallel to the hanging samples. A test coupon was removed every thirty minutes. Total tarnish was measured by Sequential Electrochemical Reduction Analysis (SERA) on surface pads. Finally, the through holes were floated on molten solder at 245°C for three seconds and evaluated according to industry standard ANSI/IPC J-STD 003a.⁷

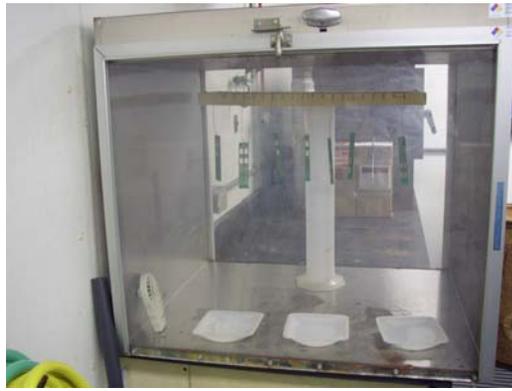
Figure 6 - Sulfur Chamber

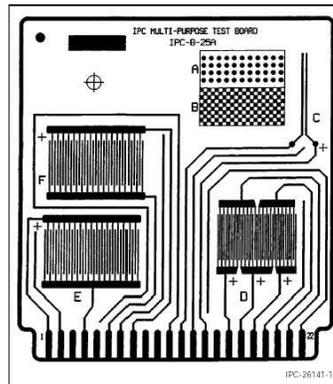
Figure 7 - B-25 Test Vehicle

A set of IPC B-25 test coupons (Figure 7) were processed through a standard immersion silver process. The boards were exposed to Class II Mixed Flowing Gas.⁸ (Method G) for nine days at Aspen Labs in a Batelle Chamber. Within the chamber, panels are subjected to chloride, sulfide and sulfate. The test panels included both immersion silver panels and a copper control. Mixed Flowing Gas exposure was measured on a scale calibrated by its effect on copper.

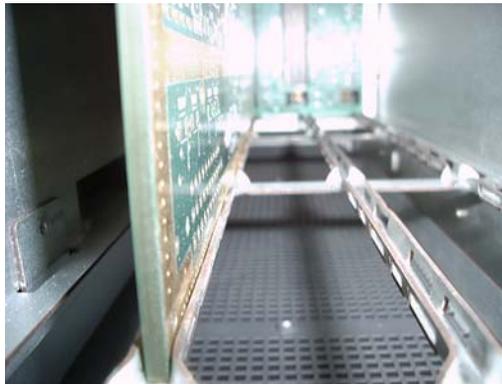
Figure 8 - Circuit Board in Cabinet Rail

The last functional test performed was a simulation of a cabinet insertion test. Electroplated copper laminate was processed through immersion silver and electroless nickel/ immersion gold, separately. The samples were exposed to the same Mixed Flowing Gas as described in the Electromigration section for 0, 5, and 9 days. The level of tarnish on the samples was measured after 24 hours, 5 and 9 days. A second set of these boards was placed in a Humidity Chamber at 85°C and 85% relative humidity (85C/85%RH) for up to five weeks. After the MFG and humidity exposures the boards were inserted to a cabinet (Figure 8) which causes friction to occur on the edges of the boards. Three pieces of copper laminate were placed on top of each bare board prior to insertion to simulate the weight of components on the board. The samples were inserted for 0, 1, 15, and 50 times and measured for surface contact resistance. Cabinet rails were cleaned with IPA and DI water between each insertion set.

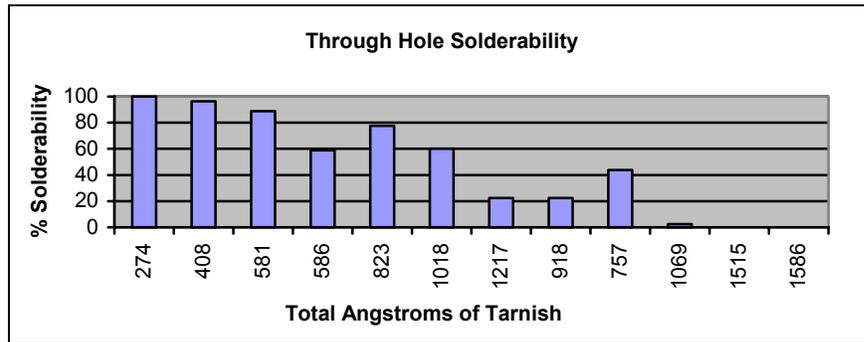
Figure 9 - Through Hole Solderability versus Total Tarnish

Overall results indicate the longer the exposure to the sulfur the greater the amount of total tarnish detected on the surface of the through hole test boards. Results from the fifth hour do not show an increased level of tarnish. This could be due to a less porous deposit. The chart does indicate that higher levels of total tarnish result in lower through hole solderability (Figure 9). Once 200 angstroms (Å) of tarnish form on the surface, visual appearance is affected. Silver samples begin to appear yellow or golden at this point. As the level of tarnish increases, the color changes to brown and may ultimately become an iridescent blue (Figure 10).

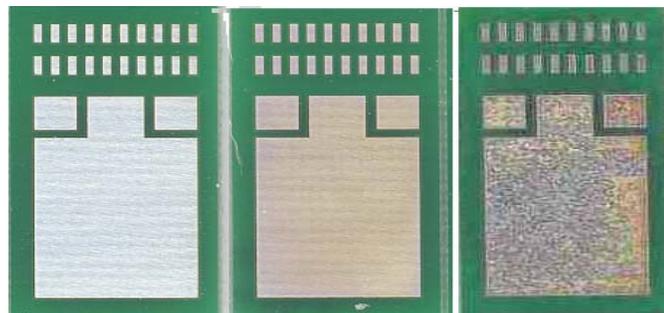
Figure 10 - Varying Silver Tarnish Levels

Figure 10 shows images of varying tarnish. The first sample is a new silver sample that was not exposed to any environment. Typically, a shiny silver deposit has a range of 0 – 100Å of total tarnish. The second sample shows a slight yellowing this is characteristic of 200 – 500Å of tarnish. The final sample shows a heavy amount of tarnish which indicates a level of 1500 – 2500Å of total tarnish.

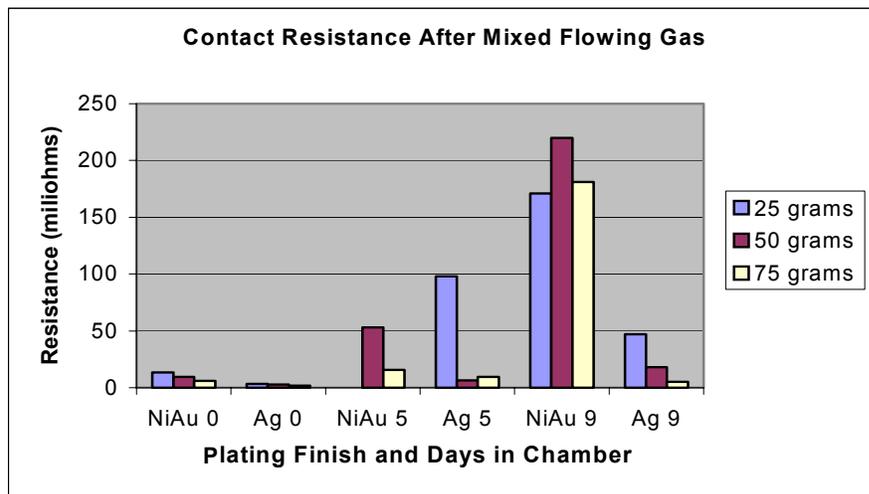
Figure 11 - Contact Resistance after Mixed Flowing Gas for 0, 5, and 9 days

The samples exposed to MFG were also measured for total corrosion after 24 hours, 5, and 9 days. The levels averaged 850, 4000, and 9500Å, respectively as copper corrosion. After the accelerated environmental exposure, the coupons were then sent to Contech Research for contact resistance testing. The samples were measured using 25, 50, and 75 gram force loads, as per the earlier discussion.

Consistently, the contact resistance data shows that an increase in force load will result in a decrease of resistance as the test probe overcomes any surface corrosion. For the immersion silver deposits, resistance stayed below 50 miliohms up to 9 days in the Batelle chamber for each force load. The electroless nickel/immersion gold samples began to show large increases in resistance after 5 days. The humidity and cabinet insertions also appeared to have little effect on the contact resistance of immersion silver. Again the silver results maintained a small deviation through the testing even with increased insertion and extended humidity exposure. Similar trends were observed with surfaces that had been aged with 85°C/85%RH.

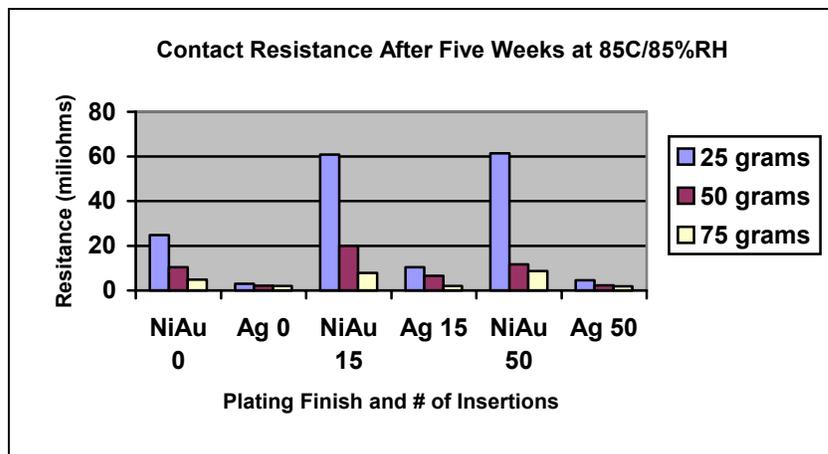
Figure 12 - Contact Resistance After Five Weeks Humidity

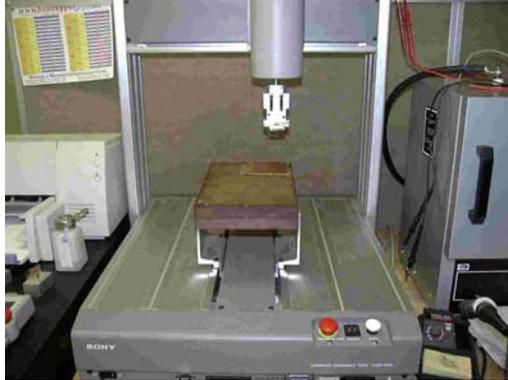
Figure 13 - Contact Resistance Testing

Contact testing was conducted using a 50-microinch gold plated copper alloy burr free spherical radius probe. The probe had a diameter of 0.0625 inches. Resistance was measured by EIA 364 Test Procedure with a 100ma-test current and a 20mV open circuit voltage. A probe force of 25, 50, and 75 grams was used.⁹ For an OEM involved in the study, maintenance of low-resistance electrical conductivity in a potentially contaminating environment is a key concern.
