Cray X1: Extreme Performance Requires Extreme Reliability

Abstract

PCB Requirements for Cray X1

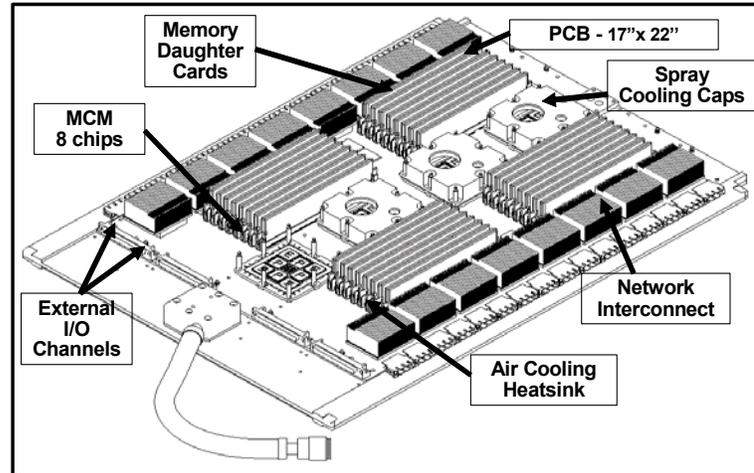
Figure 1 - Node Assembly

The design of the Node PWB called for a 34-layer board, having eight signal plane pairs, with sixteen layers of power and ground. Both sides of the finished PCB would require metalization. An overall bare copper board with an Organic Solderability Preservative (OSP) that would allow a shelf life of at least 12 months, two different types of plating; bondable gold in the MCM areas, and a very closely controlled thickness of Pb/Sn for the edge connectors attach along the periphery of the finished board.

SV2 Node Module (bottom)

The size of the PCB is 22" x 17" (560 x 432 mm) and with the coupon requirements the panel size would be increased to 24" x 20" (610 x 508 mm), minimum. The thickness overall is 0.135", (3.5 mm +/- 5%), with PTH diameters down to 0.010" (0.25 mm) and very critical clearances of 0.028" (0.7 mm) through power and ground planes. This would make registration of all of the inner layers and drill locations a must to control at fabrication. Characteristic Impedance measurements would be required on all signal layers having specifications of: single line impedance of 45 Ω and differential lines of 100 Ω all with tolerances of +/- 5%. The layout of the surface called for SMT, BGA/MCM pitch of 0.040" (1mm). The total buried via layer count would be 34,685 and the total Plated Through Holes would be 66,000.

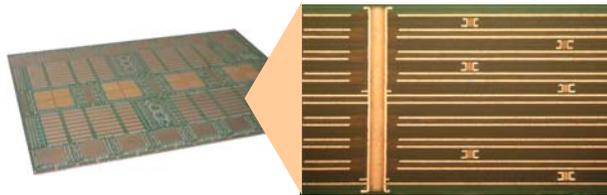
Figure 4 - Electrical Test Options

Test parameters	Equipment	
			Open/Short test	
			Flying probe type	Universal type
OPEN	Open test	Applied voltage	10V	
		Applied current	3mA-30mA	
		NG judgement	> 30 ohms	
	Latent test	---	Applied	
SHORT	Short test	Method	Field measurement	
		Applied voltage	10V	
		Applied current	3mA-30mA	
		NG judgement	< 10M ohms	
	High Voltage test	Applied layers	Between Gnd/S, V/S	Between S/S
		Applied voltage	350V	200V
		NG judgement	< 10M ohms	< 10M ohms

Flying probe type tester

Moreover this will only capture gross opens and shorts. Any types of defects that are not a clear open or short, reducing line dimensions or spacing, another type of test must be used. LAtest is used to find these types of defects and it is used in conjunction with a flying probe electrical design. This will capture any "mouse bites" or even dish downs where the cross sectional area is reduced. LAtest² or Latent Defect Test measures the Resistance of the lines (Rdc) reporting differences from known calculated values.

Further the flying probes can also be used to test electrical continuity of the traces and insulation resistance between layers. Yet another test employed is finding high DC resistance vias. All of the Plated through holes are measured to ensure that only known good boards are used in the SMT assembly and, again increase the final board yields through process improvements.

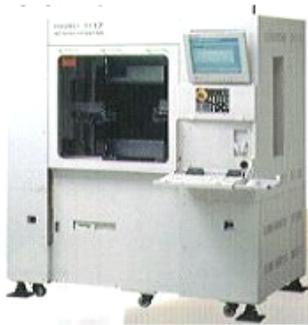
Figure 5 - Rpth Testing

Low resistance TH measurement

- (1) Resistance measurement with IVHs (Interstitial Via Holes) or PTHs (Plated Through Holes)
- (2) High Resolution of 5 aF for Capacitance Measurement (1aF=10-6pF)
- (3) Detection of High Resistance Short Circuits with Capacitance Measurement
- (4) Four-Terminal Resistance Measurement Function

Probe work area	600 (W) × 500 (H) mm
Thickness	0.6 to 10 mm
Number of steps	40,000 steps (300,000 for continuous testing)

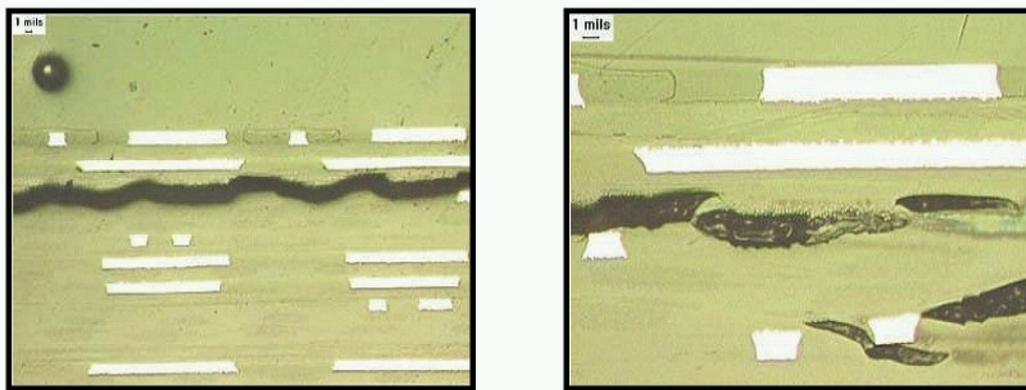
Figure 6 - Solder Shock Delamination of BT/Epoxy Materials

As Cray moved into the current product, there was little urgency to conduct this test in the early stages of development. Because of issues with the bus block attach shear strengths, Cray was required to increase the SMT reflow temperature from 210°C to 240°C and experimented with various solder pastes. At this point it made sense to conduct the IPC solder shock test of 6X shocks at 288°C. Unfortunately, these boards had via to via delamination in the BGA, bus block and MCM areas.

The root cause has not been found to date, although many attempts to eliminate this defect have been tried. Some of the processes tried were additional bakes of 24 hrs and 5 days prior to solder shocking, additional baking during various processes, elimination of thermal reliefs, and maximizing drill size in the relief pads. One of the supplier tried different materials types without any success.

Many board specifications have specific quality requirements that are taken for granted and are not tested as new part numbers are built. Cray's previous product was a 22-layer board constructed with another material, and had 18-42 mm BGA components on a 1mm grid. This product has been in service for many years. During its production there were solder shocks performed on various regions of the board without any notable issues.

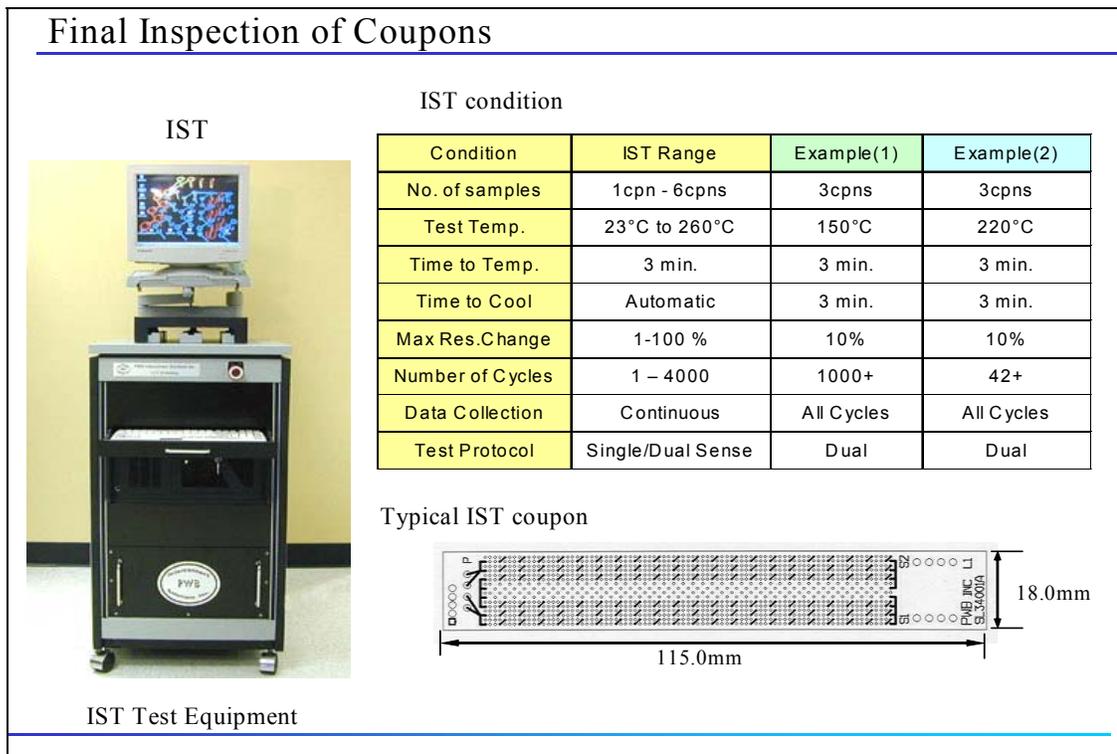
Figure 7 - IST/CIST Requirements

Final Inspection of Coupons

The requirement is to pass a minimum of 10 cycles, without exceeding a 10% resistance increase within the various interconnect structure test circuits. The coupon design included 3 primary structures, which would be stressed simultaneously to determine the hierarchy of failure. The 3 independent circuits include Plated Through Vias (PTV), Buried Vias and the internal interconnect between the copper foils and PTV barrels, located in the upper and lower region of the substrate. During each thermal cycle (heating and cooling) the resistance of all circuits is continuously measured and compared to the initial resistance profile, once failure is determined in 2 of the 3 circuits the testing is stopped.

In the case of Cray it was considered that the systems end use environment experienced a low operating temperature delta, reducing concerns related to long term wear out of the interconnect structure. Cray chose to run all IST test coupons from 23°C to 220°C, in order to represent the conditions of multiple assembly and rework cycles. The intention of this testing protocol was to apply high-level strain throughout the interconnect structure and identify the presence of latent failures.

Following IST testing a report is generated which identifies the performance of each circuit within the coupon. Thermo-graphic analysis (Infra-red imaging) is utilized to identify the locations of specific failure sites; micro-sections can be taken to understand the root cause of coupons failing to meet the minimum criteria. The hierarchy of failure has identified that PTV barrel cracking is the dominant failure mode followed by the internal interconnect (due to pad rotation), the buried vias have proven extremely robust throughout the history of testing.

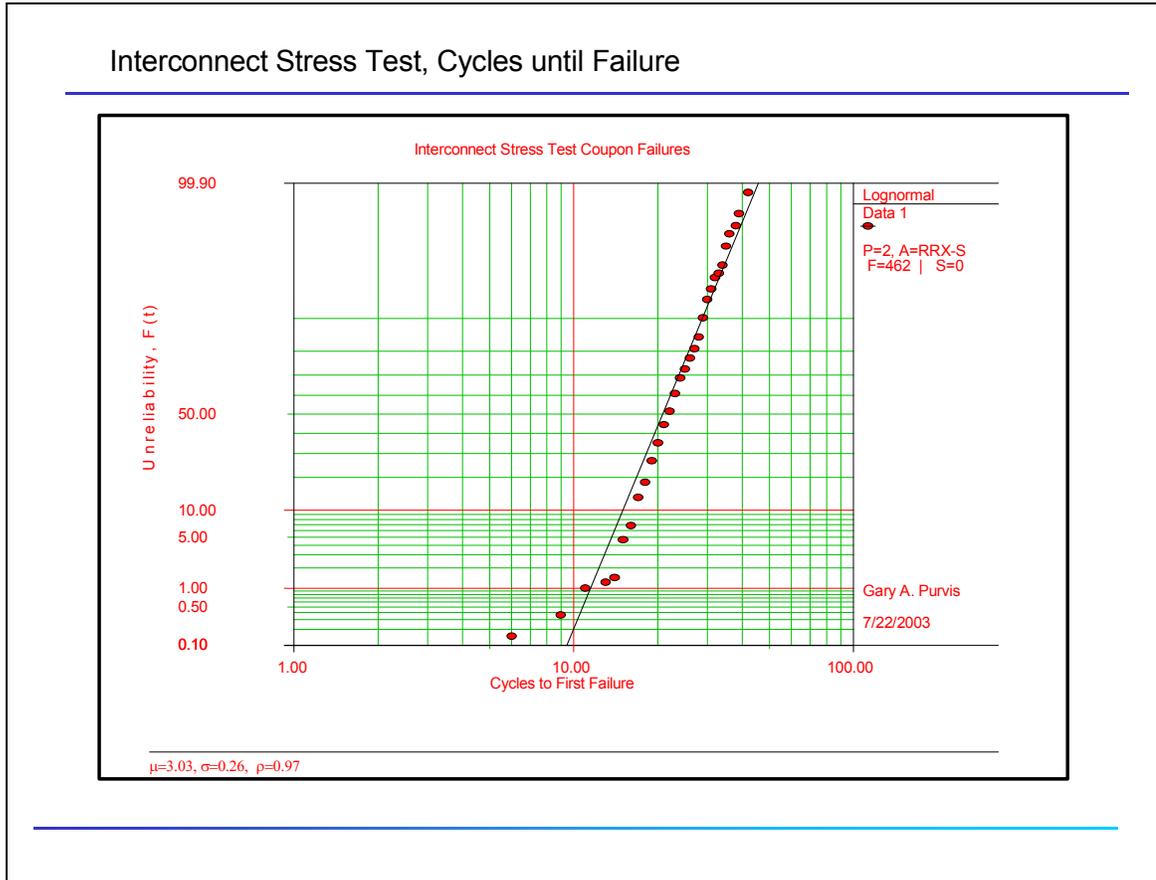
Figure 8 - IST Lognormal Results

The graph below shows IST test coupon first failure data for the X1 node boards. The data fits a lognormal distribution with a mean of 20.67 cycles and a sigma (shape parameter) of 0.26. Well over 1,000 coupons have been tested to date, but only 462 samples were included in the graph over a ten-month period of time.

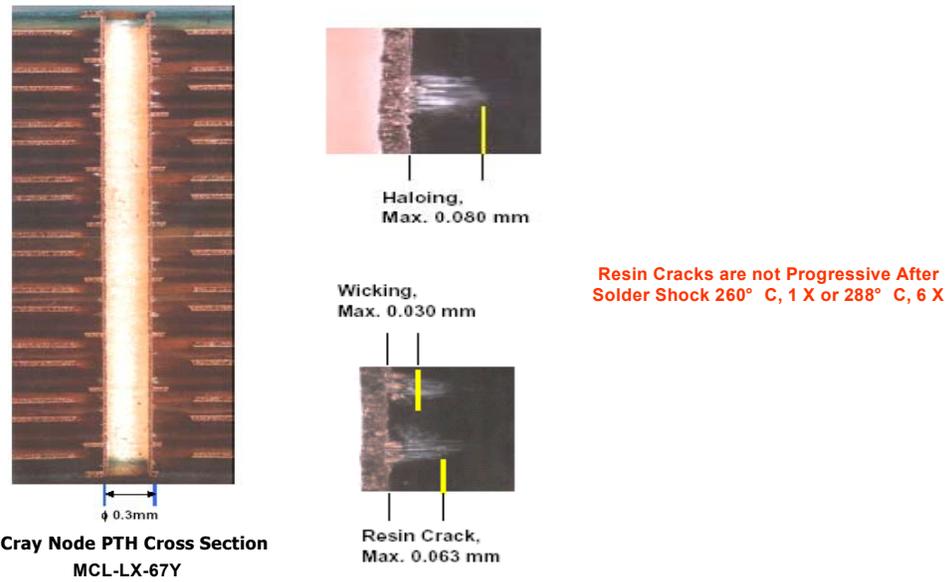
Figure 9 - Failure Analysis Micro Cracking

All coupons that fail prior to 10 cycles are cross-sectioned by the suppliers, and failure analysis is conducted. Since production started there have been only 4 boards with coupon failures at our 10 cycle criteria. Two were misregistered via to pad only in the coupon area; the board was acceptable for use. Two were caused by resin cracks and radial micro cavities.

The radial micro cavities were found to be a plating issue, where the thickness of the copper plating had very small cavities and therefore very thin plating. This also was process related and corrections were made to the plating process without any further failures.

Failure Analysis of Radial Cracks; Wicking and Haloing

The supplier scrapped these boards. After failure analysis it was determined that these defects were process related and changes were made to ensure reliability in both the drilling and desmear process. Although present in the PWB as seen in Figure 9, they were further subjected to solder shock at 260°C and still at 288°C for 6 times. The micro cracking in the resin did not propagate into the structure and were not progressive in nature. A post drill baking cycle was added and eliminated this problem from future manufacturing lots.
