Manufacturing and Reliability Evaluation of a Lead-free Electronics Network Card

Jasbir Bath, Solectron Corporation, Milpitas, CA, USA

Objective

Enable a lead-free soldering process for the electronic network card at the contract electronic manufacturer by a partnership of OEM customer, contract manufacturer, board, component and solder paste supplier.

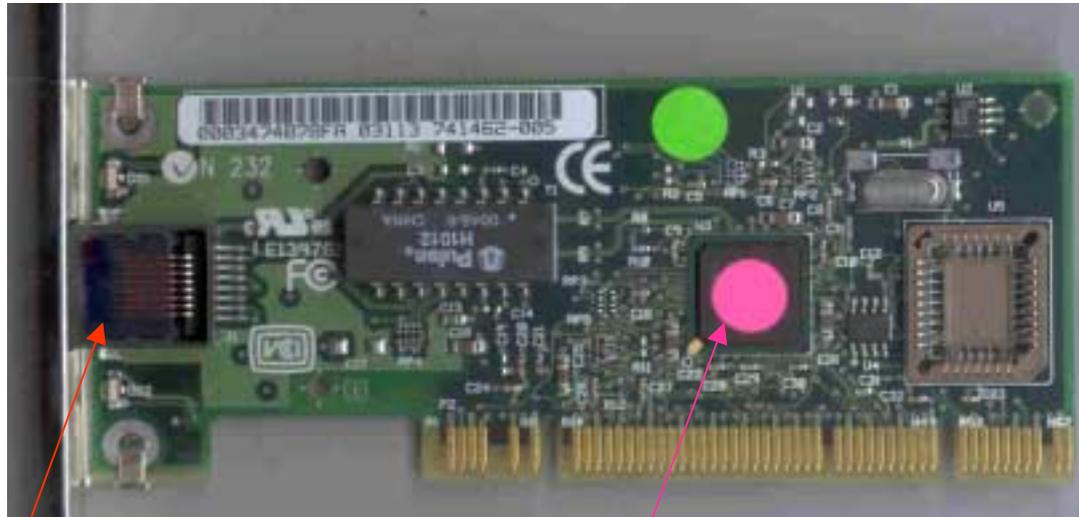
Topside

Image of fully assembled board

RJ45
Connector

Lead-free
BGA

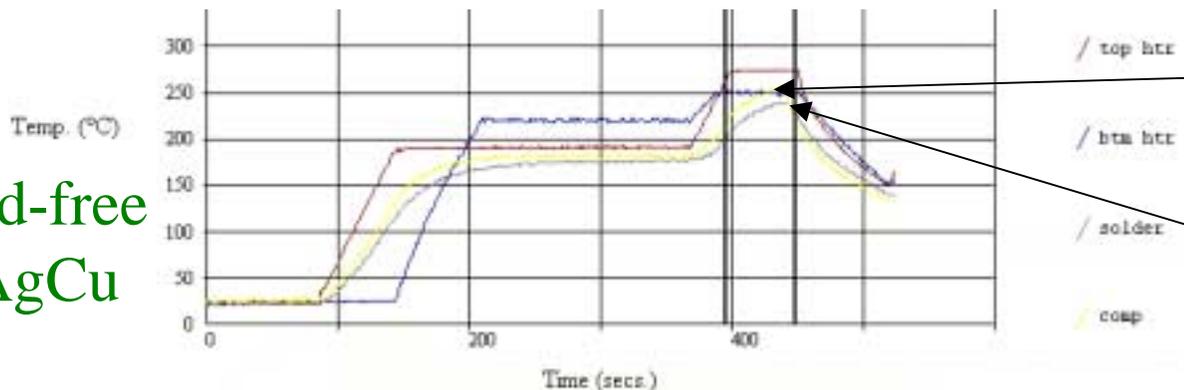
Lead-free
SnAgCu

Component
top 255°C

Solder joint
240°C

Tin-lead (Sn37Pb) BGA rework profile			Lead-free Sn3.9Ag0.6Cu BGA rework profile	
	Peak	Time over 183°C	Peak	Time over 217°C
BGA solder joint temperature	208°C	62 seconds	240°C	48-54 seconds
BGA component top body temperature	219°C		255°C	
32°C increase in solder joint temperature for lead-free SnAgCu BGA rework				
36°C increase in component body temperature for lead-free SnAgCu BGA rework

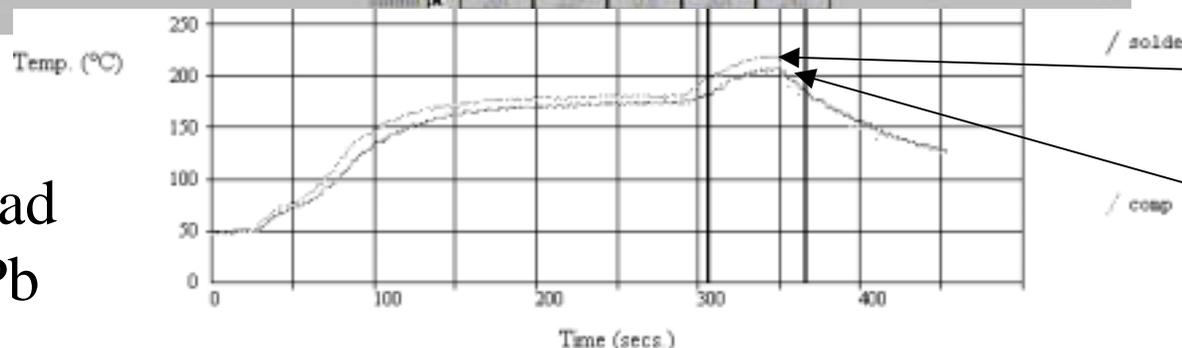
Tin-lead
Sn37Pb

Component
top 219°C

Solder joint
208°C

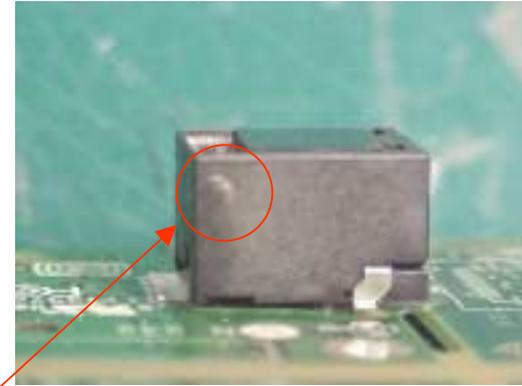
- Non-wetting at some center LED center leads
- RJ45 connector Popcorning
 - RJ45 Popcorning Root Cause was Moisture Absorption.
 - DOE Performed to Eliminate Popcorning by Baking Components. All Remaining Parts Baked Prior to Assembly (80°C for 48 Hours)
 - No further issues in subsequent builds
- PCB Silkscreen Discoloration
 - Slight Silkscreen Discoloration Was Determined to Pass Customer Workmanship Standards Criteria.

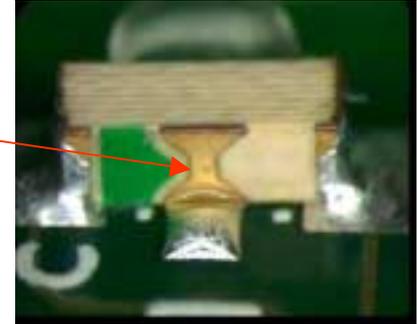
- Non-wetting at LED center lead
- BGA rework successful (Passed X-Ray inspection, ICT, FT)

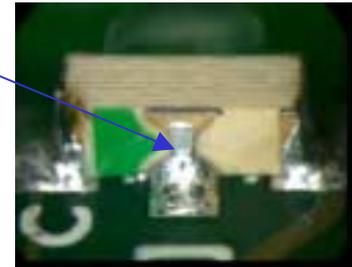
- Increased stencil aperture opening for LED center lead. LED solder joints had better solder fillets. **No non-wetting defect at LED. All Future builds used increased stencil aperture opening.**
- BGA rework successful (Passed X-Ray inspection, ICT, FT)

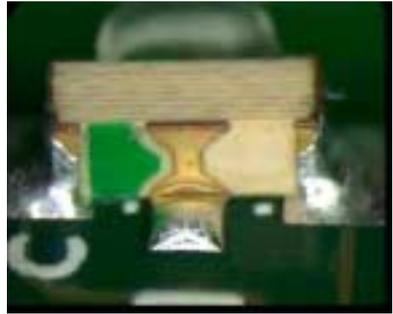
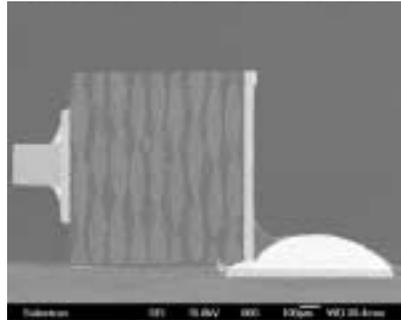
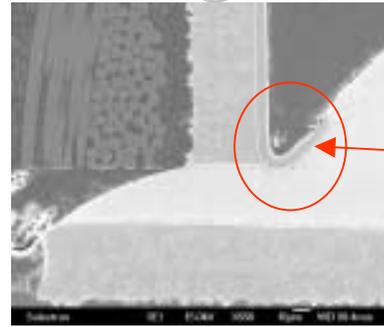
Metal burr at 45° angle

SnAgCu soldered LED: **non-wetting** solder joint (5mils stencil)

- Where the Pad Meets the Lead, There Is a "Metal Burr" Sticking up From the LED Component Lead Cutting.
- The Lead-free SnAgCu solder paste has slower wetting compared to the SnPb paste and the surface tension of the SnAgCu is higher than tin-lead.
- The metal burr acts to increase the solder damming action with the higher surface tension SnAgCu solder.
- The Higher Liquidous Solder Tension of SnAgCu solder remains centered on the Pad Instead of Wetting up the Lead.
- The Picture of Good Wetting has the metal burr either flush against the lead or protruding horizontally or downwards
- Component Spec Is 0.1mm Length for Burr and Can Not Be Eliminated. This is likely to be a contributor to the intermittent nature of this problem

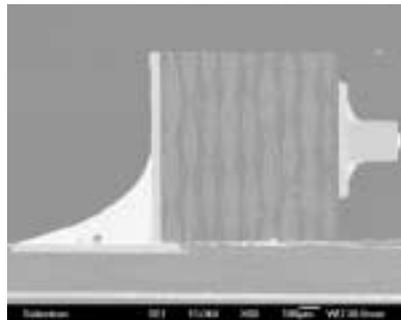
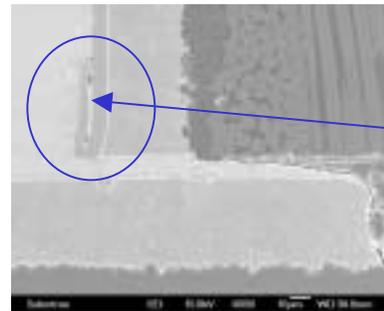
Metal burr against component

SnAgCu soldered LED – **good** solder joint (5mils stencil)

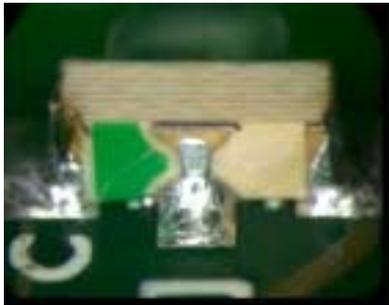
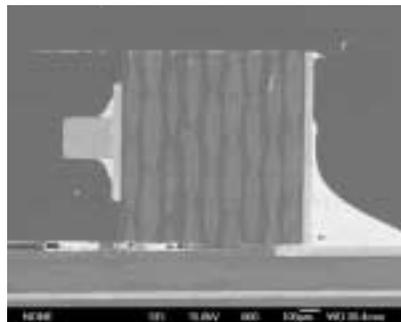
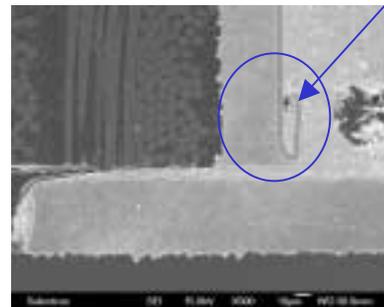
Sn37Pb soldered LED – **good** solder joint (5mils stencil)

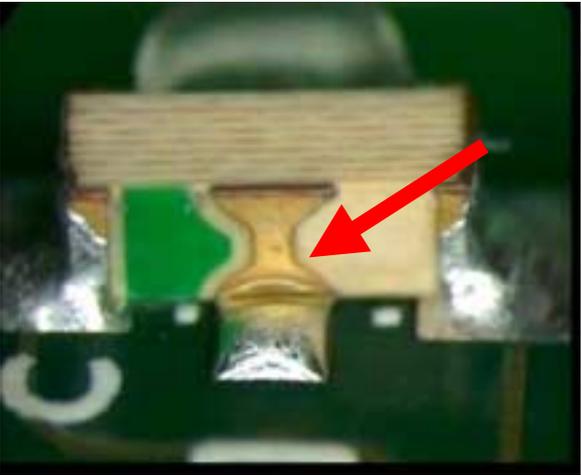
Non-Wetting on Center Lead

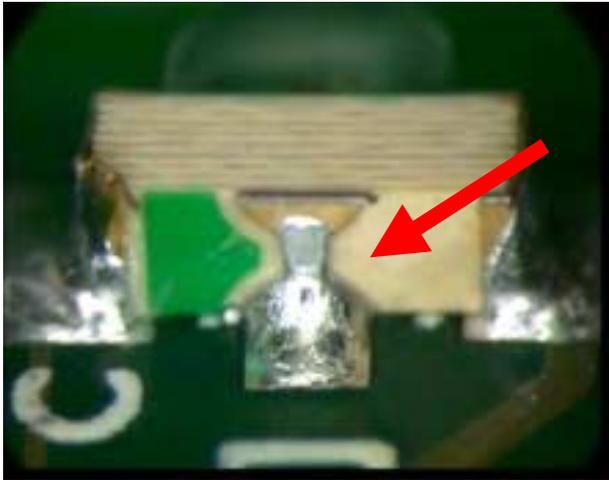
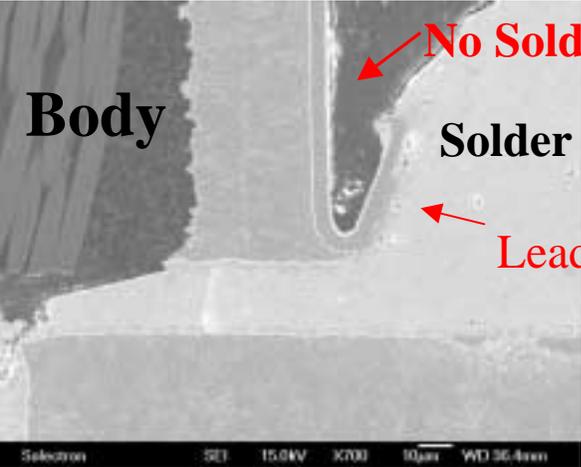
Good-Wetting on Center Lead

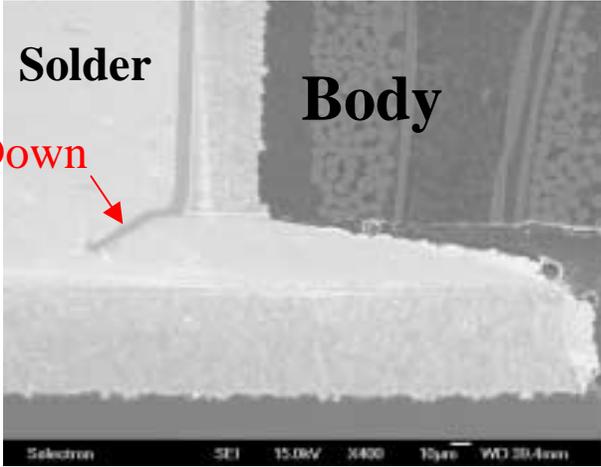
Lead Burr Down

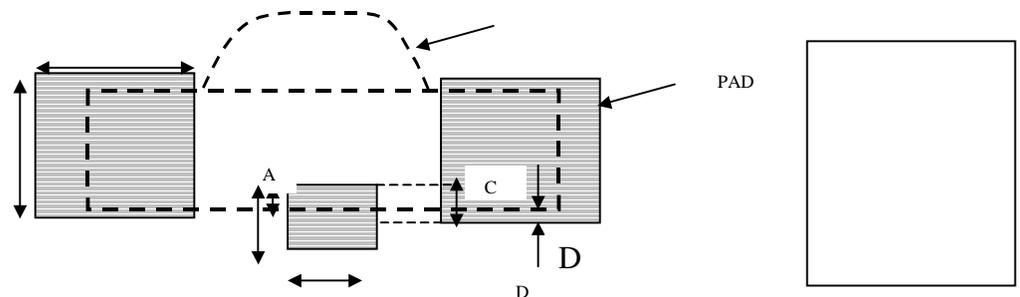
- The LED Center Lead to Pad Geometry shows the lead is barely sitting on the pad
- Component supplier recommends a center lead land Pattern 0.4mm Larger than the design used on this product
- The varying length and angle of metal burr together with the Lead to Pad Geometry causes this problem together with the higher surface tension and slower wetting of the SnAgCu solder
