Reliability and Failure Analysis of Lead-Free Solder Joints

Michael Meilunas and Anthony Primavera, Ph.D.
Universal Instruments Corporation
Binghamton, NY

Abstract

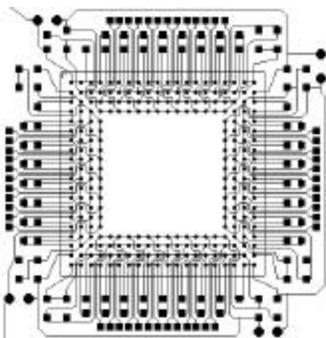
Figure 2 – Completed Daisy-Chain

The assembly test boards were 1.524 mm thick multi-layered panels that utilized a tetrafunctional FR-4 core with minimum nominal glass transition temperature of 175°C. Eight BGA components were assembled to the topside of each board. The eight sites, or coupons, corresponding to the BGAs are routed such that an individual BGA assembly may be removed from the test board without interrupting the I/Os of the other components. Solder mask protected traces are located on the surface of the test board and connect each BGA site to a gold edge finger connector that is utilized to interface to an event detector. Additional traces run from the various points within the coupon daisy chain to exposed probe pads located around the perimeter of the footprint. These probe pads were included to facilitate testing by isolating the solder joints within the assembly to sets of two or three bumps. The coupons share a common ground return. Non-solder mask defined (NSMD) pad sizes of 0.508, 0.5588 and 0.6096 mm diameters are incorporated into the PCB design. The pads are approximately 0.0559 mm thick. The test boards were supplied with copper OSP and ENIG finishes. Figure 2 shows the daisy-chain of a completed assembly.

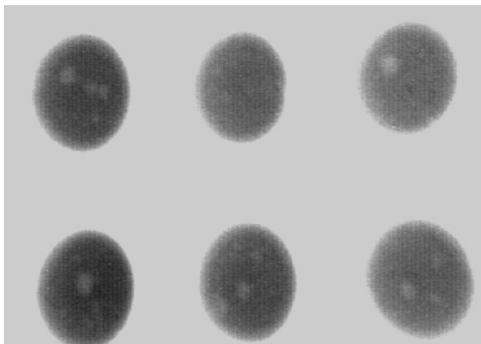
tinned pads. A typical Sn/Ag/Cu/Sb x-ray image may be found in Figure 3. In general, voiding was greater in Profile 2 Sn/Ag/Cu/Sb assemblies than Profile 4 Sn/Ag/Cu/Sb assemblies. Few voids were observed among the other alloys.

Figure 3 – Voids in Sn/Ag/Cu/Sb Solder Joints Following Assembly to ENIG PCB (Profile 2)

X-ray inspection revealed that many of the Sn/Ag/Cu/Sb assemblies contained numerous voids within the solder joints. Although no voids were detected whose individual cross-sectional area exceeded 10% of the joint cross-section, several Sn/Ag/Cu/Sb joints contained a cumulative void cross-sectional area of 12-15%. Overall, the Sn/Ag/Cu/Sb voiding was more severe in samples assembled to the ENIG PCBs than those assembled to copper OSP PCBs. These findings agree with published data¹ that reports the alloy is susceptible to large voids and void content decreases on bare copper compared to

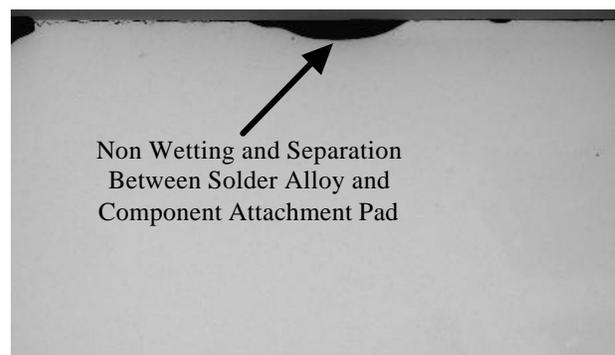
The Sn/Ag/Cu failure, which occurred at 2465 cycles, was the result of poor wetting and a separation between the electroless nickel plating on the package and the Sn-Ni intermetallic layer, as shown in Figure 4. No other joint in the component appeared fractured. The next Sn/Ag/Cu failure occurred at 7598 cycles and regularly thereafter. The first failure, not being representative of solder performance (i.e. non-fatigue), was excluded from Lifetime analysis.

Figure 4 – First Failure of Sn/Ag/Cu Solder Joint: 2465 Cycles (20 min. cycles)

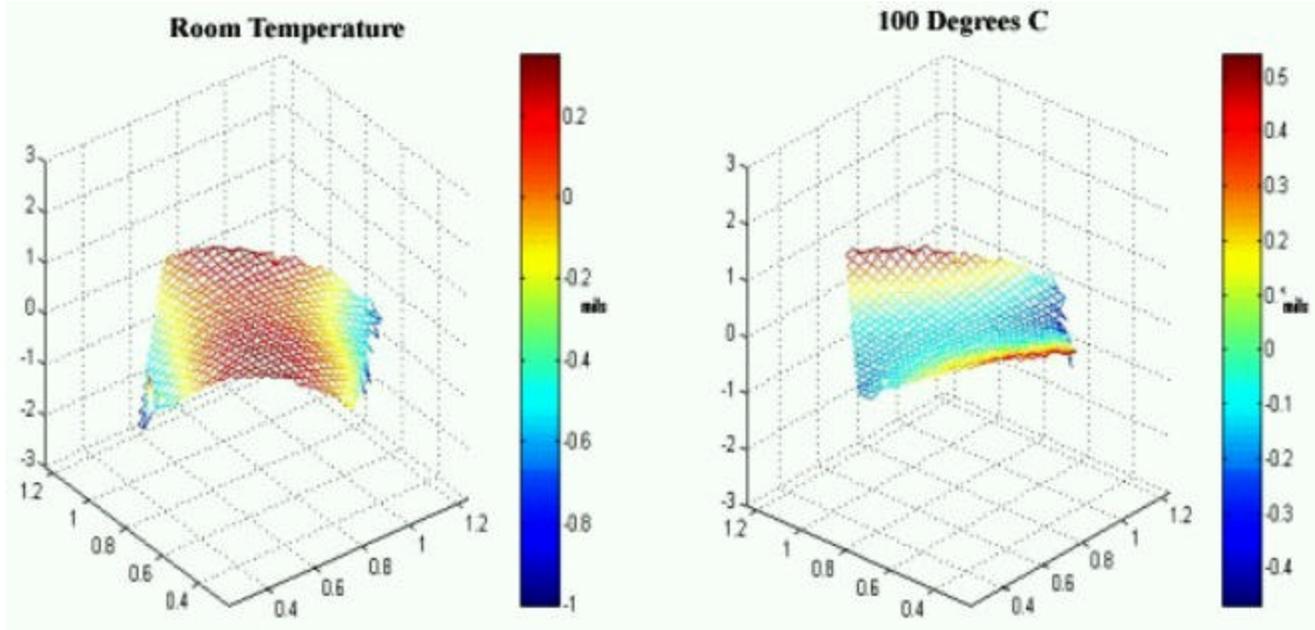
Visual inspection of five failures from the Sn/Ag/Cu/Sb sample set occurring at 1576, 1961, 3990, 3604 and 5491 cycles indicated that the glass die had delaminated from the underfill material. The delamination was possibly due to the high reflow temperatures required to assemble lead-free components. All five Sn/Ag failures (at 1534, 2262, 2452, 4140 and 4575 cycles) have also shown evidence of delamination. The effects of the delamination were evaluated by comparing delaminated samples to non-delaminated samples using Shadow-Moiré interferometry. The Moiré images show that the delaminated parts fluctuated during thermal cycling between a convex shape with the outer joints in tension to a bi-modal, or saddle shape with many of the outer joints in compression (Figure 5). Non-delaminated parts fluctuated from a slightly convex shape at room temperature to a relatively flat shape at higher temperatures. The out-of-plane stress that resulted from delamination gave rise to column shaped BGA joints during reflow and lead to severe solder fracture (see Figure 6) in thermal cycling. The delaminated parts were deemed package construction failures and were not used in Lifetime analysis.

Figure 5 – Images Produced with Shadow-Moiré Interferometry of Delaminated Component (Ball Side Up)

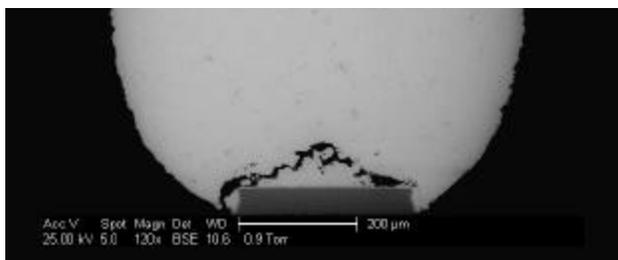
Figure 6 – First Failure of Sn/Ag/Cu/Sb Solder Joint Due to Package Delamination: 1576 Cycles (20 min. Cycles)

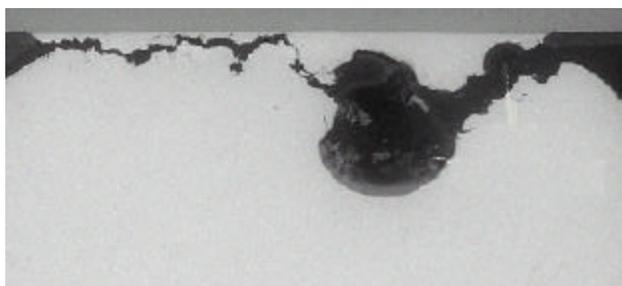
The remaining Sn/Ag/Cu/Sb failure, which occurred at 5082 cycles was attributed to in-plane solder fatigue that had been expedited by numerous voids in the bulk solder near the package attachment pad. Figure 7 shows a failed solder joint that was affected by the presence of voids. This failure was included in Lifetime analysis because voiding was inherent to the Sn/Ag/Cu/Sb solder alloy. Failures began occurring regularly at 6150 cycles and large or numerous voids were often present in the earliest Sn/Ag/Cu/Sb failures.

Figure 7 – Sn/Ag/Cu/Sb Failure with Voids in Crack Region: 5082 Cycles (20 min. Cycles)

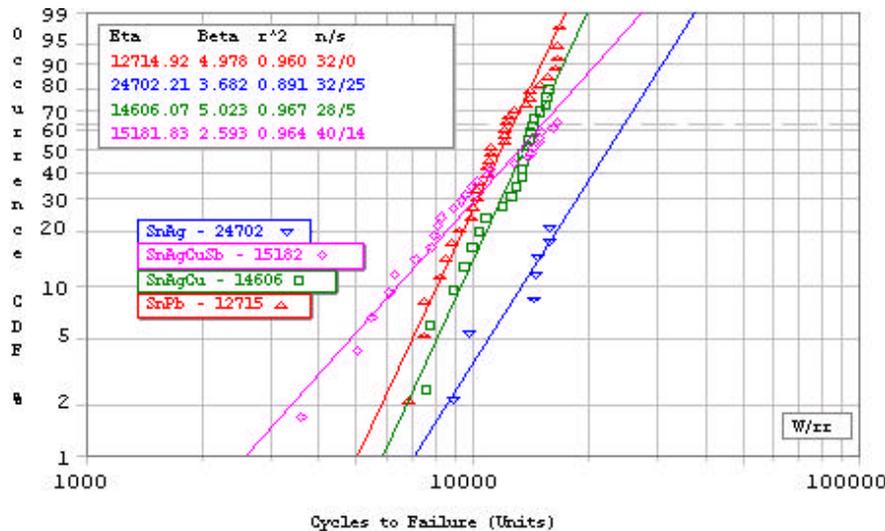
Figure 9 contains a Weibull plot summarizing the data from TG1 on ENIG boards. The plot shows that the Sn/Ag alloy resulted in a characteristic lifetime, Eta, which was 78% greater than that of the Sn/Pb alloy. The Sn/Ag/Cu alloy performed approximately 15% better than the Sn/Pb, and the Sn/Ag/Cu/Sb nearly 16% better. However, simply comparing Eta values undermines the importance of the successive failure rates of each alloy, which is best described by the slope, Beta. In general, lower Beta values indicate slower failure rates or a greater time between failures. This means that it is more difficult to predict when failures will occur. Comparing the Beta values clearly shows that the Sn/Ag/Cu/Sb alloy fails at a slower rate than the other alloys. This results in a higher characteristic lifetime than the Sn/Pb and Sn/Ag/Cu alloys, but also means that the probability for an early failure is increased as demonstrated by the first five fatigue failures occurring in the Sn/Ag/Cu/Sb sample set. It is believed that the presence of voids randomly located in the Sn/Ag/Cu/Sb solder arrays may have led to many of the ENIG sample set’s earliest failures and low successive failure rate.

Figure 9 – Weibull Plot of TG1 Data Accumulated on ENIG PCBs

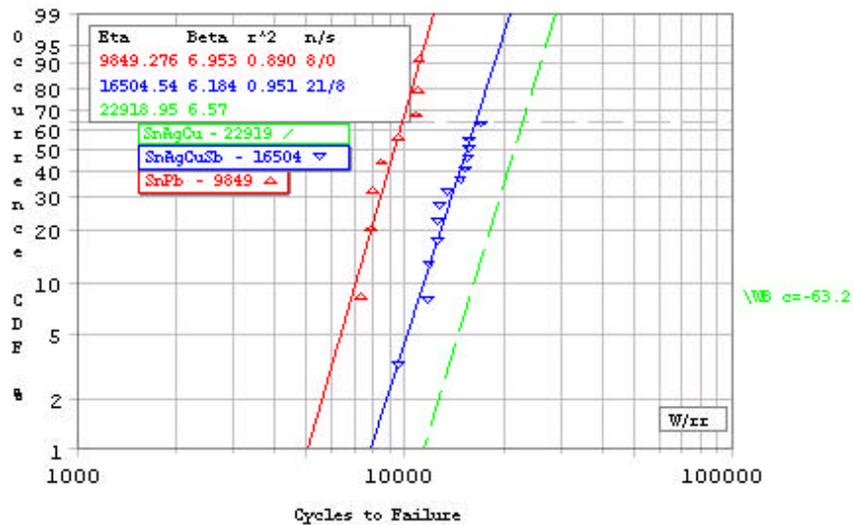
Figure 10 contains a Weibull plot of the data accumulated by TG1 on copper OSP boards. The dashed line is the predicted Sn/Ag/Cu plot based on zero failures through 16700 cycles and assuming a Beta of 6.57 (the average Beta value of the Sn/Pb and Sn/Ag/Cu/Sb sample sets) and a confidence level of -63.2%. The Weibull plot contains three distinct trend lines with the Sn/Ag/Cu/Sb

Eta value 68% greater than the Sn/Pb Eta value and the Sn/Ag/Cu Eta 133% greater than the Sn/Pb Eta. No plot is provided for the Sn/Ag sample set due to the high number of delamination failures discussed earlier in the paper. The two fatigue failures of Sn/Ag on OSP boards were recorded at 9533 and 10271 cycles.

Figure 10 – Weibull Plot of TG1 Data Accumulated on Copper OSP PCBs

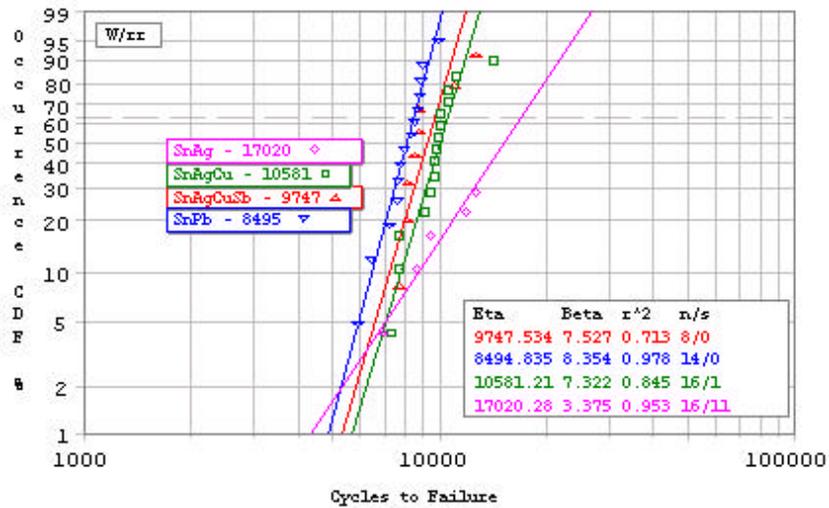
TG2 reliability data on ENIG boards is found in the Weibull plot of Figure 11. As with the TG1 ENIG data, the Sn/Ag alloy has the highest characteristic life with an Eta value of 17020 cycles. The Sn/Ag characteristic life found by TG2 was twice as long as the Sn/Pb alloy. First failure for this alloy occurred at 6945 cycles with four additional failures having been detected through 16000 cycles. The Sn/Ag/Cu alloy demonstrated a lifetime of 10581 cycles, or 25% greater than the Sn/Pb with first failure occurring at 7356 cycles. The Sn/Ag/Cu/Sb alloy had a characteristic life approximately 15% greater than the Sn/Pb with first failure at 7713 cycles and a lifetime of 9747 cycles.

Figure 11 – Weibull Plot of TG2 Data Accumulated on ENIG PCBs

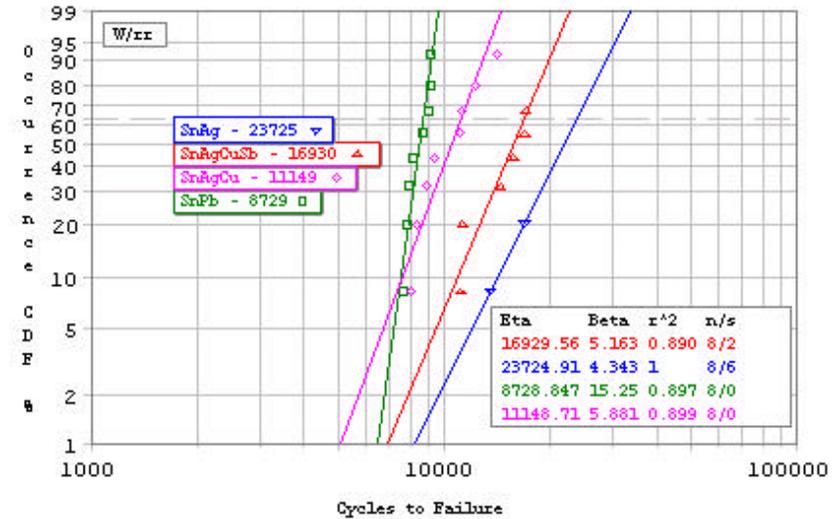
Figure 12 contains a two parameter Weibull plot of all the component fatigue failures from TG2 on copper OSP PCBs. For TG2, the three lead-free alloys were found to have significantly higher characteristic lives than the Sn/Pb samples. The Sn/Pb alloy BGA samples have an Eta of 8729 cycles with the first fatigue failure occurring at 7631 cycles and regularly thereafter. The Sn/Ag/Cu/Sb showed a characteristic life 94% higher than Sn/Pb with an Eta of 16930 and first failure at 11134 cycles. The Sn/Ag/Cu alloy had a 28% higher characteristic lifetime (11149 cycles with first failure occurring at 8051 cycles), compared to Sn/Pb samples. Similar to TG1, the Sn/Ag alloy showed the highest characteristic life with a predicted Eta of 23725 cycles. Only 2 of 8 Sn/Ag packages failed through 16700 cycles. The first TG2 Sn/Ag failure on copper OSP PCBs occurred at cycle 13521.

Figure 12 – Weibull Plot of TG2 Data Accumulated on OSP PCBs

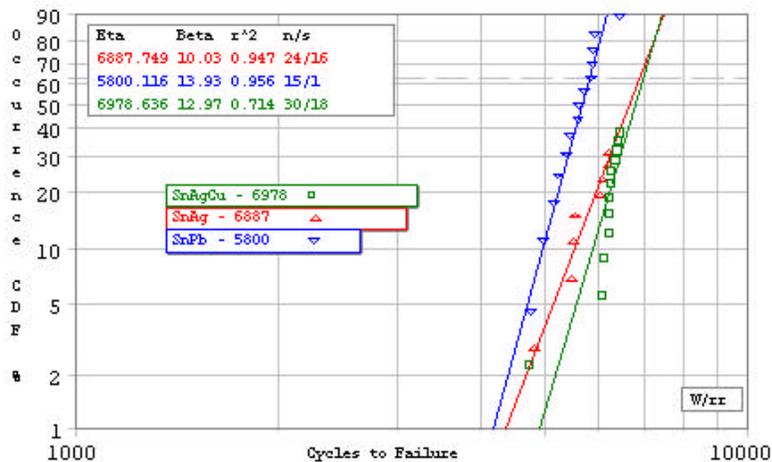
The reliability results of TG1 and TG2 were compared to those of a companion study conducted at Nokia Mobile Phones in Irving, Texas.⁹ The companion study utilized identical PCBs and components, but incorporated different pastes, reflow parameters and a -40/125°C thermal cycle. The reliability results for the Sn/Pb, Sn/Ag and Sn/Ag/Cu alloys on OSP and ENIG PCBs are summarized by the Weibull plots of Figures 13 and 14.

Figure 13 – Weibull Plot of -40/125°C Data Accumulated on OSP PCBs

As with the previous Weibull plots, non-fatigue failures have been removed as have early failures that significantly increase the Beta value and improperly improve the characteristic life. These failures included many interfacial failures between the ENIG component finish and solder alloy. Similar to the TG1 and TG2 data, the lead-free alloys show a reliability improvement when assembled to copper OSP. The results indicate that, for this thermal cycle (and reflow conditions), the Sn/Ag/Cu alloy demonstrates the greatest reliability regardless of surface finish. The Sn/Ag alloy outperforms Sn/Pb on copper OSP assemblies, but fared poorly on ENIG finish. The reasons for such differences are not clearly understood, it is believed that the Sn/Ag alloy was negatively impacted by intermetallic and grain boundary formations which reiterates the importance of reflow profile and thermal cycle parameters on the reliability of lead-free alloys. For more details concerning the companion studies refer to.⁹

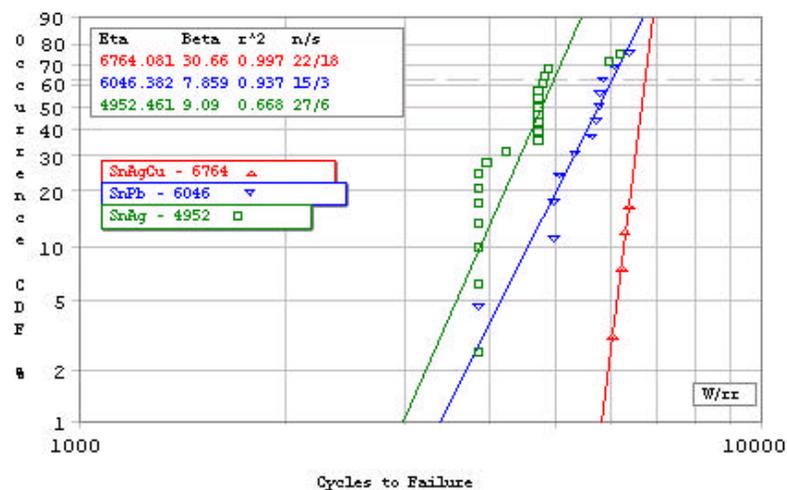
Figure 14 – Weibull Plot of -40/125°C Data Accumulated on ENIG PCBs

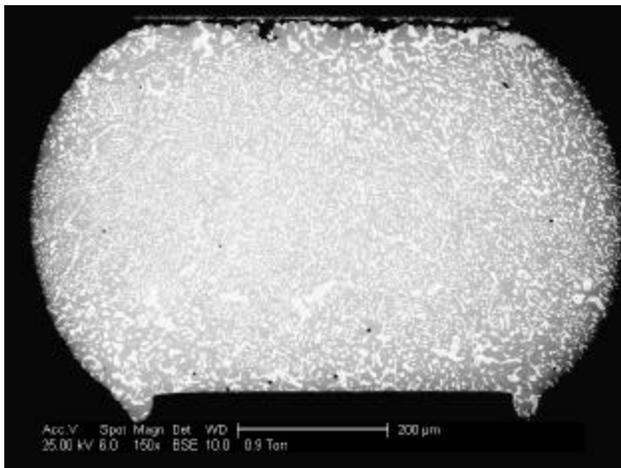
100% of the Sn/Pb failures from both TG1 and TG2 evaluated contained fractured solder joints. Figure 15 shows a Sn/Pb solder joint on an ENIG PCB that failed at cycle 6801. This joint was fatigued through the bulk solder material located in the solder mask defined region of the joint near the component body. The crack path is well defined and clearly visible under microscopic examination. Nearly identical results were obtained for all the Sn/Pb samples; bulk solder fatigue in the SMD region of the joints.

Figure 15 – Failed Sn/Pb Solder Joint after 6801 Cycles (20 min. Cycles)

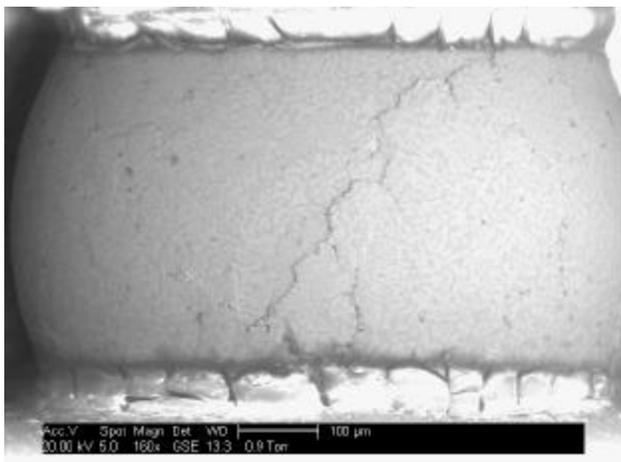
The final TG1 Sn/Pb failure occurred at cycle 16698. Although the package was electrically open, one joint that was electrically good contained a vertical crack visible on the surface of the joint as shown in Figure 16. The crack appears to coincide with the grain boundary that has formed during temperature cycling. No such crack was observed in any other Sn/Pb component.

Figure 16 – Electrically Good Sn/Pb Solder Joint after 16698 Cycles (20 min. Cycles)

Vertical cracking, similar to that seen in the Sn/Pb sample of Figure 16, was observed in several lead-free failures (Figure 20). The joints were electrically good and the vertical crack was not found by event detection or 4-point measurements. However, visual inspection identified vertical cracks in many assemblies. Unlike the vertical crack found in the Sn/Pb sample, these cracks were large enough to view with x-ray, as shown in Figure 21. It is supposed that these vertical cracks may lead to spalling in some of the lead-free samples before in-plane fracture is completed, thus introducing a new failure mode.

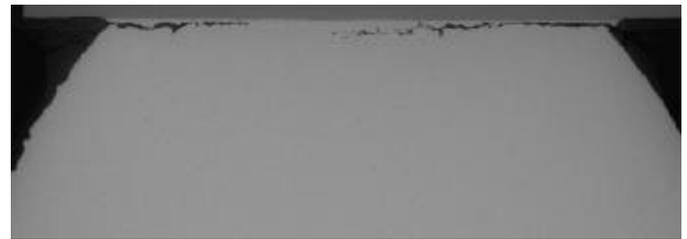
Analysis of the lead-free failures revealed not only a variety of failure modes, but also many interesting and potentially important issues associated with the alloys. Most noticeable was the existence of two distinct fracture paths: well defined cracks similar to that observed in Sn/Pb failures and fine microcracks that were often difficult to detect without the aid of SEM. The differences become clear when comparing Figures 17 and 18. Figure 17 is that of a Sn/Ag/Cu solder joint following 10885 thermal cycles. A single, wide fracture surface extends across the solder joint in the SMD region near the component. The crack path is fairly straight and remains in the bulk solder just below the intermetallic region. Cracks of this nature were easily located by 4-point

Figure 17 – Failed Sn/Ag/Cu Solder Joint after 10885 Cycles (20 min. Cycles)

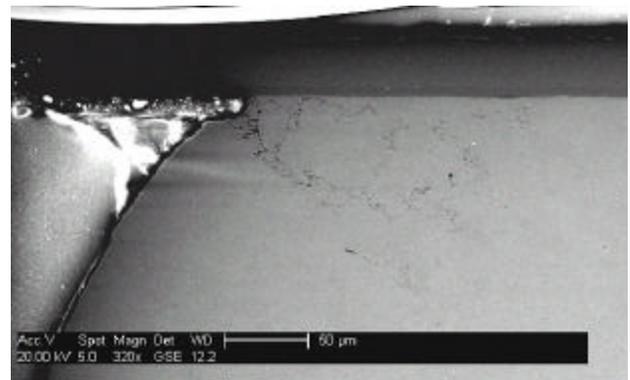
continuity measurements. Figure 18 is that of a Sn/Ag/Cu solder joint after 7598 cycles. A very fine crack with multiple fronts has propagated through the joint, resulting in a “shattered” appearance. Portions of the crack are located in the bulk solder while other portions have propagated into the intermetallic region. The formation, location and propagation of microcracks in Sn/Ag alloys in and near the intermetallic region has been noted in other works.¹⁰⁻¹¹ The “shattered” cracks of this experiment were often difficult to isolate with a 4-point meter, and required careful comparisons between pre- and post-cycle resistance measurements to locate. Additionally, the event detector output corresponding to assemblies containing microcracks was often similar to output associated with noise or intermittent failure. The event detection criteria was based on IPC SM-785, with a 300 Ohm resistance level and a 200 nanosecond time duration. However, resistance changes as small as 5-25 Ohms for a 40 nanosecond duration were measured with a more sensitive event detection system in certain lead-free samples during thermal cycling. These small resistance levels were confirmed to coincide with crack propagation. Thus selection of low resistance thresholds may be required for testing of lead-free solder compared to eutectic Sn/Pb solder.

Figure 18 – Failed Sn/Ag/Cu Solder Joint after 7598 Cycles (20 min. Cycles)

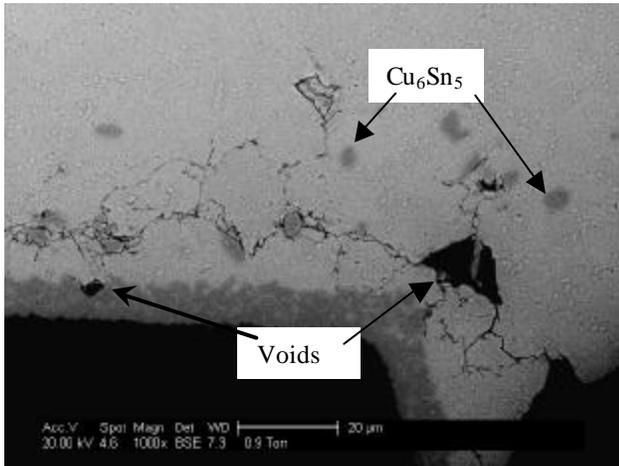
Generally, the wide, single path style cracks were observed near the component body in the SMD region of the joints. However, the “shattered” cracks were just as likely to occur near the PCB pad as they were near the component pad. Figure 19 shows the region of a Sn/Ag solder joint on a Cu OSP PCB pad. The crack has

propagated around the NSMD PCB pad through the bulk solder. No correlation between cycles to failure and the “shattered” crack locations (component side vs. PCB side) was observed. No correlation between crack type and cycles to failure was observed.

Figure 19 – Failed Sn/Ag Solder Joint on Cu Pad after 10204 Cycles (20 min. Cycles)

Figure 19 also shows that several small voids exist in the crack region. These voids may be the result of intermetallic formation and/or internal stresses which deform the joint. The small voids were most often observed at or near the thick, continuous layer of Cu-Sn that formed between the solders and copper OSP PCBs. This intermetallic region consisted primarily of Cu_6Sn_5 although some specimens contained a very thin layer of Cu_3Sn between the copper pad and Cu_6Sn_5 intermetallic. Many papers have been published documenting the presence of the Cu-Sn intermetallic layers including.^{5, 17} Measurements indicate that the post-reflow intermetallic thickness was approximately 0.0043 mm for all three lead-free alloys and grew to excess of 0.00635 mm by the onset of solder fatigue. Less Cu-Sn intermetallic was observed in the Sn/Ag/Cu and Sn/Ag/Cu/Sb on Cu OSP assemblies than was observed with the Sn/Ag, possibly due to the presence of Cu within the alloys which limited the interaction between the copper board and solder. Sn/Pb samples on copper PCBs contained both Cu_6Sn_5 and Cu_3Sn but the thickness was limited.

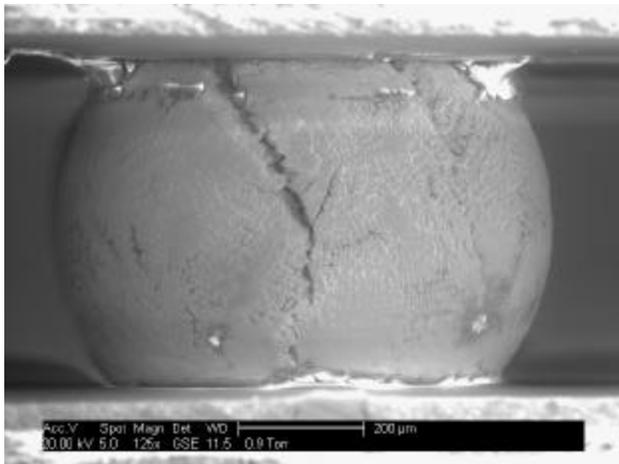
Figure 20 –Sn/Ag/Cu/Sb Solder Joint Vertical Crack after 16700 Cycles (20 min. Cycles)

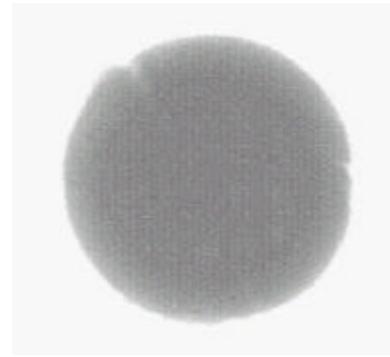
Figure 21 – Electrically Good Sn/Ag/Cu Solder Joint after 14115 Cycles (20 min. Cycles)

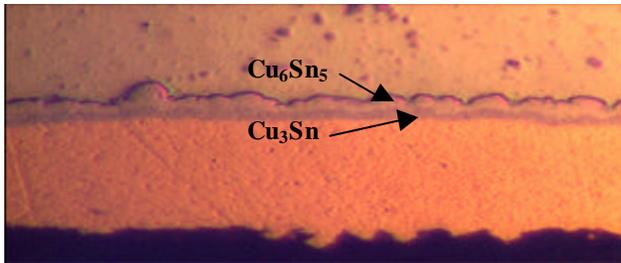
were characterized by a blocky, irregular shape and were in excess of 0.0040 mm thick following reflow (Figure 22). The growth of Ni-Sn during thermal cycle was not as dramatic as the growth of the Cu-Sn intermetallic. The largest Ni-Sn intermetallic observed measured approximately 0.0057 mm thick after 9036 20 minute thermal cycles. The composite intermetallic layer thickness near the attachment pad has been compared to other lead-free soldered samples found in literature as presented in Table 6. The composite layers of intermetallic have been shown to grow significantly faster than Sn/Pb alloys on both copper and nickel pad surfaces.

Figure 22 – Sn/Ag/Cu Solder Joint on Cu Pad Post-Reflow (Profile 2)

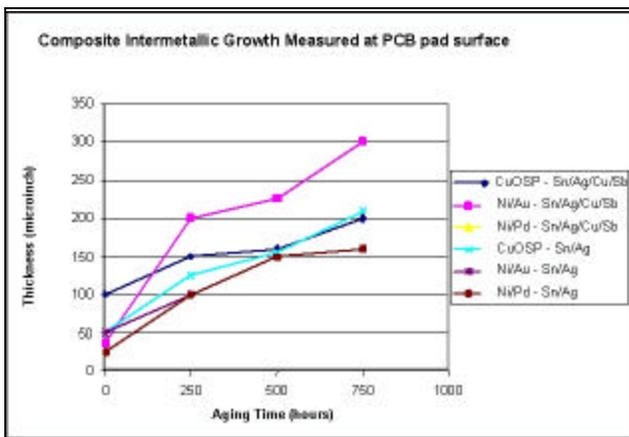
Figure 23 and Table 6 show the accelerated growth of the composite intermetallic layer for several lead-free solders as a function of time (thermal exposure).

Figure 23 – Intermetallic Growth Rate

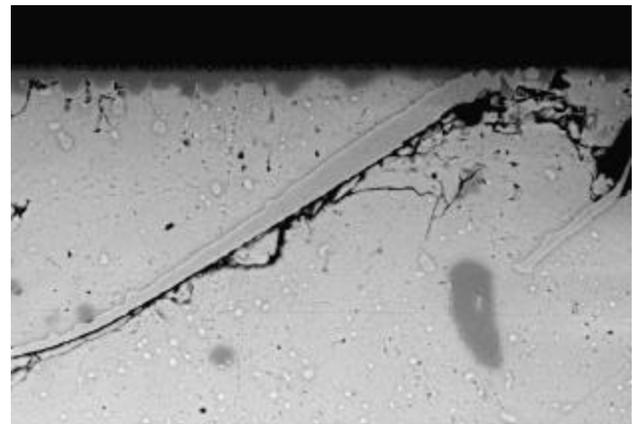
There is sufficient evidence to suggest that Cu-Sn and Ag₃Sn intermetallics may temporarily redirect cracks that typically run parallel to the component or PCB pad through the predominantly Sn matrix. Figure 24 is one of several Sn/Ag/Cu solder joints that contained large Ag₃Sn plates that formed at a 45° angle to the component pad. Instead of propagating along the pad region, the crack path runs alongside the plate towards the center of the solder joint. This increase in path length may translate into longer joint life, however plate orientation may run in any direction, even parallel to the crack path.

Figure 24 – Failed Sn/Ag/Cu Solder Joint after 14340 Cycles (20 min. Cycles)

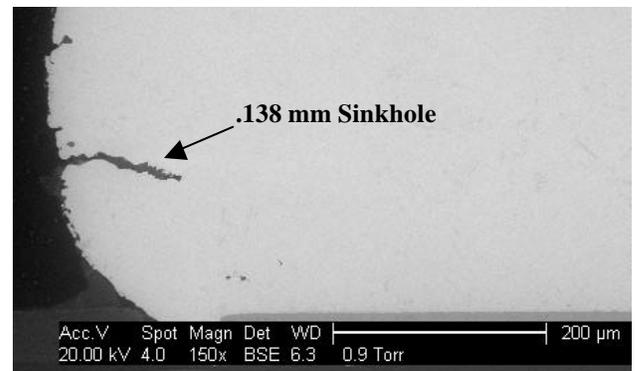
Another phenomenon observed in the lead-free assemblies has been termed “sinkholes”. The sinkhole may be described as a long, thin void originating at the solder joint surface that appears to form during reflow and grow during thermal cycling. Sinkholes appeared to be most common in the Sn/Ag/Cu and Sn/Ag/Cu/Sb alloys. Cross-sectioning revealed one sinkhole extending approximately 0.138 mm (about 1/6th of the solder joint diameter) into a Sn/Ag/Cu/Sb solder joint (Figure 25). The effects of the sinkhole on the thermal or mechanical behavior of the joints is uncertain. No failures were directly associated with sinkholes.

Figure 25 – Sinkhole Void Sn/Ag/Cu/Sb Solder Joint after 12500 Cycles (30 min. cycles)

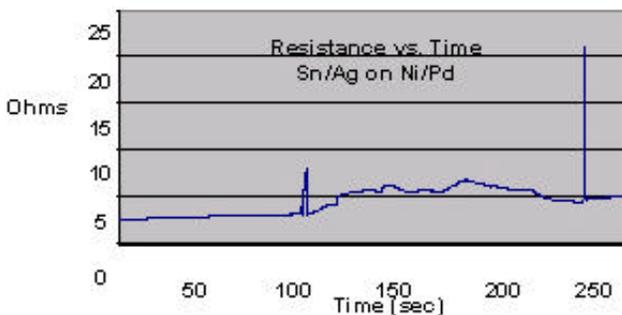
Test criteria used in this research for event detection was a modified IPC SM-785 requirement for resistance levels. A 300 Ohm resistance level and a 200 nanosecond time duration was utilized due to the extremely sensitive nature of the lead-free samples to propagation of fine cracks. Resistance changes as small as 5-25 Ohms for a 40 nanosecond duration were measured for some of the lead-free samples during thermal cycling. Use of event detection equipment with low trigger thresholds is therefore recommended for testing of the lead-free alloys. Figure 30 shows two low resistance events recorded by an oscilloscope during a 300 second interval of a thermal cycle test.

Figure 30 – Resistance Versus Time During Cycling
