# Materials Compatibility and Aging for Flux and Cleaner Combinations

Kim M. Archuleta and Rochelle Piatt

Sandia National Laboratories

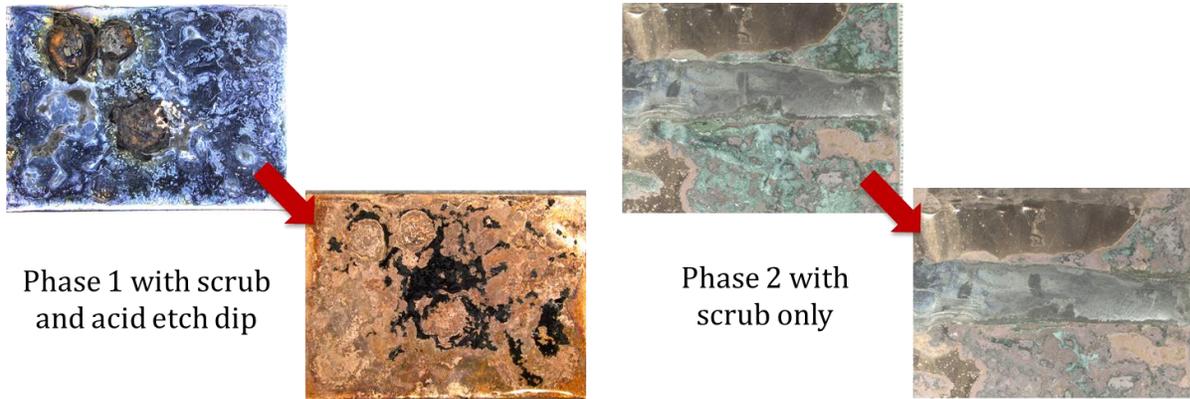
**Figure 1. Post aging coupons cleaned to observe degree of etching.**

Methods for Phase 1 and Phase 2 are similar, and are described in this section. Visual inspection at actual size and 6X magnification of coupons and boards from both phases at the termination of four weeks aging allows comparison of damaging effects on the materials involved. A corrosion level rating method was developed in order to compare the flux and cleaning agent combination results. The ratings take into account residue, corrosion, etching, staining, and pitting, as well as ionic residue data for Phase 2 (Tables 1 – 3). The number scale increases with the amount of residue or damage by corrosion.

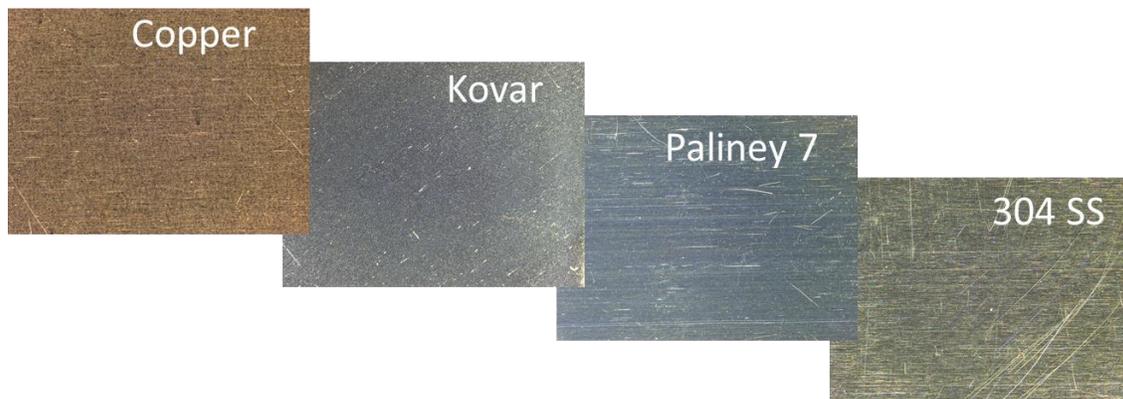
**Figure 2. Phase one metal coupon materials before flux treatment.**

Metal coupons were prepared by cleaning in 10% phosphate based detergent solution with 40 kHz ultrasonics at 30 °C, and rinsed in DI water of > 16 MOhm-cm resistivity. The Cu was also treated with a 15 second acid dip with DI water rinse. Pre-treatment images were taken of all materials.

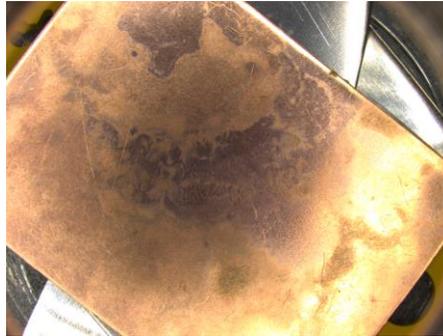
**Figure 3. Phase one metal coupon materials stacked in glass jar full of silicone oil.**

A small amount of heat treated flux was combined with each defluxer and placed with coupons in a silicone oil environment and aged, to determine which combinations present the higher risk in use. The flux treatment process consisted of:

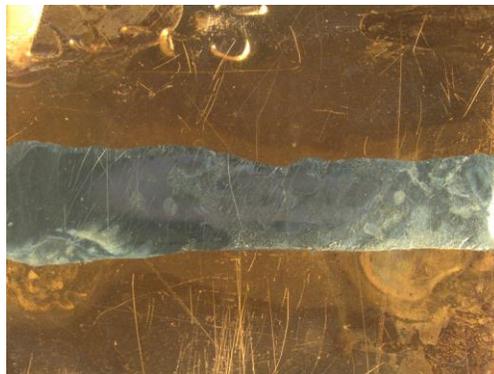
**Figure 4. Phase two OFE coupon with solder strip.**

For the Cu coupons a tin-lead solder wire was hand soldered across the coupon at only the higher temperature of approximately 380 °C. After cooling, but within 24 hours, half were treated by each cleaning method. Below are the process steps followed for the coupons:

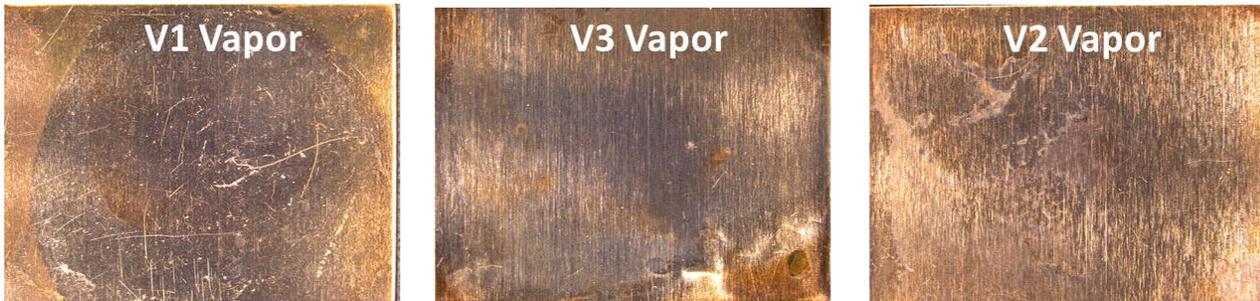
**Figure 5. Best of Low Temperature; RMA flux D2 with vapor defluxers.**

In Phase 1 the least amount of damage to the metal coupons was seen when using RMA flux with added vapor degreaser fluid, which typically resulted in minor staining or residue. A slight increase in staining was noted for the higher temperature tests (Figures 5 – 6).

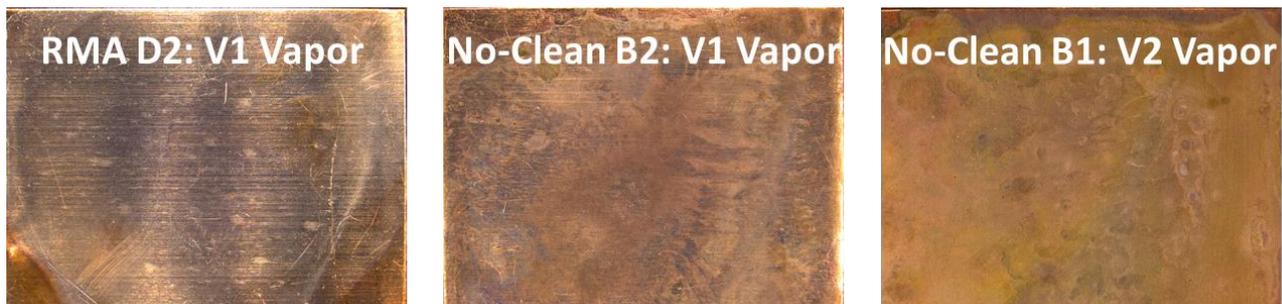
**Figure 6. Best of High Temperature, no-clean flux B1 & B2 or RMA Flux D2.**

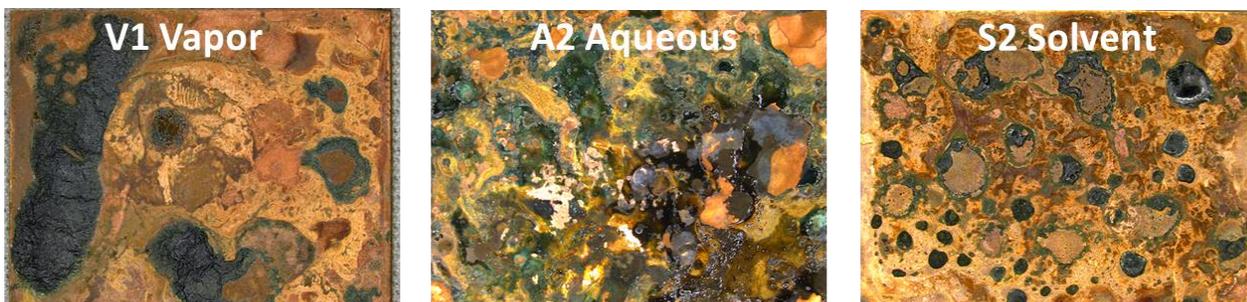
**Figure 7. Worst of Low Temperature, C1 water soluble ORH1 flux.**

The greatest amount of damage was seen with the ORH1 flux and, in general, the aqueous defluxers. However, solvents and vapor defluxers (as well as no cleaning) created substantial corrosion as well (Figures 7 – 9). It is noted that all coupons in Phase 1 were in aging solution stacked on one another, thus it is possible that galvanic corrosion accelerated or decelerated coupon damage. The flux C, water-soluble ORH1, and Cleaner A1 rating as seen in Figure 9-a is higher due to staining on other coupon materials. Fluxes B1 & B2, no-clean, are most dependent on cleaner for the Low Temperature tests, as seen in Figure 9-b.

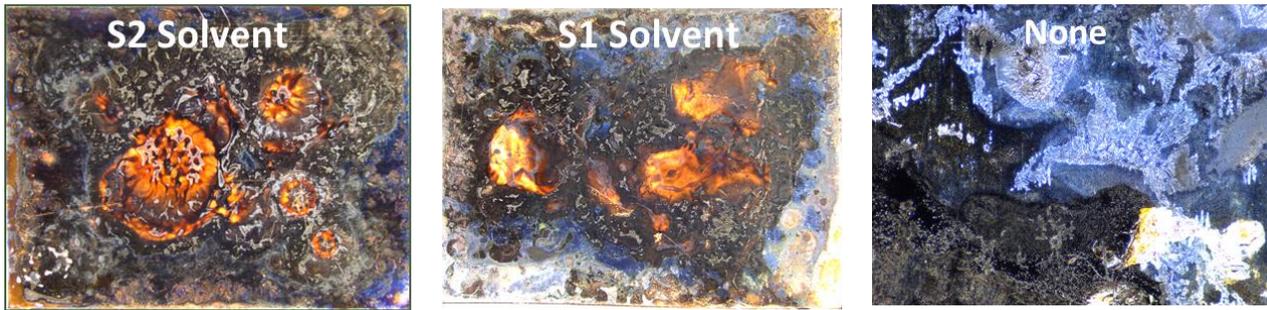
Figure 8. Worst of High Temperature, C1 water soluble ORL1 flux.

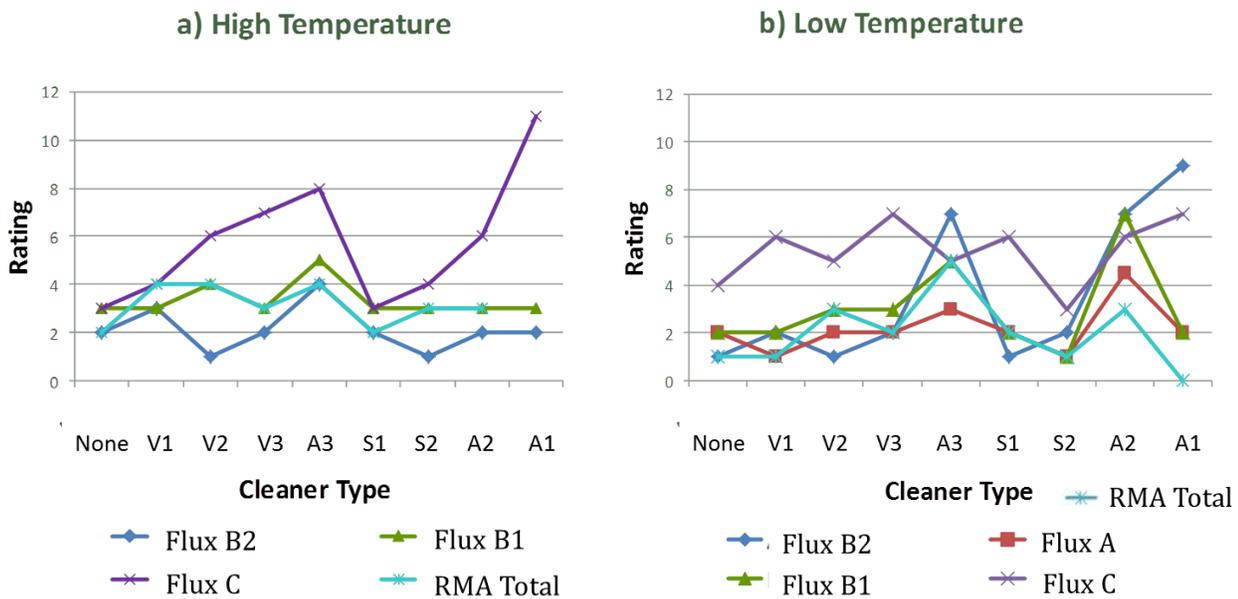
Figure 9. Rating results graph for Phase 1 a) High and b) Low temperature trials.

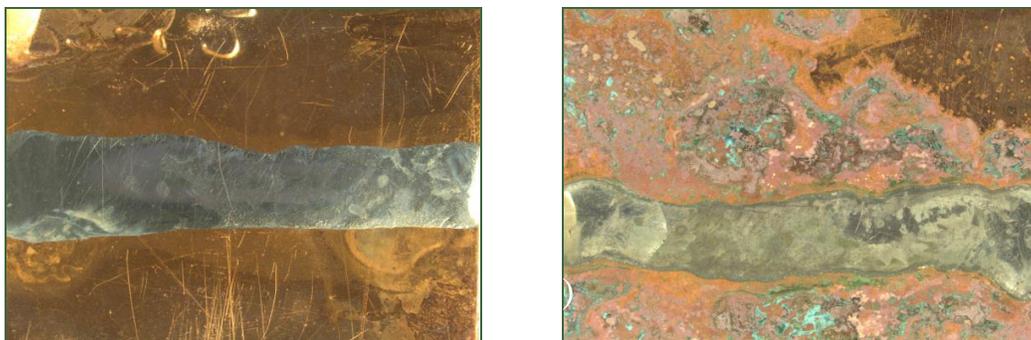
Figure 10. Clean A: a) BEST, RMA flux D, defluxer A3, b) WORST, ORH1 flux, defluxer V3.

In Phase 2, a lesser amount of damage was seen across the range of testing. The highest rating for damage and ionic residue was associated with the ORH1 flux and, in general, the vapor phase defluxing. The least corrosion was observed on RMA flux with aqueous cleaning. As seen in Figures 10 – 12, the brief cleaning (Clean B) was little different than the longer cleaning cycle (Clean A), when little physical cleaning action is present (no scrubbing or impingement spray).

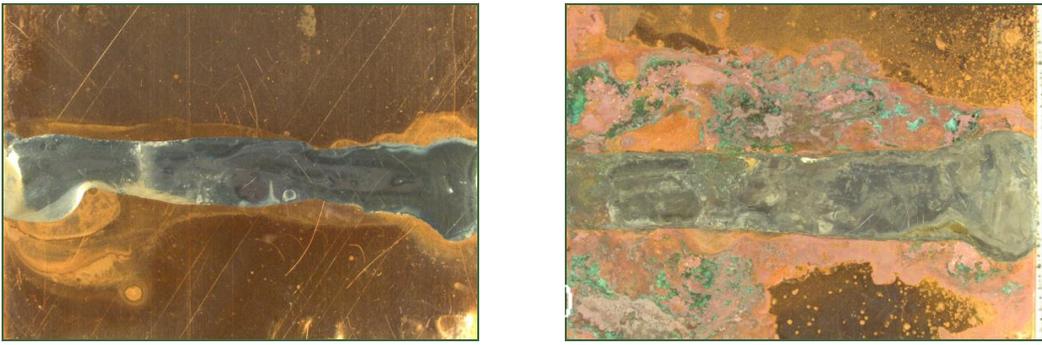
Figure 11. Clean B: a) BEST, RMA flux D, defluxer A1, b) WORST, ORH1 flux, defluxer V1.

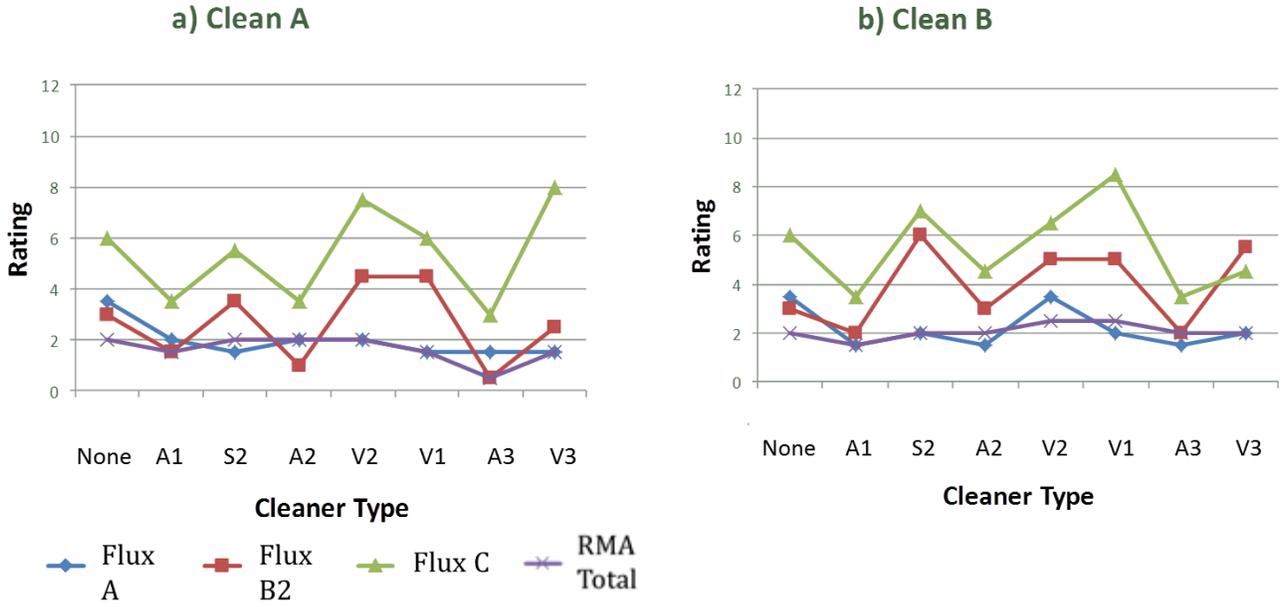
Figure 12. Rating results graph for Phase 2 a) Clean A and b) Clean B.

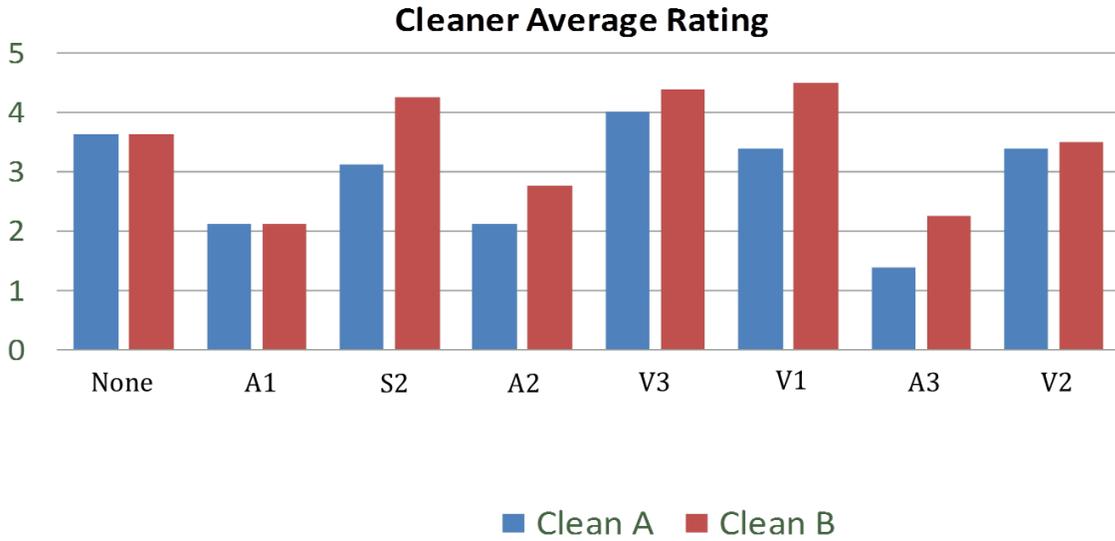
Averaging the rating values for like combinations of cleaning agents and fluxes in Phase 2, shown in Figure 13, resulted in generally best clean and least damage for the aqueous cleaning agents, with measurable increase between Clean A and Clean B for A2 and A3, but not A1.

Figure 13. Average of ratings for all cleaner and flux combinations for Phase 2.

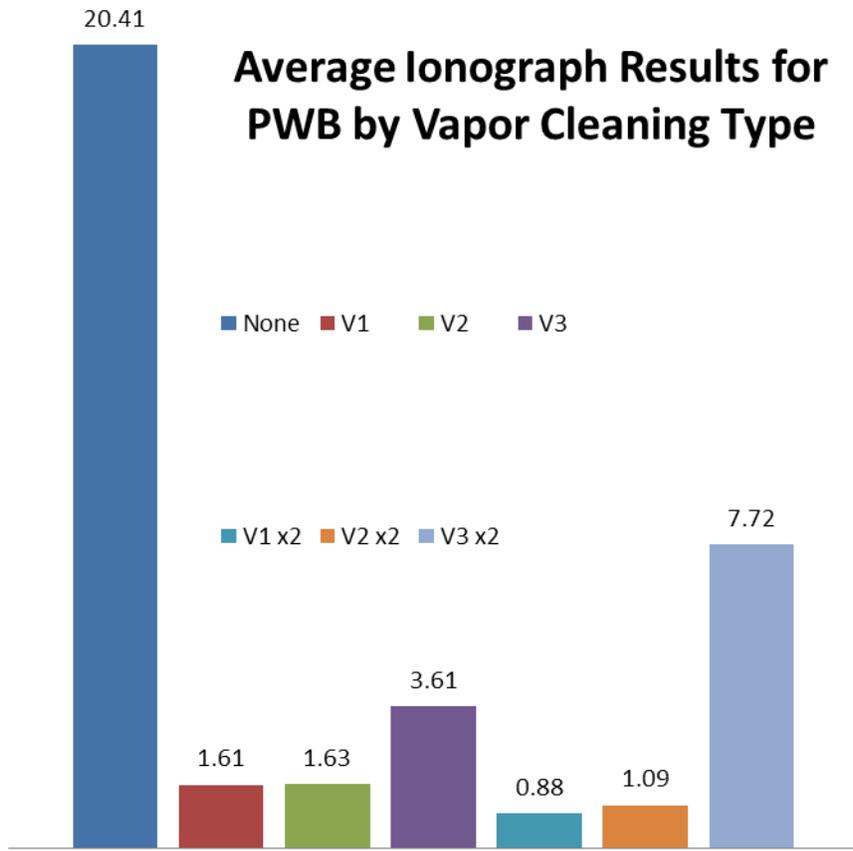
Figure 14. Printed wiring board ionic residue, in micrograms/square inch.

One set of boards was cleaned by a typical vapor cleaning, the second set cleaned with a double amount of cleaning cycles, but as seen in Figure 14, all fell below 10 micrograms per square inch of sodium chloride equivalent. The PWB double cleaned in V3 defluxer appears to have increased residue in comparison to the same cleaning done with a single cycle, which indicates the variation in the soldering and cleaning is probably on the order of the amount of residue measured. However, it is likely that as V3 showed results worse than V1 and V2 in both single and double cleaning cycles, and left visible residue on the boards (see Figure 15) that it fares least well in this comparison.

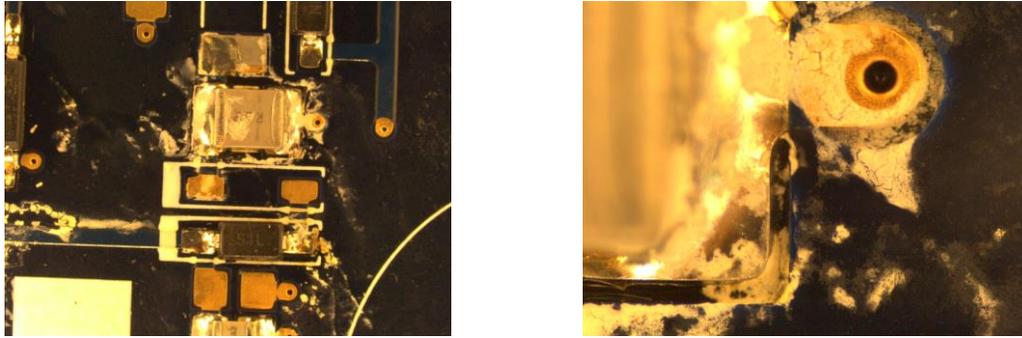
**Figure 15. Printed wiring board with the greatest visible flux residue, V3 vapor defluxer.**

In Phase 2 most corrosion occurred with the vapor defluxers. Performance of the vapor defluxers on Cu coupons may be due to lack of physical pre-clean, or insufficient repetitions of vapor condensation. These results confirmed the need for appropriate cleaning method to achieve low corrosion risk, and verified that higher halide fluxes are more likely to result in corrosion. The PWB cleaning demonstrated that for RMA flux, no corrosion was observed on any board, and white residue was present for only one defluxer type.

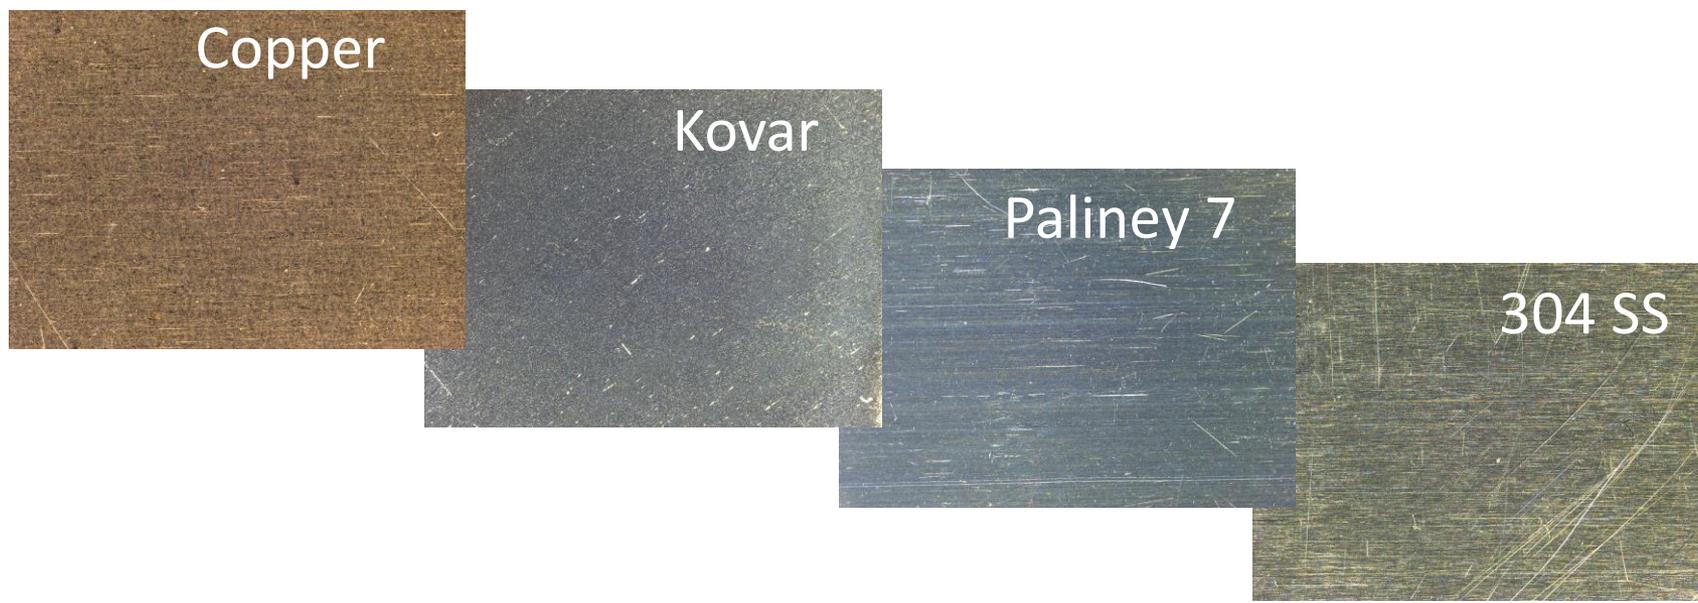
Metal coupons are prepared by cleaning in 10% phosphate based detergent solution with 40 kHz ultrasonics at 60 °C, and rinsed in DI water of > 16 MΩ-cm resistivity. The Cu is also treated with a 15 second acid dip with DI water rinse. Pre-treatment images were taken of all materials.

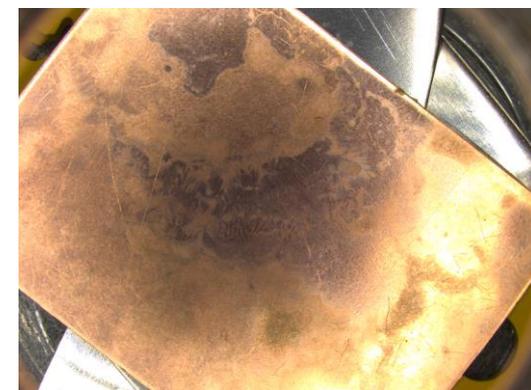
- 0.18 mL flux applied by droplet or brush onto Cu coupons
- Coupons placed on hot plate at a temperature selected to mimic the typical soldering processes at higher heat:
  - lead-free solder (370 – 450 °C) for 30 – 60 seconds
  - tin-lead solder (230 – 280 °C) for 1 - 4 minutes
- Cool to ambient, place coupons in jars.
- Add 6.0 mL silicone oil & 0.18 mL defluxer
- Gently agitate, cover
- Store at ambient temperature for 4 weeks

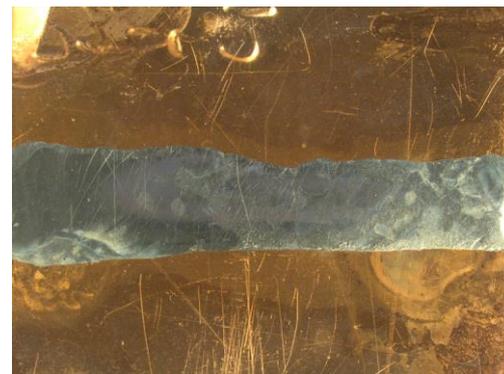
**PWB:** hand solder, RMA flux, vapor defluxing of 3 & 6 cycles

Ionic residue is measured with an Ionograph before parts begin the 4 week 65 % humidity at 30 °C exposure .

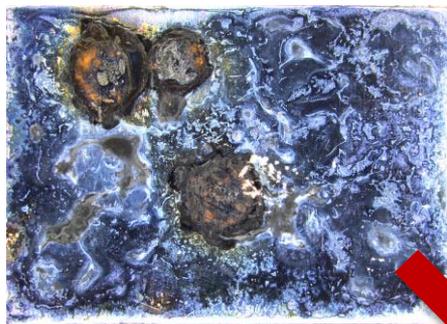
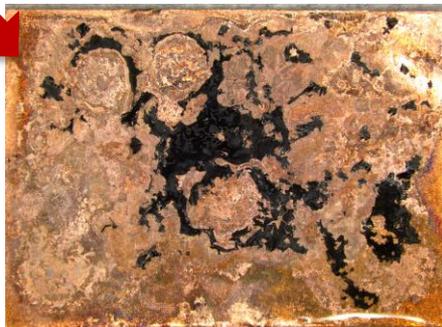
Phase 1 with scrub  
and acid etch dip

- Coupons inspected first time immediately upon removal
- Again after cleaning by scrub in ethanol (in some cases copper was also acid dipped in order to view substrate)

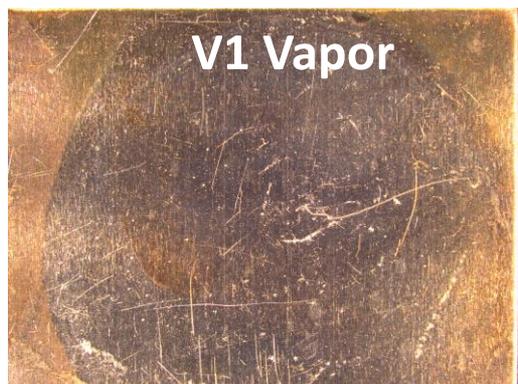
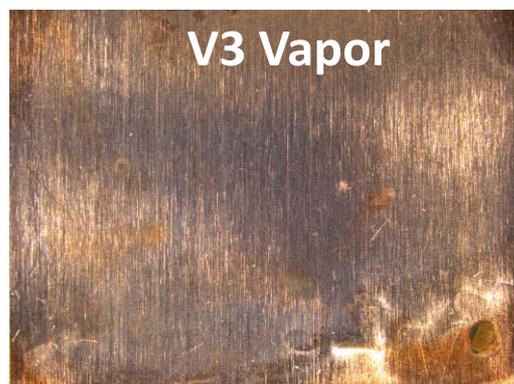
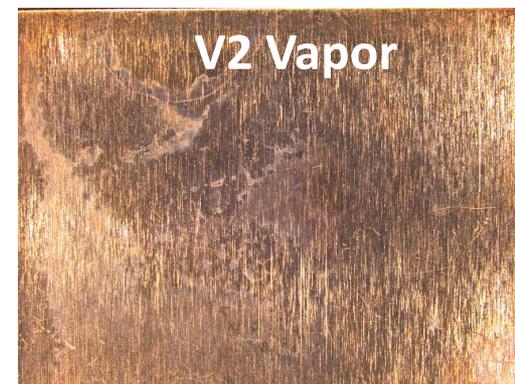
**Figure 1:** Best of Low Temperature; RMA flux D2 with vapor defluxers

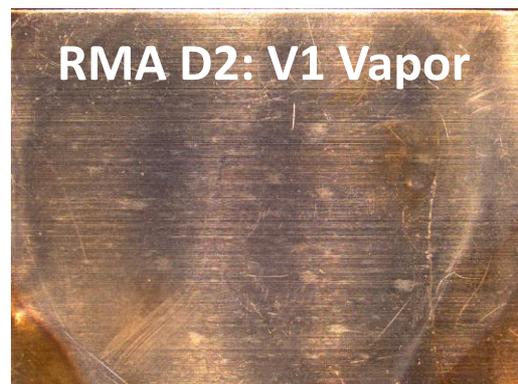
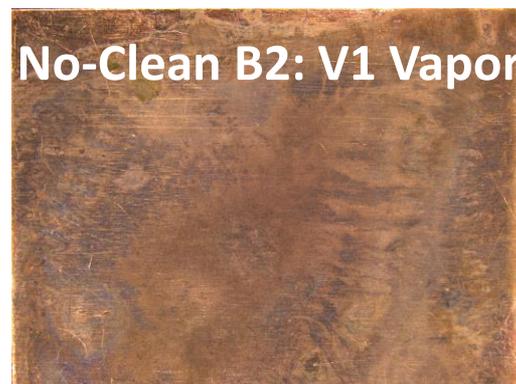
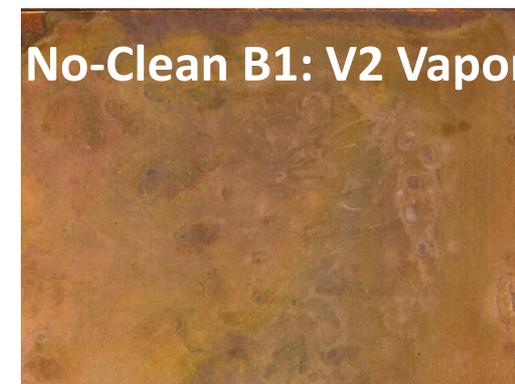
**Figure 2:** Best of High Temperature, no-clean flux B1 & B2 or RMA Flux D2

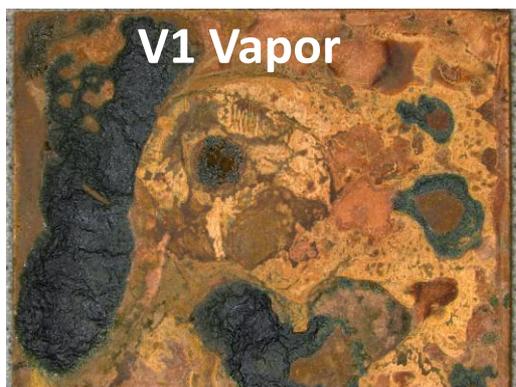
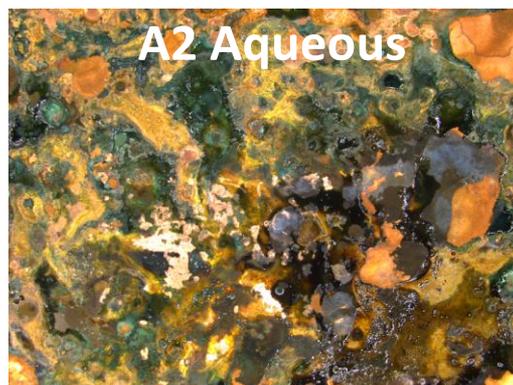
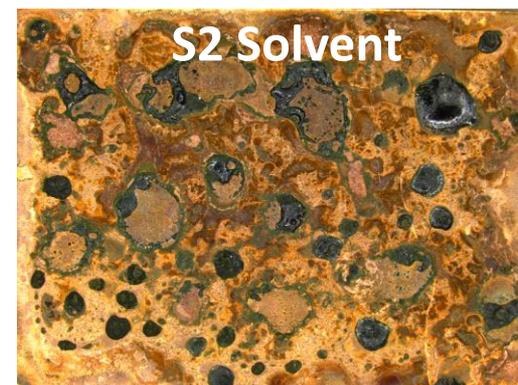
**Figure 3:** Worst of Low Temperature, C1 water soluble ORL1 flux

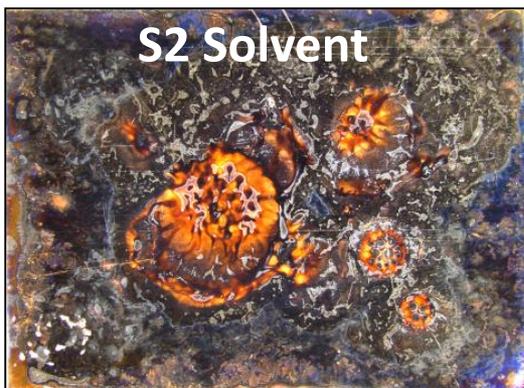
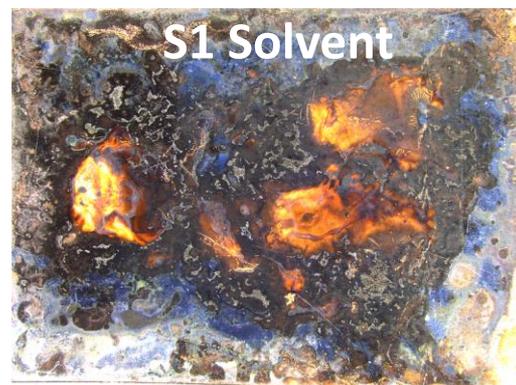
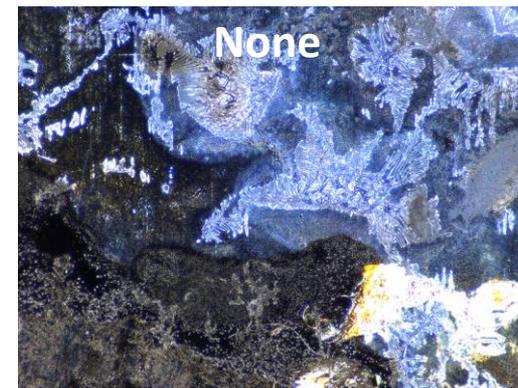
**Figure 4:** Worst of High Temperature, C1 water soluble ORL1 flux

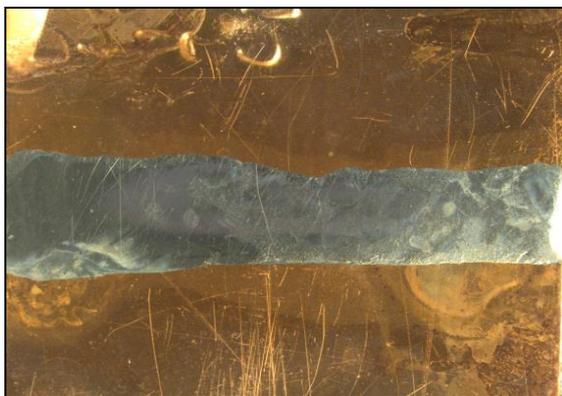
**Figure 5:**  
Clean A,  
BEST, RMA  
flux D,  
defluxer A3

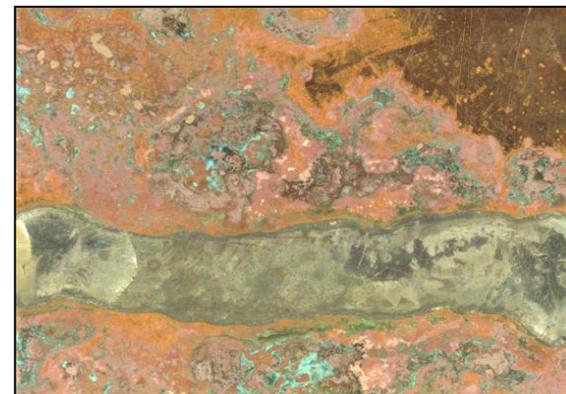
**Figure 6:**  
Clean A,  
WORST,  
ORH1 flux,  
defluxer V3

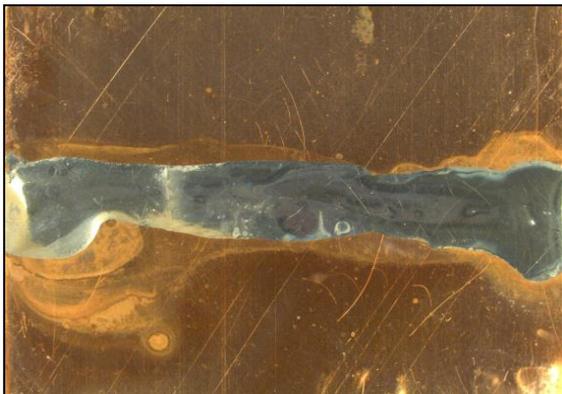
**Figure 7:**  
Clean B  
BEST, RMA  
flux D, DI  
water  
defluxer A1

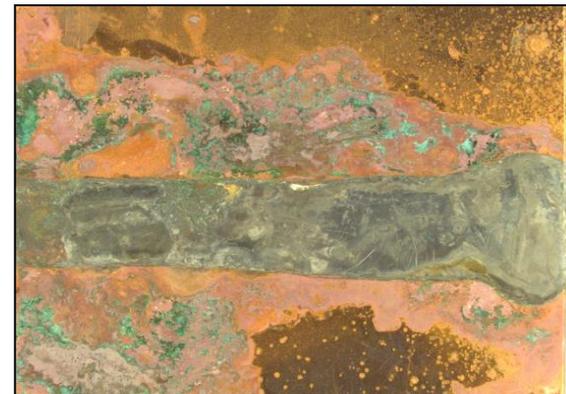
**Figure 8:**  
Clean B,  
WORST,  
ORH1 flux,  
defluxer V1

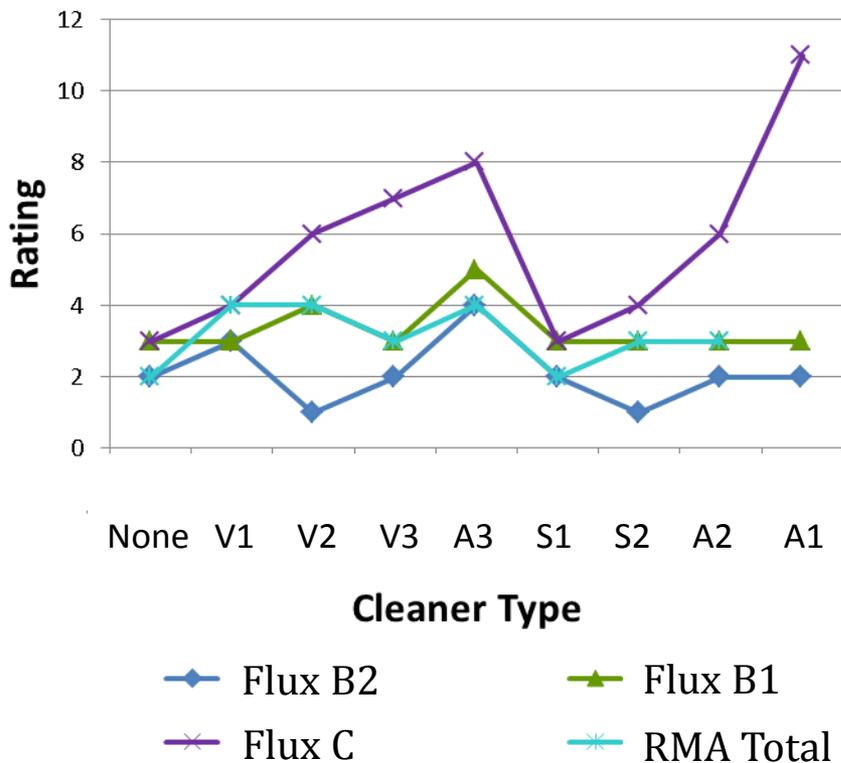
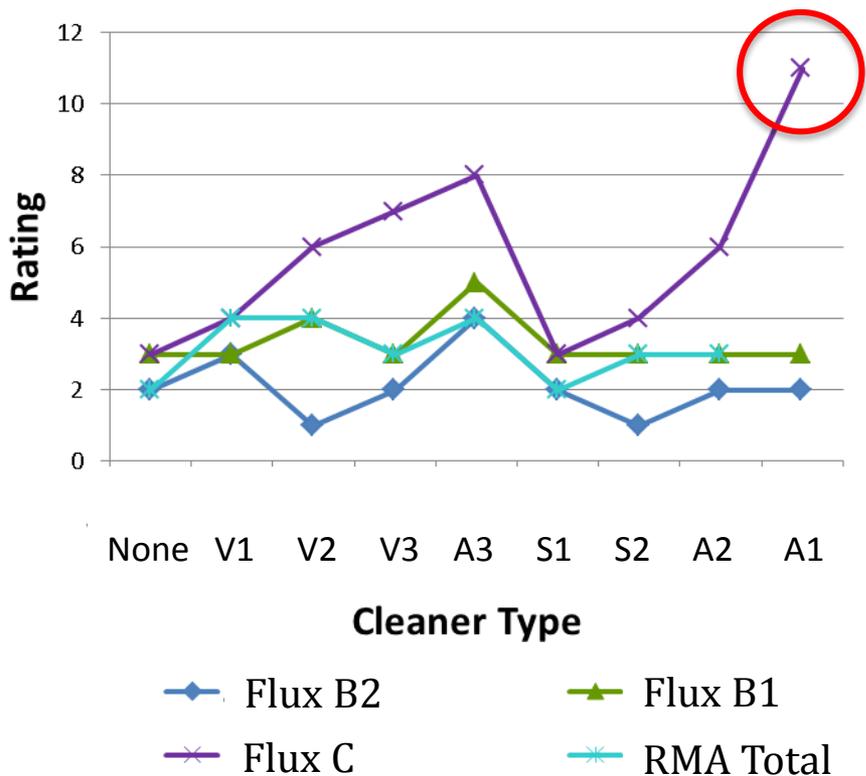
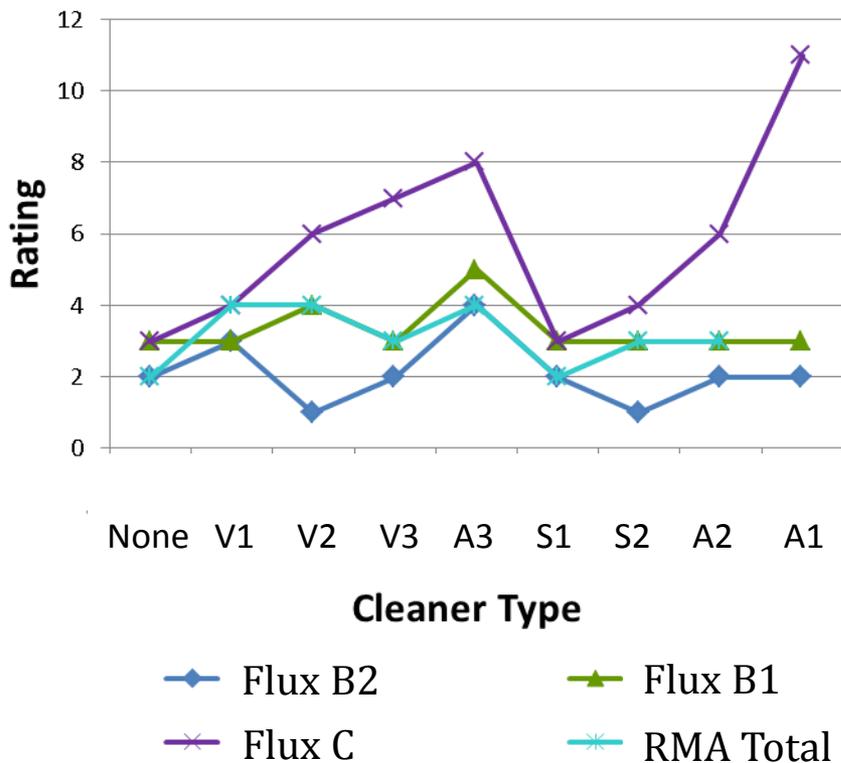
Figure 9: High Temperature

Notes: Fluxes B1 & B2, no-clean, most dependent on cleaner. Flux C, ORH1, worst for both temperatures.

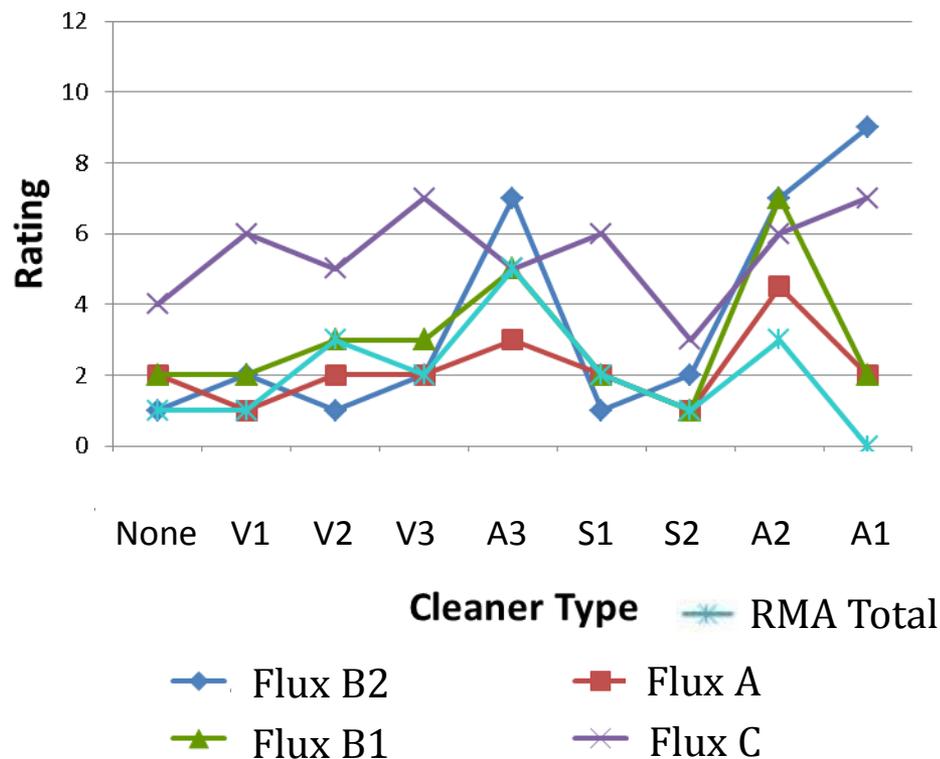
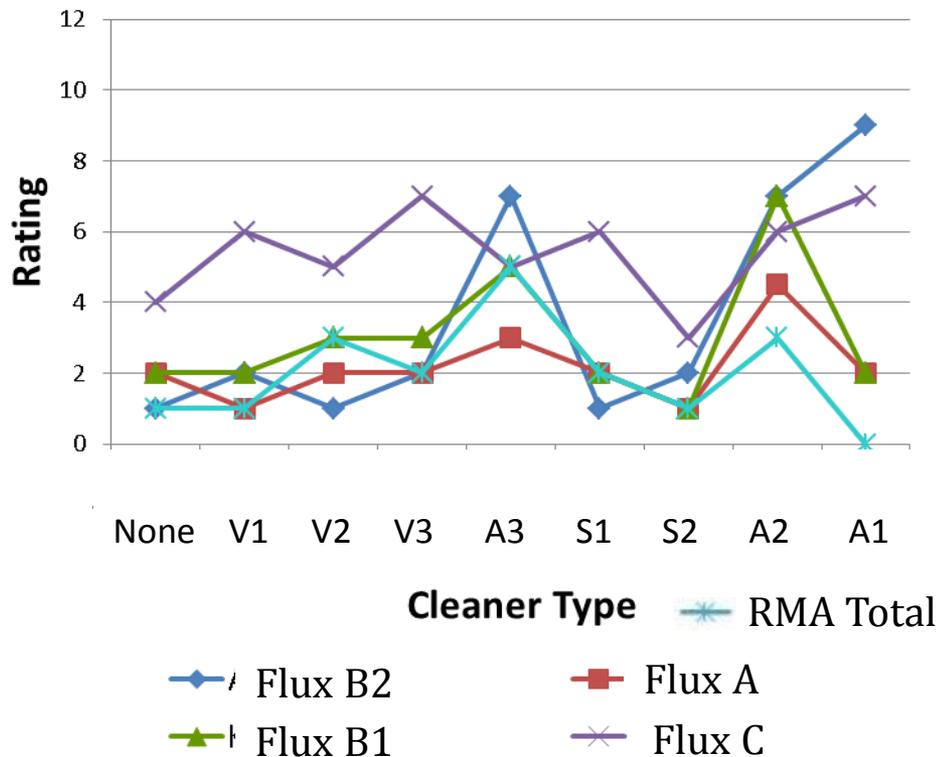
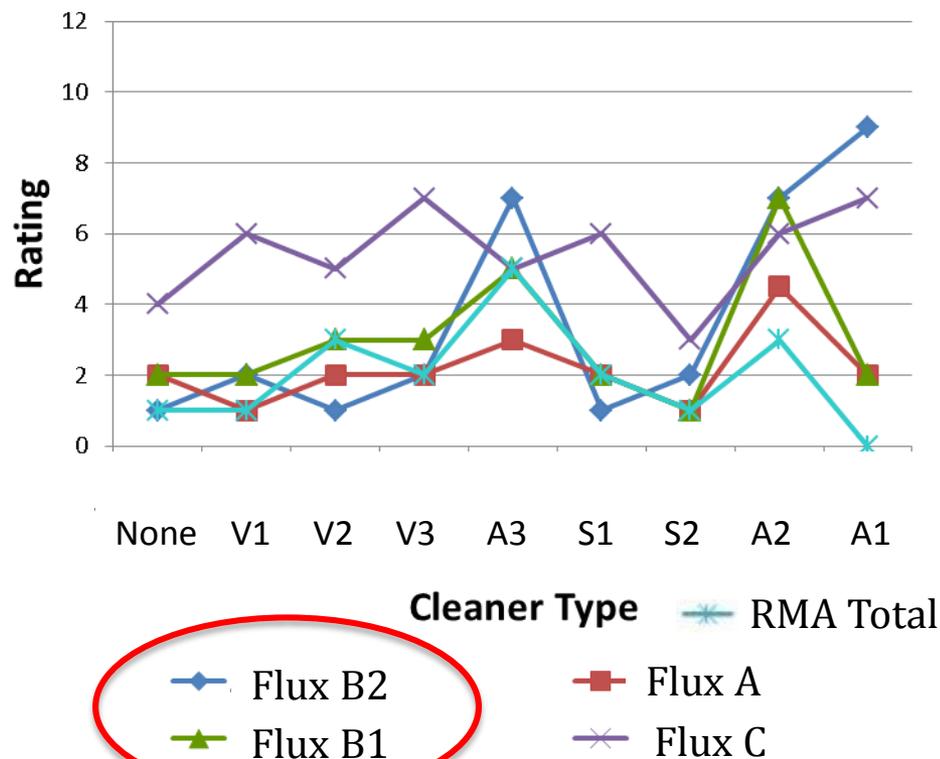
Figure 10: Low Temperature

Note: Flux C, water-sol ORH1, and Cleaner A1 rating is higher due to staining on other coupon materials

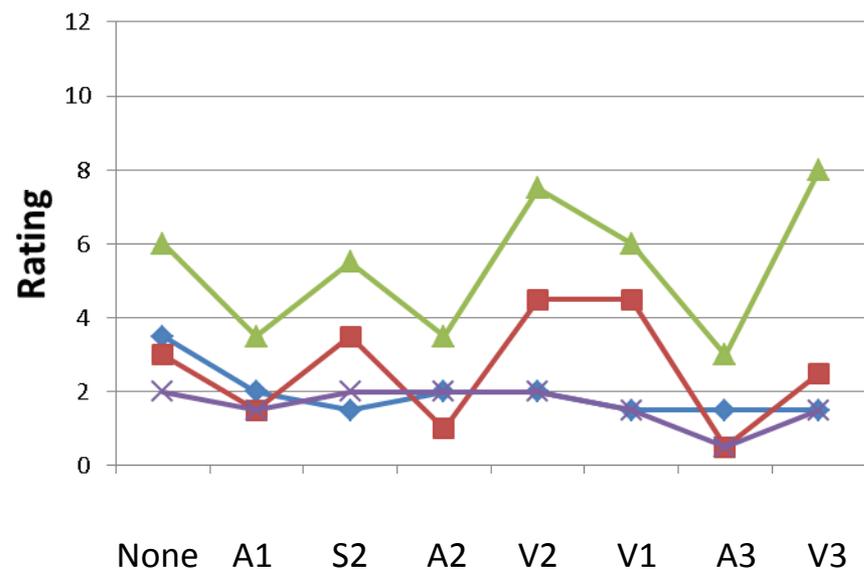
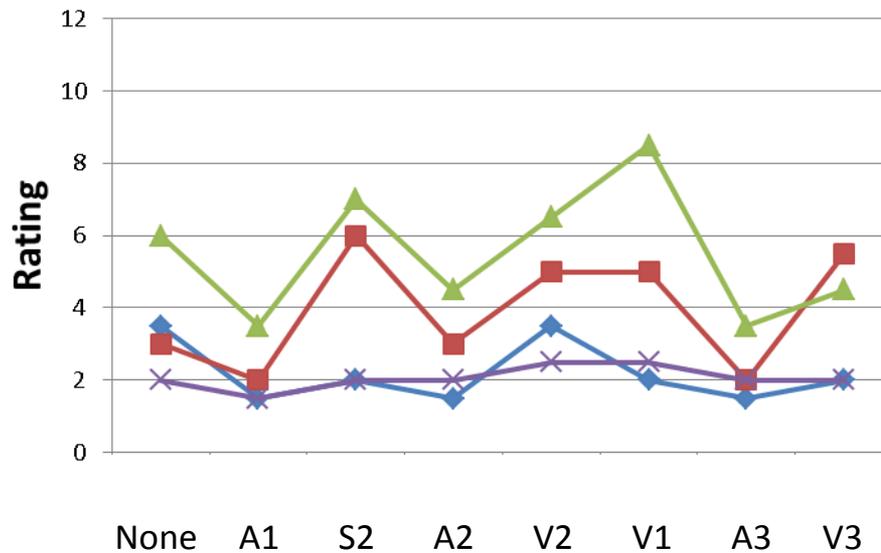
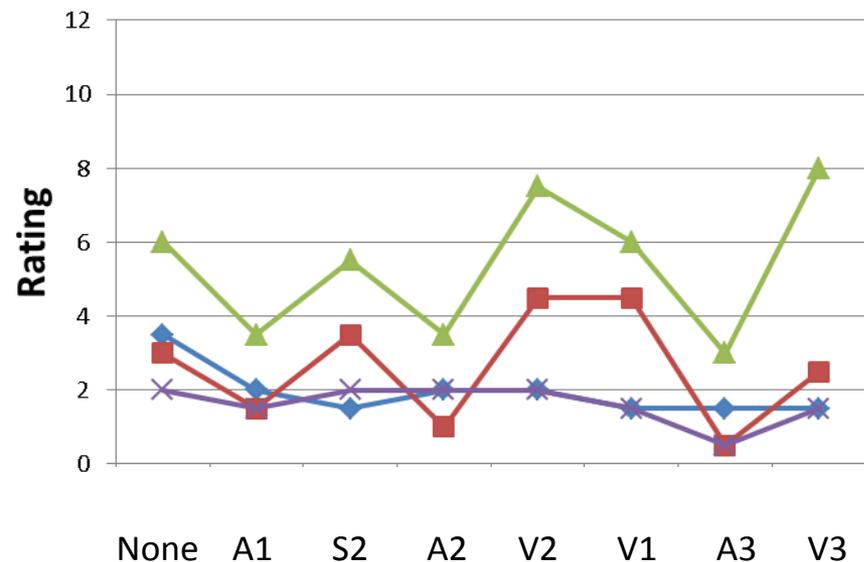
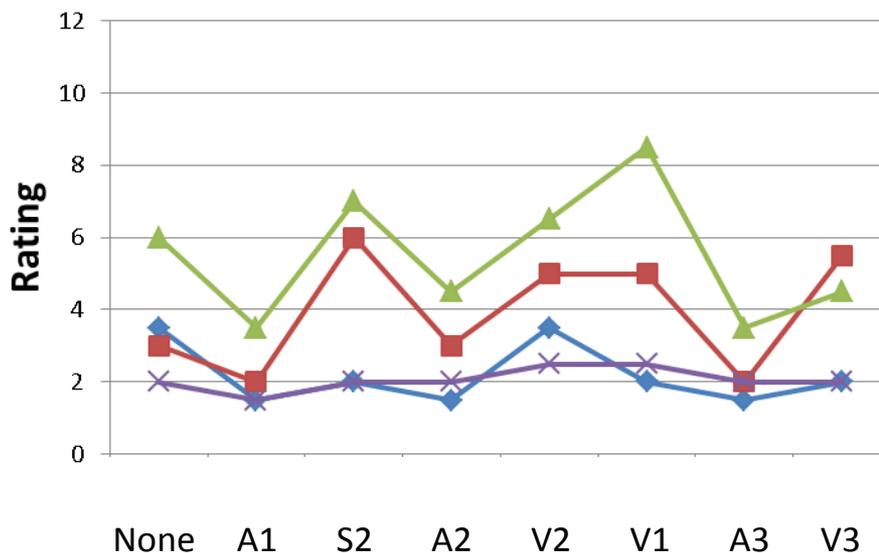
Note: A very minimal clean and rinse was little different from a more thorough clean and rinse, when little physical cleaning action is present (no impingement spray, etc.)

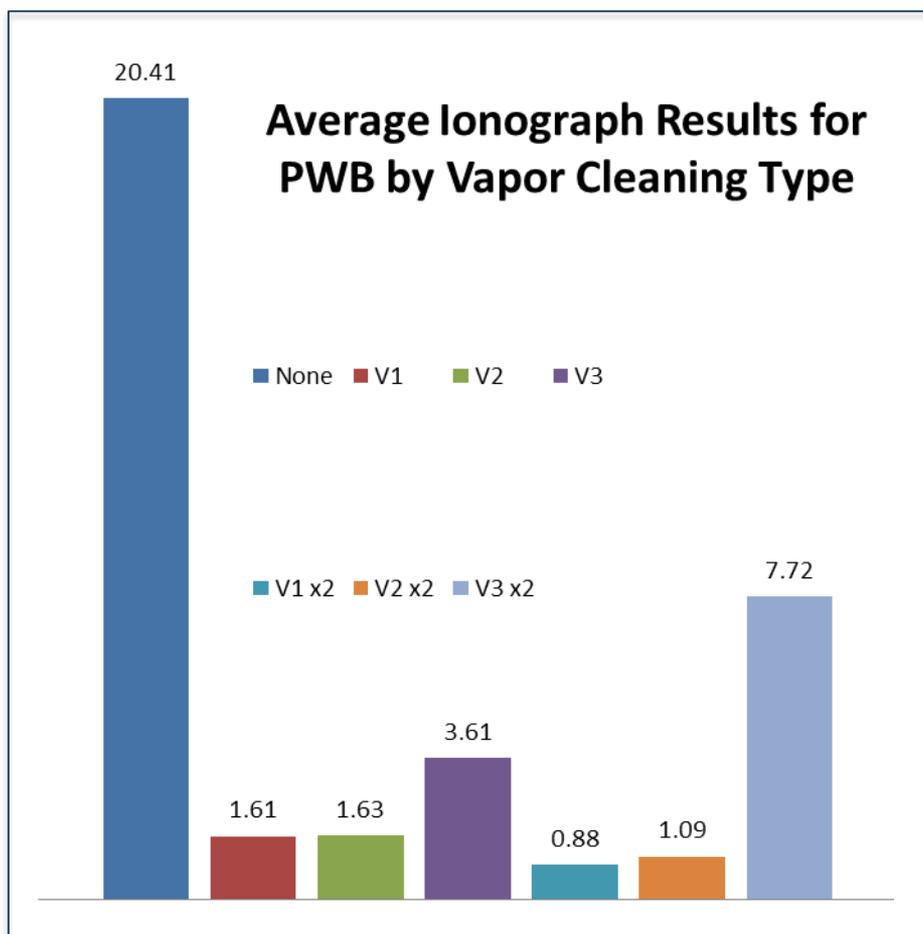
**Figure 14: PWB Ionic Residue**

One set of boards was cleaned by a typical vapor cleaning, the second set cleaned with a double amount of cleaning cycles. All used Sn-Pb solder with RMA flux at elevated (380<sup>0</sup>C) temperatures.

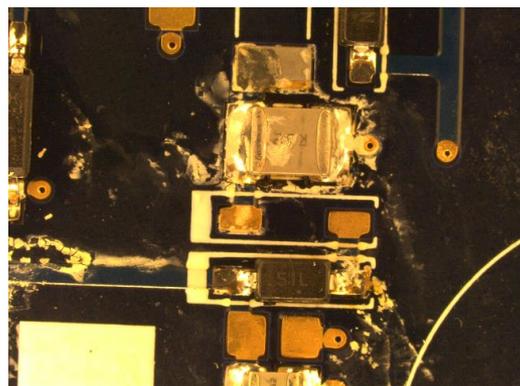
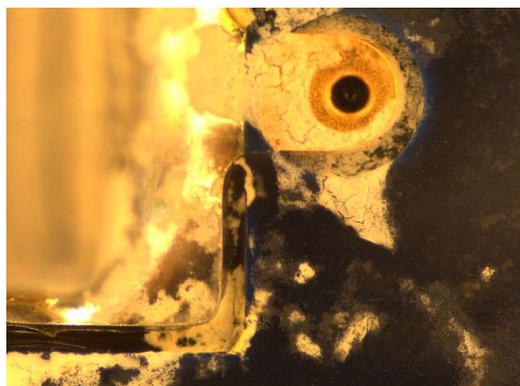
**Figure 15: PWB Flux Residue**

One PWB example had visible residue: V3 Vapor defluxer. V3 had the highest Ionograph readings as well.
