Assembly Cleanliness and Whisker Formation

Polina Snugovsky¹, Eva Kosiba¹, Stephan Meschter², Zohreh Bageri¹, Jeffrey Kennedy¹

**Final Inspection after 16,000
hours 25°C, 85%RH**

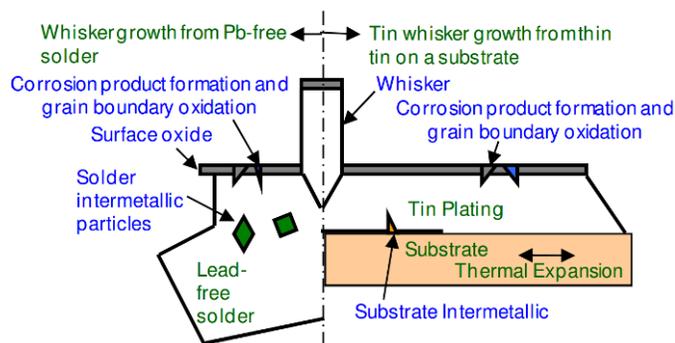
Local compressive forces within the solder joint are thought to be responsible for the nucleation and growth of tin whisker.³ Figure 1 provides a schematic representation of some of the compressive forces, experienced by a solder joint or a component lead, which may lead to the growth of a whisker. It is believed that the tin whisker provides a means of relieving the stress built up within the material due to the compressive forces. When exposed to high humidity levels, as in this study, it has been shown that the Sn reacts with oxygen to form Sn oxides, SnO or SnO₂, resulting in a volume expansion.⁴ This expansion provides the local compressive force acting on the bulk solder.

Figure 1: Source of compressive stress contributing to whisker growth⁵

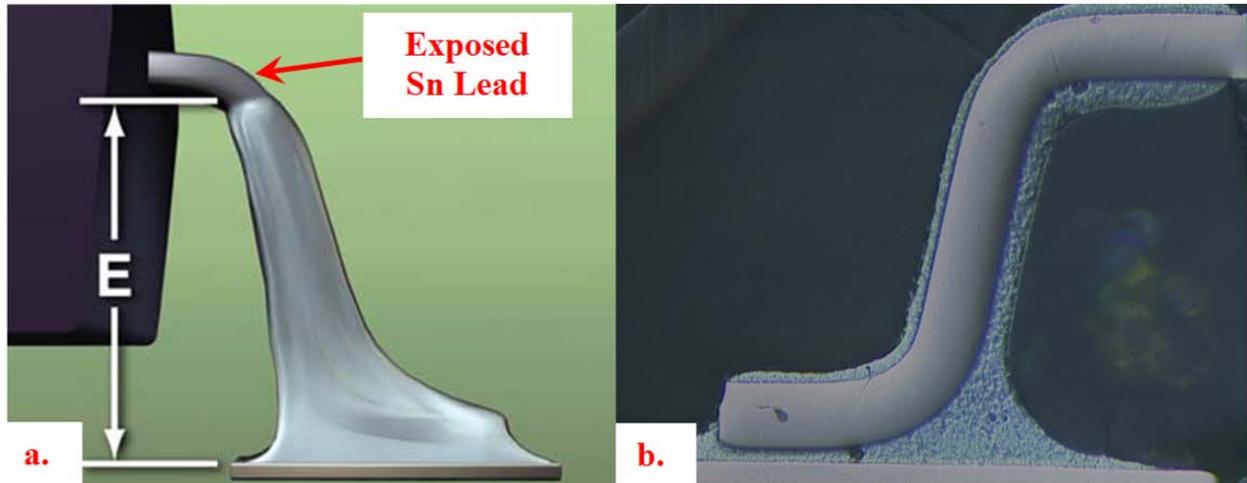
Oberndorff et al. found that fewer and shorter whiskers grew on Sn plated components assembled with SnPb than on loose components when exposed to high temperature, high humidity conditions (60°C/93% RH).⁶ The opposite was found to be true for Pb-free assemblies. During assembly using a SnPb solder, the solder is expected to wet a portion of the lead and form a fillet while the rest of the lead maintains its original plating material (Figure 2a). Due to the higher reflow temperatures used to assemble SAC solders, the electroplated Sn on the lead frame melts. The solder is therefore likely to completely wet and cover the lead (Figure 2b).³

Figure 2: (a) Schematic for a typical solder joint of a leaded component using SnPb solder⁷, (b) cross section showing solder joint formed with Pb-free solder

It has been previously proposed that covering a lead completely with SnPb solder would provide some mitigation for whisker growth.² The same however can not be said for SAC solder alloys, where, it has been found that whiskers grow directly from the solder.⁸ The rough surface produced by SAC alloys, through the dendritic growth of β Sn resulting in surface shrinkage voids, provide locations to entrap contaminants. It may, for example be difficult to clean unreacted flux from the rough surface of a solder joint during production. When exposed to high humidity, it is also possible that these shrinkage voids provide locations for moisture to condense.

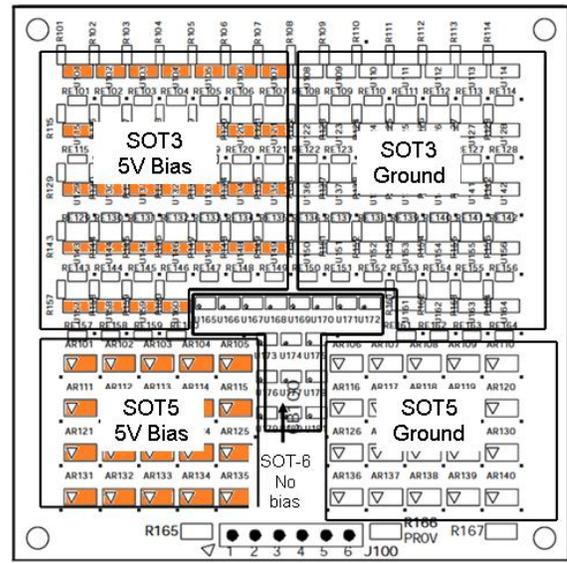
Figure 4: Test Vehicle Electrical Schematic

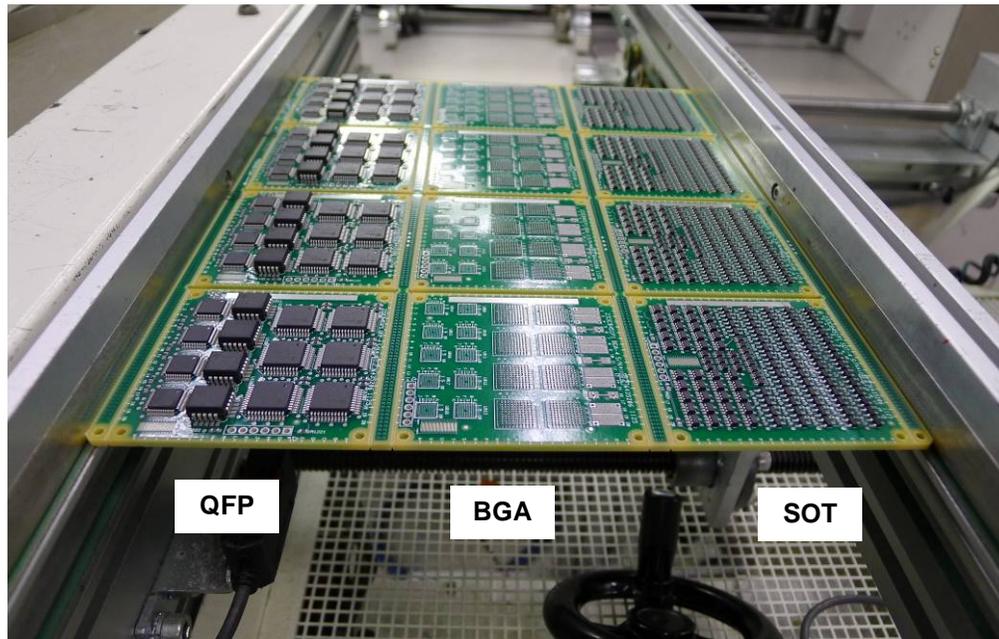
The test vehicle was assembled as part of a panel (Figure 5) which included 4 of the boards described above (SOT board) as well as two other board types: a BGA board (not populated in the image) and a QFP board. The panels were assembled at Celestica between August 9-17, 2011, using a SAC305 solder paste

Figure 5: Test Vehicle Panel Assembly including QFP, BGA and SOT boards

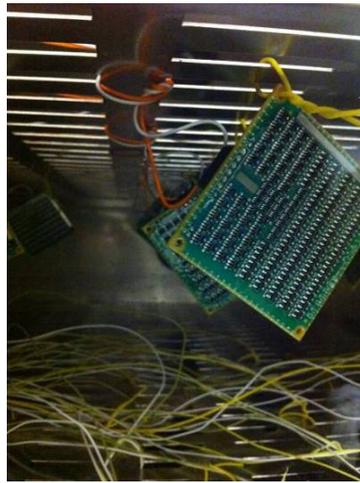
Assemblies were then placed in a temperature and humidity chamber (Figure 8 and Figure 9). The samples were all connected to a power supply set at 5V. The chamber was set to run at 25°C and 85%RH. All precaution was taken to prevent condensation..

Figure 8: Samples in Temperature/Humidity Chamber

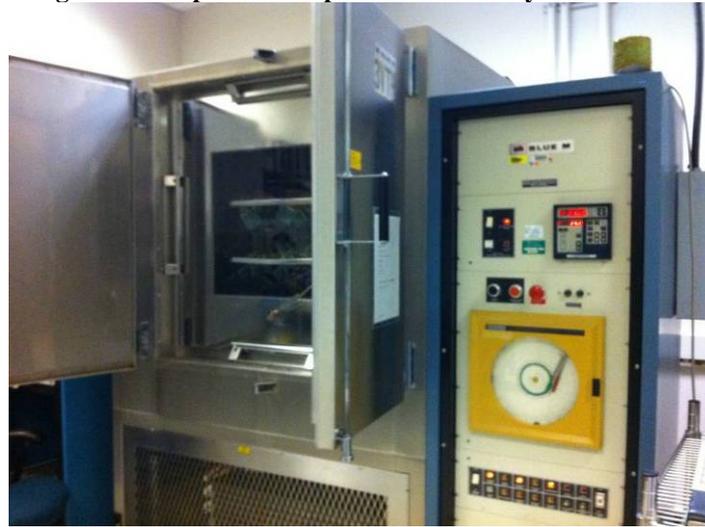
Figure 9: Temperature/Humidity Chamber

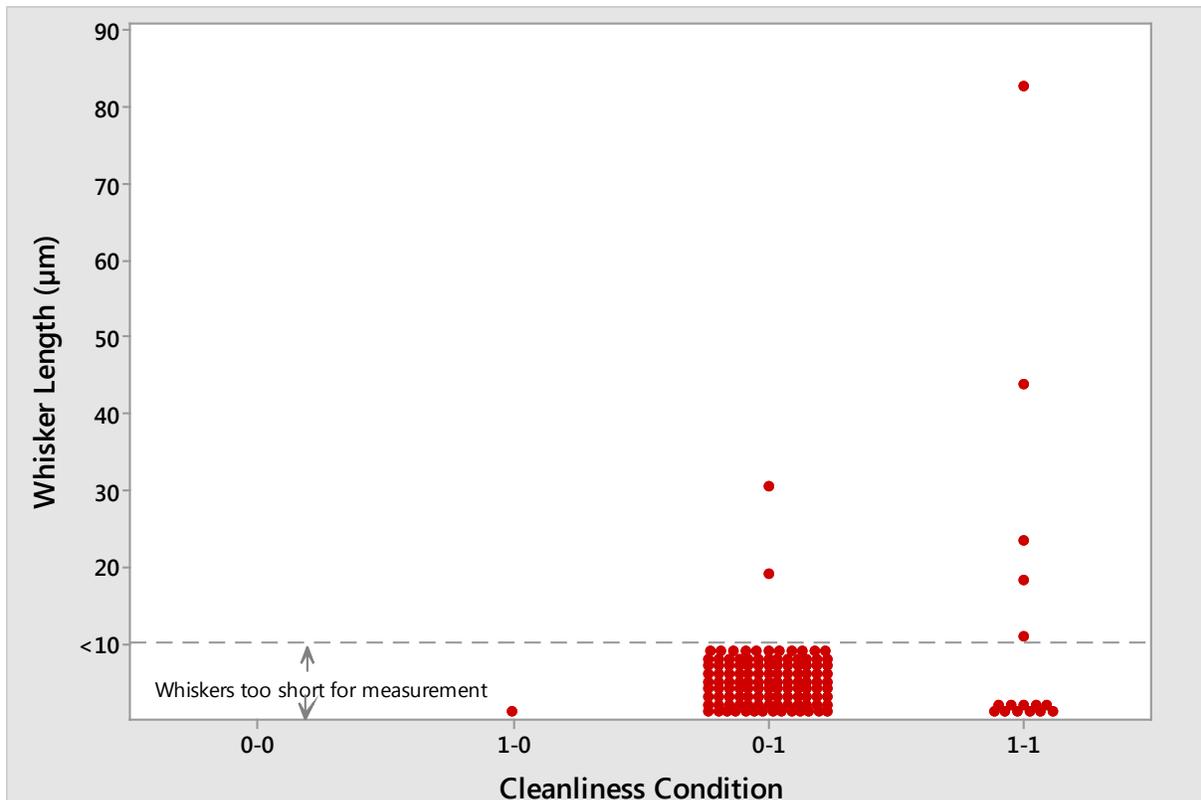
After 16000 hours of exposure at ambient temperature and high humidity assemblies built with clean components then further cleaned after assembly exhibited no whisker growth. Only one whisker was observed on SOT3 components when contaminated components were used and the assembly was cleaned prior to exposure, and this whisker did not exceed 10µm. Contaminated assemblies, both with clean and with contaminated components exhibited more whisker growth on SOT3s. The contaminated assembly built with clean components resulted in the most whiskers at 117, however only two measured longer than 10µm. On the other hand, contaminated assemblies with contaminated components produced 16 whiskers in total on SOT3, however 5 were longer than 10µm and one reached a total length of almost 83µm.

Figure 10: Length of Whiskers on SOT3 after 16000 hrs at 25°C/ 85% RH

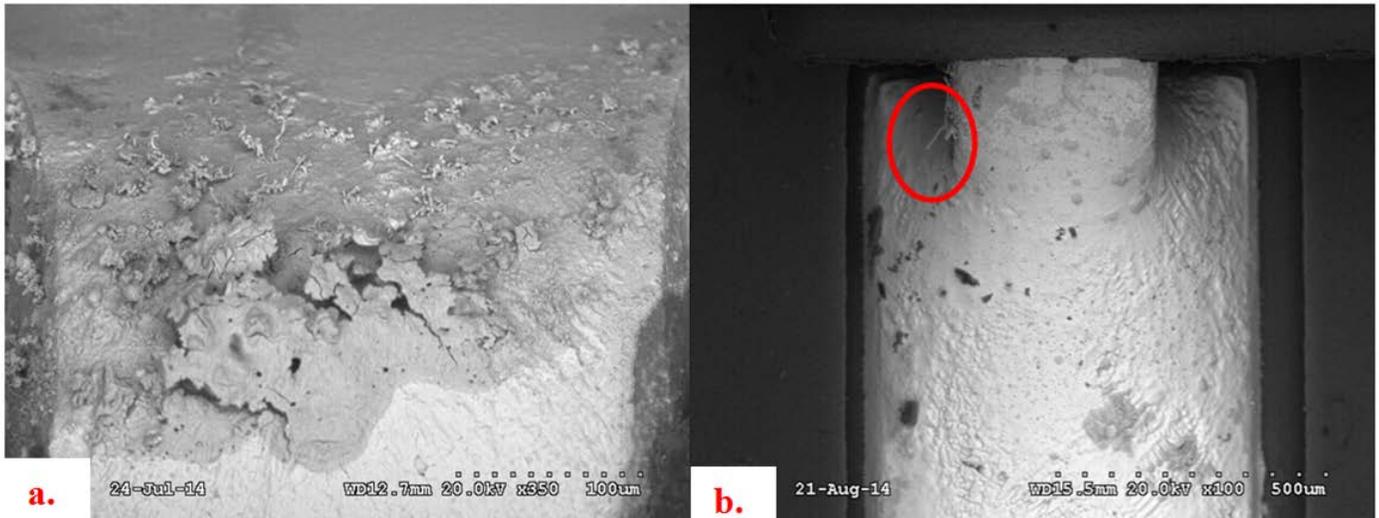
Figure 11: SOT3 after 16,000 hours at 25°C/85% RH. Contamination condition 0-1 (a) showed more whiskers than contamination condition 1-1 (b) however they were generally shorter

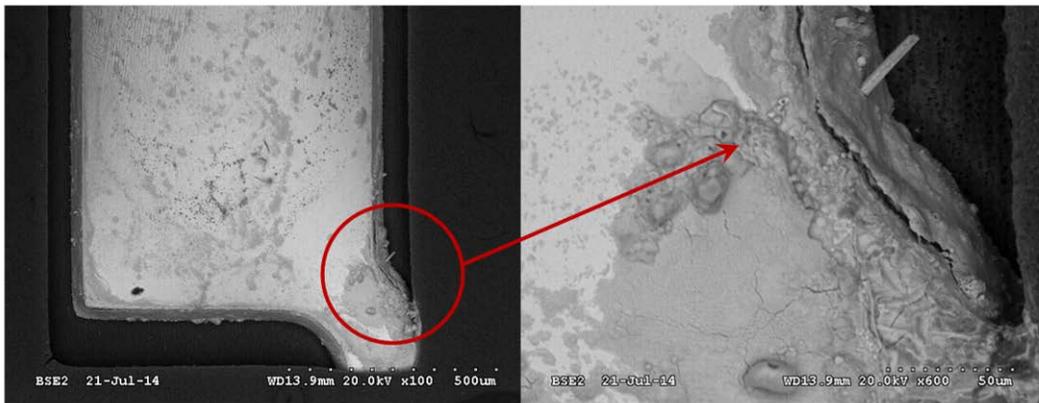
Whisker growth on the SOT3 components directly correlated with the degree of oxidation observed (Table 10). No oxidation was visible on the assemblies built with clean components and then cleaned again prior to exposure. Consequently no whiskers were observed. A small amount of oxidation occurred when contaminated components were used, and the assembly was cleaned prior to exposure, resulting in one very short whisker. Contaminated assemblies showed a greater degree of oxidation and resulted in the formation of whiskers; both normal and hollow shaped whiskers were observed. Figure 12 shows oxidation forming around an intermetallic compound (IMC) which is likely the result of differing chemical potentials between the bulk β Sn and the IMC structures. A whisker is found to have formed near by. Figure 13 shows a whisker growing from an area of high oxidation.

Figure 13: Whisker growing near site of oxidation on SOT3 at contamination condition of 0-1

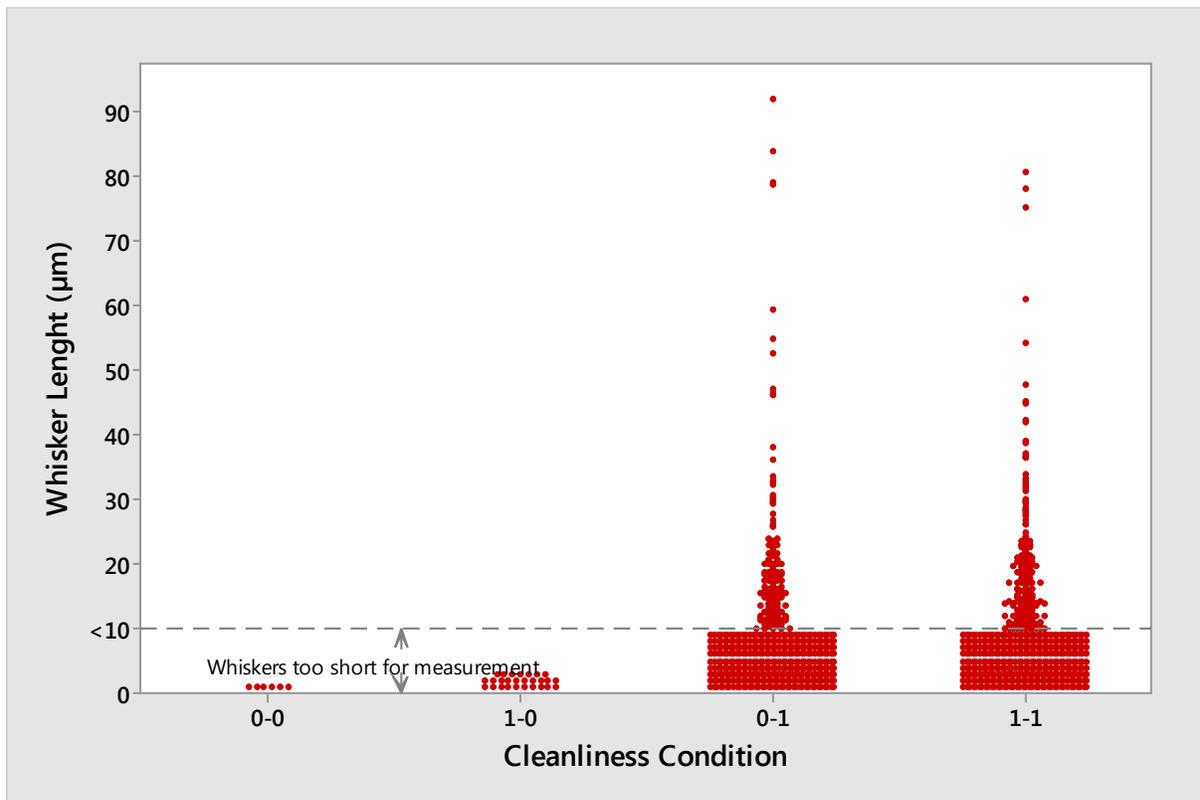
SOT5s, which have lead frames of Cu194, exhibited the most whisker growth of the three component types. Cleaned assemblies, both with clean and with contaminated components showed some whisker growth, a total of 6 and 27 whiskers respectively, however none were longer than 10µm. Contaminated assemblies, both with clean and with contaminated components, exhibited a great deal of whisker growth with over 90% of the leads exhibiting some degree of whiskering. The most whiskers were observed on the contaminated assembly with contaminated components, however the longest whisker was observed when clean components were used.

Figure 14: Length of Whiskers on SOT5 after 16,000 hrs at 25°C/ 85% RH

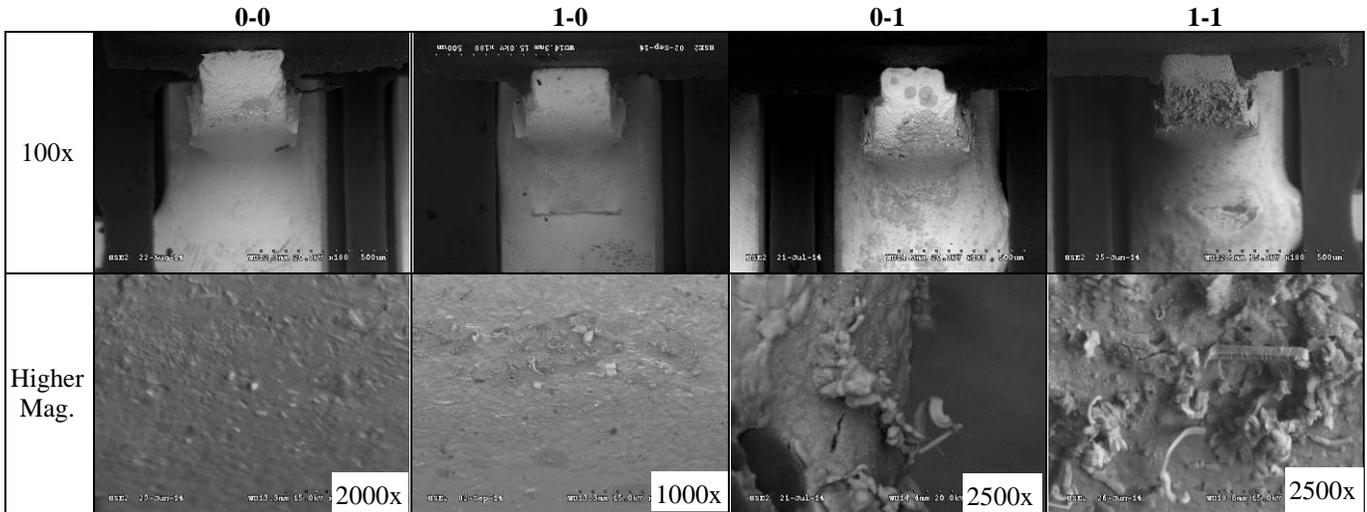
Figure 15: Recrystallized grain, oxidation occurring around IMC on SOT5, contamination condition of 1-0

Table 11 provides a summary of the observed oxidation levels on SOT5 components. Similar to the results on the SOT3 components, SOT5 showed very little oxidation and whisker growth on cleaned assemblies, both with clean components and with contaminated components. Where whiskers did appear, they were very short. On clean assemblies built with contaminated components, there was some recrystallization of grains observed as well as a small amount of oxidation forming around IMC particles (Figure 15). When boards were contaminated (both clean and contaminated components) oxidation and consequently whisker growth increased in both density and length. Every component that was part of the contaminated assembly subset experienced some degree of whisker growth as did over 90% of the leads. When long whiskers occur (Figure 16), they are very thin, approximately 0.1 to 0.4µm, and are not visible at magnifications of 250-300x (Figure 17). These extremely thin whiskers usually appear to be straight, but are sometimes kinked (Figure 18).

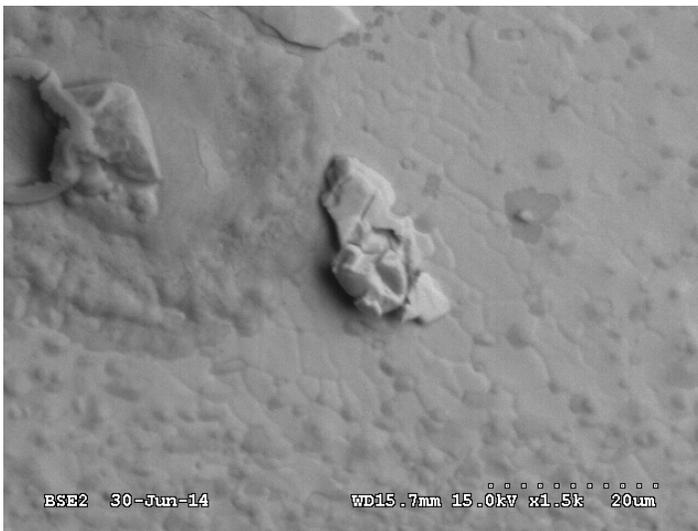
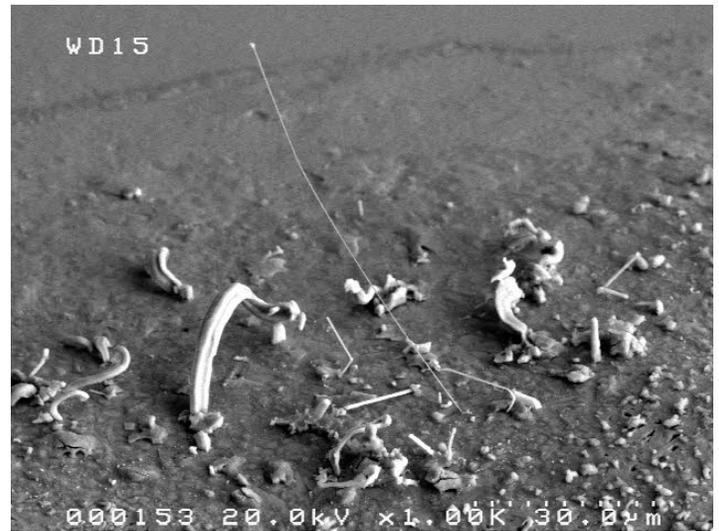
Figure 16: Long, thin whiskers (0.1- 0.4µm diameter) on SOT5 with a contamination condition 1-1

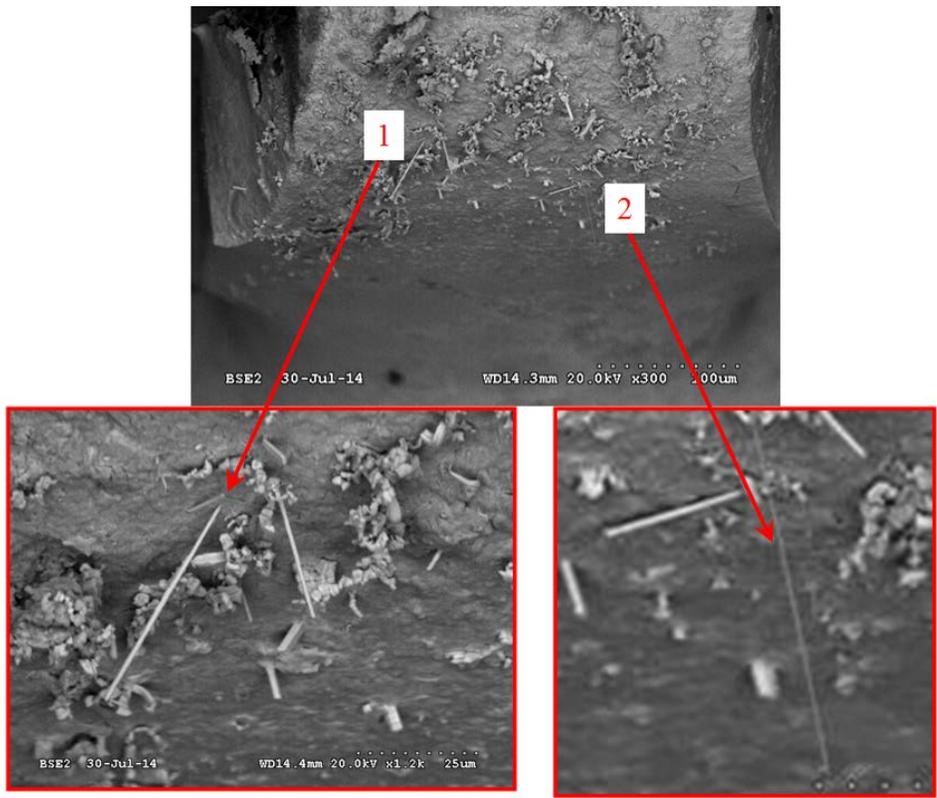
Figure 17: Very long, very thin whiskers on SOT5, contamination condition 1-1

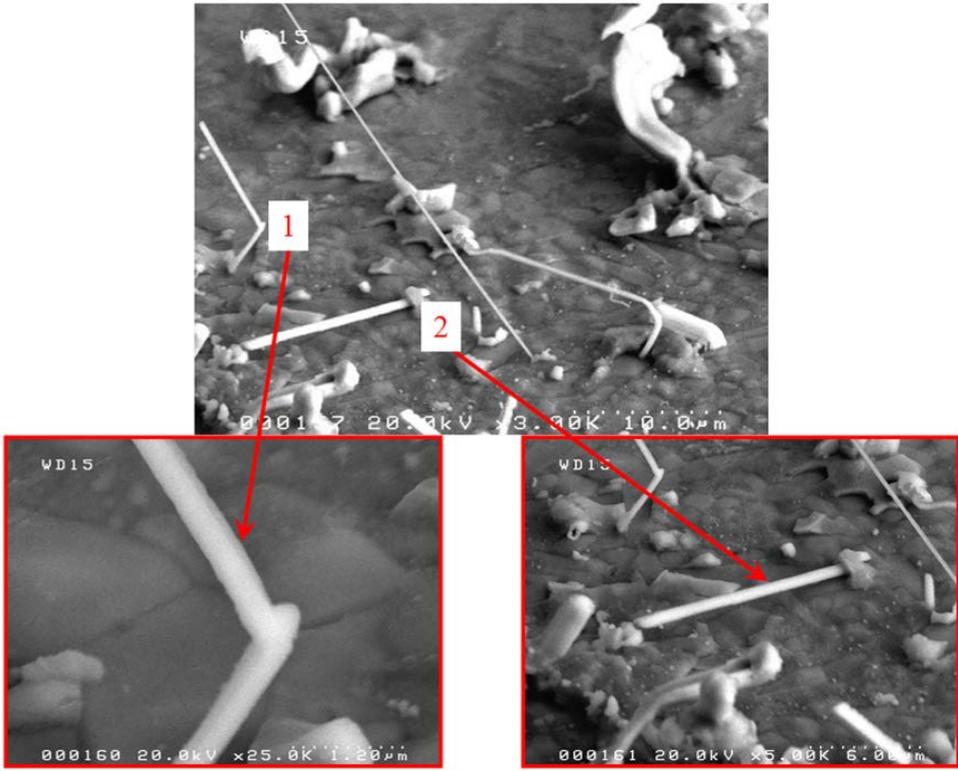
Figure 18: Both straight (2) and kinked (1) long whiskers appear on SOT5 on SOT5, contamination condition 1-1

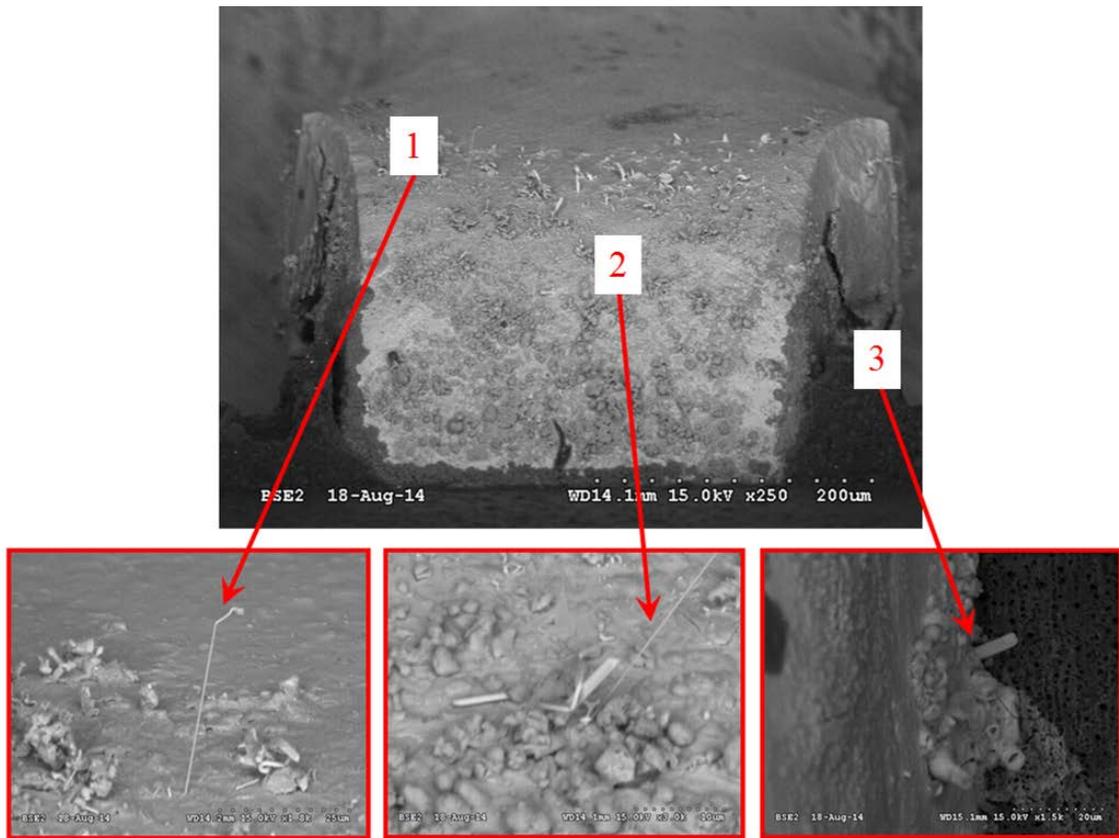
Figure 19: Whiskers of different dimensions growing from a SOT5, contamination condition 1-1 long, kinked whisker (1), very long, very thin whisker (2) and hollow whisker (3)

Both hollow and “normal” whiskers were observed after 16,000 hours of 85C/85%RH (Figure 19). Figure 20 is a schematic showing the relative location of each type of whisker; “normal” whiskers grow in locations L4, L3 and L1, hollow whiskers grow on L2, and L5.

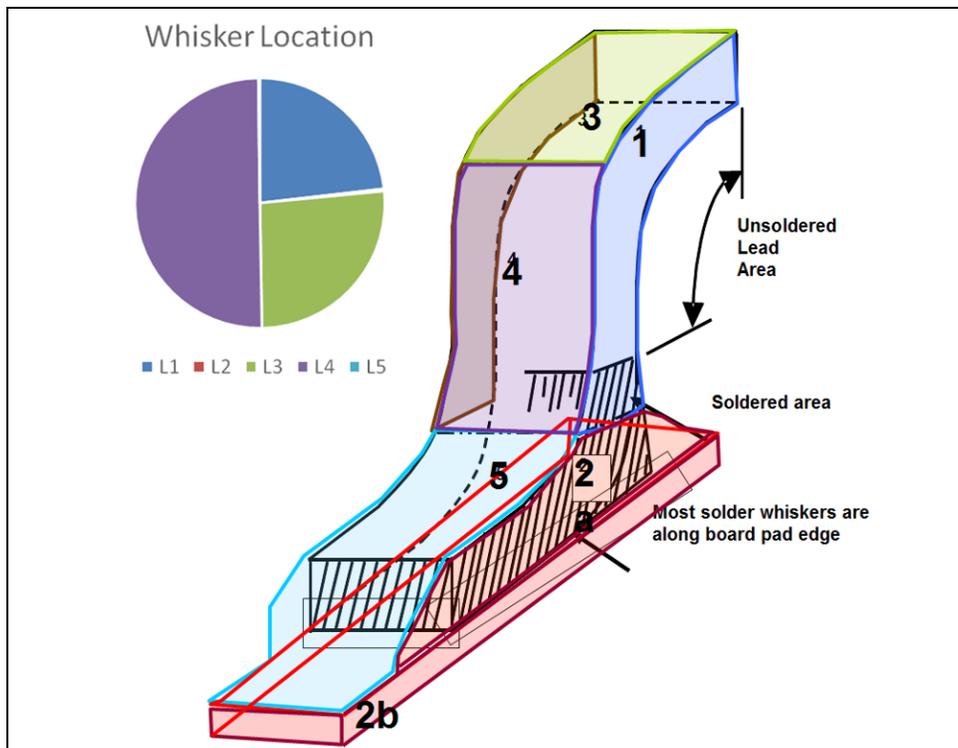
Figure 20: Schematic showing location of whiskers on a lead

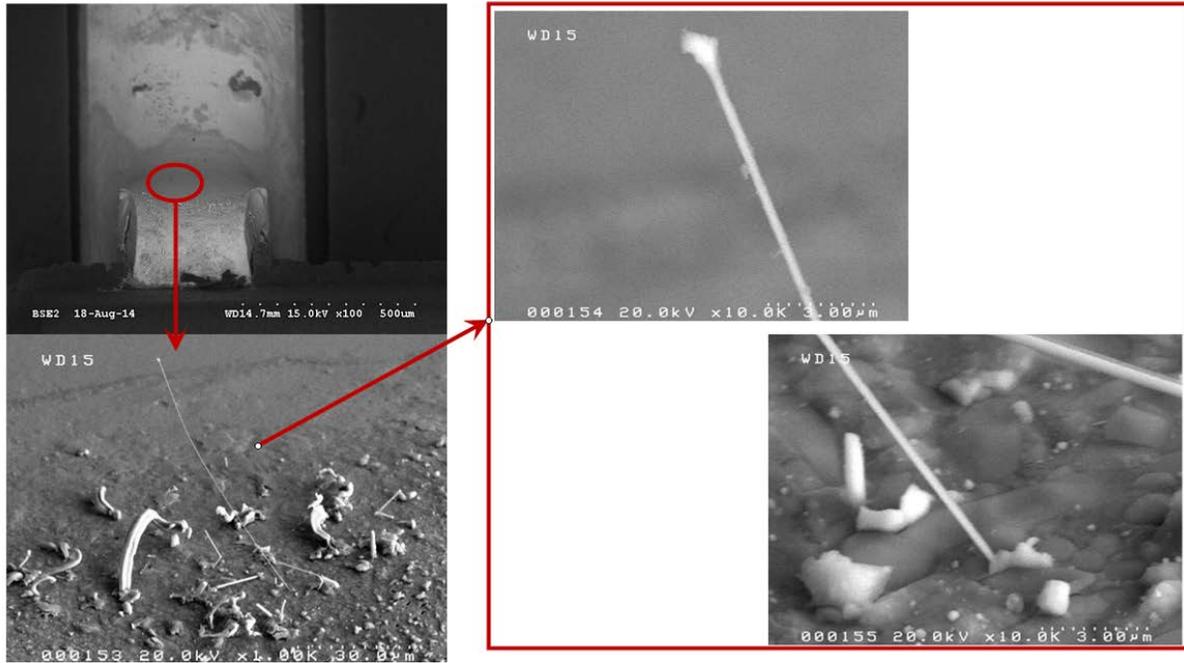
Figure 21: Whisker growing on SOT5 with contamination condition 1-1 after 16,000 hrs at 25°C/85%RH (Length – 80.7µm, Diameter – 0.3µm)

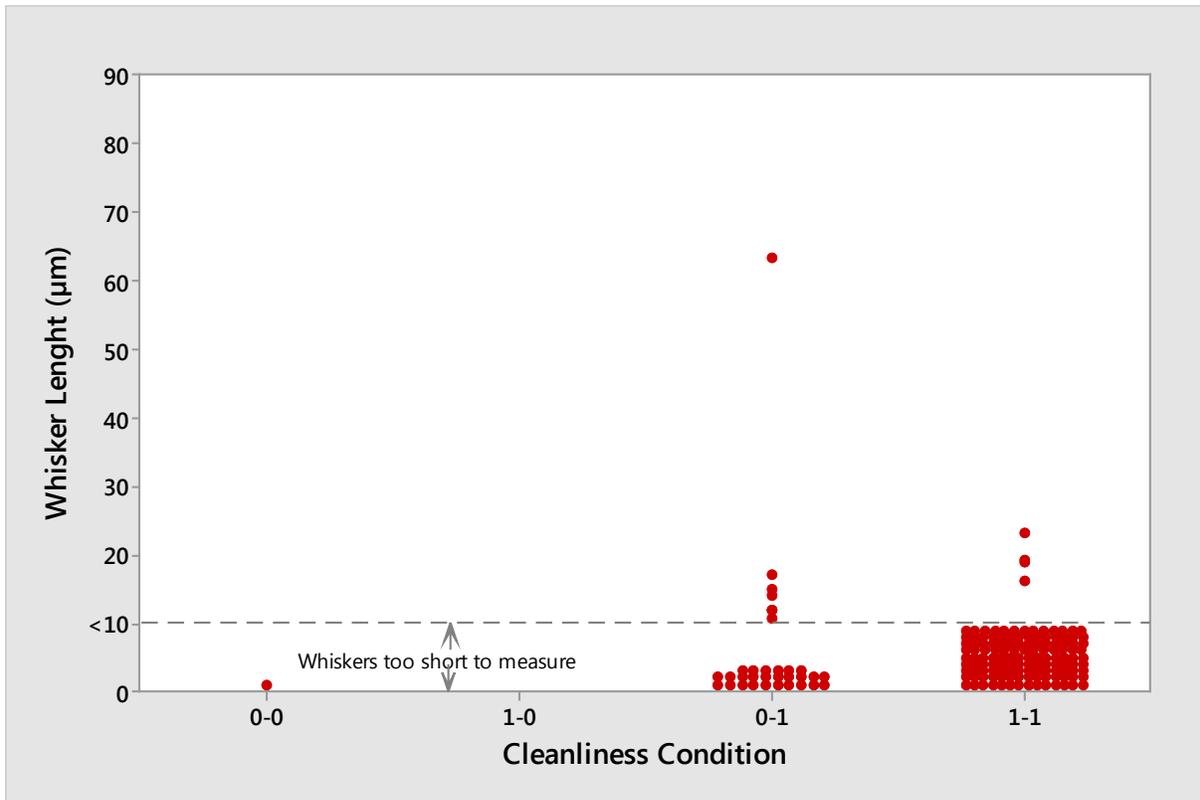
SOT6 components on clean assemblies, exhibited very little whiskering with only one whisker growing on an assembly built with clean components and none when contaminated components were used. This one whisker did not exceed 10µm. The contaminated assemblies showed a significant amount of whiskering, with over 40% of leads exhibiting whiskers. The contaminated boards with contaminated components showed more whiskers with a total of 126, however with clean components longer whiskers were observed with a total of 7 exceeding 10µm.

Figure 22: 7 Longest Whiskers on SOT6 after 16,000 hrs at 25°C/ 85% RH

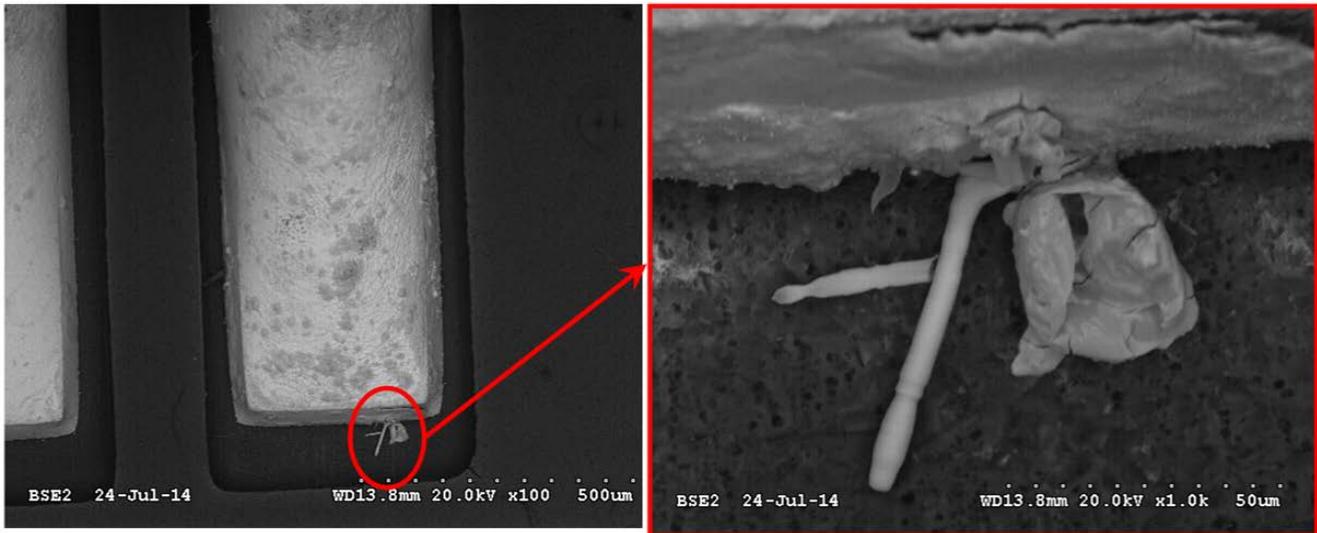
Figure 23: Hollow whiskers growing on SOT6, contamination condition 0-1 in location L2

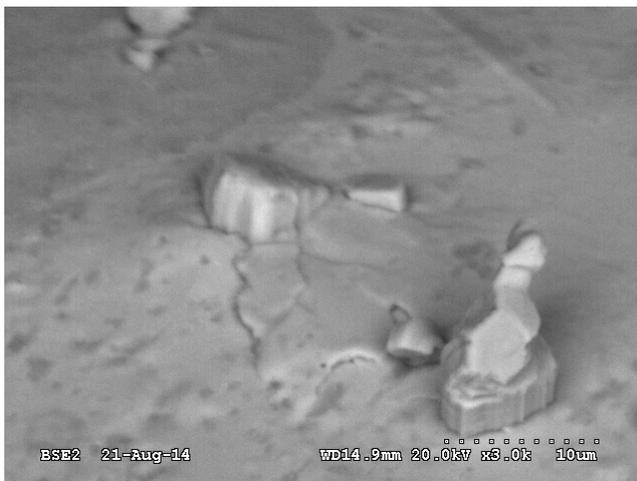
Figure 24: Many short whiskers SOT6, contamination condition 1-1

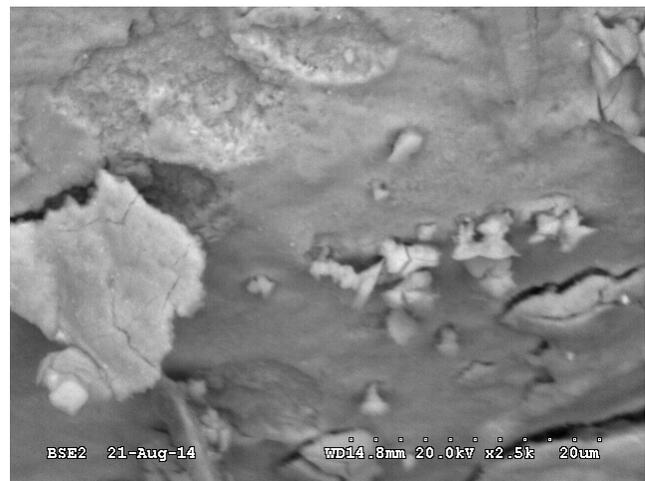
Figure 25: Whiskers at site of oxidation SOT6, contamination condition 1-1

Similar to the SOT3, the SOT6 leads are made from Alloy 42 leadframe material plated with matte Sn. The amount, and length of whisker growth correlates to the degree of oxidation observed on the lead (Table 14). Similar to the SOT5s, most “normal” whiskers were found in locations L4, L3 and L1, while the hollow whiskers could be found L2 and L5 (Figure 23). In general, where there was a high degree of oxidation; contaminated assemblies – there appeared many short whiskers (Figure 24). These whiskers often appeared at the site of the oxidation (Figure 25).

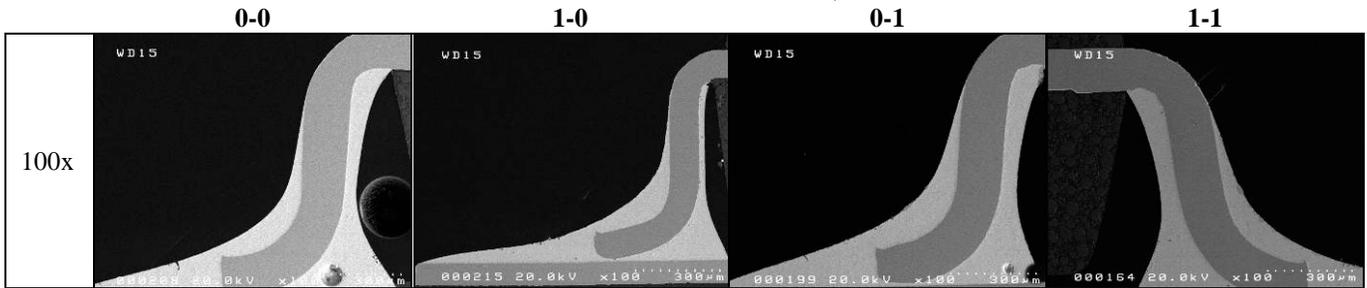
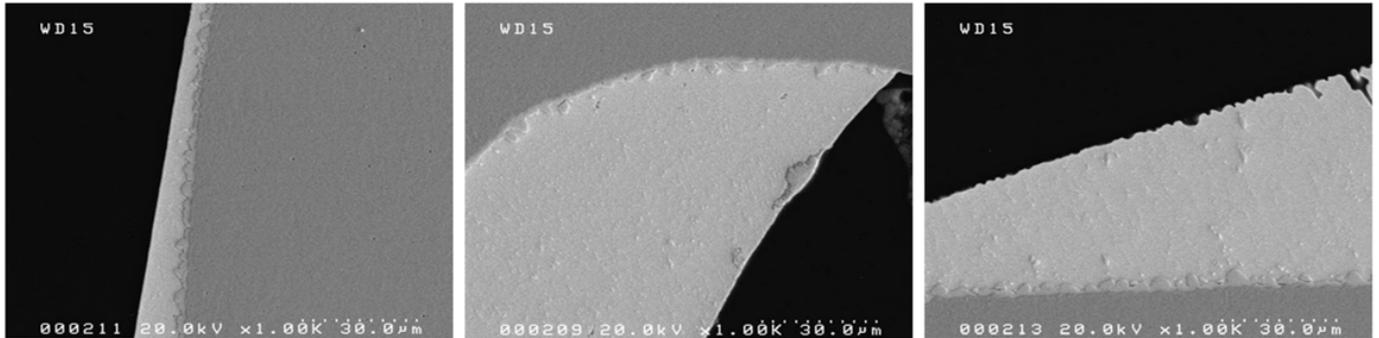
Figure 26: Little to no oxidation visible on SOT5 after 16,000 hrs at 25°C/85%RH with contamination condition 0-0

Further analysis of the test samples was performed by cross sectioning. In this study SOT5s, made from Cu194, was the focus as they exhibited the highest degree of whisker growth. Samples that were assembled using clean components, and then further cleaned after assembly (contamination condition 0-0) had no visible oxidation either at the surface of the solder, or throughout the bulk (Figure 26). This corresponded to very little whisker growth, with no whiskers growing beyond 10 μ m. Cross sections of samples built with contaminated components but cleaned after assembly (contamination condition 1-0), showed little to no surface oxidation. There was however, corrosion visible in the bulk of the solder (Figure 27) which propagated through the interdendritic spaces. The formation of this oxide within the bulk may contribute to compressive stress which ultimately lead to whisker formation.¹³

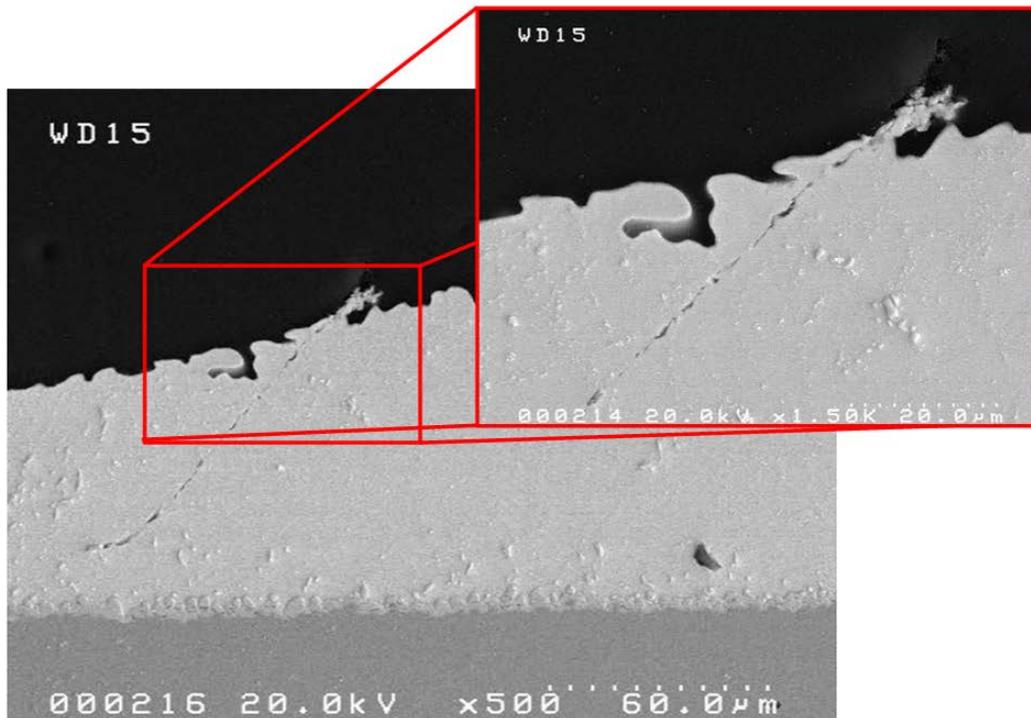
Figure 27: No surface oxidation, corrosion in interdendritic spaces within solder on SOT5 after 16,000 hrs at 25°C/85%RH with contamination condition 1-0

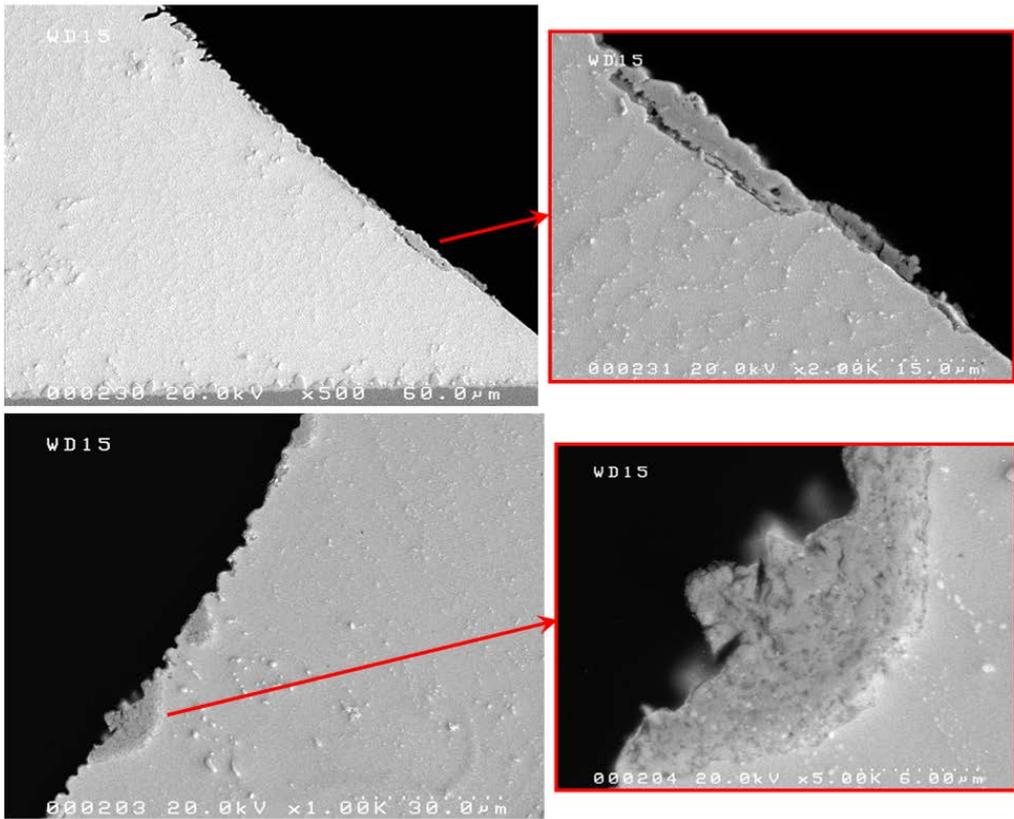
Figure 28: Significant surface oxidation on SOT5 after 16,000 hrs at 25°C/85%RH with contamination condition 0-1

Samples which were cleaned after assembly, both those assembled with clean components (0-1) and those with contaminated components (1-1) showed a significant degree of surface oxide formation (Figure 28). The amount and degree of whiskering also increased in direct correlation as seen in the whisker inspection results above. By analyzing the cross sections of these assemblies, it was also clear that the whiskers themselves experienced oxidation (Figure 29, Figure 30).

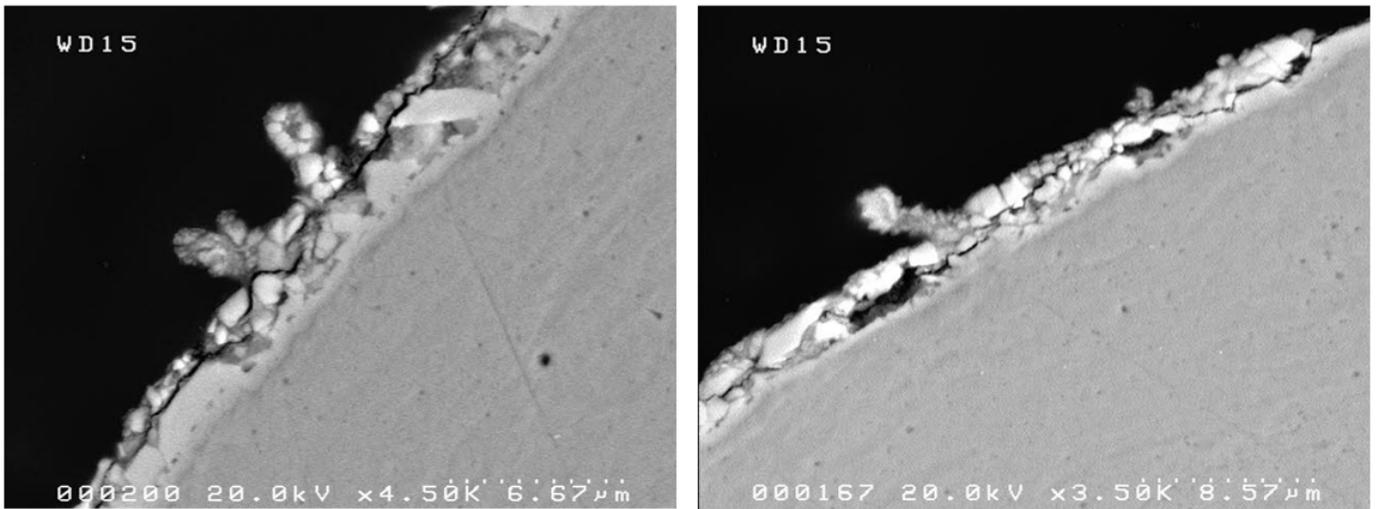
Figure 29: oxidized whiskers observed on SOT5 after 16,000 hrs at 25°C/85%RH with contamination condition 0-1

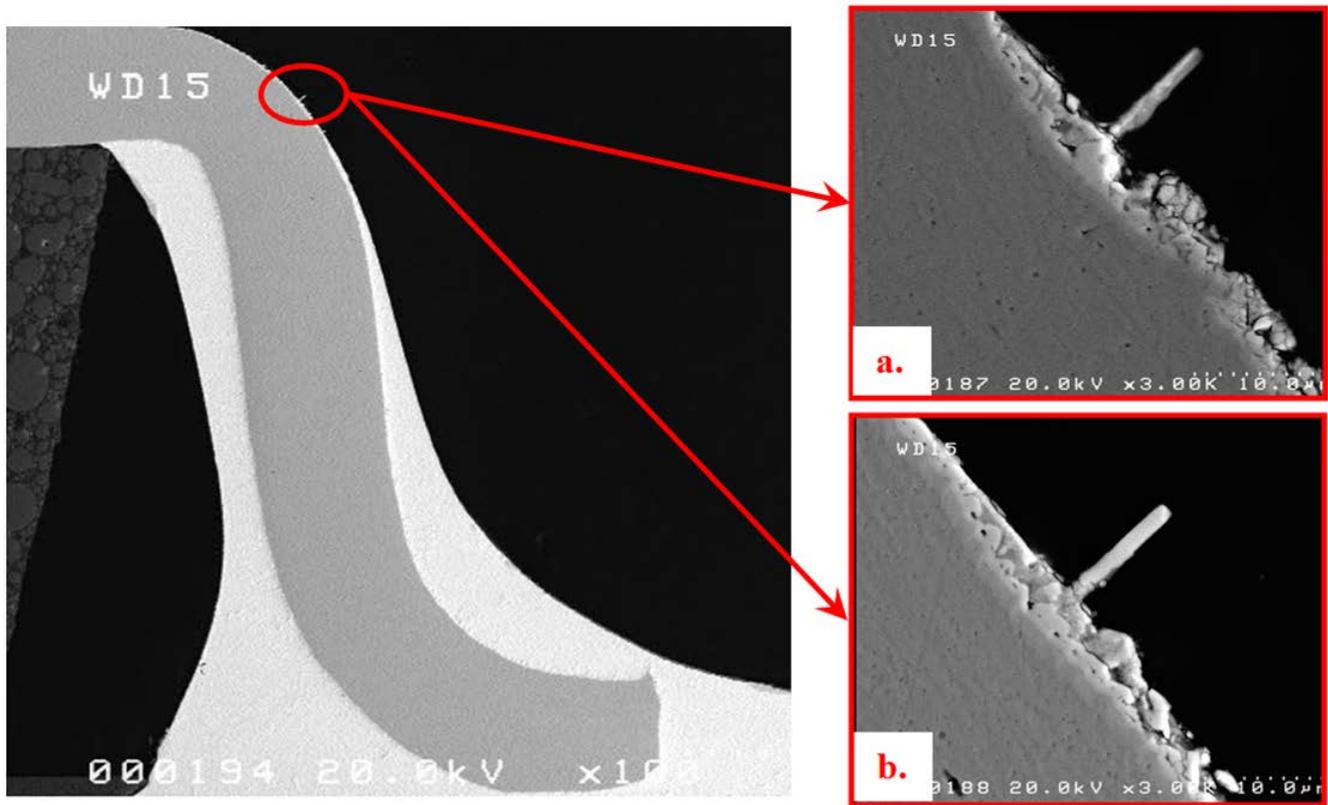
Figure 30: Oxidized whiskers observed on SOT5 after 16,000 hrs at 25°C/85%RH with contamination condition 1-1. Cross sectioning to successive planes, (a.) and (b.) illustrates the degree of oxidation through the whisker

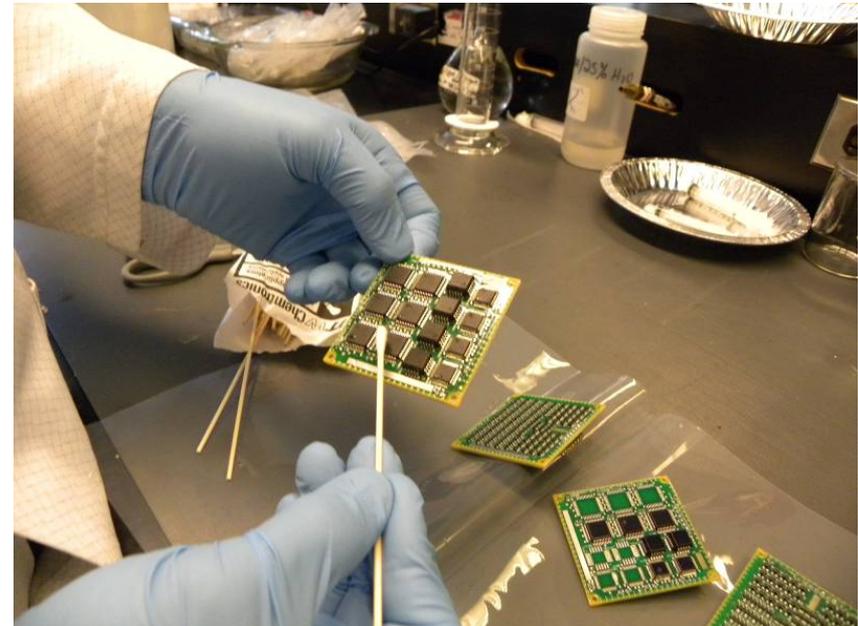
Post Assembly Contamination

- Boards submerged in solution
 - (160ppm chloride salt)
- Agitated for 30 minutes at room temperature
- Solution beading on component bodies removed prior to bake

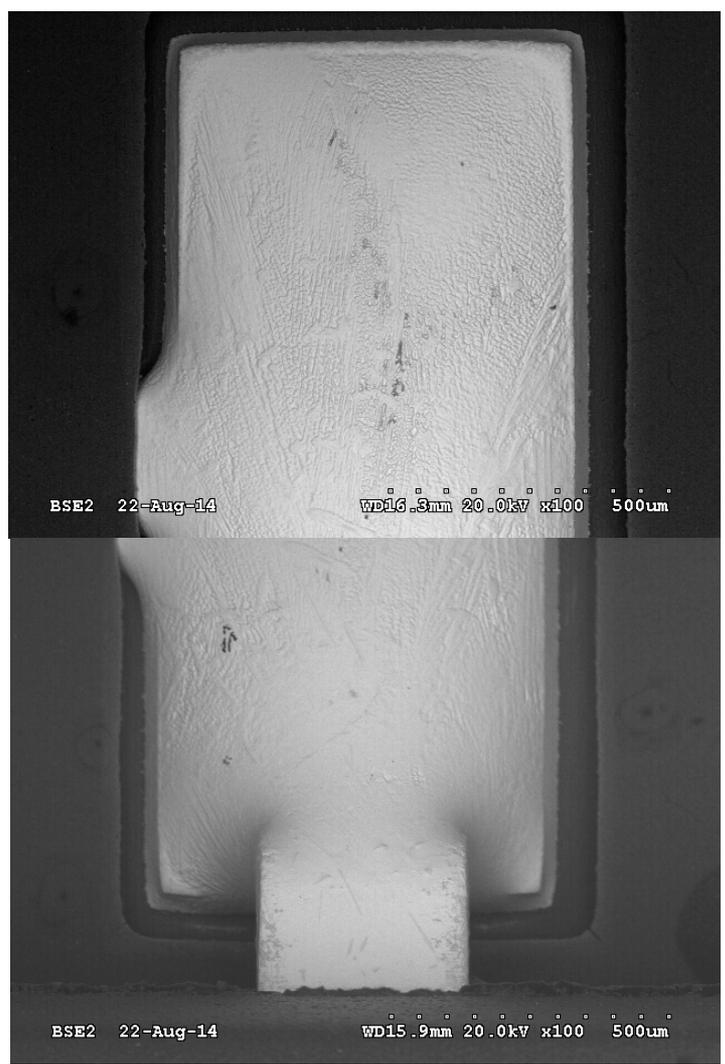
SOT3 1-0

- Small Amount of Oxide
- 1 Short Whisker

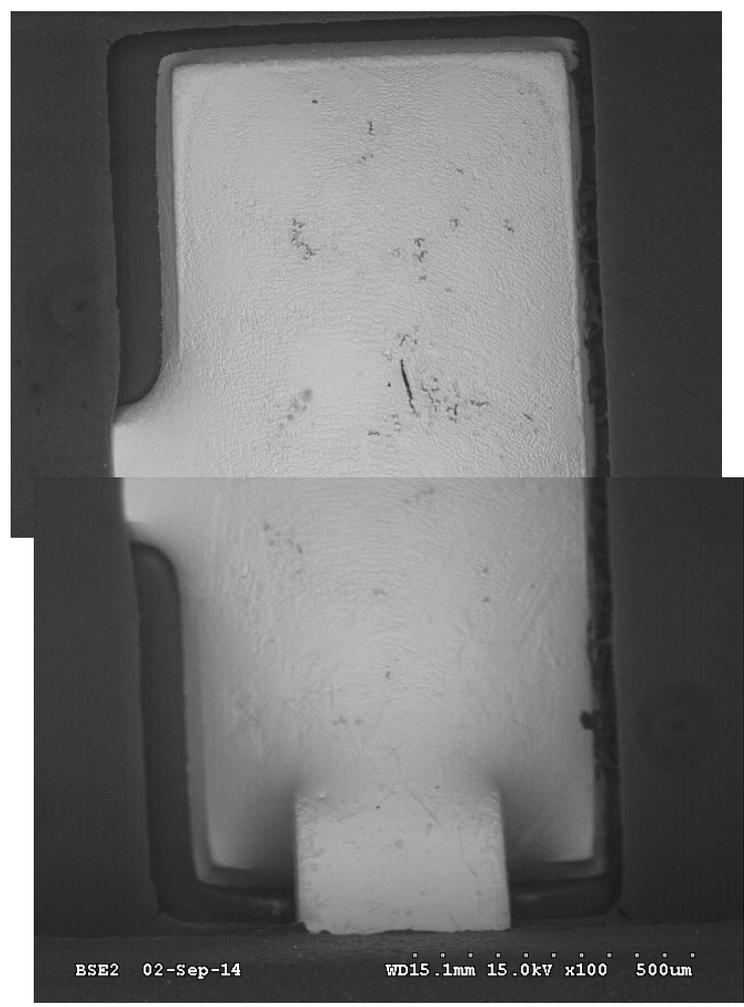
SOT3 0-1

- Significant Oxide Formation
- Many Short Whiskers
- Whiskers formed near site of Oxidation
