Assembly Cleanliness and Whisker Formation

Polina Snugovsky¹, Eva Kosiba¹, Stephan Meschter², Zohreh Bageri¹, Jeffrey Kennedy¹

**Final Inspection after 16,000
hours 25°C, 85%RH**

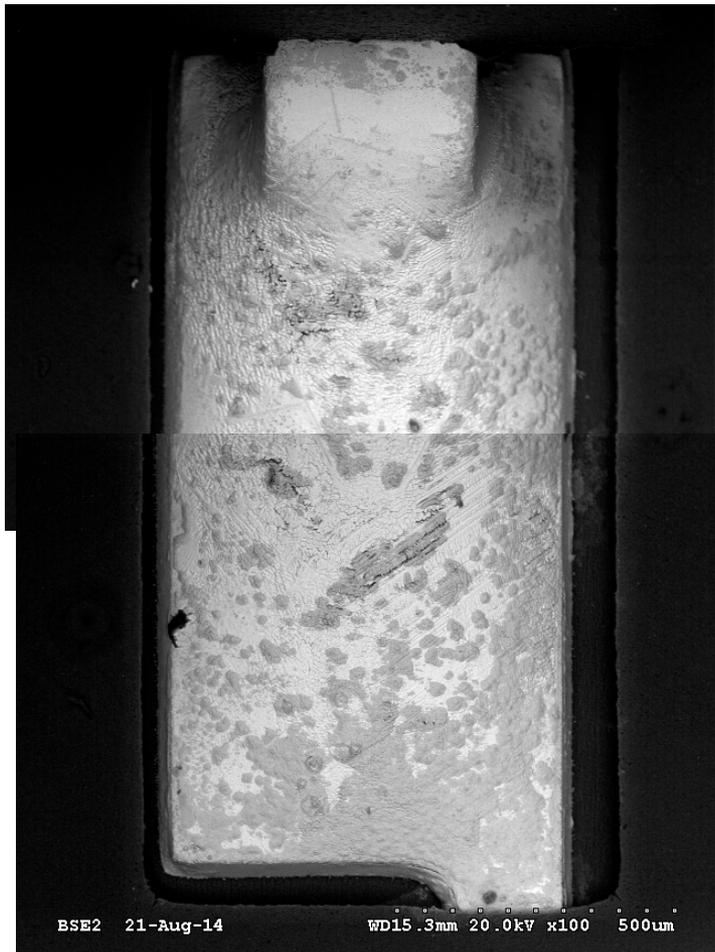
SOT3 1-1

- Significant Oxide Formation
- Short Whiskers
