A High Reliability, Stress-free Copper Deposit for FPC, Polyimide and Rigid-Flex

Jason Carver
Alvin Kucera
OM Group Electronic Chemicals
Maple Plain, MN

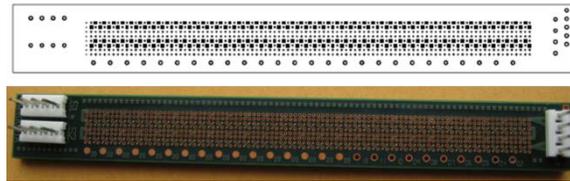
Figure 1. GM40001A

Reliability was also evaluated using an IST testing system. IST coupon design GM40001A with a thickness of 3.18 mm comprised of 14 ½ oz. copper layers was used for evaluation. The coupon was constructed using the same substrate as the ICD coupon and contained 0.25 mm and 0.38 mm PTHs and 0.15 mm micro vias (MV). All coupons were precycled at 260°C six times to simulate the assembly process. The IST equipment was set to cycle between 25°C and 150°C (PTH) or 25°C to 190°C (MV) with 3 minutes of heating and 2 minutes of cooling. Coupons were tested for 1000 cycles or to failure defined as a 10% increase in resistance. Failure mode was evaluated and documented. This coupon is comprised of two circuits, S1 being PTH and S2 being MV, with S1 being evaluated first followed by S2. These IST coupons were electroplated in a commercially available sulfuric acid based copper plating solution to increase the total copper deposit thickness to 28-30 microns. A picture of the IST coupon is shown in figure 1.

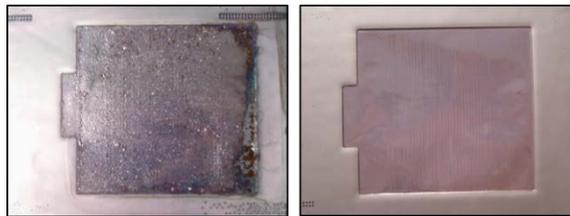
The effect of the additives on the electroless copper deposit was first evaluated using PI substrates that historically have been problematic for electroless copper processing. These materials are all PI substrates found commonly in the manufacturing of flexible PCBs. Comparative studies were visually performed with and without the additives to determine their effectiveness at reducing or eliminating blistering and peeling of the copper deposit. Figure 2 and 3 represent materials that have shown poor coverage on an additive free electroless copper solution. With the addition of the additives a significant improvement is observed.

Figure 2. Sequentially laminated Rigid-Flex PI window cut-outs exposed to electroless copper processing. Electroless copper (left) and electroless copper with stress reducing additives (right)

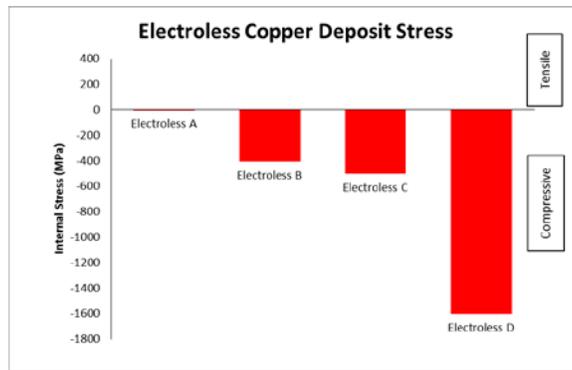
Deposit stress can be measured in a number of ways. A common method in the electroplating industry is through the use of a spiral contractometer. The copper deposits of four electroless copper solutions containing different additives were evaluated using a production spiral contractometer. Figure 4 indicates that internal stress of the deposit is significantly affected by additives. Typical electroless copper solutions utilized in PCB manufacturing are similar to Electroless B and C and D. With the addition of select stress reducing additives, labeled Electroless A, the stress of the deposit is reduced significantly.

Figure 4. Electroless copper deposit stresses measured by spiral contractometer. Additives in the electroless copper solution have a significant influence on the resulting deposit stress.

Electroless copper solutions containing additives from Electroless A in Figure 4 were evaluated further to determine the influence on PCB reliability. Specifically, the resulting copper deposit's reliability was evaluated on interconnects within multilayer PCBs when exposed to thermal stress. The substrate was processed through these solutions and replenished accordingly with chemical components to maintain consistent operating conditions. Operating in this way allows the solution to increase in electroless copper byproducts, such as formate, sulfate, additives, etc., similar to how commercial electroless copper systems are operated. In general, electroless copper solutions are controlled by analysis of the main chemical components as well as the specific gravity of the solution. As electroless copper solutions increase in specific gravity, undesired properties, such as solution instability, deposit defects, and byproduct formation, become more pronounced. Ultimately, these properties can affect the reliability of the copper deposit.

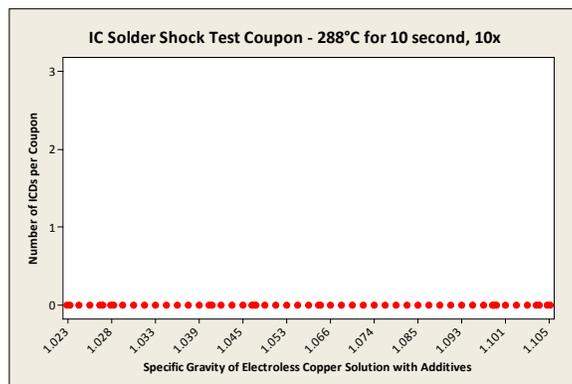
ICD solder shock test coupons were processed through these solutions at various specific gravity levels and evaluated accordingly. In all situations there were no ICDs encountered. Each data point in figure 5 represents 12 interconnects evaluated in 7 PTHs for a total of 84 opportunities per data point. In total, approximately 4500 interconnects were evaluated.

Figure 5. 10x Solder Shock test from a bath specific gravity of 1.02 – 1.10.

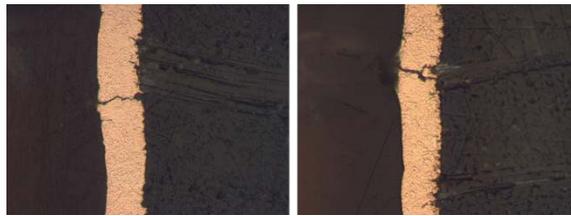
As mentioned previously, all IST coupons that failed to reach 1000 cycles were evaluated by cross section to determine the root cause of failure. In all instances, the failure was attributed to cracking of the copper plating, or barrel cracks, as shown in figure 6. There were no failures attributable to the electroless copper deposit or ICDs.

Figure 6. Examples of IST sense circuit failures identified by cross section evaluation as copper plating cracks.

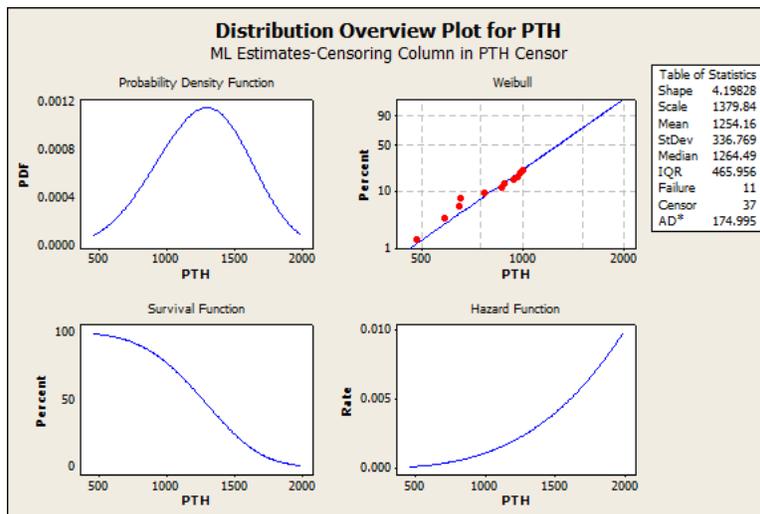
Next, Life Data Regression Analysis was performed with the two predictors, specific gravity and deposit thickness, to determine their effect on IST cycles to failure. The data was fit using a Weibull distribution. In both cases, the two factors were not statistically significant at $\alpha = 0.05$. Since the two factors were not significant, the results were pooled together and fitted to a Weibull distribution shown in figure 7. The results were then compared to historical data of electroless copper without stress reducing additives and similar coupon construction. The comparison is shown in figure 8. Note that the historical IST data was performed at a lower preconditioning temperature of 230°C. It is generally accepted that preconditioning at higher temperatures is a more critical test with regard to IST failure.

Figure 7. Distribution overview plot of all IST coupons based on cycles to failure. The data was right censored at 1000 cycles.

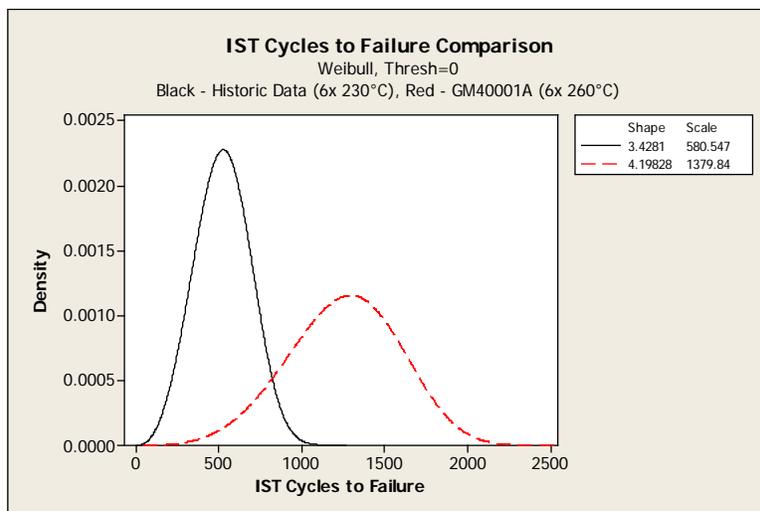
Figure 8. Comparison of IST cycles to failure of the PTH with (red) and without (black) stress reducing additives.

The additives had no negative effects on interconnect reliability of the electroless copper deposit when compared to historical data of an electroless copper solution without stress reducing additives. Next, the S2 circuit, which contained the MVs, was evaluated. After 1000 cycles there were no defects present at any parameters evaluated. A cross section is shown in figure 9. No additional evaluation was necessary. Due to the IST coupon design and test parameters used in this study, the S2 circuit

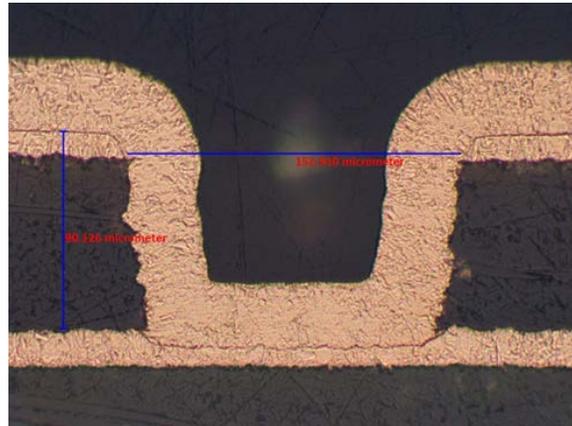
has already experience up to 1000 cycles during testing of the S1 circuit. Therefore, the S2 circuits have experienced up to 2000 cycles of heating and cooling.

Figure 9. Cross section of an IST coupon MV after 1000 cycles.

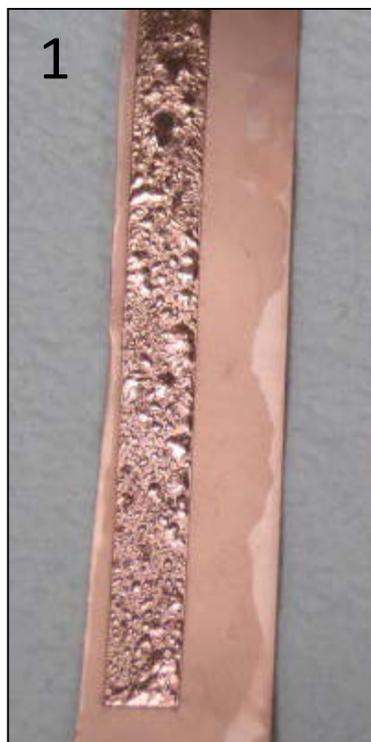
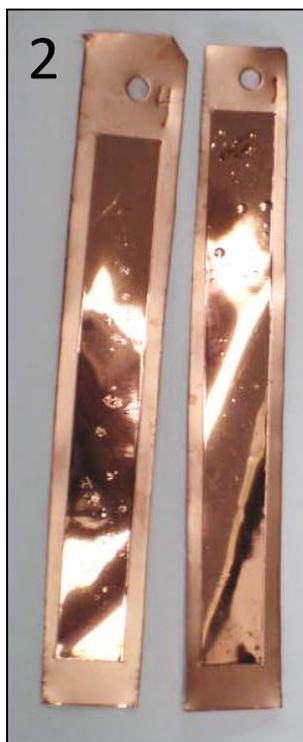
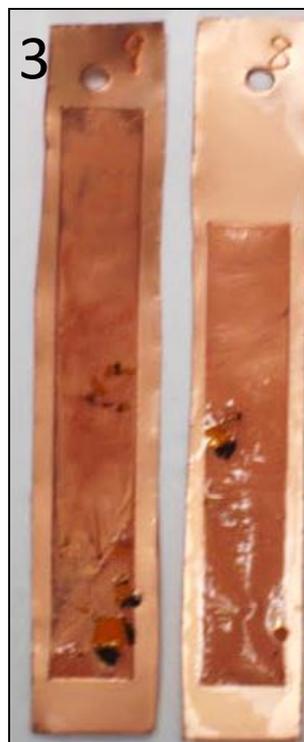
Processing Polyimide Substrates

imide functional group

Base hydrolysis of an amide:

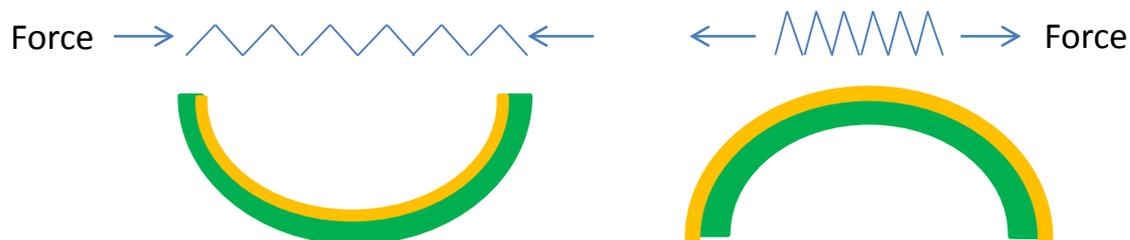
Tensile (left) and Compressive (right) stress. The copper deposit can be thought of as a spring that is either under tension (stretched) which is tensile stress or compressed (pushed together) which is compressive stress.

- › Compressive stress causes blistering of the copper deposit on smooth surfaces that lack anchoring sites such as a roughened surface. EC typically has compressive stress.

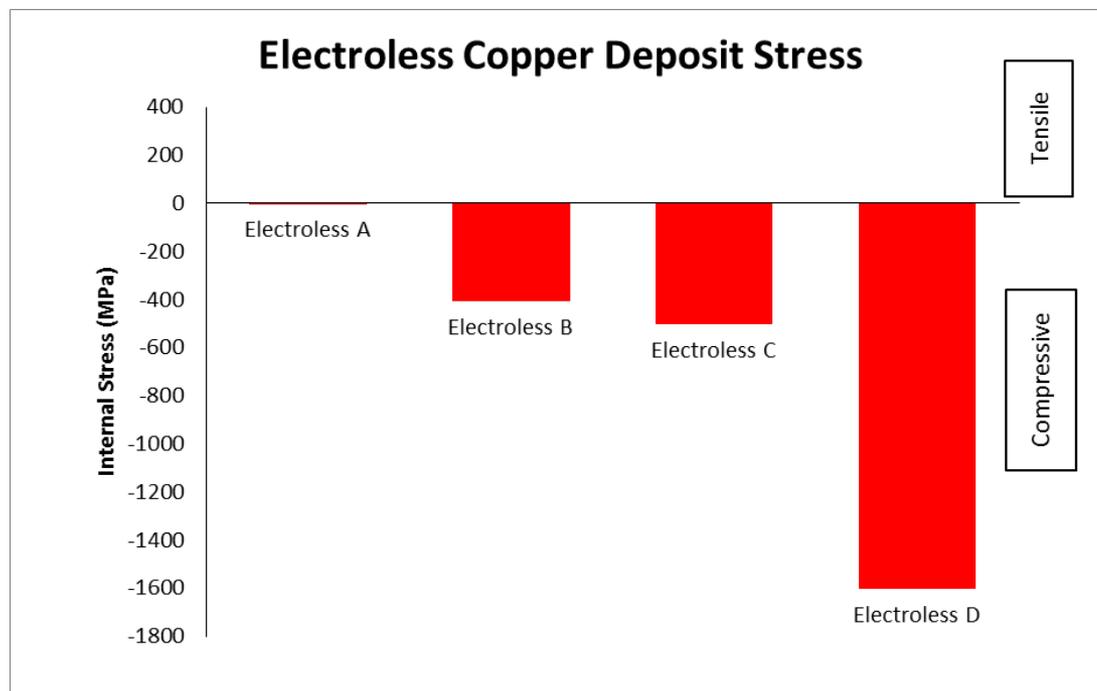
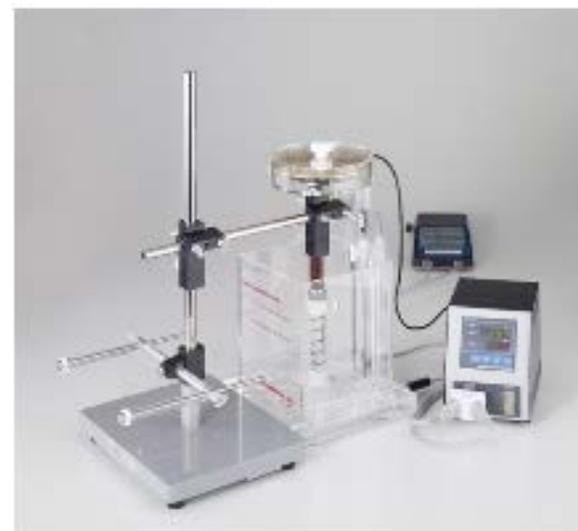
Deposit Stress Meter

- Electroless A has low stress due to select additives.
- Electroless B, C, D are typical EC formulations used in PCB production.
- EC formulation and additives are critical to reducing deposit stress.

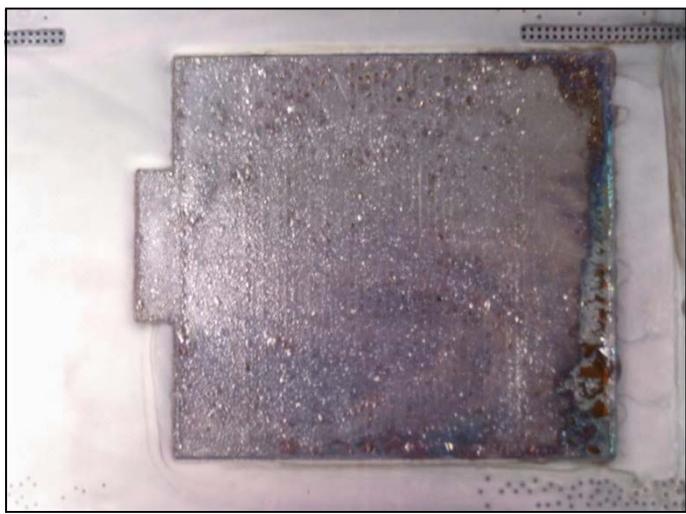
EC without additives

- Electroless A has a blister-free deposit on polyimide rigid-flex and flex circuits.

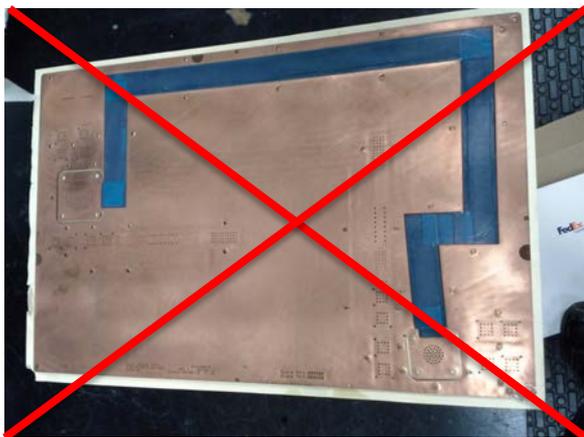
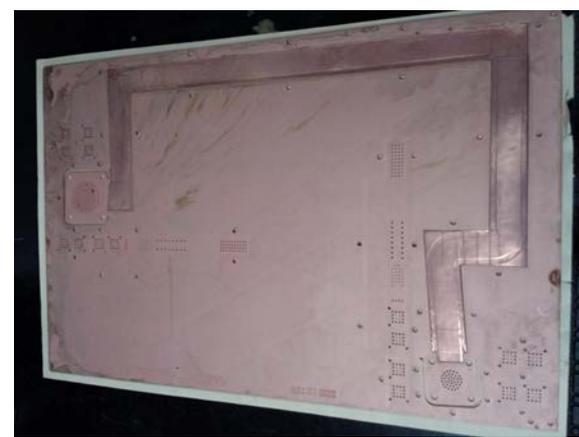
Rigid-flex and window cut-outs

- › PI windows can be processed without taping
- › Blister-free deposit on rigid flex window and hole wall

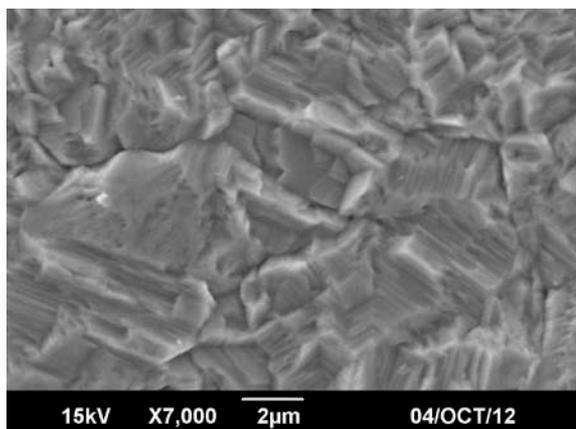
Rating = 5

- Visual inspection of the EC deposit on the copper interconnect can help identify potential problems with interconnect reliability. Rating 1-5, 5=best

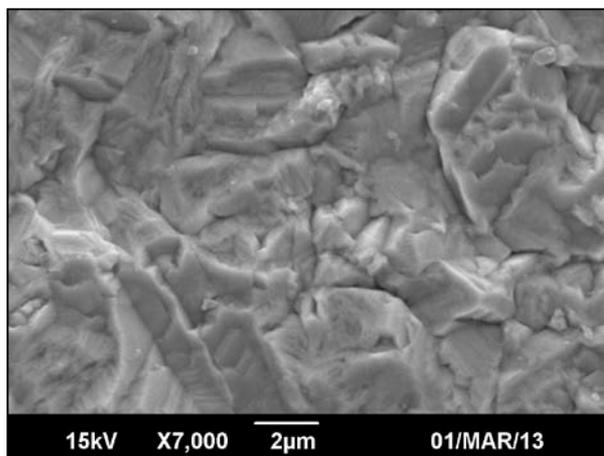
SG = 1.04

- Large, angular deposit across a wide range of solution specific gravity with additives present.

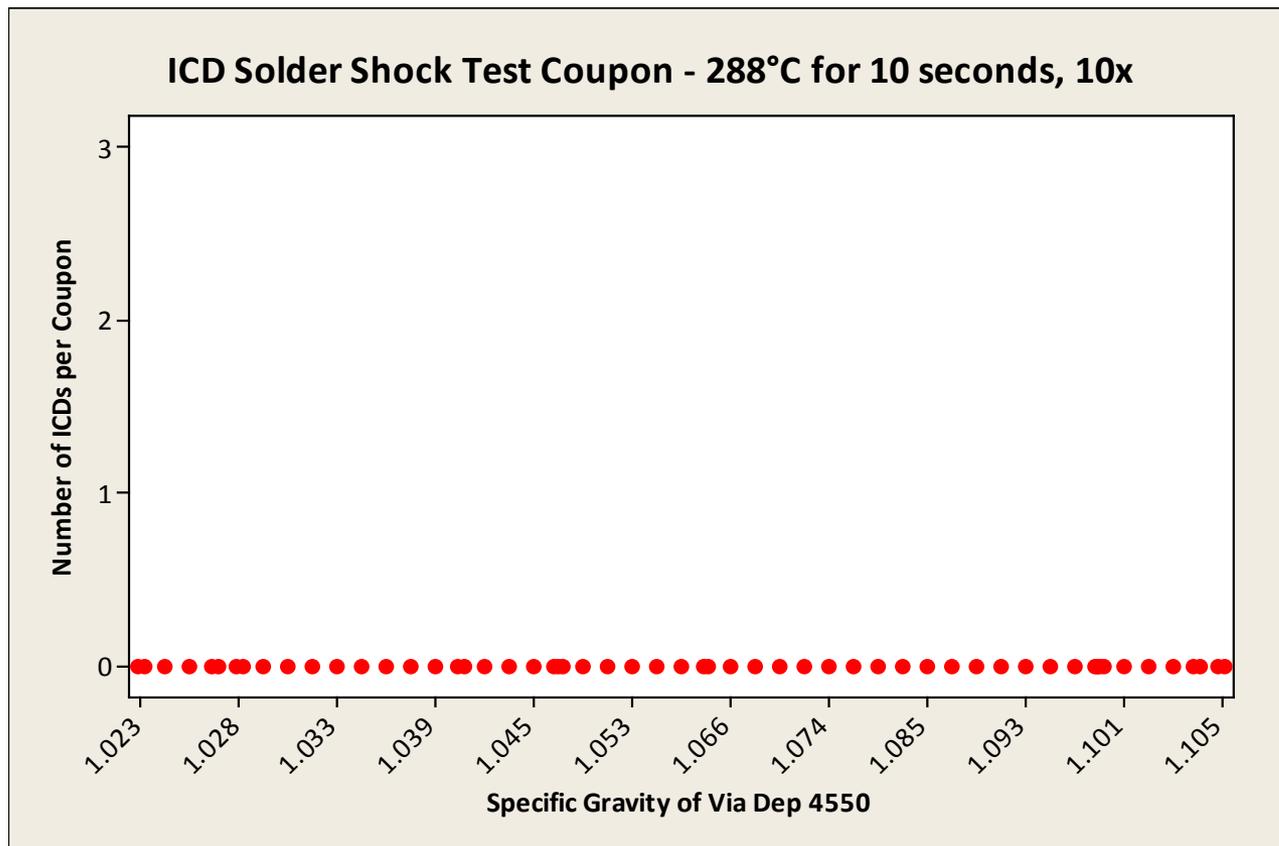
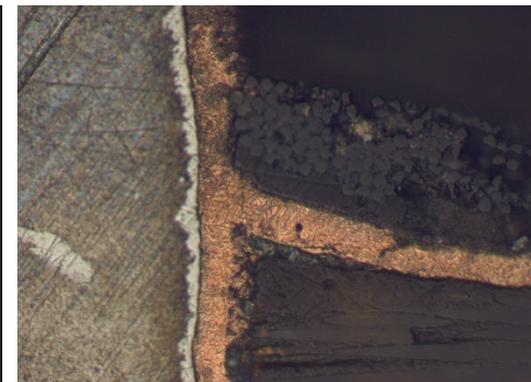
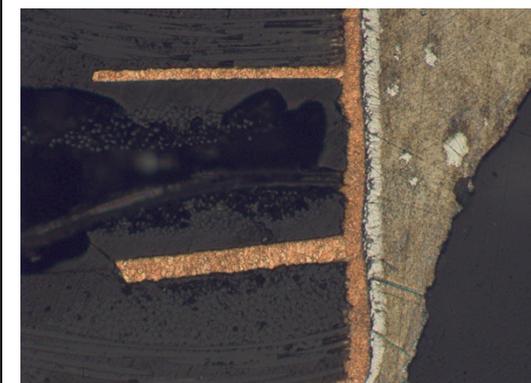
Solder Shock Results

- No failures were encountered on the interface of the interconnect and plated copper through hole.

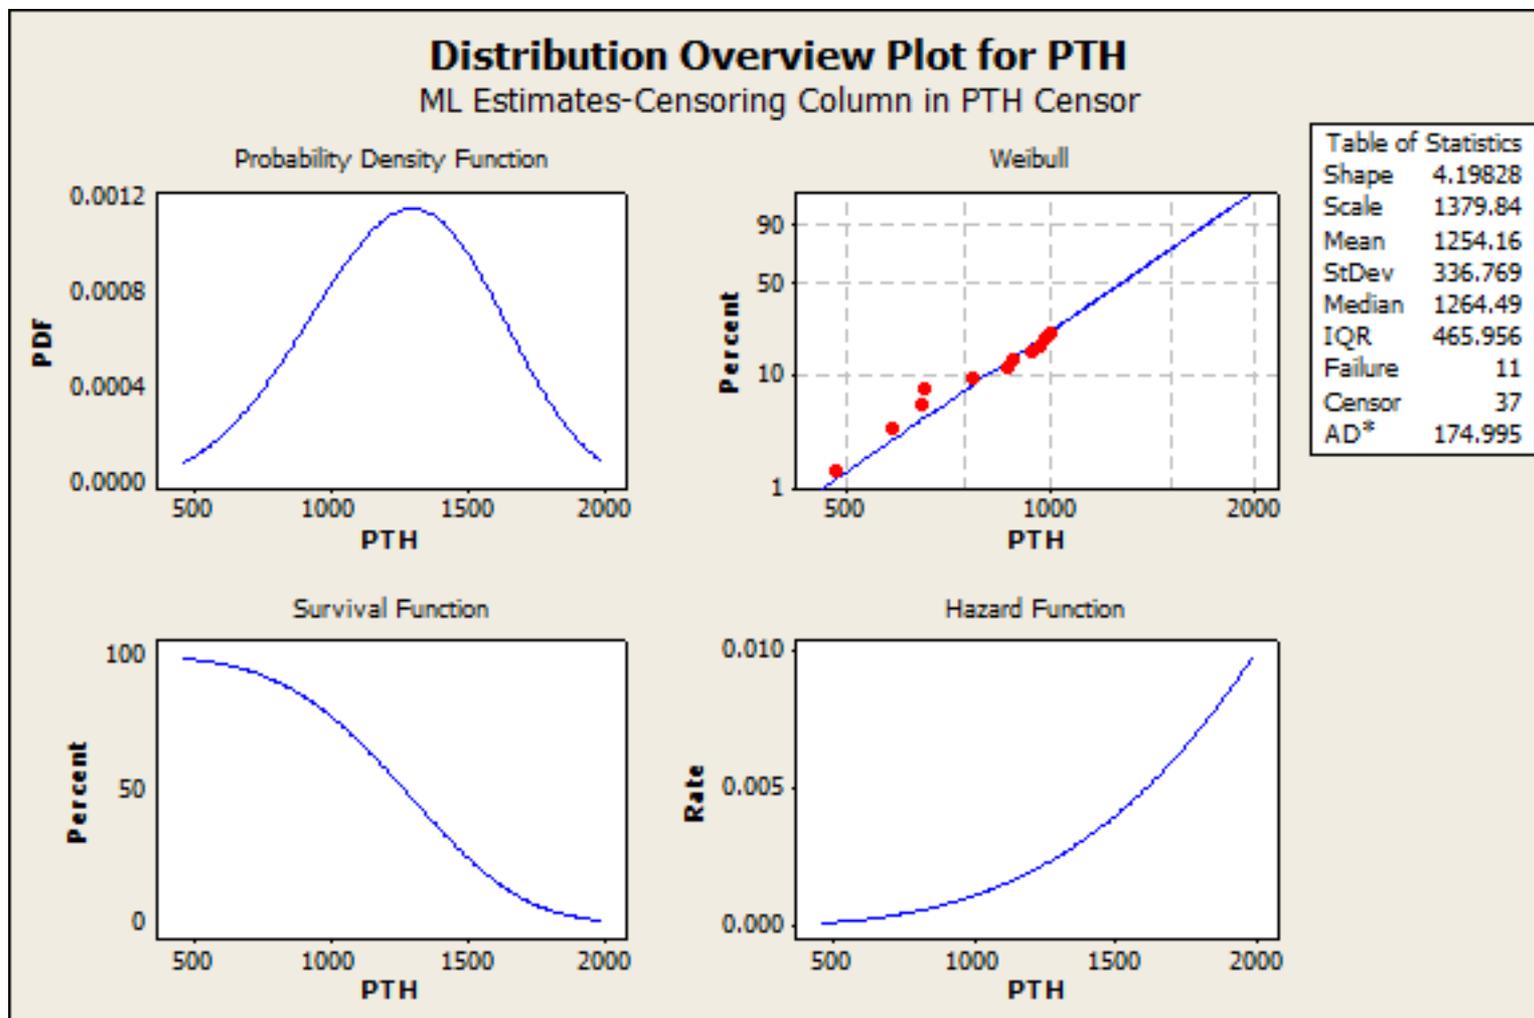
- PTH cycle results were pooled and fitted to a Weibull distribution.

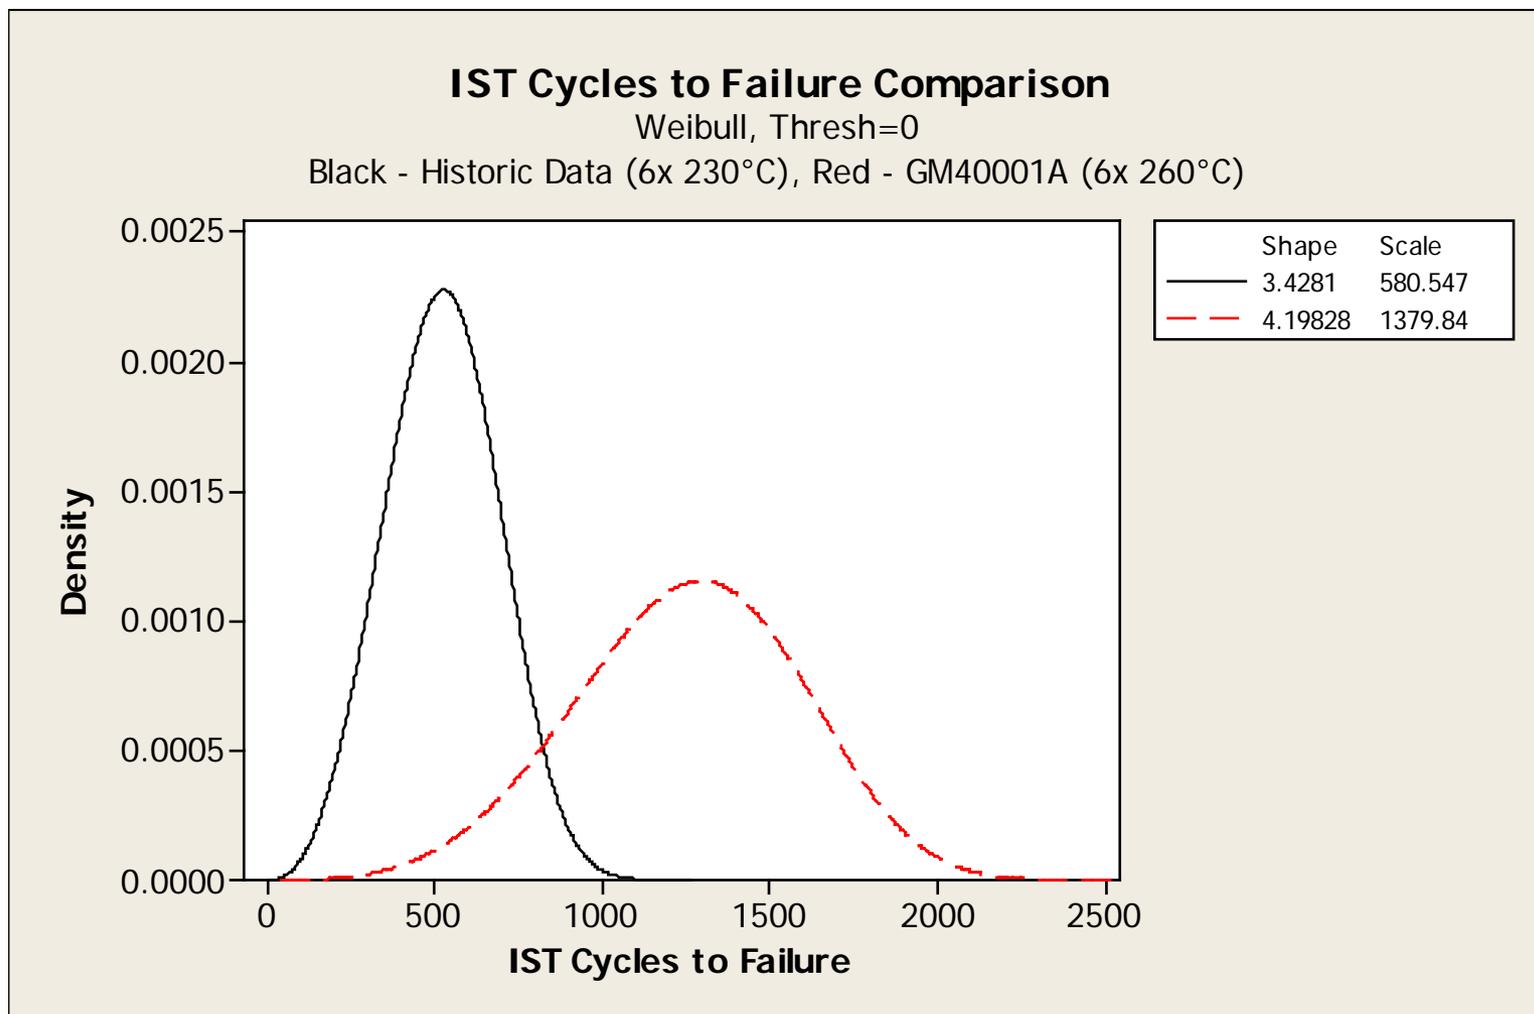
- Results were compared to historical data of similar IST coupon construct.

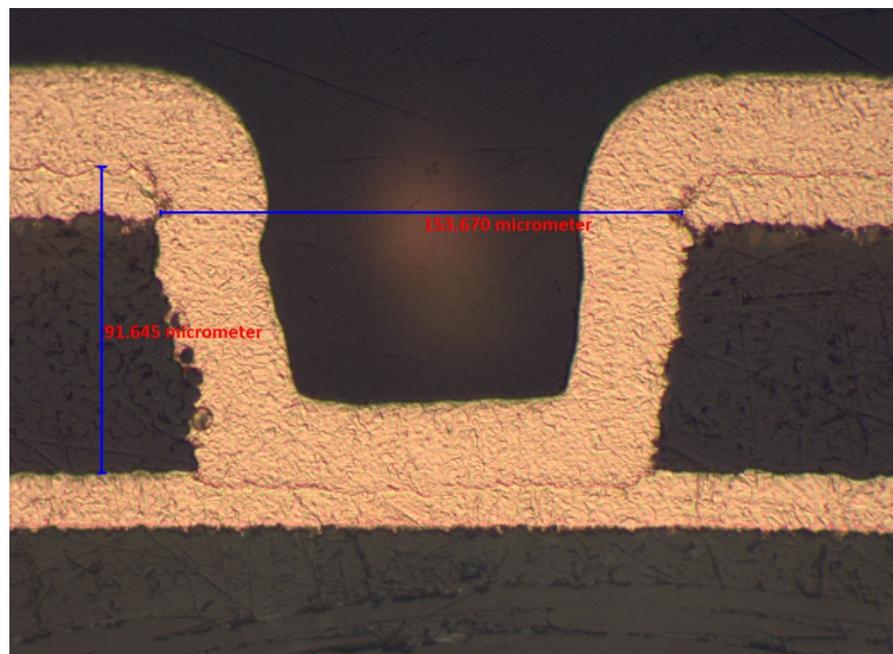
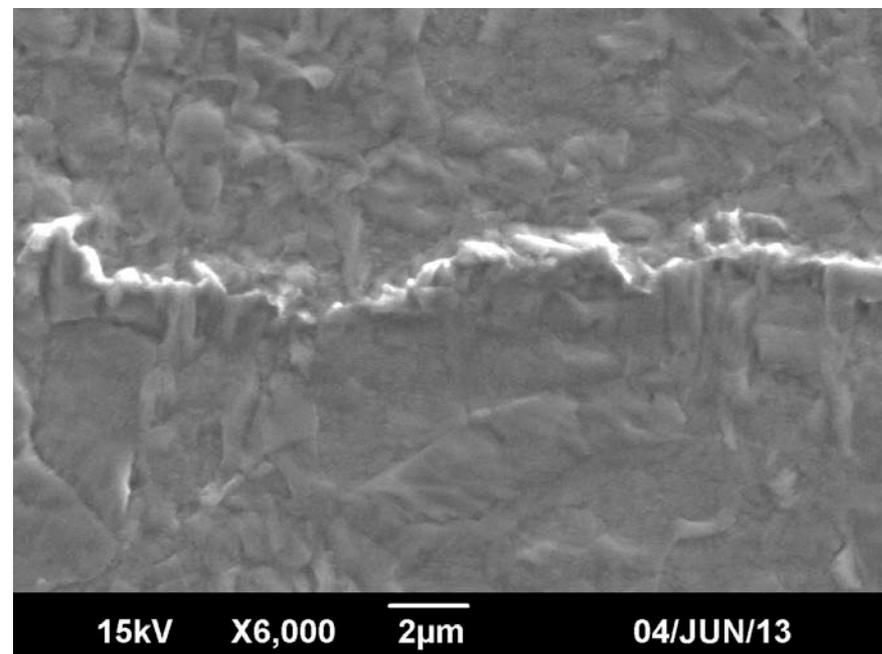
IST Micro Vias (S2)

- No failures on any of the IST coupons after 1000 cycles.
- Cross section evaluation showed no plating cracks or separation at copper clad/electroless copper/plated copper interface of the capture pad.
