Testing Printed Circuit Boards for Creep Corrosion in Flowers of Sulfur Chamber: Phase 2A

Haley Fu iNEMI, Shanghai, China

Prabjit Singh
IBM Corporation, Poughkeepsie, NY, USA

Qualification Test for Creep Corrosion in Flowers of Sulfur Chamber – Phase 2

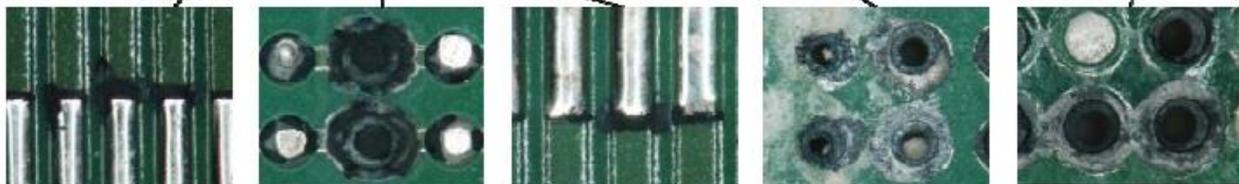
- Edge corrosion readily developed on Pb-free HASL boards
- Heavy creep corrosion occurred on ImAg boards soldered with organic acid flux.
- High resistance short in some heavy creep corrosion areas

Finish-flux	L1	L2	L3	L4	L5	L6	L7	L8	L9	L10	L11	L12	L13
ImAg-OA			6.09%				2.24%						25.7%
ImAg-roain							81.09%		11.09%				
HASL-OA	8.94%			25.12%	74.08%

Figure 5: First test run 20 day results from company C.

Based on field experience and prior mixed flowing gas (MFG) testing, an ideal test should cause more creep corrosion on test PCBs with ImAg finish than on test PCBs with Pb-free HASL finish; and it should cause more creep corrosion on test PCBs soldered with organic acid flux than those soldered with rosin flux. The Company C test results are summarized in **Table 1**. Only the PCBs with ImAg finish soldered with organic acid flux suffered creep corrosion. The PCBs with ImAg finish soldered with rosin flux and the PCBs with HASL finish suffered with organic acid flux and rosin flux suffered no creep corrosion. The table also shows that the creep corrosion occurred early in the test and did not progress much after 5 days. This observation held true for all subsequent tests. The 20 day test results, both optical and electrical, obtained by Company C are shown in **Figure 5**.

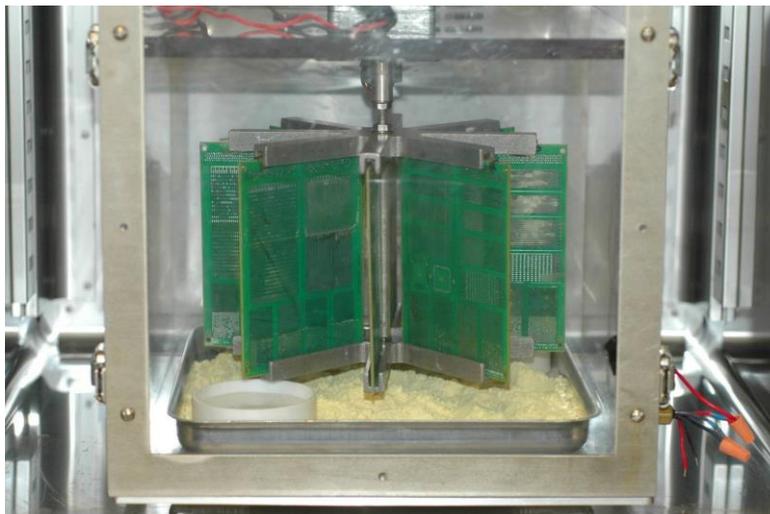
Figure 6: Setup with increased area of sulfur bed used in the 2nd run.

In the second FOS test runs, the area of the sulfur bed was increased to decrease the PCB loading effect. In some of the company setups, the sulfur bed practically covered the whole base of the FOS chamber, as shown in **Figure 6**. In others, the diameters of the petri dishes holding the sulfur were increased. Tests were done under the following 4 conditions:

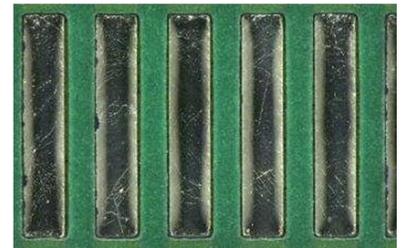
Figure 8: Company D 2nd test results.

The Company D 2nd test results are shown on **Figure 8**, which shows creep corrosion on PCBs with ImAg finish soldered with organic acid and rosin flux and no creep corrosion on PCBs with HASL finish soldered with organic acid flux. Company B was the only one that reported creep corrosion on Pb-free HASL PCBs which is not expected based on field and MFG test experience; these failing PCBs were soldered using organic acid flux.

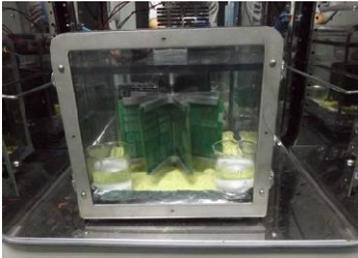
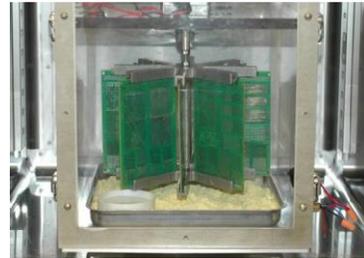
Å/day Silver	Å/day Copper
1060	1032

Å/day Silver	Å/day Copper
-184	84

Figure 9: Copper and silver corrosion rates in the third test run.

The copper and silver corrosion rates in the third test run are listed in **Figure 9**. The reason for the negative corrosion rate for silver in the Company C FOS chamber may be due to the flaking off of the corrosion product before the post-exposure mass can be measured.

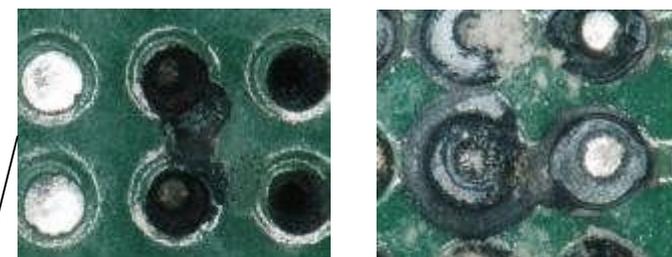
1st run in Company C: 20 day test results

- Edge corrosion readily developed on Pb-free HASL boards
- Heavy creep corrosion occurred on ImAg boards soldered with organic acid flux.
- High resistance short in some heavy creep corrosion areas

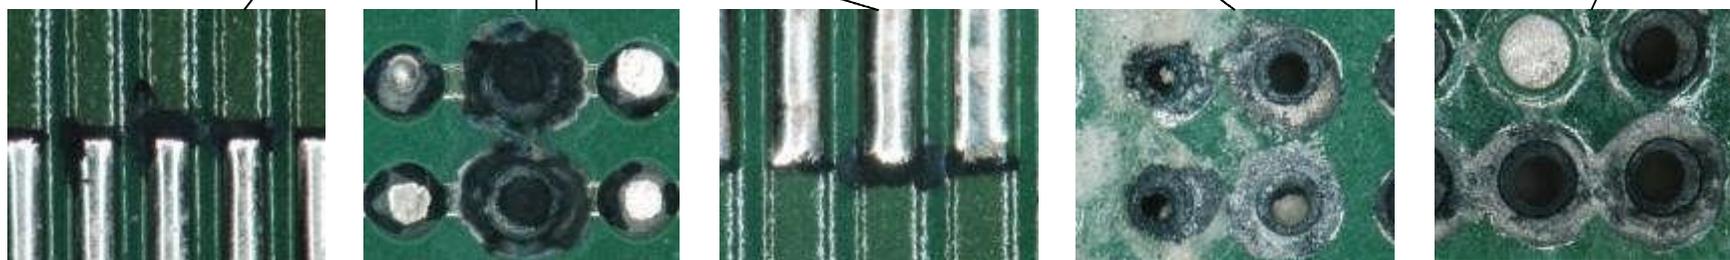
Finish-flux	L1	L2	L3	L4	L5	L6	L7	L8	L9	L10	L11	L12	L13
ImAg-OA							5.03k	2.29k					35.75k
ImAg-rosin								81.98k	11.05k				
HASL-OA	3.94k			35.12k	74.09M

- **I-O: ImAg, organic acid flux**
- **I-R: ImAg, rosin flux**
- **H-O: Pb-free HASL, organic acid flux**

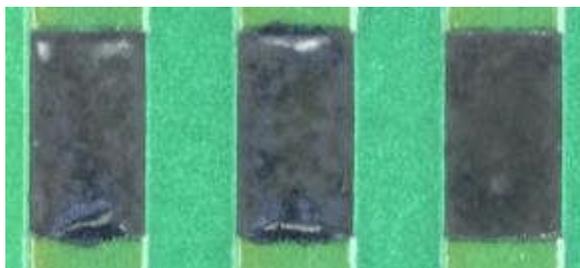
L2

I-O Card

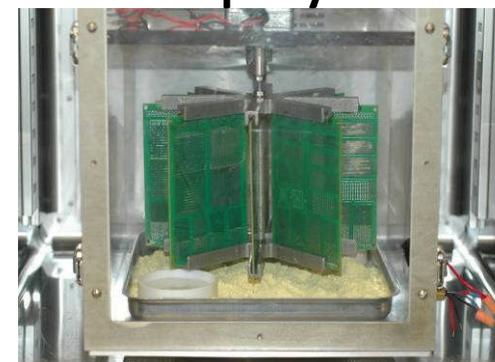
Company D

Å/day Silver	Å/day Copper
866	1472
