Review of Interconnect Stress Testing Protocols and Their Effectiveness in Screening Microvias

Edward Arthur¹, Charles Busa², Wade Goldman P.E.², Alisa Grubbs²

Abstract

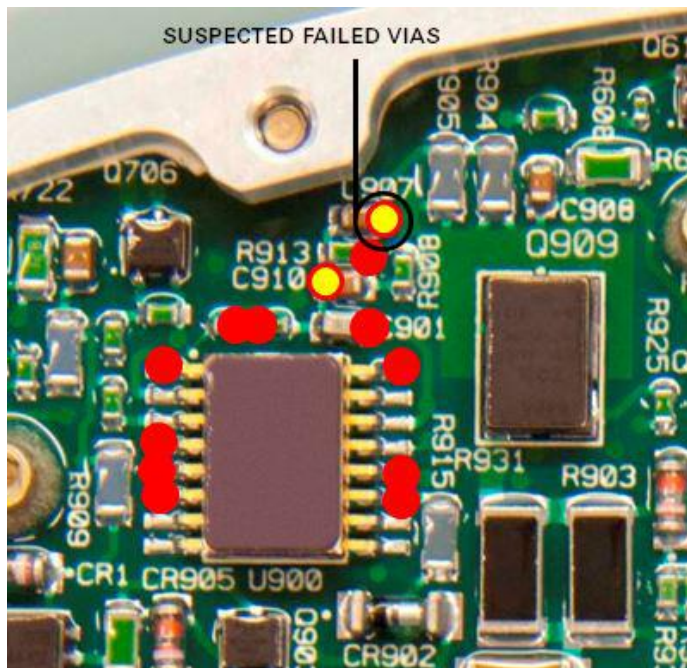
Top Side of Interest

Microvias of interest
